## 2.3 Channel geomorphology in the Study Area

### **2.3.4 Bank stability**

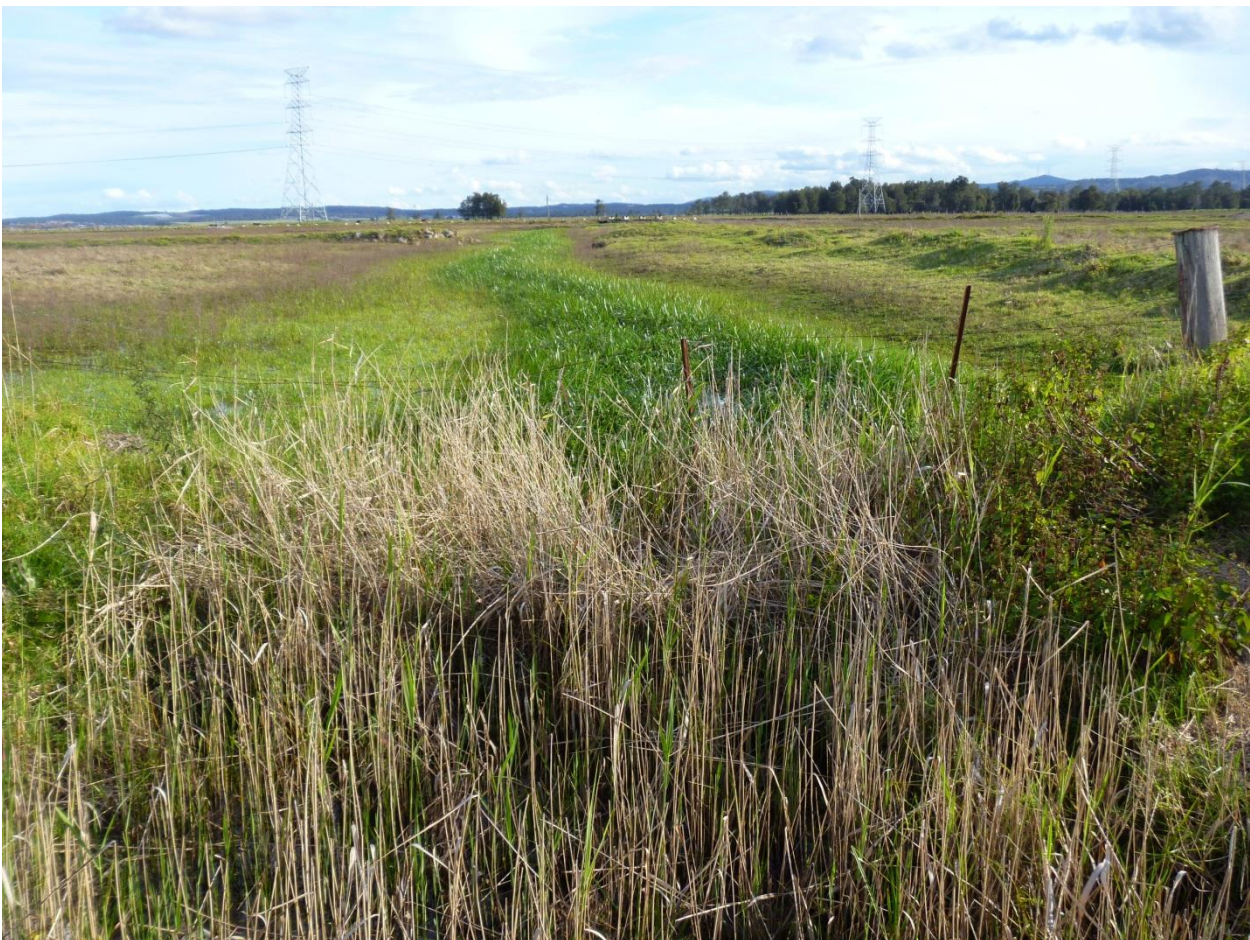
Table 2-1 shows the integrated bank erosion hazard scores for these reaches within the Study Area. In general, the erosion scores for individual sub-points were either 'very low' or 'low' (Figure 2-8) but isolated sub-points had high bank instability risk which pushed the reach-length risks to 'moderate' or 'high'.

**Figure 2-8** Stable vegetated channel with 'very low' bank erosion risk (Purgatory Creek)

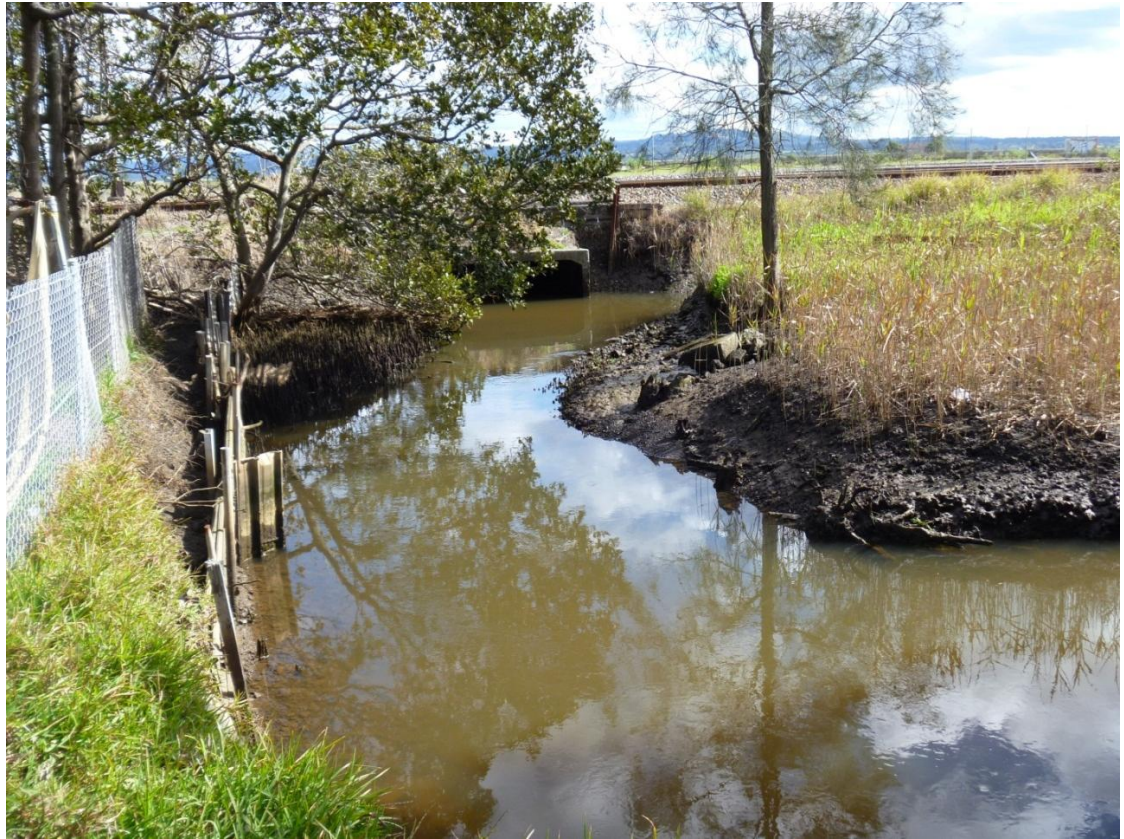
However, some localised sheet and rill erosion was observed along the margins of the Swamp where urbanisation has resulted in increased and concentrated runoff, leading to elevated risk at sub-points within the watercourse reach. For example, the drainage ditch banks next to Maitland Road exhibited rotational slump failures (i.e. material moving downward and outward along a curved slip surface) on the downstream side of the culvert which diverts water under the railway line (Figure 2-9).

**Figure 2-9** Maitland Road Creek bank erosion and retaining wall

This type of failure is common in cohesive material banks such as the ones in the Study Area with slopes less than sixty degrees (Watson and Basher, 2006). They are commonly caused by scour at the base of the bank and in this case are a result of re-directed flow through the culvert at an artificial angle to the bank, lack of new sediment material from the upstream reach due to deposition above the culvert and tidal inundation which has resulted in minor scour associated with increased ebb velocities. In the Maitland Road stretch an attempt has been made to reduce this bank erosion by deployment of a basic retaining wall structure in the bank. However, these walls were also being undermined at their upstream face and under the intersection between the wall and the channel bed.
