# Biodiversity Management Plan

Billabong Creek Environmental Water Regulators (Parts 2A & 2C)

May 2026

Project Number: 251144

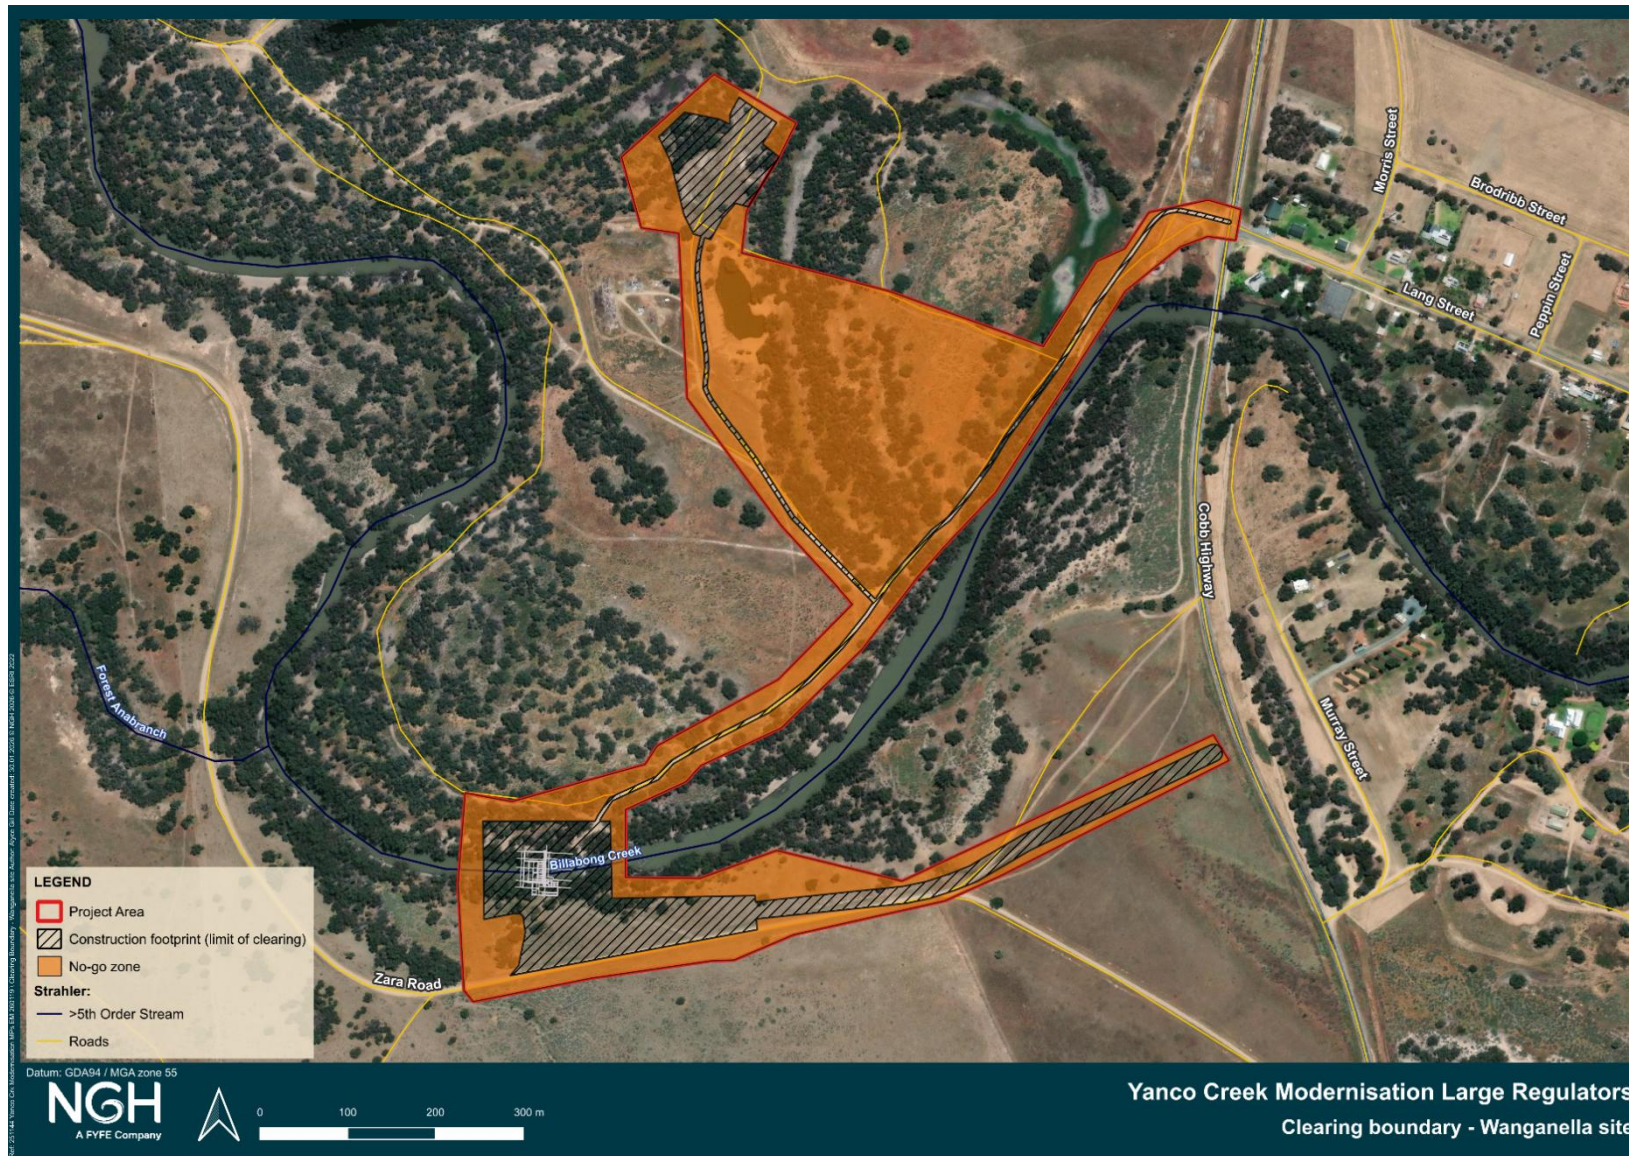
Figure 5-1 Clearing boundaries and no-go zones – Wanganella

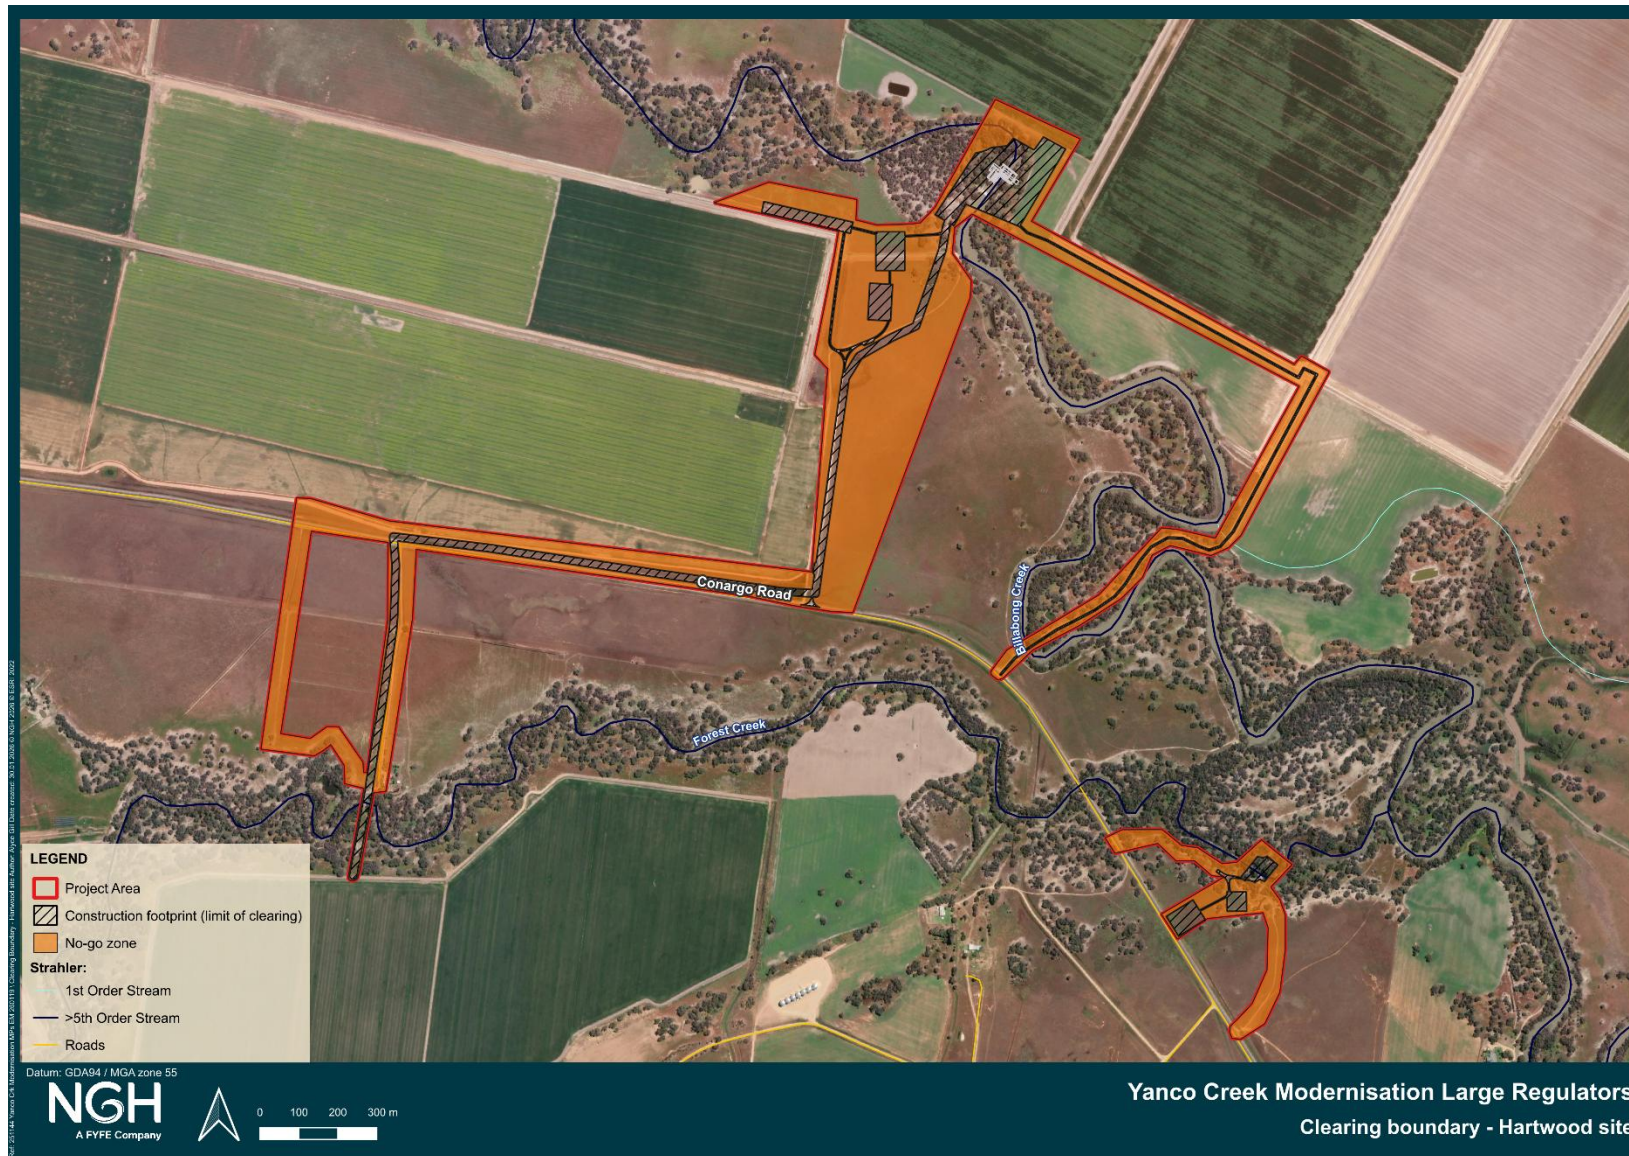
Figure 5-2 Clearing boundaries and no-go zones – Hartwood

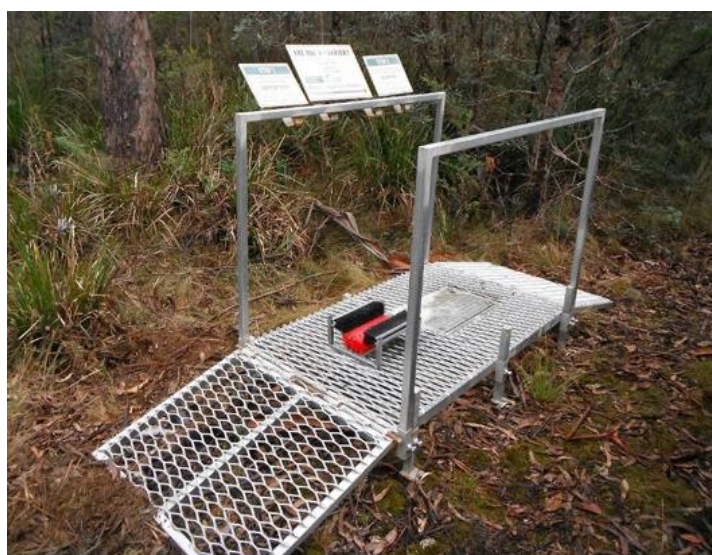
Figure F1 Boot-cleaning station (Source: DPIE, 2020)

If pathogens are detected onsite, boot-cleaning stations will be installed at the site entrance/exit and office to help reduce their potential spread. The boot-cleaning station may be a simple system with fixed brushes that construction personnel can use to scrub their shoes (see Figure F1).

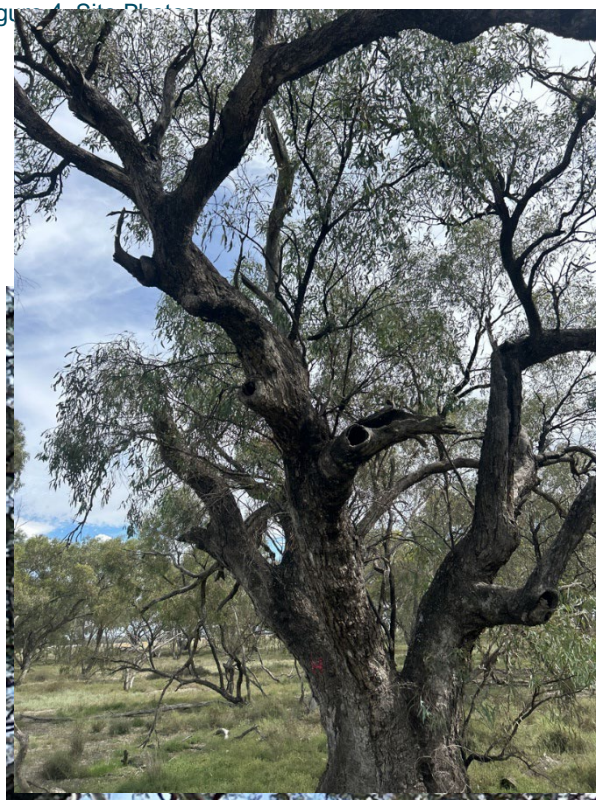
Figure 6. Hollow-bearing tree

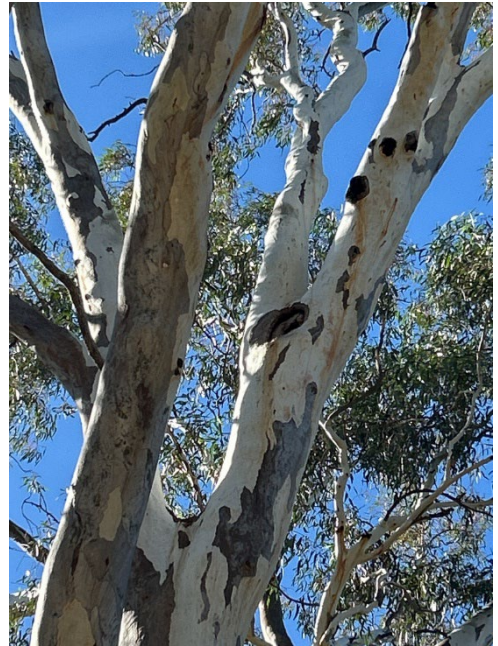
Figure 6. Hollow-bearing tree
