# Billabong Creek Environmental Water Regulators (SSI-50831979) - Removal of Scarred Trees and Salvage of Hearth | Environmental Management Plan

NSW DCCEEW – Water Group

May 2026

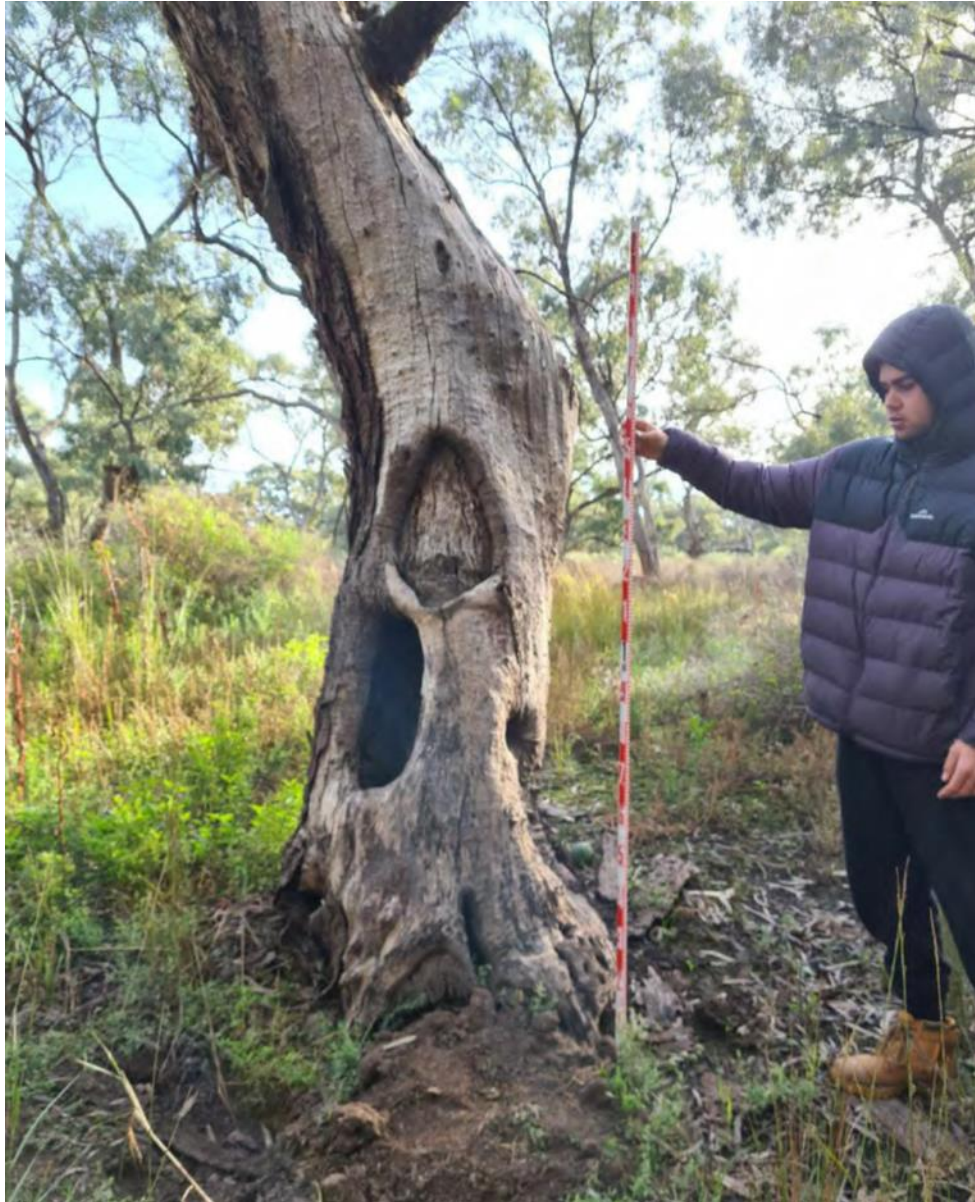
Figure 8 Photo of Wanganella Scarred Tree

- Is within a moderate condition patch of PCT 7 - *River Red Gum - Warrego Grass - herbaceous riparian tall open forest wetland mainly in the Riverina Bioregion*
- Does not have mid-storey vegetation in the area around the tree
- Has no habitat features (eg. Fallen branches, rocks etc – as this area is used for informal camping)
- Is not a threatened species or part of a threatened ecological community
- Is dying and is in very poor condition
- Has hollows

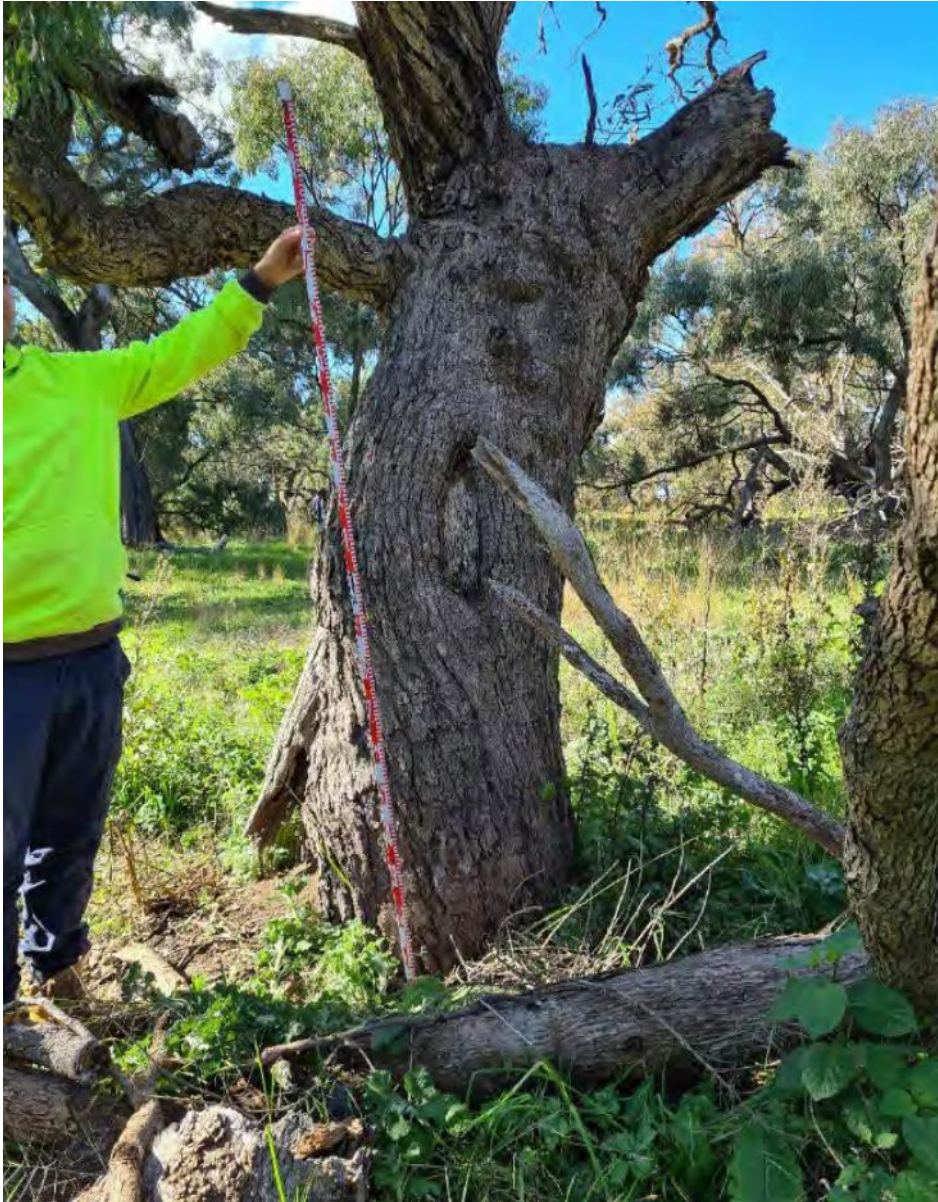
Figure 9 Photo of Hartwood Scarred Tree

- Is within a moderate condition patch of PCT 13 - Black Box - Lignum woodland wetland
- Does not have mid-storey vegetation in the area around the tree
- There are habitat features such as fallen branches around the tree
- Is not a threatened species or part of a threatened ecological community
- Is healthy and is in good condition
- Has hollows

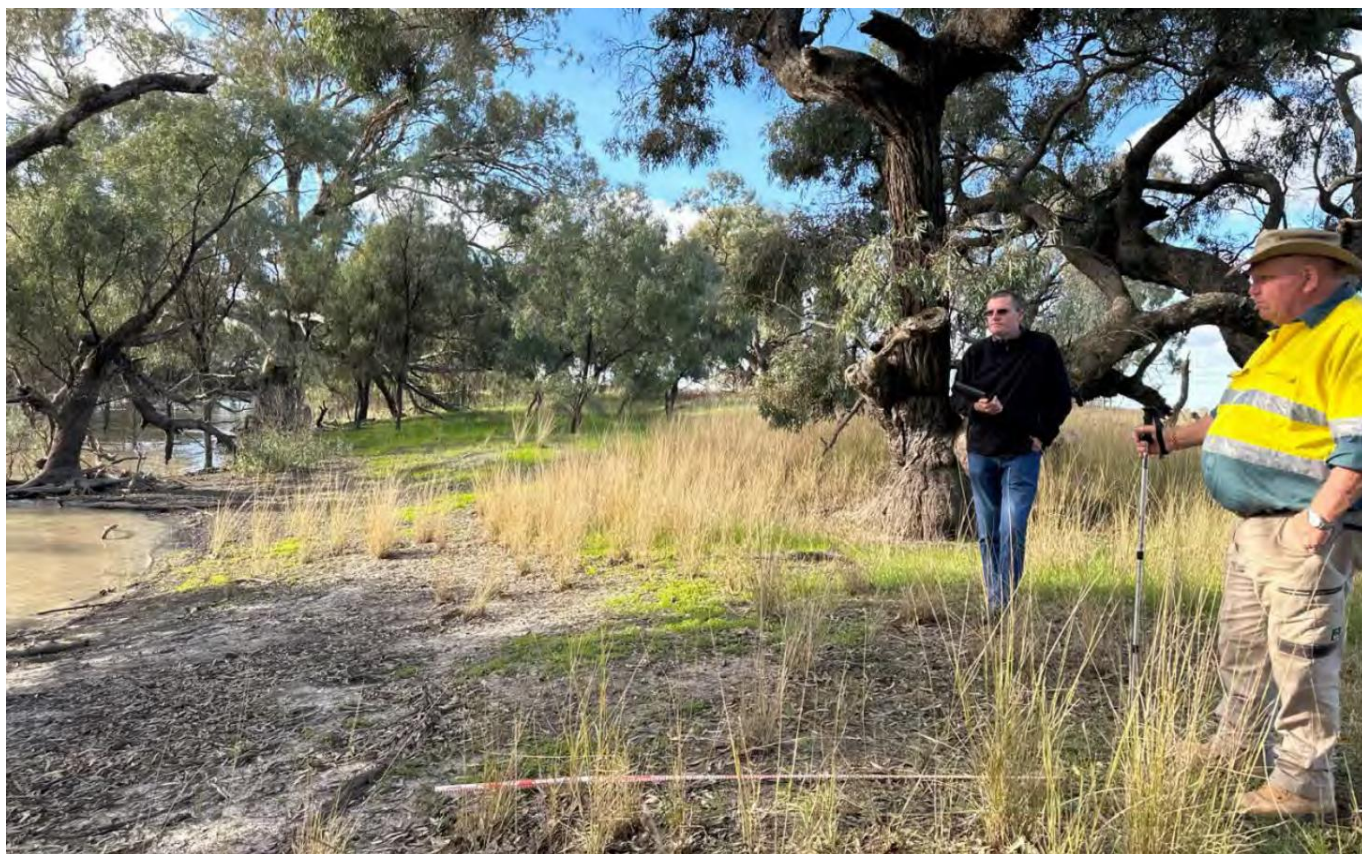
Figure 10 Photo of Hearth site

Hartwood Hearth is (See Figure 10):

- Within a moderate condition patch of PCT 13 - Black Box - Lignum woodland wetland
- Trees and mid-storey vegetation is absent in the immediate area around the hearth and the area consists of bare earth and sparse grass
- There are no habitat features such as fallen branches around the hearth site

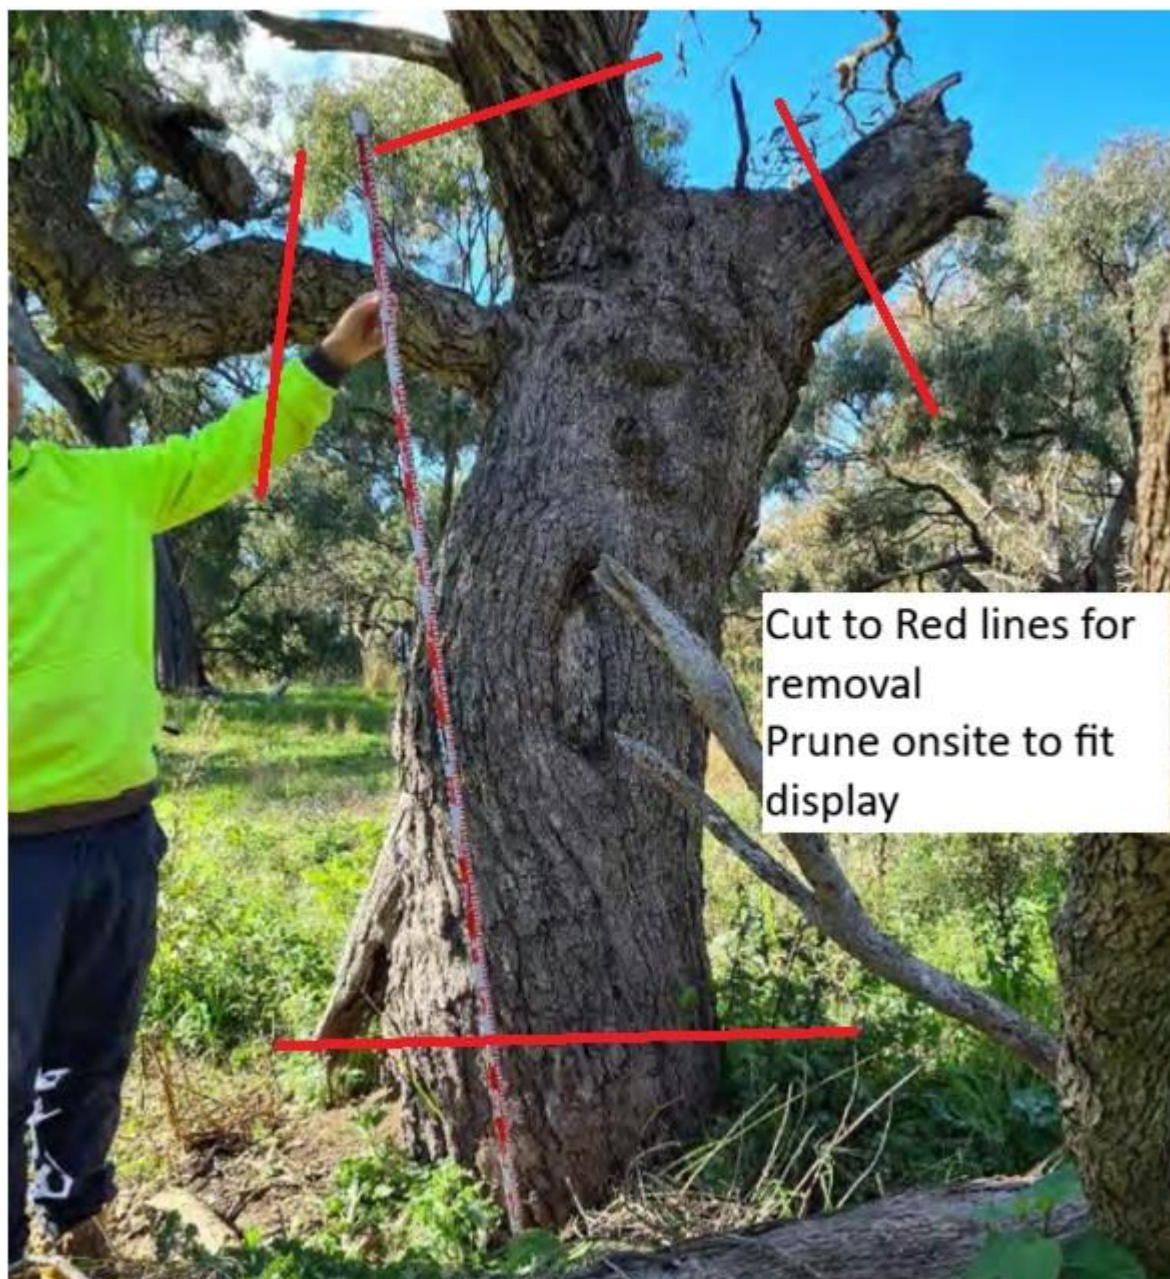
Figure 11 Hartwood Weir Scarred Tree 4 Trunk and Branch Cut Locations

- by a qualified arborist,
- in the presence of a qualified archaeologist and representatives of the RAPs
- in a manner to avoid damage to all culturally modified surfaces
- to include any cultural practices recommended by the RAPs

The stump of the trees and any remaining sections of the trees would remain in-situ and be cleared/managed/reused by the construction contractor in compliance with the relevant management plans. Rehabilitation of the sites would occur as part the site-wide Rehabilitation Plan. The Rehabilitation Plan is currently being developed and further information will be provided within the Biodiversity Management Plan, a sub-plan of the Construction Environmental Management Plan.
