## 5.0 Aboriginal Heritage Field Survey Results

### 5.1 Physical Description of the Construction Sites

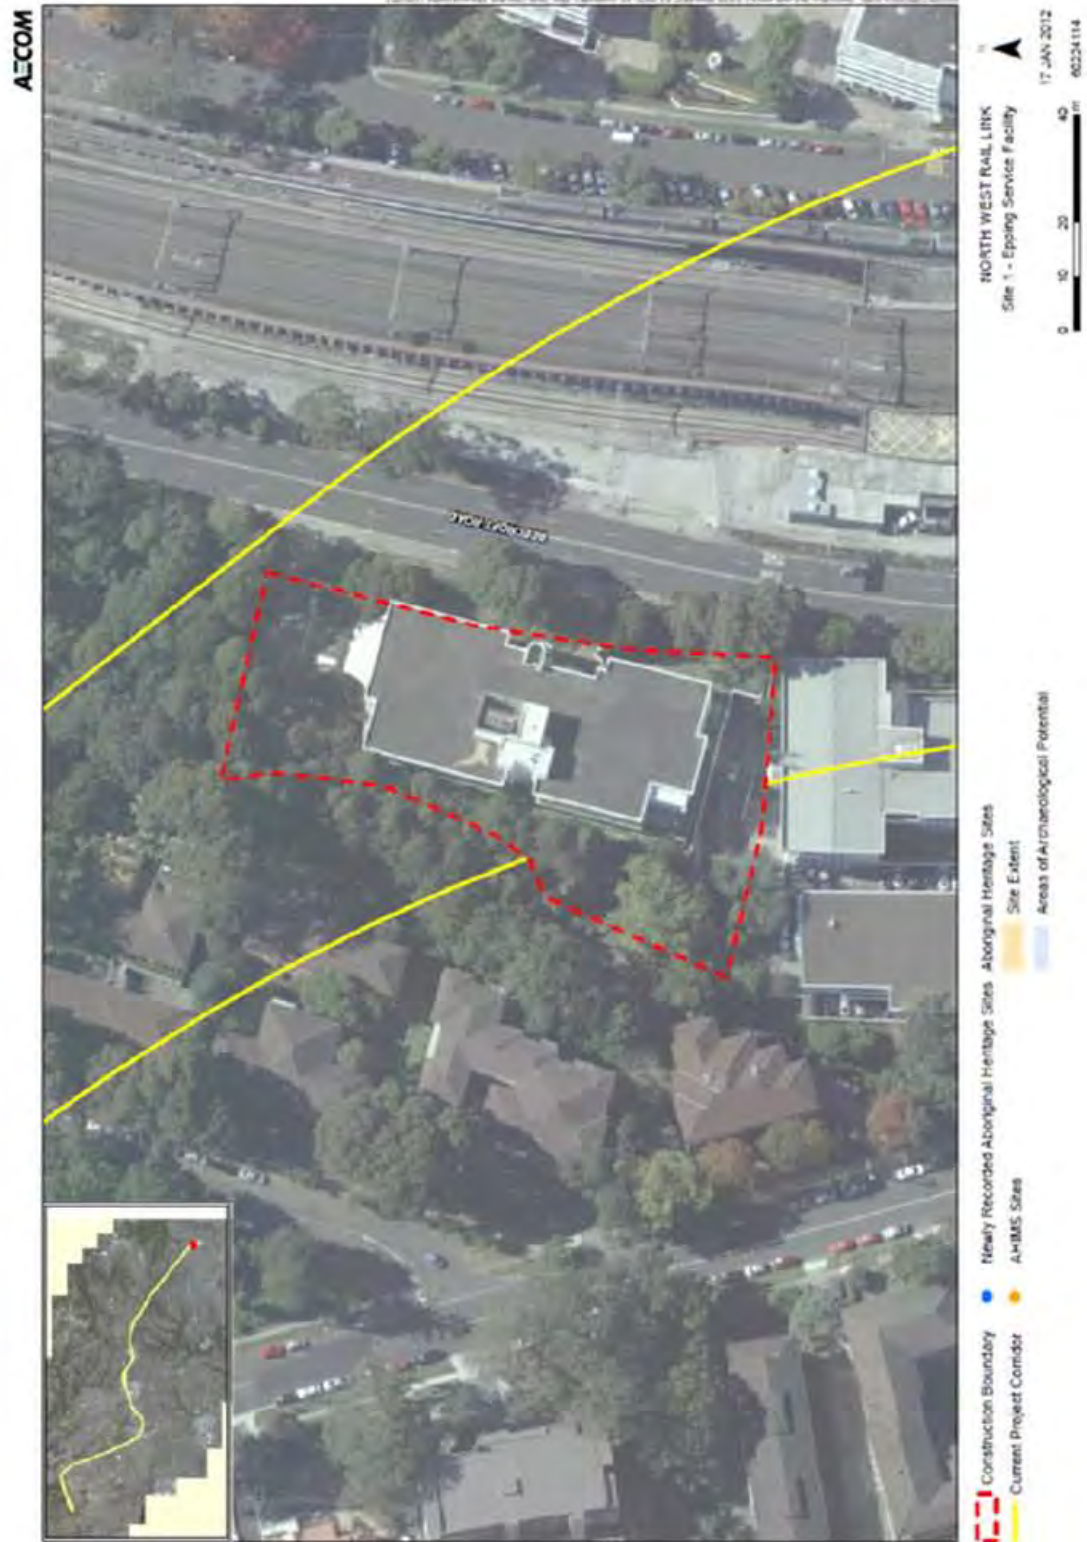
**Figure 5.1** North West Rail Link Construction Site 1—Epping Service Facility, showing impact zone (construction boundary).

Construction Sites 1 and 2 (Decline and Epping services facility) may be described as disturbed with a high level of ground surface impact arising from the processes of residential development and transport infrastructure. There is no potential for Aboriginal heritage in the NWRL impact zones at Epping due to the already developed nature of the area (Figures 5.1 and 5.2).

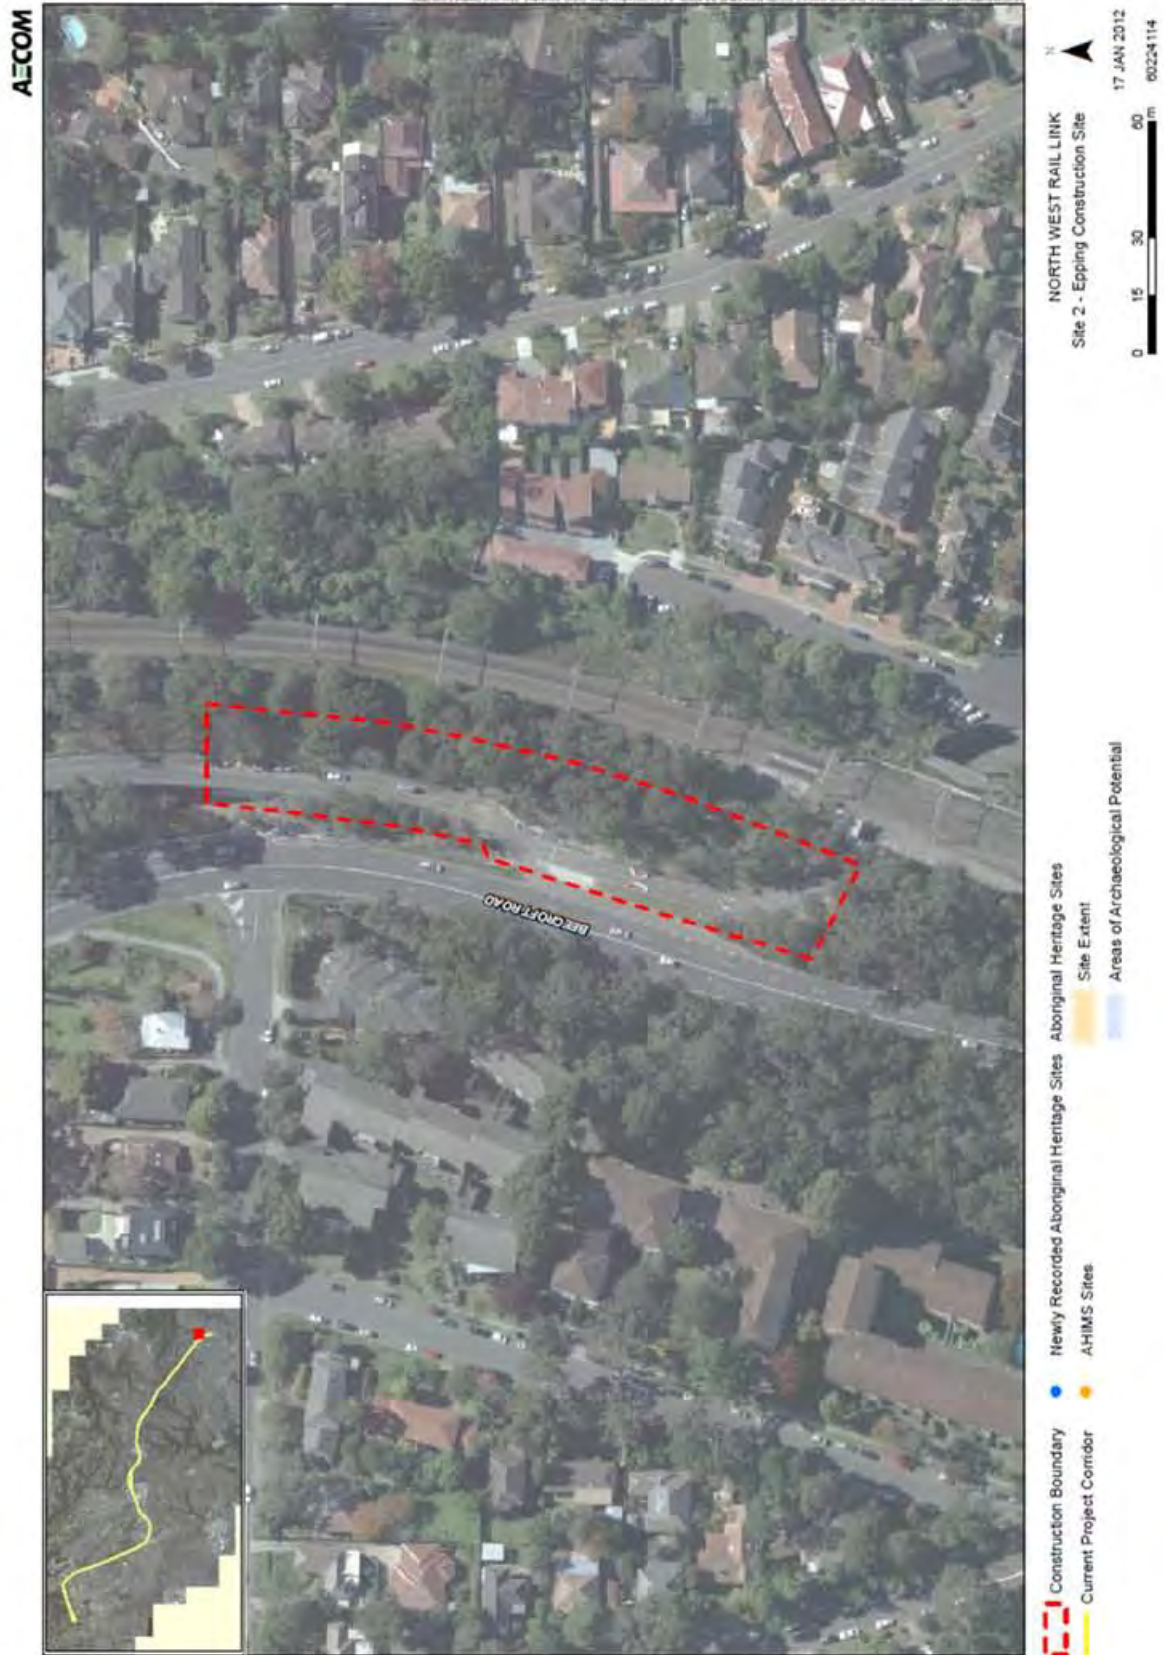
Figure 5.2 North West Rail Link Construction Site 2—Epping, showing impact zone.

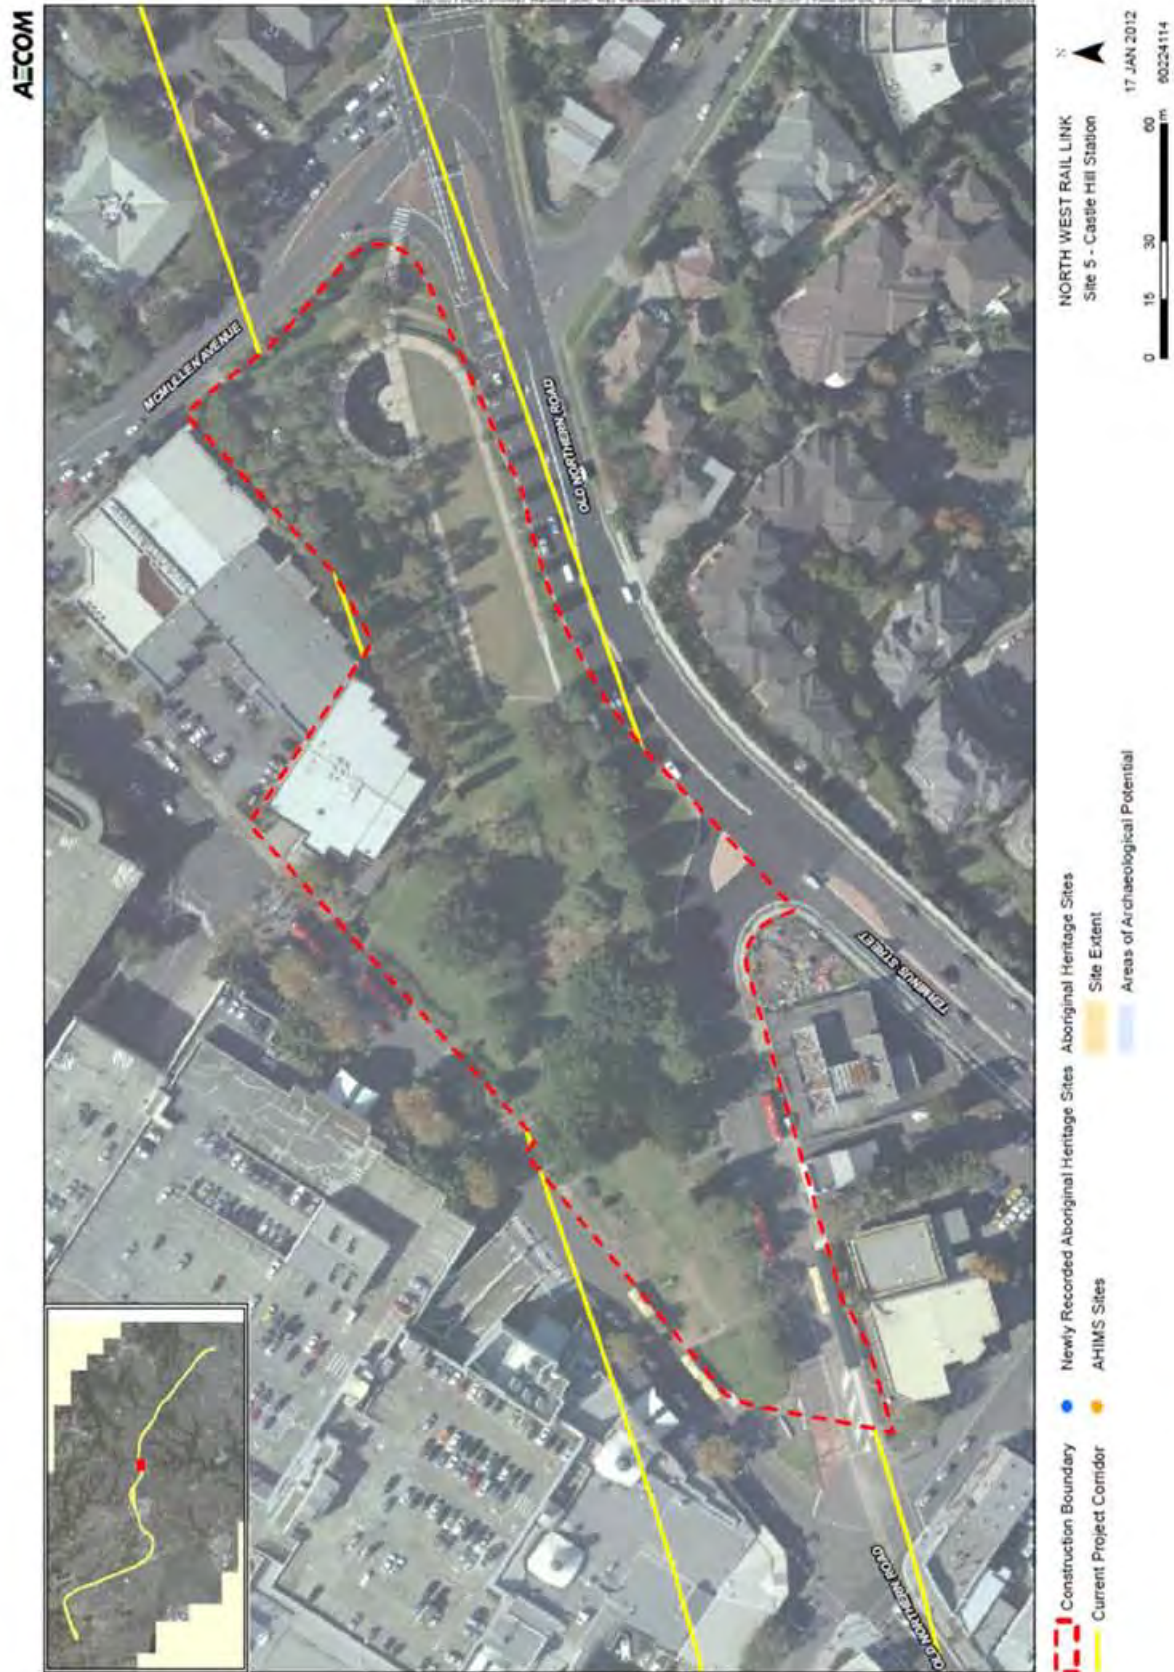
**Figure 5.5** North West Rail Link Construction Site 5—Castle Hill Station, showing impact zone.

Construction Site 5 (Castle Hill Station) is to be located within the Arthur Whitting Reserve, between Old Northern Road and Old Castle Hill Road. Survey found that this land has been highly disturbed by landscaping, including gardens, lawns and exotic trees. The construction of the adjacent roads and bulk excavation around the buildings at the eastern end of the park have also caused significant disturbance. Ground surface visibility was approximately 20% with a number of small soil exposures near trees and pedestrian traffic routes. No Aboriginal objects and/or sites were observed within this construction site. There is a very low potential for intact Aboriginal sites to be present at this construction site (Figure 5.5).

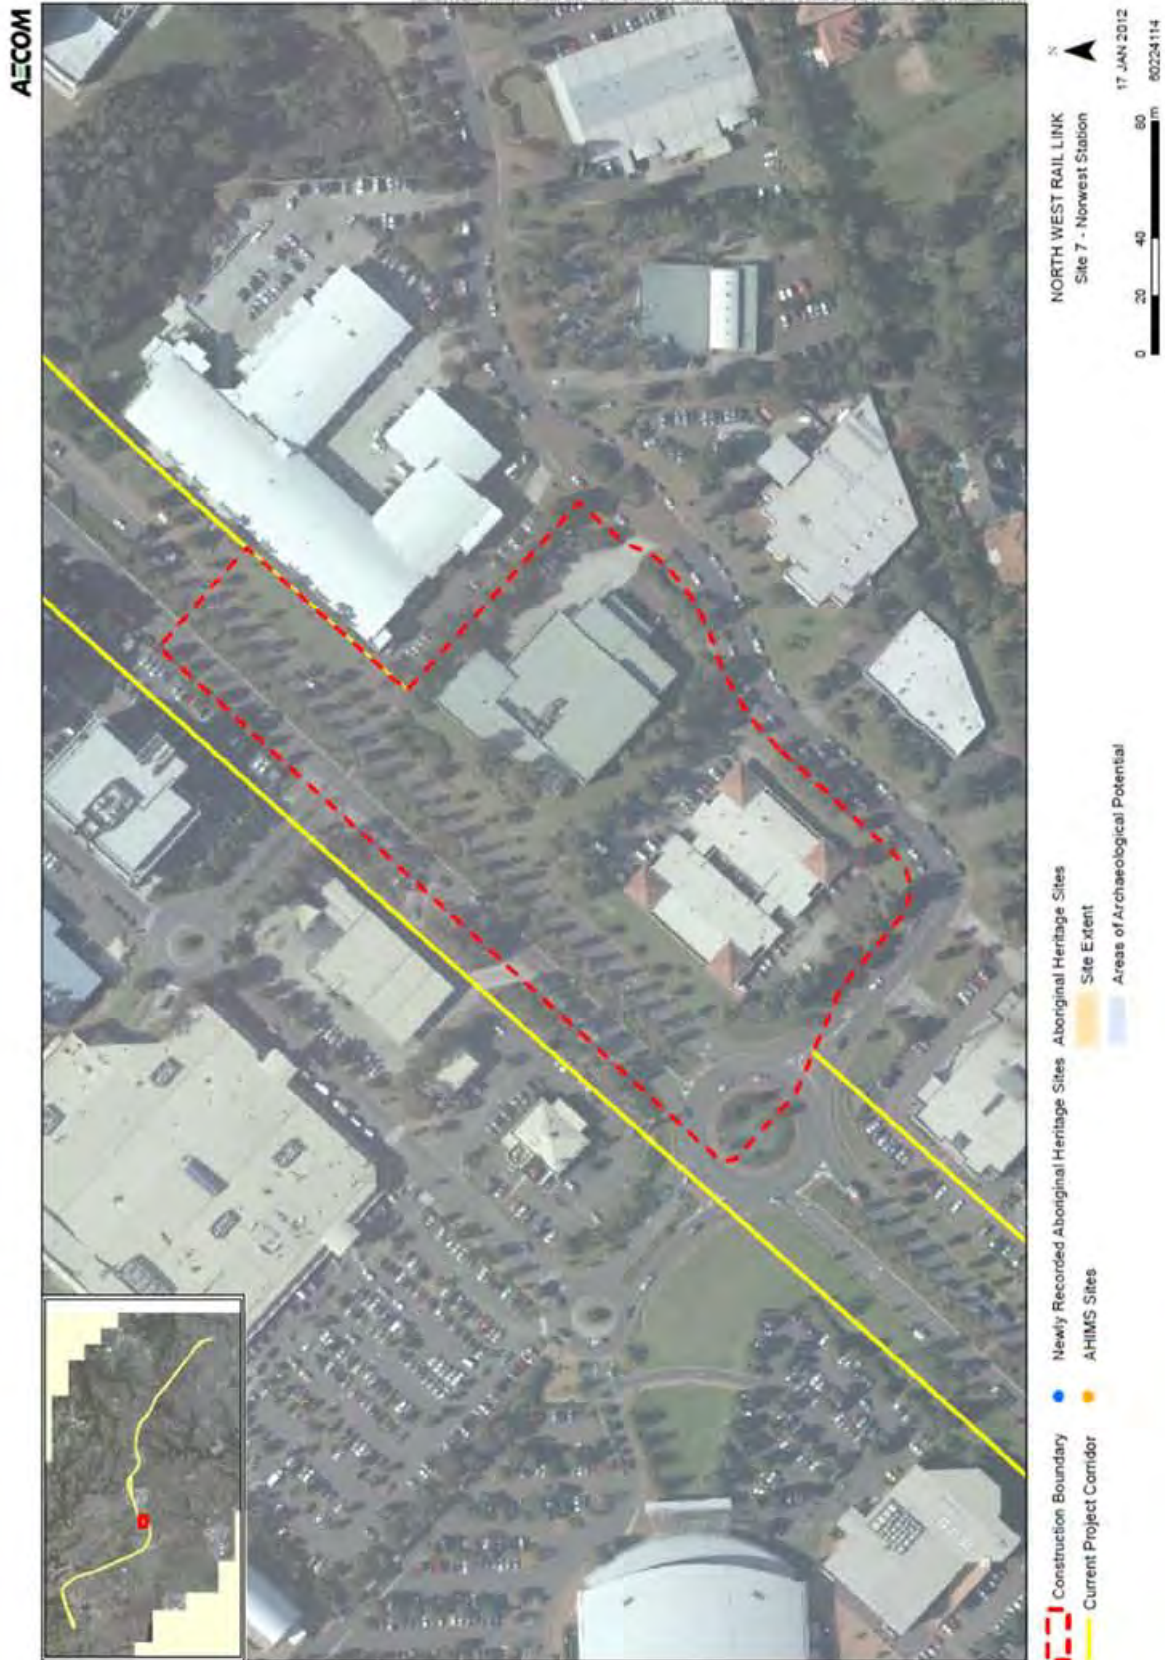
**Figure 5.7** North West Rail Link Construction Site 7—Norwest Station showing impact zone.

Construction Site 7 (the Norwest Station) had approximately 30% ground surface visibility due to grass cover, existing buildings and roads (no ground exposures were present).

The area was found to be highly disturbed by modern buildings, cut and imported fills, roads and landscaping. This construction site was assessed to have very low to no potential for intact Aboriginal sites (Figure 5.7).

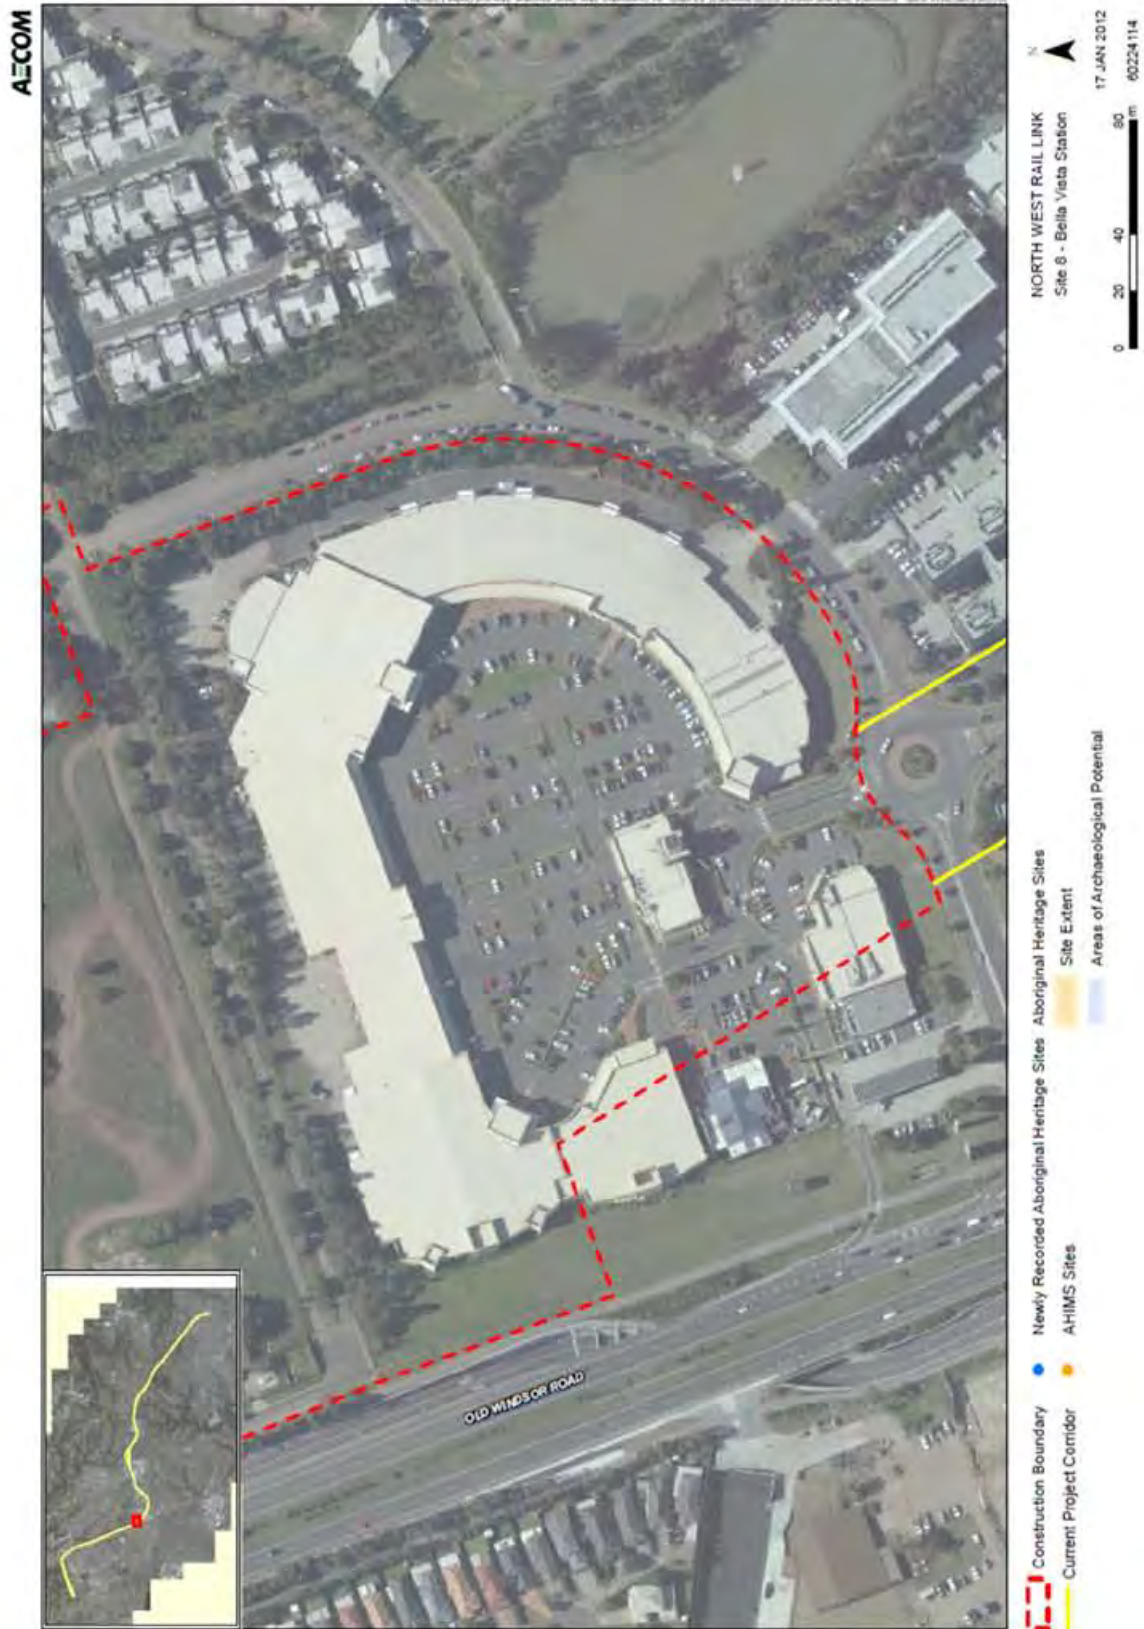
**Figure 5.8** North West Rail Link Construction Site 8—Bella Vista Station showing impact zone.

Construction Site 8 (Bella Vista Station) is proposed to be contained within the land of the Homemaker Collection Shopping Centre on the corner of Old Windsor Road and Celebration Drive. Survey in this area recorded 10% ground surface visibility with exposures along the northern end of Celebration Drive.

This construction site has already been highly impacted by development. The course of the creek bank along the northern end of Celebration Drive has been modified. As such this construction site has very low to no potential for Aboriginal heritage sites (Figure 5.8).
