Figure 4-7.2 Investigation locations, exceedances, summary of contaminated land survey and land uses Section 5-2 Broughton Street to Iron Cove Creek

Figure 4-8.1 Investigation locations, exceedances, summary of contaminated land survey and land uses Section 6-1 Iron Cove Creek to Bland Street

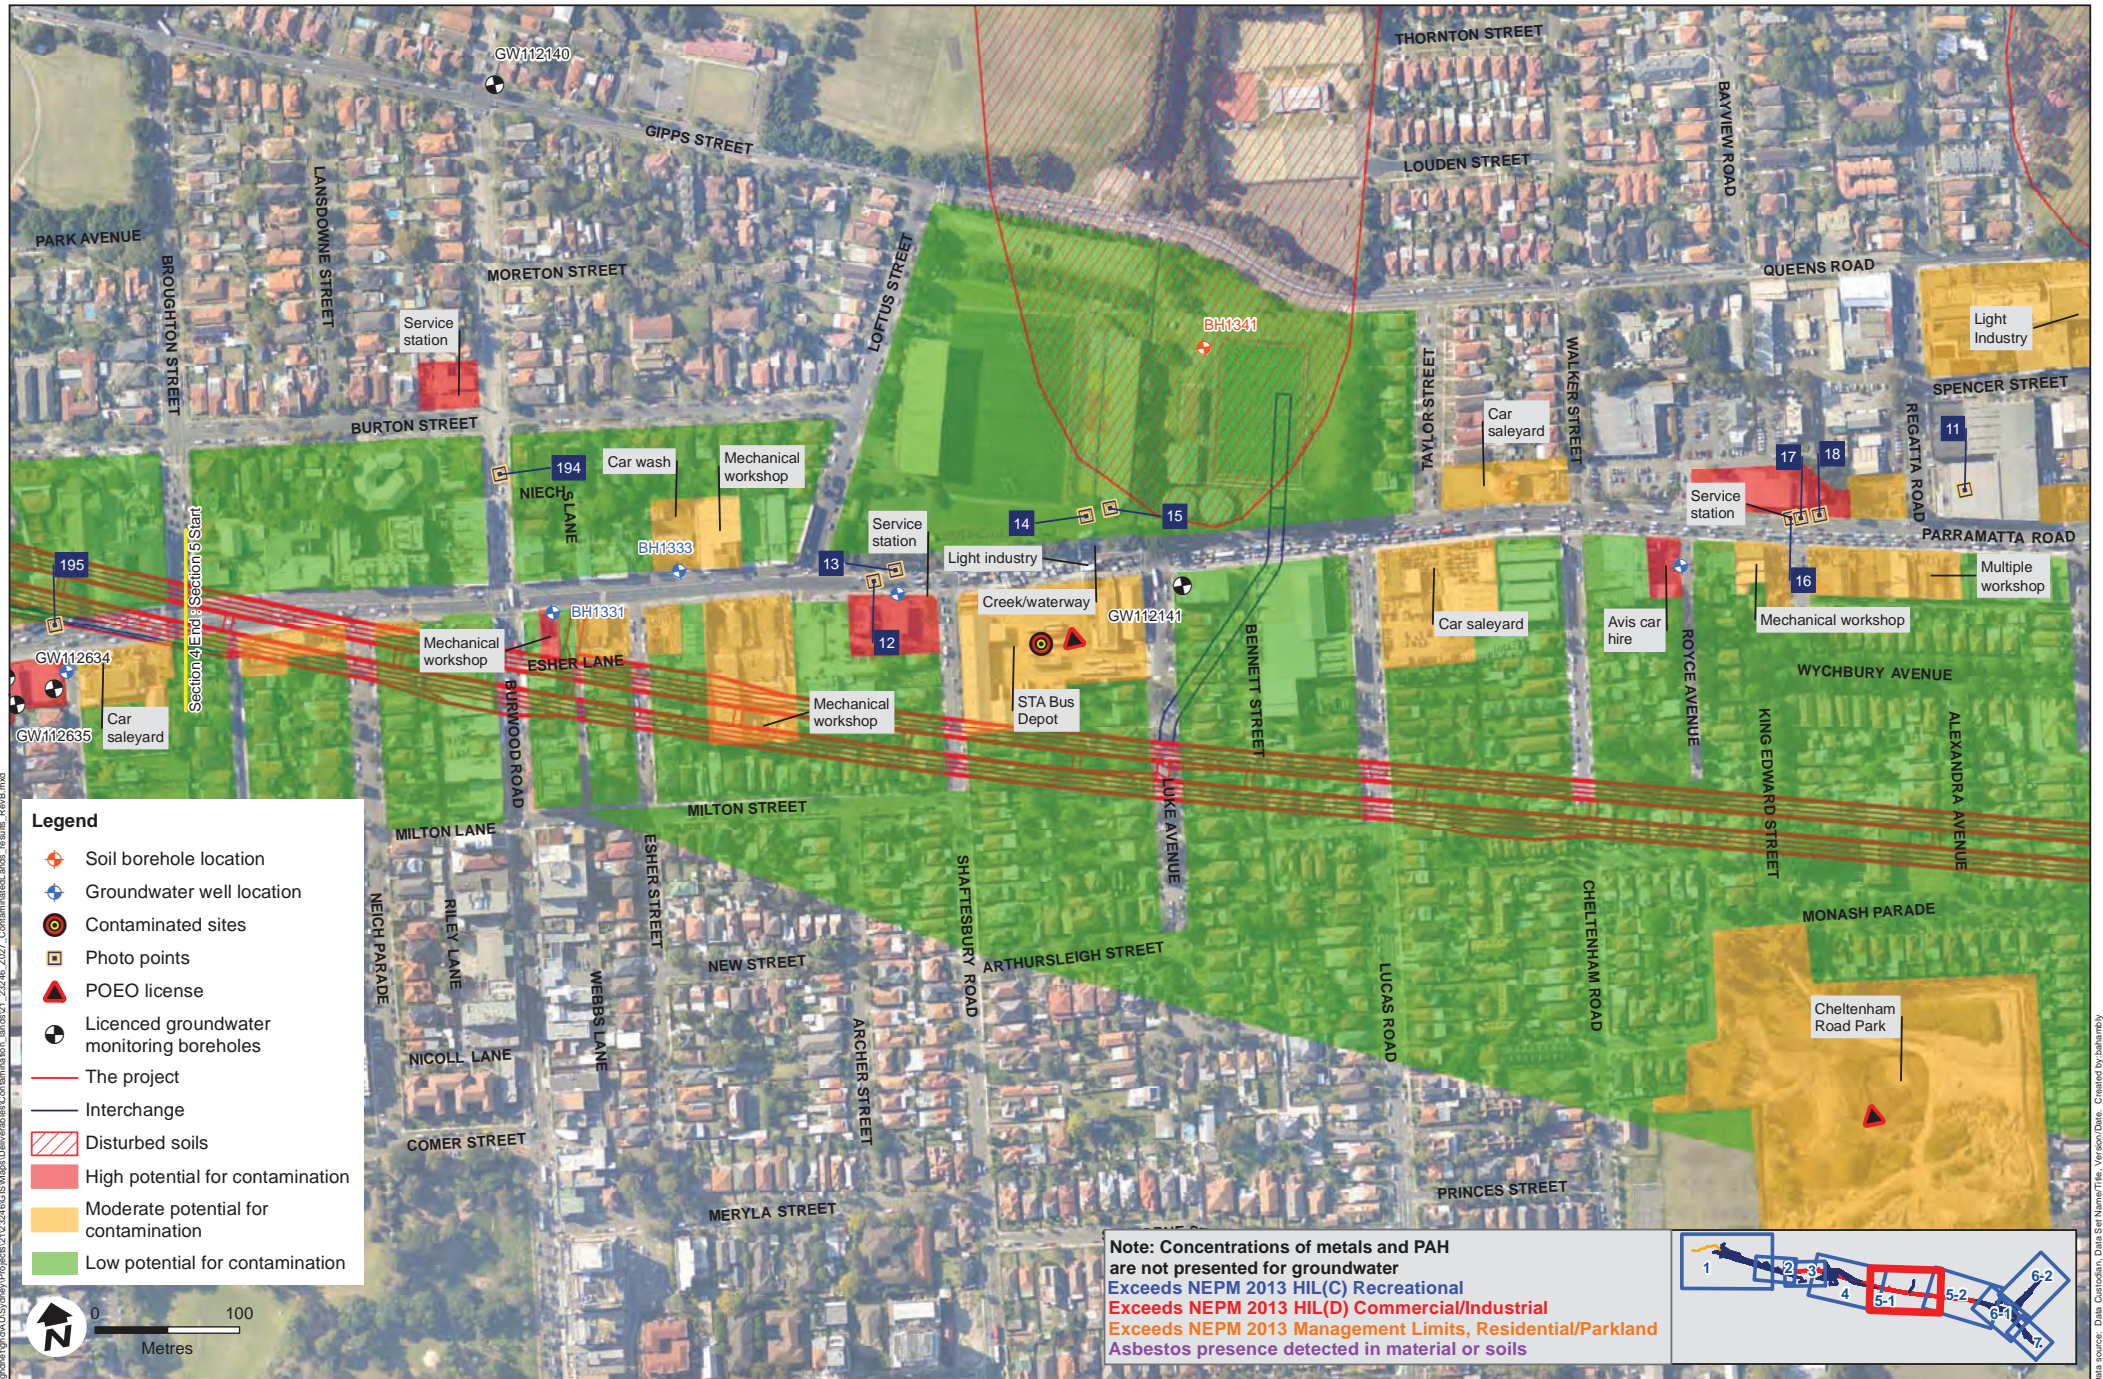
The site, owned by the State Transit Authority (STA), is located on the corner of Parramatta Road and Shaftesbury Road and functions as a bus depot. The site was previously contaminated with petroleum hydrocarbons which affected both soil and groundwater. Groundwater contained light non-aqueous phase liquids (LNAPL). The site has been investigated by Sinclair Knight Merz (SKM) and Environmental Resources Management Australia (ERM). The site has been audited by a EPA Auditor and has been indicated as suitable for use as a commercial/industrial site. The site audit statement was issued 26 October 2009 and noted the residual soil and groundwater contamination on the site as the contamination issues may be effectively managed by the EMP prepared for the site. The notification is categorised as former and is defined as the EPA has determined that the contamination is no longer significant enough to warrant regulation. There are no publicly available reports for review for this site. EPA has issued a notice of completion of agreed voluntary remediation proposal (notice number 20104402) issued on 25 March 2010. The location is shown on **Figure 4.7-1**.

This section generally does not contain any known occurrences of ASS (Land and Water Conservation 1997a and 1997b), with the exception of an area denoted as disturbed terrain (elevation between two and four metres AHD) which is present in the project footprint at Concord Oval and is detailed on **Figure 4.7-1**.

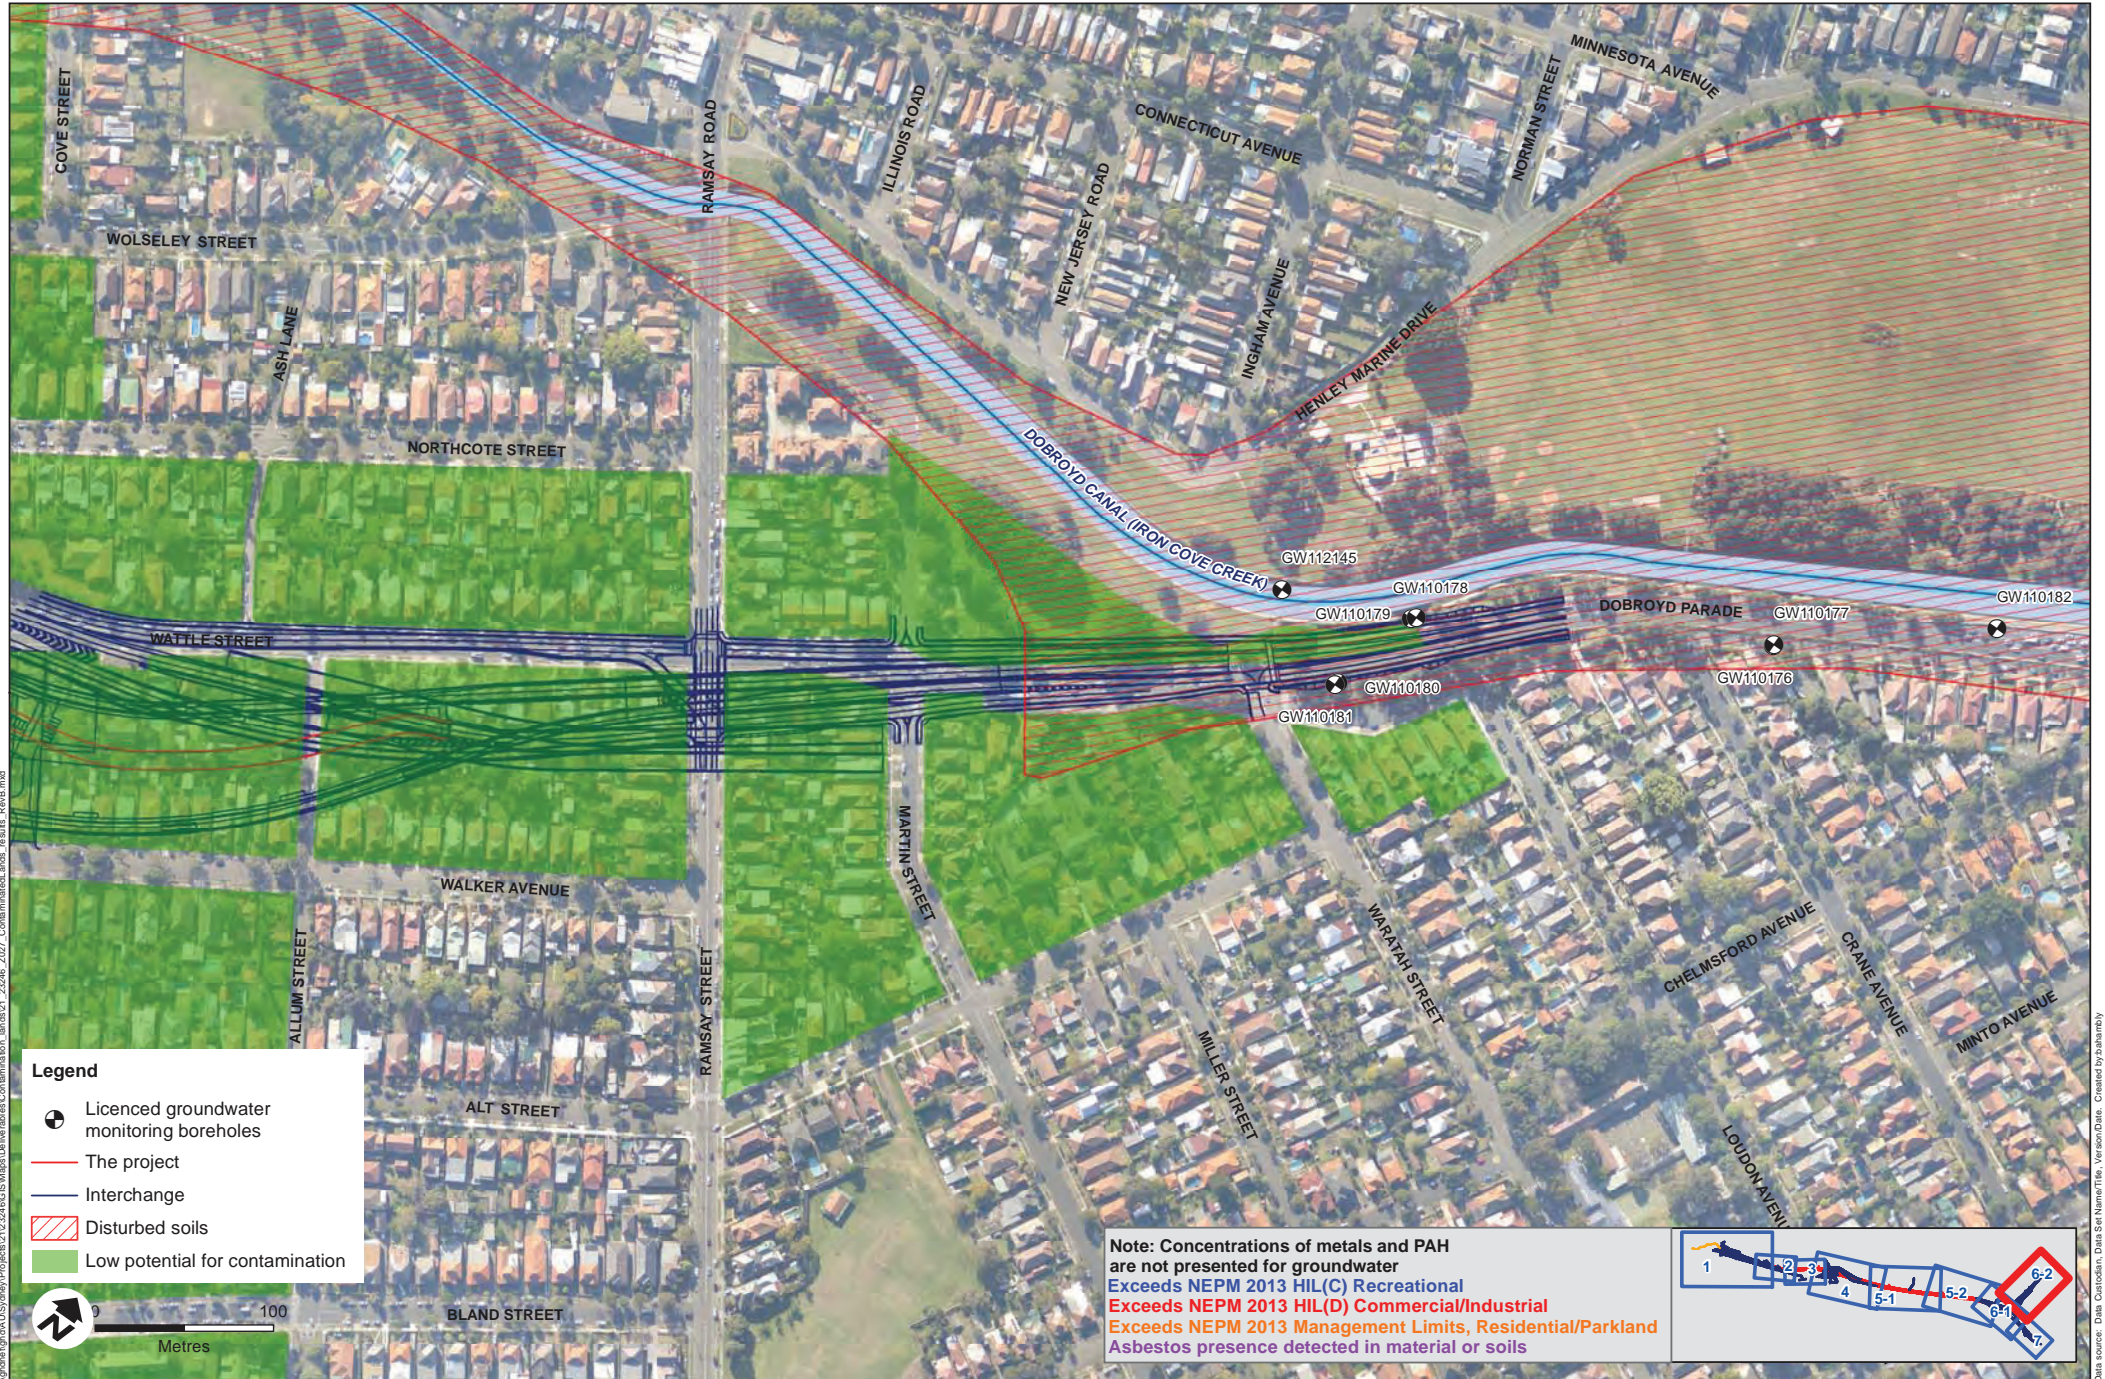
Figure 4-8.2 Investigation locations, exceedances, summary of contaminated land survey and land uses Section 6-2 Wattle street

A search of the NSW Groundwater Works (NSW Government 2015d) website reported nine groundwater boreholes within a 500 metre radius of the project corridor. The boreholes reported are noted in **Table 4-42**, and their locations are detailed on **Figures 4.8-1** and **4.8-2**.

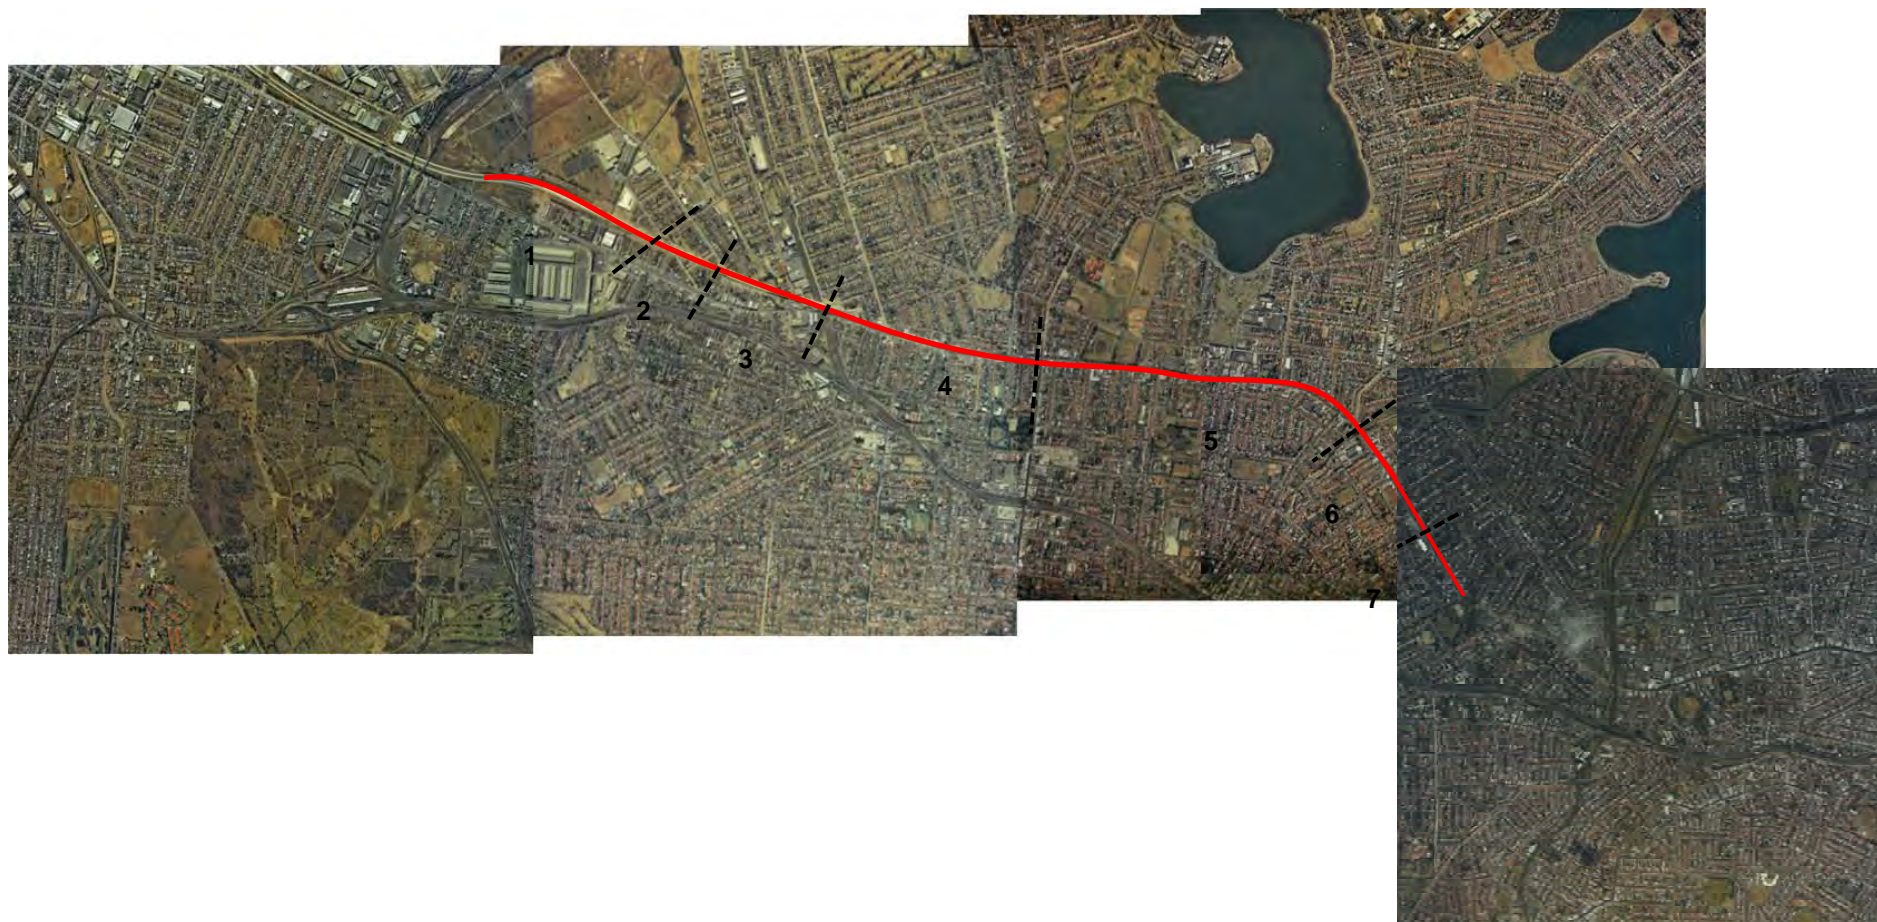
1991

A selection of aerial photographs was examined in order to ascertain past activities and land uses at the site. The years examined were 1930, 1951, 1961, 1970, 1982, 1991, 2002 and 2005. **Table 4-30** provides a summary of the observations, while aerial photographs are provided in **Appendix A**.
