Clarrie Hall Dam Raising EIS

Contamination Preliminary Site Investigation

Prepared for Tweed Shire Council

E230041 DUN-EMM-EN-RPT-006

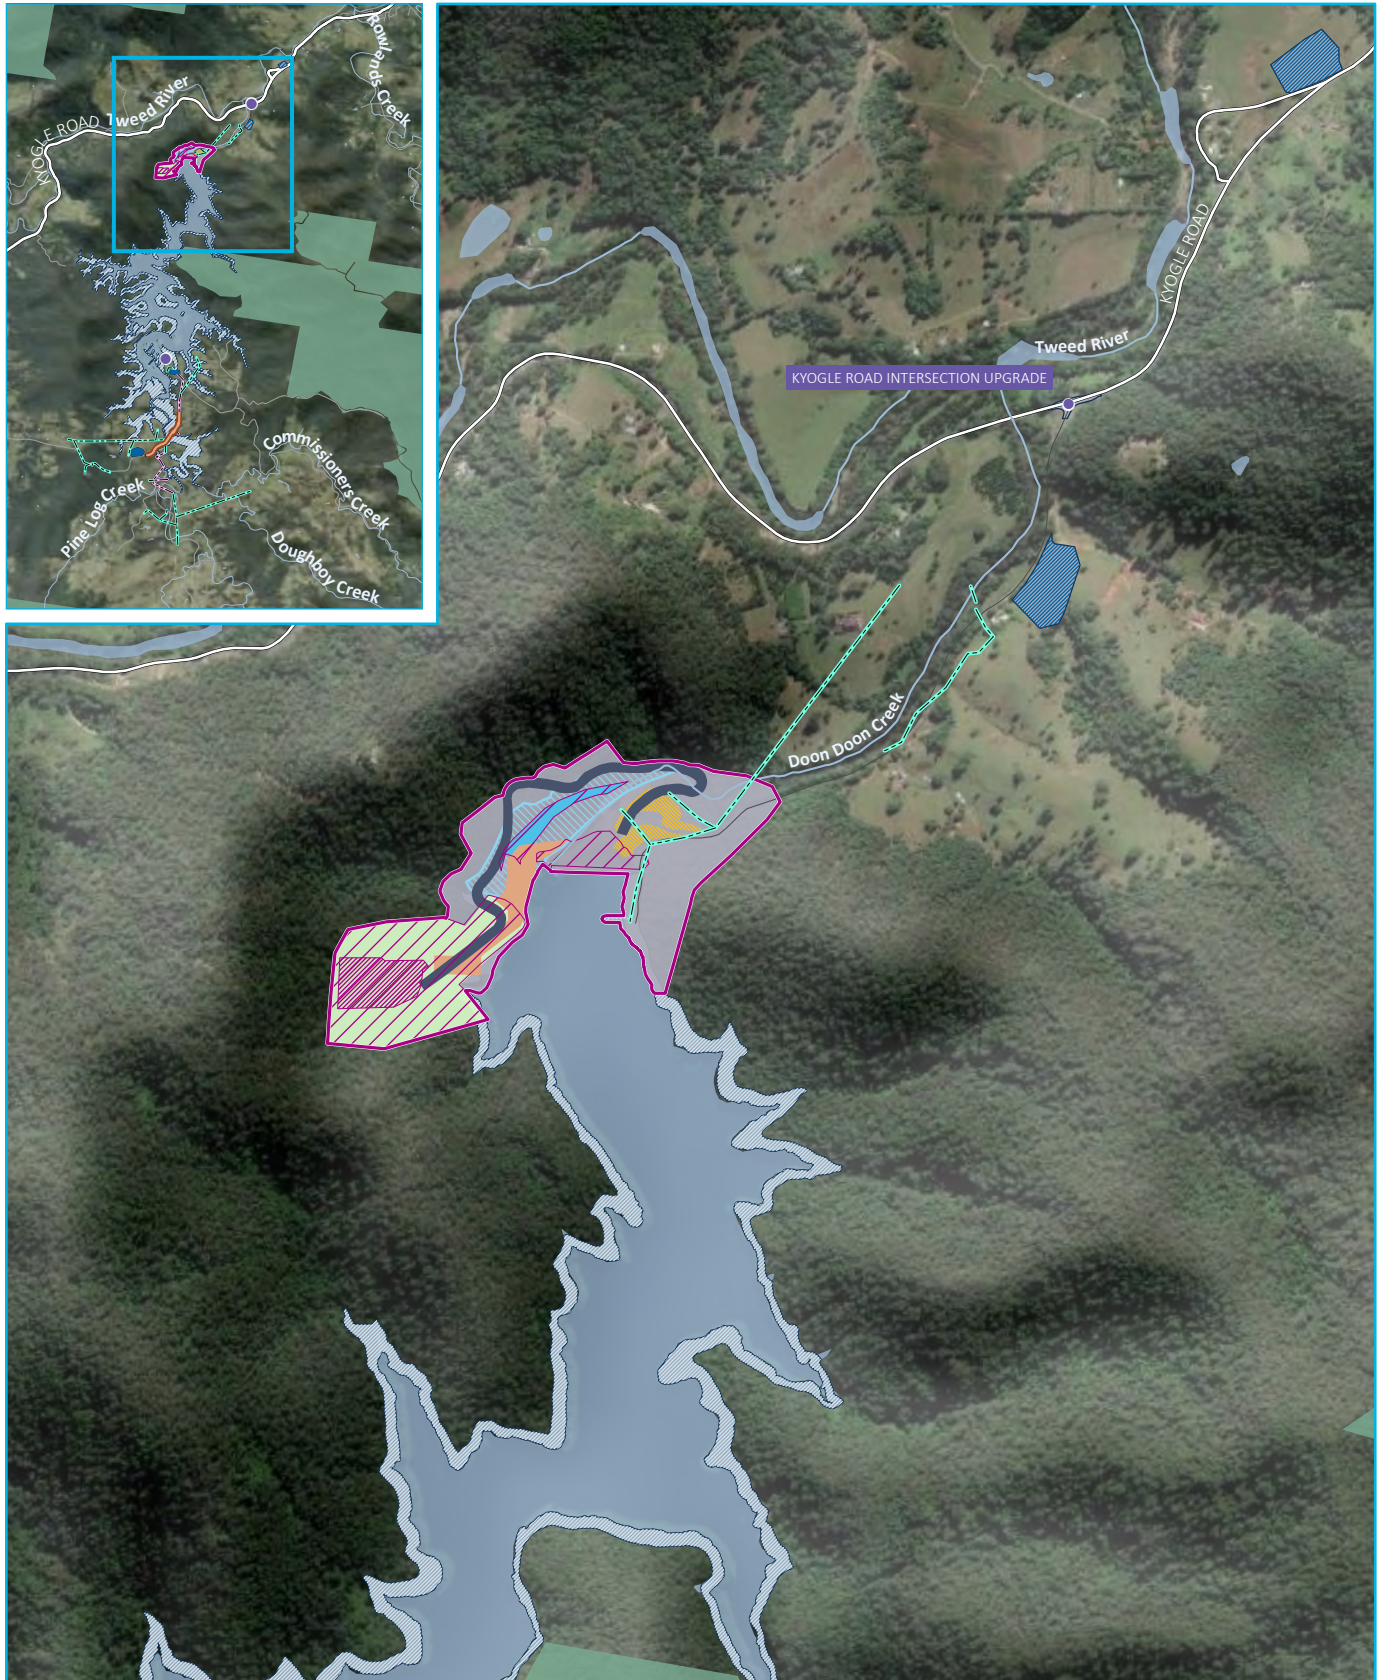
The Proposal overview can be seen in Figure 2.1.

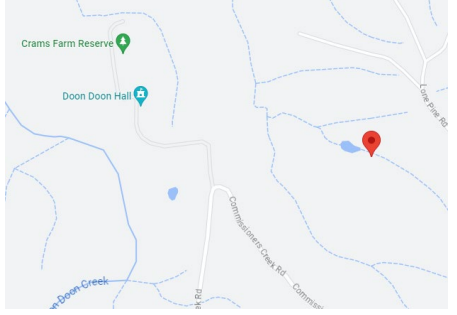
79 Lone Pine Road, Doon Doon	<p>A drum of diesel is located on the property along with empty diesel drums.</p> <p>Occasional use of Roundup™ occurs along the driveway.</p>

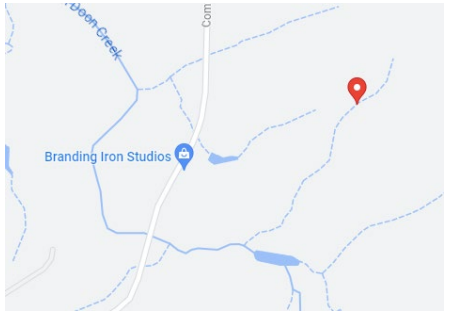
60 Commissioner Creek Road, Doon Doon	<p>Landholder noted that there is a potential car and caravan disposal site to the north-east of the property which has been covered and revegetated, however they are not aware of the exact landfill burial location. This area is not in close proximity for the PMF and is not considered to be a contamination risk.</p> <p>Occasional use of Roundup™ occurs on the property.</p>

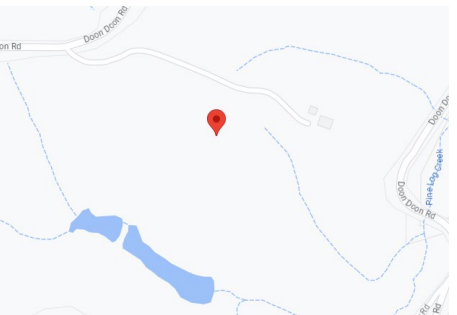
484 Doon Doon Road, Doon Doon	<p>An abandoned diesel above ground storage tank (AST) is located on the property and hasn't been used in approximately 10 years. There is a stain on the ground under the diesel tank.</p> <p>Doon Doon Hall used to be located at the end of the driveway but was relocated to Crams Farm Reserve more than 10 years ago.</p>

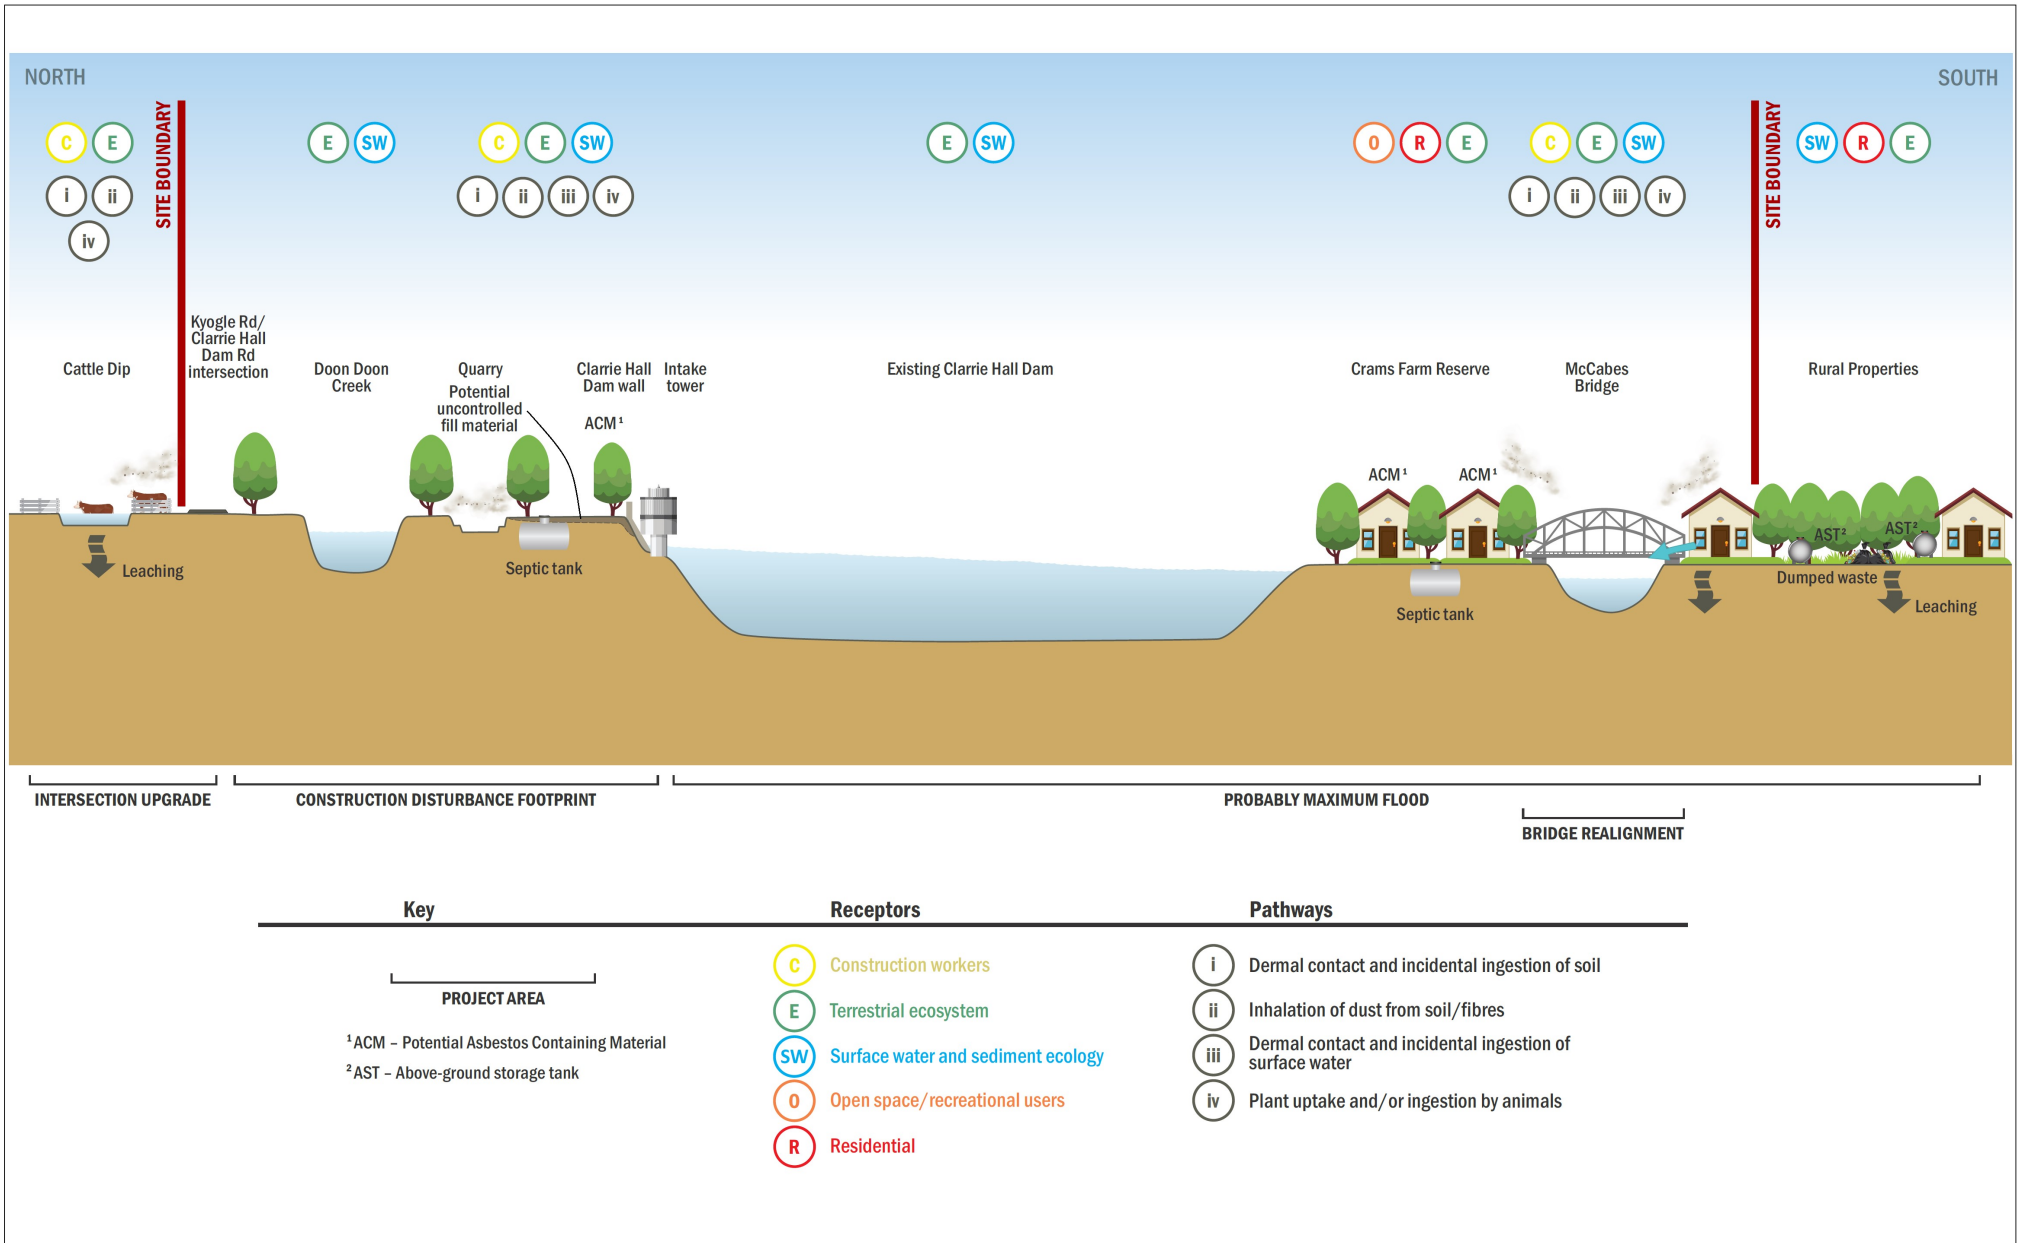
The preliminary CSM for the construction works is presented in Figure 5.2 below.
