# Appendix J Technical Paper: Statement of Heritage Impact (maritime)

**Statement of Heritage Impact**  
**Barangaroo Ferry Hub, East Darling Harbour**  
Report for Transport for NSW

Report Number: PR22016-2

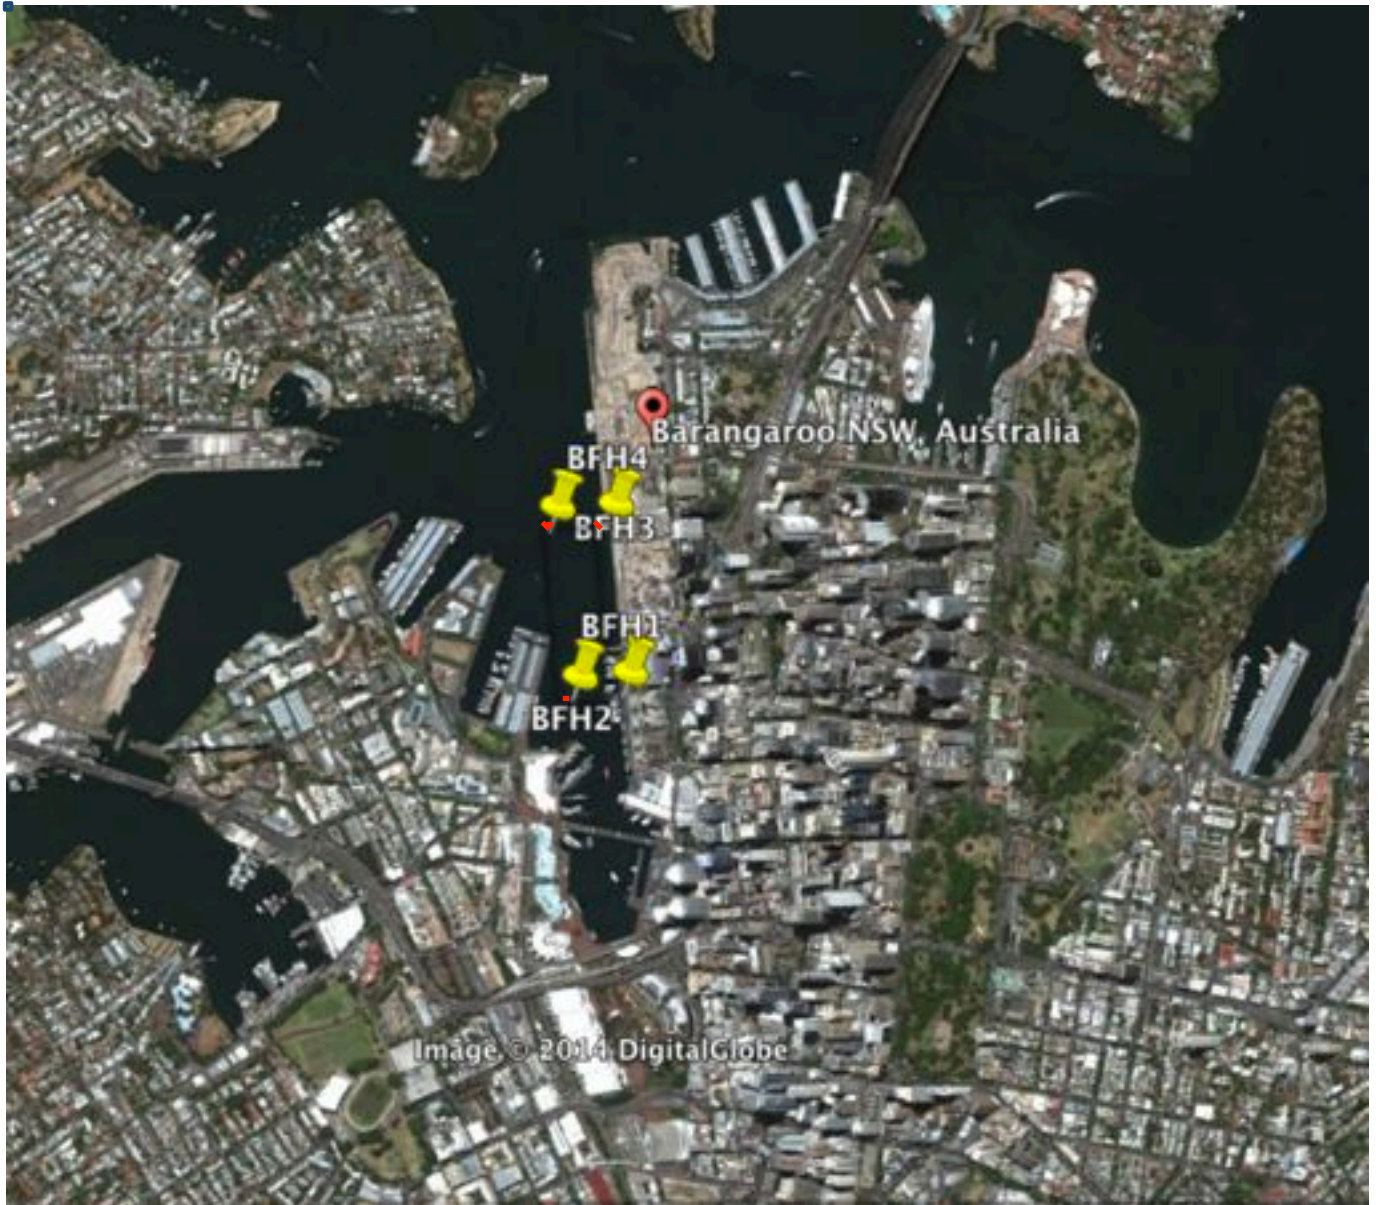
**Figure 1:** Map of central Sydney showing Darling Harbour, Barangaroo and the study area in red. The yellow pins illustrate the study area boundary coordinates (BF1-BF4). Image courtesy: Google Earth / Digital Globe 2014.

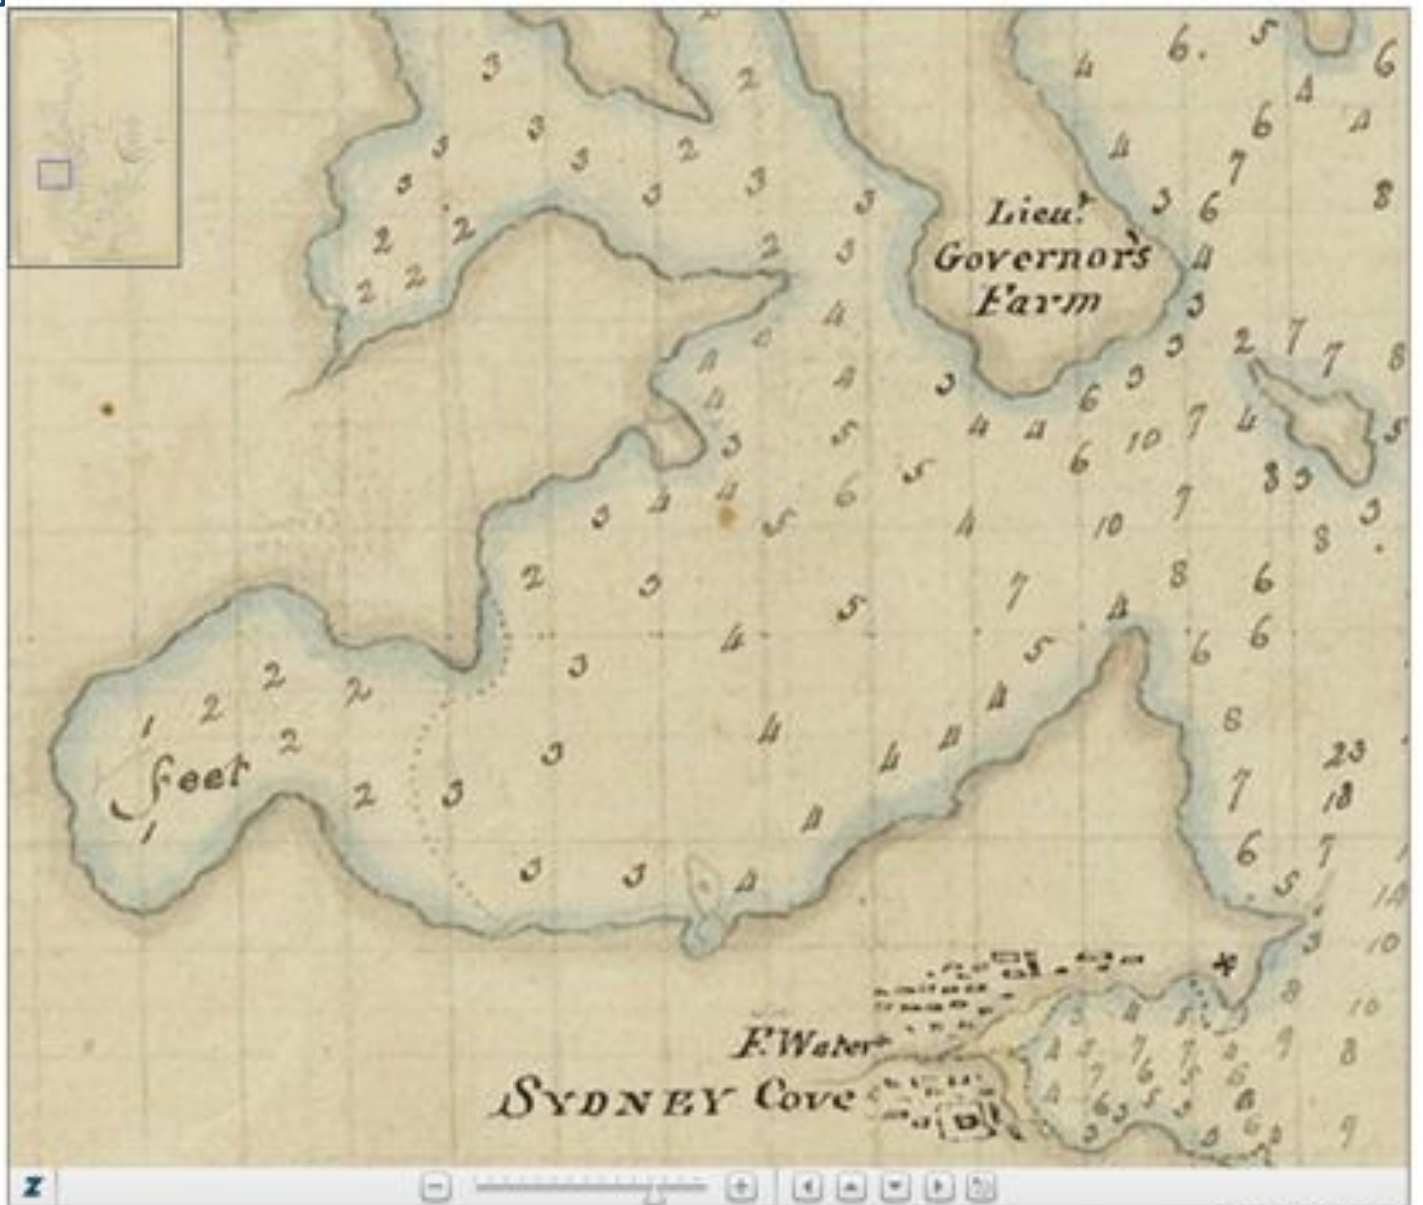
**Figure 2:** Extract from John Hunter's Chart of Port Jackson as surveyed in 1788. Image shows the shoreline and depth of water in Darling Harbour including the study area. Image courtesy: State Library of NSW (Z/M2 811.15/1788/1).

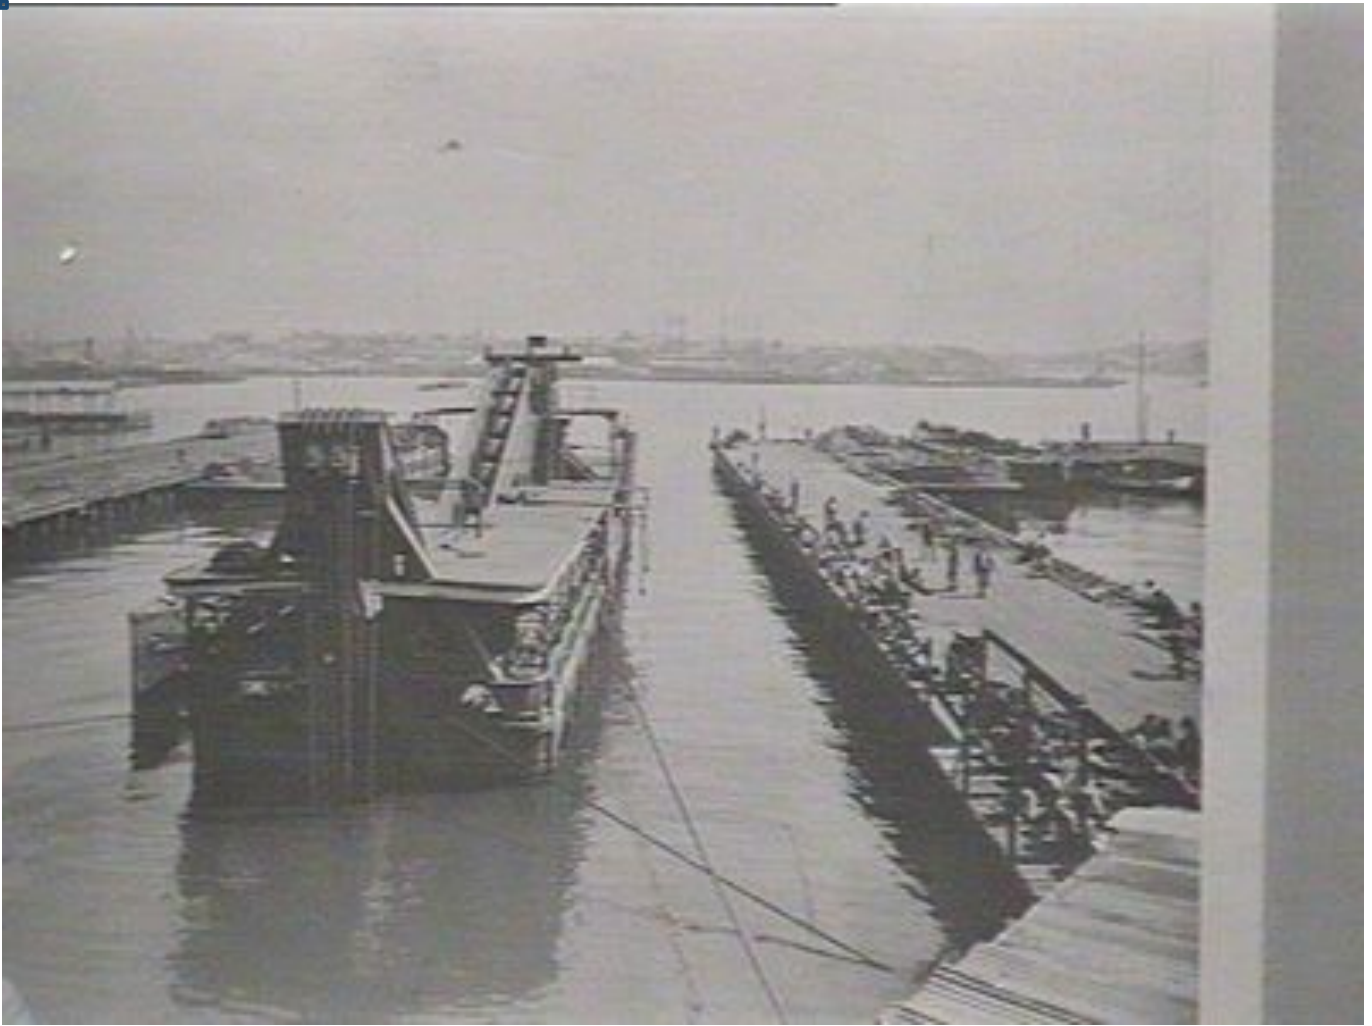
**Plate 1:** Historic dredging between the wharves of Darling Harbour within the study area at the foot of Margaret Street. Image courtesy: Government Printing Office/State Library of NSW (d1\_47746).

It wasn't just the foreshore being developed. References to the dredging of Darling Harbour appear in the local Sydney newspapers as early as 1875 (Anon. 1875a; 1875b) and continue throughout to the 1880s (Anon 1878; 1879; 1881; 1883; 1888:1889). One article in the Evening News (Anon. 1888) makes reference to annual dredging with in excess of 240,000 tonnes of sediment removed by one of the three dredgers in that year alone. Historic photographs, such as that in Plate 1, show dredging taking place around the wharf infrastructure adjacent to the study area.

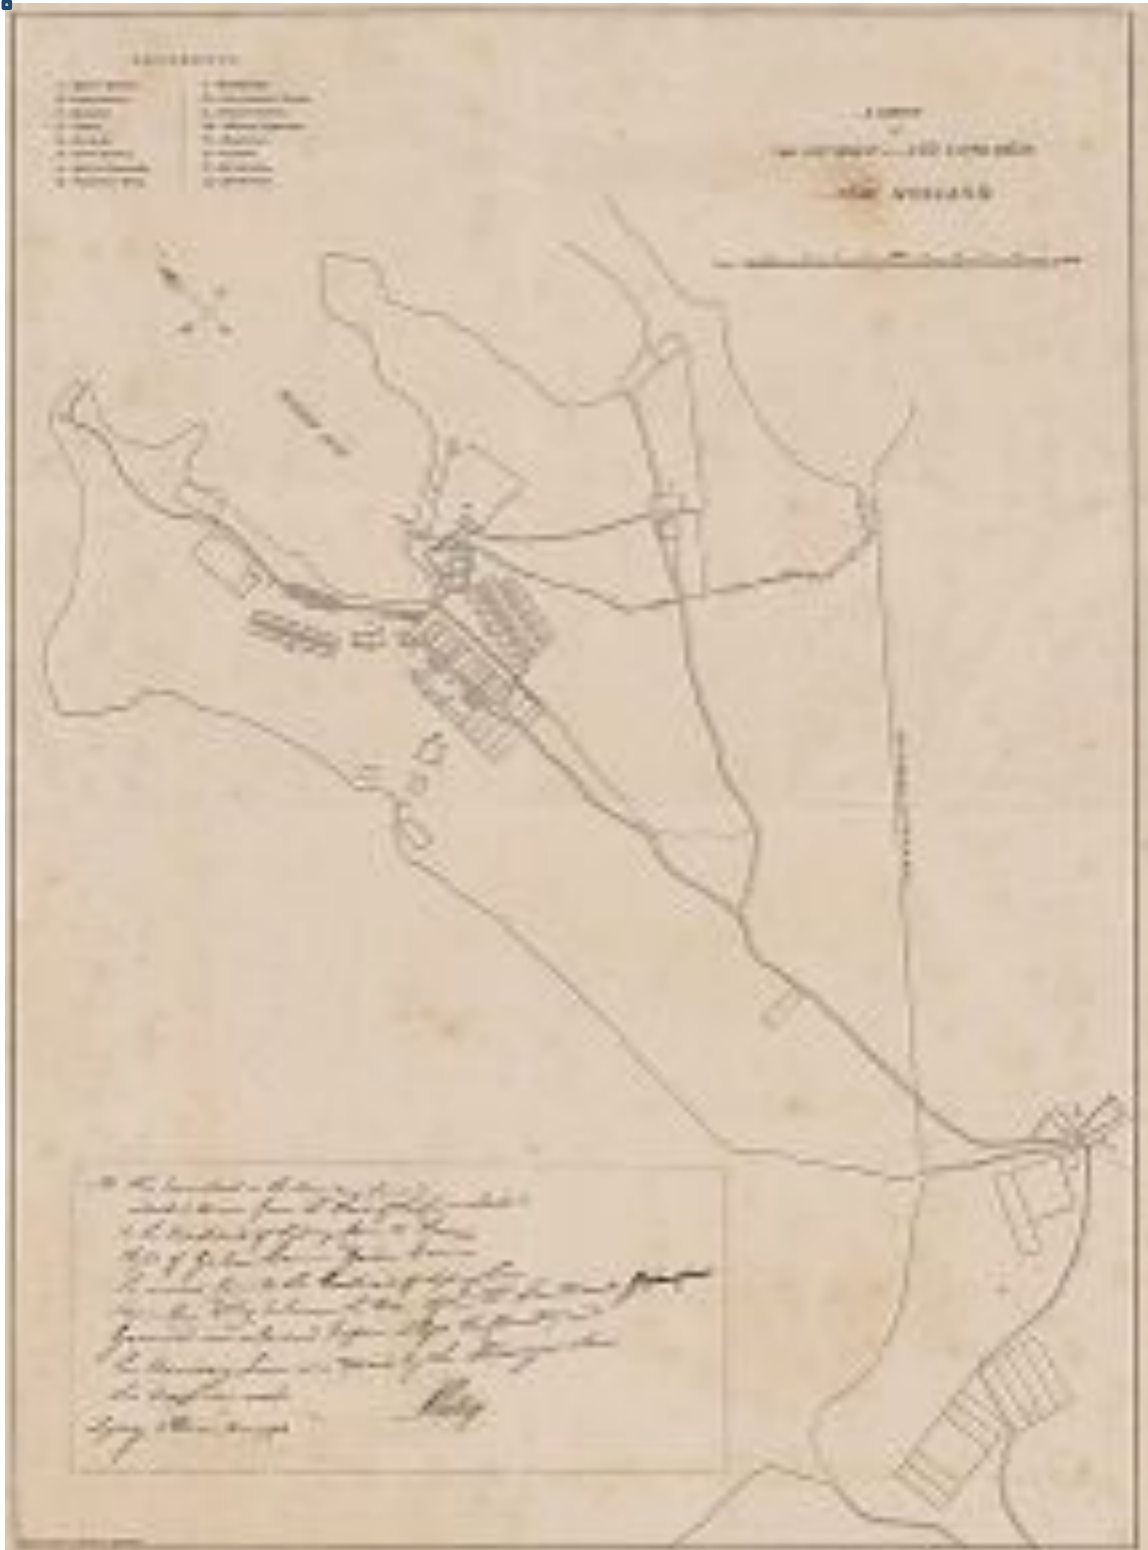
**Figure 3:** A survey of the settlement of New South Wales, New Holland 1792. Engraved by A. Dulon and L. Poates. Image courtesy: National Library of Australia (nla.map-f306v).

By 1792, four clearly delineated settlement areas are evident on the eastern shore of Darling Harbour (Philip 1792; Figure 3). It is not until Lesueur's plan of 1802, however that this part of the colony is

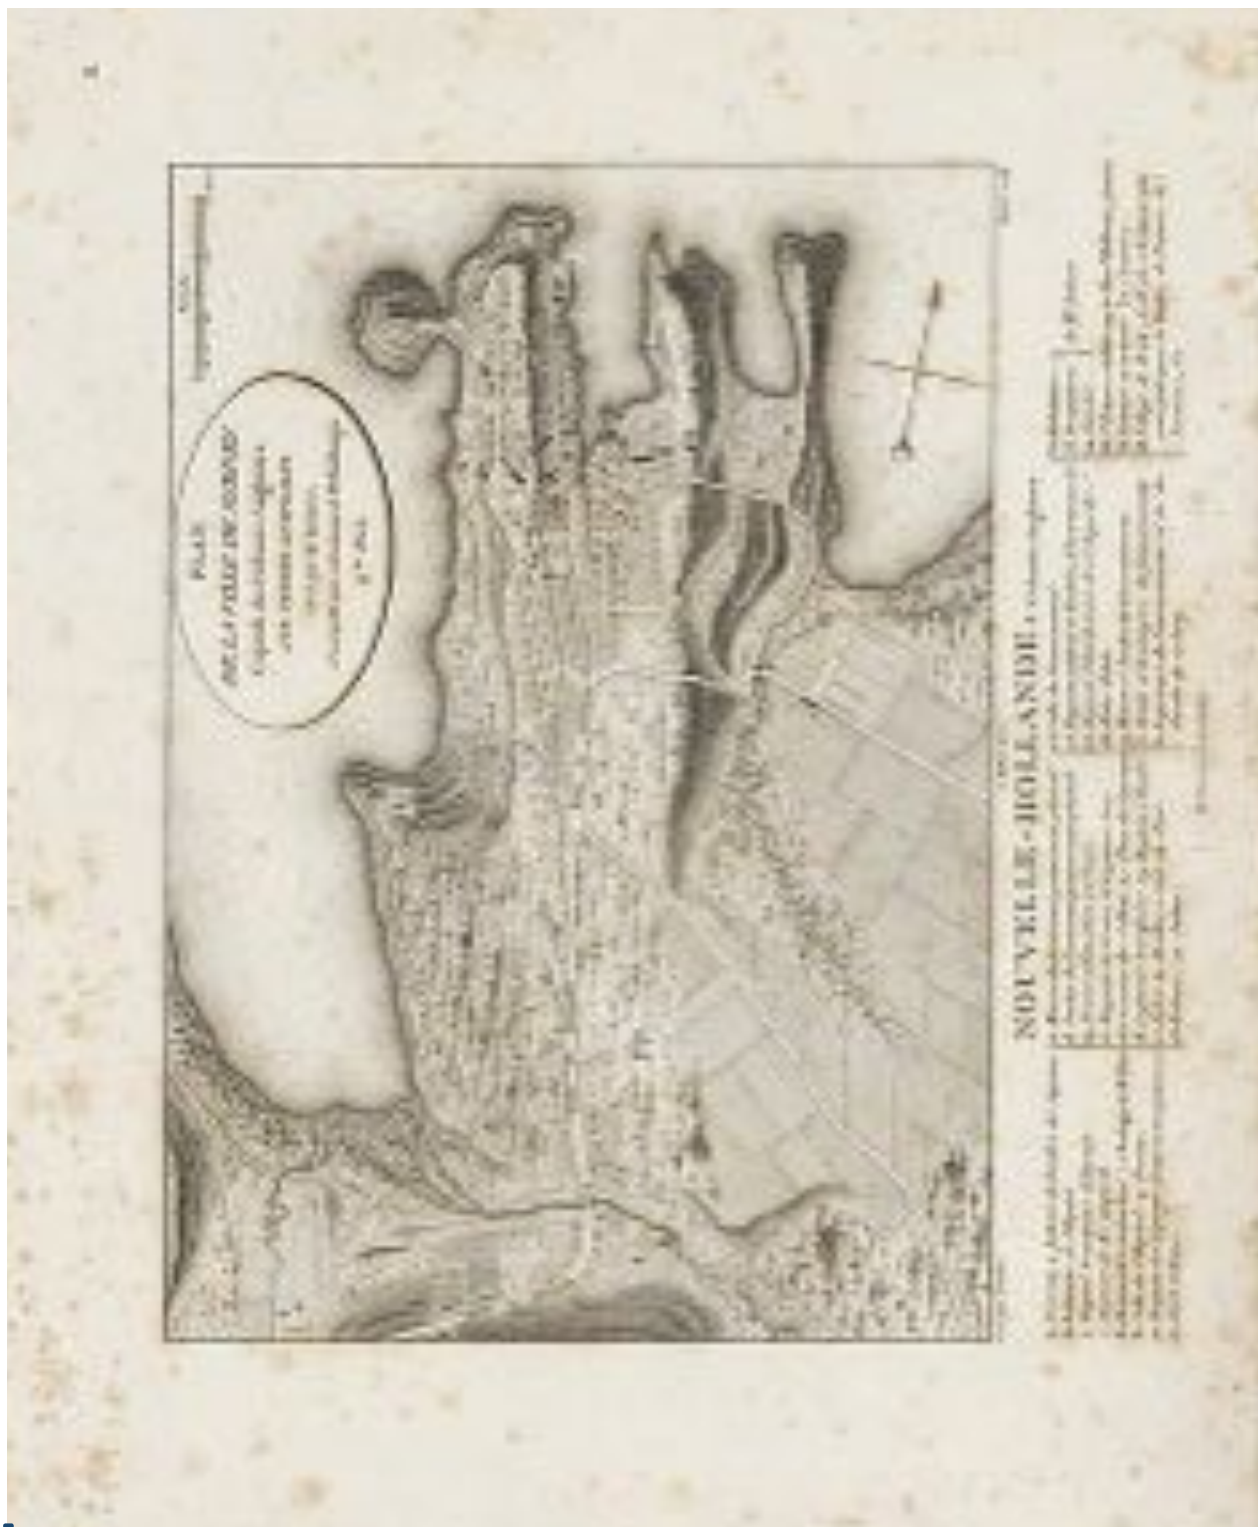
**Figure 4:** Plan de la ville de Sydney: Capitale des colonies Anglaises, aux terres Australes. Engraved by Charles Alexandre Lesueur 1802. Image courtesy: National Library of Australia (nla.map-f307v).

well represented (Figure 4). The eastern shore, now Barangaroo, is shown to have rocky cliffs with steep gradients and a protracted intertidal zone. Together with the number of creeks meandering through the head of Darling Harbour and the type of vegetation depicted, this area can be taken to have been predominantly swamp or marshland; fertile hunting ground for Indigenous Australians, but much less inviting for the settlers.

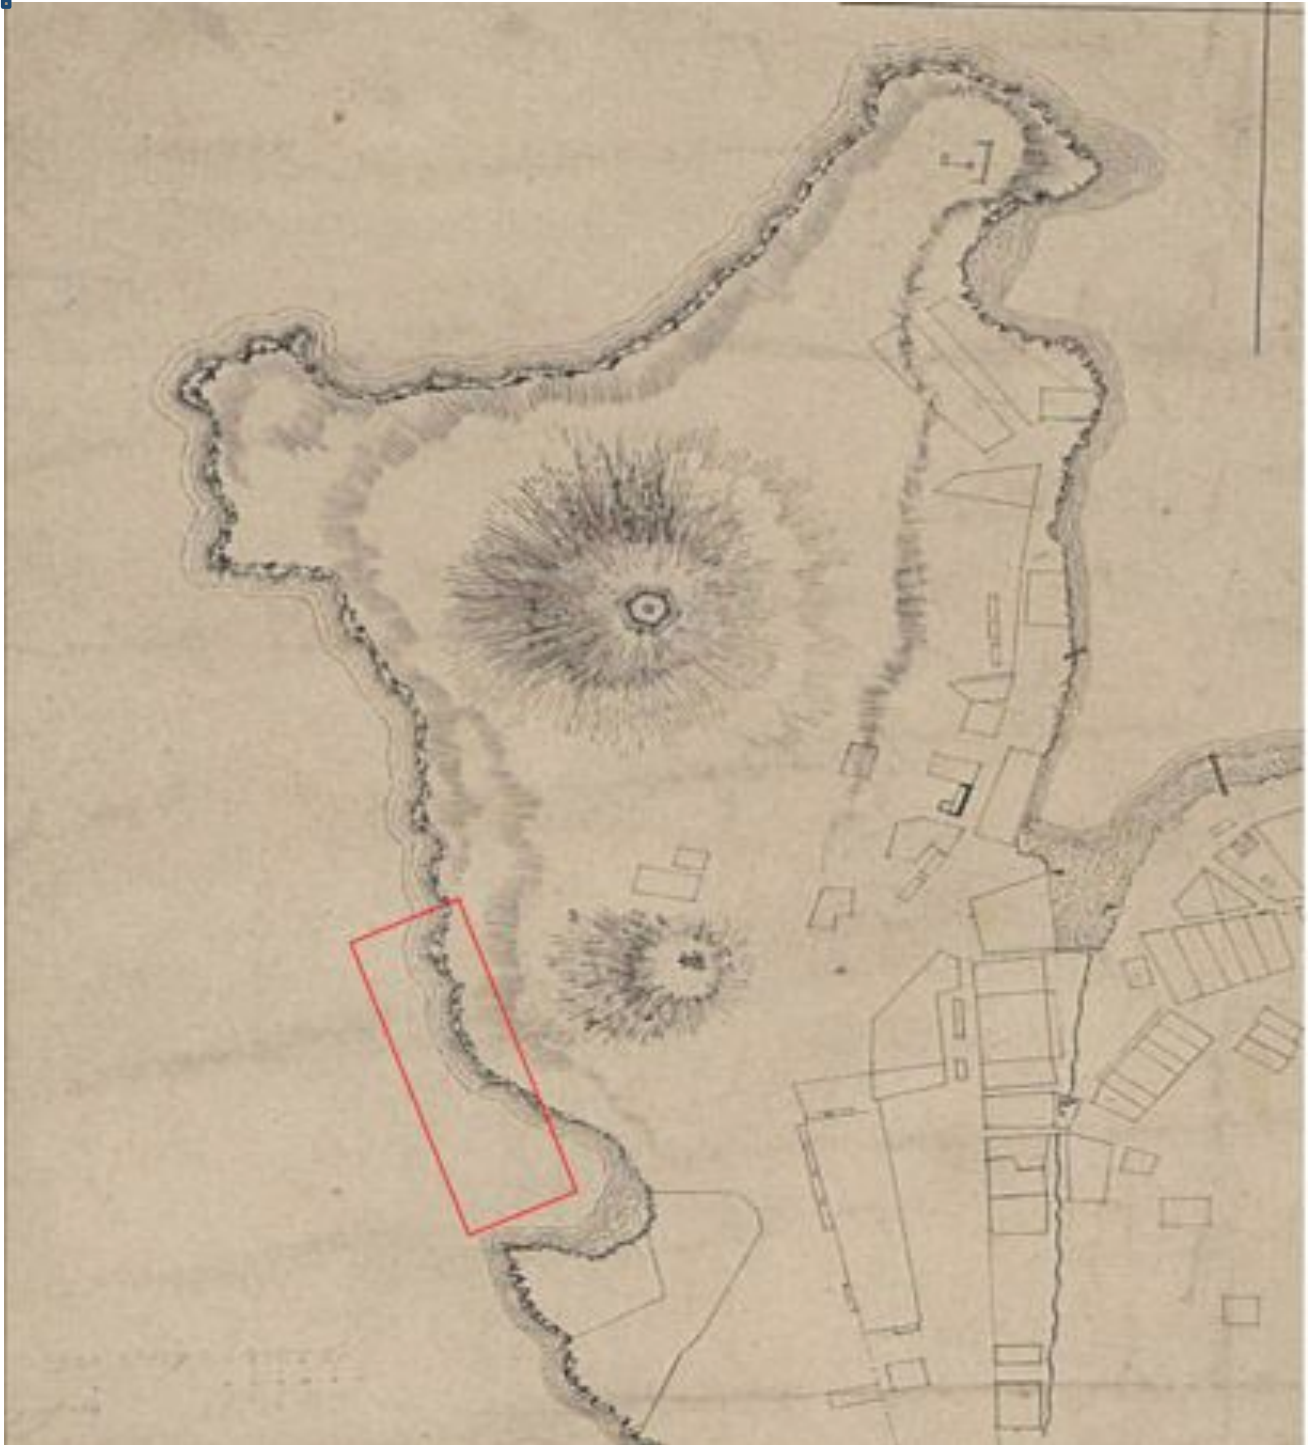
**Figure 5:** 1807 plan of its environs prepared by Charles Grimes, Surveyor General. Plan indicates a rocky foreshore. The approximate location of the Barangaroo South redevelopment, adjacent to the study area, is shown in red. Image Courtesy: The National Archives (UK) (CO 700/NewSouthWales18). Image reproduced from Casey (2010: 19).

Charles Grimes, Surveyor General and James Meehan, Assistant Surveyor of Lands, both prepared plans of Sydney in 1807 (Figure 4; Figure 5). These plans show a rapid increase in development of the land to the east of Darling Harbour. Two long thin rows of buildings visible to the southwest of the government windmill are thought to be allotments and houses. Readily identifiable by their orientation at an angle to the continuation of Soldiers' Back Row (renamed Kent Street in 1810), these appear more clearly in later plans and surveys (Casey 2010:17; Sydney Gazette 6 October 1810). Few of the early maps give a true impression of the topography of Sydney Harbour and it is only the location and orientation of the earliest buildings that help to identify the realities of the shoreline contours.

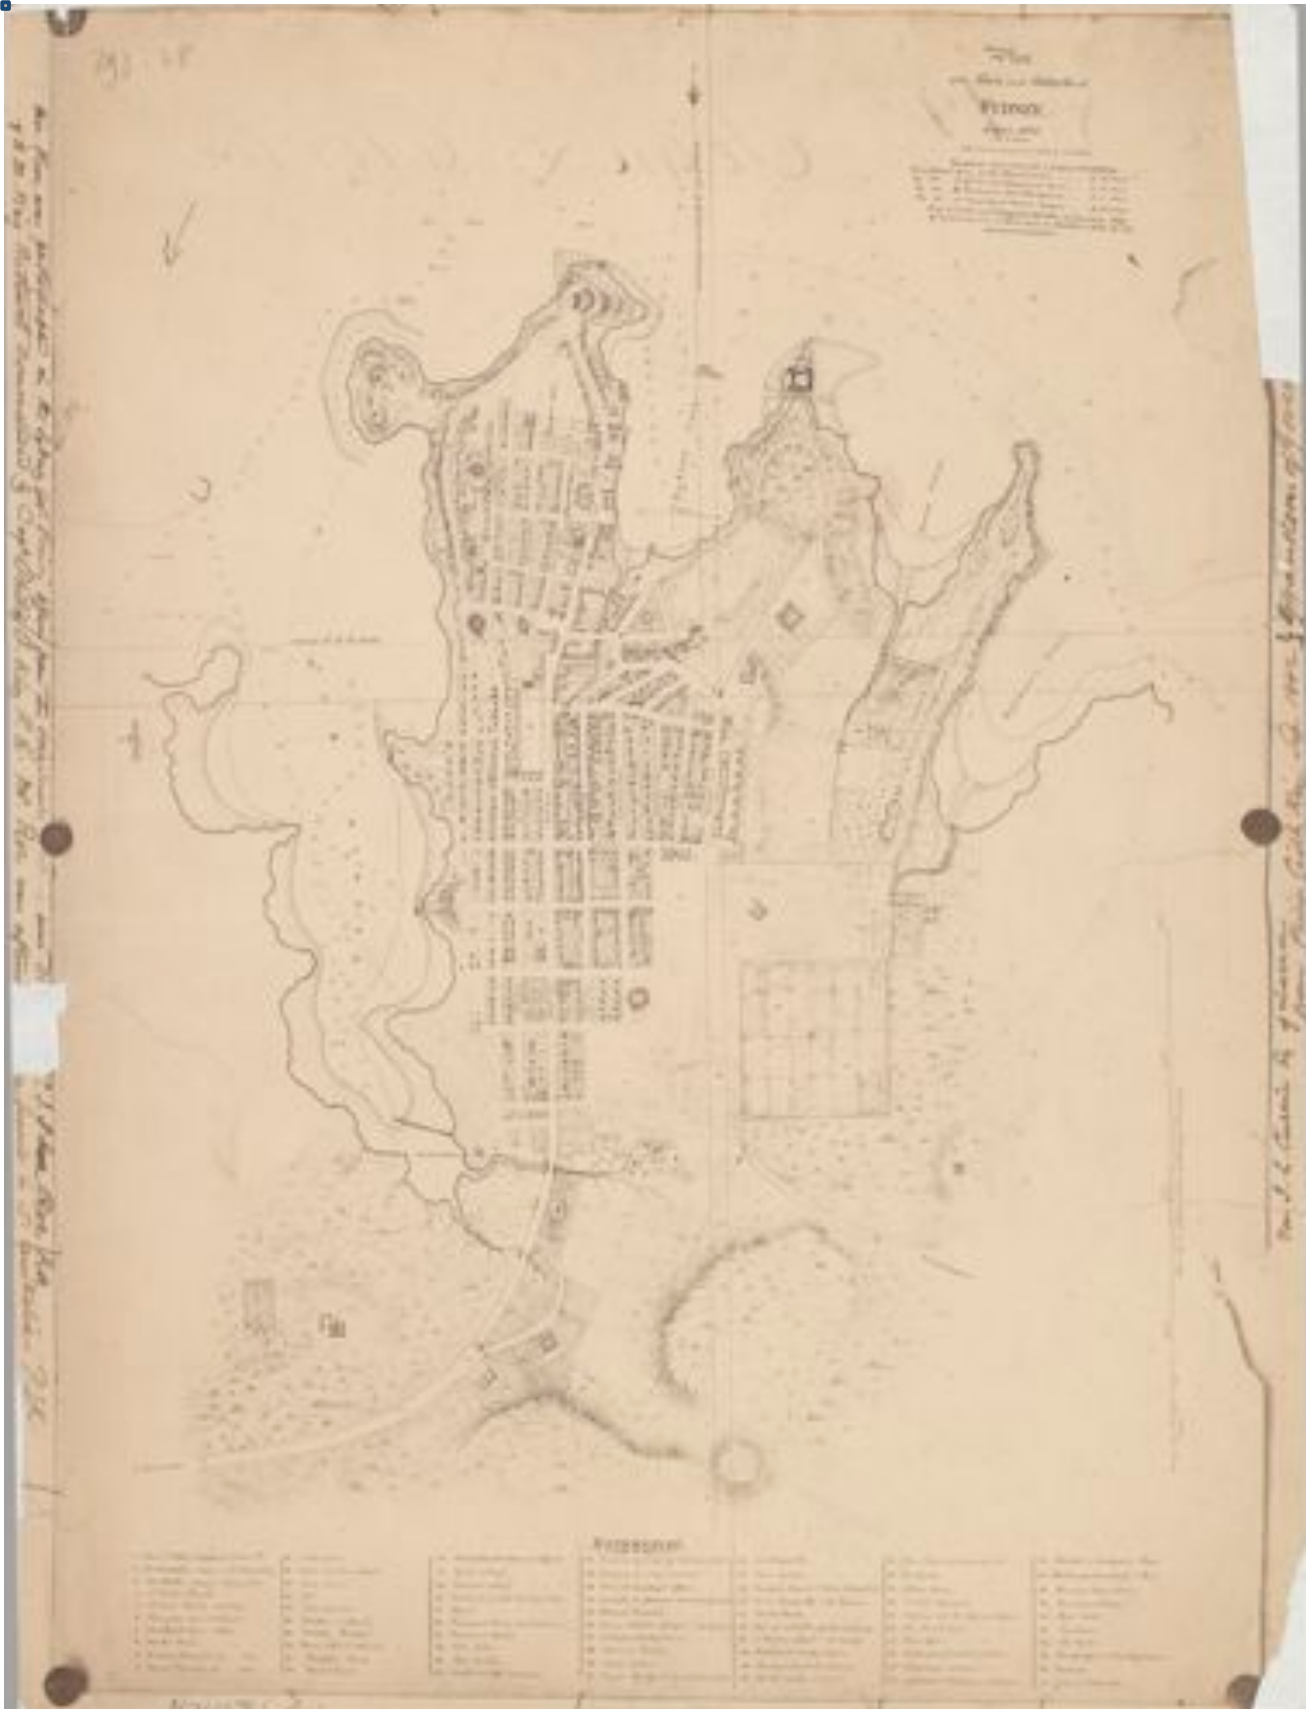
**Figure 7:** John Roe's Plan of Sydney dated 1822. Image shows modification of eastern Darling Harbour as a result of the development of maritime infrastructure (Arthur's Wharf). Image courtesy: State Library of Victoria (H24501).

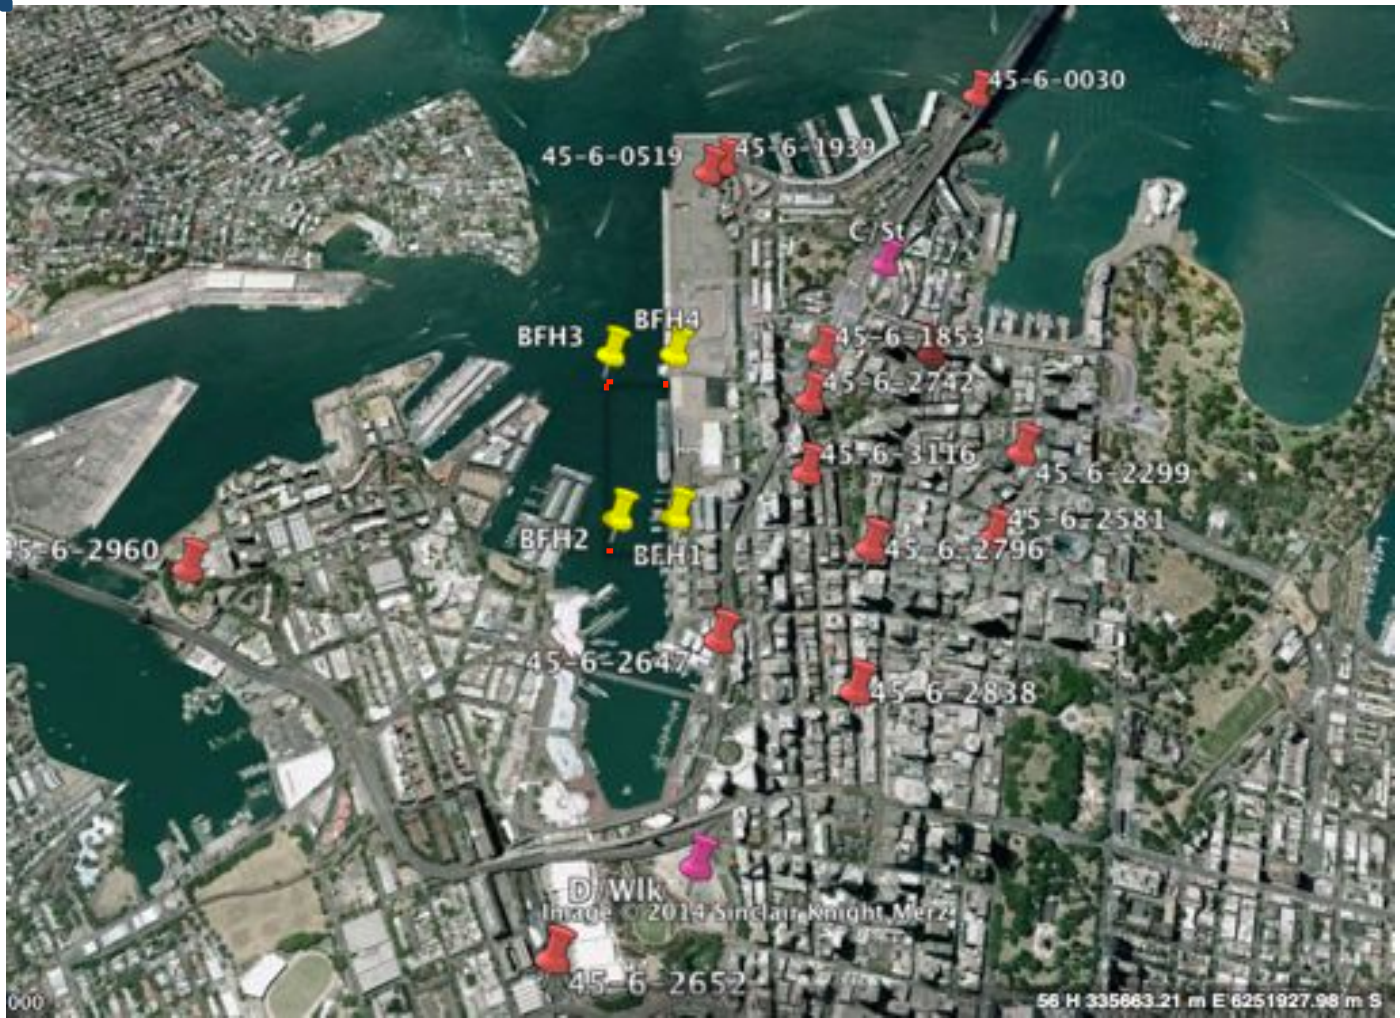
**Figure 9:** Map of central Sydney showing Darling Harbour, Barangaroo and the study area in red. The yellow pins illustrate the study area boundary coordinates (BF1-BF4), the red pins indicate Aboriginal sites previously recorded in AHIMS (Appendix 1) and the pink pins provide approximate locations for two Aboriginal sites mentioned in the literature, but not recorded in AHIMS i.e. the Cumberland Street campsite and the Darling Walk shell deposit. Image courtesy: Google Earth / Digital Globe 2014.

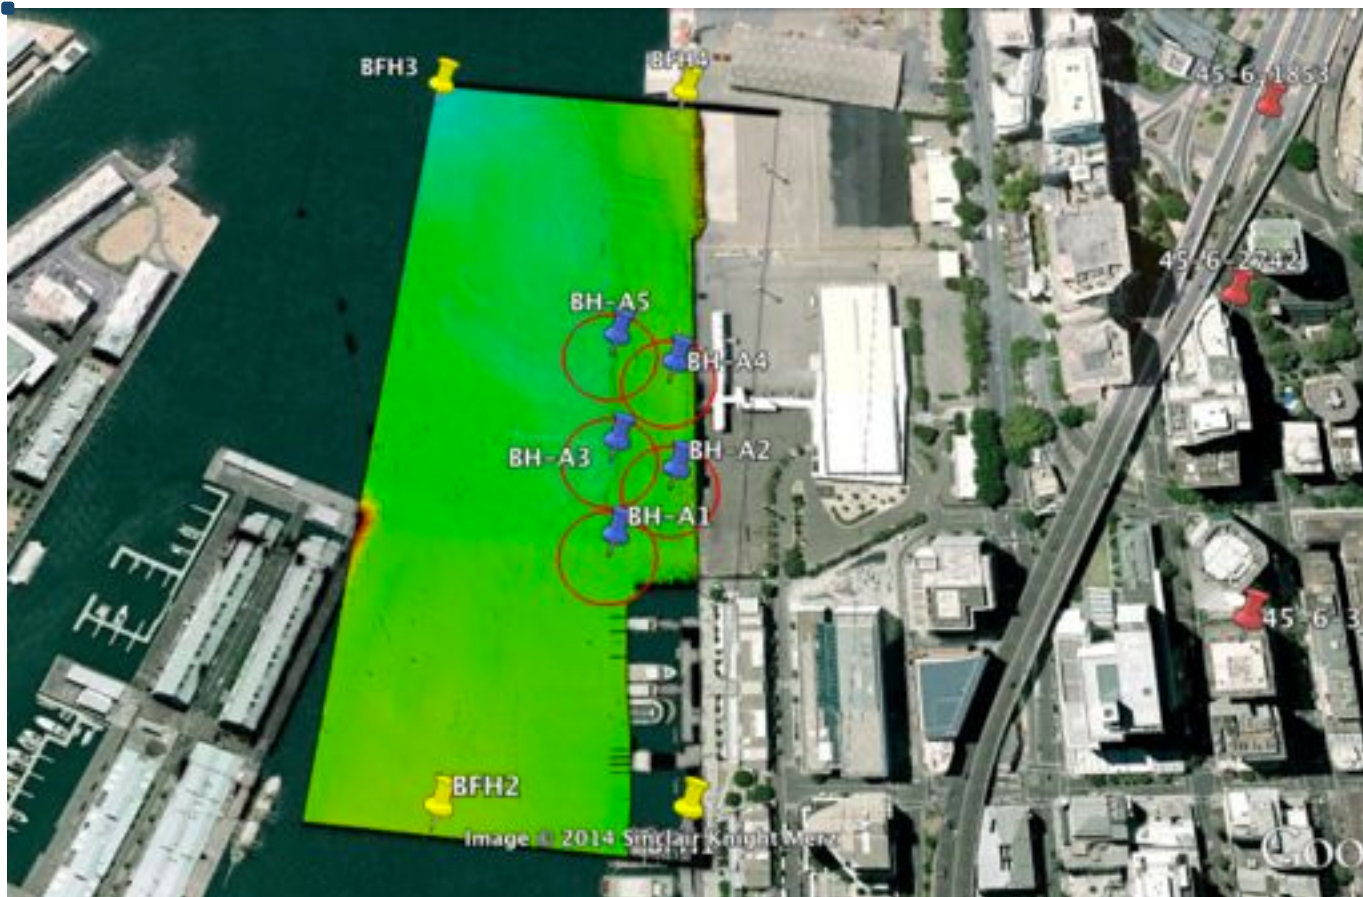
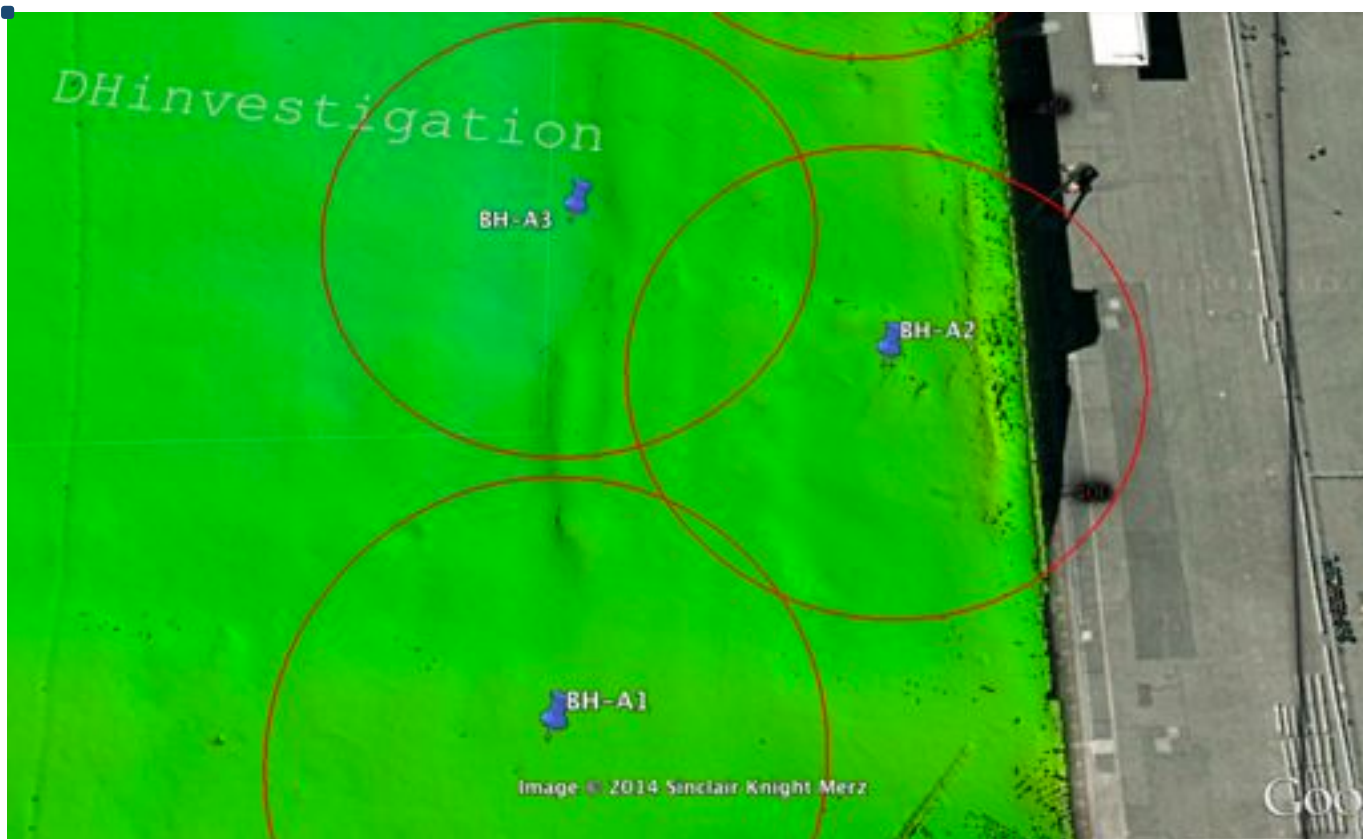
**Figure 10, Figure 11:** Map of the study area with the multi-beam data boreholes overlaid (Figure 10 above) with a close up of boreholes BH-A4 and BH-A5 (Figure 11 below). At least 30 individual anomalies have been identified on the seabed. The borehole locations (blue pins) and 30-metre buffer (red circle) will impact several of these anomalies. Image courtesy: Google Earth / Sinclair Knight Merz / Sydney Ports 2013-4.

The DSTO side-scan data verifies the multi-beam data gathered by Sydney Ports in 2013 and provides a more detailed image of the seabed in the study area, than was previously available. Within the BH-A1 buffer, for example, the side-scan data shows a rectangular anomaly that was not visible in the multi-beam data. The side-scan data provides confirmation that seabed anomalies present in November 2013 are still present today (Figure 12, Figure 13). This could be interpreted in one of three ways, that is, that the targets are:

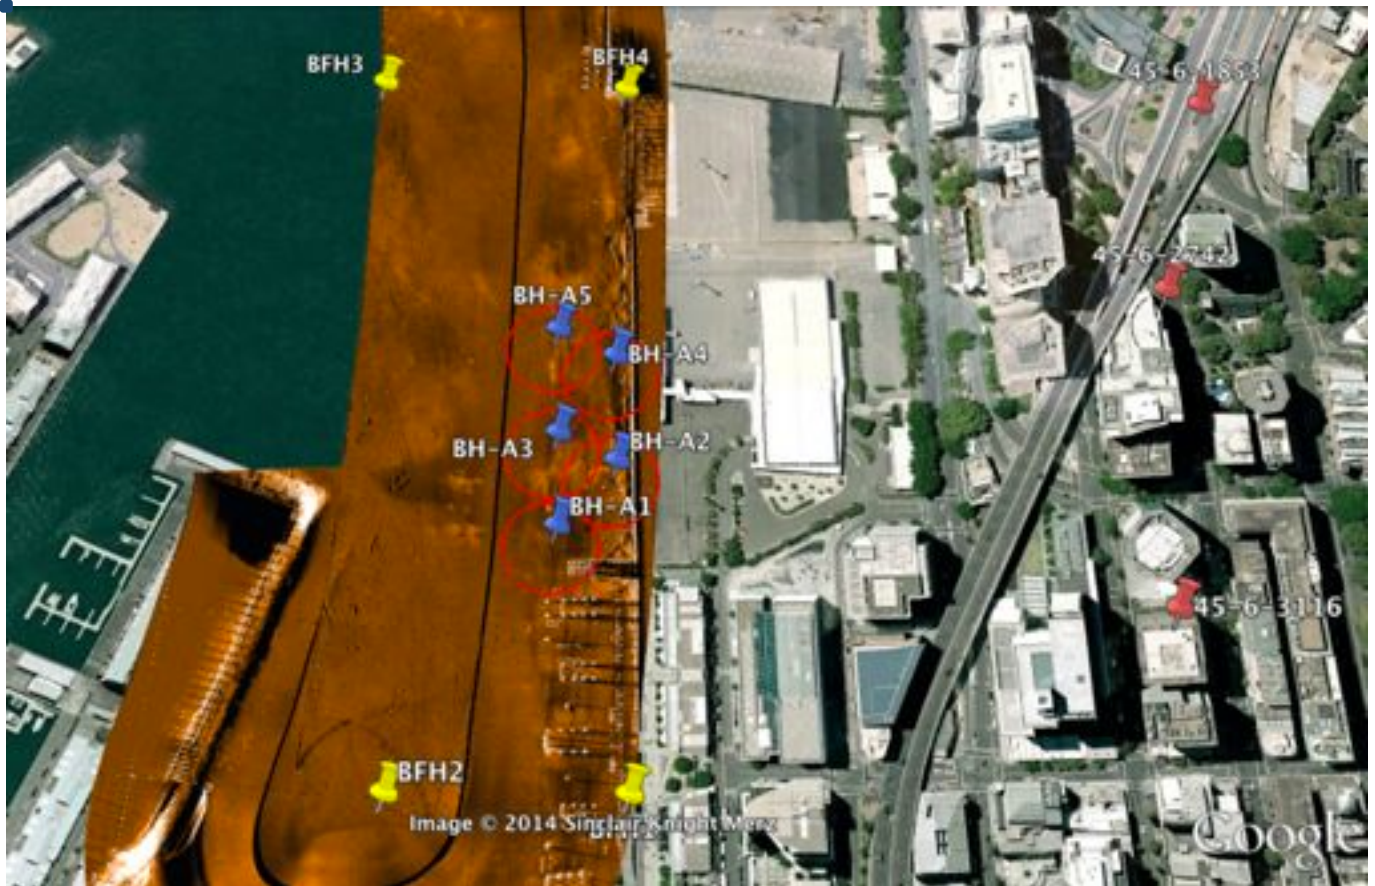
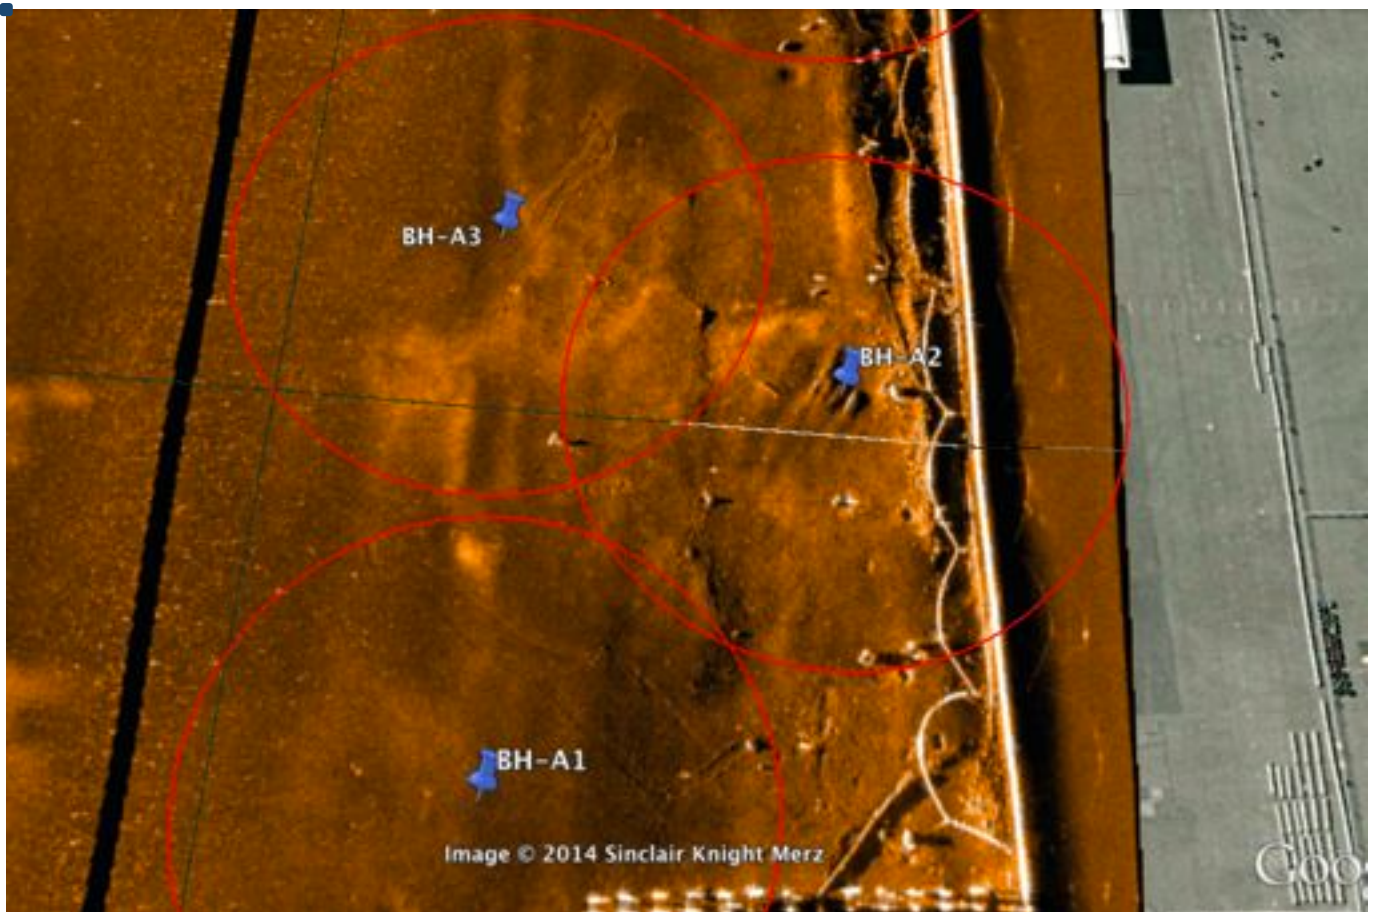
**Figure 12, Figure 13:** Map of the study area with the side-scan data, borehole locations (blue pins) and borehole impact areas overlaid (red circle) (above) with close ups of BH-A4 and BH-A5 (below). At least 30 individual seabed anomalies have been identified, with at least three anomalies per borehole impacted. Note the additional clarity provided by the side-scan data. Image courtesy: Google Earth / Sinclair Knight Merz / DSTO 2013-14.

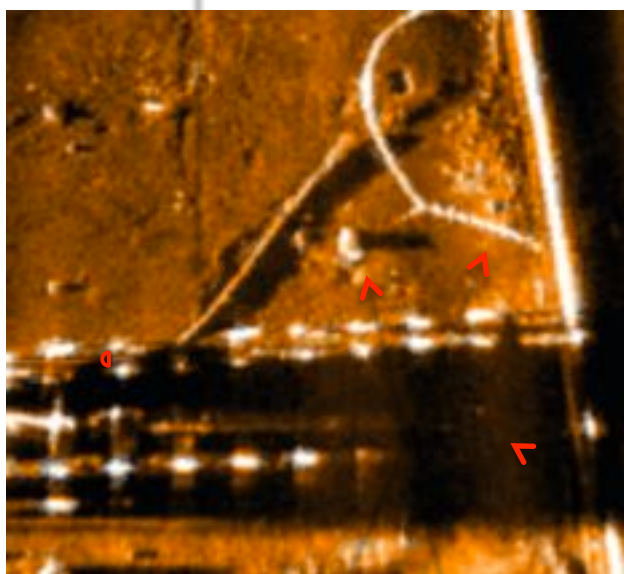
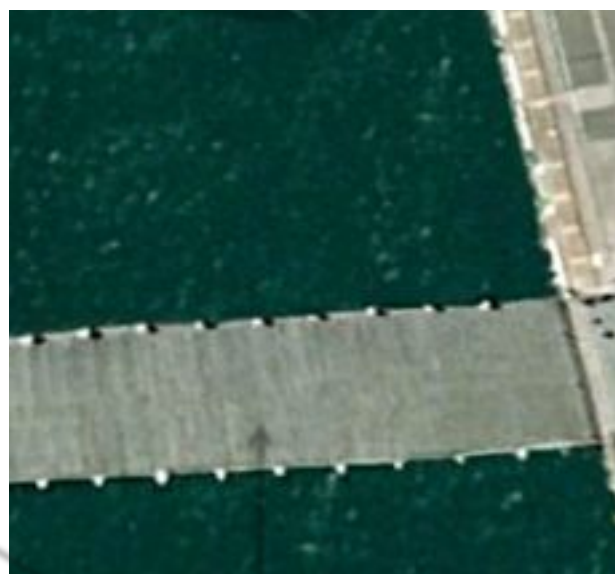
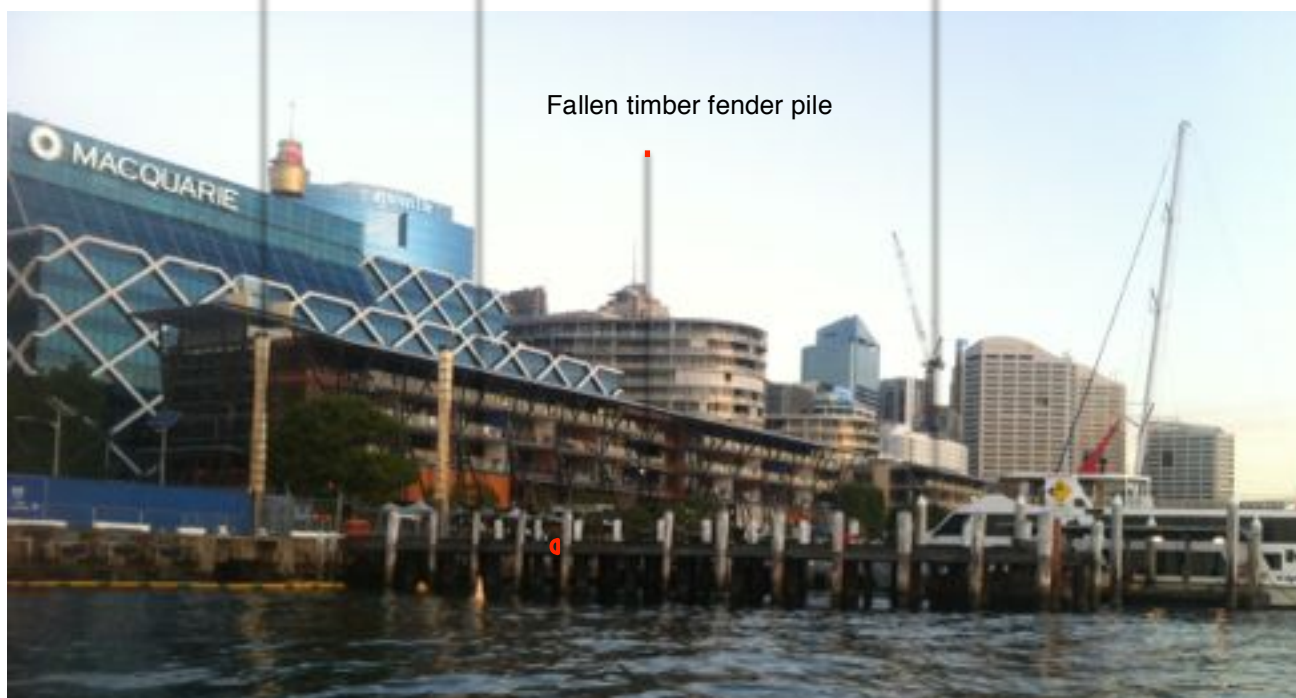
Fallen timber fender pile (ST-26)

Silt Curtain

Mooring Block

Timber jetty encapsulating a wash wall

Fallen timber fender pile

**Figure 15:** Sonar targets in context. An outline of the timber jetty encapsulating the wash wall is visible in the 2014 side-scan image (top left), as is target ST-26 (the fallen timber fender pile), a section of the silt curtain and the navigation buoy mooring block. The timber jetty, with pile in place, is visible in the 2009 aerial (top right). The silt curtain and navigation buoy are not. The photo (bottom) was taken during the 2014 visual inspection. This shows the silt curtain, yellow navigation buoy, timber jetty and gap from where the fender pile has fallen. Images courtesy: DSTO/Google Earth - Sinclair Knight Merz.

Figure 15 demonstrates how, by considering the environment topside (i.e. how the harbor is being used within the study area), that it was possible to tie many of the sonar targets to features topside. Importantly, no items of Aboriginal or European heritage significance were identified during the visual inspection. As a result it is considered that no items of Aboriginal or European heritage significance will be impacted during the proposed early works and that the works can proceed in accordance with the recommendations contained in Section 8.

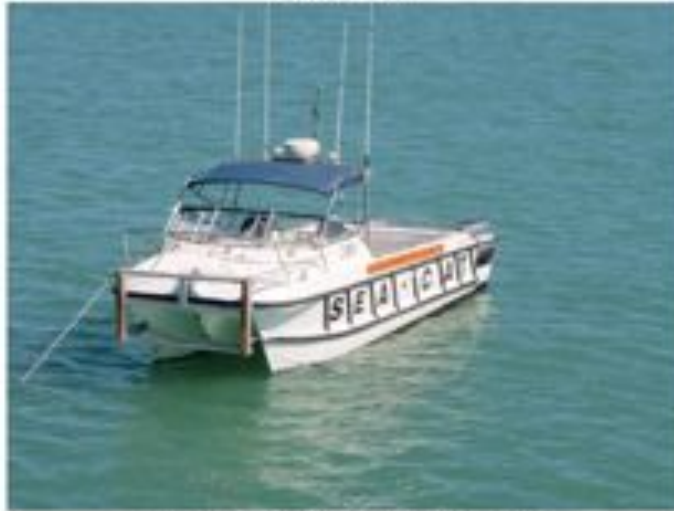
"MV SEA CAT"

MV Sea Cat on Station Darwin Harbour

"SEA CAT"	
Specifications	
Type of vessel	Work Boat
Operator	Australian Barge Hire Pty Ltd
Survey	NSW Maritime 2C
Built	2004
Construction	Fibreglass
Measured length	7.47 m
Moulded breadth	2.40 m
Moulded Depth	0.70 m
Engines	Twin 175 hp Mercury Optimax Outboards
Fuel Capacity	300 litres
Service Speed	20 knots
Road Transport	Drop Deck Semi Trailer
