# Appendix J Technical Paper: Statement of Heritage Impact (maritime)

**Statement of Heritage Impact**  
**Barangaroo Ferry Hub, East Darling Harbour**  
Report for Transport for NSW

Report Number: PR22016-2

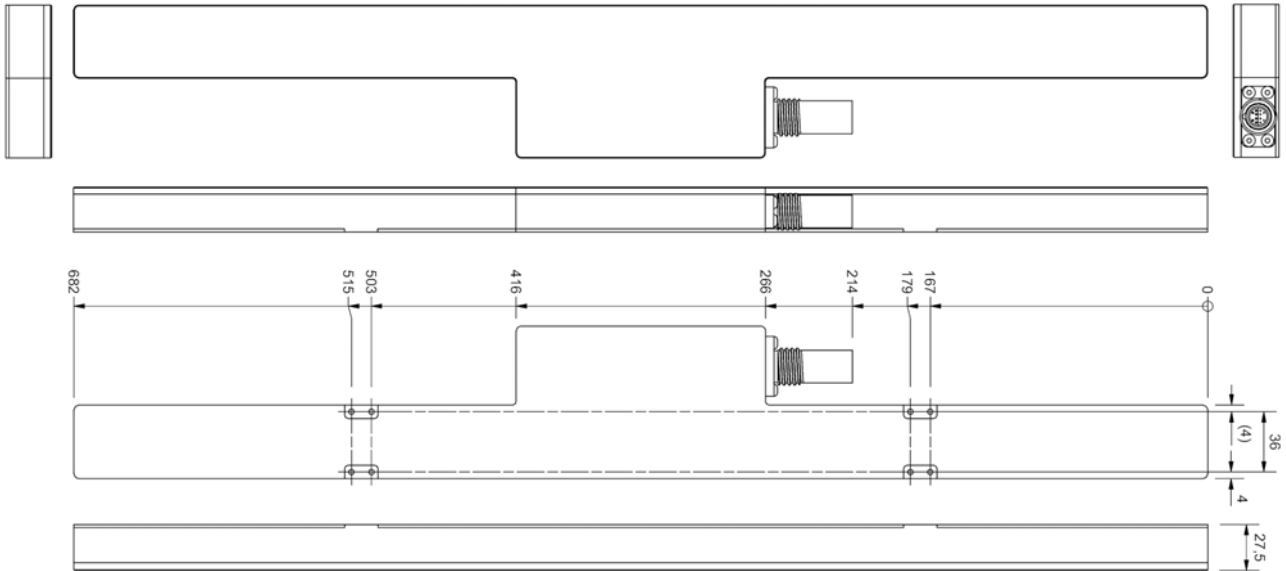
Solstice 3000 shown

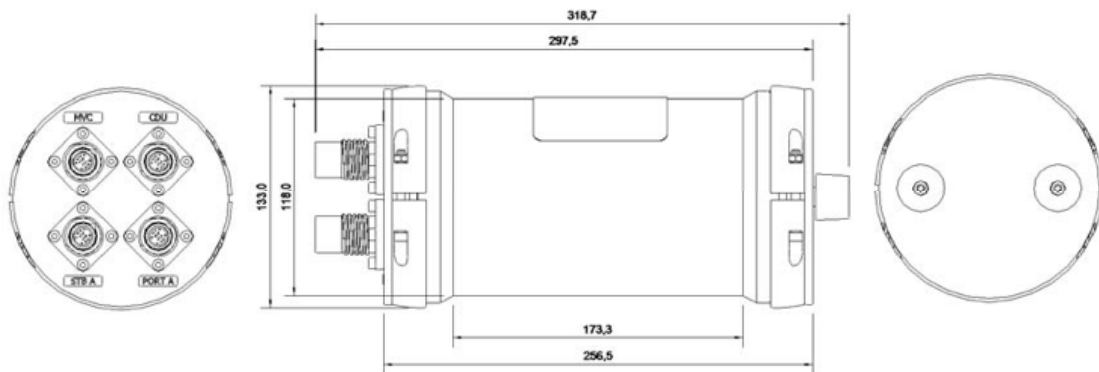
Optional Payload Pressure Vessel (PPV) Shown
