## 4.0 Existing environment

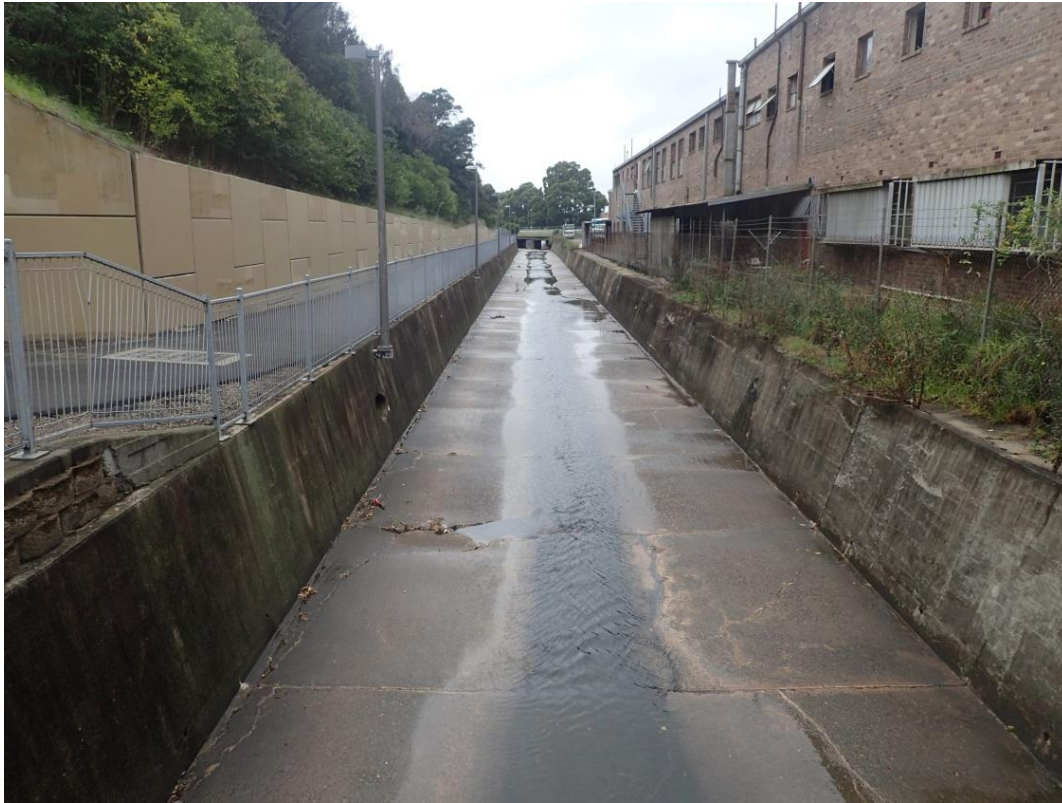
**Figure 5** Wolli Creek concrete-lined trapezoidal channel upstream of Kingsgrove Road

The upper section of Wolli Creek, from Beverly Hills to Bexley Road, is generally anthropogenically modified with hard engineered lining with the majority consisting of a concrete-lined trapezoidal channel (refer to photographic example in Figure 5). This upper section is owned and managed by Sydney Water as part of its trunk drainage system. Sydney Water owns and manages the creek from its beginning until Bexley Road where it enters Crown Land.

The upper section consists of a mix of open concrete-lined trapezoidal channels, reconstructed semi-natural watercourse channel, underground concrete channels, piped channels and rock-lined channels. Given the channel protection material, the channels here are devoid of geomorphic features, apart from the occasional sediment deposition slug that forms around / behind a channel intrusion, such as a bridge pier, or debris blockage. The susceptibility for in-channel erosion is minimal.

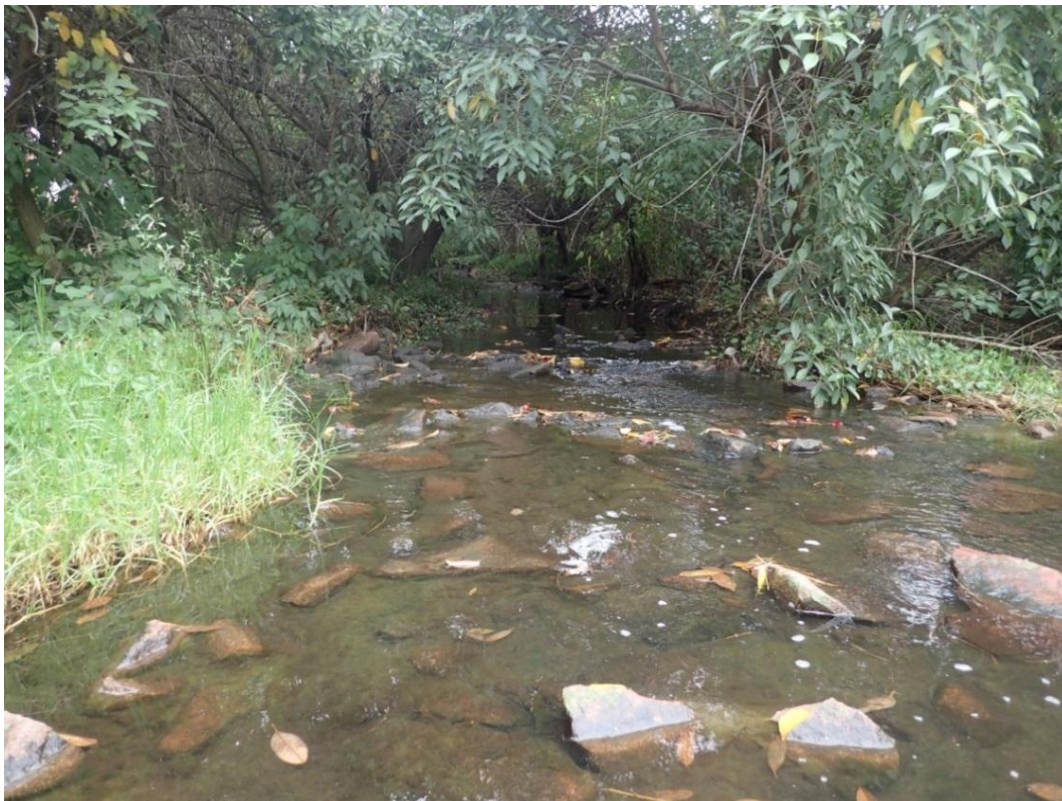
**Figure 6** Constructed 400 m reach of grouted rock rip-rap and vegetation near The Crescent

The reconstructed semi-natural watercourse channel extends for around 400 metres near The Crescent, Kingsgrove. The 400 metre reach of formed, but unlined, earthen channel is constructed of grouted rock rip-rap and vegetation (refer to Figure 6). Although naturalised, this reach is heavily degraded with sedimentation and infested with weeds. However, the grouted rock-rip rap means that the channel at this point is generally stable, with the bed and banks likely to be resistant to erosion. Downstream of The Crescent, the channel then returns to a constructed concrete-lined trapezoidal channel. Through the M5 Linear Park a number of water treatment measures are present; notably a Gross Pollutant Trap (GPT) operated by Sydney Water near Beaumont Street, Kingsgrove. The GPT filters low flows, resulting in some hydraulic head loss, particularly when partially blocked, though is bypassed in high flows.

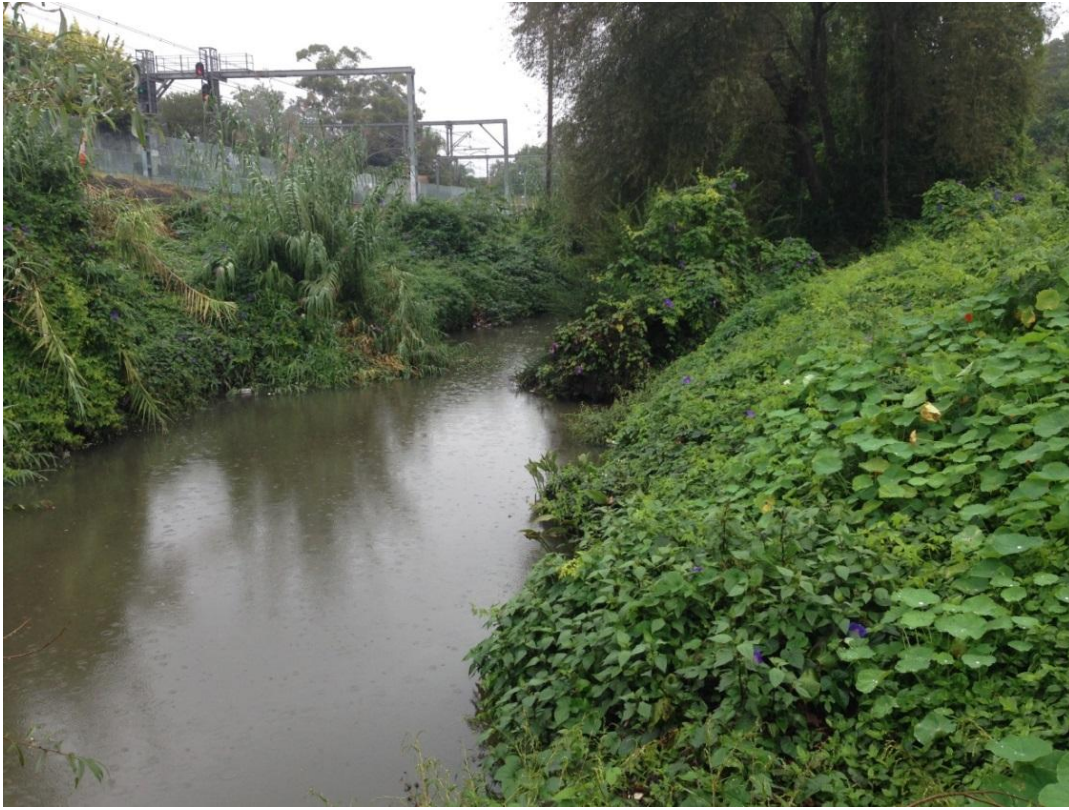
**Figure 7** Wolli Creek downstream of Bexley Road, near Illoura Park (looking upstream)

At Bexley Road the creek passes through a box culvert before flowing into a modified (shaped), but more natural, channel (the lower section) (refer to Figure 7). Downstream of Bexley Road, the creek features alluvial banks within a confined valley setting containing a number of modifications to accommodate the railway line, urban development, bridge crossings or recreational sports fields. This section of the creek is densely vegetated, predominately with weed species. The channel traverses through a short, confined valley setting with floodplain pockets before transitioning into a partly confined meandering, platform controlled setting.

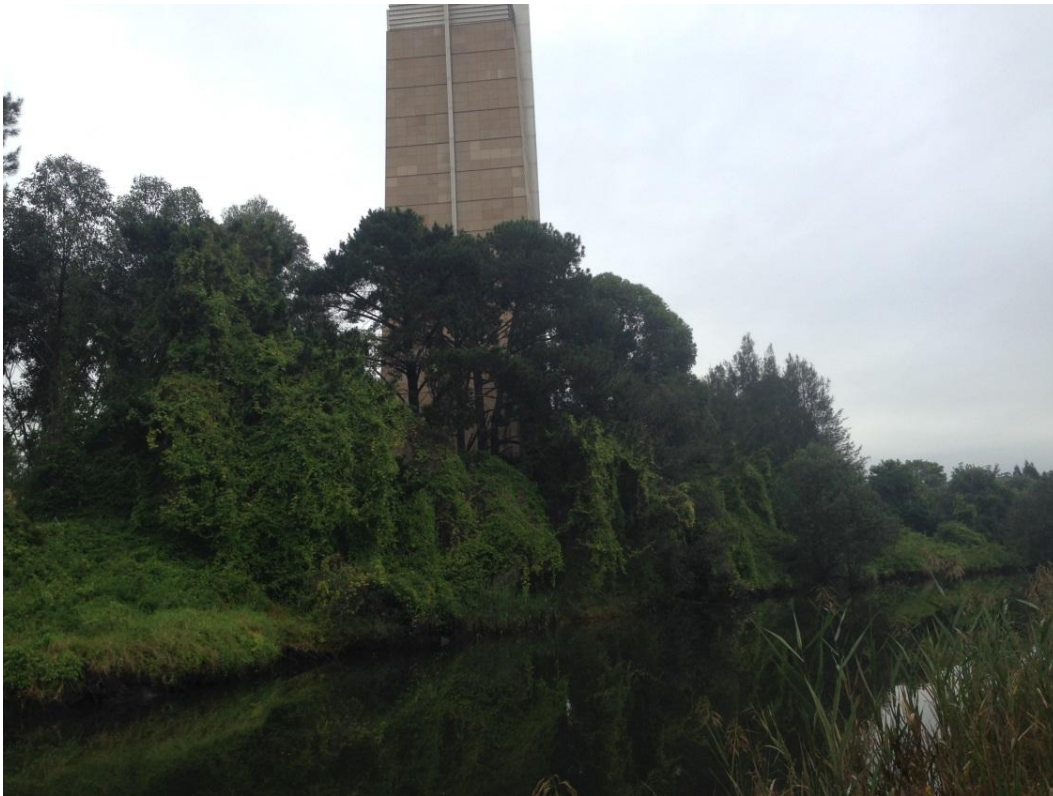
**Figure 8** The existing M5 East Motorway ventilation outlet and groundwater treatment plant discharge location near Turrella Station

The watercourse travels through the Wolli Creek Regional Park and is joined by Bardwell Creek on the northern side of the passenger rail line at Bardwell Park. Treated groundwater from the existing M5 East Motorway tunnel is discharged into the creek near Turrella Station (refer to Figure 8). A weir and associated fishway (refer to Figure 9) at Turrella Park, near Henderson Street regulates flow before reaching its confluence with the Cooks River adjacent to Wentworth Park, Wolli Creek.

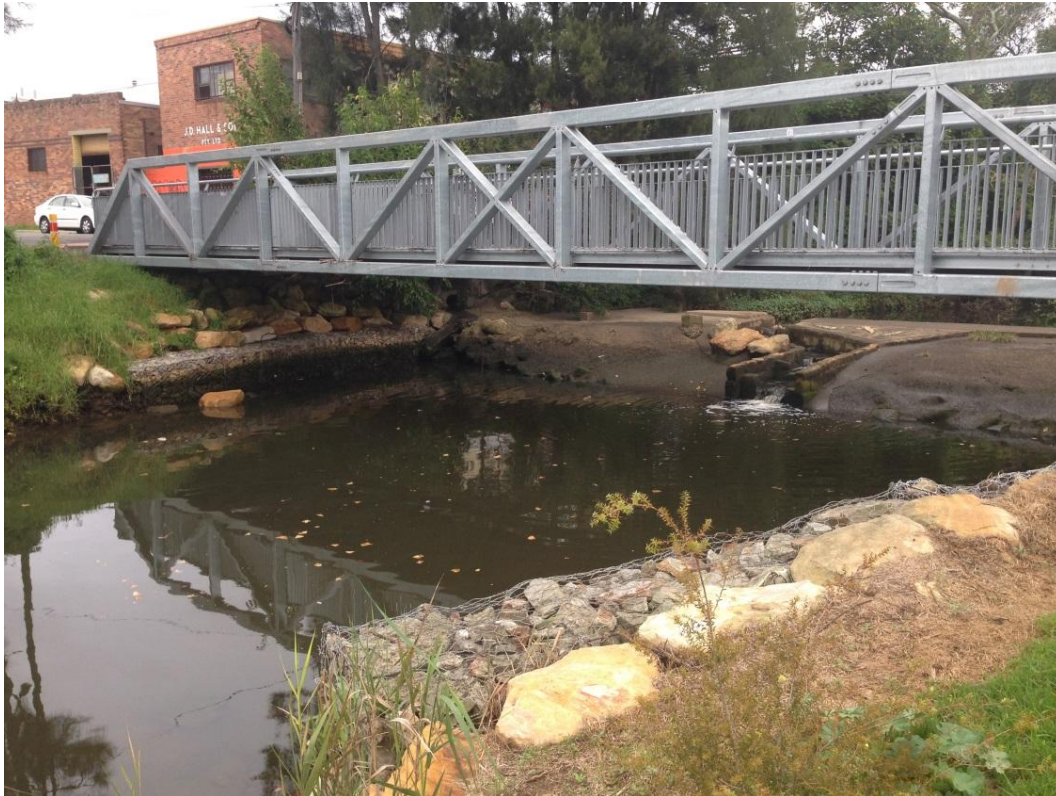
**Figure 9** Wollie Creek Turrella Weir fishway at Henderson Street

Based on the vegetation present it is expected that the majority of the tidal limit is roughly at the Turrella (Henderson Street) weir, with the upper extent (i.e. king tide) in the vicinity of the confluence of Bardwell Creek (MHL, 2005).

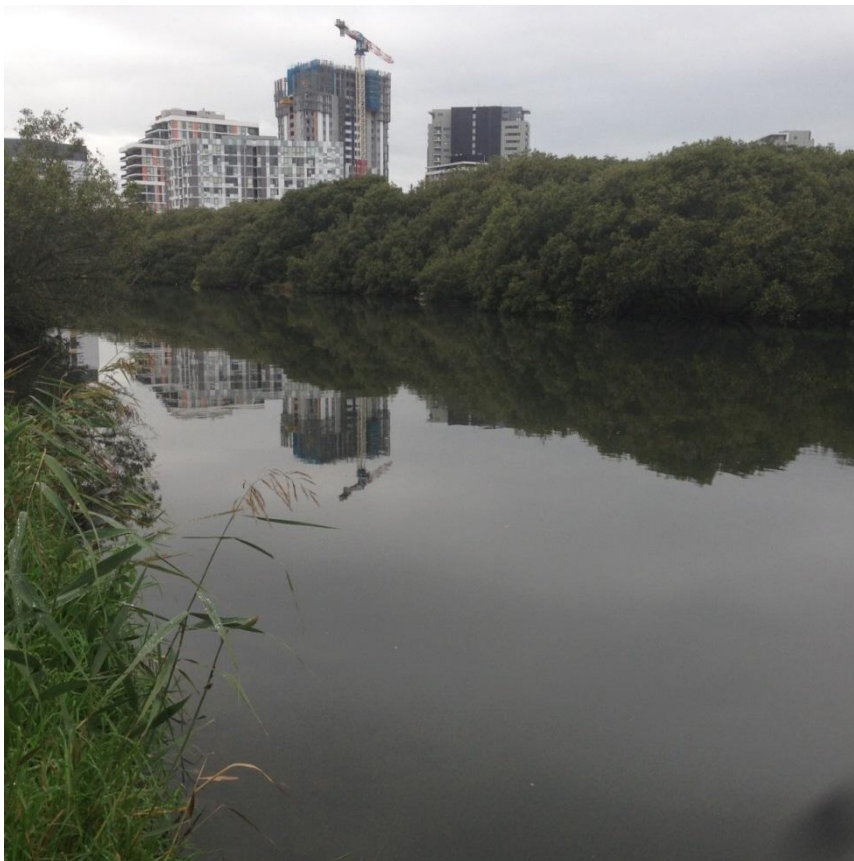
**Figure 10** Downstream extent of Wollie Creek, looking from Waterworth Park to the mangroves on the southern bank

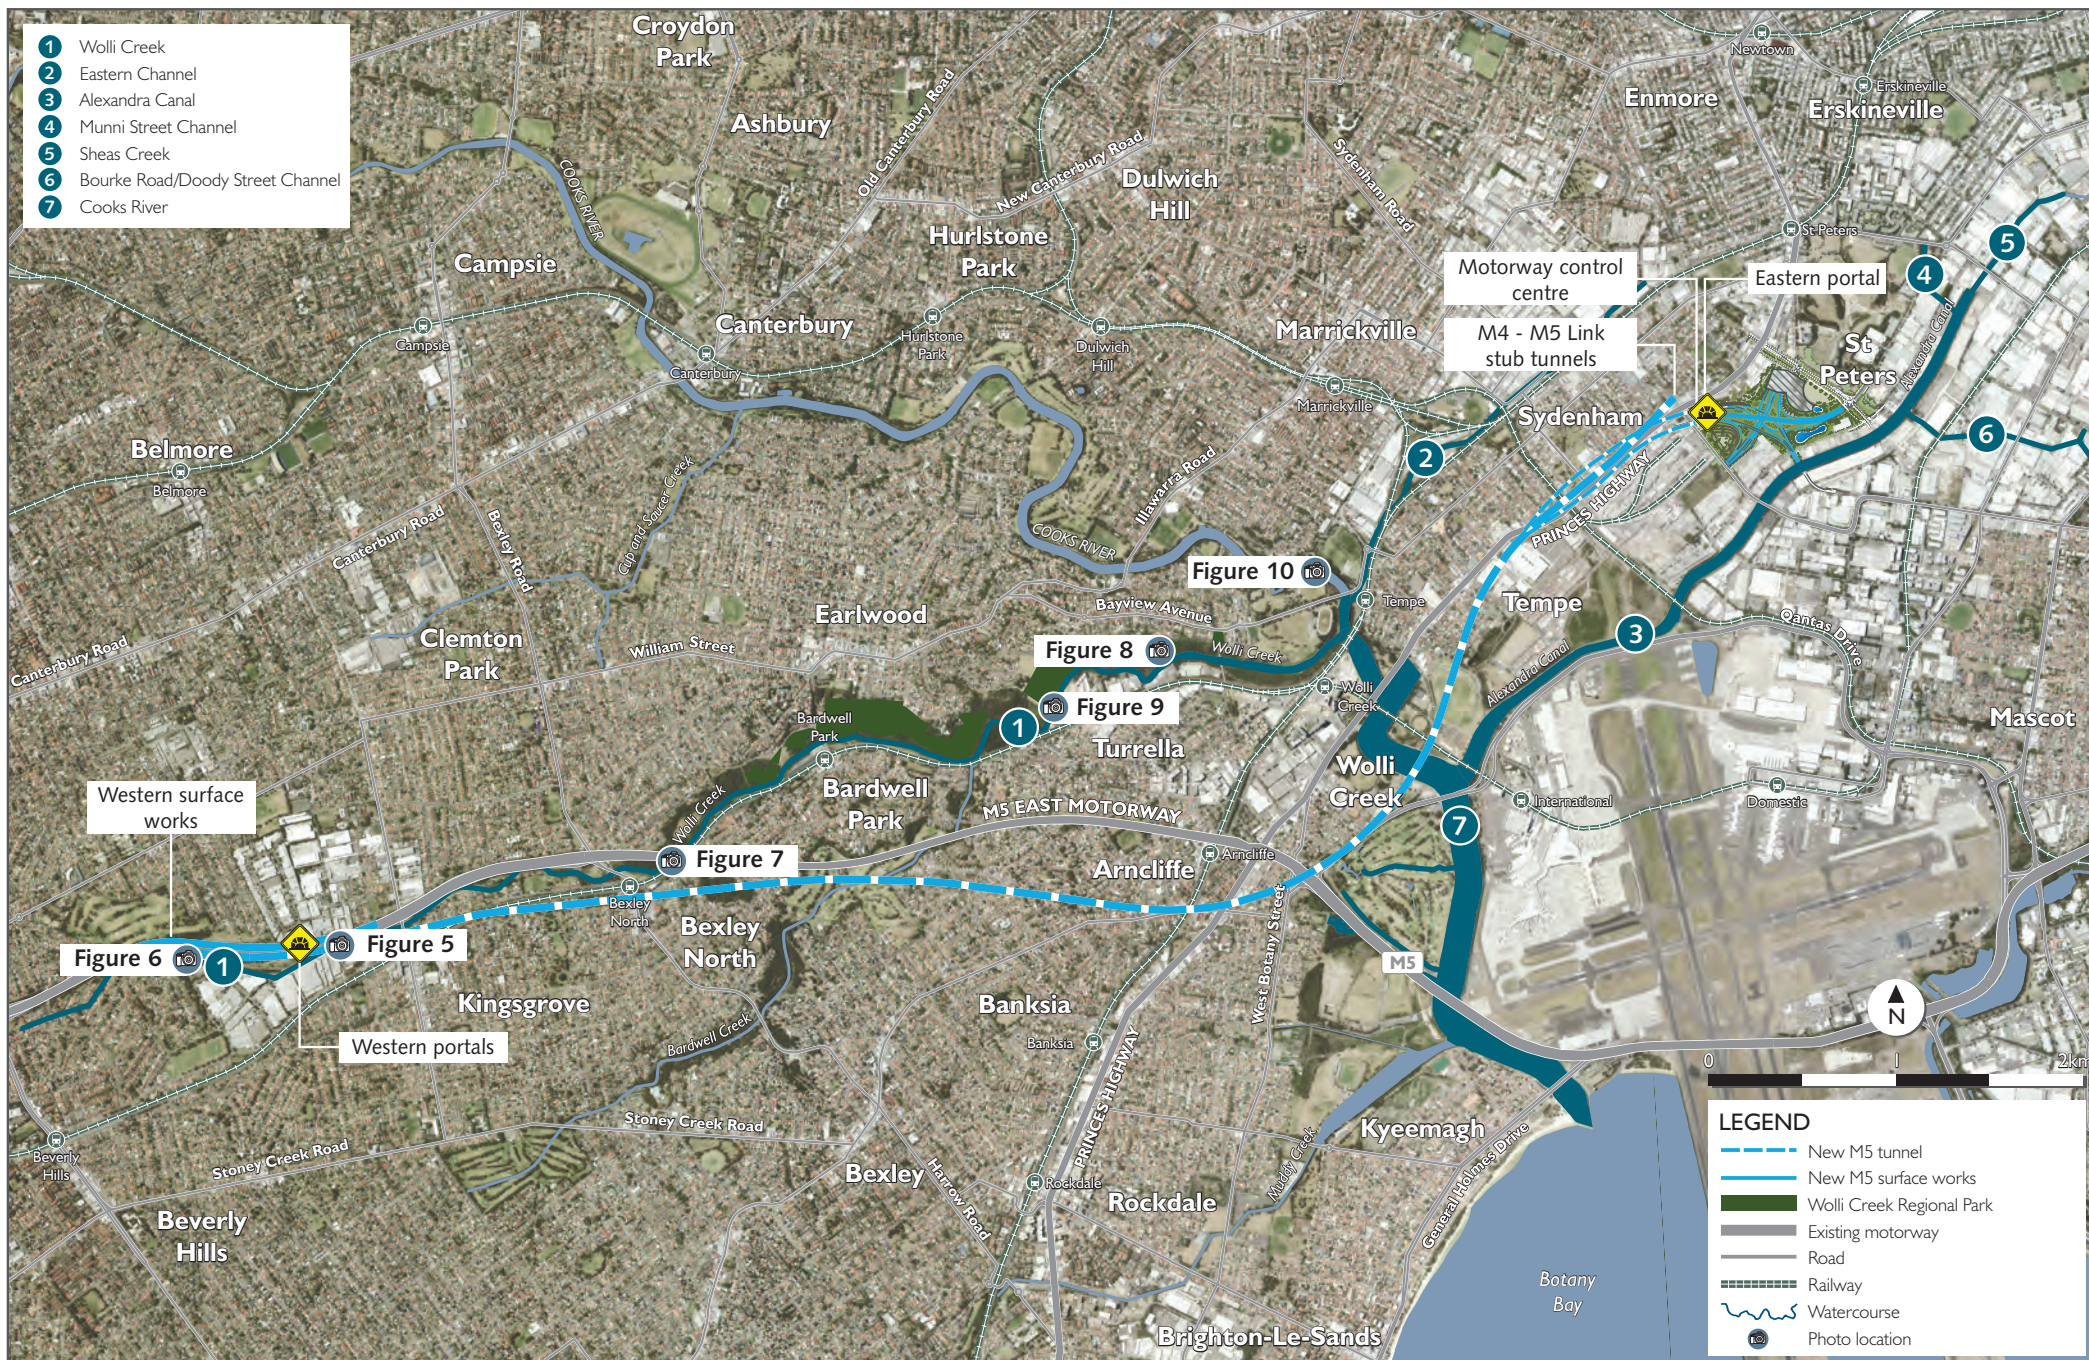
Figure 11 Location of photos shown in Figures 5 - 10

The locations of photographs shown in Figure 5 to Figure 10 are shown in Figure 11.
