Rankin Park to Jesmond  
Water Quality and Watercourse  
Impact Assessment Report

Job Number 22-17656  
Revision 0  
Date 25 Oct 2016

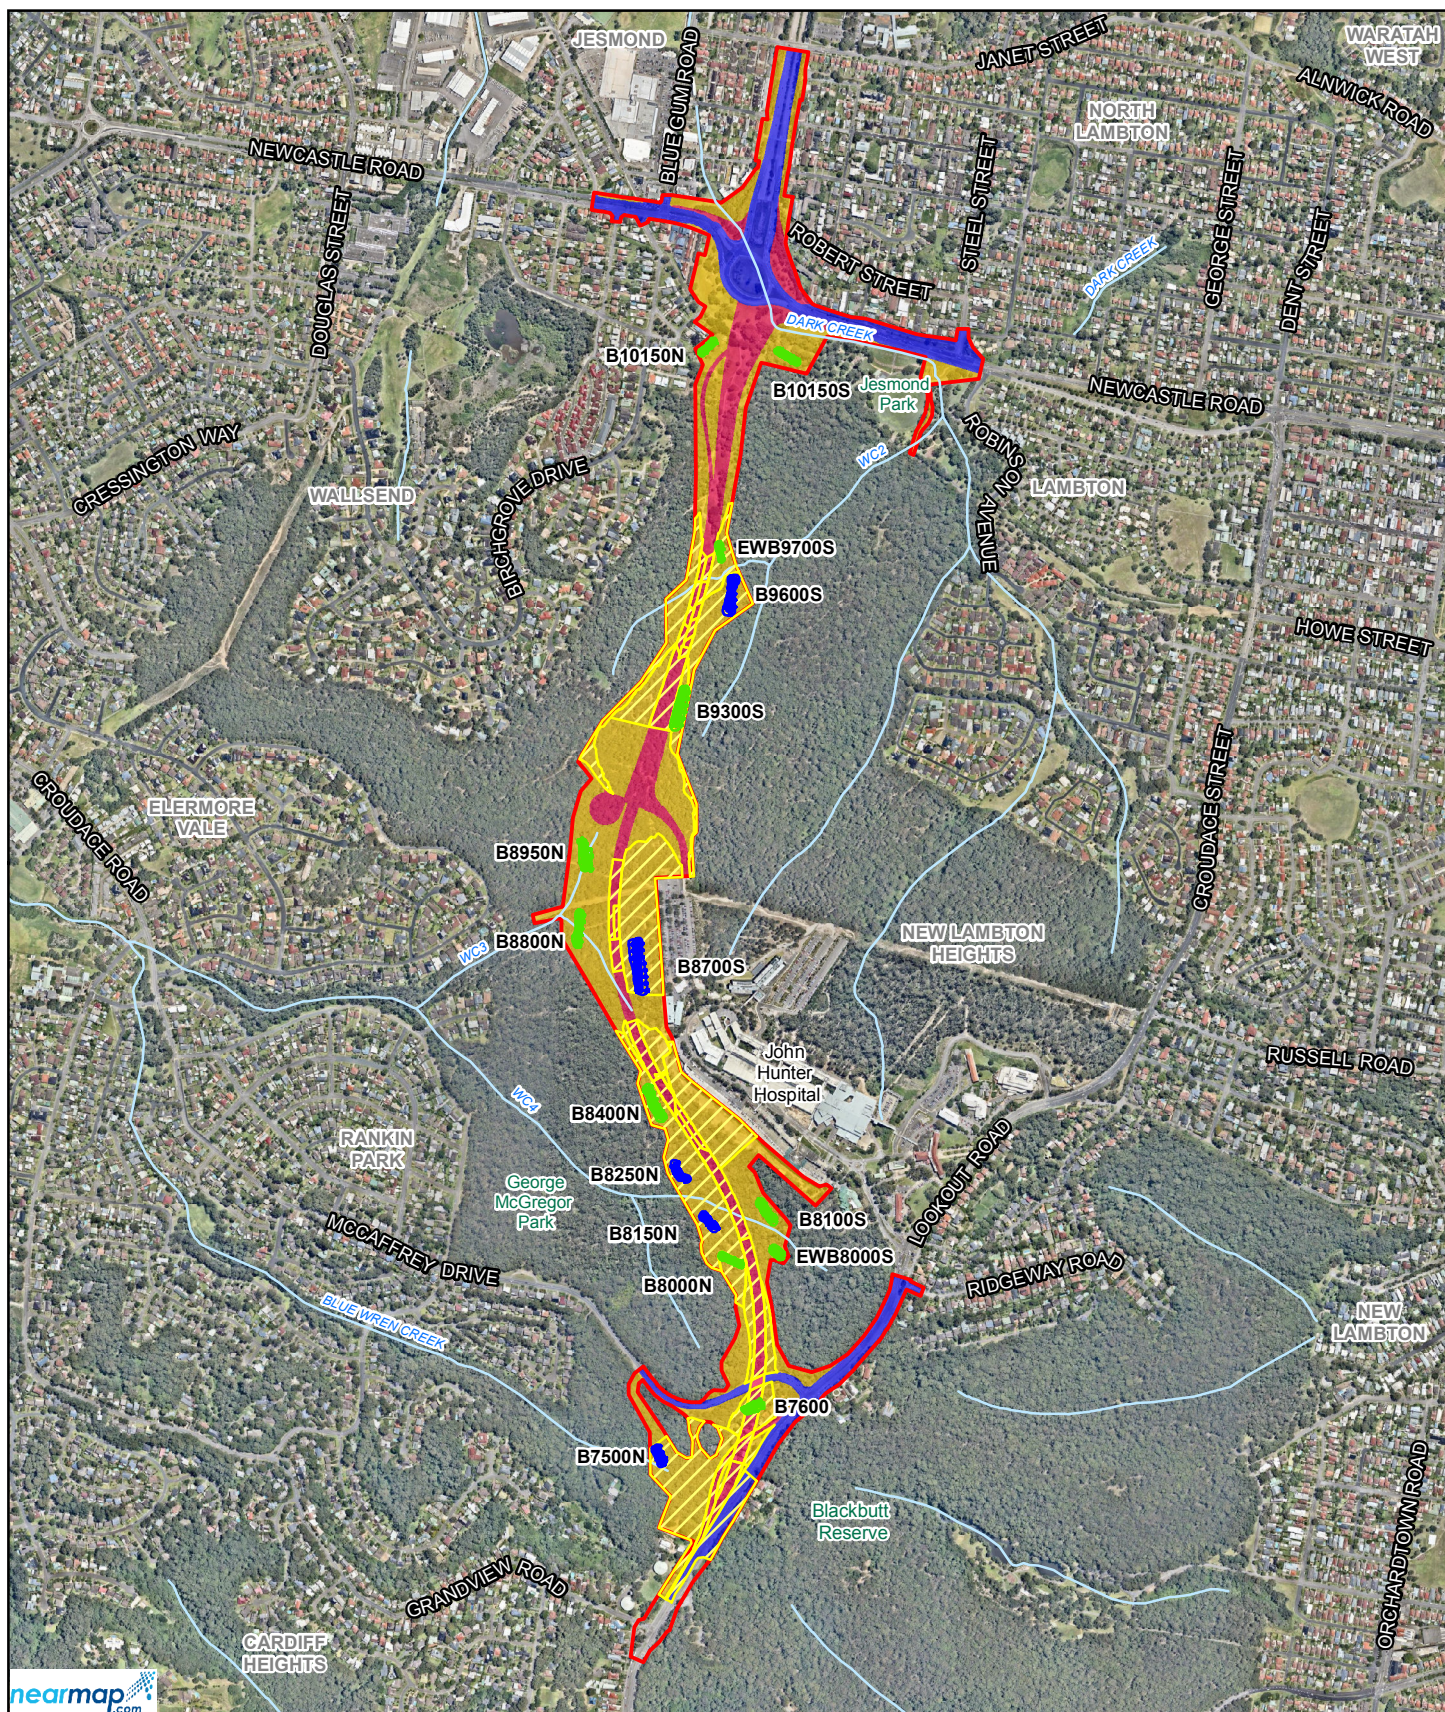
#### Figure 4-1

#### Construction footprint catchments

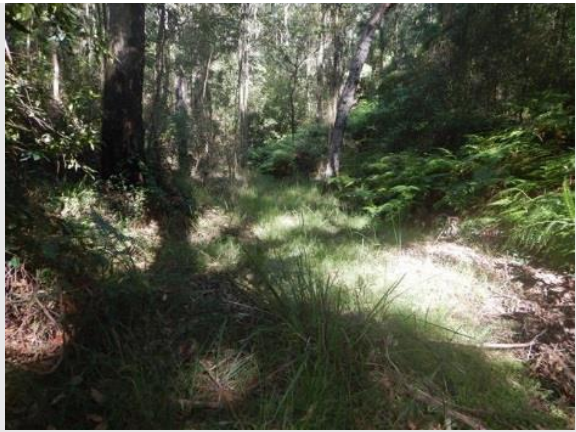
| Photograph | Description |
|---|---|
| | <p>Upstream view of fill deposit within narrow valley.</p> |

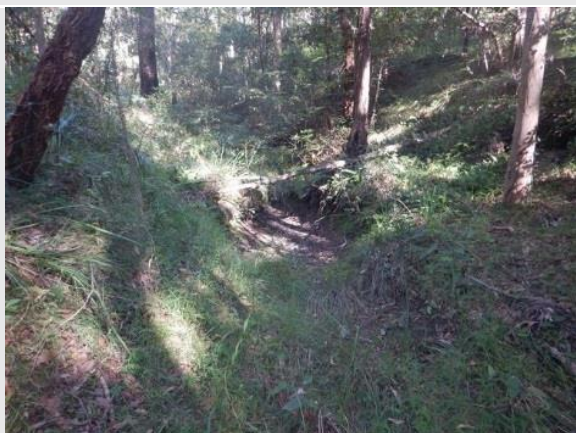
| Photograph | Description |
|---|---|
| | <p>Upstream view of scour hole in fill deposit.</p> |

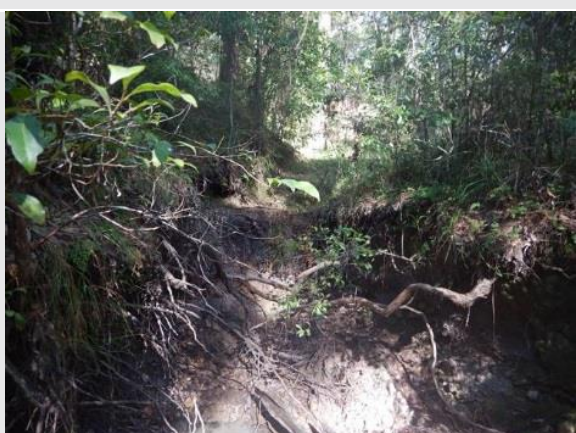
| Photograph | Description |
|---|---|
| | <p>Upstream view of gully head.</p> |

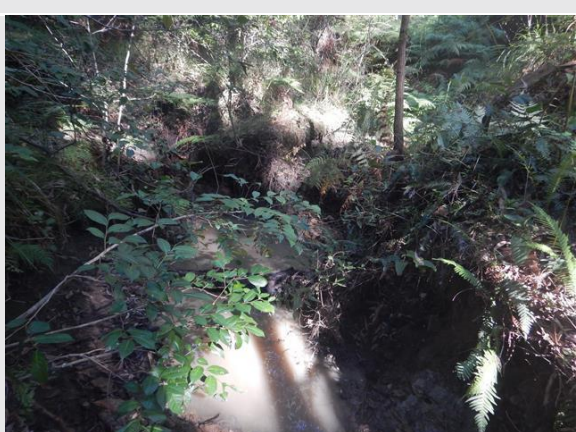
| Photograph | Description |
|---|---|
| | <p>Downstream view of incised channel below gully head.</p> |

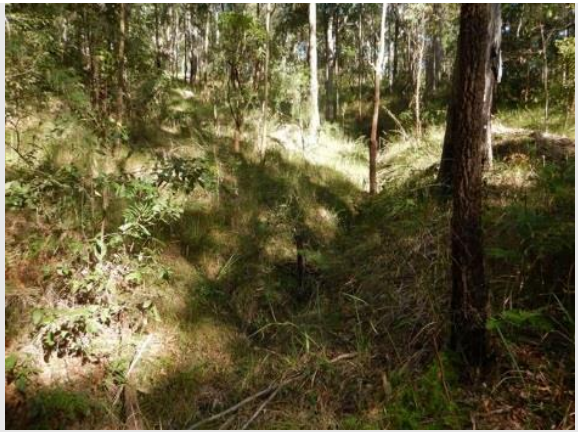
| Photograph | Description |
|---|---|
| | <p>Upstream view of upper steep gradient reach.</p> |

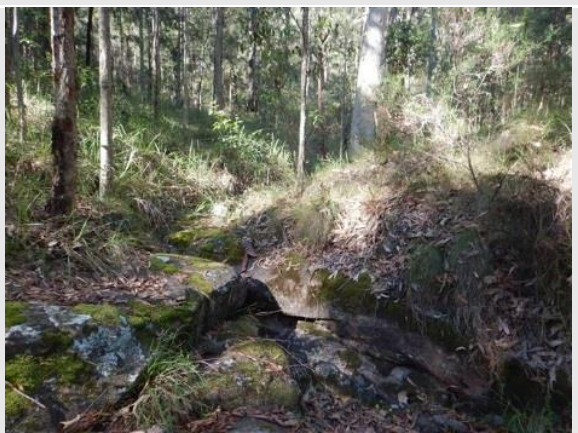
| Photograph | Description |
|---|---|
| | <p>Upstream view of bedrock bound reach.</p> |

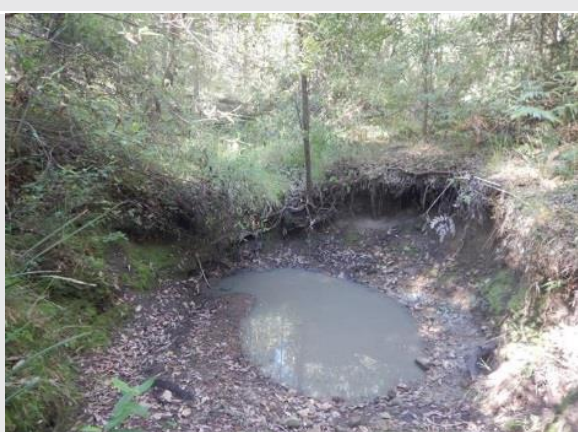
| Photograph | Description |
|---|---|
| | <p>Upstream view of gully head at downstream extent of the southern branch.</p> |

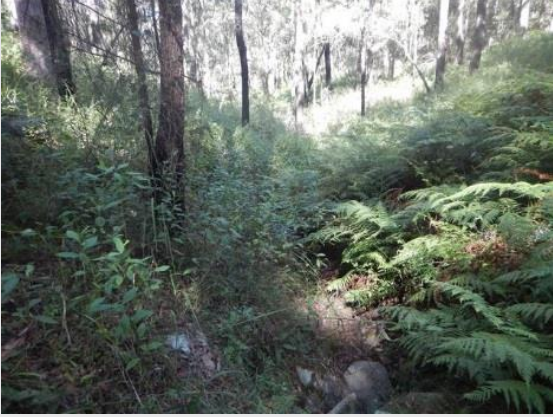
| Photograph | Description |
|---|---|
| | Downstream view of upper steep reach. |

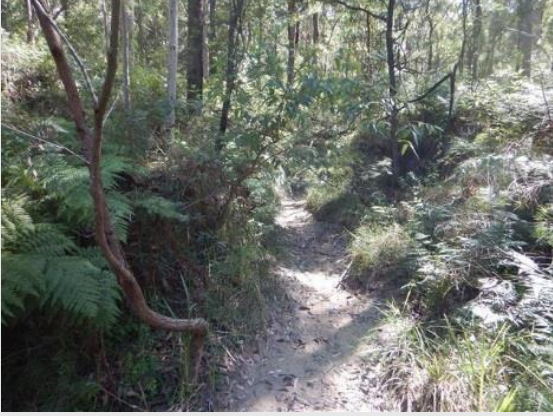
| Photograph | Description |
|---|---|
| | Upstream view in channelised section downstream of gully head. |

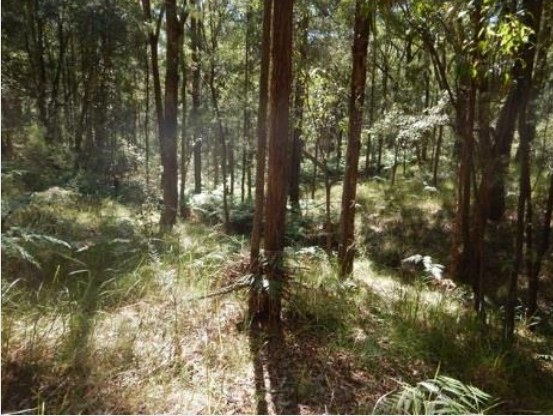
| Photograph | Description |
|---|---|
| | Downslope view to upper steep reach. |

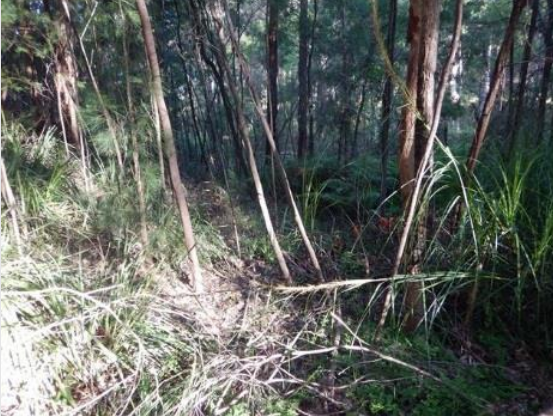
| Photograph | Description |
|---|---|
| | Upstream view displaying well vegetated fill deposit in valley floor. |

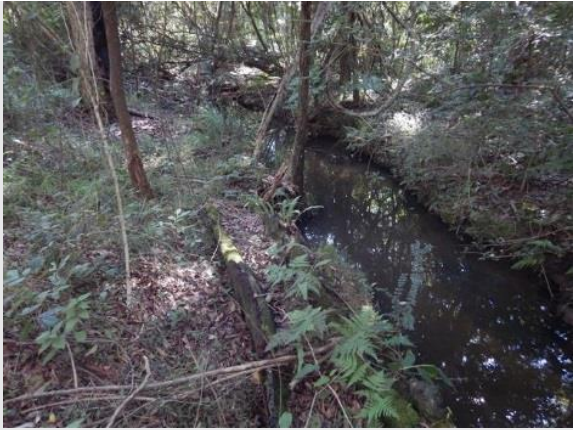
| Photograph | Description |
|---|---|
| | <p>Downstream view of Watercourse 4 displaying continuous channel.</p> |

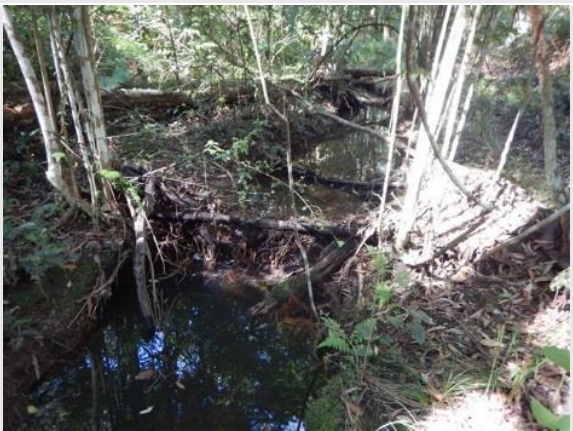
| Photograph | Description |
|---|---|
| | <p>Upstream view of Watercourse 4 displaying debris/root step.</p> |

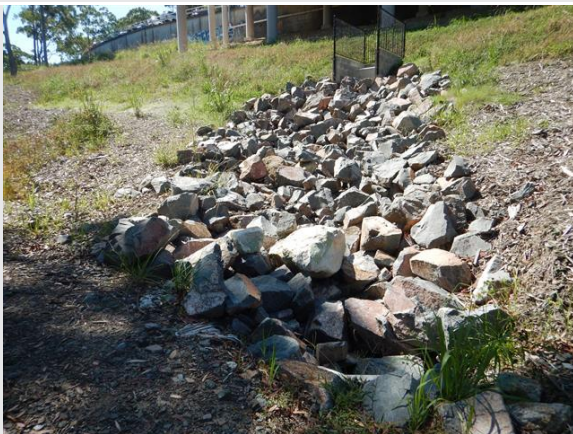
| Photograph | Description |
|---|---|
| | <p>Existing drainage outlets downslope of carpark at John Hunter Hospital.</p> |

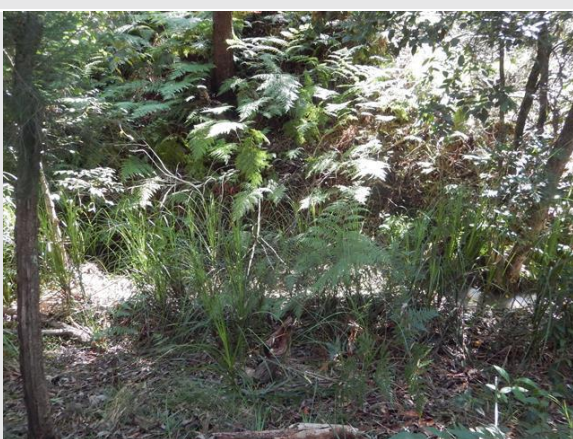
| Photograph | Description |
|---|---|
| | <p>Across channel view of gully tributary with fill deposit in narrow valley.</p> |

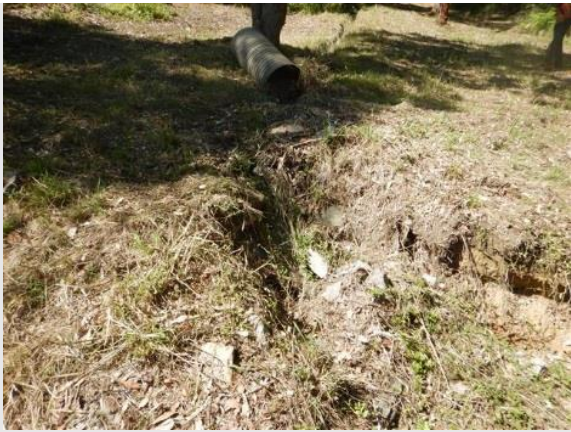
| Photograph | Description |
|---|---|
| | <p>Upstream view of gully erosion on hillslope downstream of existing drainage outlet from Lookout Road.</p> |

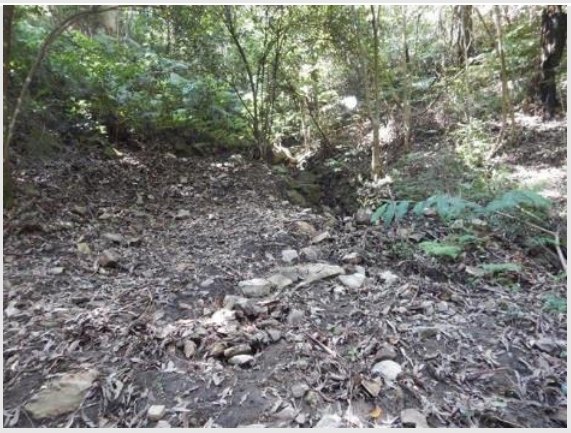
| Photograph | Description |
|---|---|
| | <p>Upstream view of debris deposit from scour along the upper steep gradient reach.</p> |

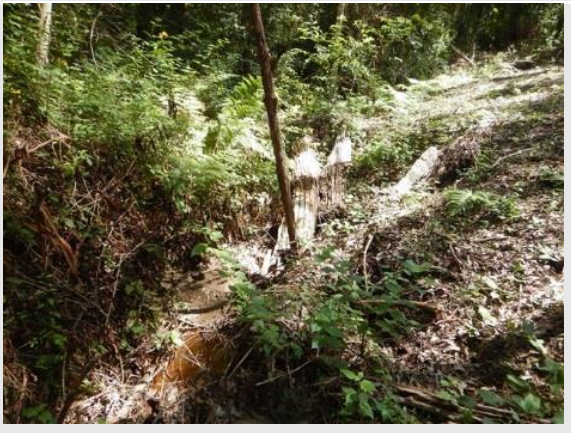
| Photograph | Description |
|---|---|
| | <p>Downstream view of defined channel in lower reach.</p> |
