### **ABORIGINAL CULTURAL HERITAGE ASSESSMENT REPORT**

## **MOUNT PIPER TO WALLERAWANG TRANSMISSION LINE UPGRADE PROJECT**

AUGUST 2025

Report prepared by  
OzArk Environment & Heritage  
for GHD on behalf of Transgrid

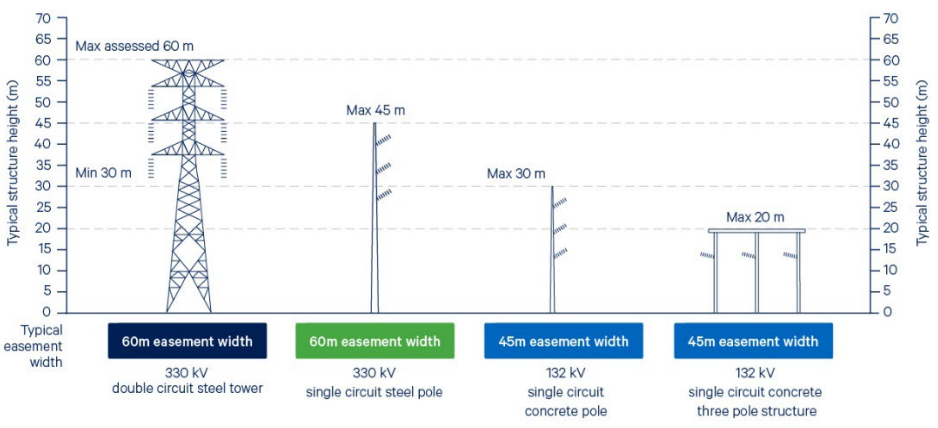
Transmission structures	<p>Transmission structures for the project include approximately 28 new steel lattice towers and four steel and/or concrete pole structures. Transmission structures would range in height from approximately 14 to up to 60 m, however these heights would be subject to detailed design. The image below presents an indicative illustration of the types of structures proposed for the project and their maximum heights.</p>

<p>The diagram illustrates four types of transmission structures with their typical structure heights and easement widths. The y-axis represents 'Typical structure height (m)' from 0 to 70. The x-axis represents 'Typical easement width'.</p> <ul style="list-style-type: none"> <li><b>330 kV double circuit steel tower:</b> 60m easement width, height range from 30m (Min) to 60m (Max assessed).</li> <li><b>330 kV single circuit steel pole:</b> 60m easement width, height up to 45m (Max).</li> <li><b>132 kV single circuit concrete pole:</b> 45m easement width, height up to 30m (Max).</li> <li><b>132 kV single circuit concrete three pole structure:</b> 45m easement width, height up to 20m (Max).</li> </ul> <p>Figure not to scale.</p> <ul style="list-style-type: none"> <li>The steel transmission structures would generally be spaced between 100 m to 550 m apart and the pole structures about 30 m to 50 m apart.</li> <li>New conductors, earth wires and optical ground wire (OPGW) would be installed on the new transmission structures for the new 330 kV and existing 132 kV lines.</li> </ul>

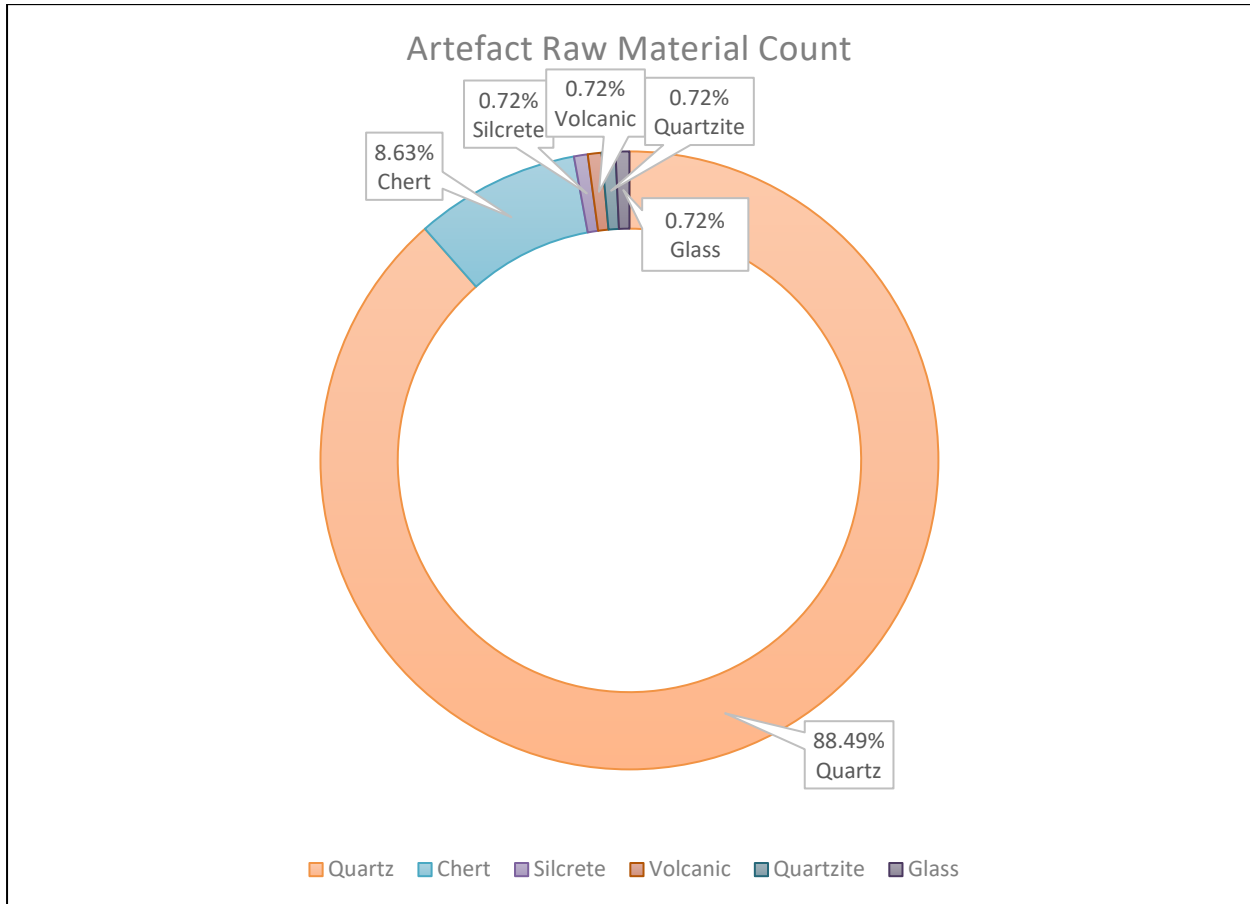
**Figure 7-6: Chart displaying a count of raw materials.**

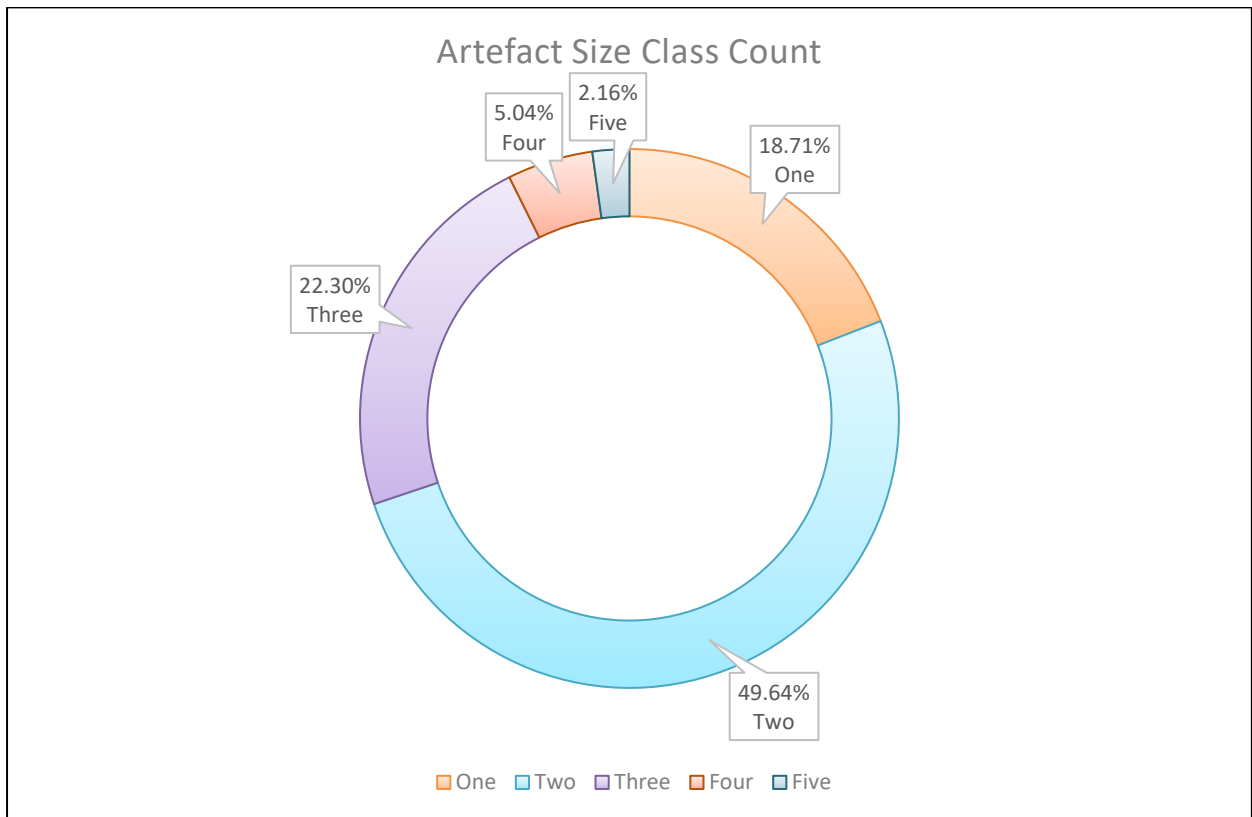
**Figure 7-7: Chart displaying a count of artefact sizes**

All artefacts were assigned a size class based on their size in length:
