## 3 Statutory Controls

### 6.2.2 Old Man's Valley Cemetery/Higgins Family Cemetery, sandstone receptacle, cool room, site of Higgins homestead/memorial and sandstone stairs

### 6.2.3    Hornsby Quarry Industrial Machinery and Buildings

**STAGE 2 PACHCI**

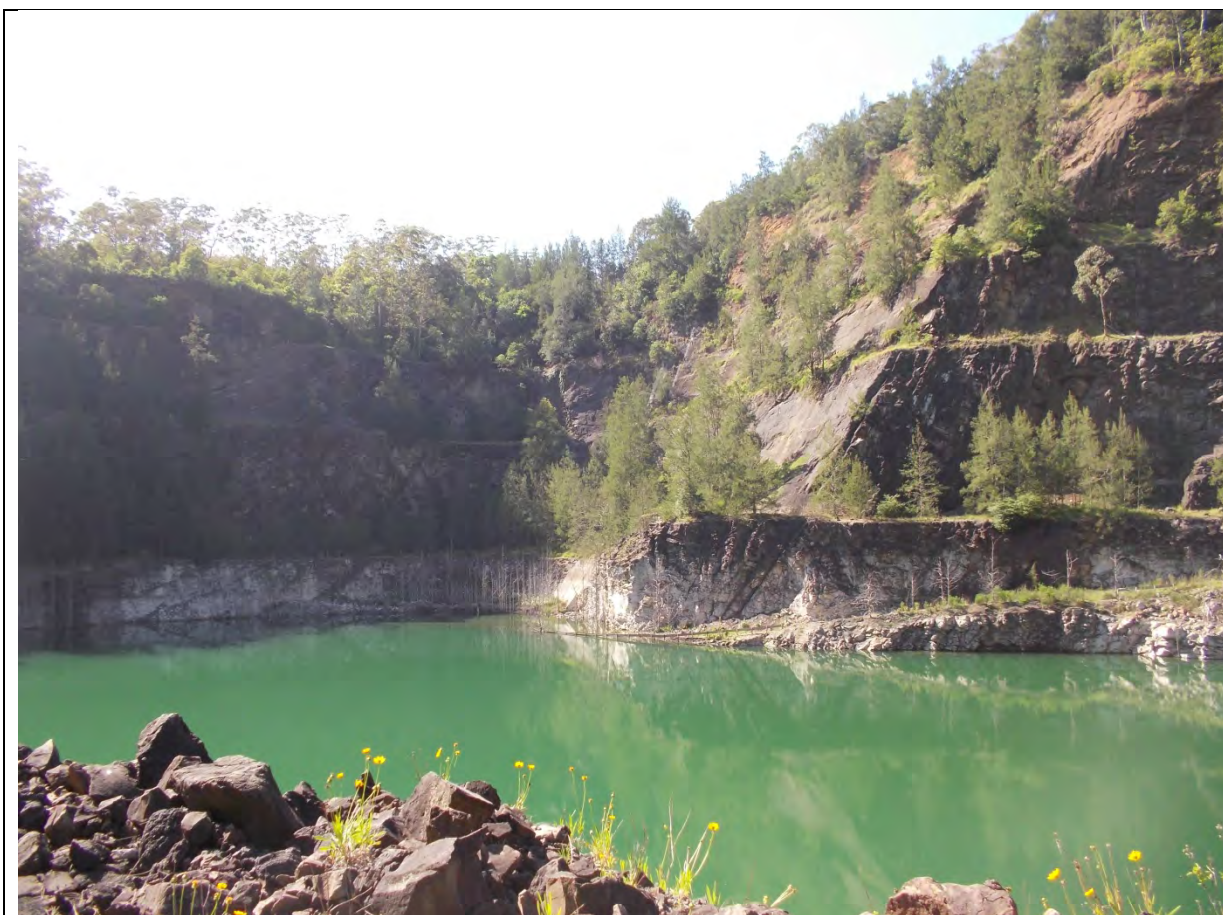
**Plate 1**      **Diatreme Hornsby Quarry**

A diatreme is a natural, geological feature composed of a long vertical pipe or plug, in this case composed of dolerite. It was formed when magma extruded through the overlying strata in a past volcanic event. At the Hornsby location the dolerite core is surrounded by volcanic breccia containing coal, sandstone and shale (see Plate 1). The volcanic event that formed it has tentatively been dated to between 50 and 210 million years BP (Parsons Brinckerhoff Australia Pty Ltd, 2004:175).

The diatreme has been exposed in the wall of the Hornsby Quarry as a result of excavation to extract blue metal between 1903 and the quarry's closure in the 1990s. The Diatreme Hornsby Quarry is an oval shaped depression in the landscape measuring around 300 metres by 200 metres. Its sides are stepped down in terraces and the base of the depression has filled with water from natural run-off and rain. Due to water covering the lower portions it was not possible to estimate the total depth of the feature during field inspections. Although the NSW State Heritage Inventory and Hornsby LEP listings also note surrounding vegetation as a feature of the item, there are no descriptions in either listing of the heritage value of the vegetation. Vegetation clearance has previously been undertaken within and surrounding the quarry void. Regrowth is currently present both within the void and in the immediately surrounding area.

The view-lines to the diatreme will be partially obscured once deposition in the Hornsby Quarry void reaches a certain level. This will impact on the item's heritage significance, but the finished fill level is anticipated to still provide partial views to the heritage item, and the portion of the diatreme obscured by fill material would be protected by the spoil material and is a reversible loss of local significance. Currently the area is unsafe for public access, meaning that views to the item in its current form are not possible.

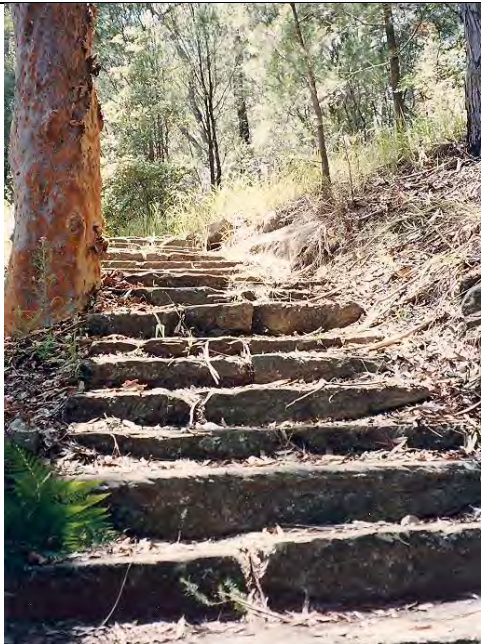
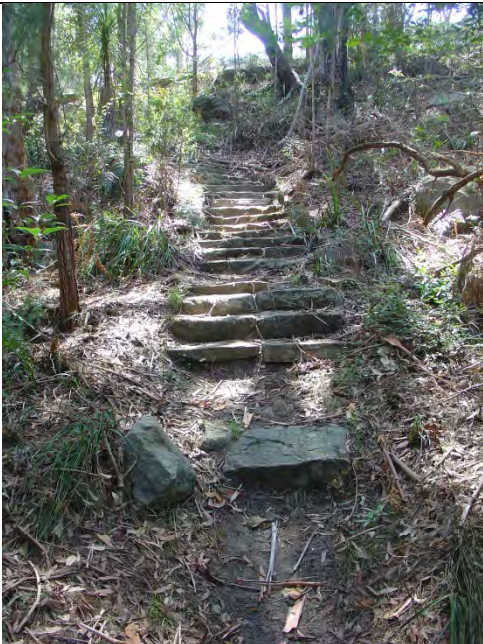
| <p><b>Plate 2</b>      <b>Heritage Walk Depression era stairs</b><br/>circa August 1994 (Hornsby Shire Council, 1994)</p> | <p><b>Plate 3</b>      <b>Heritage Walk Depression era stairs</b><br/>circa December 2013</p> |

The sandstone stairs connect a current vehicle track to the upper slopes of the area close to the contemporary Hornsby Aquatic and Leisure Centre. The stairs are made of hand-carved sandstone (see Plate 2 and Plate 3). A past assessment noted reference to the stairs being a depression era (circa 1930s) development made as part of unemployment relief works. The same study however also noted oral history evidence from Higgins family descendants stating that the stairs predated this, having been present in the 1920s linking some of the Higgins family houses (Parsons Brinckerhoff Australia Pty Ltd, 2004:169). This suggests that, like the nearby receptacle and cool room, the stairs are evidence of the use and development of the area by the pioneer settlers of the Higgins family.

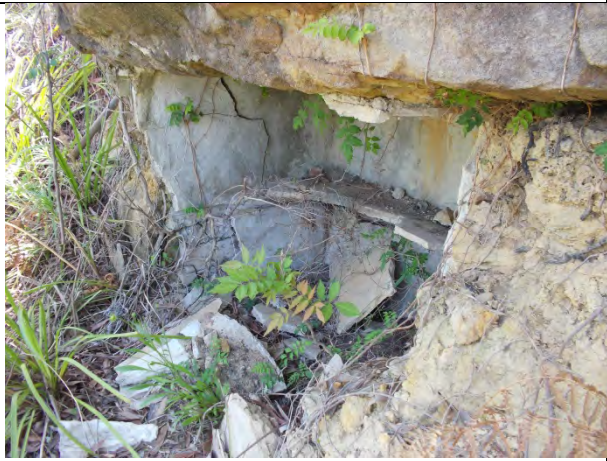
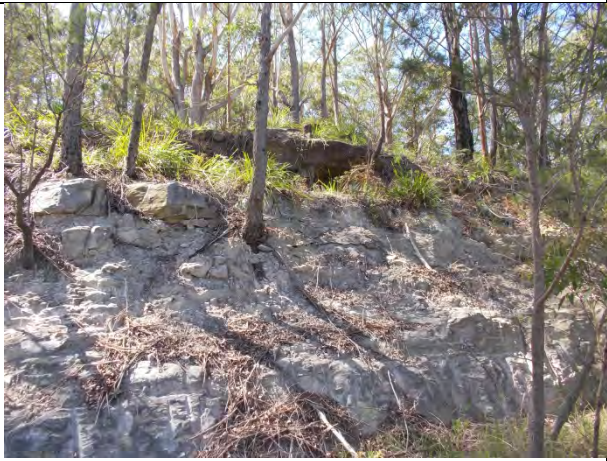
| <p><b>Plate 4</b>      <b>Cool room</b></p> | <p><b>Plate 5</b>      <b>Cool room location</b></p> |

The cool room contains two shelves and has been built into a natural sandstone overhang. It is lined with concrete and metal, with broken glass evident in and around it, possibly dating to the period of use (see Plate 4 and Plate 5). The cool room itself is approximately one metre wide and one metre high. It is located upslope from a vehicle track. A past assessment identified it as a communal cool room that was equidistant between the historic Higgins family structures: McKenzie House, McKinnon House and Thomas Higgins IV House (Parsons Brinckerhoff Australia Pty Ltd, 2004:171).

The cool room, built into a sandstone overhang, is an element that could potentially be damaged by vibration. This item, although adjacent to an existing vehicle access track and the stockpiling area that would be utilised during works, is approximately 250 metres from the proposed conveyor alignment and 200 metres from the road widening works. It is therefore assessed as unlikely that the cool room would be affected by vibration generated by the project.

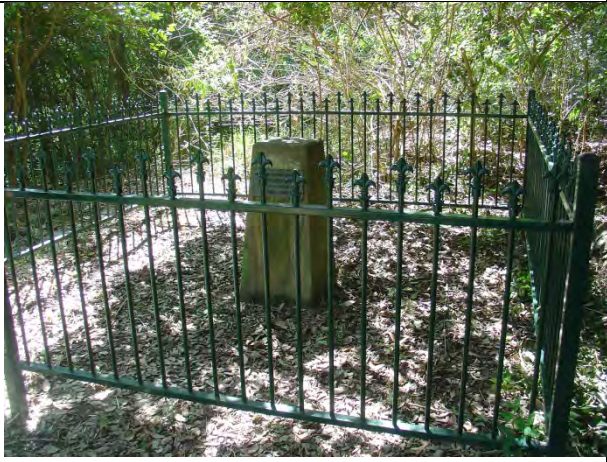
| <p><b>Plate 6</b>      <b>Old Man's Valley Cemetery</b></p> | <p><b>Plate 7</b>      <b>Higgins Homestead/Memorial</b></p> |

The various homes of the Higgins family that were once in this area have since been demolished. At the site of the original family homestead an area has been fenced off and a memorial was erected there in 1970. The memorial has the following text written on it: "On this site stood the homestead of the Higgins Family Pioneers of the Hornsby District 1834 – 1970" (see Plate 7). The area has been identified as having subsurface potential for intact deposits relating to the Higgins Family Homestead and the demolished structures and features that were associated with it.

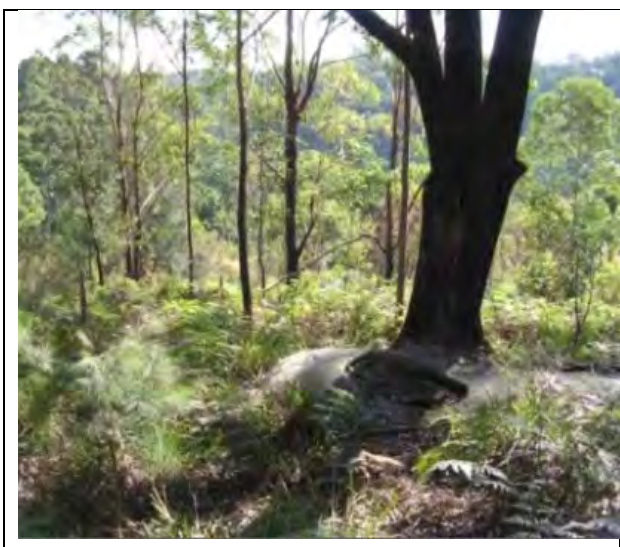
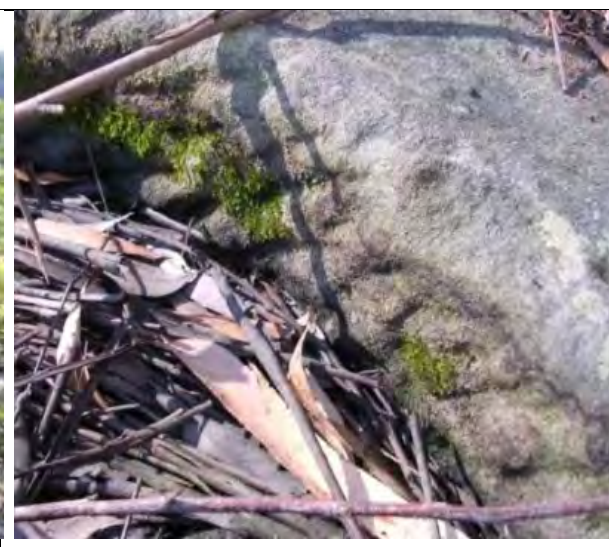
| <p><b>Plate 8      Sandstone receptacle (Parsons Brinckerhoff Australia Pty Ltd, 2004:173)</b></p> | <p><b>Plate 9      Sandstone receptacle (Parsons Brinckerhoff Australia Pty Ltd, 2004:173)</b></p> |

The sandstone receptacle is located further up the slope that contains the cool room, and downslope from the contemporary Hornsby Aquatic and Leisure Centre. It is oval in shape with sparrow pecking visible on its inner edges and an engraved motif on a stone within the oval basin of the receptacle (see Plate 8 and Plate 9). It is most likely associated with the Higgins family and could date to the same period as the nearby cool room, but its precise date and purpose have not been identified during previous studies.

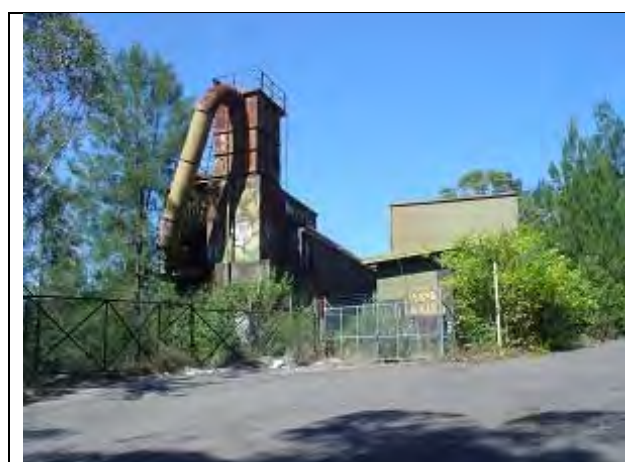
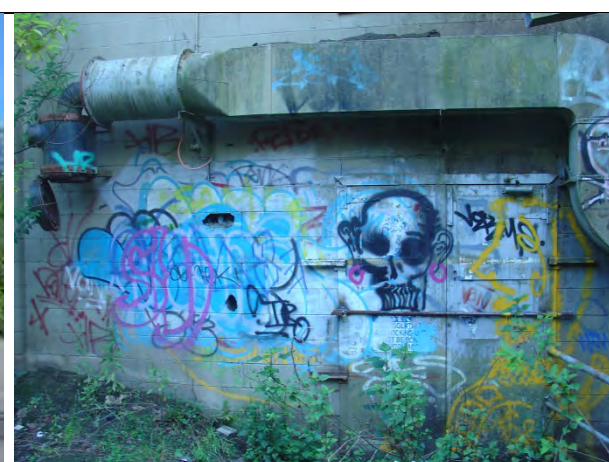
| <p><b>Plate 10      Hornsby Quarry Machinery</b></p> | <p><b>Plate 11      Hornsby Quarry structure with graffiti</b></p> |

Remnant structures and equipment from the period of operation for the Hornsby Quarry are still extant in this area. Although the quarrying of blue metal in the Hornsby area first started around 1903, these items date to the latter quarry period of commercial operation from the 1960s onwards. Structures remnant in this area include a steel-frame workshop, concrete block office, pieces of equipment, a crushing and screening plant, an administration building, a sub-station, pumps, stairs, pipes and fences. The structures have been subject to natural deterioration and impacts from vandalism, including rubbish dumping, intentional breakage and graffiti (see Plate 10 and Plate 11).

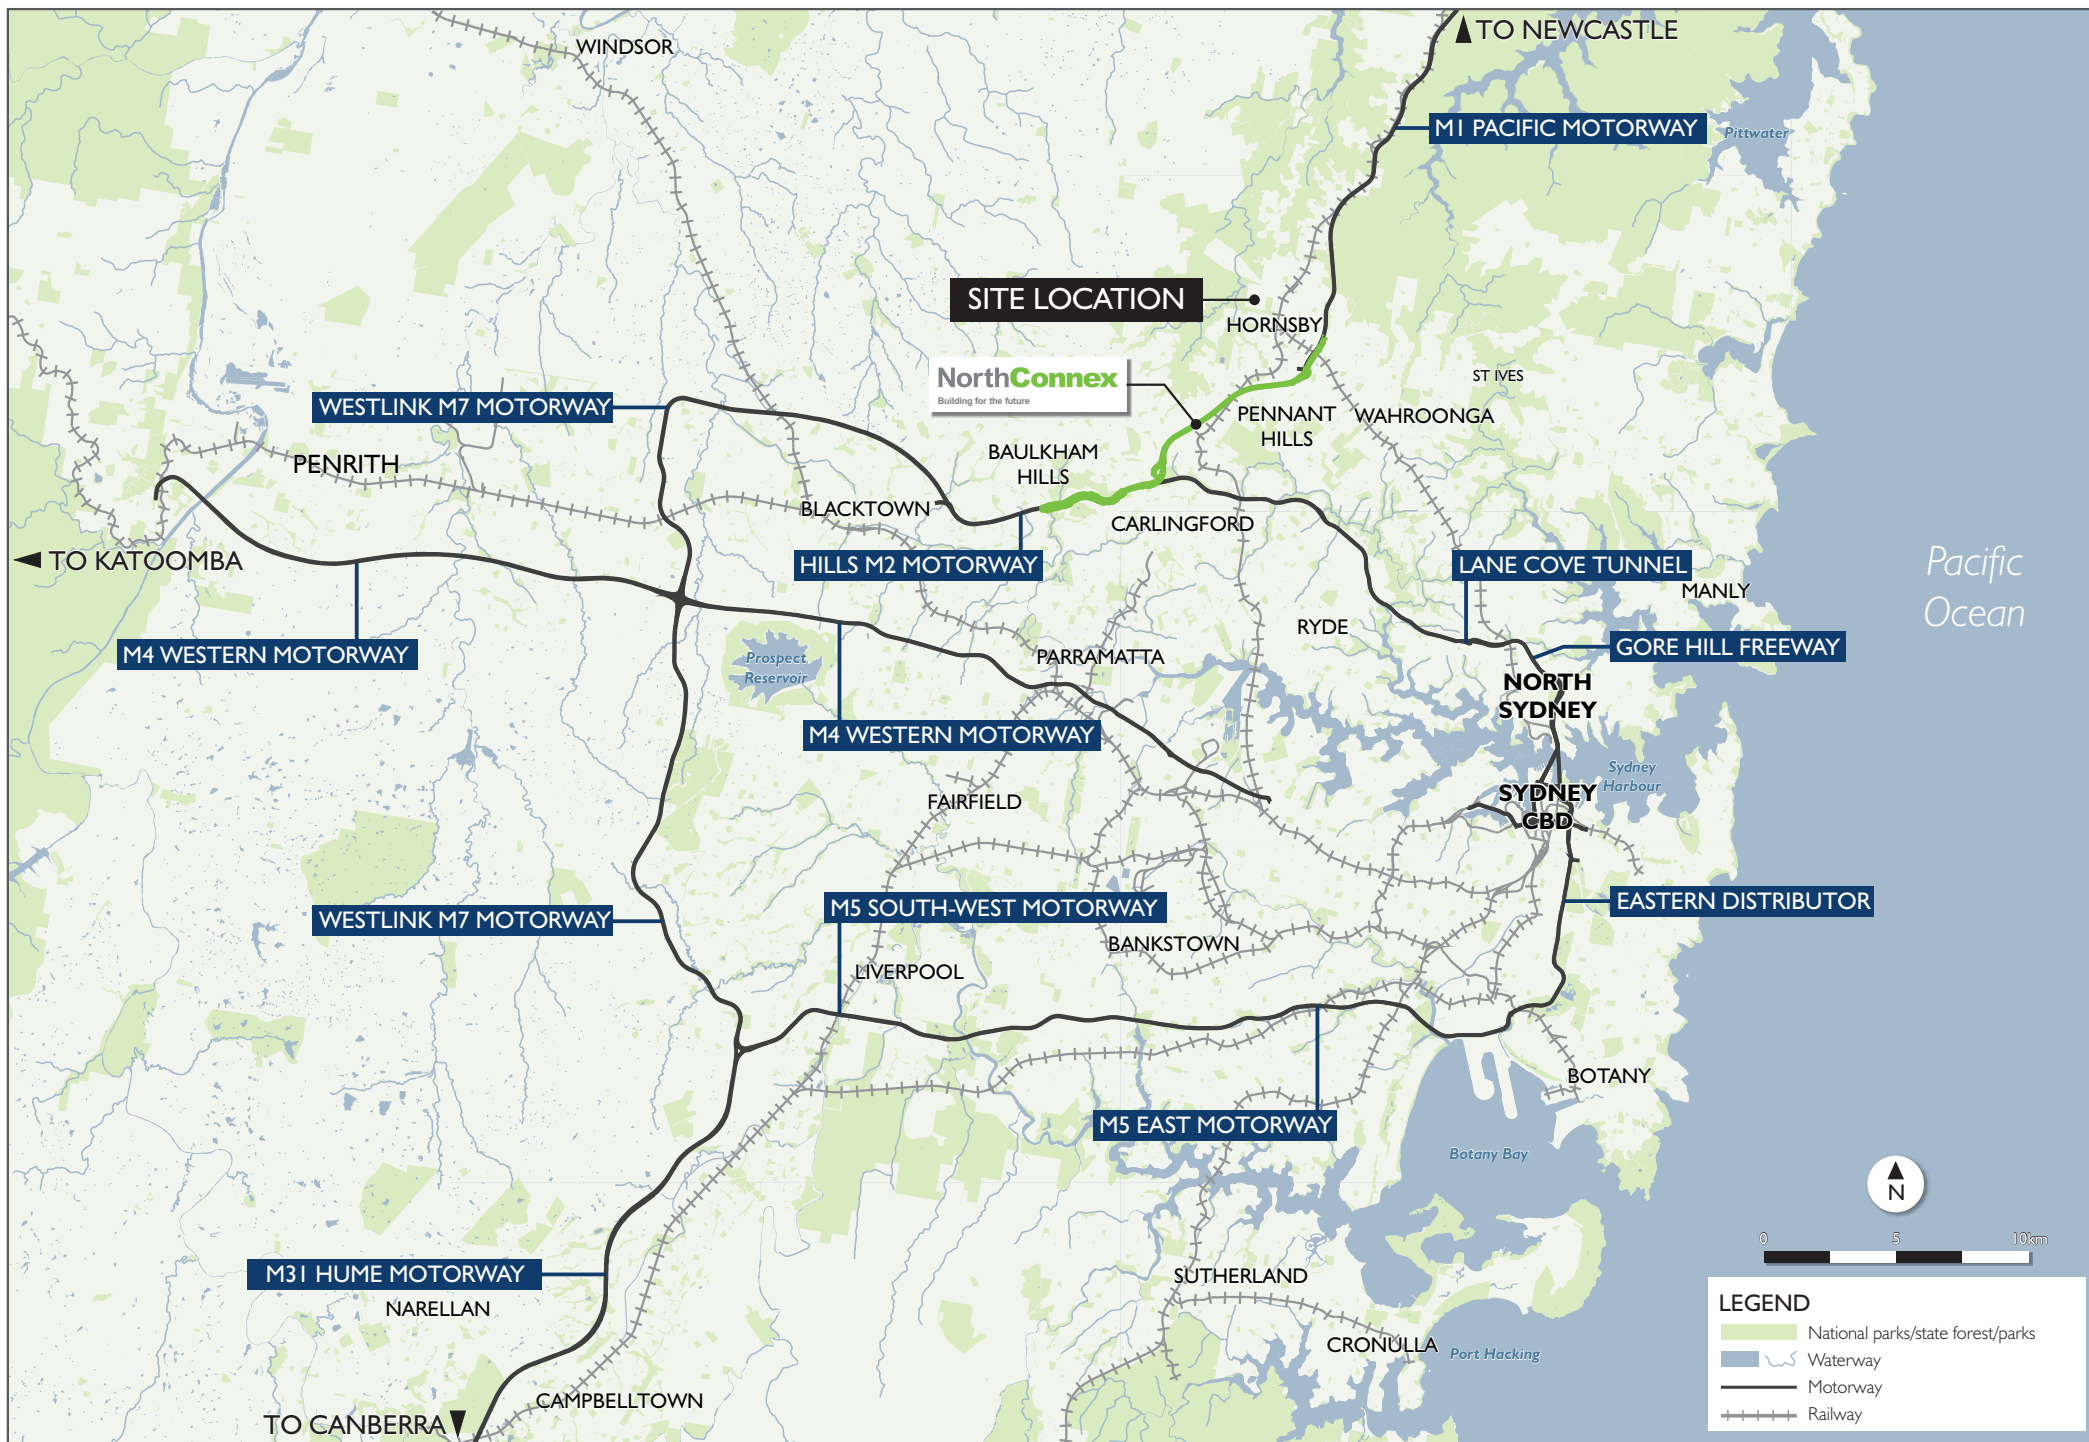
Figure 1 Regional context of the project

The Hornsby Quarry site is located off Bridge Road on the western side of the Hornsby town centre. The site covers about 35 hectares and is owned by Hornsby Shire Council (refer to Figure 1).

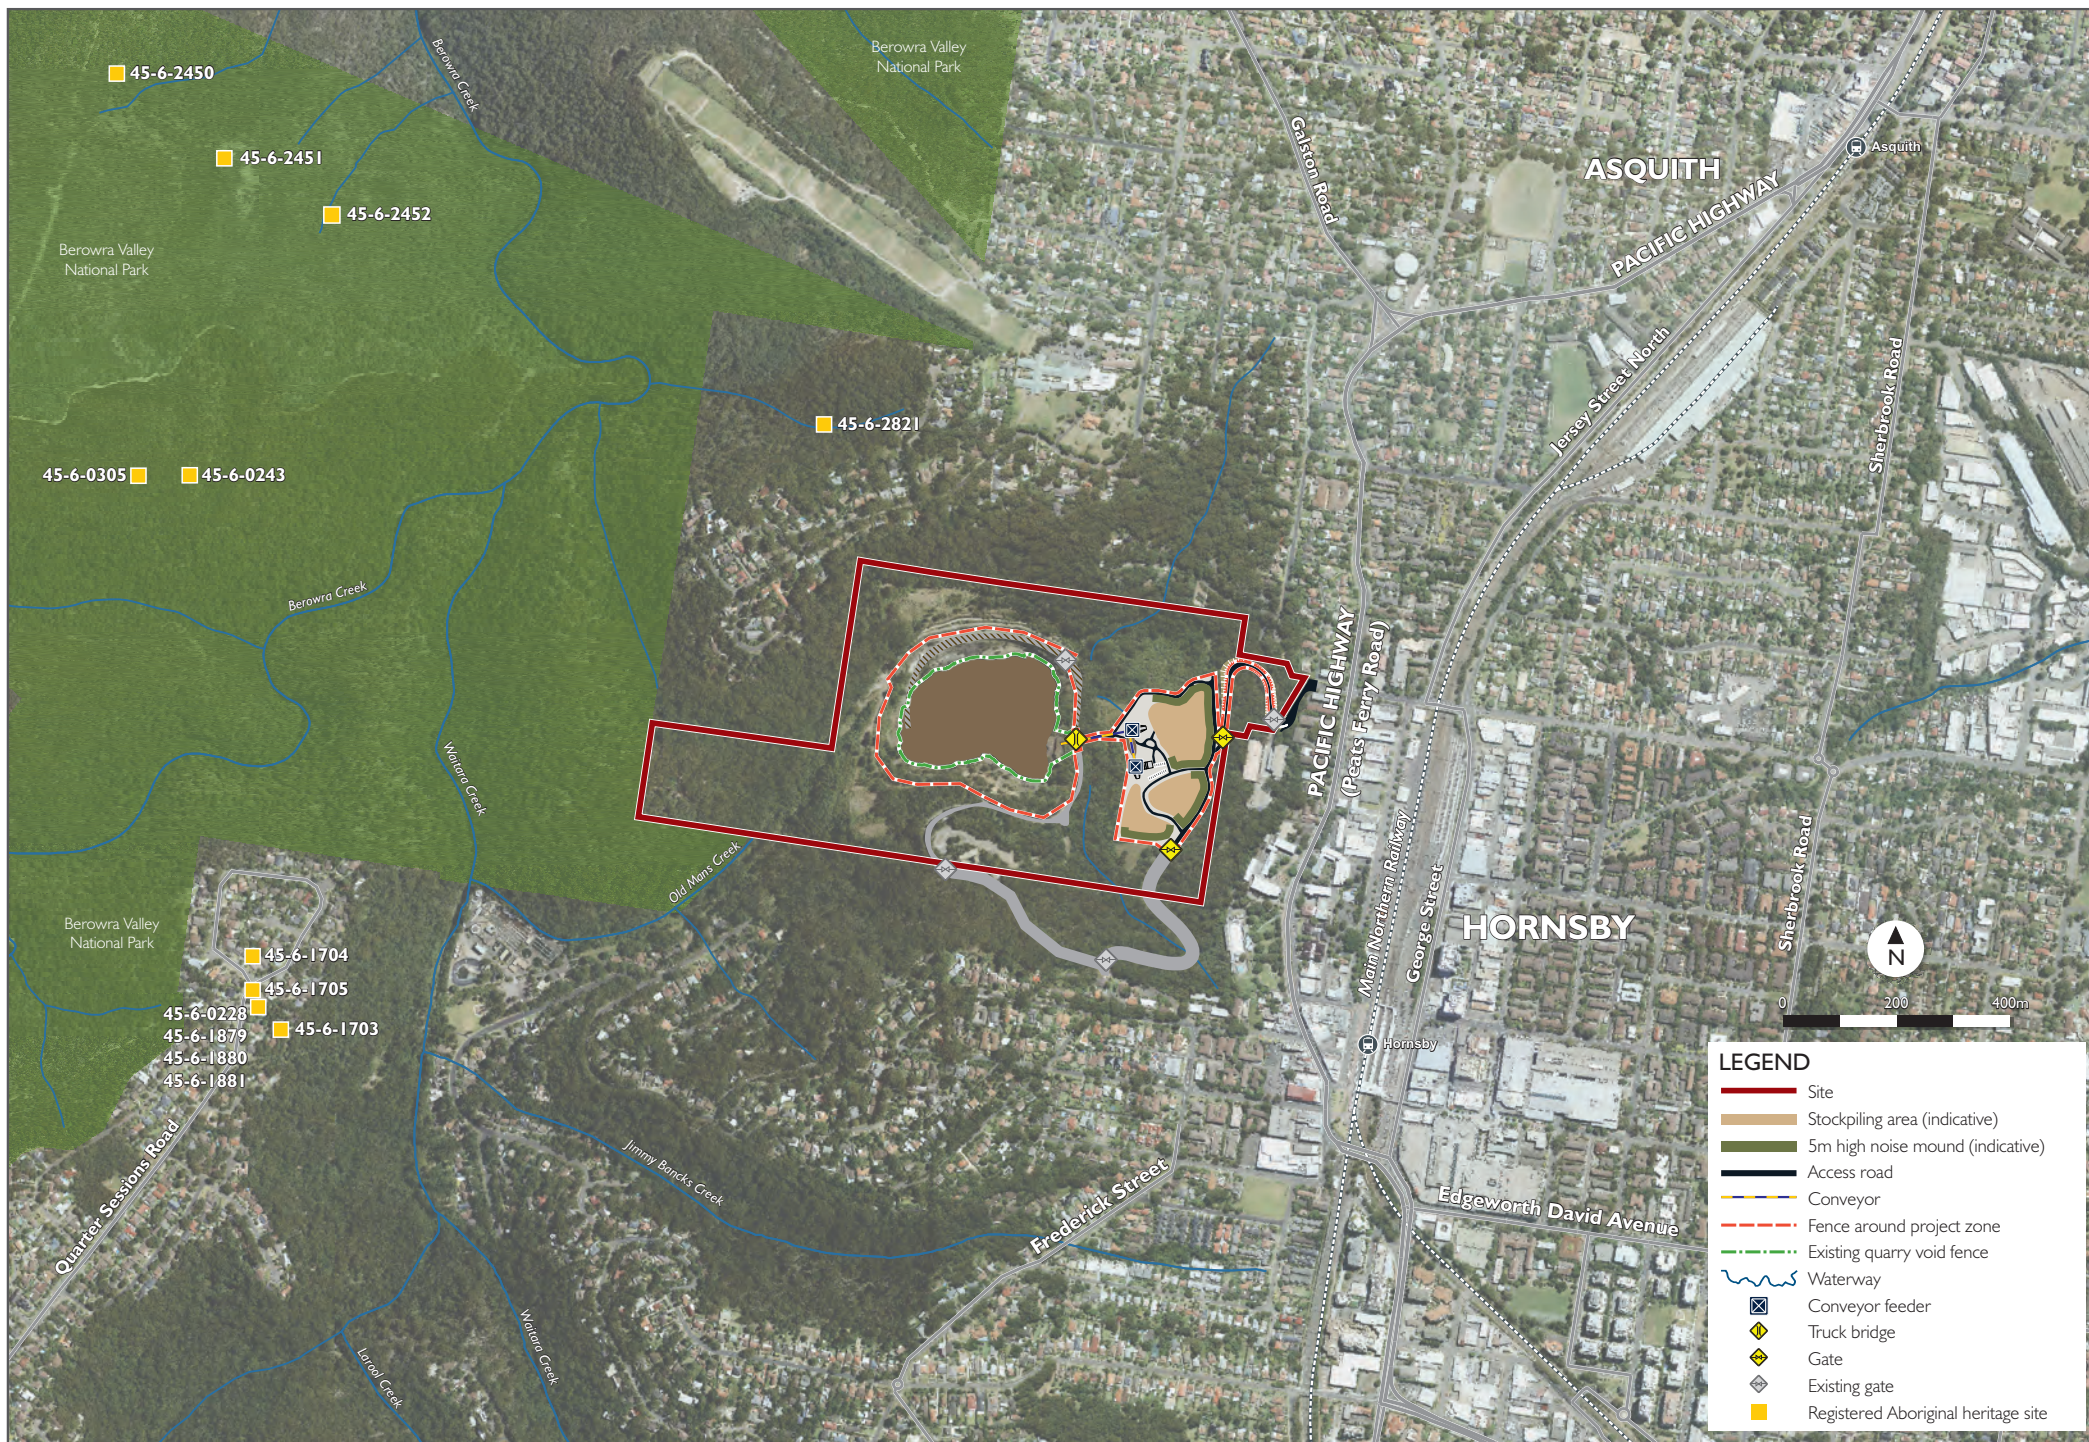
Figure 3 Proposed spoil management footprint and AHIMS sites

Initial investigations and Stage 2 assessments were completed between September and November 2013 (AECOM, 2013) and January 2014 (AECOM, 2014) as part of the investigation of spoil management locations for the NorthConnex project. The past reports identified the potential environmental constraints related to Aboriginal heritage within areas of the Hornsby Quarry site. This Aboriginal cultural heritage report supplements past assessments, and identifies potential Aboriginal heritage constraints within the footprint of the project. The study area for this assessment is shown in Figure 3.

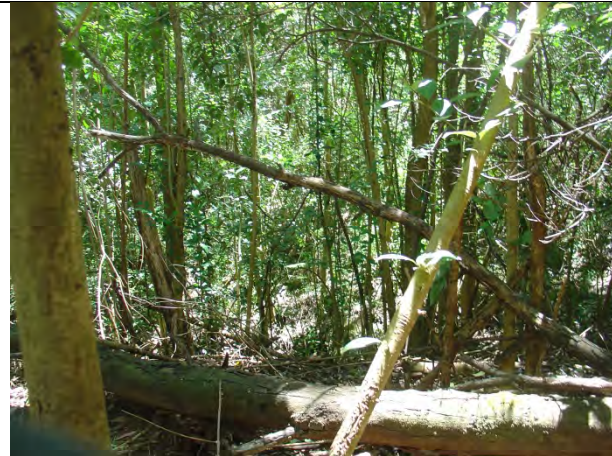
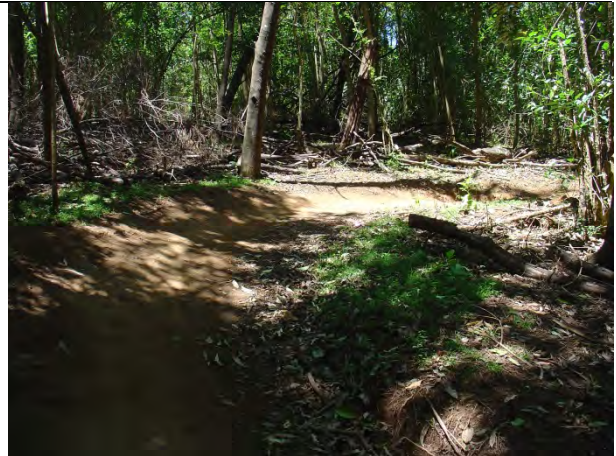
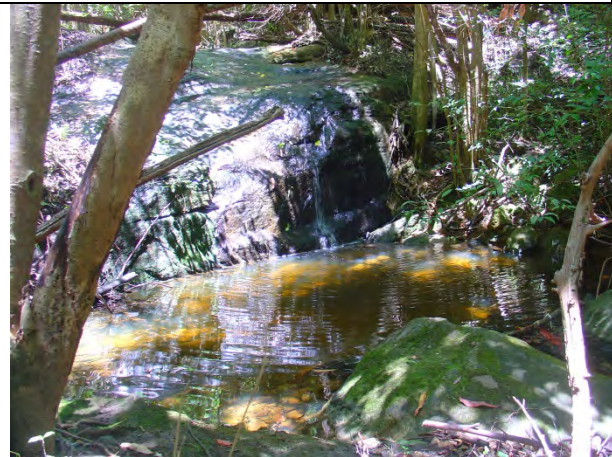
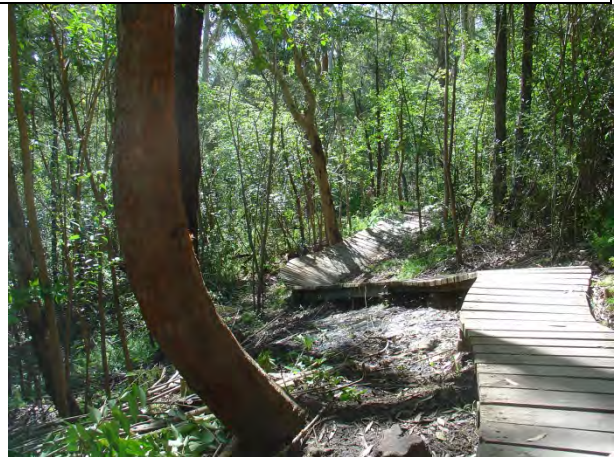
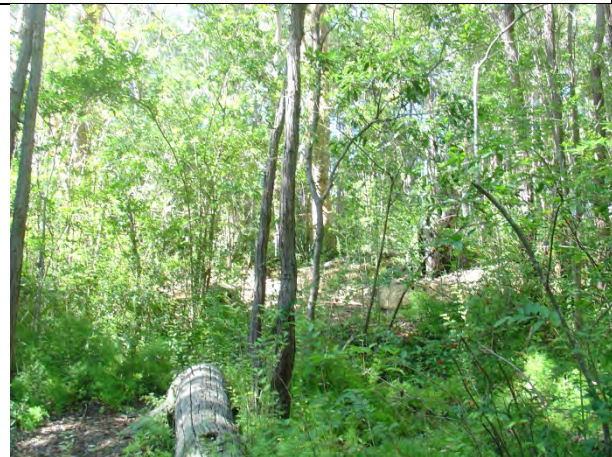
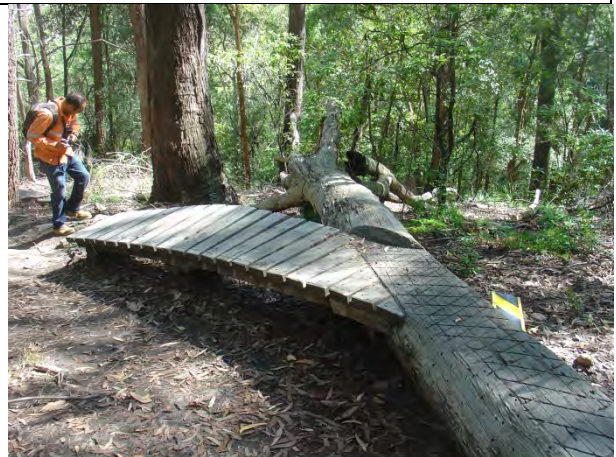
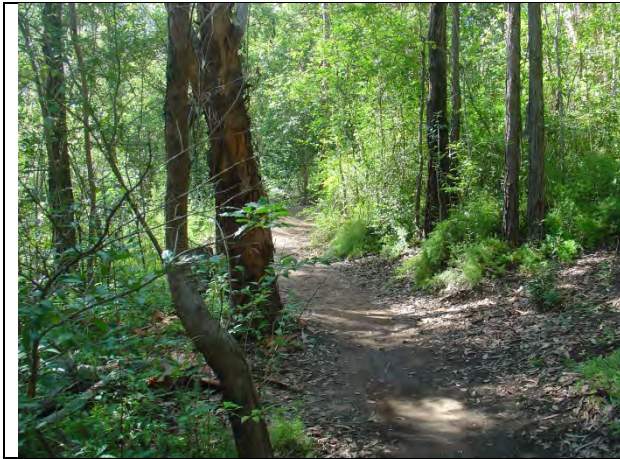
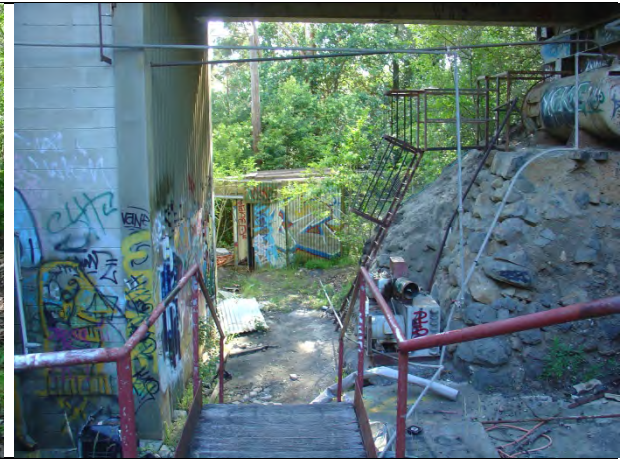
Ground Surface Visibility (GSV) during the inspection averaged 35 per cent overall due to vegetation and leaf litter. Vegetation throughout the area was a mix of mature vegetation and regrowth. Regrowth was predominant in the quarry and park areas, denoting vegetation clearance as a past impact. Impacts within the area included Hornsby Quarry, vehicle, bike and walking tracks, park areas and erosion (refer Plate 3 to Plate 8).

A total of 26 transects were walked across the study area, 16 of which were approximately 280 metres in length and eight were approximately 900 metres in length (refer to Figure 4). Details of individual transects are provided in Table 8 along with ratings based on the archaeology scientific ratings included in Appendix D. Transect locations are shown on Figure 4. All other AHIMS sites in the figure are based on coordinates provided by AHIMS.

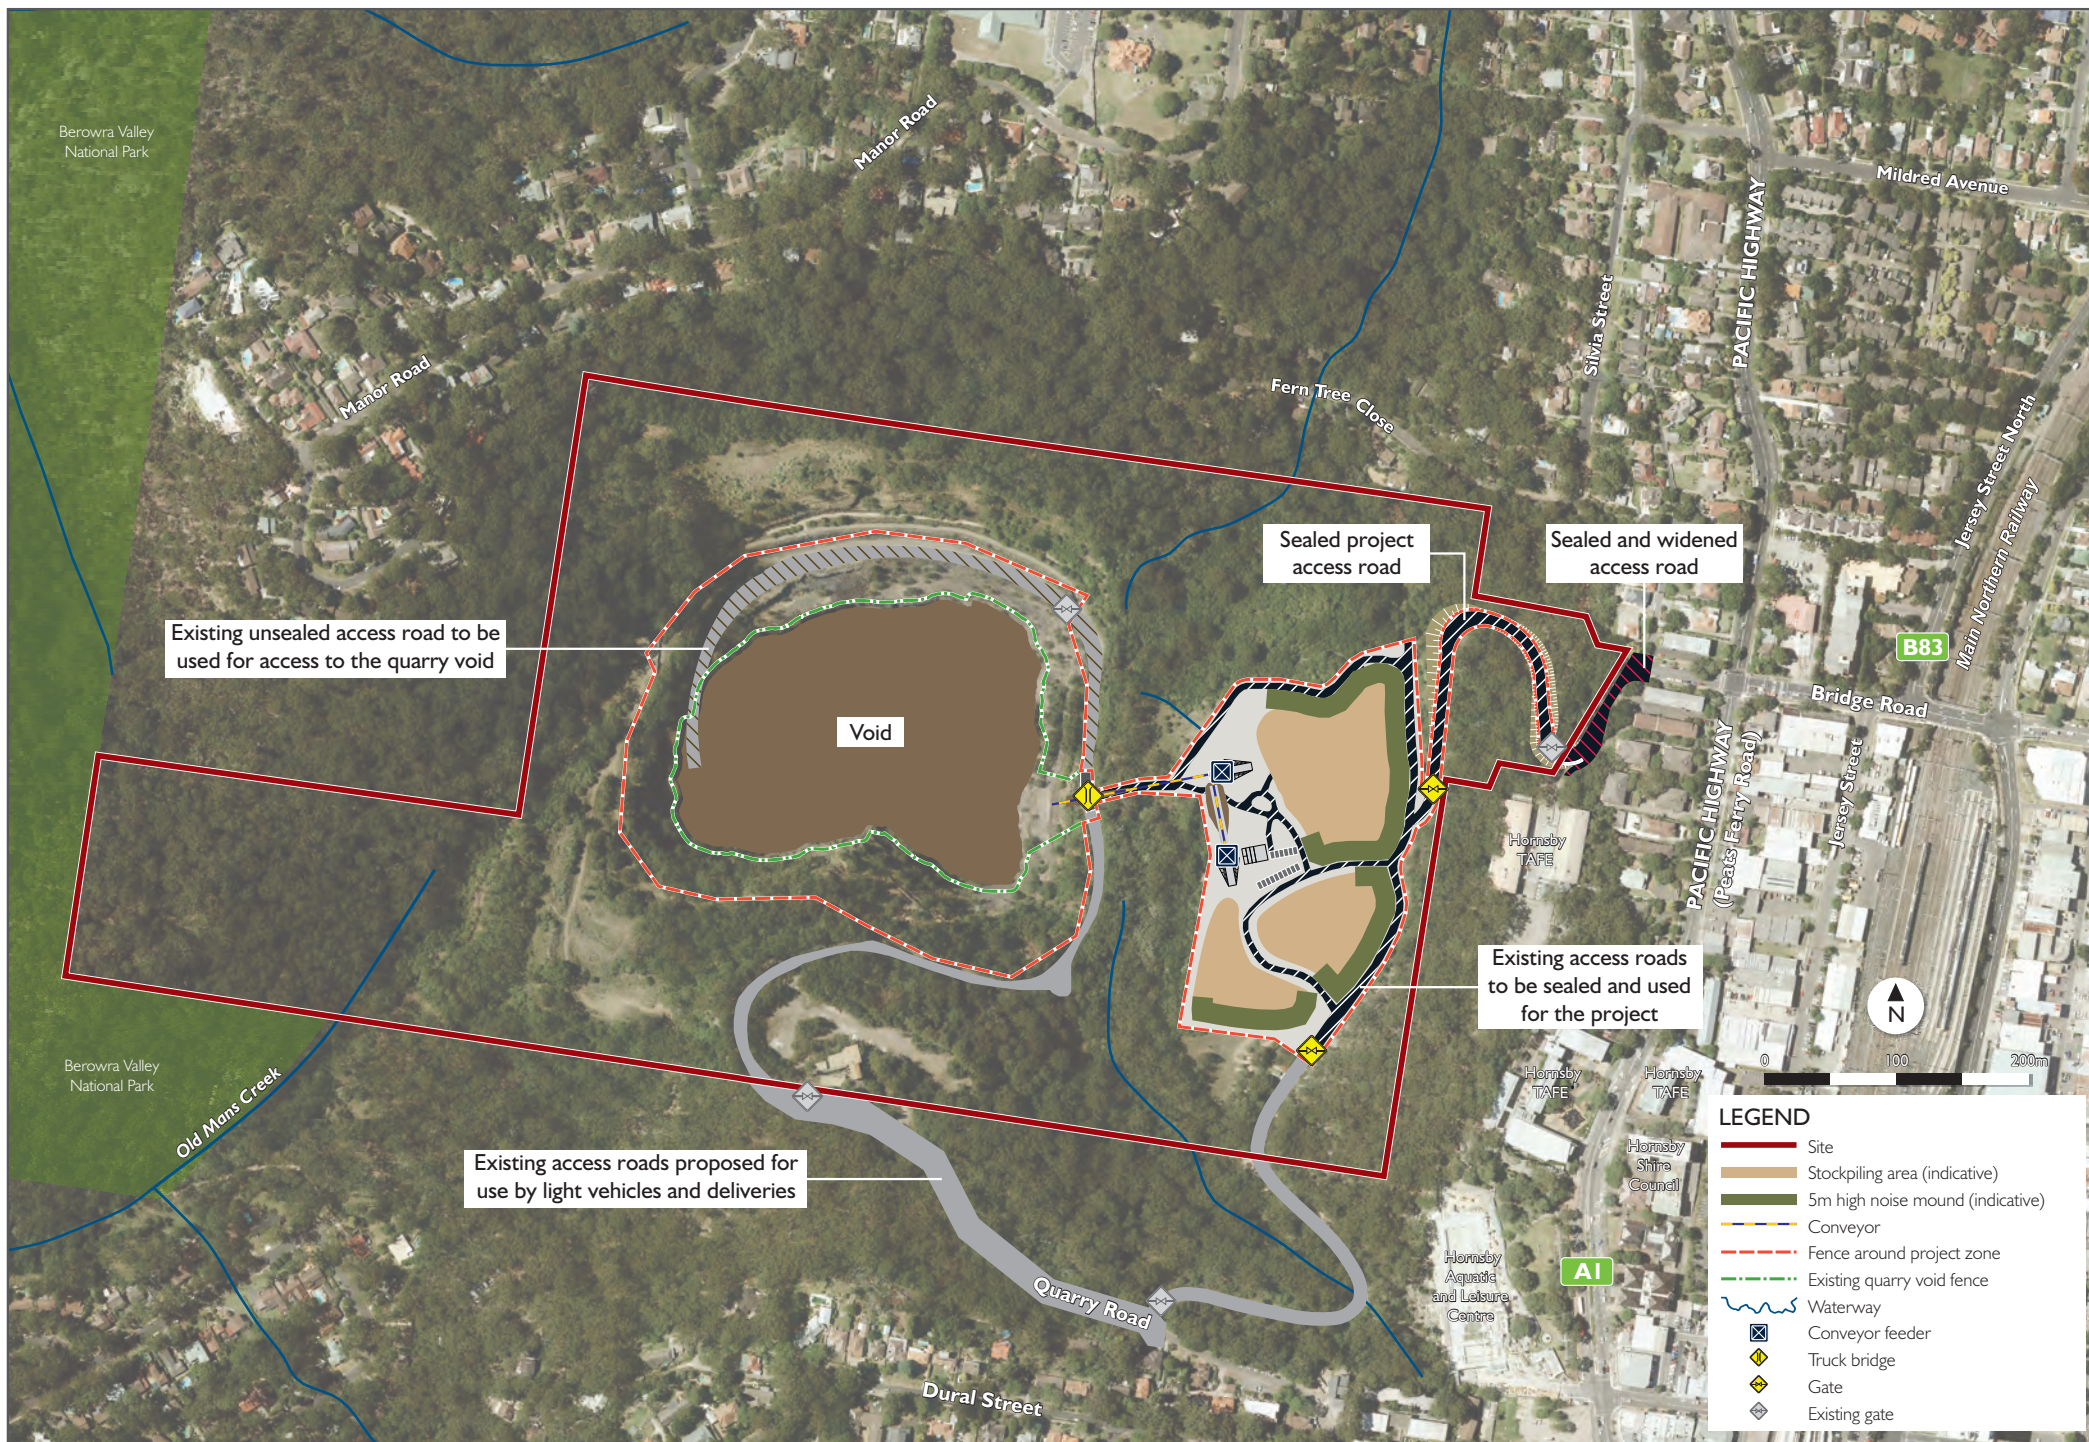
Figure 1 Indicative Site layout

The Hornsby Quarry site is located around 21 kilometres north west of the Sydney Central Business District, in Old Mans Valley to the west of Hornsby town centre. The site covers about 35 hectares and is owned by Hornsby Shire Council (Council) (refer to Figure 1). The site is accessed via local Council roads, including Quarry Road (off Dural Street and other local roads) from the south east and Bridge Road (off the Pacific Highway) from the north east.

The general location and key features of the project are shown in Figure 1.
