The Northern Road – Mersey Road, Bringelly to Glenmore Parkway, Glenmore Park

Environmental Representative Monthly Report

December 2020

ER ENVIRONMENTAL SITE INSPECTION REPORT

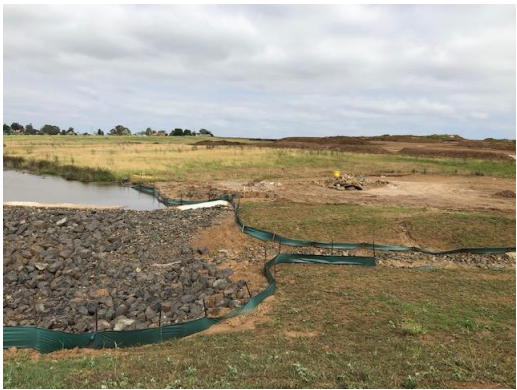
No	LOCATION (Chainage/ Description)	ISSUE/COMMENT	PRIORITY/ RISK (I, H, M, L)	ACTION	Agreed Close out date	Response
1	Dam 3 area	<p>Laydown area has not yet completely been removed due to various reasons including wet weather and general delays. Work has progressed with all stored materials now been removed and a small pile of concrete waste remains. Rehabilitated and landscaping is expected to be completed by the Christmas shutdown.</p>

L	Continue with current plan of remediating this area and completing the landscaping as quickly as possible.	Please provide update by the 15/12	Area has been cleaned up and waste removed. Final hydroseeding expected on Tue 15 th December 2020.

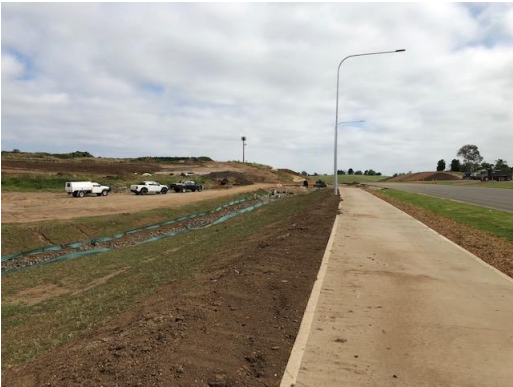
No	LOCATION (Chainage/ Description)	ISSUE/COMMENT	PRIORITY/ RISK (I, H, M, L)	ACTION	Agreed Close out date	Response
2	Dam 3 area	<p>Some sediment fence observed to still require some maintenance after the recent rainfall events. Also, some minor rilling on batter observed to the north of the Dam 3 culvert inlet.</p>

L	Undertake maintenance on sediment fence and tidy batter prior to next rainfall event.	20/11/20	Sediment fence has been freshened up in places.

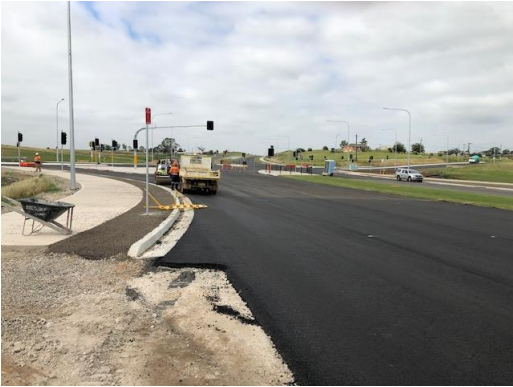
1	Adams Road intersection	<p>Positive observation – the majority of TNR6 and Adams Road intersection are nearing completion. Pavements have been completed. Line marking, TCS, signage and landscaping is currently being completed in preparation for opening prior to Christmas.</p>

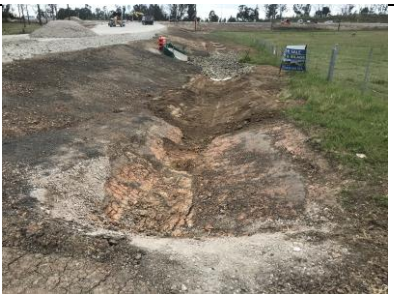
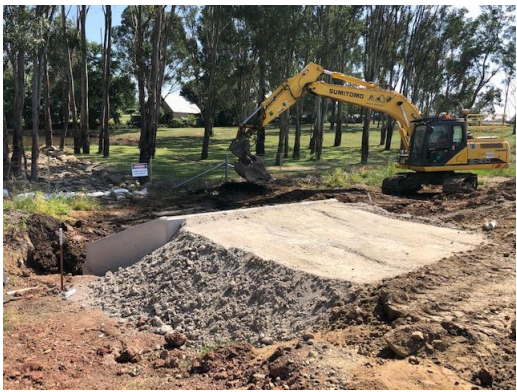
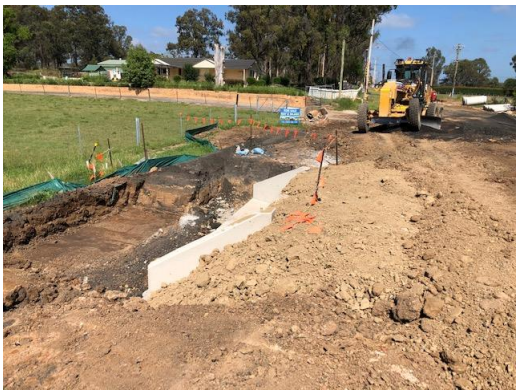
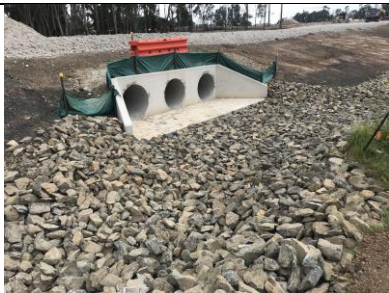
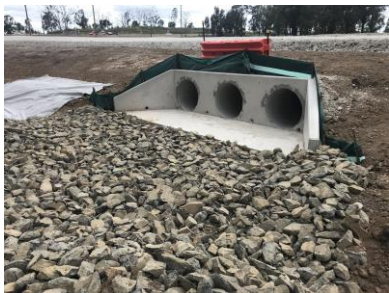
Noted, with thanks.
2	Kings Hill Road	<p>Works in progress – culvert and headwalls have now been completed. Backfill and inlet and outlet dissipaters are currently being completed in preparation for the road formation to be completed</p>	L	As works in progress are completed, ensure that all ERSED controls are reinstated to minimise the need to install controls prior to rainfall or prior to the reopening of the road.	4/12/20

Checks have been placed in the drains at the toe of the batters

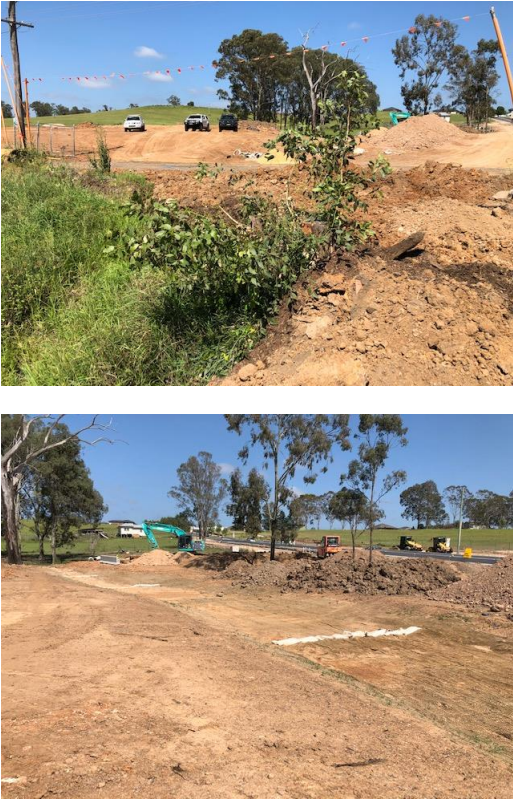
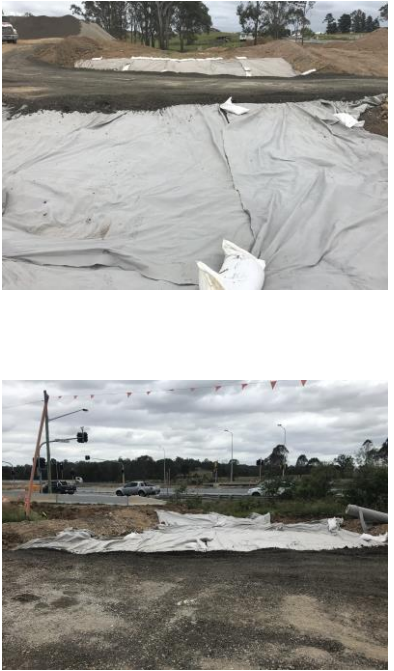
4	Bradley Street	<p>Works in progress – work in area is progressing, however, it has meant that the clean water drain through the area has been removed for construction.</p>

L	<p>Recommend that the clean water drain and pathway through the site is better set up, so that just the haul road needs to be covered prior to rainfall.</p> <p>New soil that has been tipped in the area needs tidying up and consolidated.</p> <p>Sediment fence or bunds should be installed to protect the jute lined clean water drain.</p>	4/12/20	<p>Blue metal has been used to create all-weather crossing and as a final in line check</p>

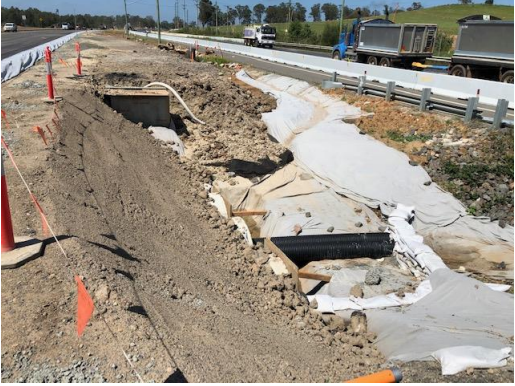
5	Bradley Street culvert eastern side	<p>Clean water path is well set up through the new culverts, however, the batters and drains around the inlet need some work to cover and/or stabilise.</p>	L	<p>Ensure that all clean water areas are covered or stabilised prior to rainfall.</p>	4/12/20	<p>Green soil glue will continue to be applied in this area after the weekends major switch.</p>

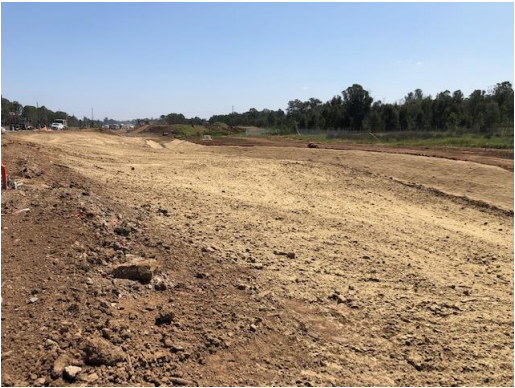
6	East side of southbound north of Bradley Street	<p>Positive observation – areas to the east of the southbound carriageway are progressively being completed, stabilised with hydromulch and landscaped. Currently on target for completion prior to Christmas.</p>

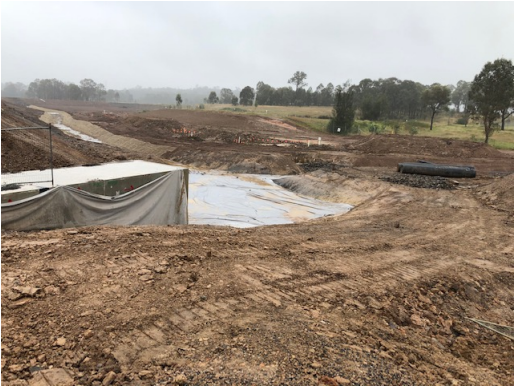
3	Outlet of N3 culvert	<p>Area all drains toward the retention basin area. Culvert has been partially blocked to hold back water in channel as a sediment control.</p> <p>Where possible it would be good to try and complete some of the rock work at the outlet of the culvert or as a minimum attempt to install the geofabric on the batters.</p> <p>Also, area should be reviewed to see where additional erosion controls can be added to</p>	M	<p>Where possible it would be good to try and complete some of the rock work at the outlet of the culvert or as a minimum attempt to install the geofabric on the batters.</p> <p>Also, area should be reviewed to see where additional erosion controls can be added to minimise the amount of</p>	17/12/20

<p>minimise the amount of sediment that may end up accumulating in the channel.</p>

<p>sediment that may end up accumulating in the channel.</p> <p>Tackifier should also be applied in selective areas to assist in erosion control.</p>		
4	Bradley Street	<p>Clean water path needs to be established over/through the temporary road in the southern portion of the Bradley Street site prior to the shutdown to ensure material is not eroded.</p>
