# **The Northern Road – Mersey Road, Bringelly to Glenmore Parkway, Glenmore Park**

## **Environmental Representative Monthly Report**

**January 2021**

## ER ENVIRONMENTAL SITE INSPECTION REPORT

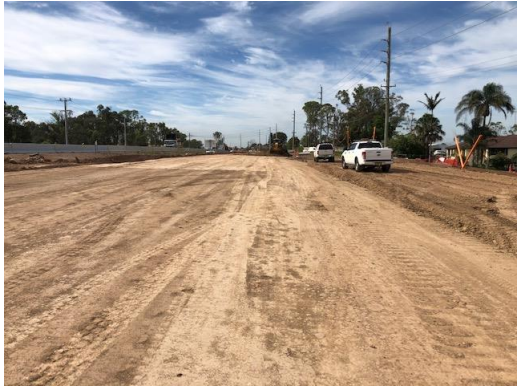
1	GRS Towing	<p>Fill outside GRS towing is currently not being directed to a stabilised batter chute.</p>

M	<p>Fill outside GRS towing should be directed to a batter chute to ensure water does not flow down the batter uncontrolled.</p> <p>Also, additional sediment controls should be installed so as the sediment fence is not the only protection.</p>	15/01/21

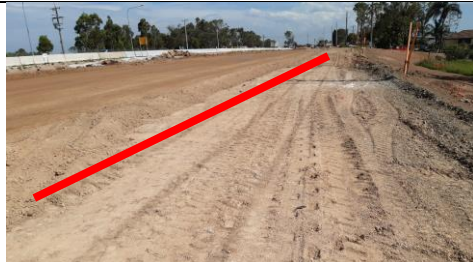
<p>A windrow has been shaped as part of construction to retain a portion of potential rainwater that falls within the road alignment. This is a temporary measure to prevent scouring of the batter to the West.</p>
2	North of GRS towing	<p>Fill slopes towards the driveway to the north of GRS Towing and the water will be flow towards the cut/fill line near the corner of the driveway.</p>	M	<p>Ensure there is a stabilised batter chute at this point and install additional controls at (or near) the toe of the batter.</p>	15/01/21	<p>As above. This section of site will be revisited with controls revised next week as construction progresses and prior to the next rain event.</p>

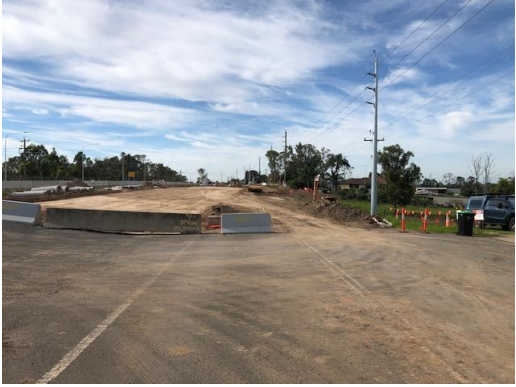
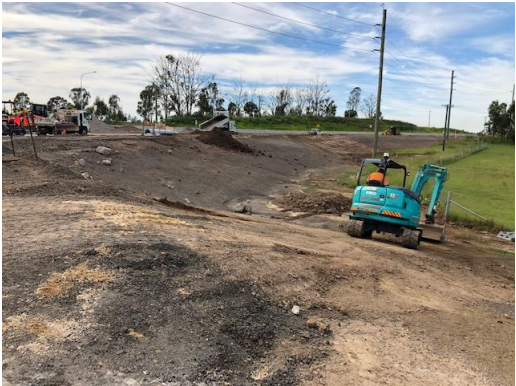
3	Kings Hill Road	<p>Batters are currently being trimmed and prepared for topsoil and landscaping treatments.</p> <p>ITS is currently being installed and intersection and Kings Hill Road being prepared from pavement to be laid prior to the end of the week.</p>

M	Complete work as planned prior to the end of the week/opening of intersection. Works include batters trimmed, topsoiled, landscaping and hydro-mulching, installation of sediment fence along concrete drain.	15/01/21

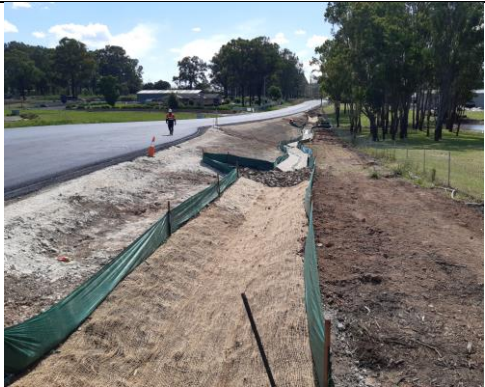
<p>Asphalt paving in place ready for the opening of Kings Hill this week. Jute mesh in place, and silt fence in place along both sides of the concrete swale.</p>

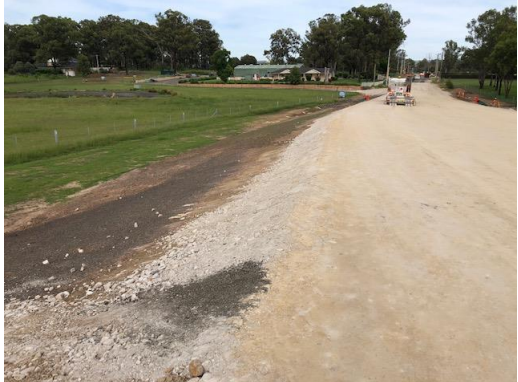
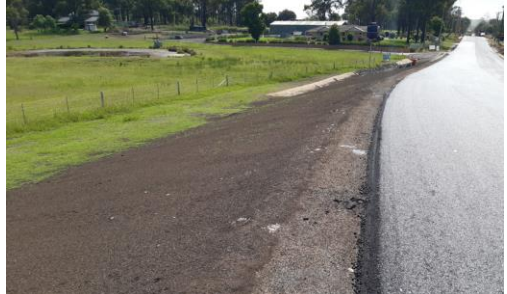
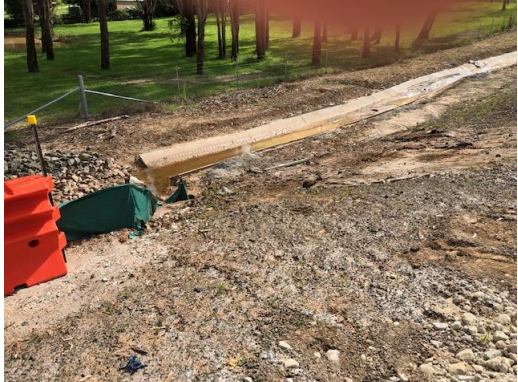
4	Kings Hill Road	<p>Some sediment control maintenance required after recent rainfall.</p>

M	Maintain sediment controls around headwall prior to the weekend.	15/01/21	Silt fence has been refreshed and the general area has been tidied ready for the opening of the road tonight.
5	Kings Hill Road	Design for the drainage line above the pavement drainage headwall is unclear.	L	Review design of the drain upstream of the headwall. If there is no drain in the design, consider keeping this drain to ensure water in this area is directed down the drainage line. Drain lining could be jute, topsoil and seed if concrete or rock doesn't want to be installed here.	15/01/01	Drain lining is jute mesh and has been put in place as shown in item 3.

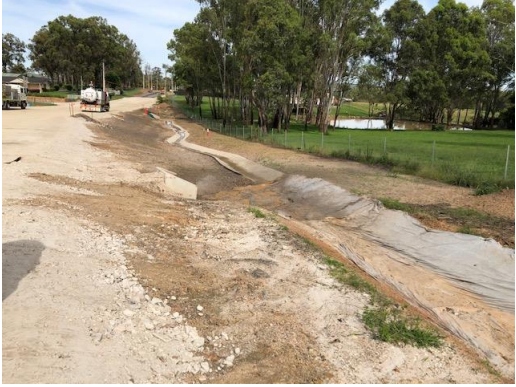
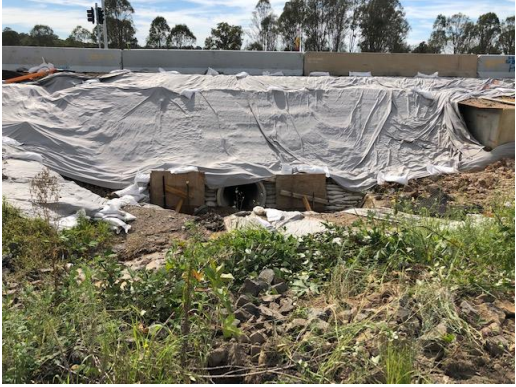
6	Bradley Street	<p>Maintenance required on controls in and around the clean-water path after the recent rainfall.</p> <p>Erosion and sediment control plan discussed for future culvert extension.</p>

M	<p>Tidy geo-fabric around the clean water path prior to the weekend.</p> <p>Commence installing controls discussed as part of the future erosion and sediment control plan prior to weekend where possible.</p>	15/01/20

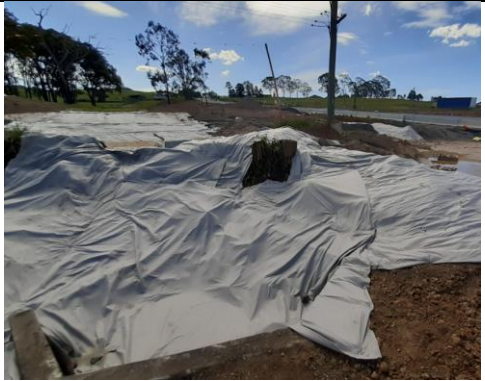
<p>Above: Perspective looking uphill to Bradley Street. Area has been refreshed with geotextile to make the clean water path more robust against scour in the event of rainfall.</p>

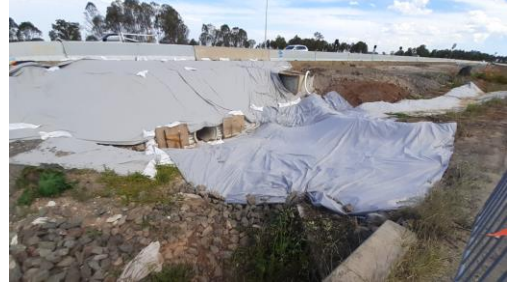
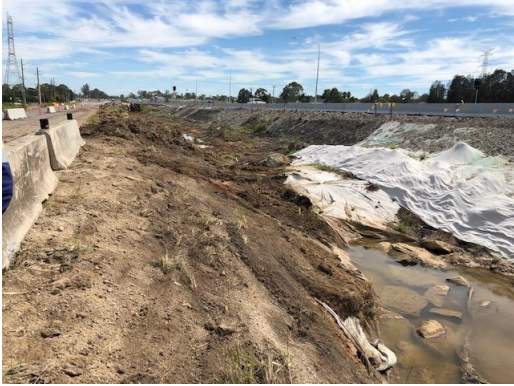
<p>Above: Clean water flow path through to P12 from Bradley Street has been refreshed with new geotextile and a small sump on the Southern upside.</p>
		<p>Maintenance required on controls in and around the clean-water path after the recent rainfall.</p> <p>Erosion and sediment control plan discussed for future culvert extension.</p>

<p>Tidy geo-fabric around the clean water path prior to the weekend.</p> <p>Commence installing controls discussed as part of the future erosion and sediment control plan prior to weekend where possible.</p>	15/01/21

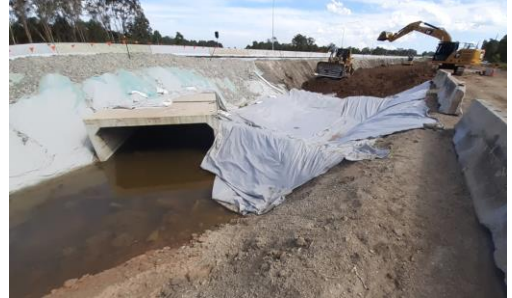
<p>The 45-degree culvert on the Northbound side of TNR has new controls in place. Water flowing down the median can be captured in a lined sump. Next week this area will be further formalised to further ensure clean and dirty water separation.</p>

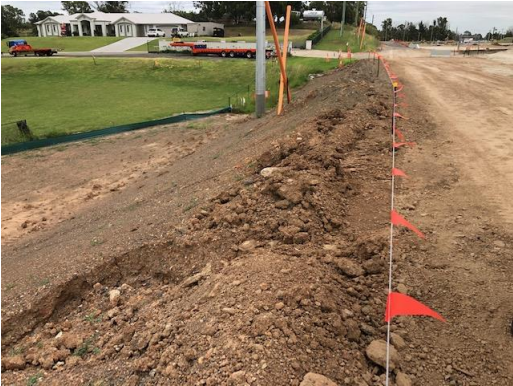
1	GRS Towing	<p>After recent earthworks the fill outside GRS towing is currently not being directed to a stabilised batter chute.</p>

M	<p>Fill outside GRS towing should be directed to a batter chute to ensure water does not flow down the batter uncontrolled. Look at directing all water to the cut fill line and then ensure water is flowing through sediment controls.</p> <p>Also, additional sediment controls should be installed so as the sediment fence is not the only protection.</p> <p>Amend batter scour above the headwall that developed during the last rainfall event.</p>	29/01/21	<p>Material has been placed along the edge to direct flows away from stabilised batter chute and north towards stable grassed area where water can slowly make its way down towards the lower flow path.</p>

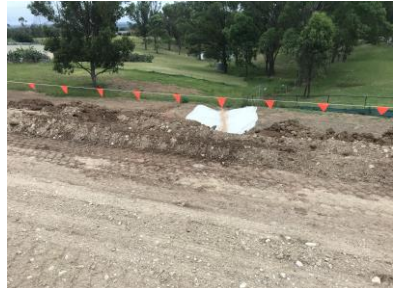
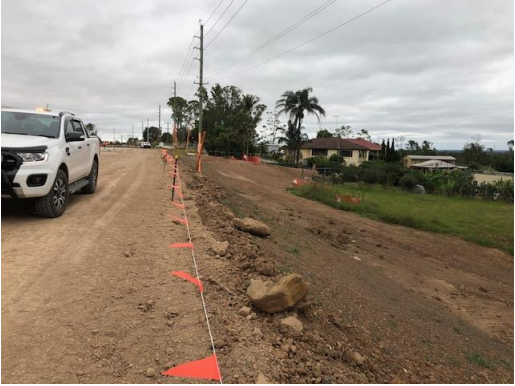
<p>Water will now flow down over grassed area</p>
2	Chain-of-Ponds Road	Work has just commenced in area. Erosion and sediment controls have already commenced being installed, which is good to see, however, some additional work is required on the controls around the headwalls.	M	<p>Extend the earth bunds around the tops of the headwalls to connect to the sediment fences on either sides of the headwalls to separate clean and dirty water.</p> <p>Install geofabric on all exposed earth at the inlets of the culverts on the clean water sides of the sed fence and earth bunds.</p>	27/01/21

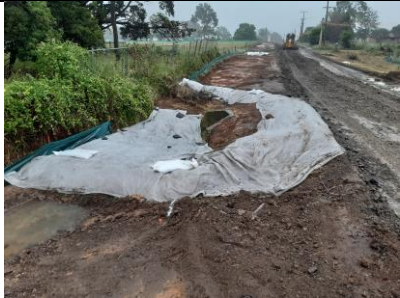
<p>The bund walls have been extended to the sediment fence and geotextile placed in the middle</p>

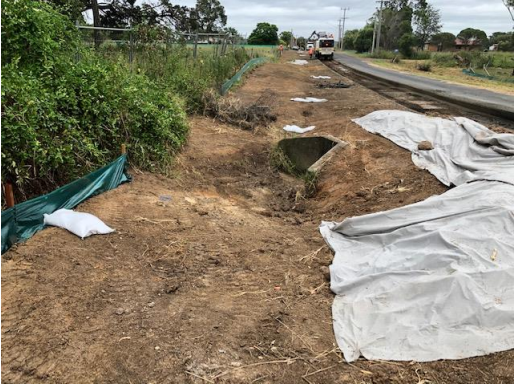
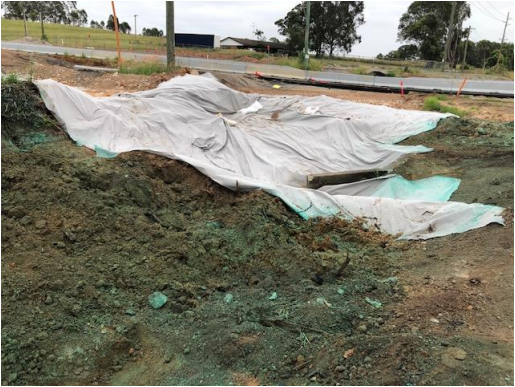
section to reduce site water ingress and provide a clean water diversion for oncoming water.
3	Bradley Street	<p>Sump and bund on upstream side of the culvert appears to have been disturbed recently as part of the clearing or other activity.</p>

M	Bund on the southern side of the culvert inlet needs to be tidied, strengthened and stabilised with geofabric lined spillway.	29/01/21

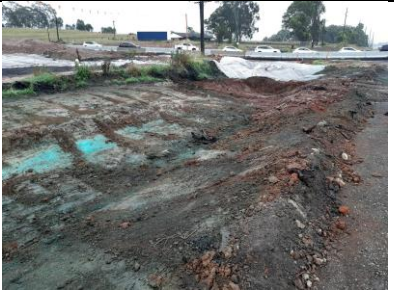
<p>28/1/21 The area on the Southern side of the drain inlet has been tidied by removing excess material to create additional sump capacity. Geotextile re-positioned to form a spillway.</p>

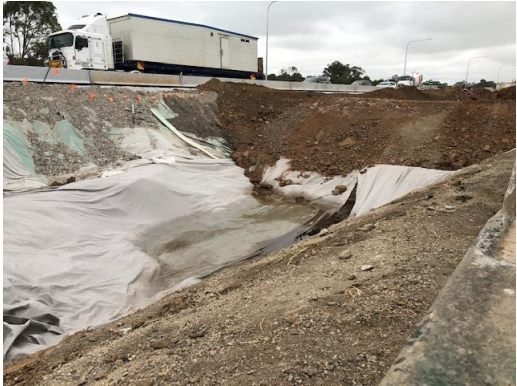
4	Culvert to the south of P12	<p>New culvert has been blocked as per the ESCP and old culvert inlet has been shaped and lined. Due to recent work in the median area, additional controls are required to ensure dirty water isn't going into inlet.</p>

M	<p>Sandbag pipe culvert to provide a sump area. Move bund closer to the culvert work to minimise the area to be protected as discussed on the site. Line any exposed areas around the culvert with geofabric to minimise the risk of erosion.</p>	29/01/21

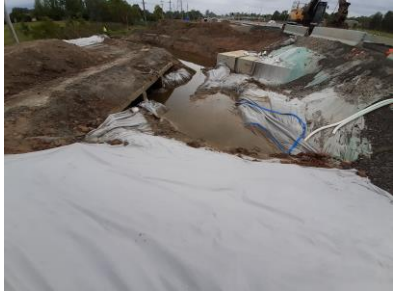
<p>The batter above the existing culvert was lined with geotextile to prevent erosion and scour. TfNSW and CPB Environment personnel inspected P12 area P12 on the morning of the 1/2/21 and spoke with site crewman to provide direction to enhance controls in this area.</p>
5	Gates Road	<p>Works in progress – work is underway in area and is currently in progress. Once work is complete in this area erosion and sediment controls are to be reinstated prior to the forecast rainfall.</p>	M	<p>Install erosion and sediment controls prior to rainfall as per the ESCP.</p> <p>Ensure that the culvert is protected and only clean water is passing through the culvert and allowed into the clean water area. Pull, seal and line batters where required. Install bunds at the tops of the batters to ensure water is not flowing over batters uncontrolled, and direct to a lined batter chute and ensure water is going through sediment controls before it leaves site.</p>	29/01/21

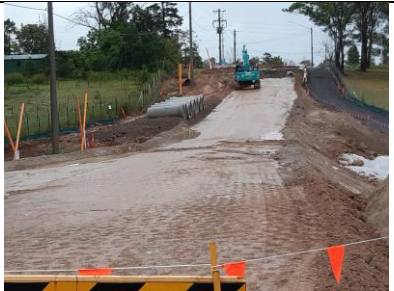
<p>Windrows installed down both sides of the new formation. Batters tidied up with an excavator. Sumps were made deeper on the Western &amp; Eastern side of the culvert.</p>
