# **The Northern Road – Mersey Road, Bringelly to Glenmore Parkway, Glenmore Park**

## **Environmental Representative Monthly Report**

**February 2021**

ER ENVIRONMENTAL SITE INSPECTION REPORT

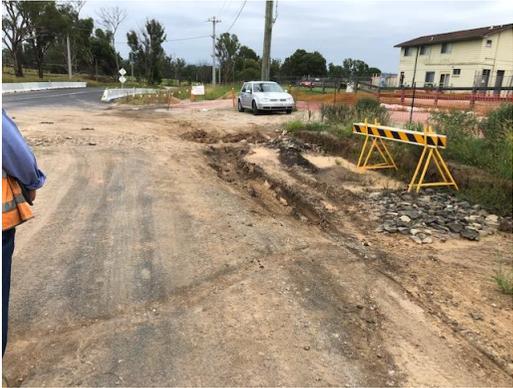
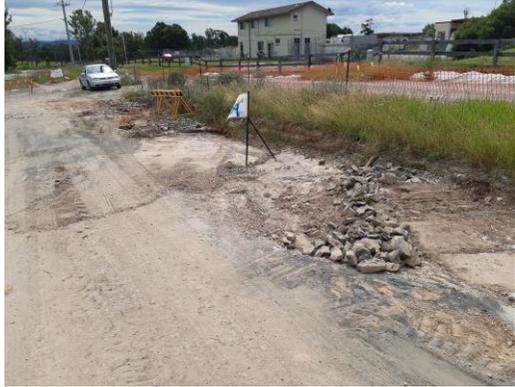
1	Littlefields Road	<p>Controls were observed to have been installed in the past along the north side of Littlefields Road, however, controls need to be maintained and renewed particularly now that there is more activity and earthworks in the vicinity.</p>

<p>This series of rock checks have been cleaned out to enable greater capacity in the event of rain.</p>
---	-------------------	---	---	---	----------	---

M	Maintain and reinstate controls down the north side of Littlefield Road. Clean out rock checks and install additional rock checks or similar earth bunds as required.	12/02/21

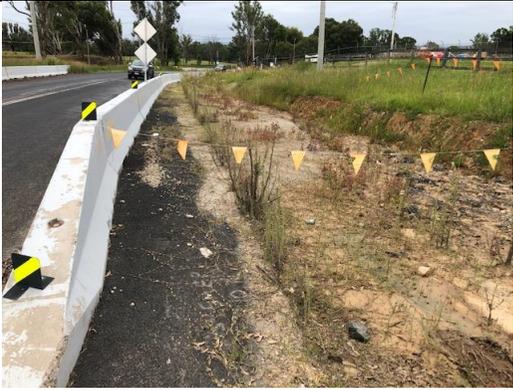
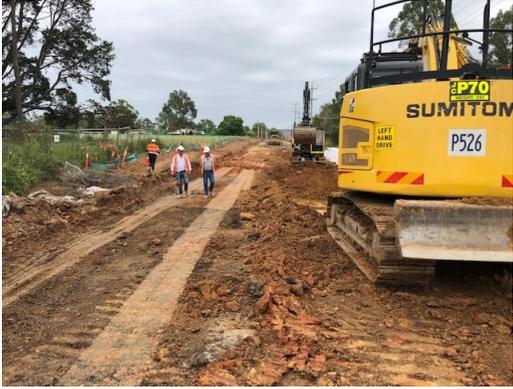
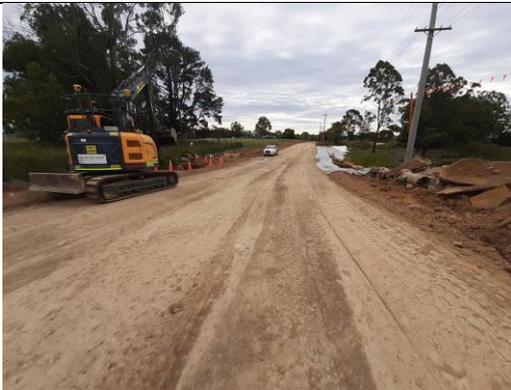
2	Chain-of-Ponds Road	<p>Works in progress - Transverse culvert has been removed to allow for the removal of unsuitable material, protection of water main and the installation of a new transverse culvert. Depending on how much is achieved prior to the weekend, a temporary clean water path may need to be installed.</p>

<p>A clean water flow path has been established using a temporary black max pipe. The inlet and outlet have been geotextiled at the end of the day 12/2/2021. The excavator prepared sumps to the side of the inlet. Bunding was also installed both sides of the road alignment to prevent water flowing into the clean water system.</p>

M	<p>If new transverse culvert cannot be installed prior to the weekends forecast rain, a clean water path must be established. A temporary pipe could be installed, or a clean water path lined with geofabric. If a lined clean water path is chosen, ensure it banded either side so that dirty water cannot enter the drain without going through sediment controls. Also, install sumps or similar on either side of clean water path to capture dirty water.</p>	12/02/21

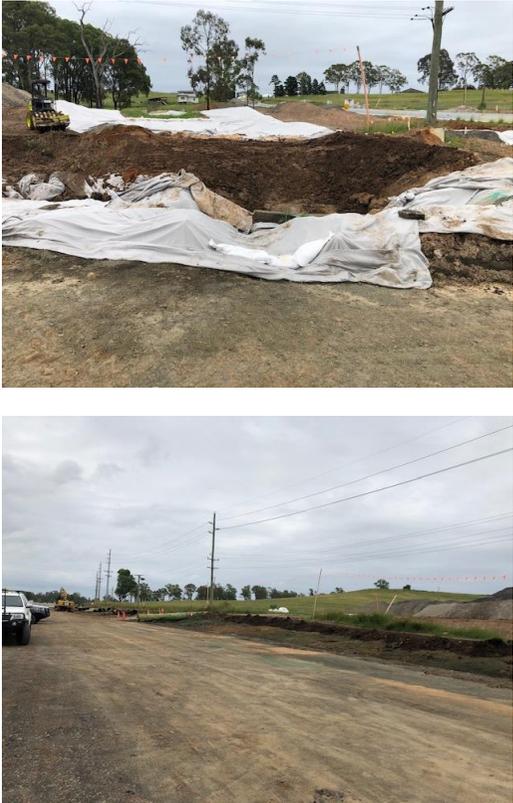
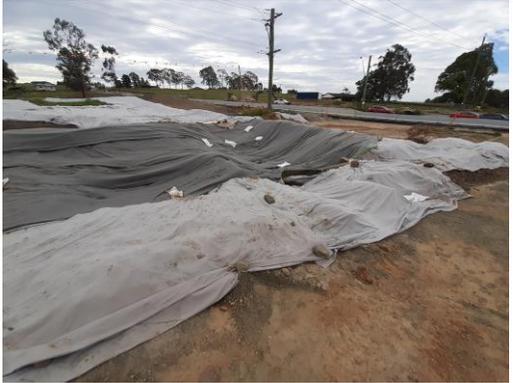
<p>3</p>	<p>Bradley Street</p>	<p>Work in progress – geofabric lining removed to allow for the removal of the old watermain pipes. Installation of new pipe culverts is proposed to commence in near future.</p>

<p>the clean water flow path that connects into the triple cell culvert system was reinstated following the removal of the redundant water main. Controls that lead into the triple cell culvert were further enhanced at the end of today (12/2/2021) and included covering the area with geotextile and strategically positioned sandbags.</p>
----------	-----------------------	--	----------	--	-----------------	--

<p>M</p>	<p>Ensure controls are reinstalled prior to the next forecast rain to create a clean water path through the work area.</p> <p>Clean water catch drains should also be constructed to ensure clean water is captured and transferred through the transverse clean water path.</p>	<p>12/02/21</p>

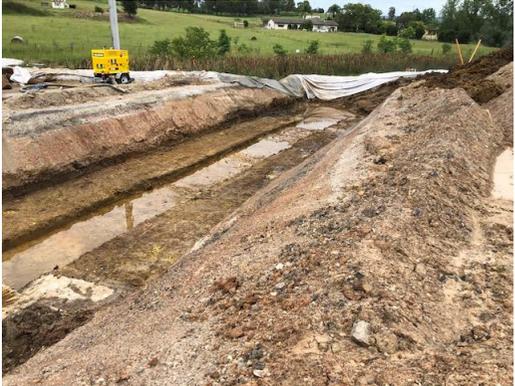
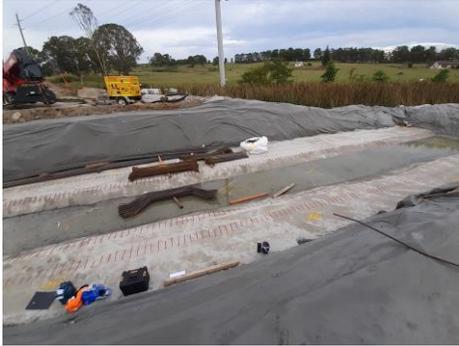
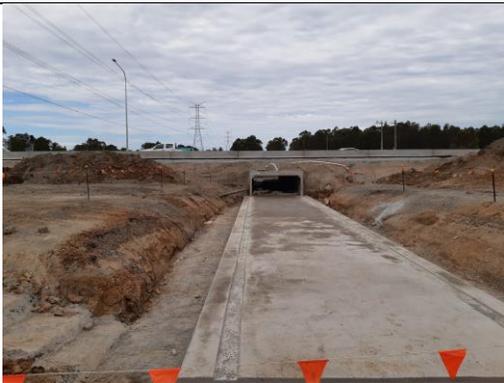
4	P12/Surveyors Creek culvert	<p>Works in progress – culvert excavation complete. Concrete blinding is programmed to be installed tomorrow or Thursday. Once blinding is installed, batters could be lined and area could be treated as “clean water” if all sources of dirty water are protected.</p>

<p>CPB poured a concrete blinding layer within the 45-degree culvert excavation on 10th February 2021. Batters within the excavation were lined with geotextile with the inclusion of a stabilised spillway on the Western side. This addition reduces the potential for water to enter in contact with bare earth within the excavation.</p>
5	P12 Flood overflow culvert	Works in progress – Steel fixing currently underway. Formwork should be completed tomorrow and concrete slab poured on Thursday.	M	Complete work as planned prior to the forecast weekend rain.	12/02/21

M	Continue with work as programmed. Line batters after blinding to make a clean water area.	12/02/21

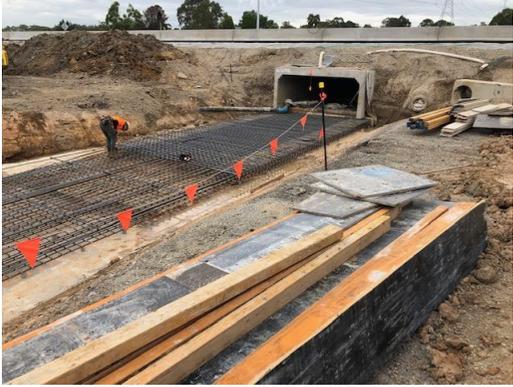
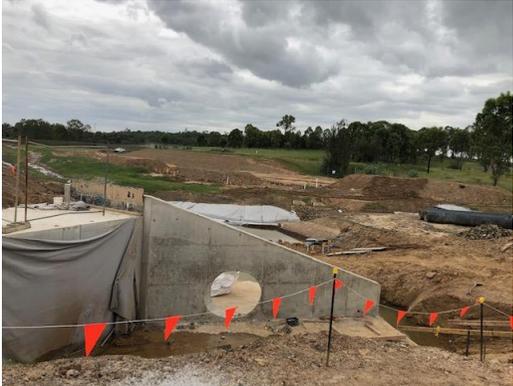
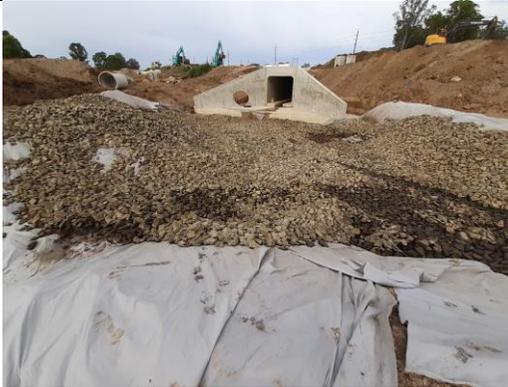
<p>The concrete blinding layer was completed by 11/2/2021. The majority of formwork was completed by 12/2/2021.</p>
6	<p>Area to north of DEOH gate</p>	<p>Works in progress – wingwalls for culvert were stripped yesterday. Work on dissipater and surrounding areas now needs to be completed as quickly as possible.</p>

<p>A covering of geotextile and rip-rap rock plus bunding was placed below the large culvert at S3. The road alignment above the culvert was further progressed this week with the inclusion of no-fines drains and spray seal both North and South of the DEOH access thus increasing stabilised ground surfaces in the overall project catchment.</p>

M	<p>Install rock dissipater (if possible by the weekend) and commence completing remainder of work in the vicinity in preparation for the traffic switch in mid-March.</p>	<p>12/02/21 – please provide update on progress.</p>

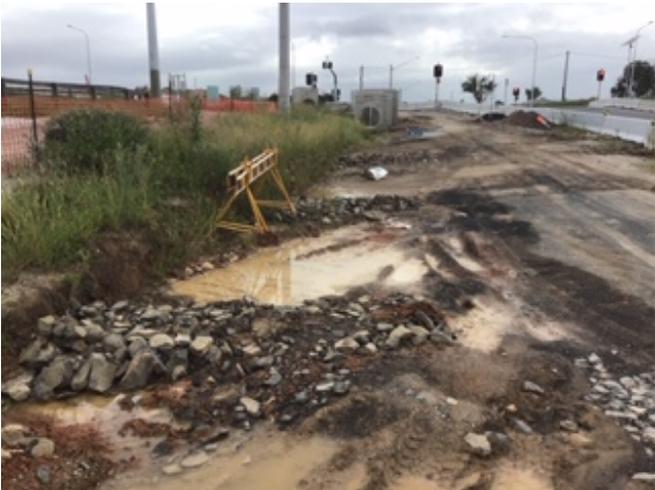
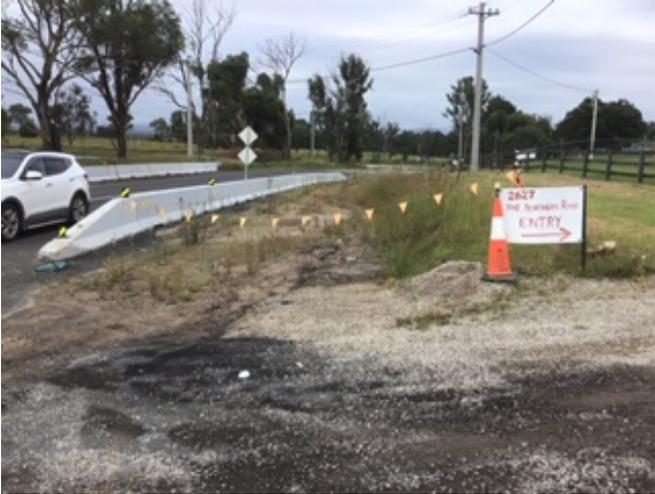
No.	LOCATION	CONTROL	RECOMMENDATION / COMMENT	PRIORITY	PHOTOGRAPH
1	North side of Littlefields Road	Rock bund sediment traps	<ul style="list-style-type: none"> <li>• Provide maintenance/improvements to the existing traps upslope of the private access (ie refer to the top photo).</li> <li>• Install 2 traps downslope of the private access (refer to the lower photo).</li> </ul>	High - without delay.

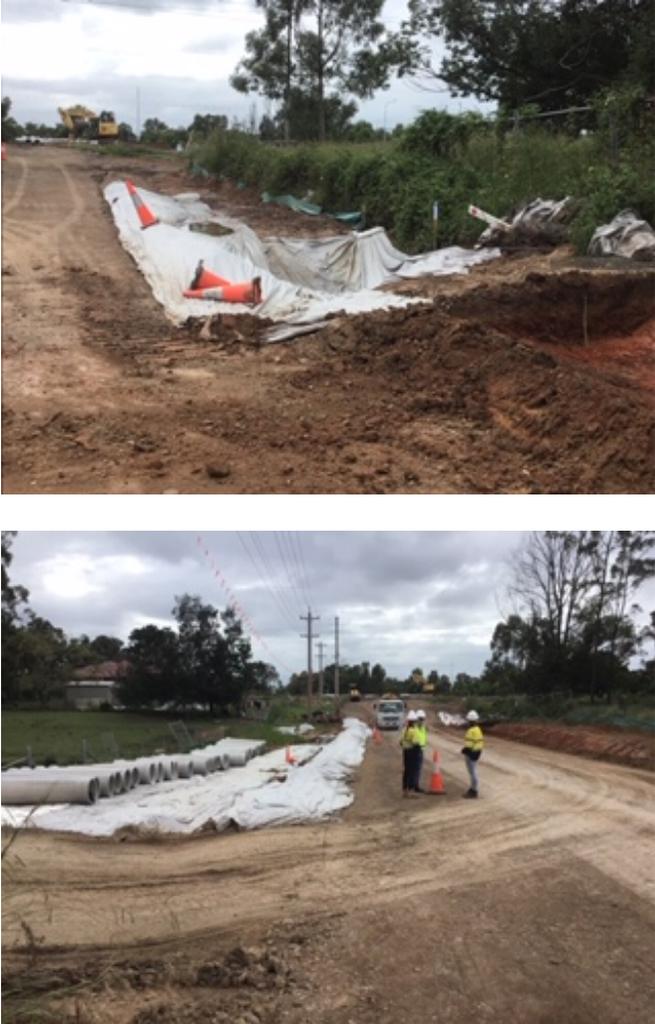
No.	LOCATION	CONTROL	RECOMMENDATION / COMMENT	PRIORITY	PHOTOGRAPH
3	Chain-O-Ponds Road	Sand bag sediment traps	Install sand bags to treat road runoff prior to flowing into 'clean' water areas (eg inlet of the temporary pipe culvert).	High - prior to the forecast rainfall

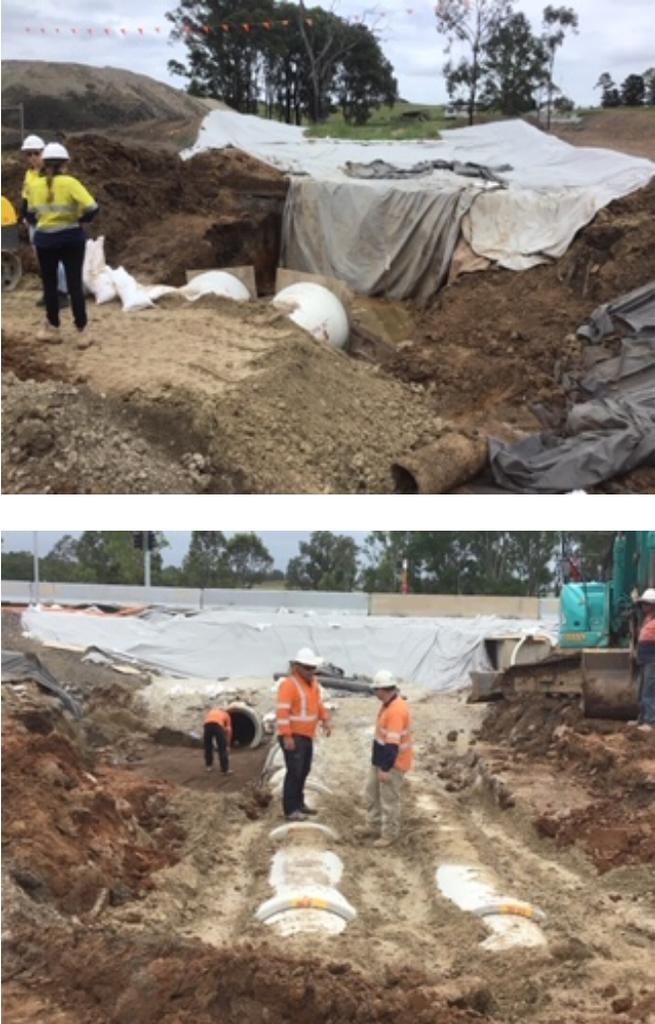
No.	LOCATION	CONTROL	RECOMMENDATION / COMMENT	PRIORITY	PHOTOGRAPH
4	Pipe culvert works on the south side of Bradley Street	'Clean' water flow path	Pipe laying in progress with a geofabric lined flow path to be established prior to forecast rainfall (ie good practice).	Observation - to note only

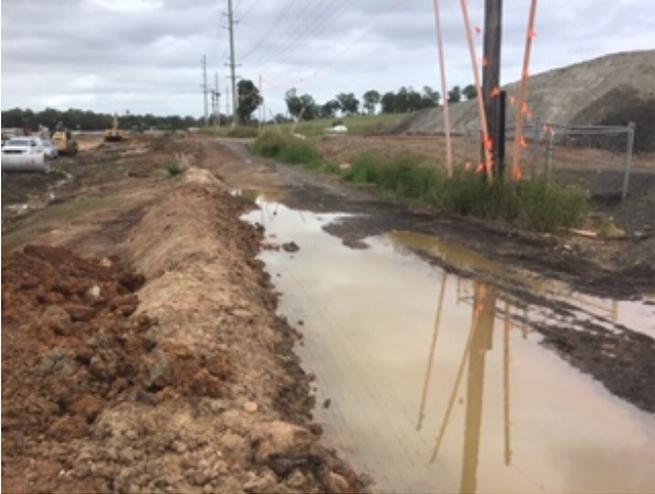
No.	LOCATION	CONTROL	RECOMMENDATION / COMMENT	PRIORITY	PHOTOGRAPH
5	South side of the Bradley Street pipe culvert works at above point 4	'Clean' runoff	Construct the permanent 'clean' water diversion drain to discharge into the culvert.	High - immediately culvert & inlet protection works are completed

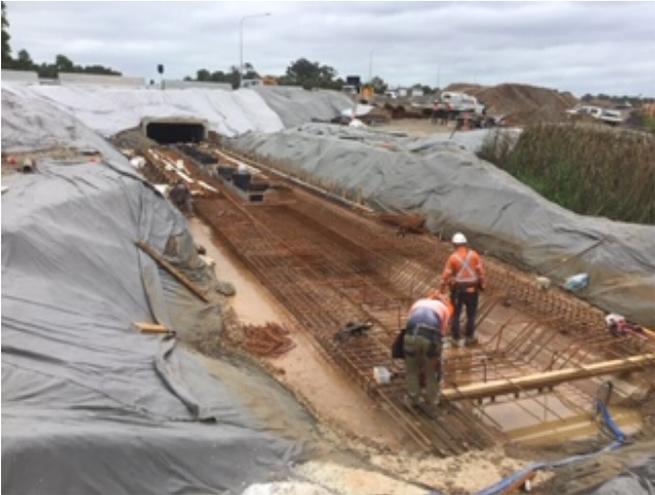
6	P12 - Surveyors Creek box culvert works.	'Clean' water flow path	Works proceeding well with 'clean' creek flows soon able to be diverted through the works area via the lower fish passage channel.	Observation - to note only

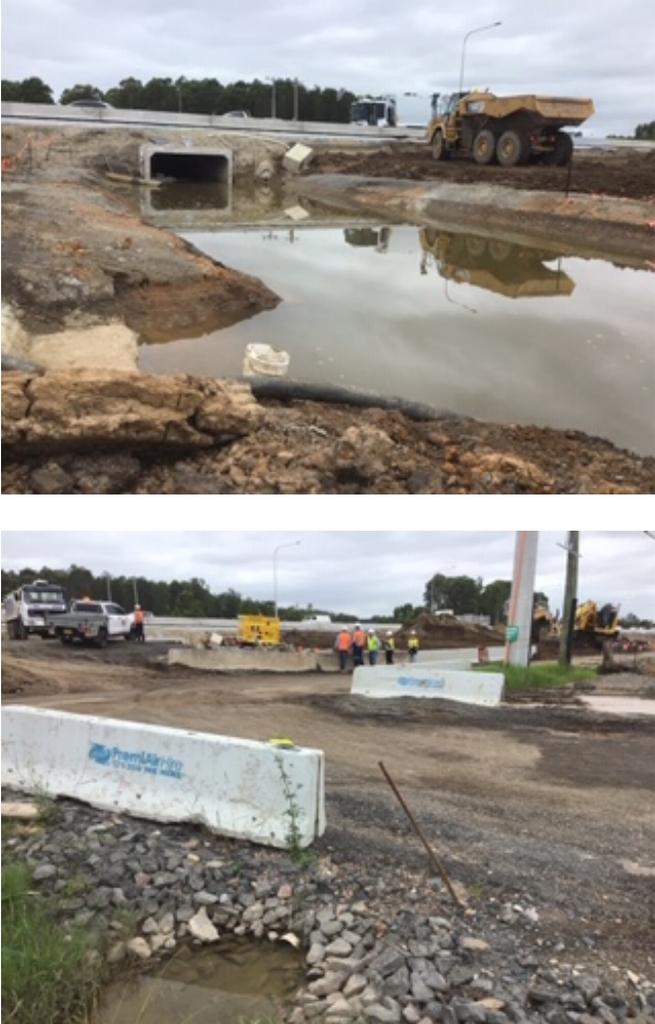
No.	LOCATION	CONTROL	RECOMMENDATION / COMMENT	PRIORITY	PHOTOGRAPH
7	P12 - Surveyors Creek flood overflow box culvert	'Clean' water flow path	<ul style="list-style-type: none"> <li>• Works proceeding well with the units scheduled to be installed.</li> <li>• Install a temporary pipeline to drain the culvert excavation as much as practical &amp; convey 'clean' flows to the adjacent vegetation (ie culvert cannot be completed/'day lighted' due to conflict with proposed services works).</li> </ul>	<p>Observation - to note only</p> <p>High - without delay</p>

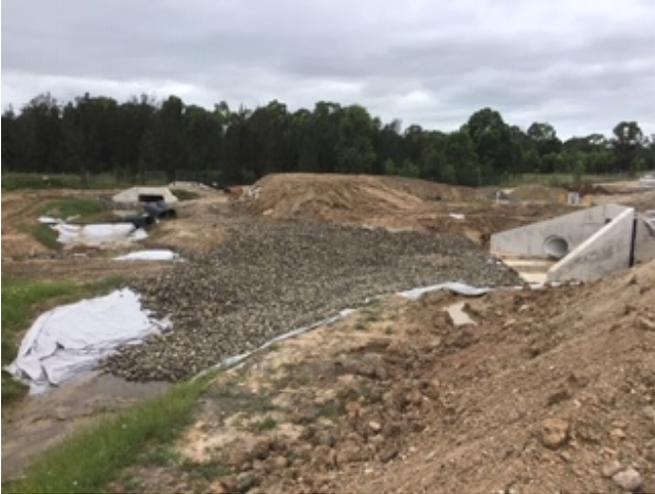
No.	LOCATION	CONTROL	RECOMMENDATION / COMMENT	PRIORITY	PHOTOGRAPH
8	Box culvert outlet channel & adjacent channel north of the DEOH gate	'Clean' water flow paths & adjacent sediment control	<ul style="list-style-type: none"> <li>• Good response from last inspection with the outlet channel lined with rock rip rap.</li> <li>• Line &amp; stabilise the adjacent channel with rock rip rap (ie along the left side of the photo).</li> <li>• Treat 'dirty' runoff prior to entering the 'clean' water channels via installation of sediment fences, application of soil binder or similar.</li> </ul>	<p>Observation - to note only</p> <p>High - without delay</p> <p>High - immediately following the completion of earthworks which includes channel lining, backfilling behind the culvert head &amp; wing walls, fill batter shaping, stockpile works</p>

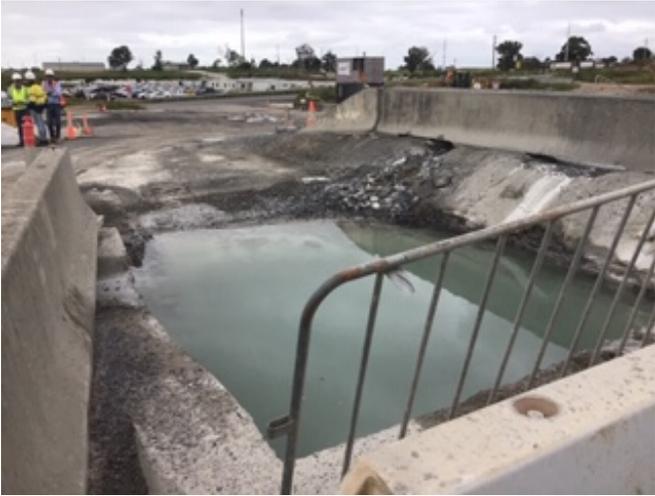
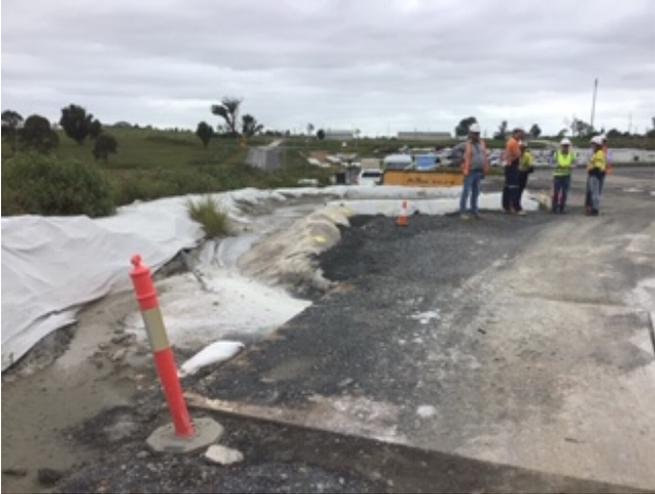
9	Concrete batch plant	Contamination ponds	General agreement that the contamination ponds were functioning satisfactorily with adequate maintenance.	Observation - to note only
