The Northern Road – Mersey Road, Bringelly to Glenmore Parkway, Glenmore Park

Environmental Representative Monthly Report

June 2021

Appendix A. Site Inspection Reports

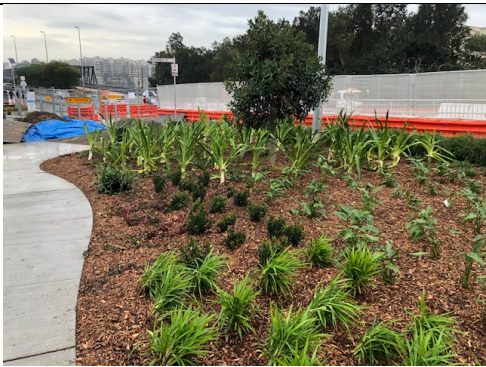
No	LOCATION (Chainage/ Description)	ISSUE/COMMENT	RISK (H, M, L)	ACTION	Agreed Close out date	Response
1	ICL	Positive observation – landscaping is continuing being completed to a high standard.	N/A	N/A	N/A	N/A

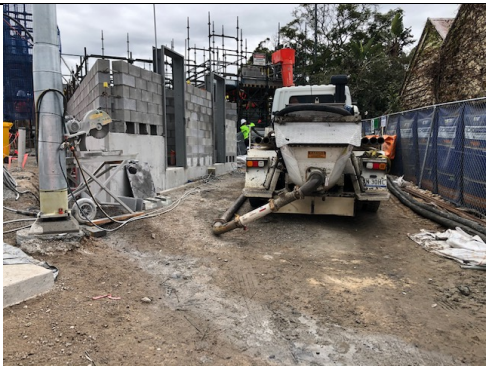
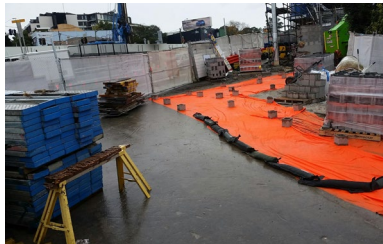
2	ICL	Works in progress – Concrete pour was being prepared for this morning, however the team held off the pour to see what the rain was going to do. The rain started at the start of the inspection, the concrete pour was postponed until the rain stopped. Once the call was made to postpone, the site teams commenced installing the event based controls and tidying the site.	L	Recommend the installation of event based controls and tidying of site be monitored during the morning to ensure the site is well set up prior to sending the team home for the day.	03/06/21	<p>A small area of Block 2 (immediately adjacent to the HS01 building, between Callan and Toelle Streets) remains unsealed as all other areas have been sealed with a combination of permanent concrete footpaths, existing asphalt road surface (yet to be removed) and compacted gravel. The small, unsealed area remaining will have the following end of day controls implemented each day:</p> <ul style="list-style-type: none"> - Geofabric - Linear array of sandbags to assist with any water that does move across the site.

<p>The above controls are in addition to the boundary controls already in place at the top of Toelle Street. Subsequent weekly enviro inspections and general day-to-day observations of the work area have verified that the above mentioned controls are being implemented daily.</p>

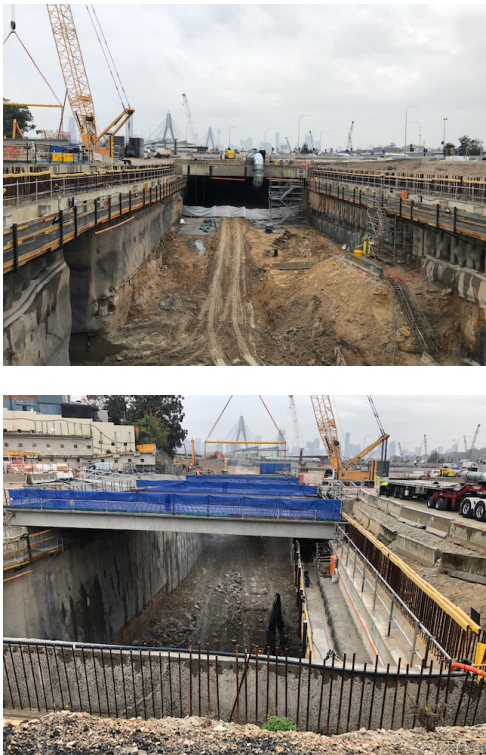
3	RRY – M4 Cut and cover	General observations – Excavation continuing in the cut and cover. Super-T girders being landed during the inspection.	N/A	N/A	N/A	N/A

No	LOCATION (Chainage/ Description)	ISSUE/COMMENT	RISK (H, M, L)	ACTION	Agreed Close out date	Response
		<p>Positive observation – dust suppression continues to be used even during light rain to ensure any dust generation from the cut and covers is minimised.</p>

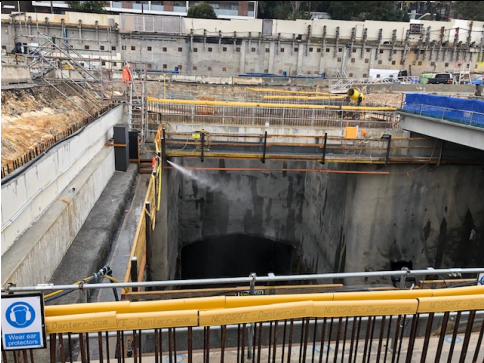
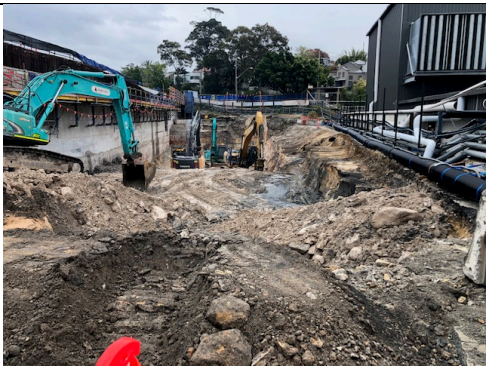
4	RRY	General observation – Rock hammering occurring between the WHT cut and cover and Shed C. It was observed by the AA that it was acceptable practice to have three hammers operating at the same time as the overall cumulative noise impact would not be significant, and the reduction in duration would be substantially more beneficial in minimising the impact.	N/A	N/A	N/A	N/A

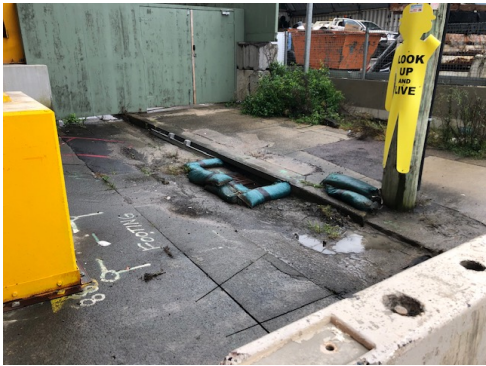
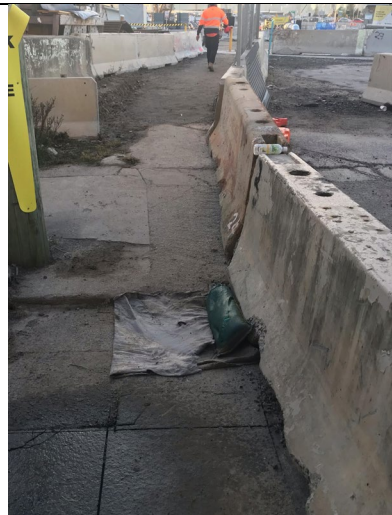
5	RRY	<p>Pit controls behind the food trucks in need of some maintenance.</p>

L	Maintain pit controls	11/06/21	As this is now a walkway, sandbags on all sides of the pit were deemed a trip hazard. This pit has a maintained and clean drain warden along with the controls in the pic below.

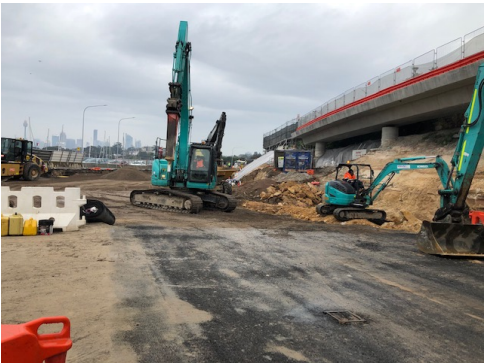
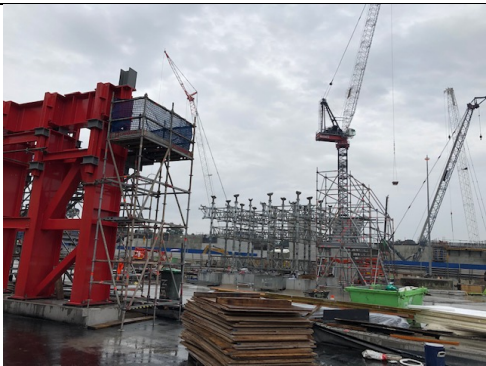
6	The Crescent/CWL	<p>General observation – site preparation underway for the delivery of the steel girder for the land bridge.</p>

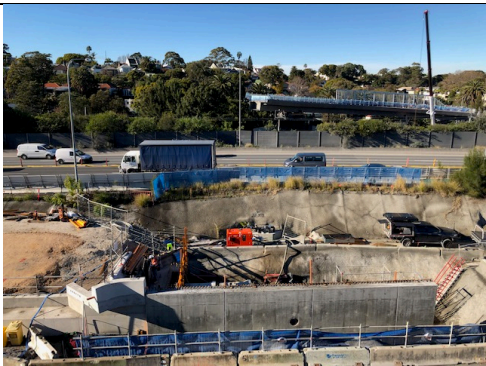
No	LOCATION (Chainage/ Description)	ISSUE/COMMENT	RISK (H, M, L)	ACTION	Agreed Close out date	Response
1	RRY – M5 C&C	General observation – construction permanent drainage installation adjacent to CWL is continuing. Pig-tail pedestrian bridge is progressing and will essentially tie into where the photo was taken.	N/A	N/A	N/A	N/A

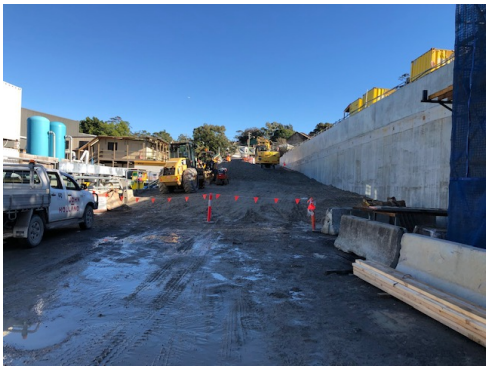
2	WHT C&C	<p>General Observation – ramp currently under construction which will be used to bring backfill material and topsoil in from Lilyfield Road for the final landscaped formation.</p>

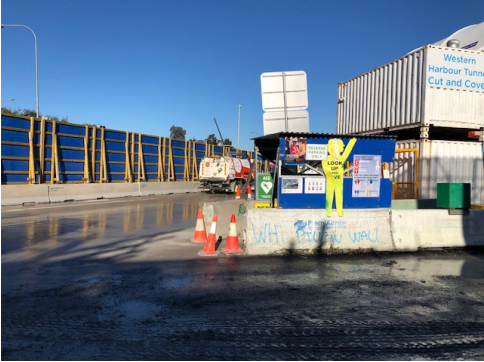
N/A	N/A	N/A	N/A
3	RRY	Positive observation – street sweepers are actively sweeping the internal haul roads to keep them as clean as possible, which	N/A	N/A	N/A	N/A

No	LOCATION (Chainage/ Description)	ISSUE/COMMENT	RISK (H, M, L)	ACTION	Agreed Close out date	Response
		<p>minimises the risk of mud tracking on the CWL.</p>

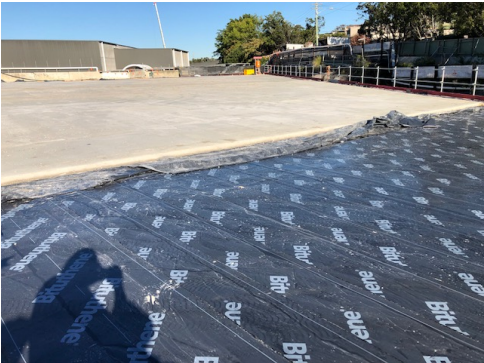
4	WHT C&C	<p>General observation – water proofing and protection slabs are progressively continuing to be installed on the deck of the cut and cover.</p>

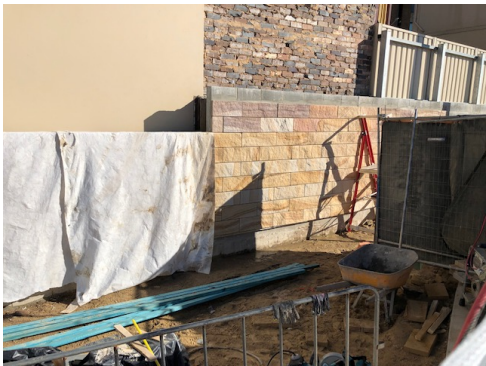
No	LOCATION (Chainage/ Description)	ISSUE/COMMENT	RISK (H, M, L)	ACTION	Agreed Close out date	Response
5	Hornsey St	<p>General observation – final sandstone cladding treatment being installed on the retaining walls between Hornsey Street and Lilyfield Road.</p>

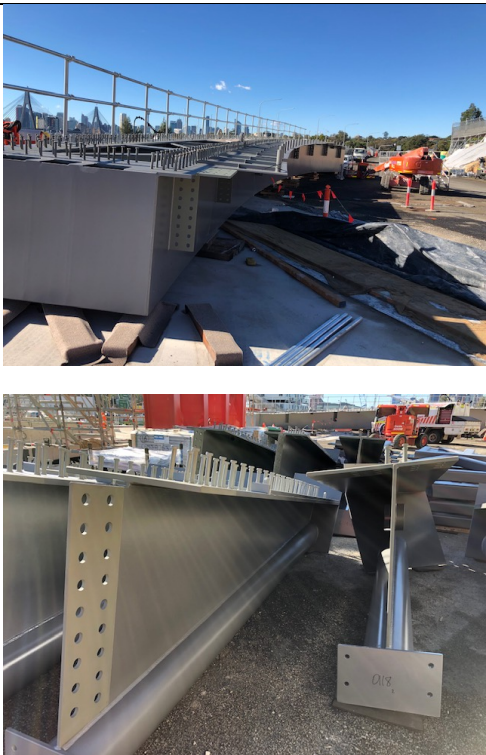
N/A	N/A	N/A	N/A
6	The Crescent/CWL	<p>General observation – the first steel girder has been delivered and will be dressed in the coming weeks before being lifted into place on the 28 and 29 June.</p>	N/A	N/A	N/A	N/A

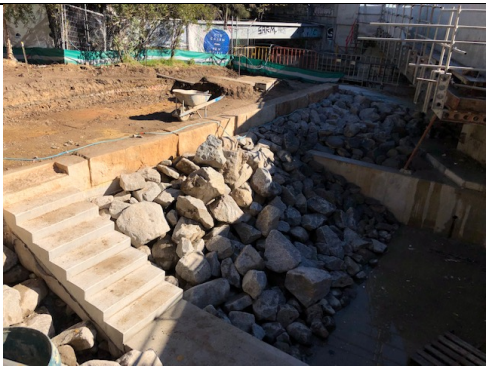
7	The Crescent/CWL	General observation – Whites Creek upstream duplication work is continuing and is being prepared for the pedestrian pathway through Buruwan Park to be reopened at the end of the month.	N/A	N/A	N/A	N/A
