M1 Pacific Motorway extension to Raymond Terrace

Non-Aboriginal Heritage Working Paper

Transport for NSW | July 2021

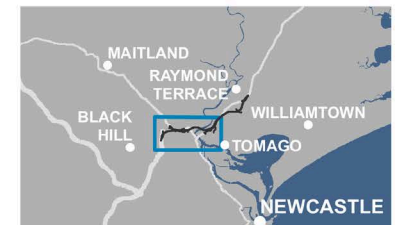
Figure 1-2 Project key features (map 1 of 2)

- Main alignment
- Adjustments to existing roads
- New ramp
- Creek realignment
- Bridges/ Viaduct
- Construction footprint
- Waterways
- Main North Rail Line

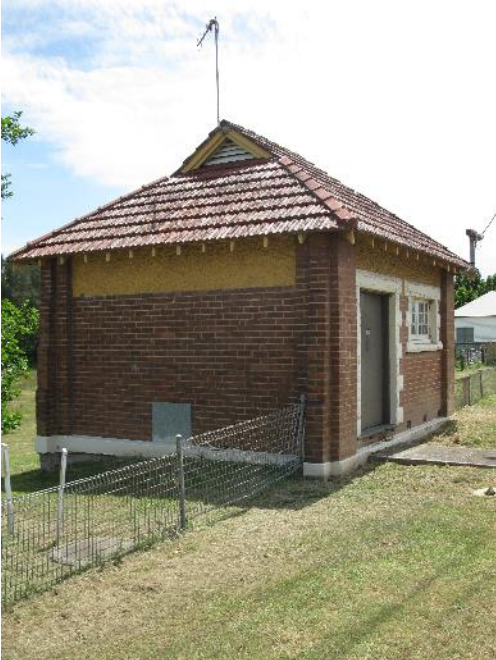
Location	Item name and register number	Results of survey
29 Eastern Ave, Tarro Lot 100 DP849413	Residence (Item 4) NLEP I548	Actual building of significance is located about 60 metres from construction footprint. No other heritage elements are in proximity to the construction footprint. Further details can be found in Section 5.4 .
6A Anderson Drive, Tarro Lot 1 DP128309	Tarro substation (Item 7) NLEP I546	<p>Survey of property to assess if any items are close to construction footprint. Building is located next to construction footprint. Further details can be found in Section 5.6.</p>

<p>Figure 4-2 Tarro substation, facing southwest, 15 December 2015</p>

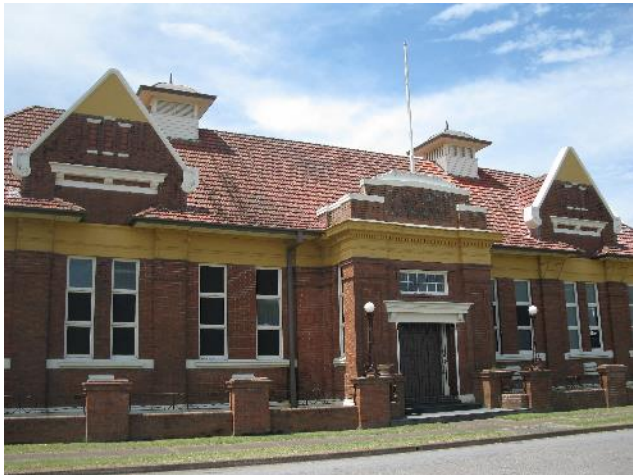
Location	Item name and register number	Results of survey
3 Woodberry Road, Tarro Lot 1 DP128309	Pumping Station (Item 8) NLEP I550	<p>Survey of property to assess if any items are close to construction footprint. Building is located next to construction footprint. The survey confirmed that the description from the NLEP is accurate, as follows.</p> <p>The main building of the Tarro Pumping Station is a large, purpose-built water pumping station in the Federation style. The building is brick built in Flemish bond with black tuck pointing, which is now faded. The building has painted render and concrete details with a parapeted and hipped Marseille tiled roof. There are two timber louver vent stacks and extended eaves supported on steel brackets, as well as ornate dormer with cast detail. The building has a Colorbond downpipe and guttering. The entrance door is a panelled timber door with glazed overlight. There are mostly replacement timber windows, some glazed and some broken, as well as some original windows. Internally virtually all equipment has been removed and the space is largely used for storage</p>

<p>Figure 4-3 Pumping Station, facing northeast, 15 December 2015.</p>

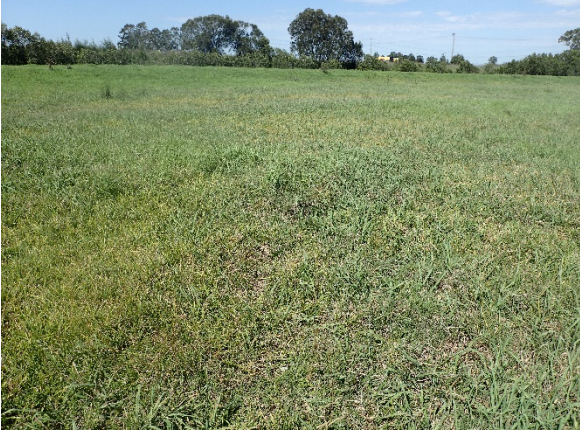
404 Maitland Road, Hexham Lot B DP405828	Hexham Shipbuilding Yards (Item 2) NLEP I180	<p>The construction footprint overlaps with the curtilage of the heritage item. The construction footprint is related to a vehicle access track, which is about 10 metres wide in this location. The majority of the project access track overlaps with an existing imported gravel vehicle track with narrow bands of grass either side. The existing track is slightly raised above the surrounding landscape, which is flat and prone to flooding.</p> <p>Several large, shallow depressions, aligned in rows, were noted on either side of the existing gravel vehicle track, as well as some pieces of timber which were located at the end of one of the depressions. The depressions range from about 20 to 40 metres long and may have originally extended from one side of the imported gravel vehicle track to the other, before the track construction. Further details can be found in Section 5.2.</p>

<p data-bbox="528 707 1465 763">Figure 4-4 Depressions in foreground and construction footprint in background, facing south. 14 March 2018.</p>
398B Maitland Road, Hexham Lot 1 DP1165954	Hannell Family Vault (Item 1) NLEP I179	<p data-bbox="528 779 1485 992">The heritage curtilage of the vault includes the entire lot which overlaps with about 10 metres of the construction footprint at the western end of the lot. This section of construction footprint comprises mostly an existing gravel vehicle track, with a small band of grass on either side. The physical building comprising the vault is located about 120 metres east of the construction footprint. Within the construction footprint there is a narrow band of grass on either side of the existing gravel vehicle track. Further details can be found in Section 5.1.</p>

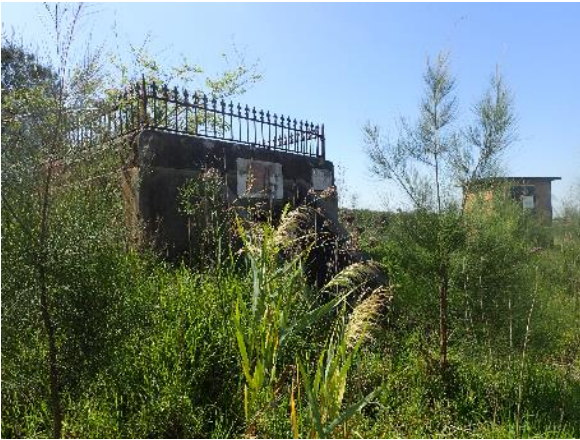
<p data-bbox="528 1476 1315 1505">Figure 4-5 Hannell Family Vault, facing southeast. 14 March 2018.</p>

The field survey of the Hannell Family Vault was carried out on 14 March 2018. The section of the heritage item curtilage located within the construction footprint comprises an existing informal gravel vehicle track with narrow grassed sections either side of the track. The vault is located about 20 metres north of the construction footprint. The vault has a lot of overgrown vegetation in close proximity. The inside of the vault was observed from the door and is empty.

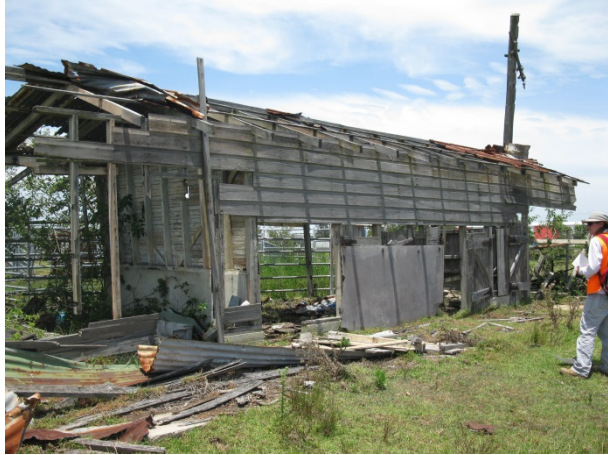
Figure 4-10 Wooden building, facing east, 15 December 2015

15 Pacific Highway, Tomago Lot 51 DP739336	Building remains and footings	<p>Detailed survey and photographic recording of site. Site comprised:</p> <ul style="list-style-type: none"> • Wooden building in poor condition, concrete footings, series of wooden doors, remnants of corrugated iron roof • Square brick tank. Very rough bricklaying, located on concrete slab, brick floor at end of concrete slab • Pile of building debris, wooden posts, corrugated iron • Secondary pile of building debris, bricks, corrugated iron, old machinery and an artificial channel north of site. <p>The nature of the construction techniques, including the types of bricks, modern, machine sawn nature of timbers etc, indicate the recent nature of the site. Additionally, the site is in extremely poor condition. There were no areas of archaeological potential, such as cess pits, identified at this location.</p> <p>It is not considered to be a heritage item, and therefore no further assessment has been carried out.</p>

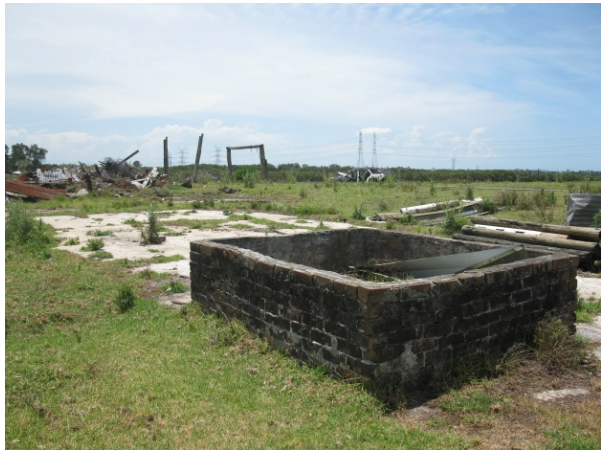
Figure 4-11 Brick tank, facing east, 15 December 2015

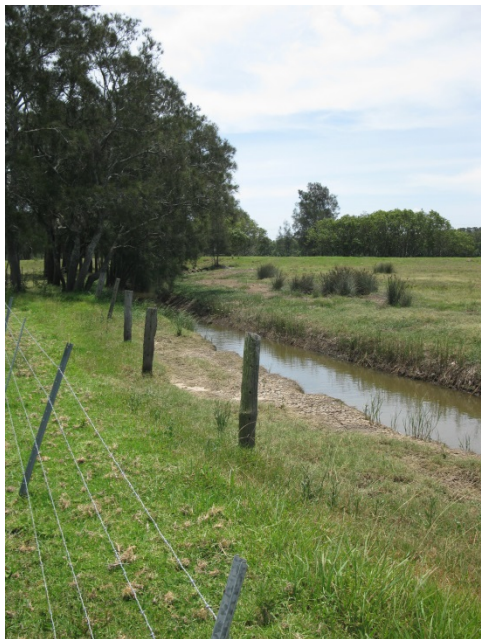
Figure 4-12 Artificial channel, facing west, 15 December 2015

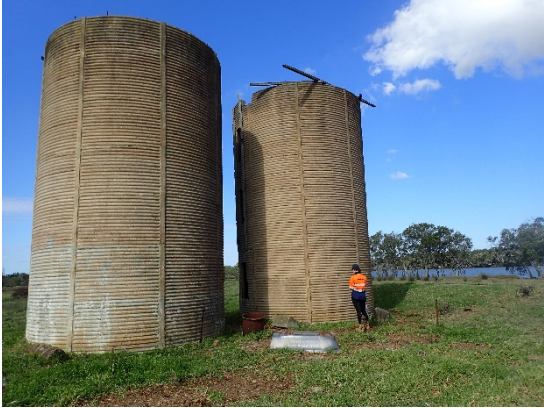
<p data-bbox="660 645 1412 705">Figure 4-15 Concrete silos with Hunter River in background, 14 March 2018</p>
<p data-bbox="108 719 327 842">1 Anderson Drive, Tarro Lot 10 DP1150648</p>	<p data-bbox="355 719 555 779">Purgatory Creek crossing</p>	<p data-bbox="660 719 1460 869">The Purgatory Creek crossing is located outside and next to the updated construction footprint. Survey was carried out as the creek crossing is located about 45 metres north of the construction footprint. The Purgatory Creek crossing is of modern construction (concrete pipe and gravel over top).</p> <p data-bbox="660 875 1372 936">No potential heritage item identified and therefore no further assessment has been carried out</p>

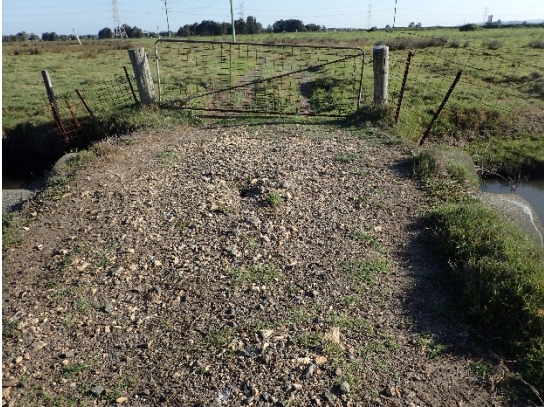
<p data-bbox="660 1393 1305 1420">Figure 4-16 Purgatory Creek crossing, 14 March 2018</p>

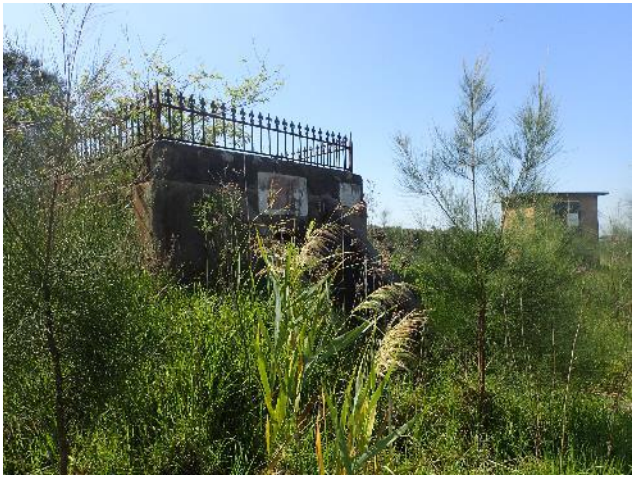
Figure 5-1 The Hannell Family Vault, facing southeast

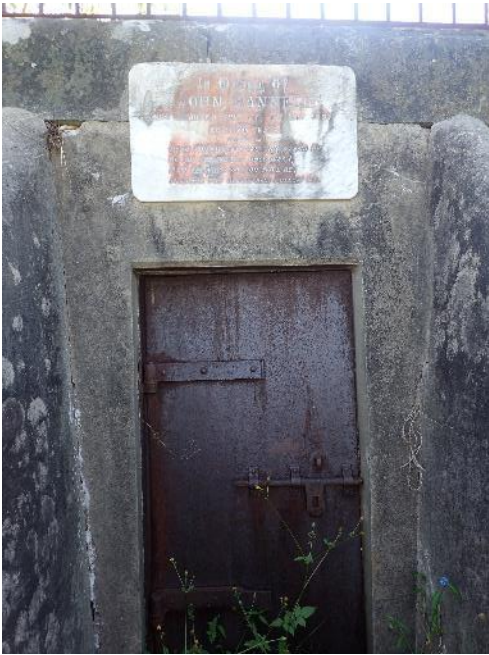
Figure 5-2 Front door of the vault

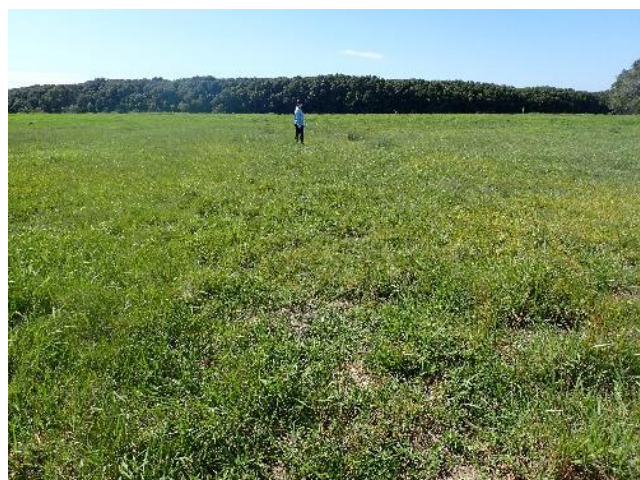
Figure 5-6 Area of shallow depressions, vehicle track in background, facing east

A review of aerial imagery from 1954 indicates that the shallow depressions noted during the survey to be next to the flood levee bank / vehicle track also occur around 185 metres north of this site, and on the west of the Hunter River (**Figure 5-8**). Like the depressions next to the flood levee bank / vehicle track, these depressions are also within 60 metres of the river bank. These shallow depressions also occur across the landscape in the general region away from the river, but close to other canals (**Figure 5-8**). The depressions are likely associated with previous agricultural land use of the area associated with irrigation and management of water, as outlined below. They are not thought to be associated with shipbuilding.

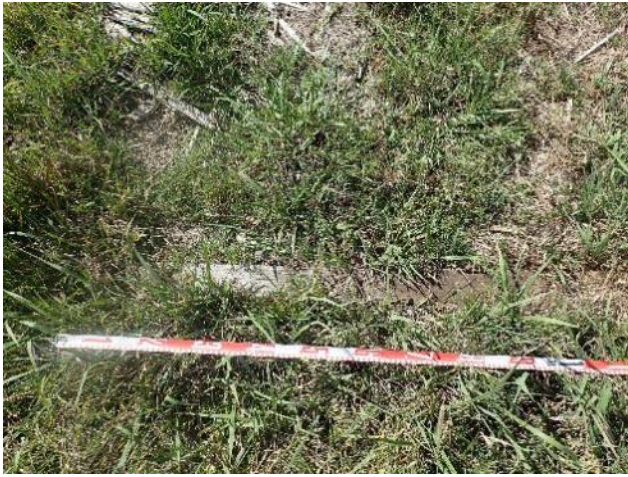
Figure 5-7 Timber fragments located at the site

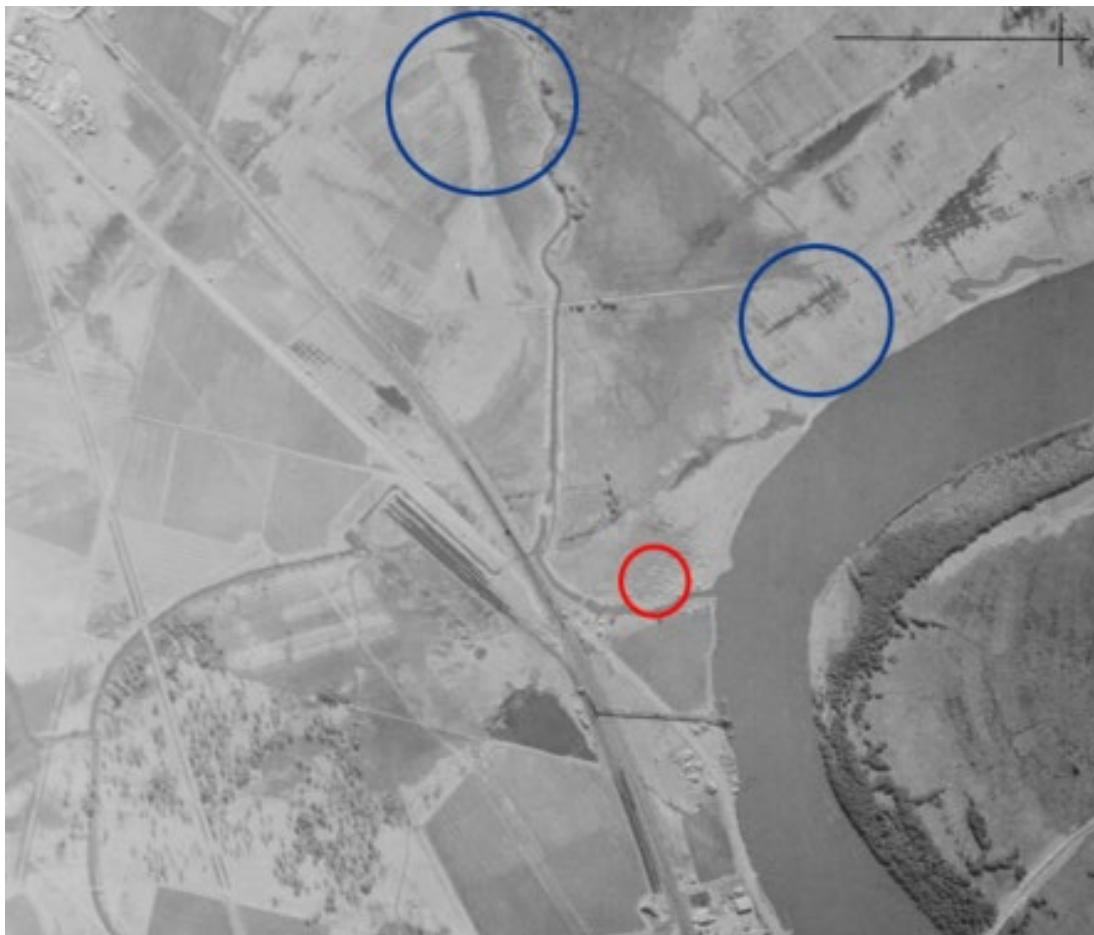
Figure 5-8 1954 aerial imagery of the Hexham Shipbuilding Yards located within red circle. Other similar shallow depressions located within the blue circles. Source: NSW Department of Finance, Services and Innovation.

The Woodberry Swamp is a low-lying floodplain and wetland area around 4,350 hectares in size, located between Maitland and Hexham on the western side of the Hunter River. The swamp is around three kilometres northwest of the Hexham Shipyards site. Flood mitigation infrastructure over the past 200 years has resulted in a separation of the floodplain from the estuary for dry-land agricultural purposes. After a major flood event in 1955, significant floodplain drainage works were carried out, including the construction of drains and levees, and the installation of tidal floodgates (DS Rayner et al. 2016). The flood levee bank and its overlying vehicle track are connected to the nearby floodgates and form part of the wider flood scheme (DPIE 2020). A parish map (**Figure 5-9**) of the area shows 'Woodberry Drainage Union' marked as immediately north of the Hexham Shipbuilding Yard. It is likely that the depressions within the curtilage of the shipbuilding site and the other nearby areas shown in **Figure 5-8** represent an early form of irrigation or water management related to the swamp and the Hunter River. The Hunter River Flood Scheme is the most recent feature of this site and has the associated levee bank overlays the identified depressions.

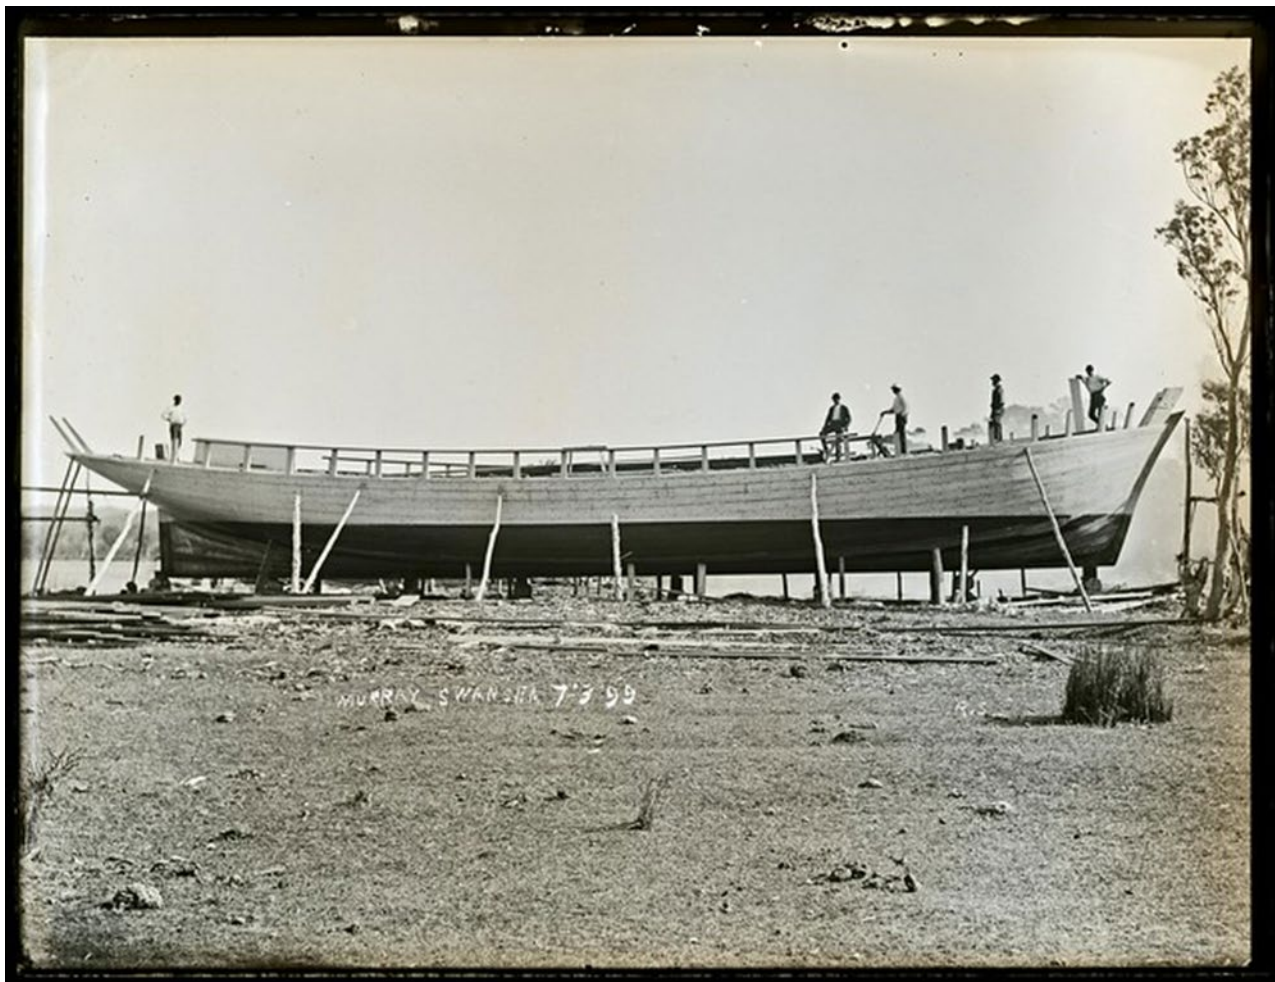
Figure 5-10 Murray's Shipbuilding Yard, Swansea, NSW, 7 March 1899. Source: Cultural Collections, University of Newcastle, NSW. <https://www.flickr.com/photos/8571926@N06/3216088679>

Shipbuilding sites in the Hunter region include the Callen Bros Yard at Stockton (around 14 kilometres southeast of Hexham), the Walsh Island State Dockyard at Kooragang Island (around 11 kilometres southeast of Hexham) and the Carrington State Dockyard (around 14 kilometres southeast of Hexham). A 1899 photo of Murray's Shipbuilding Yard (located in Swansea, around 25 kilometres south of Newcastle) shows the construction of a timber boat (**Figure 5-10**). The photo indicates that the boats were constructed above the ground, on timber supports. Later shipbuilding activity in the region includes Carrington Slipways, originally opening in the suburb of Carrington in Newcastle by John Laverick Senior in 1957, then later moving to Tomago in 1972. Situated on Old Punt Road on the Hunter River, Carrington Slipways built a range of Lady-class and First Fleet-class ferries through the 1970s and 1980s for use on Sydney Harbour, as well as *HMAS Tobruk*, *HMAS Rushcutter* and *HMAS Shoalwater* for the Royal Australian Navy, and the icebreaker the *Aurora Australis* in the 1980s. The shipyard was purchased by Forgacs Engineering in 1997, and by Civmec in 2016.

This information, particularly the photograph, suggests this was the type of activity likely occurring at the Hexham Shipbuilding Yards, and also indicates the type of archaeological remains that might be expected at the site.

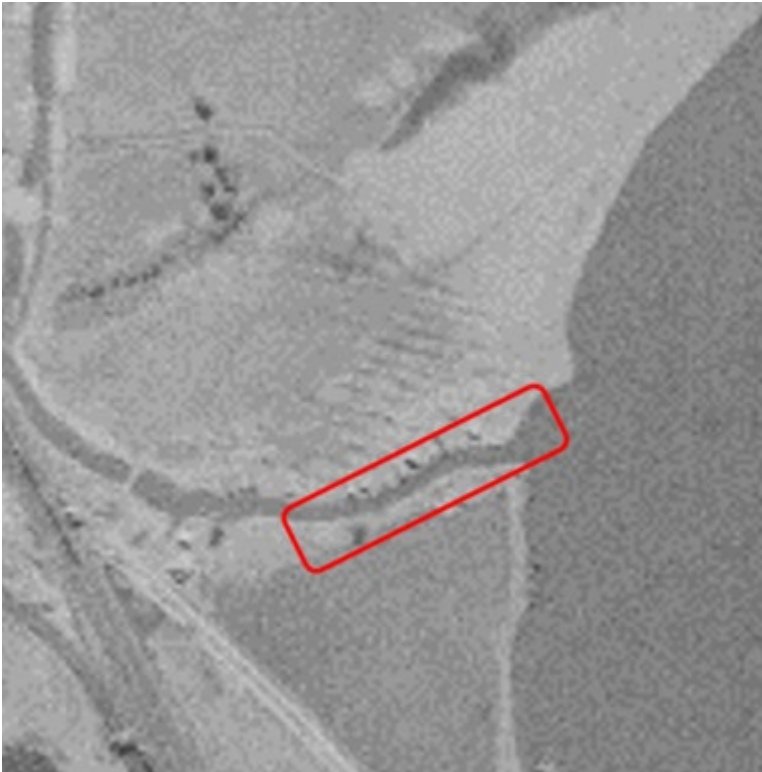
Figure 5-11 1954 aerial imagery close up showing location of structures within the red rectangle. Source: NSW Department of Finance, Services and Innovation.

Several structures next to the river along the northern bank of Purgatory Creek are visible in the 1954 historical aerial imagery (Figure 5-11). The structures were located within the heritage curtilage of the site and around 10 metres from the construction footprint. However, no physical evidence of these was identified during the field survey.

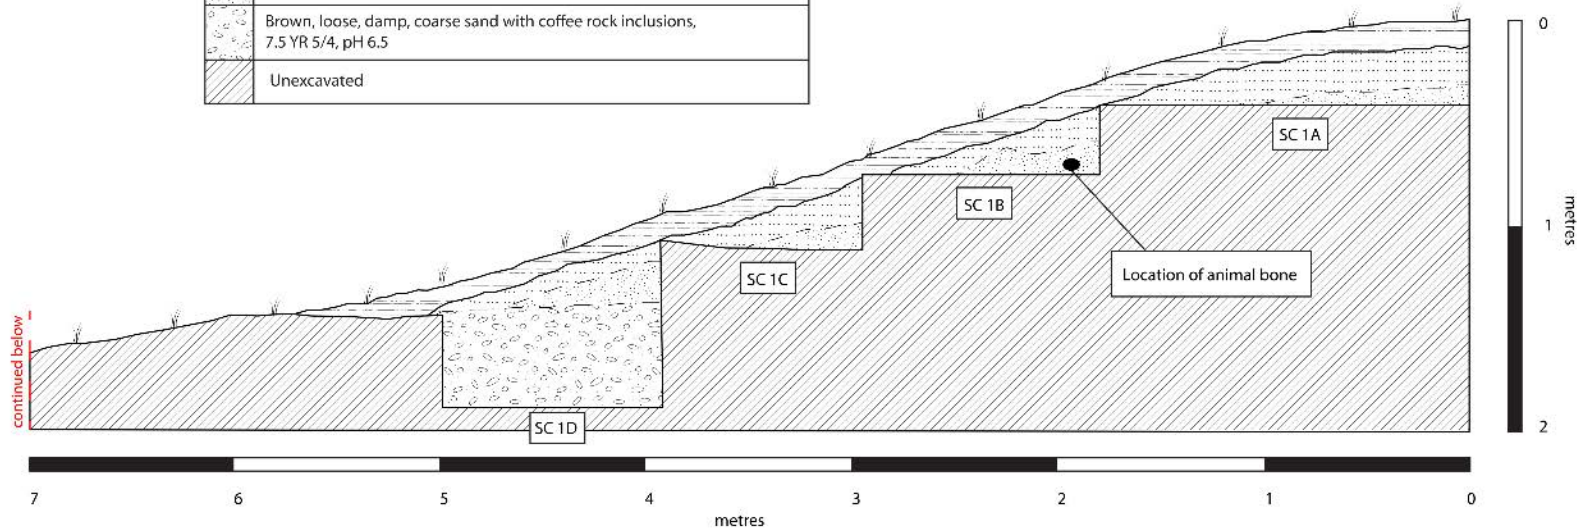
Slightly humic, dark brown, damp, friable, coarse sand, 7.5 YR 3/3, pH 6
 	Brown, loose, damp, coarse sand, 7.5 YR 4/3 pH 6.5
 	Brown, loose, damp, coarse sand with coffee rock inclusions, 7.5 YR 5/4, pH 6.5
 	Unexcavated

Figure 5-14 Stratigraphy of the western wall of Section Cut 1 (SC 1)

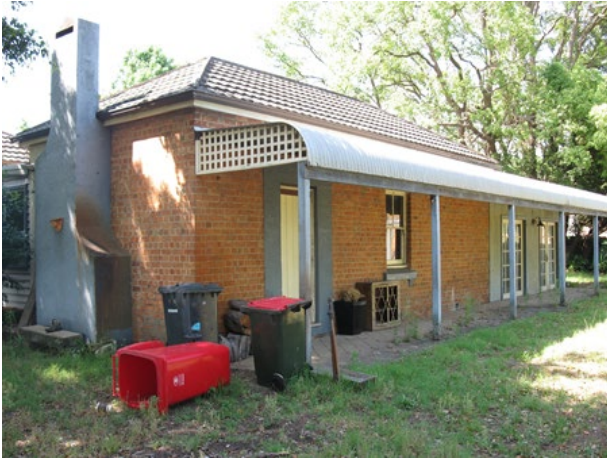
Figure 5-15 North-western section of main house that may have originally been a separate kitchen (Site 1), facing south

- **Main house.** The house is a brick building with a corrugated iron roofed verandah (**Figure 5-15**). Sections of the main house are made from weatherboard indicating that there were originally two separate brick buildings which have since been joined (**Figure 5-17**). The brick walls in this part of the house appear to have handmade bricks laid in an English bond pattern and the bricks in the eastern section of the house are laid in stretcher bond pattern. The windows in the brick buildings have decorative window sills and lintels and are double sash and timber framed. There are two chimneys and a tiled roof with one of the chimneys (on the eastern building) having a stepped corbel and terracotta chimney pot, suggestive of Edwardian style (c1901). There has been a recent extension on the south-eastern verandah and to the south-west section of the main house (**Figure 5-16**). The north-western brick section has rendered door frames and chimney. This building also has a bull nosed corrugated iron and timber verandah with decorative timber latticework and timber posts. The north-western section was also possibly the original kitchen

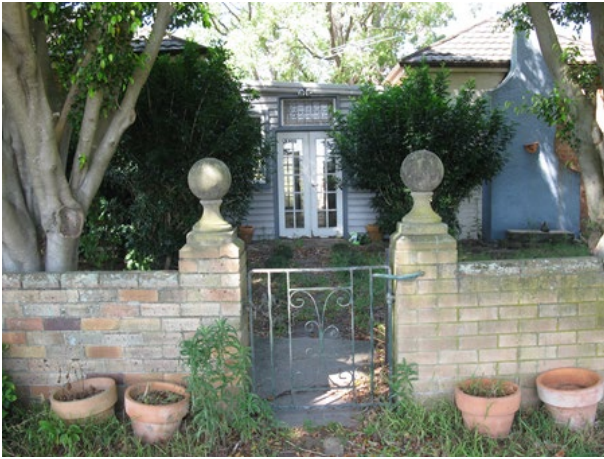
Figure 5-17 Weatherboard extension joining the two brick buildings (Site 1), facing south-west

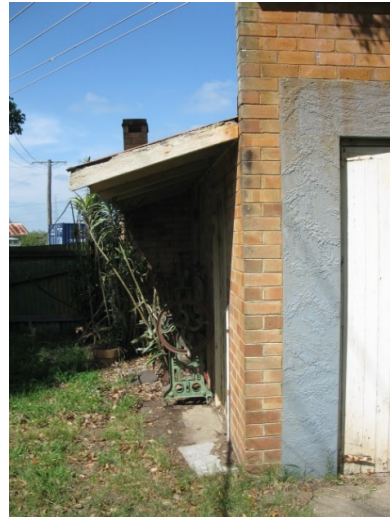
Figure 5-18 Brick laundry (Site 1), facing south-west

- **Laundry.** This separate brick building is located about 10 metres east of the house and has a corrugated iron roof with a chimney for the copper. There are double doors at the northern end of the building, and a single door and window on the side facing the main house. The bricks are laid in stretcher bond pattern (**Figure 5-18**)

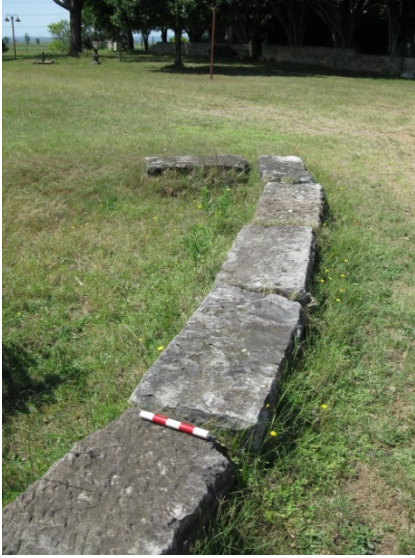
Figure 5-19 Bluestone blocks in driveway (Site 1), facing south

- **Bluestone blocks and fountain.** Large hand cut bluestone blocks are located along the side of the driveway and at the entrance gate (**Figure 5-19**) to the main house complex. There is a remnant water fountain located about 20 metres north-east of the main house in what would have been the front garden (**Figure 5-20**)

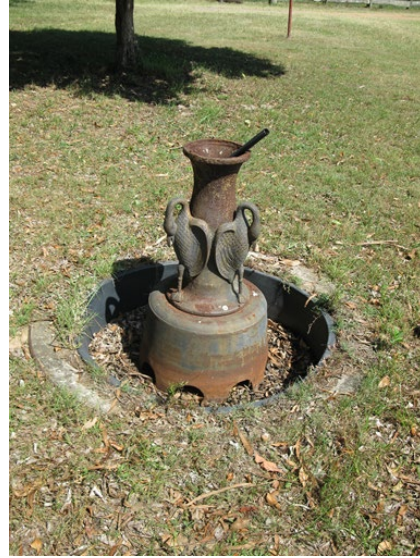
Figure 5-20 Water fountain between driveway and main house (Site 1)

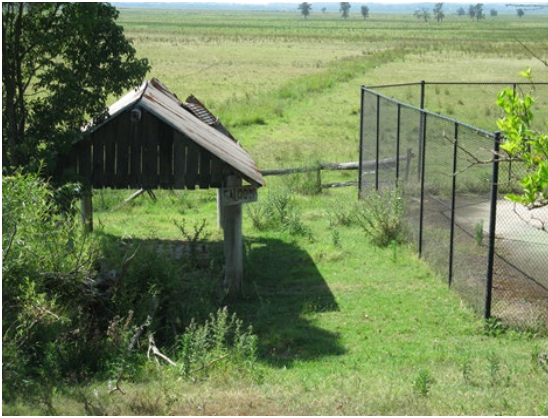
Figure 5-21 Wooden building east of tennis court (Site 1), facing south

- **Building.** There is a small open wooden building with round posts and corrugated iron roof, north of tennis court and about 30 metres south-east of the main house (**Figure 5-21**)

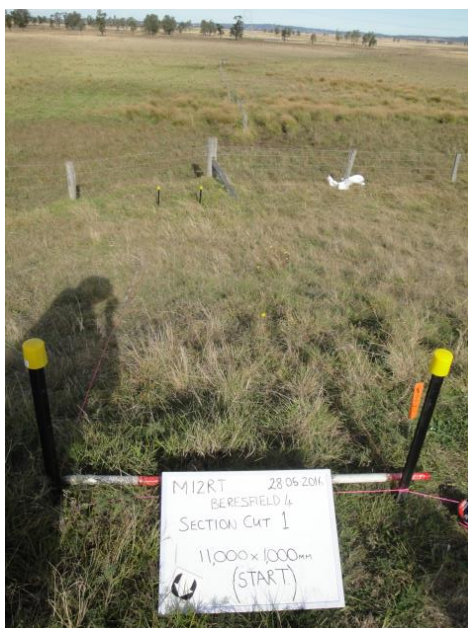
Figure 5-29 Start of the test excavation at SC 1 facing south-east, looking downhill.

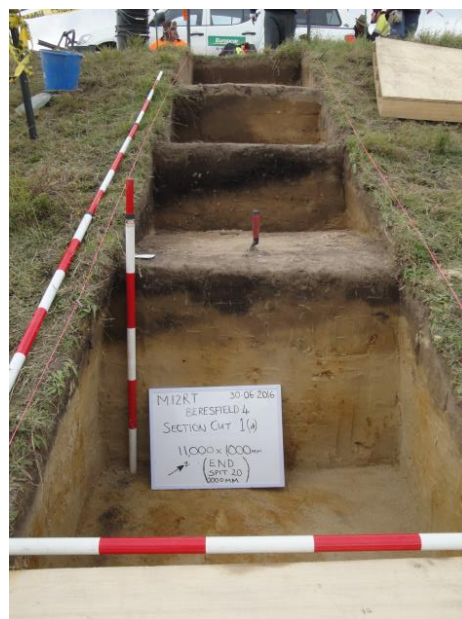
Figure 5-30 End of test excavation showing the full Section Cut 1 (SC 1), facing north-west, looking uphill.

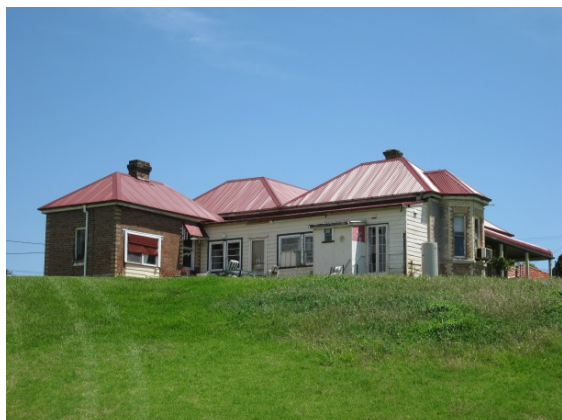
Figure 5-37 Residence located on top of a rise, facing north

The residence (**Figure 5-37**) is situated on top of a rise which slopes steeply down to level ground next to the construction footprint. Rubbish comprising rubble and building refuse has been dumped over the edge of the steep slope (**Figure 5-38**).

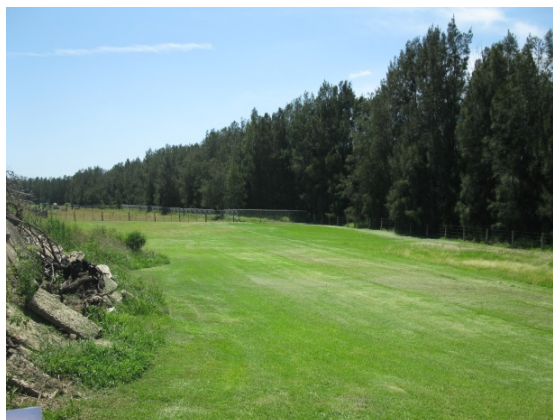
Figure 5-38 Level ground at base of rise and rubbish pile, facing east

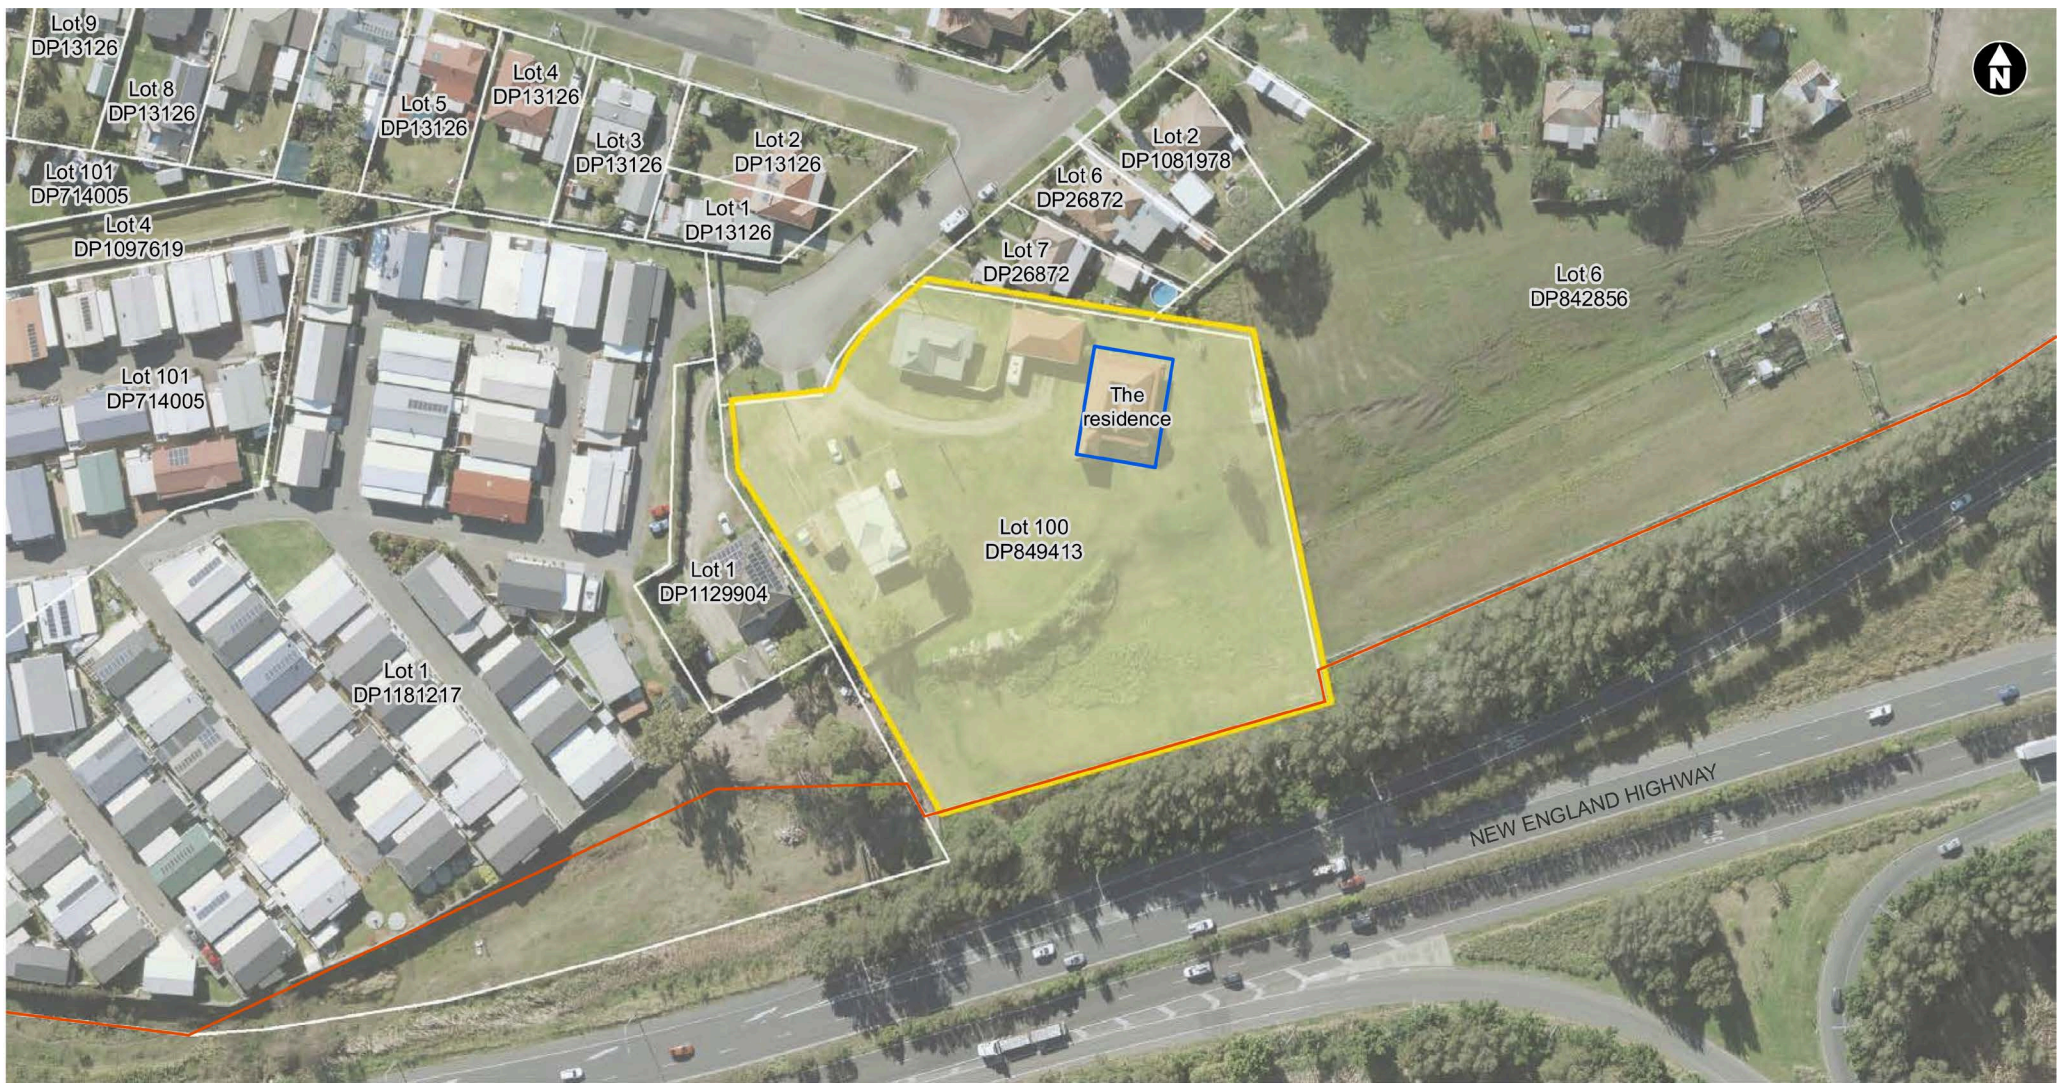
Construction footprint
 Lot
 LEP heritage curtilage

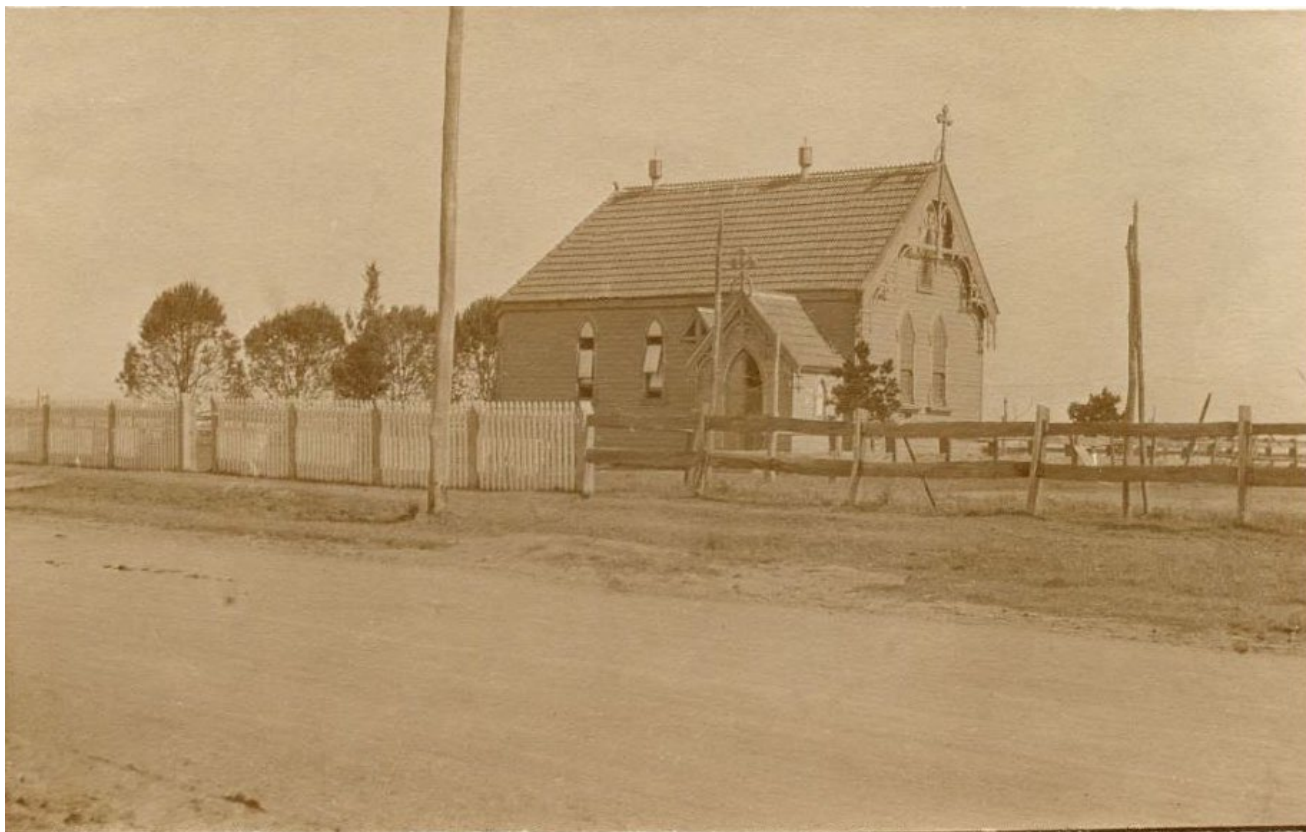
Figure 5-40 1920 photograph of St Stephen's Church, Tarro, constructed in 1905. Anderson Drive in foreground (The University of Newcastle 2020)

The Newcastle Morning Herald and Miners' Advocate (NMHMA, 23 February 1905) reported that St Stephen's Church was opened by the Bishop of Newcastle on the 22 February 1905. The church was described as being built in a Gothic style with red tiled roof and timber structure (**Figure 5-40**). The architect of the church as Peter Bennett and the cost of the building was reported to be £400. The 1905 building was built to replace an earlier church, described as St Stephen's Anglican Church, one of the oldest in the state at that time and in a state of decay. No date was given for the construction of the old church; however, the 1905 article stated that it was erected '*in the days of the very earliest settlers, perhaps 65 years ago*'. The earlier church was vacant at the time of the new church opening. The article states that the foundation stone for the new church rested on an old block laid by Bishop Broughton (the first Bishop of Australia) in 1839, but that '*the new church it was then proposed to build was never erected*'. The article suggests that there were two locations for the church, one church was proposed to be built where the foundation stone was laid in 1839 and one church was actually built around 1840 near the location of the 1905 church.

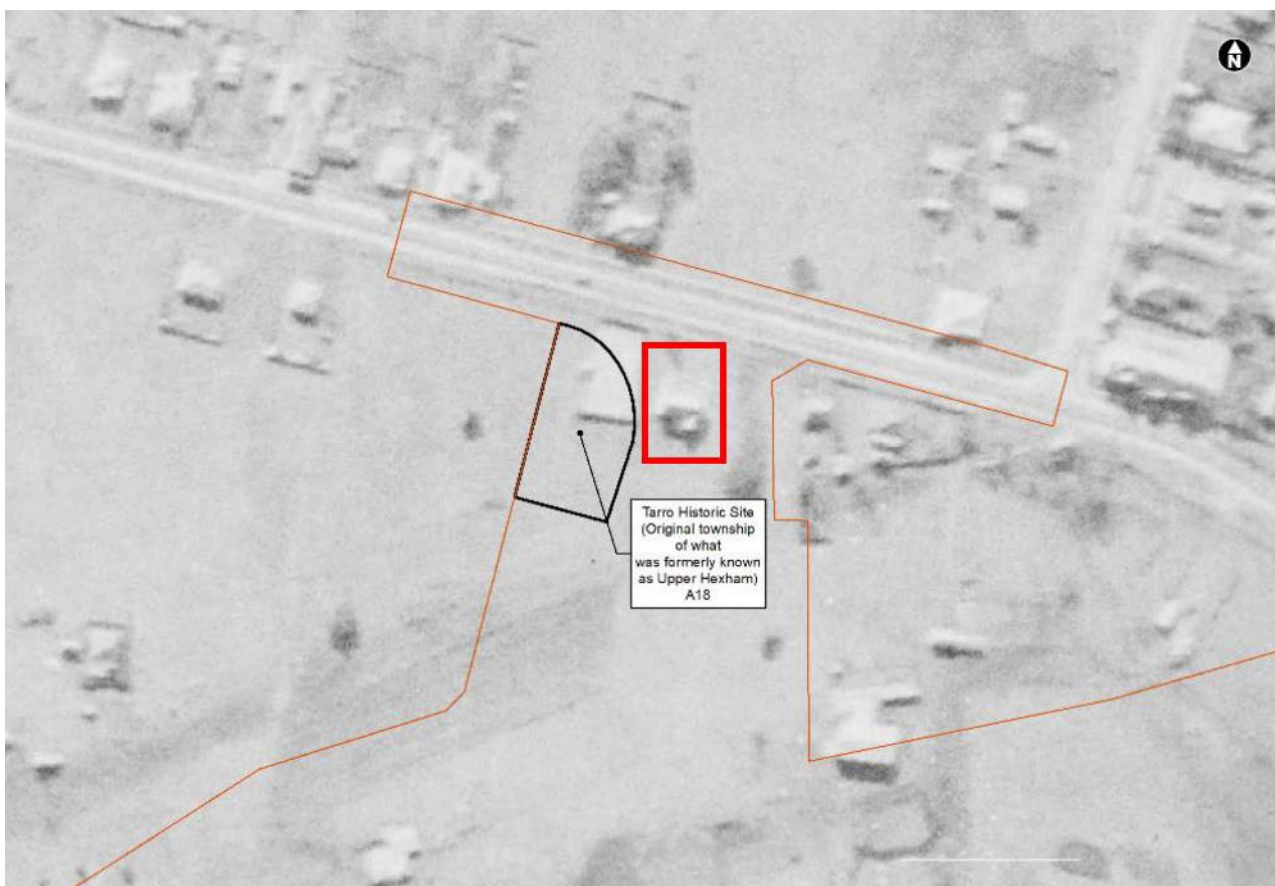
Figure 5-41 1954 aerial image of the site with 1905 church building clearly visible (in red) and site (A18 heritage curtilage) located in black. Construction footprint shown in orange.

A 1954 historical aerial image of the location of the heritage item (**Figure 5-41**) indicates the 1905 church building was located where the Tarro Interchange is now. To the east of the church there is a large rectangular shape which is likely a tennis court. The NMHMA (28 April 1926) noted in 1926 that the council was to be asked to '*attend to the gutter in front of the Church of England and tennis court*'. The dimensions of the feature in the aerial photograph correspond with the dimensions of a tennis court.

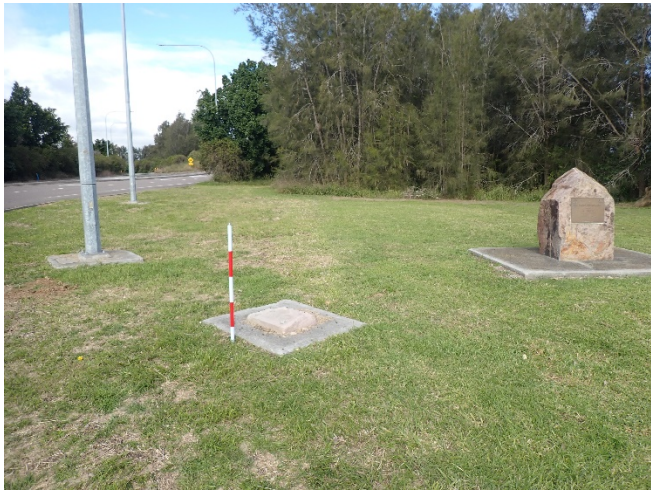
Figure 5-43 Two features of the Tarro Historic Site, facing south.

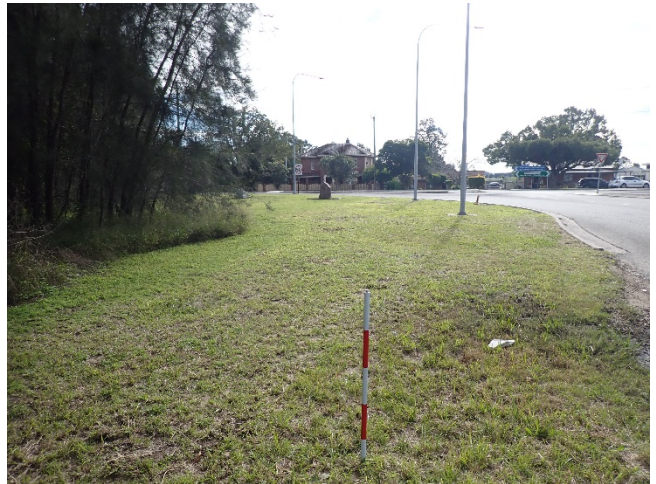
Figure 5-46 The Tarro Historic Site next to road, facing north

The field survey of the Tarro Historic Site was carried out on 29 June 2020. The northern portion of the site next to Anderson Drive contains two concrete and stone plaques, one commemorating the Tarro Interchange opening in 1996 and one to mark the location of the historic site of St Stephen's Church of England. A third concrete and stone feature is also present (**Figure 5-43** and **Figure 5-44**). No specific areas of archaeological potential were noted during the site visit. At least three quarters of the area within the heritage curtilage is covered with thick vegetation, including shrubs and trees (**Figure 5-45**). Grassed areas with more visibility were located to the north of the site and along Anderson Drive and the Tarro Interchange (**Figure 5-46**).

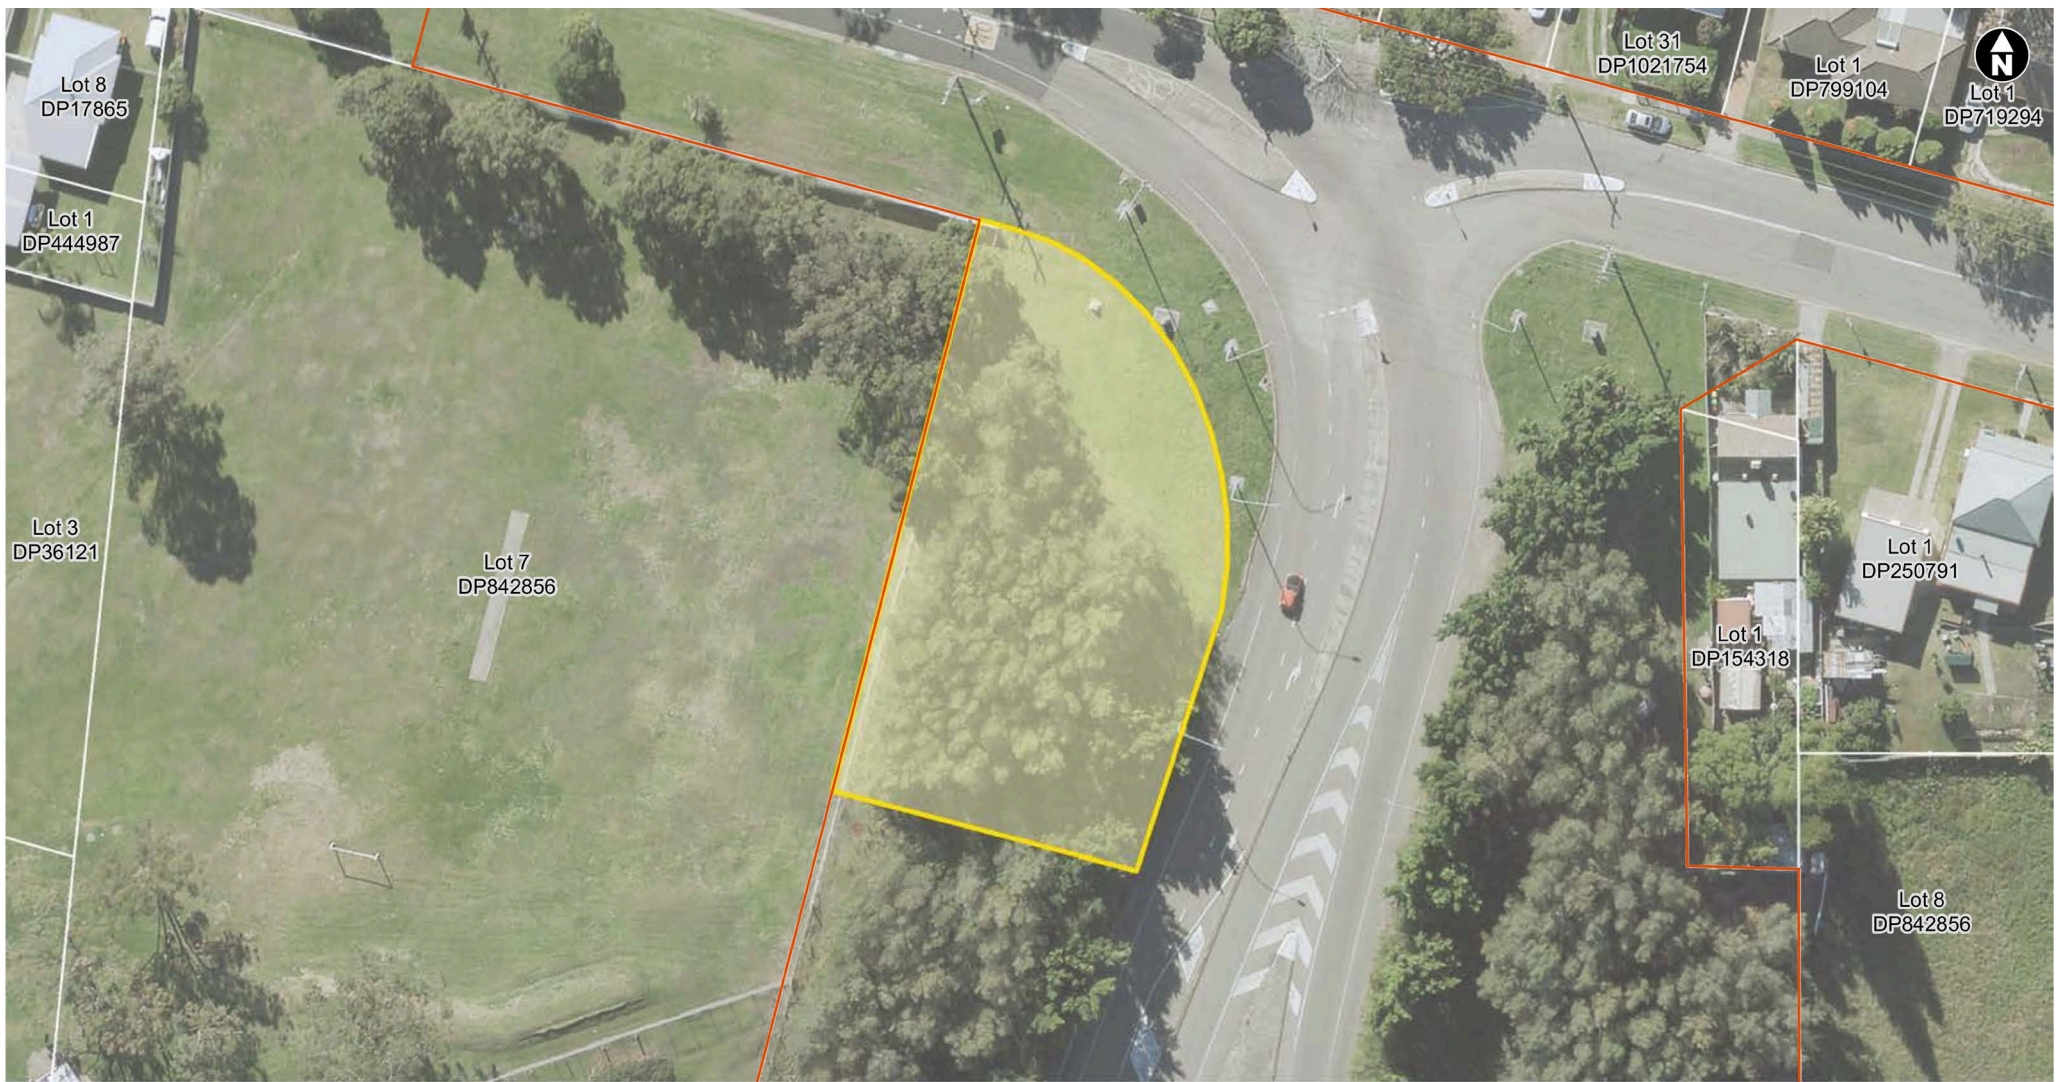
Construction footprint
 Lot
 LEP heritage curtilage

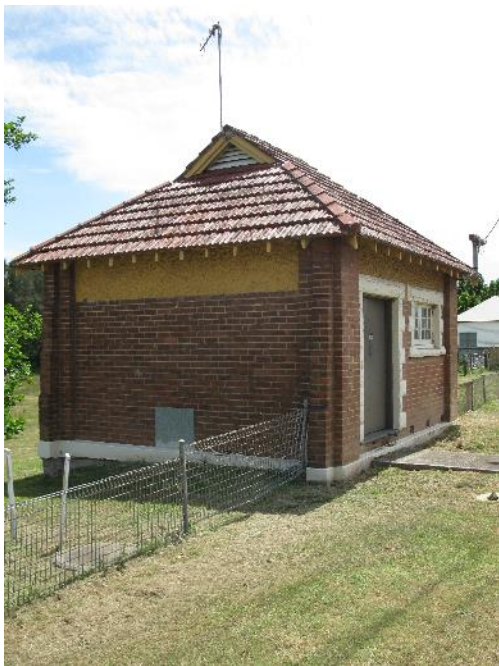
Figure 5-48 The Tarro Substation, facing southwest

The building is representative of form and style of architecture used for this particular function and a rare example of this architectural style in this region.
