M1 Pacific Motorway extension to Raymond Terrace

Non-Aboriginal Heritage Working Paper

Transport for NSW | July 2021

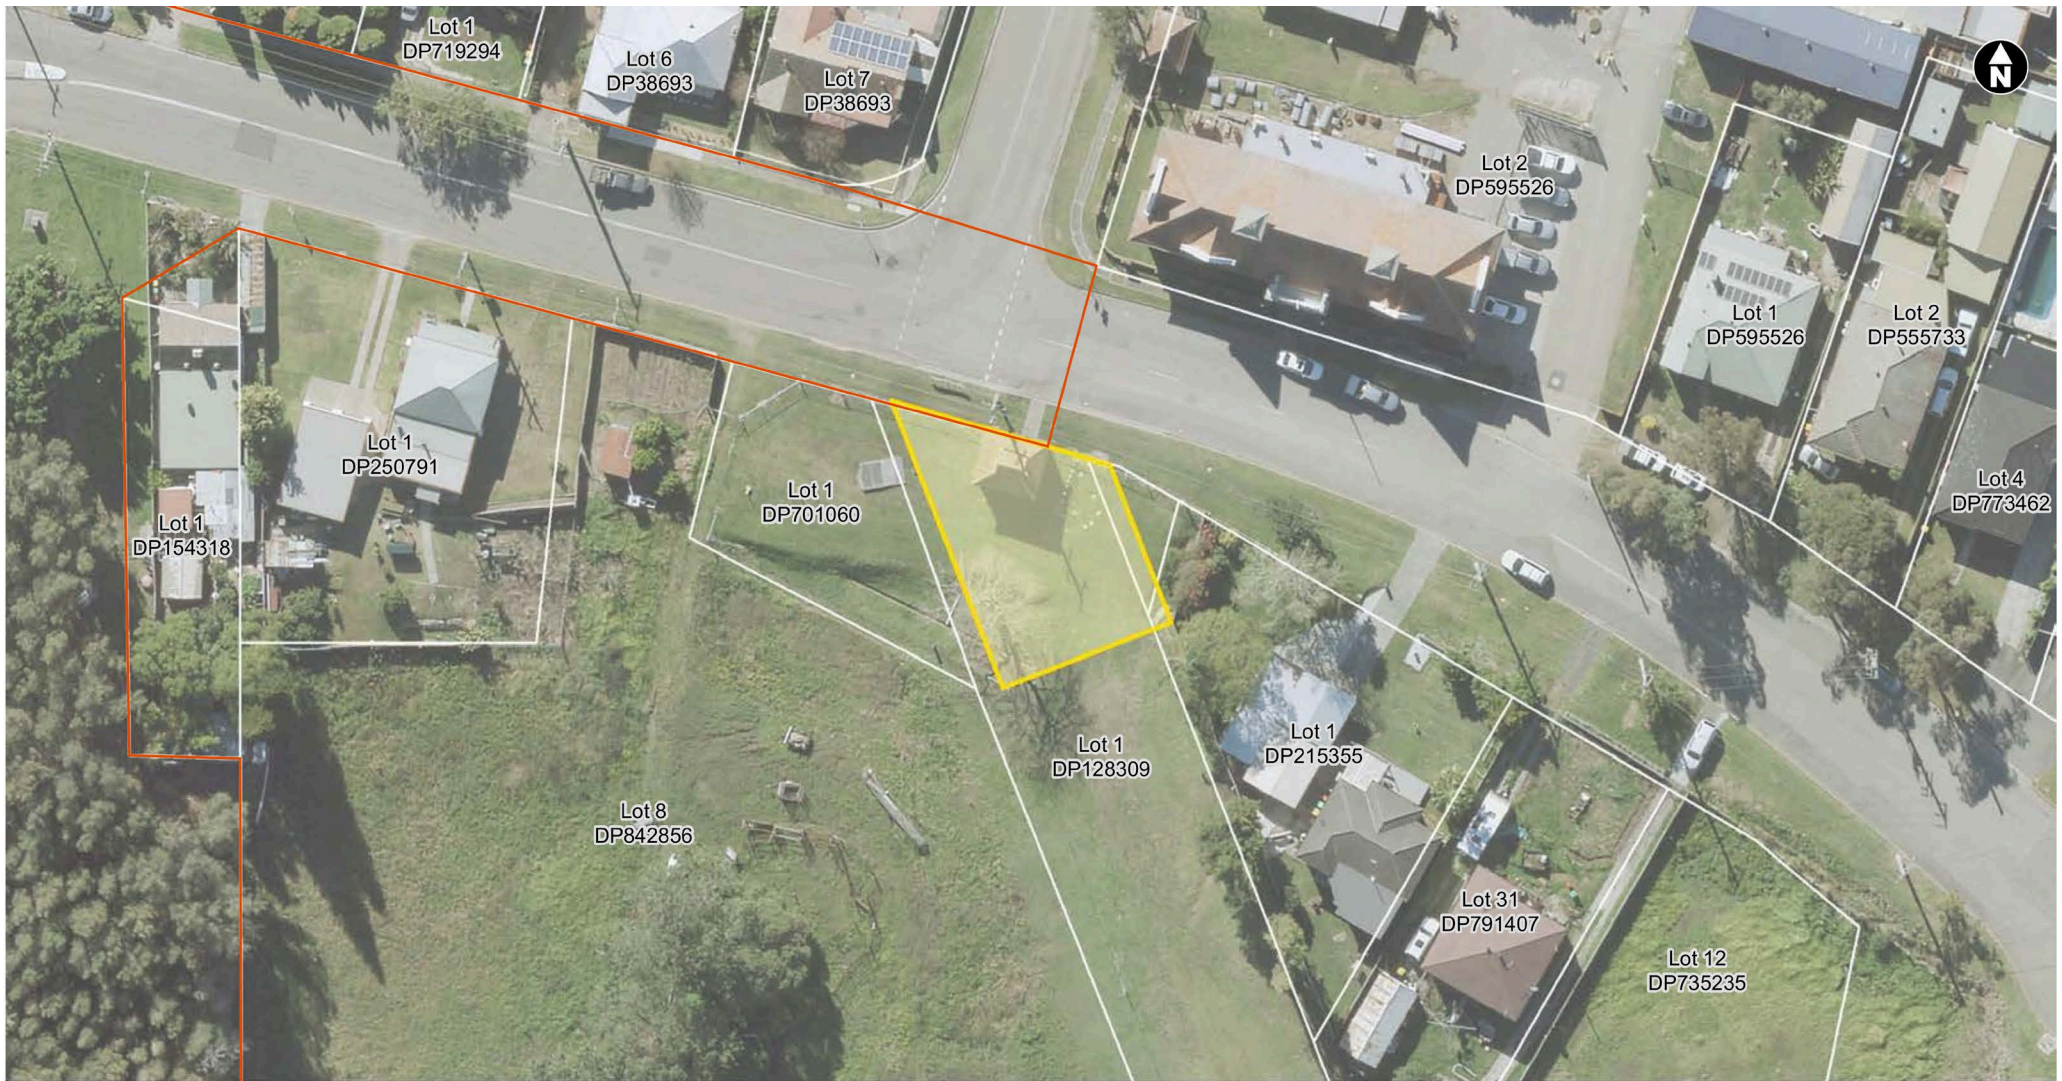
Construction footprint
 Lot
 LEP heritage curtilage

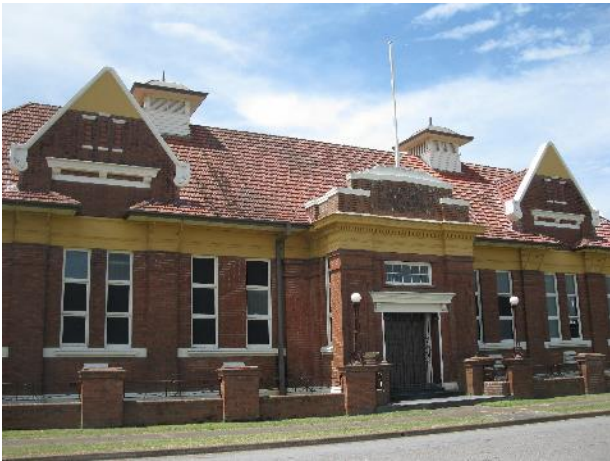
Figure 5-51 The Pumping Station, facing northeast.

The Tarro Pumping Station is an exceptionally finely detailed early 20th century water pumping station, which superseded the pumping station at the Walka Water Works near Maitland. The Pumping Station is constructed in the Federation Free Style and is the most finely constructed building remaining within the Hunter Water network. It includes a matching boundary fence and valve house. As a purpose-built industrial building it is a rare example of public architecture, built at a time when the ornamentation of infrastructure was part of the civic pride in its development. Now decommissioned, the building lacks most internal elements or machinery.

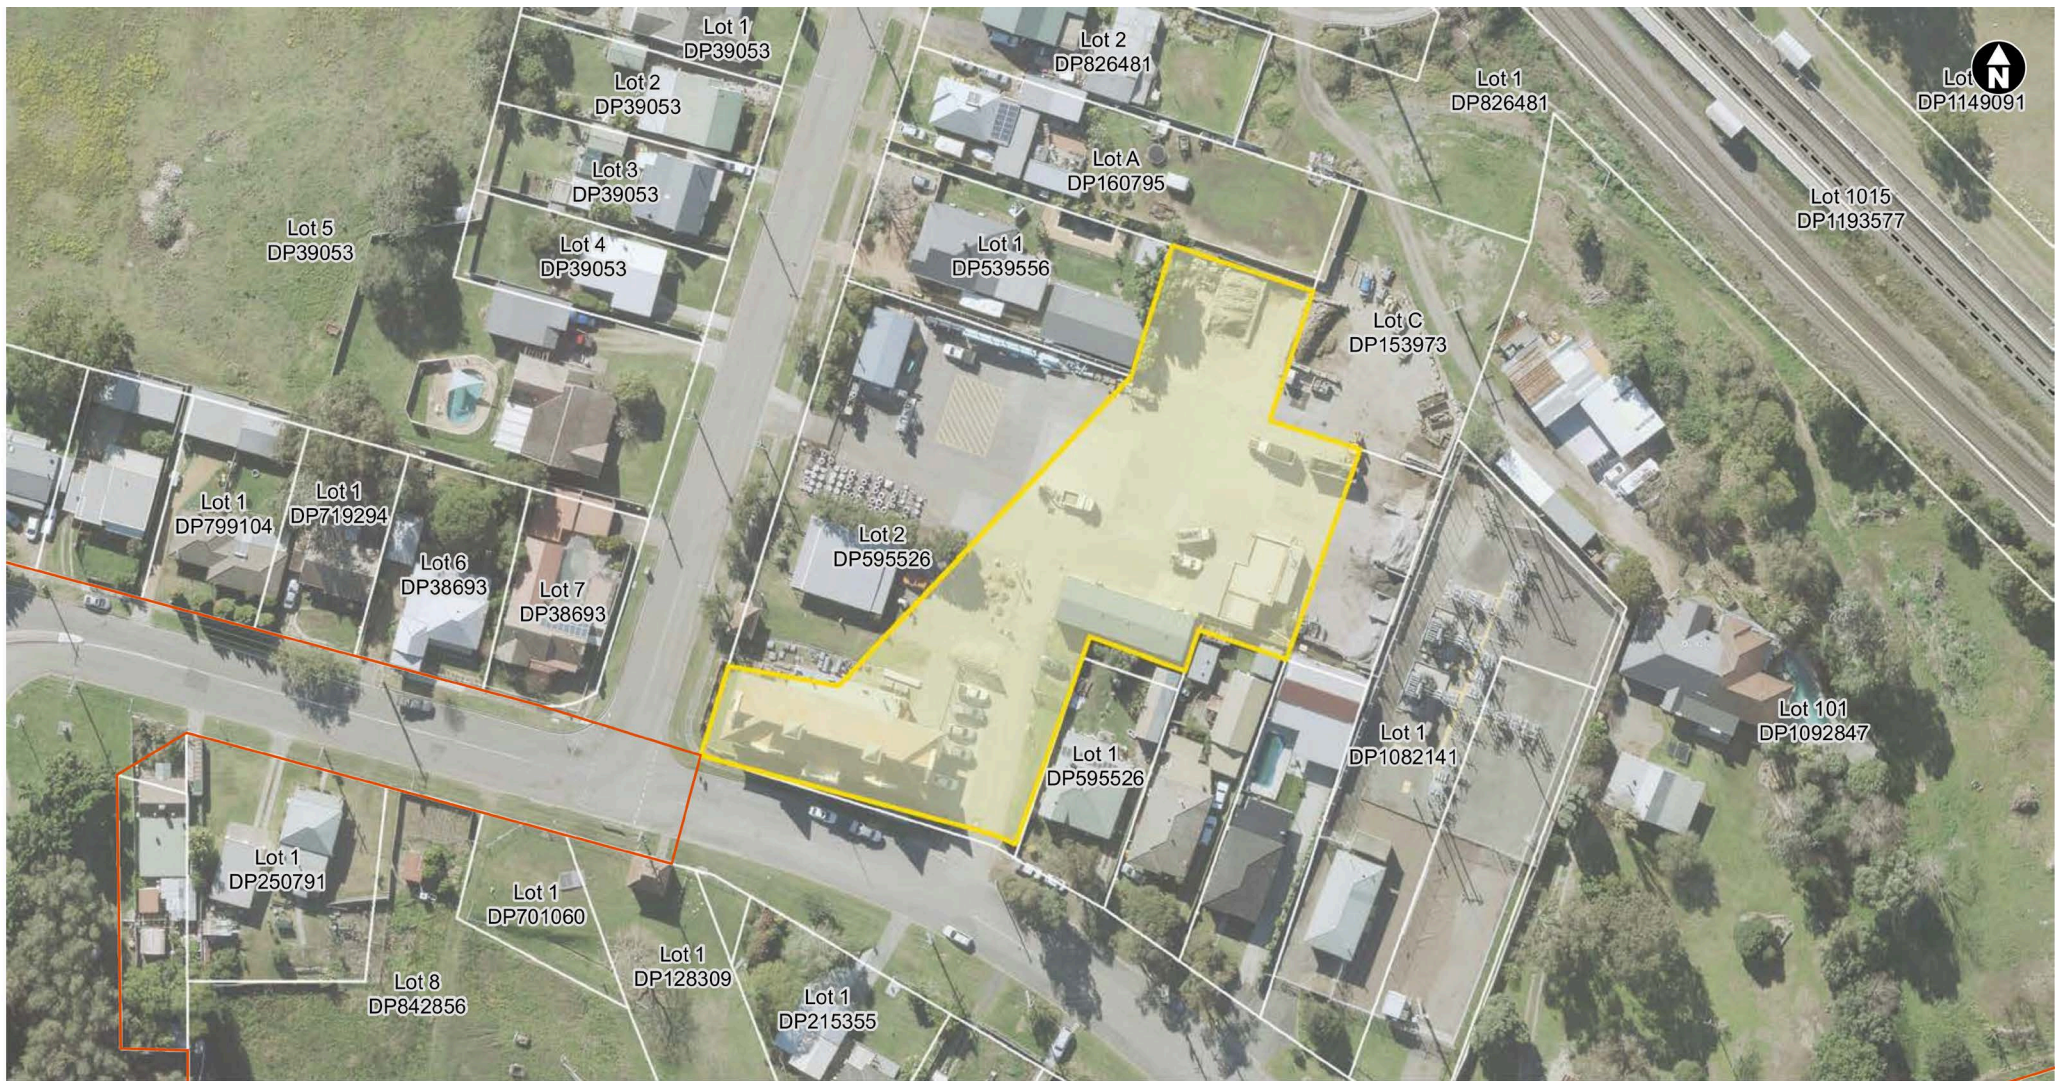
Figure 5-53 Heritage curtilage of Item 8: Pumping Station, Tarro
