M1 Pacific Motorway extension to Raymond Terrace

Soils and Contamination Working Paper

Transport for NSW | July 2021

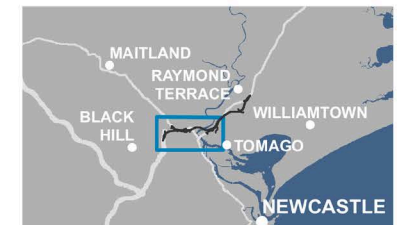
Figure 1-2 Project key features (map 1 of 2)

A detailed project description is provided in Chapter 5 of the environmental impact statement (EIS). The locality of the project is shown in **Figure 1-1**, while an overview of the project is shown in **Figure 1-2**.

- **Waterways:** The key waterways in and near the construction footprint (refer to **Figure 1-2**) include
 - Viney Creek
 - Purgatory Creek
 - The Hunter River

Several site-specific, progressive contamination and waste classification investigations were carried out at the former Rutile, Zircon and Monazite (RZM) processing facility, beginning in 2012 and described further in **Section 5.4.5** and **Section 5.4.7**). The former mineral sands processing facility is located within the construction footprint next to the Pacific Highway at Tomago (refer to **Figure 1-2** and **Figure 6-1**).

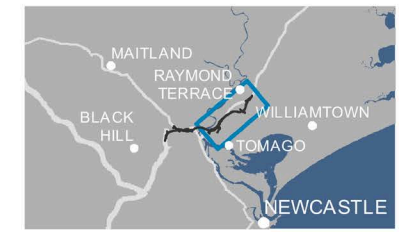
Figure 6-1 Areas of Potential Contamination Risk (map 2 of 2)

Several AOPCR have been identified within and next to the construction footprint (refer to **Figure 6-1**). **Table 6-1** provides details on their associated contaminants of potential concern, risks to environmental receivers and limitation on construction and site users, within the context of the potential for contamination and proposed construction activities. This assessment identified the following:

Previous investigations identified general fill within the construction footprint, with hydrocarbons, pesticides, metals and radionuclides identified in soil samples associated with the former mineral sands processing facility (AOPCR 5 in **Figure 6-1**). The identified contaminated material from AOPCR 5 would be remediated, in accordance with a Remediation Action Plan that would be approved by a NSW EPA accredited site auditor (refer to **Chapter 9**).

Asbestos is located within the construction footprint at AOPCR 3, AOPCR 10 and potentially where fill has been previously used at random areas within the construction footprint (see **Figure 6-1**). There is no mapped naturally occurring asbestos in the construction footprint.
