# Surface Water Quality Monitoring Program

## July 2017 to January 2018

Project: Sydney Metro City & Southwest – TSE Works

Document No: SMCSWTSE-JCG-TPW-EM-RPT-097238

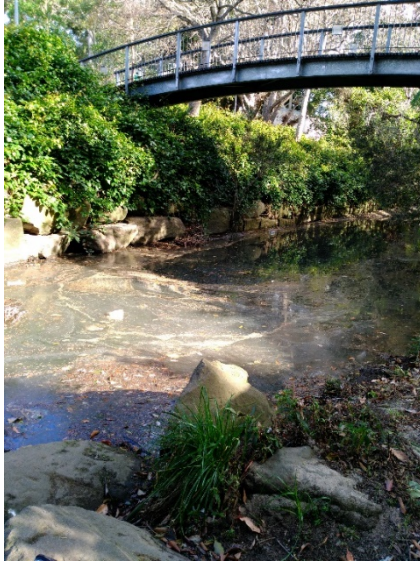
Upper Scotts Creek was odorous, turbid and contained visible rubbish and debris during all sampling events. Observed conditions are displayed in Figure 3 and Figure 4, with Figure 4 showing the least turbid for comparison. Creek was slowly flowing in all sampling events.

Figure 3: Turbid water with visible scum at Upper Scotts Creek (SW-SC-01) on Aug-17

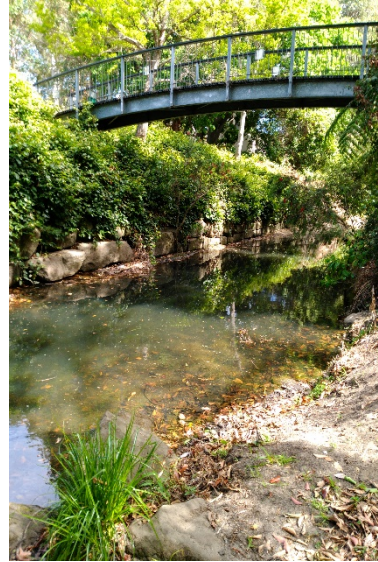
Figure 4: Clear water at Upper Scotts Creek (SW-SC-01) on Oct-17

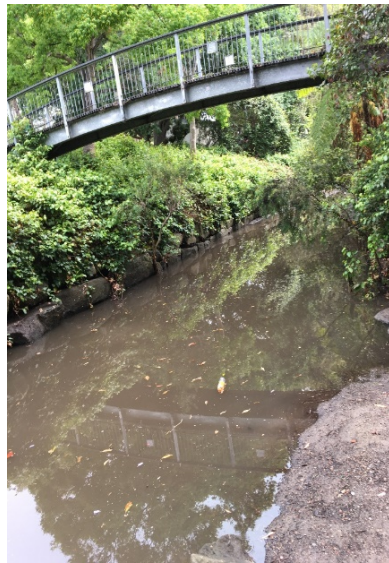
Figure 5: Murky, turbid water at Upper Scotts Creek (SW-SC-01) on Dec-17

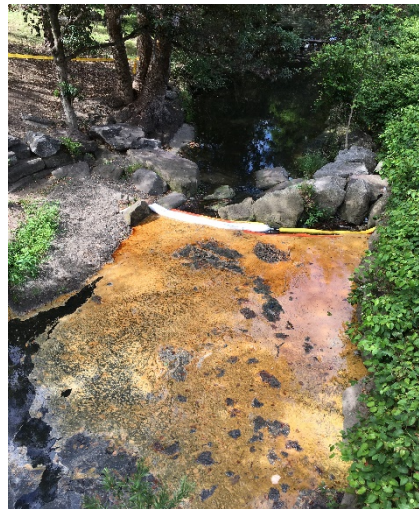
Water samples from the Jan-18 reporting period were unavailable as a result of the sampling location, and surrounding creek being marked as *danger* and isolated. Visible foam and

scum (unrelated to the Project) could be seen floating on top of the water, shown in Figure 5. A silt curtain had been installed on each terrace.

Figure 6: Visible scum within Upper Scotts Creek, with silt curtain installed Jan-18

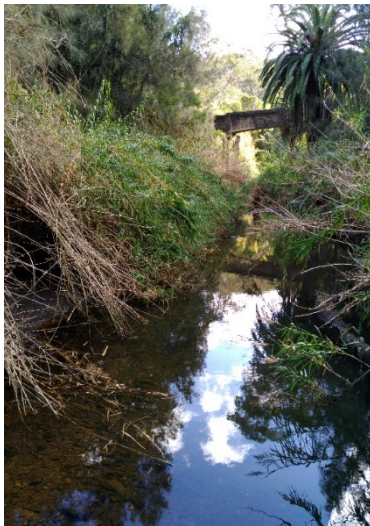
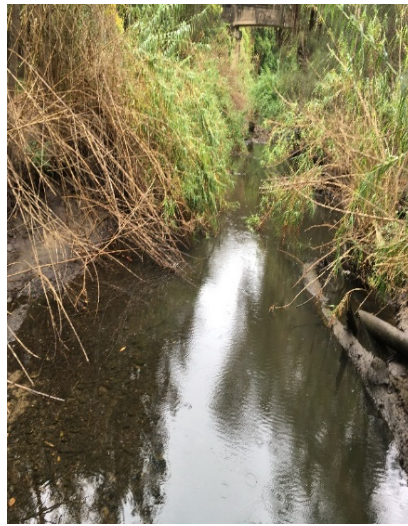
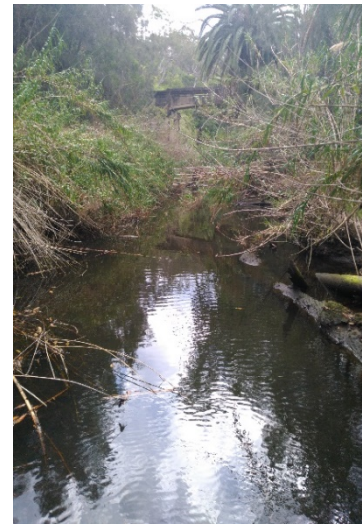
Six (6) water sampling events were undertaken during the reporting period, results are displayed in Appendix 2. Field observations describe the sampling location to be unchanged throughout the sampling period. Water was consistently observed as being clear, slow

flowing, with little to no visible rubbish. Figure 7, Figure 8 and Figure 9 show the creek system throughout the monitoring period. Water quality parameters were recorded within the assessment criteria with the exception of the following parameters:

Figure 7:- Lower Scotts Creek (SW-SC-01) on Aug-17

Figure 8: Lower Scotts Creek (SW-SC-01) Oct-17

Figure 9: Lower Scotts Creek (SW-SC-01) on the Dec-17

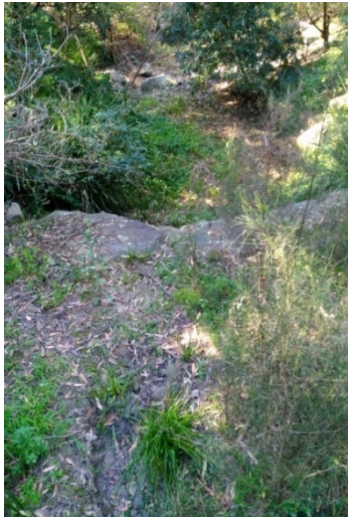
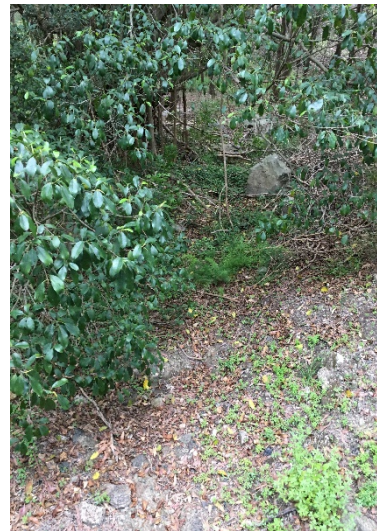
Six (6) monitoring events were conducted during the reporting period at the Upper Flat Rock Creek sampling location. However, the monitoring location was dry during all sampling

events (refer to Figure 8 and Figure 9). Monitoring events are documented in Appendix 3. As a result, no water samples have been collected.

The sampling site contains infrastructure designed to withstand and allow access during flood, suggesting the presence of water. However, no evidence of recent water flow was observed.

Figure 10: Upper Flat Rock Creek (SW-FR-01) on the Aug-17

Figure 11:- Upper Flat Rock Creek on the Dec-17

It should also be noted that the Upper Flat Rock Creek sampling point was dry throughout all sampling rounds. The appropriateness of this sampling location for ongoing monitoring will be assessed accordingly.

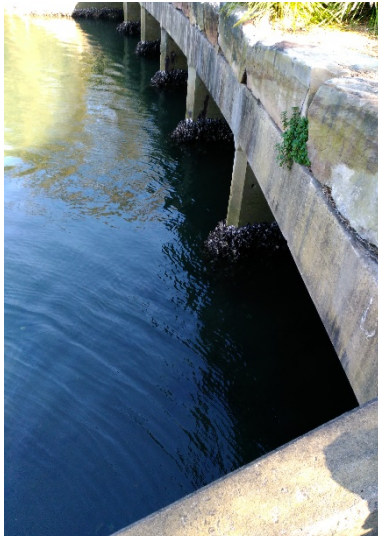
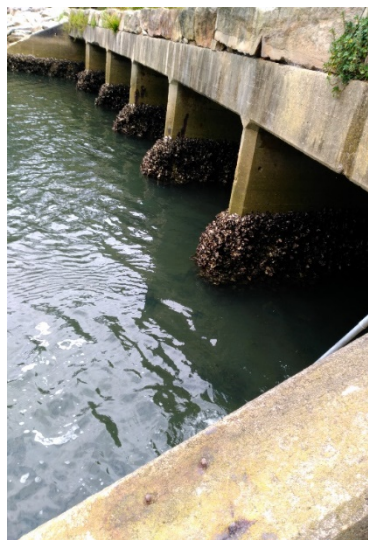
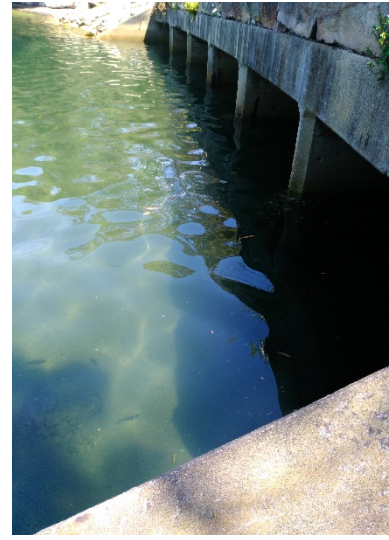
Water monitoring results are stable between each sampling period. Figure 12, Figure 13 and Figure 14 show the site conditions observed during different sampling events. All results were recorded within the adopted assessment criteria with the exception of the following parameters:

Figure 12:- Lower Flat Rock Creek (SW-FR-02) on Aug-17

Figure 13: Lower Flat Rock Creek (SW-FR-02) on Sep-17

Figure 14: Lower Flat Rock (SW-FR-02) in Oct-17

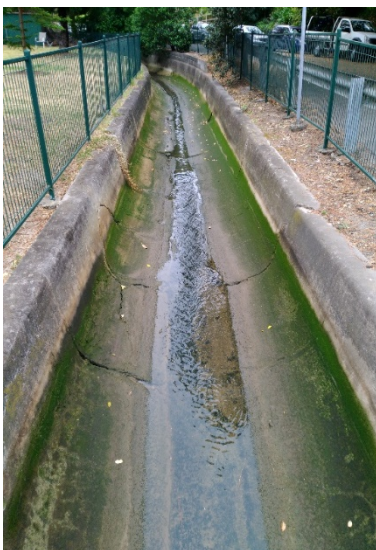
Figure 15: Shallow creek at Milson Park (SW-MP-01) on Sep-17

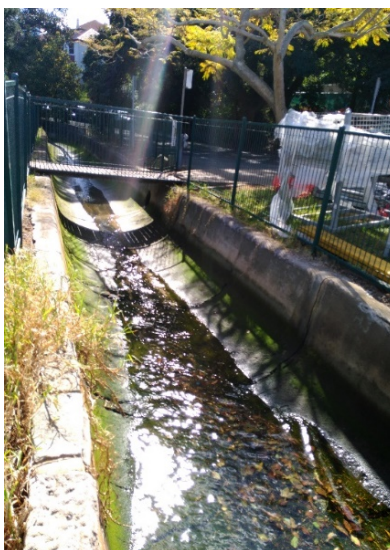
- Dissolved oxygen levels indicate that the sampling point is within an oxidative environment and were recorded above the assessment criteria on two (2) occasions (Sep-17 and Oct-2017) during the reporting period. High DO readings may be a result of quick and/or rough water flows along the discharge channel.

Figure 16: Milson Park (SW-MP-01) on the Oct-17 showing high water level

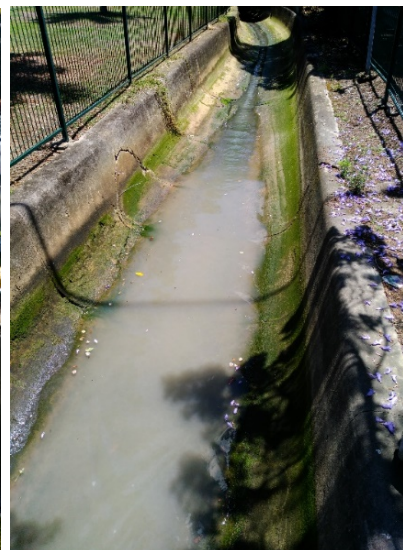
- The NTU of the water recorded for the Nov-17 and Dec-17 sampling events was above the adopted assessment criteria. The Nov-17 result was particularly high with a measurement of 100 NTU. This was coupled with visible observations of extremely cloudy water flowing down the channel as shown in Figure 17. Cloudy water was also noted during the Dec-17 monitoring event.

Figure 17: Milky water at Milson Point on Nov-17

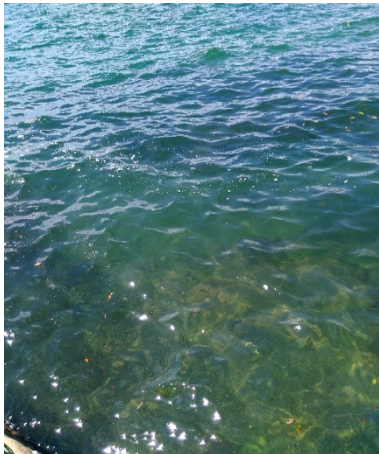
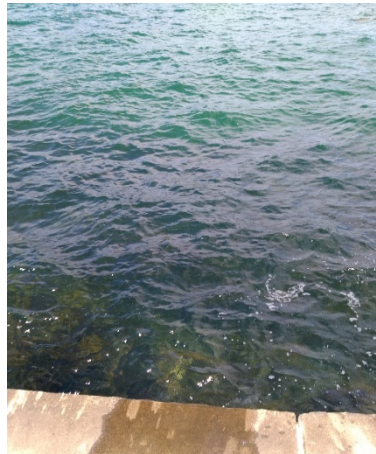
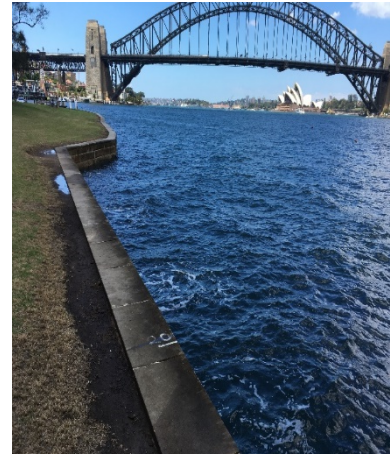
Six (6) monitoring events were undertaken at Blues Point during the reporting period with results shown in Appendix 6. Results were stable and consistent with what would be expected of a marine environment. Figure 18, Figure 19 and Figure 20 show site conditions experienced during the reporting period. All results were recorded within the assessment criteria except for the following parameters:

Figure 18: Blues Point (SW-BP-01) on Sep-17

Figure 19: Blues Point (SW\_BP-01) on Oct-17

Figure 20: Blues Point (SW-BP-01) on Dec-17

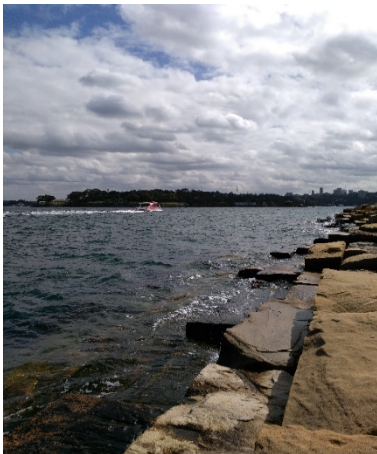
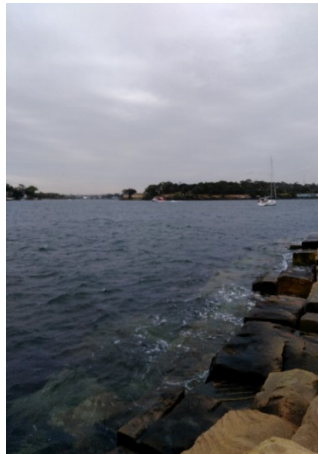
Figure 21: Barangaroo (SW-B-01) on Aug-17

Figure 22: Barangaroo (SW-B-01) on Sep-17

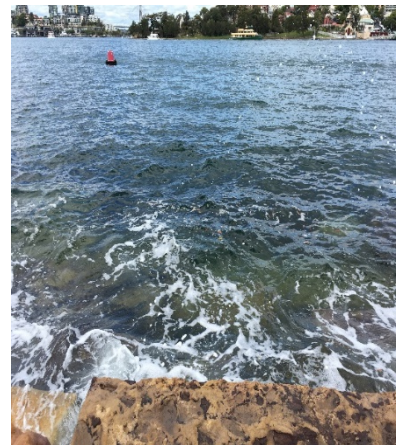
- Laboratory analysis of pH was measured marginally below the assessment criteria on one occasion at 7.8.
- The dissolved oxygen levels were also measured to be outside the ANZECC marine assessment criteria of 100% DO saturation. Results on in Sep-17 recorded oxygen saturation of 115.6%. This is likely attributed to environmental conditions such as

swell and wind. 'Choppy' site conditions were documented in field notes during this sampling round. Alternatively, results recorded during the Nov-17 and Jan-18 monitoring periods recorded dissolved oxygen levels that were below the ANZECC criteria (88.7 % and 85% respectively).

Figure 23: Barangaroo (SW-B-01) on Dec-17 showing wavy conditions

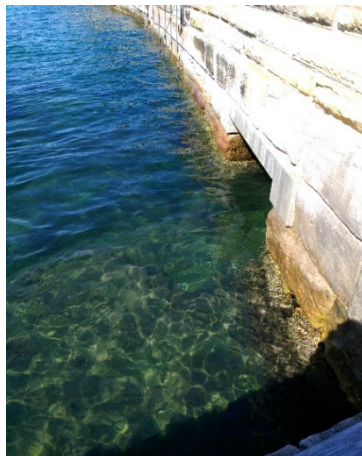
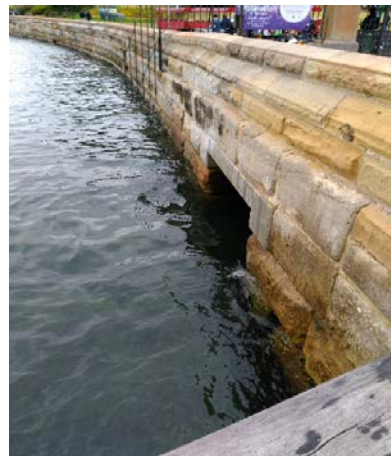
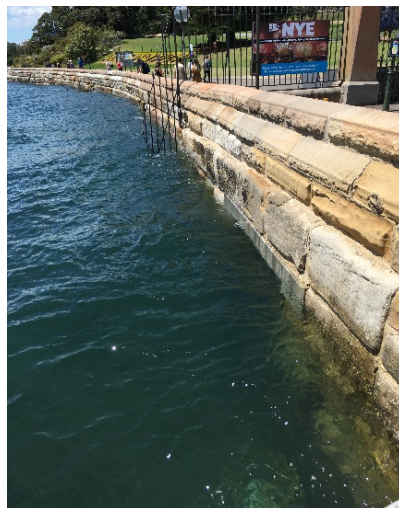
Figure 24: Farm Cove (SW-FC-01) sampling location on Aug-17

Figure 25: Farm Cove (SW-FC-01) sampling location on Sep-17

Figure 26: High tide at Farm Cove (SW-FC-01) on Dec-17

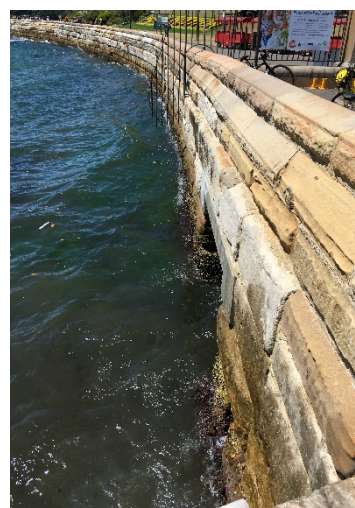
- NTU results during the Jan-18 sampling event were relatively higher than previous results. This was coupled with observation of odours, smelly, and visible brown discharge from outlet, shown in Figure 27.
- Dissolved oxygen levels were also recorded at concentrations above the adopted assessment criteria. Results from Sep-17 were above the upper limit of 110 % oxygen saturation level. It was noted that this was a windy day which could have contributed to the high dissolved oxygen result.

Figure 27: Low tide at Farm Cove SW-FC-01 on Jan-18, showing brown discharge

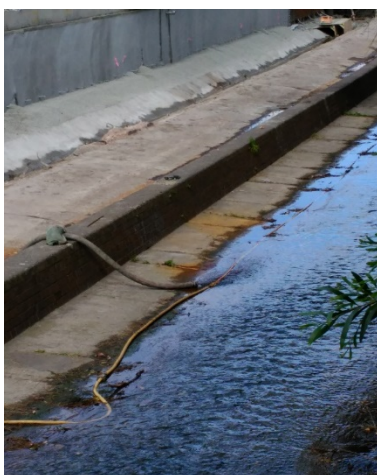
Six (6) monitoring events were recorded between August and December 2017 at the Alexandra Canal sampling site, results are shown in Appendix 9. The canal was noted as being highly disturbed which collects runoff and discharge water from several surrounding businesses, and construction activities including a construction site adjacent to the site. Dewatering was observed on 3 occasions, shown in Figure 28. Visible oil and grease was also seen running down the stream shown in Figure 29.

Figure 28: Adjacent construction site discharging water in Alexandra Canal (SW-EC-01) on Aug-17

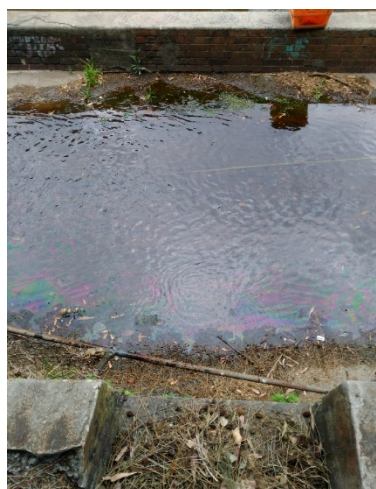
Figure 29: Visible oil and grease at Alexandra Canal (SW-EC-01) on Sep-17

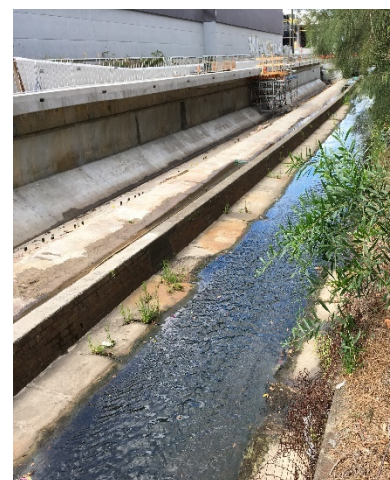
Figure 30: High water flow, clear at Alexandra Canal on Dec-17

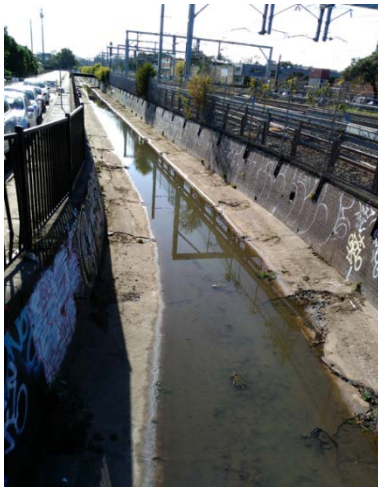
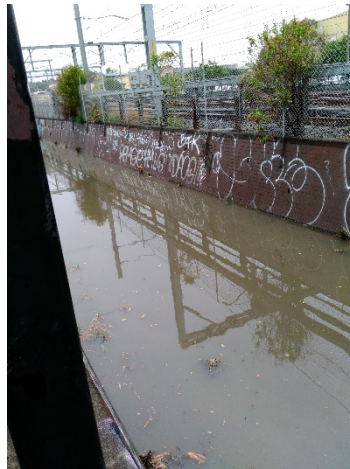
Figure 31: Low/still creek at Eastern Channel (SW-EC-01) on Aug-17

Figure 32: High level creek at Eastern Channel (SW-EC-01) on Oct-17

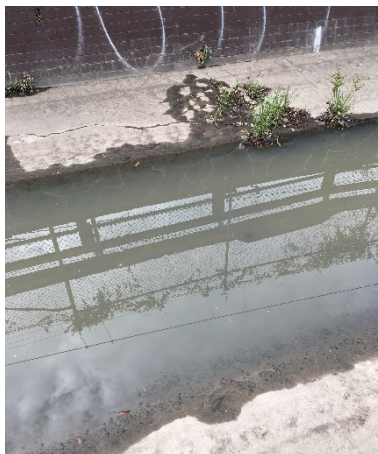
- Field observation noted the high level of disturbance to the canal. Turbidity readings ranged from 5 – 171 NTU. Odorous and turbid site conditions were identified during sampling events, with visible debris noted on most occasions, as shown in Figure 33. This supports the elevated NTU, and high TSS Levels recorded at this sampling location.

- Total iron was also recorded in excess of the assessment criteria of 0.35 mg/L on all occasions. During the Dec-17 water monitoring event, total iron was recorded at 3.5 mg/L. Total iron concentrations recorded during the monitoring period are potentially linked to the high sediment yield noted within the water column.

Figure 33: Eastern Canal (SW-EC-01) showing murky turbid water on Dec-17

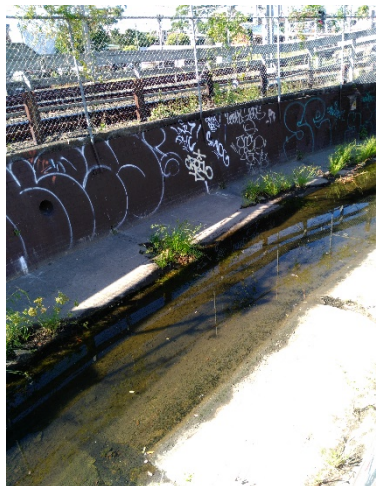
Figure 33: Settled water with vegetation at Eastern Canal (SW-EC-01) on Jan-17
