Central Station Main Works

Construction Noise and Vibration Monitoring Program Report

August 2020 - January 2021

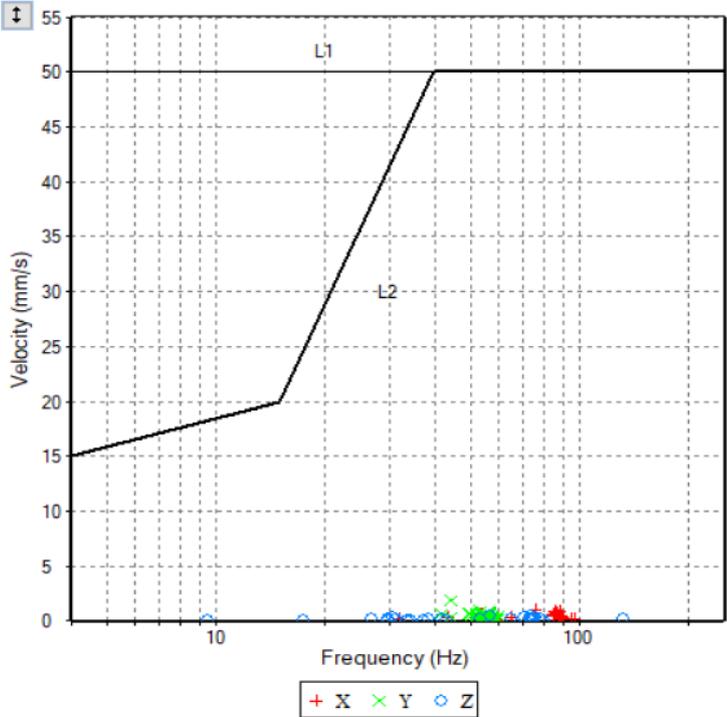
The building damage management level (BS 7385) has been presented in graph form to help with interpretation. The higher the frequency (x axis), the less stringent the criteria for velocity becomes (y-axis) up to 50mm/s. In the example below, all data points fall below both the Line 1 (L1) (less stringent) and the Line 2 (L2) (more stringent) criteria. An exceedance would be observed if data point were to be observed above the L1 or L2 lines on the graph below.

Figure 1: Example of criteria graphed. Note: All structures in the zone of potential construction impact of the Bounce Hotel demolition works are framed or reinforced, hence L1 criteria applies (50mm/s for all frequencies).

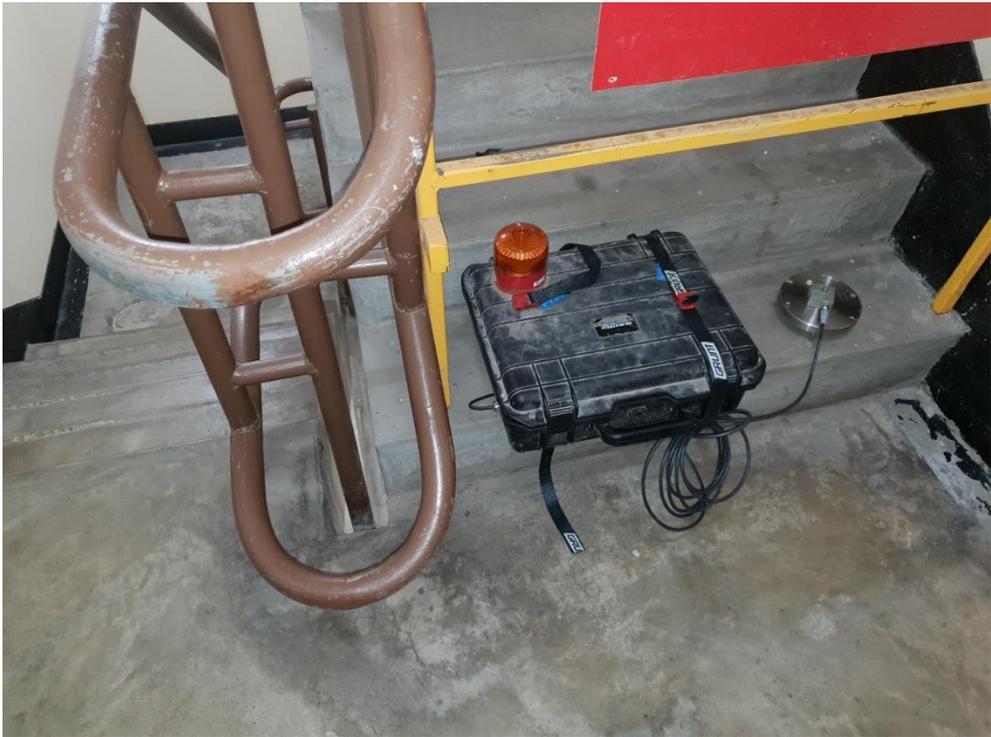
Figure 2-2: Unattended vibration Logger set up at the Dental Hospital southern stairwell

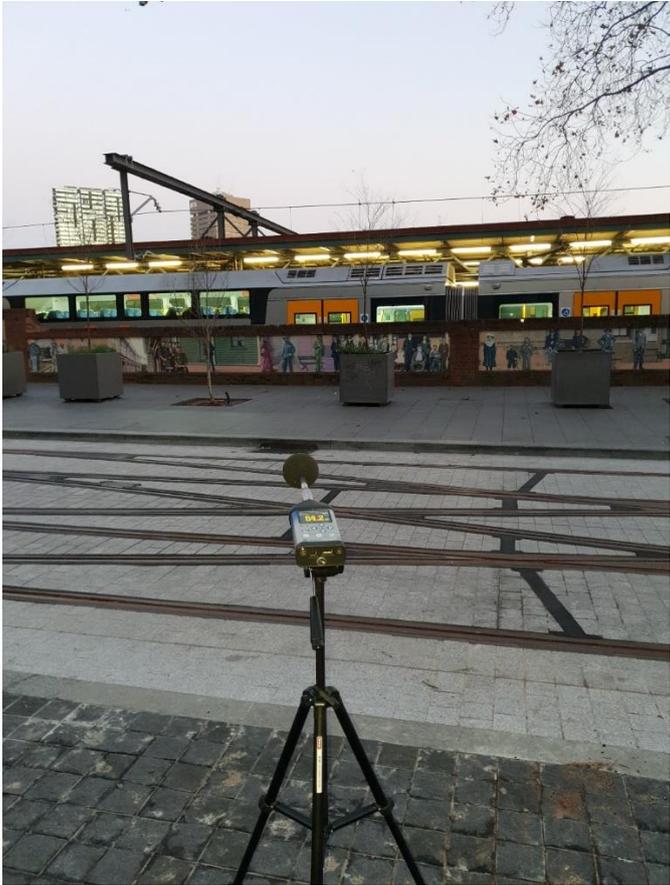
Figure 2-3: Attended noise logger setup on Chalmers St

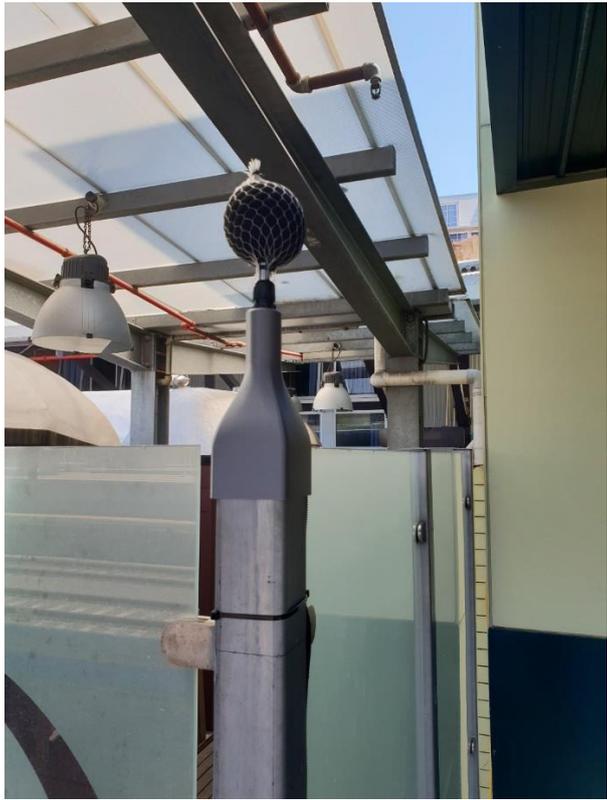
Figure 2-4: Real time noise logger setup at the YHA (Platform 1), Installed 24 October 2019

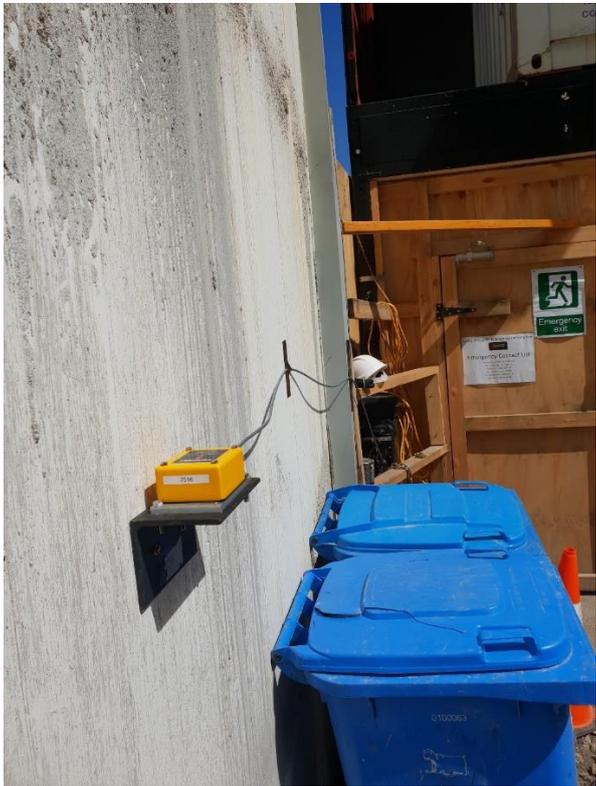
Figure 2-5a: Real time vibration logger setup on the wall of 30 Chalmers St (installed 14 October 2019- January 2021)

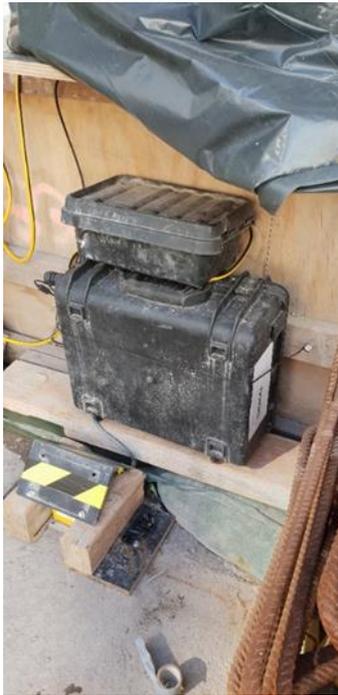
Figure 2-5b: Real time vibration logger 30 Chalmers St relocated to centre of site January 2021)

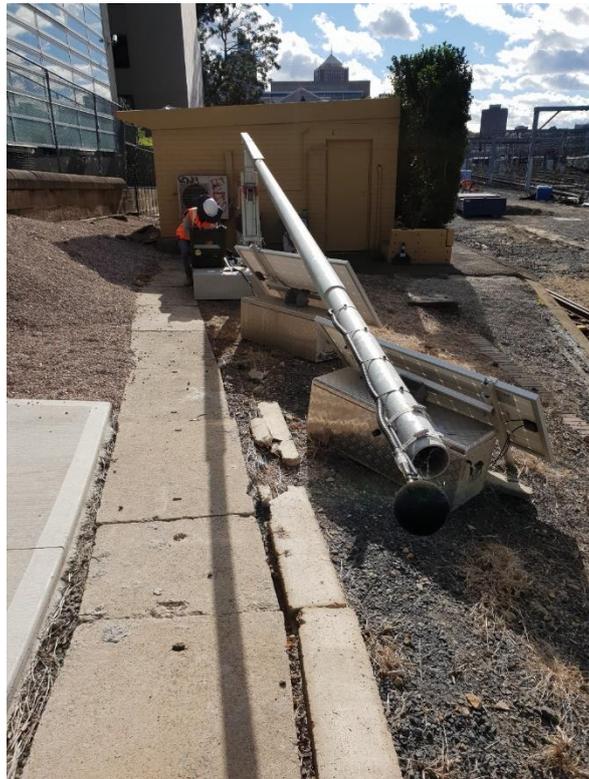
Figure 2-6: Real time noise logger setup at 54 Regent St (in the process of being serviced), installed 12/12/2018

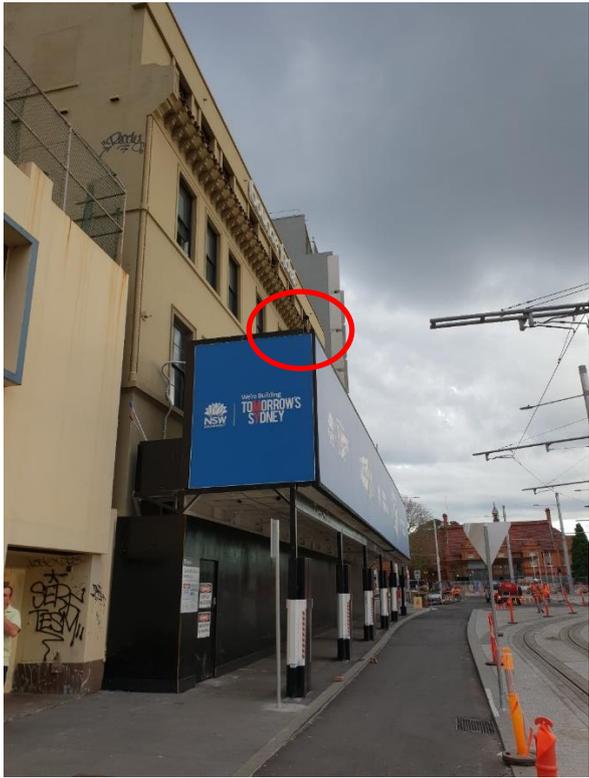
Figure 2-7: Real time noise logger Chalmers St, installed 11/01/2019

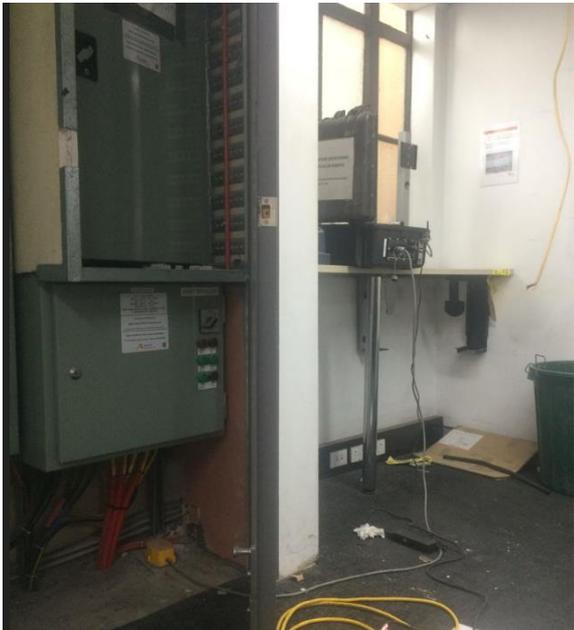
Figure 2-8: Real time vibration logger Central Electric Building, installed 11/01/19

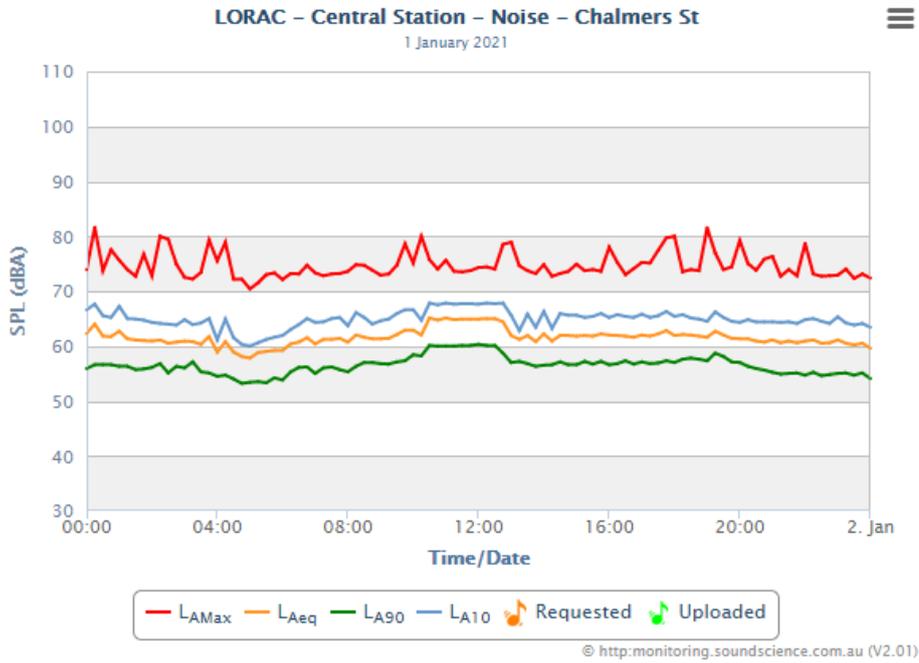
Figure 2-9: Example of real time noise monitoring data

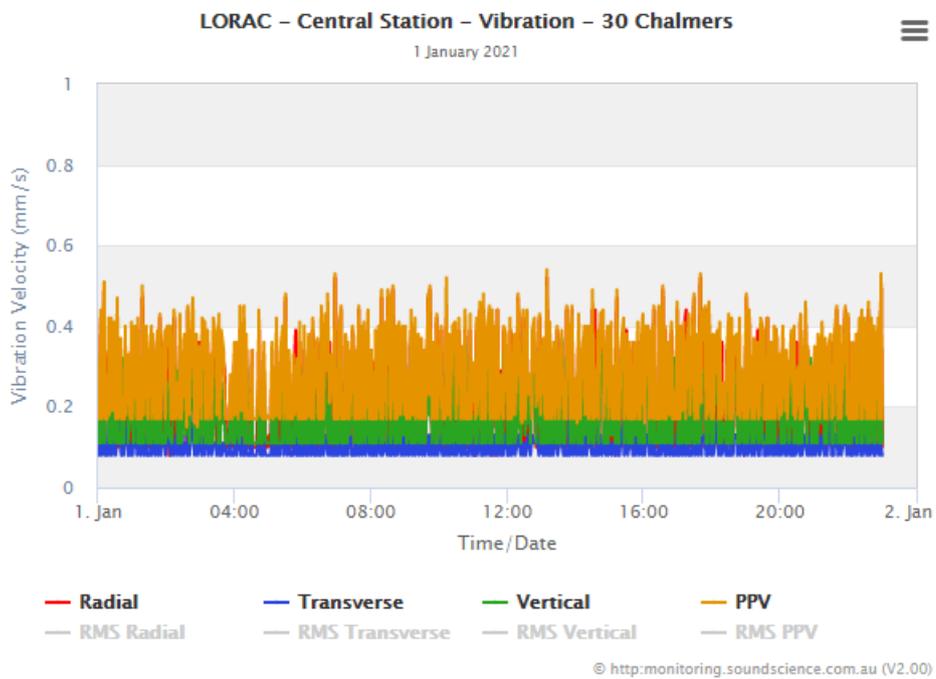
Figure 2-10: Example of real time vibration data. Graph showing general background vibration levels.

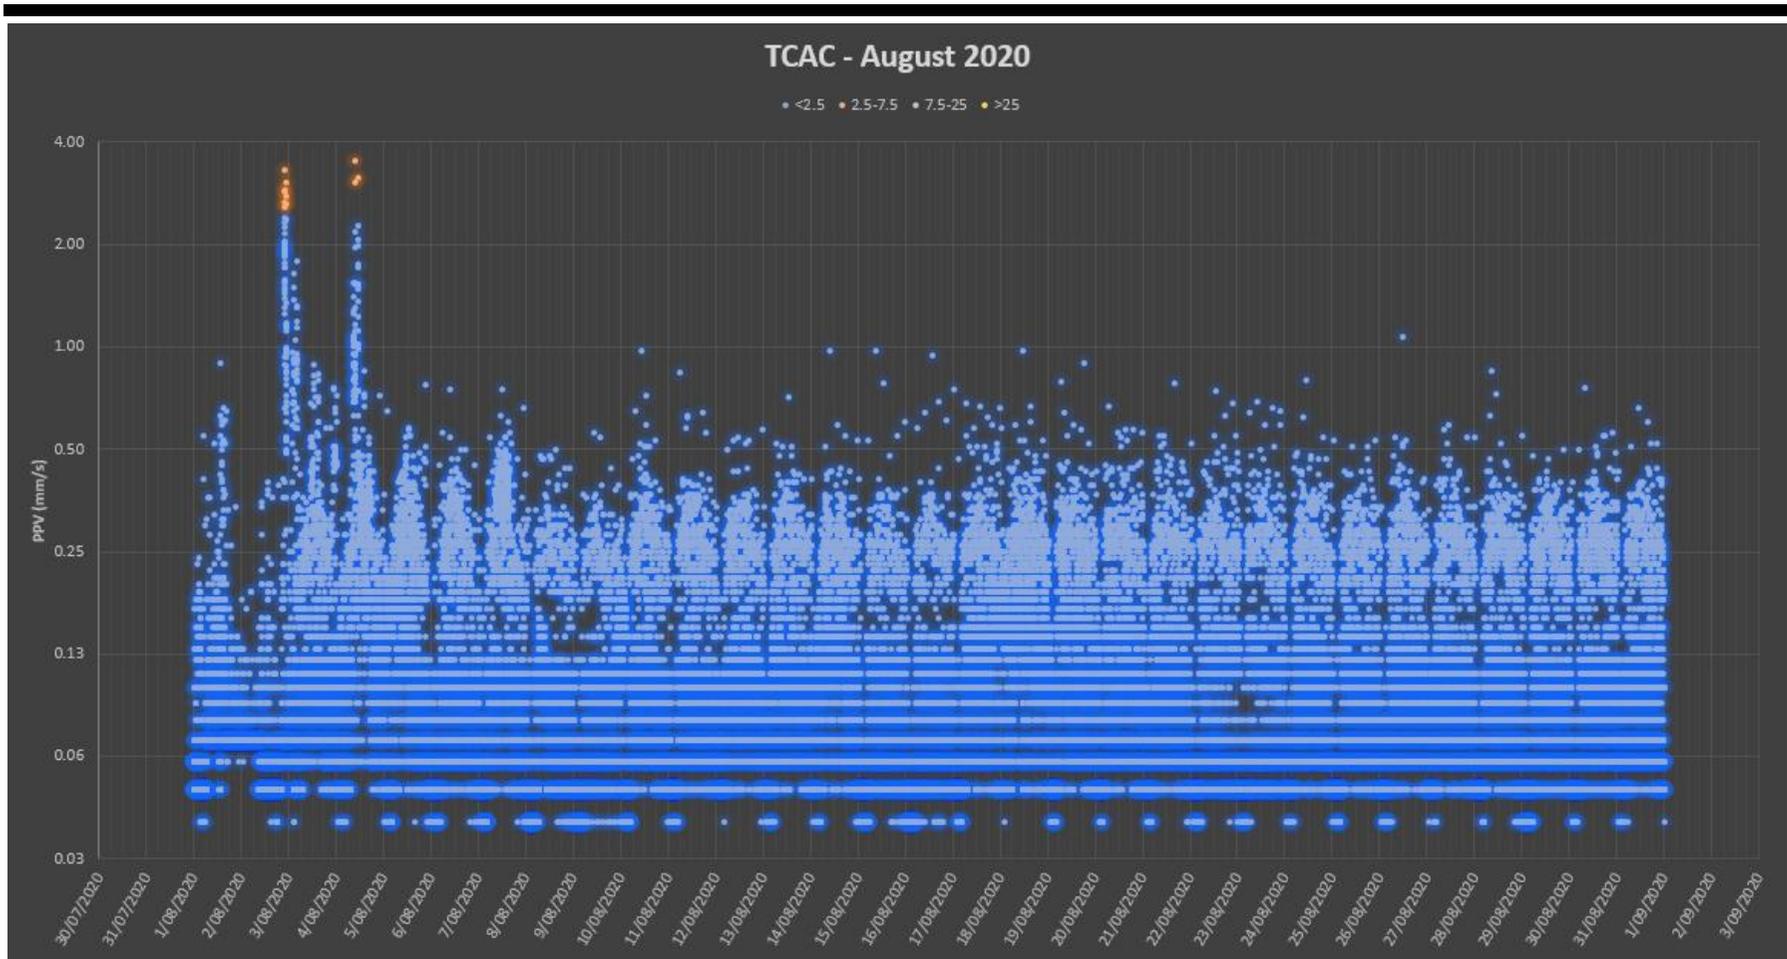
Figure B-1 TCAC - August 2020

The month of August had limited vibration intensive activities. The predominate scope of works occurring in the Northern Concourse involved installation of large steel elements.

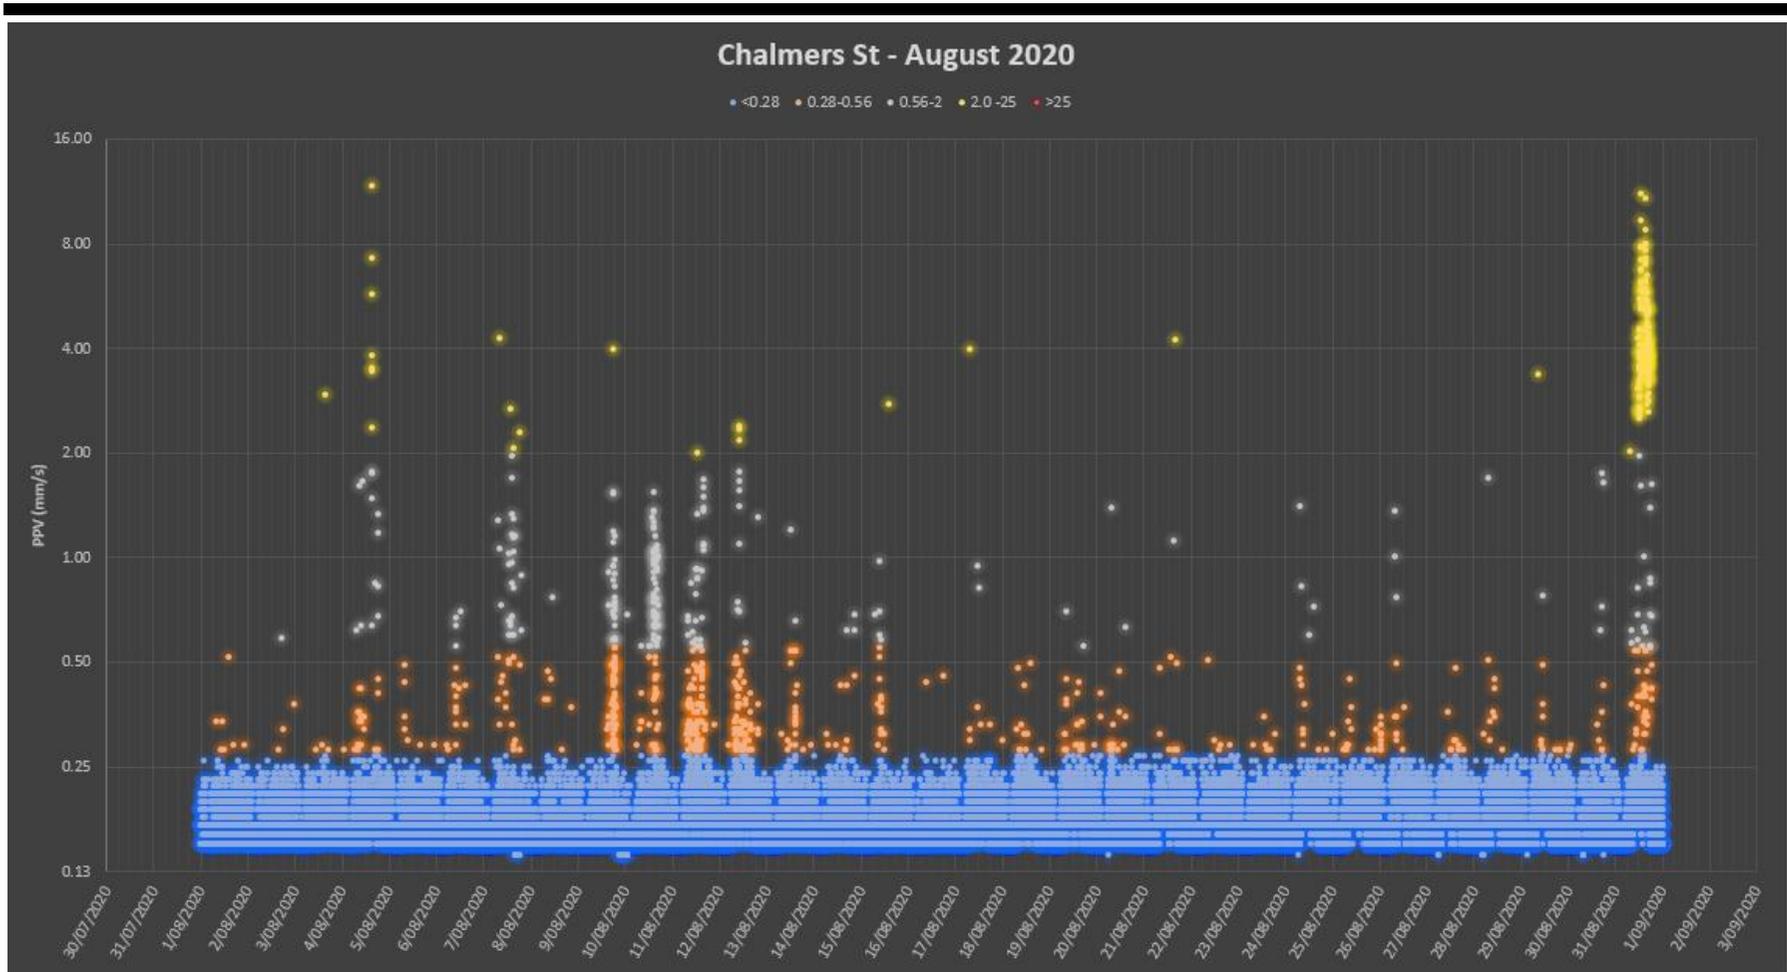
Figure B-2 Chalmers Street – August 2020

Works within Eastern Entrance throughout August consisted of some excavation activities, but primarily involved canopy tube drilling, waterproofing and concreting works. There were no instances where vibration exceeded the structural damage trigger value of 25mm/s throughout August 2020.

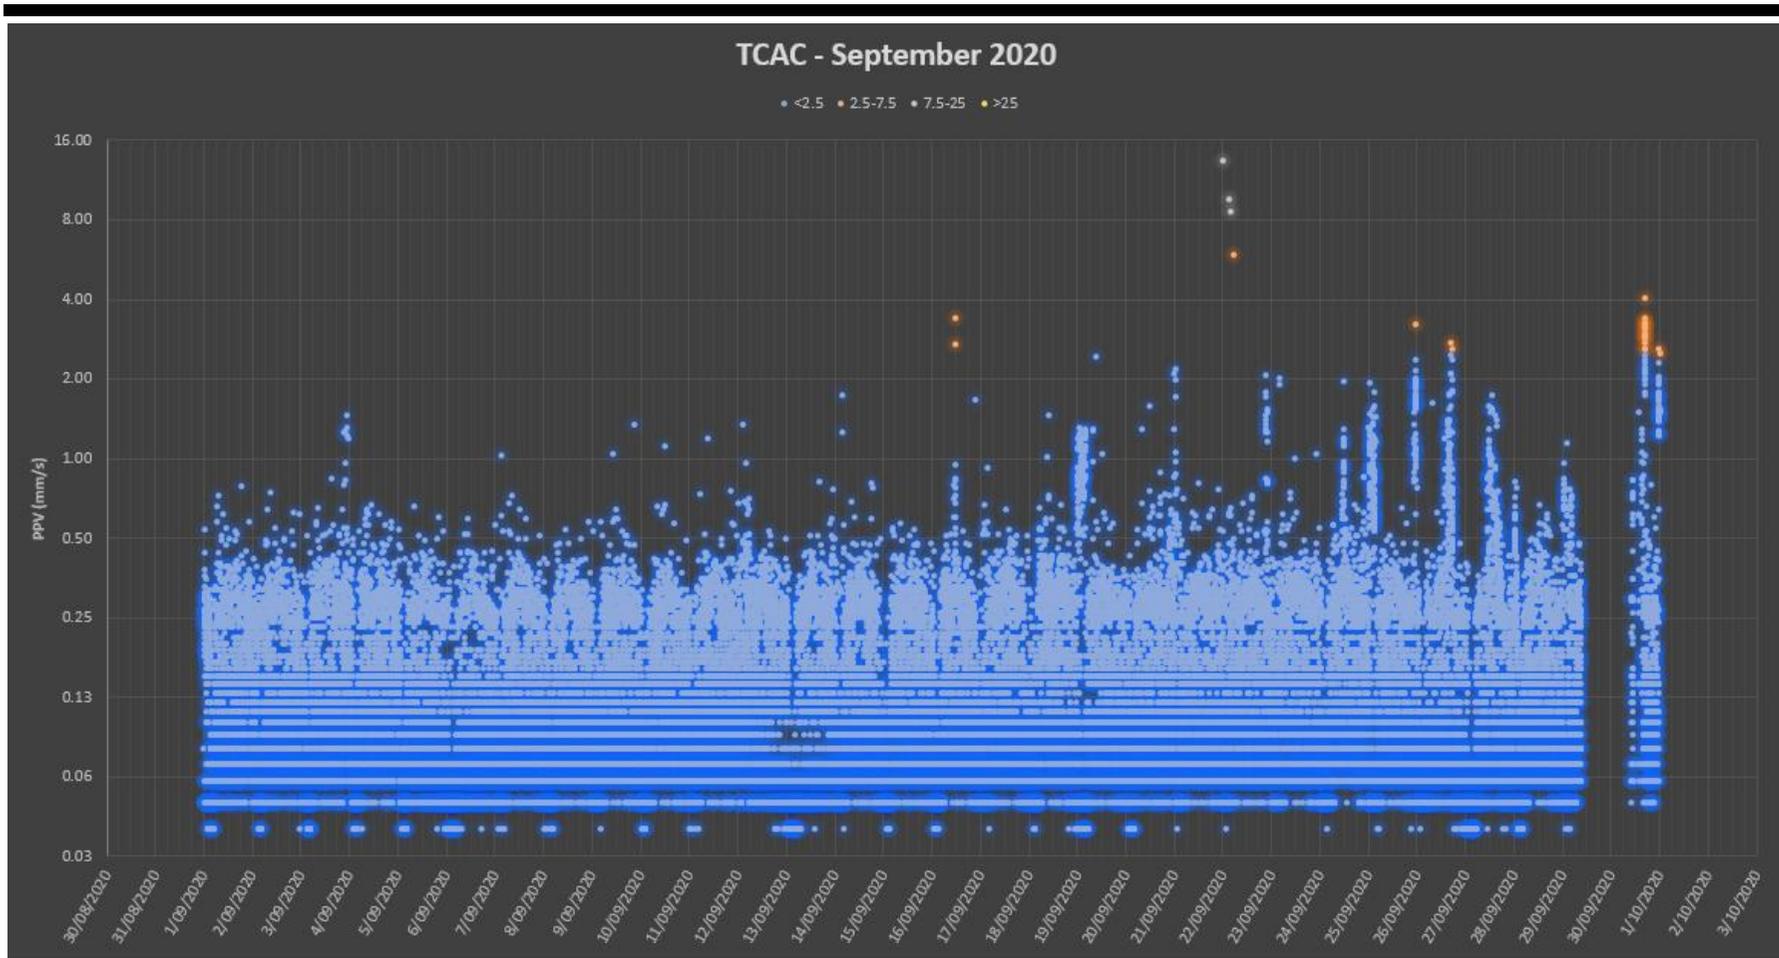
Figure B-3 TCAC - September 2020

The month of September had limited vibration intensive activities in close proximity to the Central Electric Building (CEB/ TCAC). The predominate scope of works occurring in the Northern Concourse involved installation of large steel elements. Breaking upper Northern Concourse was also occurring around the Station Masters Office, however outside of the area of influence for CEB.

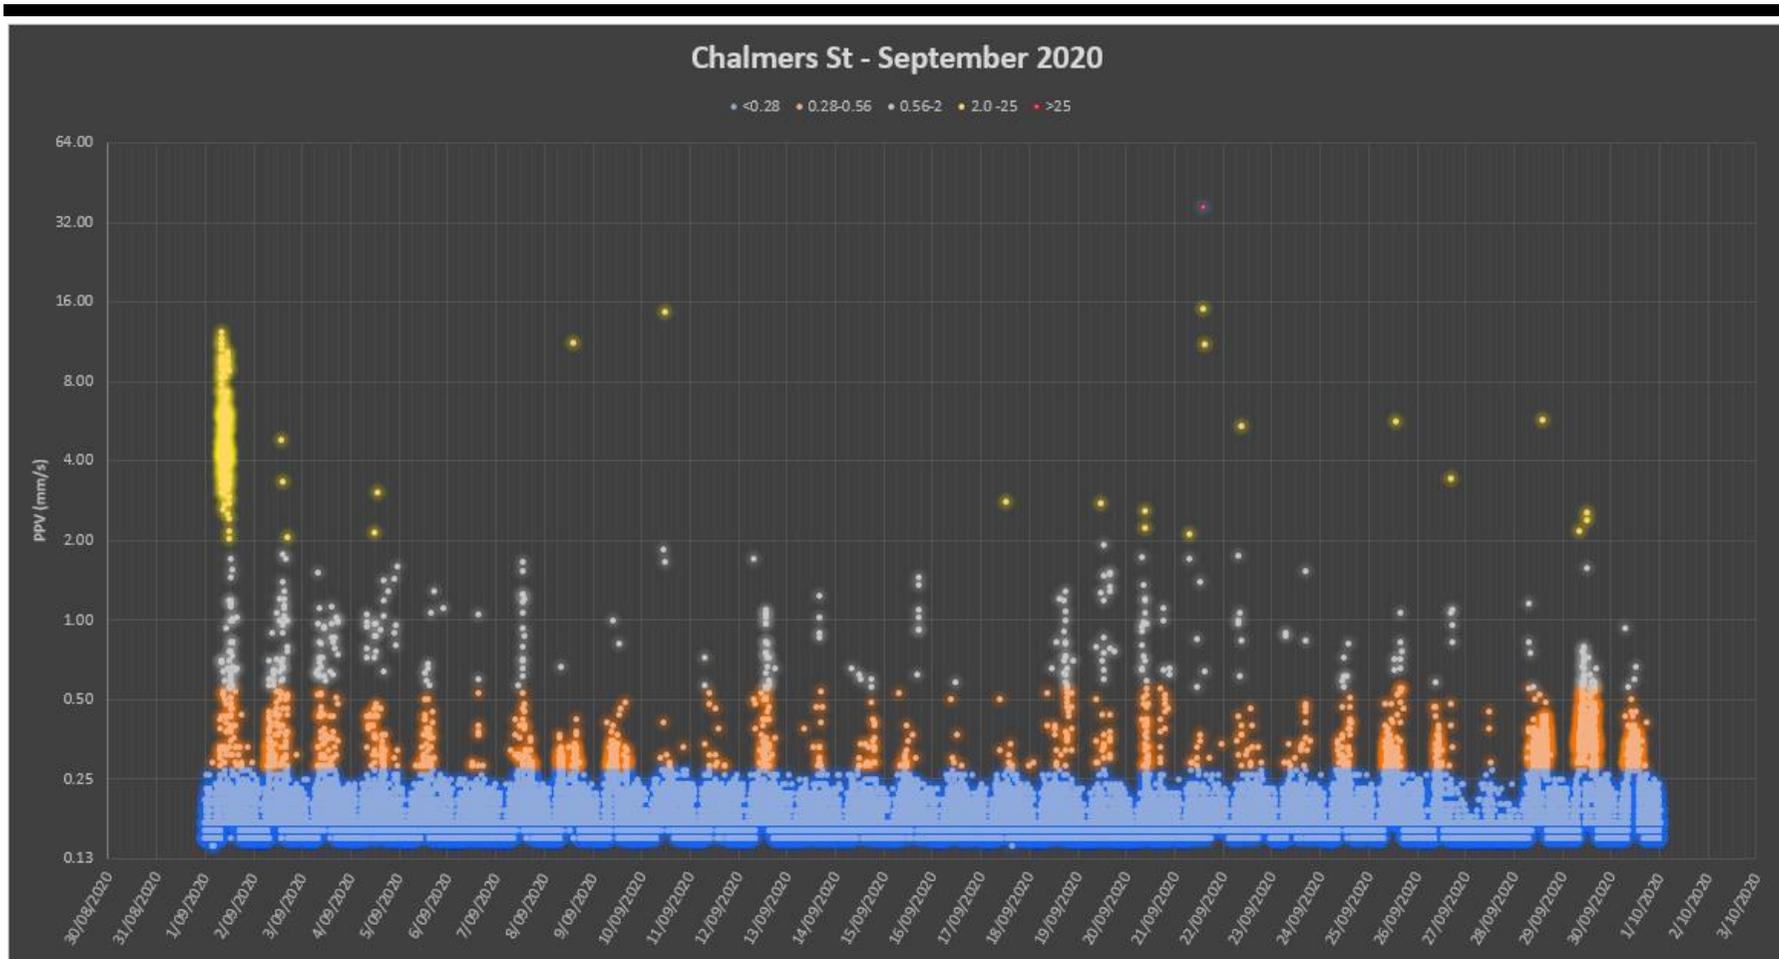
Figure B-4 Chalmers Street – September 2020

The works within the 20-28 Chalmers St site throughout September 2020 consisted of some excavation activities including the offloading of material into tipper trucks using a crane, but primarily of scaffolding and formwork. There was one instance where vibration exceeded the structural damage trigger value of 25mm/s, however this was identified as an extraneous vibration event.

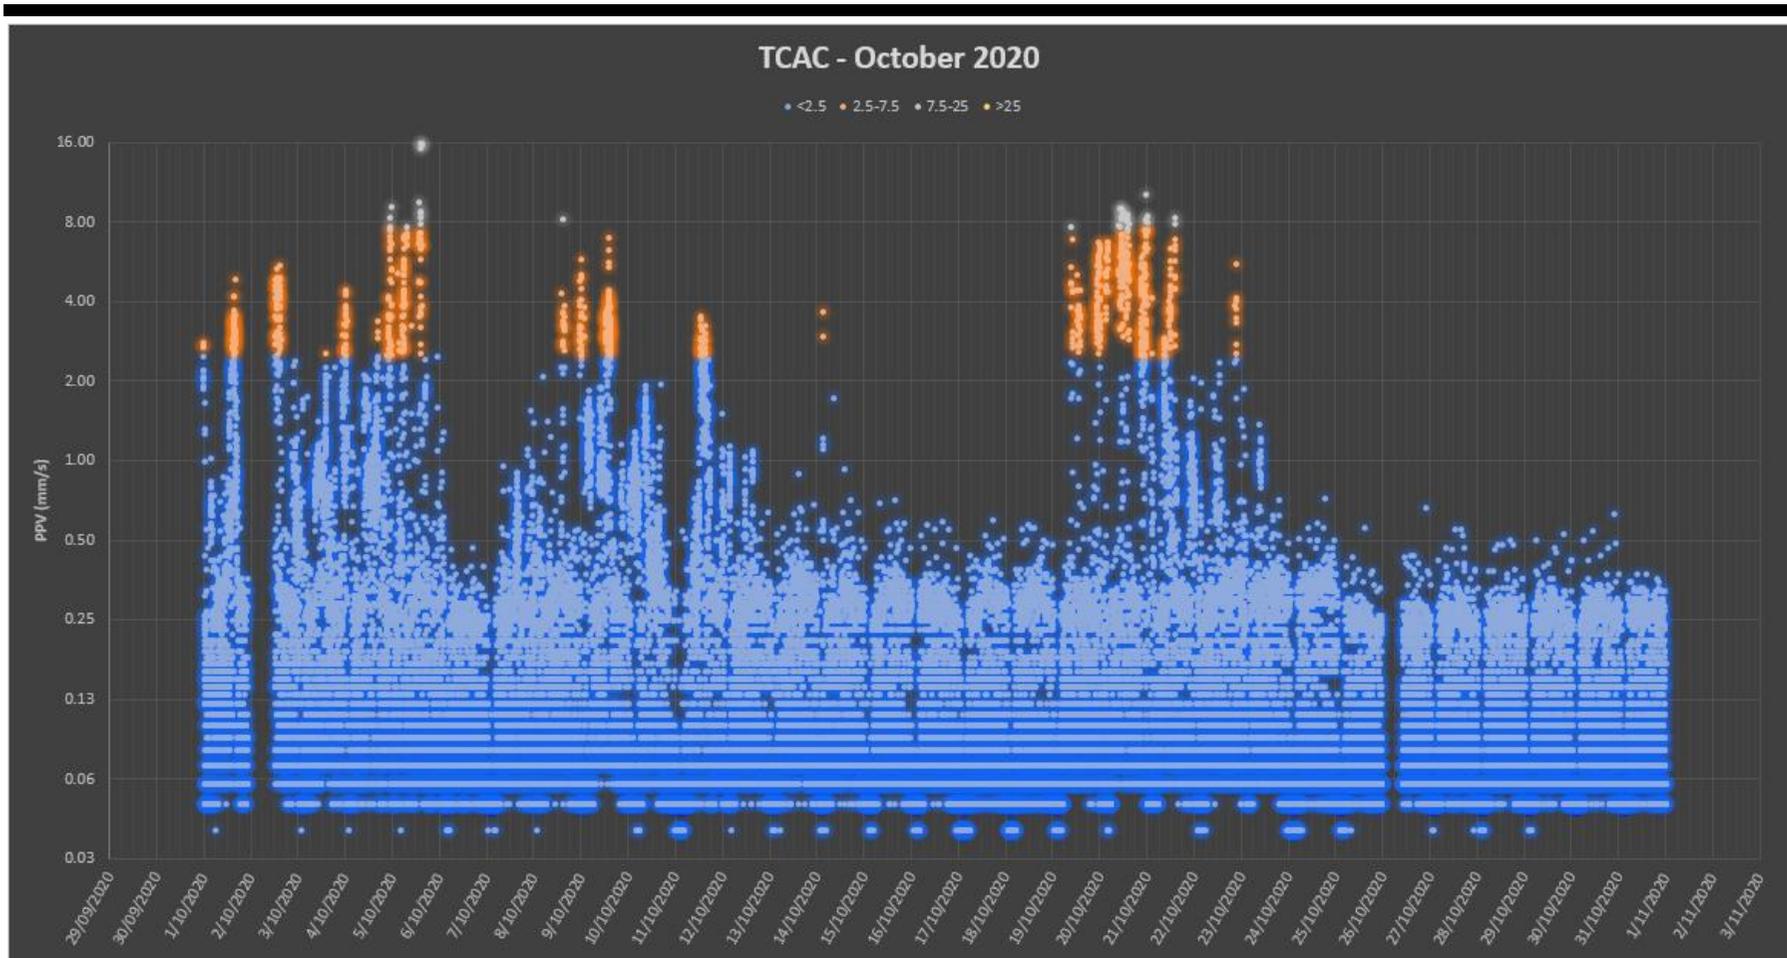
Figure B-5 TCAC – October 2020

Typical vibration although elevated from previous months for the month of October was typically below the cited 12.5 mm/s level corresponding to a near-zero probability of damage. Works in the Northern Concourse occurring consisted of breaking out piles working from west to east towards the TCAC building as well as window/door relocation on the southern and eastern elevation of the TCAC building.

Some of the elevated levels were attributed to non-vibration intensive activities occurring within the TCAC building in close proximity to the logger.

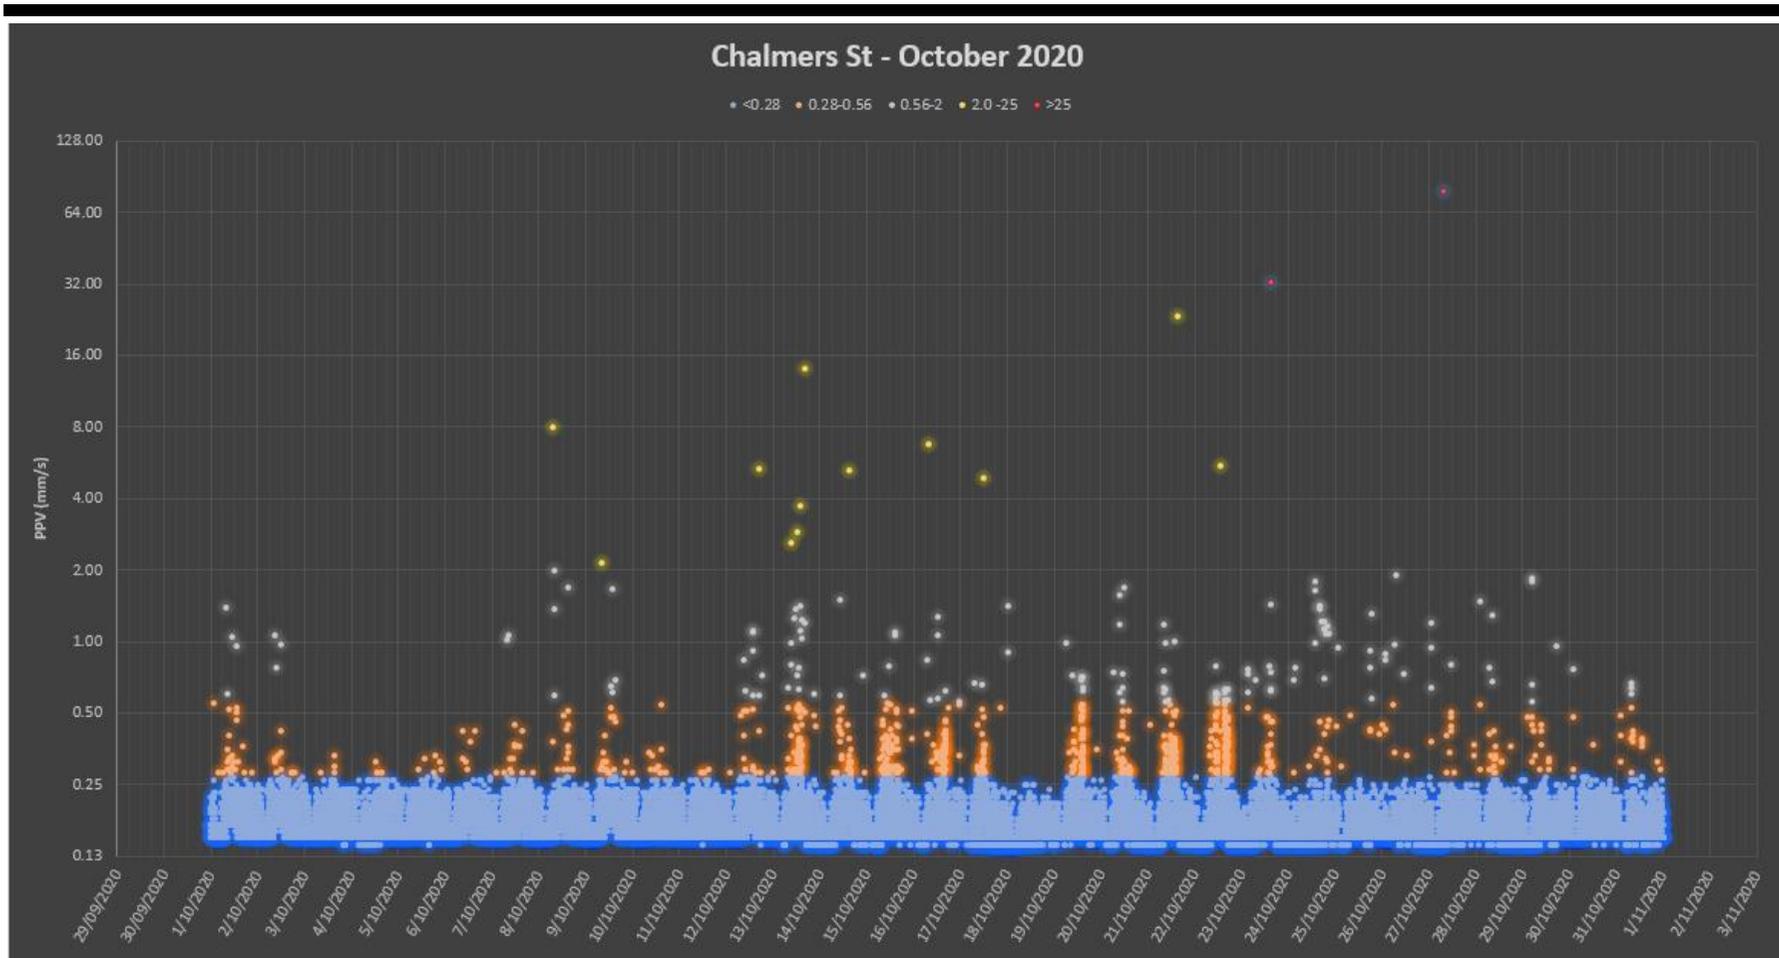
Figure B-6 Chalmers Street – October 2020

The works within the 20-28 Chalmers Street site throughout October 2020 consisted of some excavation activities including, breaking shale and sandstone, the offloading of material into tipper trucks using a crane, but primarily consisted of scaffolding and formwork. There were two instances where vibration exceeded 25mm/s, however these were identified as transient events.

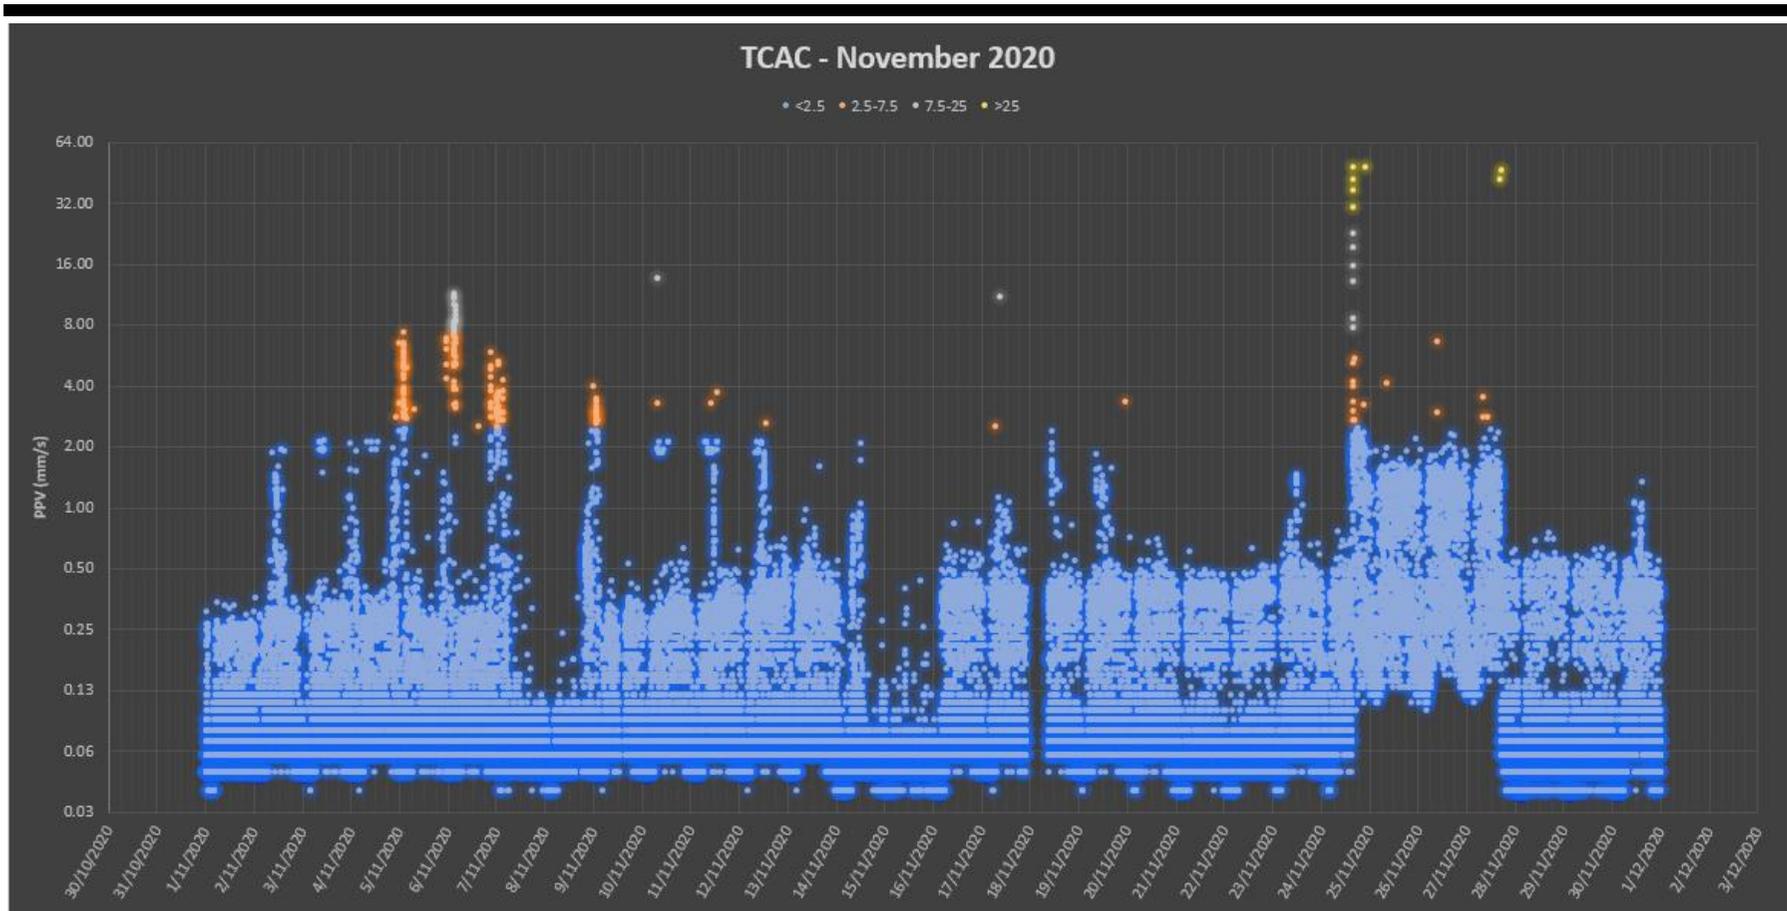
Figure B-7 TCAC – November 2020

Works in the Northern Concourse continue from the previous month for November and consisted of breaking out piles working from west to east towards the TCAC building as well as window/door relocation on the southern and eastern elevation of the TCAC building. Typically, vibration levels were below the cited 12.5 mm/s level corresponding to a near-zero probability of damage. The higher vibration activities occurred less frequently. Some of the elevated levels were attributed to non-vibration intensive activities occurring within the TCAC building in close proximity to the logger.

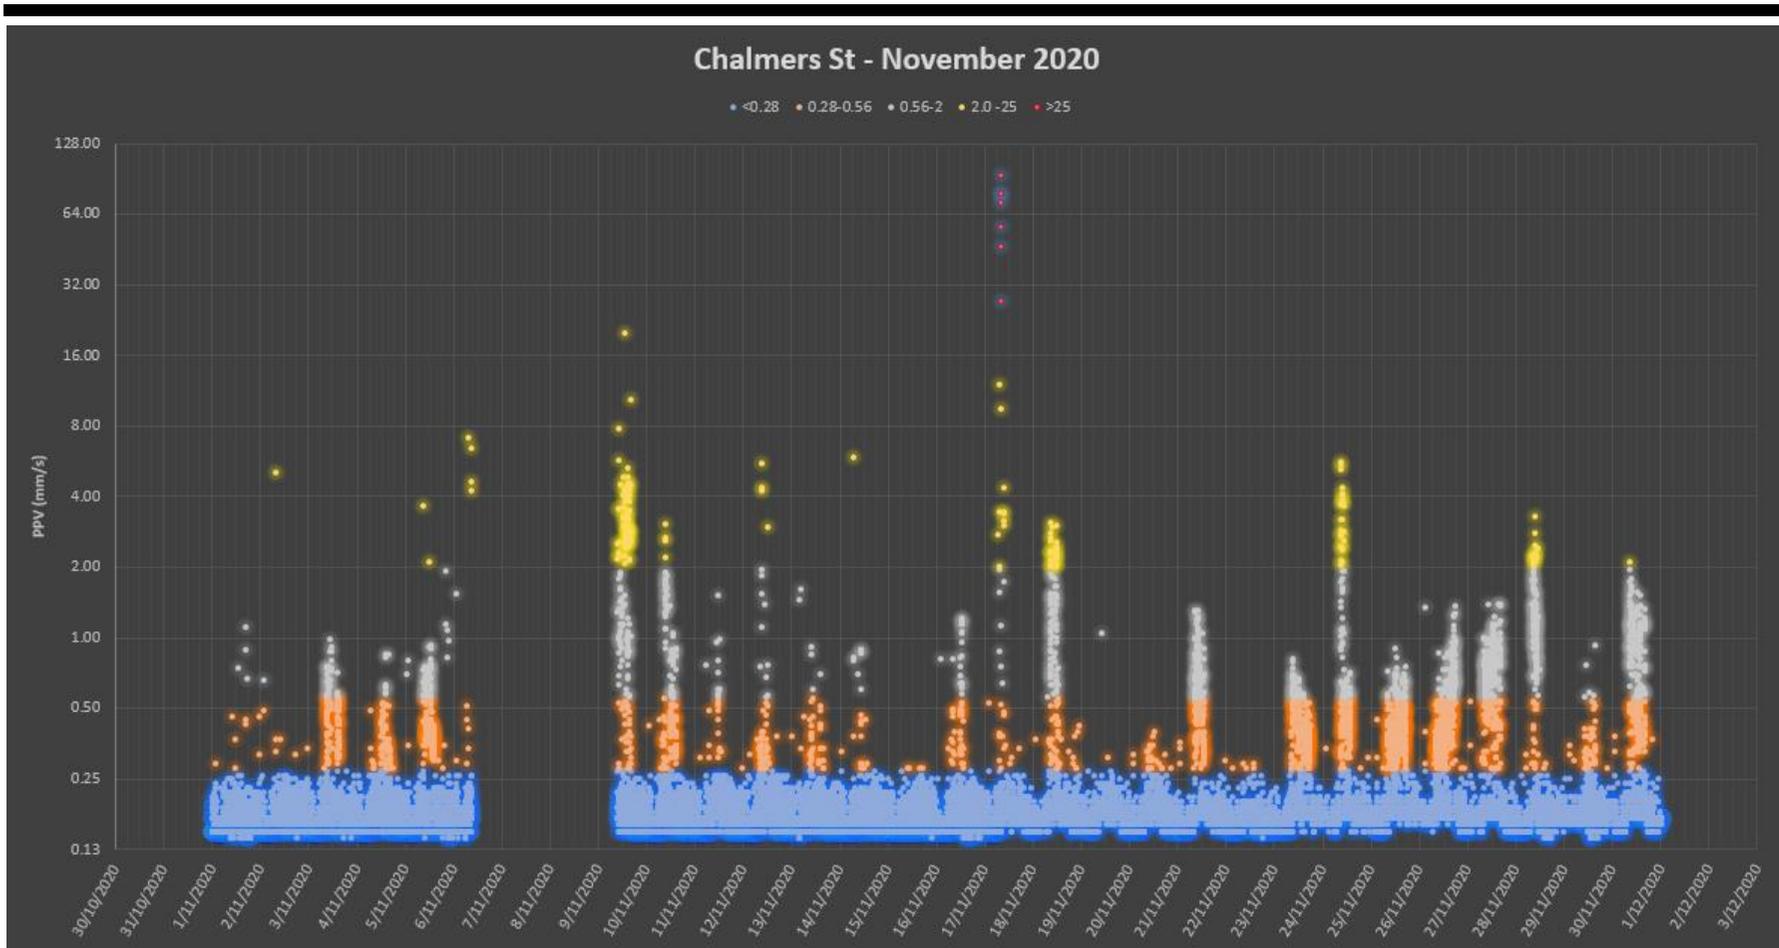
Figure B-8 Chalmers Street – November 2020

The works within the 20-28 Chalmers Street site throughout November 2020 consisted of excavation activities including, breaking shale and sandstone, the offloading of material into tipper trucks using a crane, and scabbling work. Data missing due to power issue between the 6th and 9th November 2020. There were a series of instance where vibration exceeded the structural damage trigger value of 25mm/s on the 17 November 2020. These have been identified as an extraneous vibration event occurring as a result of the logger being temporarily moved and replaced (while it continued logging) to facilitate works.

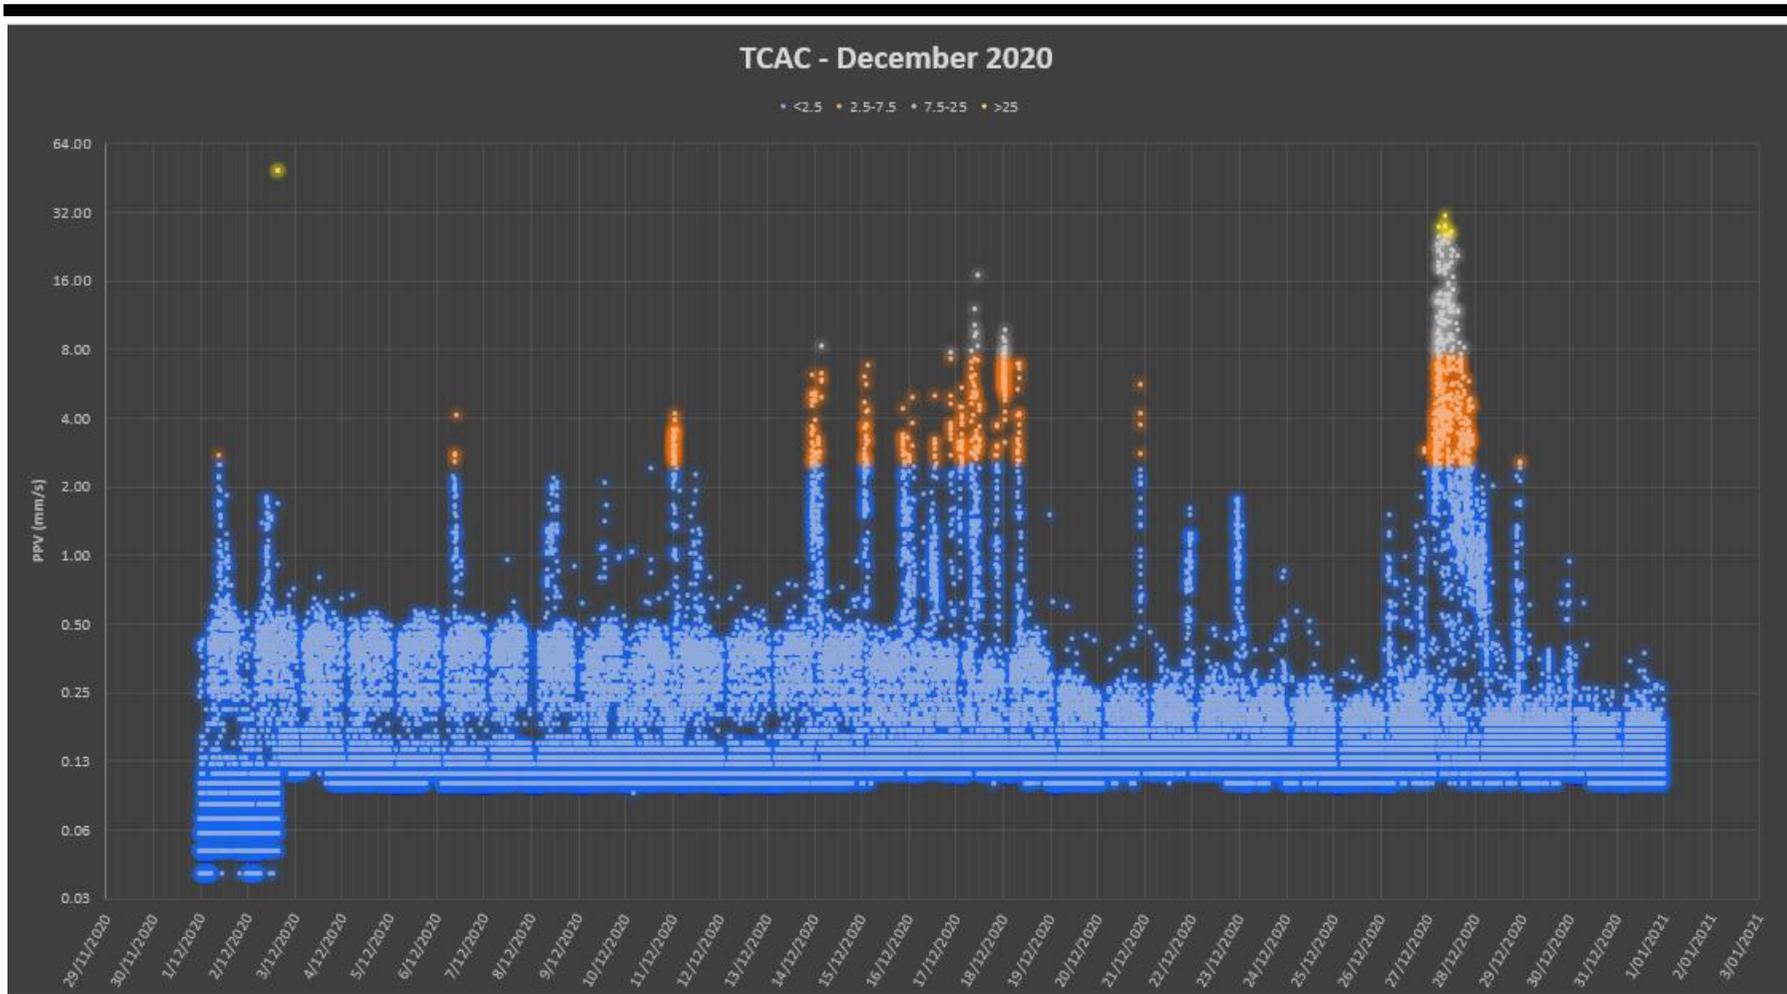
Figure B-9 TCAC - December 2020

The largest scope of vibration intensive activities commenced in the Northern Concourse in close proximity to the external façade of the Central Electric Building (CEB or TCAC). Elevated vibration levels were carefully monitored as large surface area breaking was occurring. Where possible, saw cutting occurred to reduce vibration traveling beyond localised area. The highest vibration intensive works occurred during OOH and possessions to reduce impact on commuters and Sydney Trains staff.
