Central Station Main Works

Construction Noise and Vibration Monitoring Program Report

August 2020 - January 2021

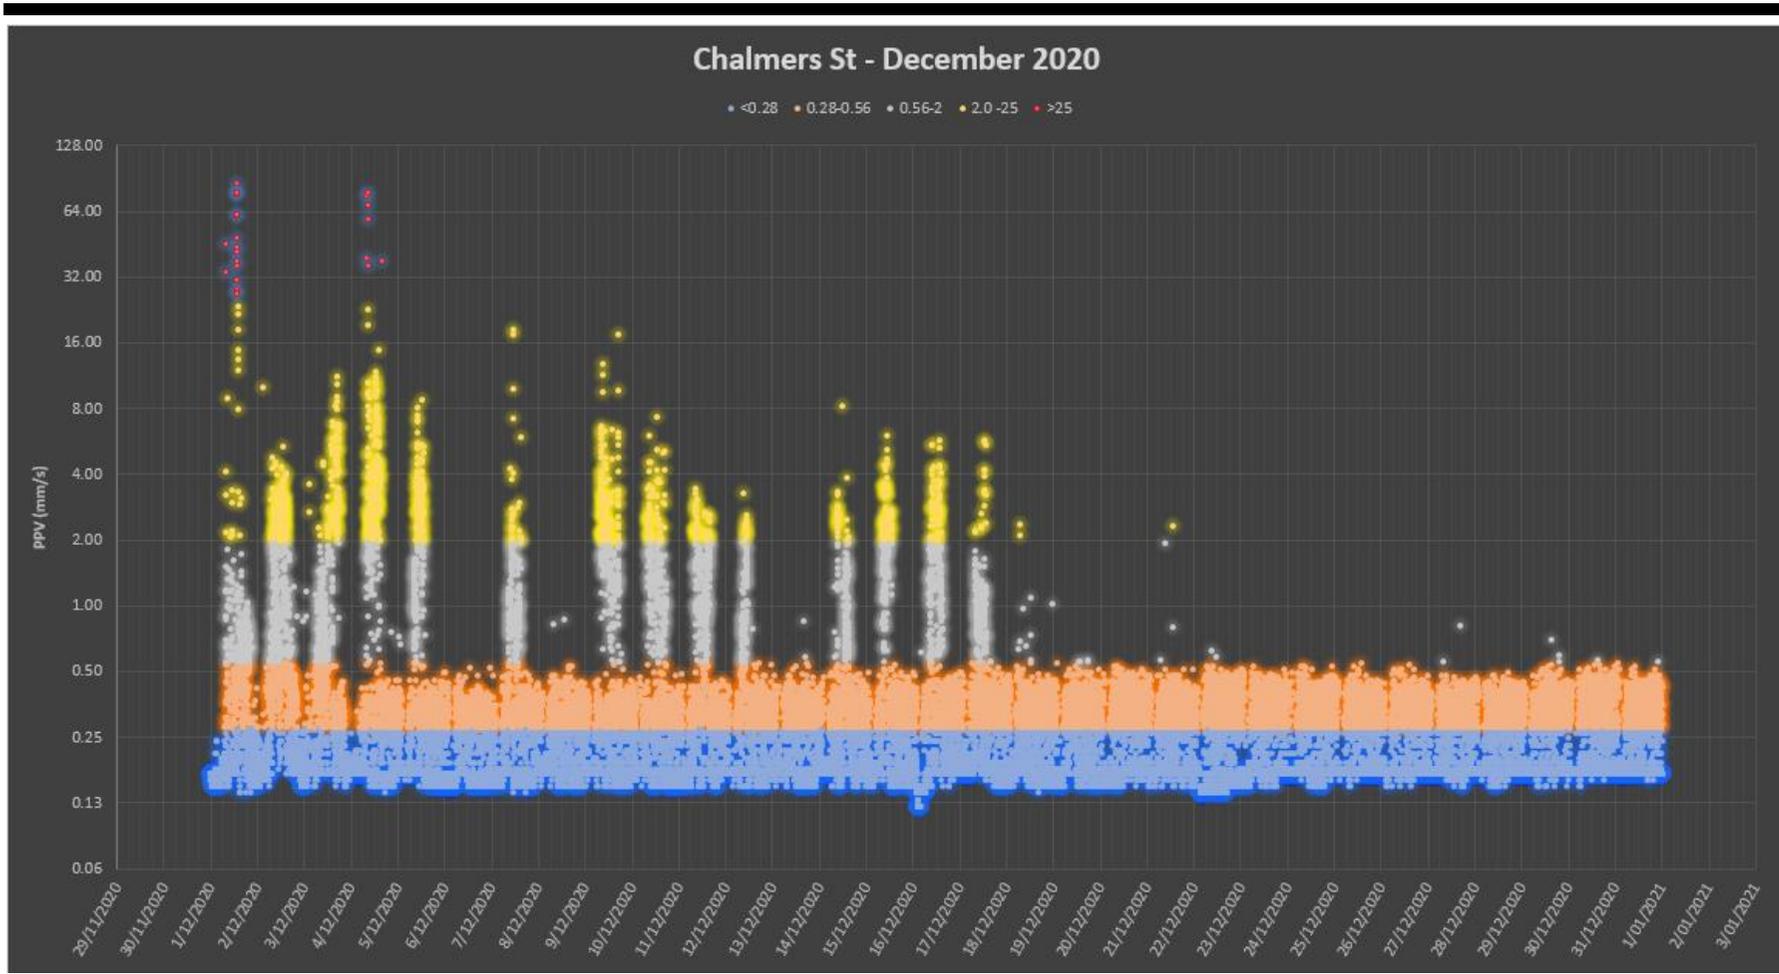
Figure B-10 Chalmers Street – December 2020

The works within the 20-28 Chalmers Street site throughout December 2020 consisted of excavation activities including, breaking shale and sandstone, and crane operations. Works at 20-28 Chalmers St finished on the 22nd of December. Typical vibration throughout the month was below 12.5 mm/s corresponding to a near-zero probability of damage. Several data points above 12.5mm/s were observed, the majority of which were determined to be associated with logger maintenance and relocation.

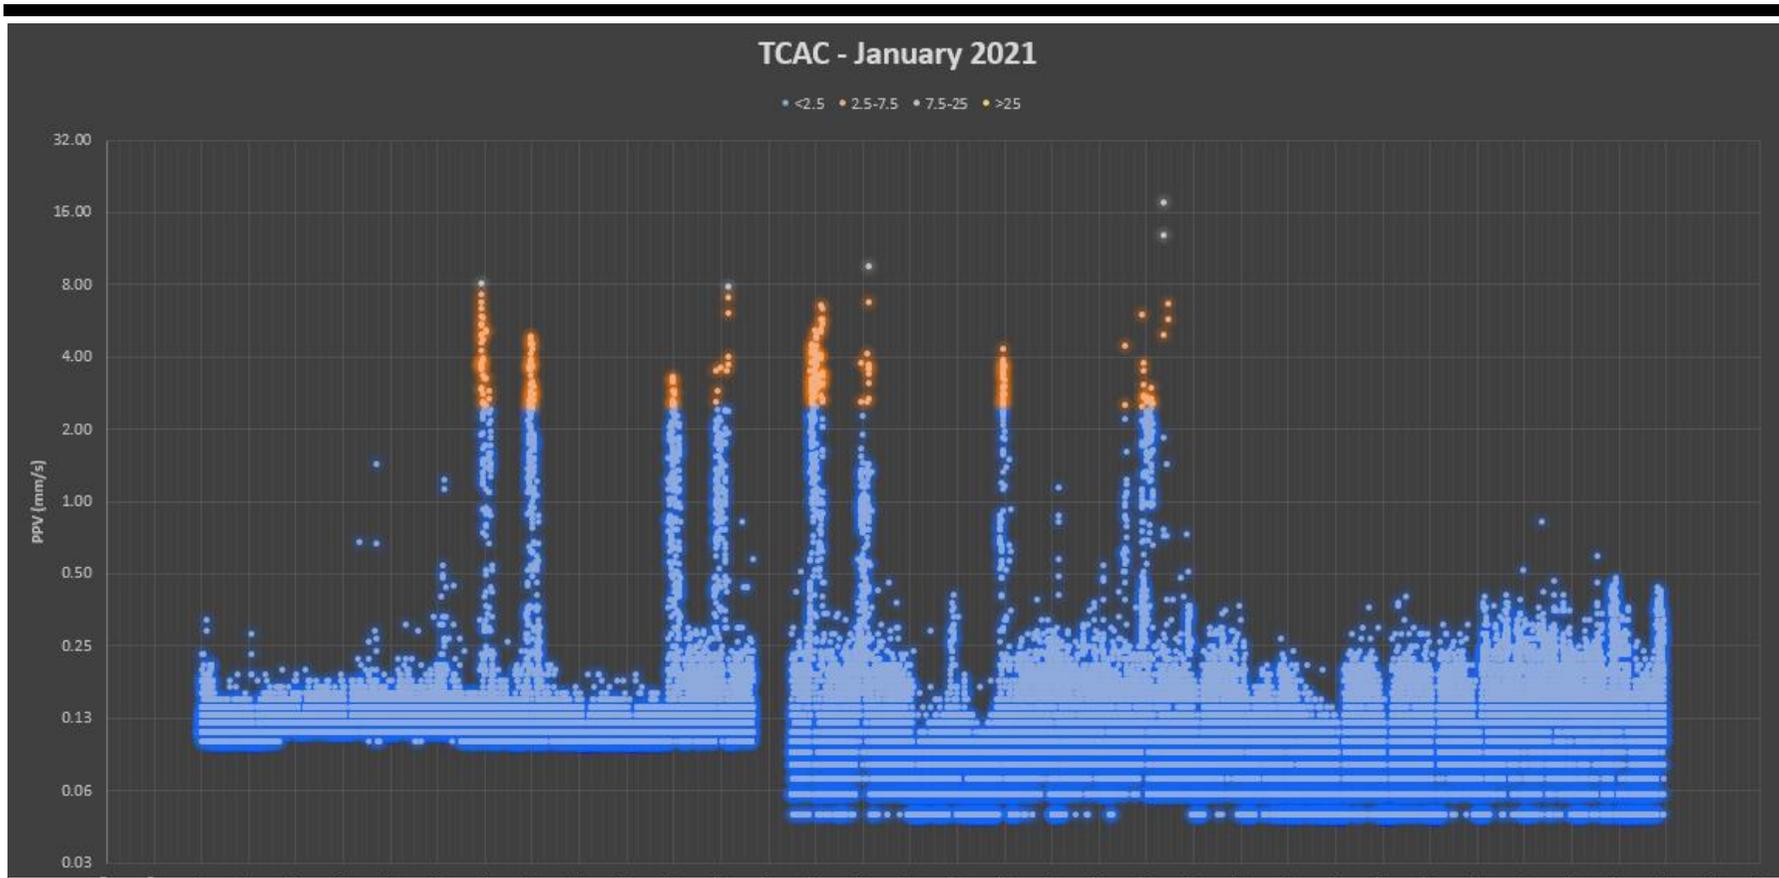
Figure B-2 TCAC – January 2021

The largest scope of vibration intensive activities continue in the Northern Concourse in close proximity to the external façade of the Central Electric Building (CEB or TCAC). Elevated vibration levels were carefully monitored as large surface area breaking was occurring. Where possible, saw cutting occurred to reduce vibration traveling beyond localised area. The highest vibration intensive works occurred during OOH and possessions to reduce impact on commuters and Sydney Trains staff.

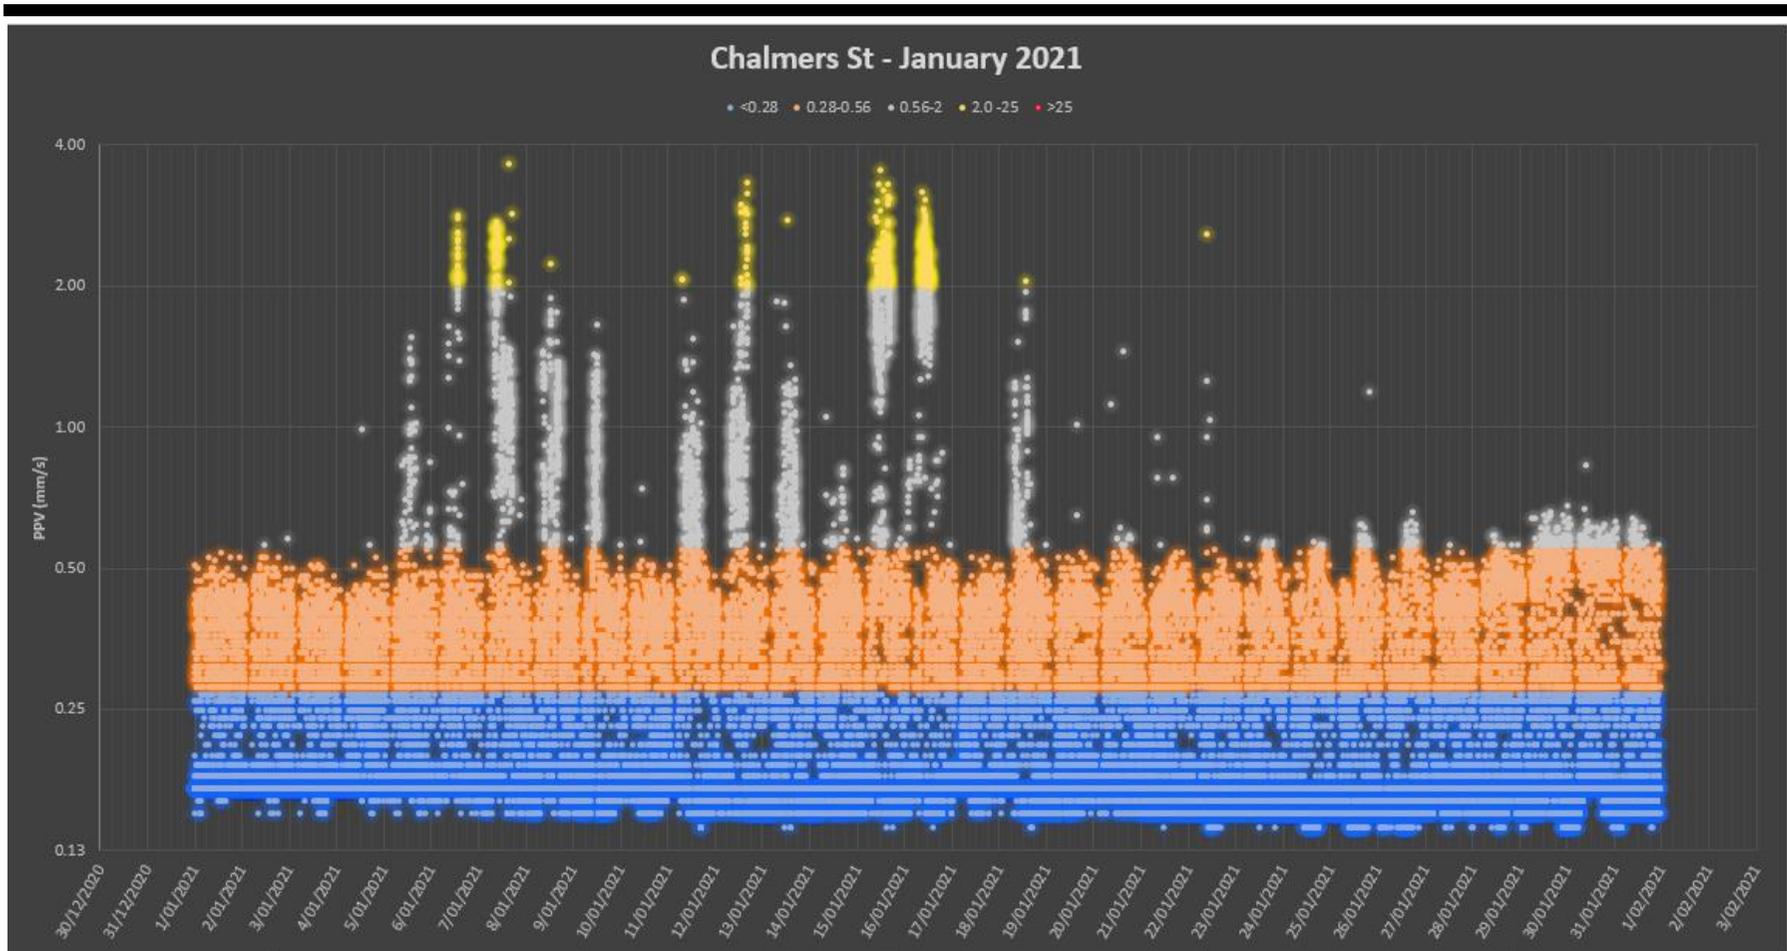
Figure B-3 Chalmers Street – January 2021

The works within the 20-28 Chalmers Street site throughout January 2021 consisted of excavation activities including breaking and excavating shale and sandstone, crane operations, and steel reo installation. Typical vibration throughout the month was well below the cited 12.5 mm/s level corresponding to a near-zero probability of damage.

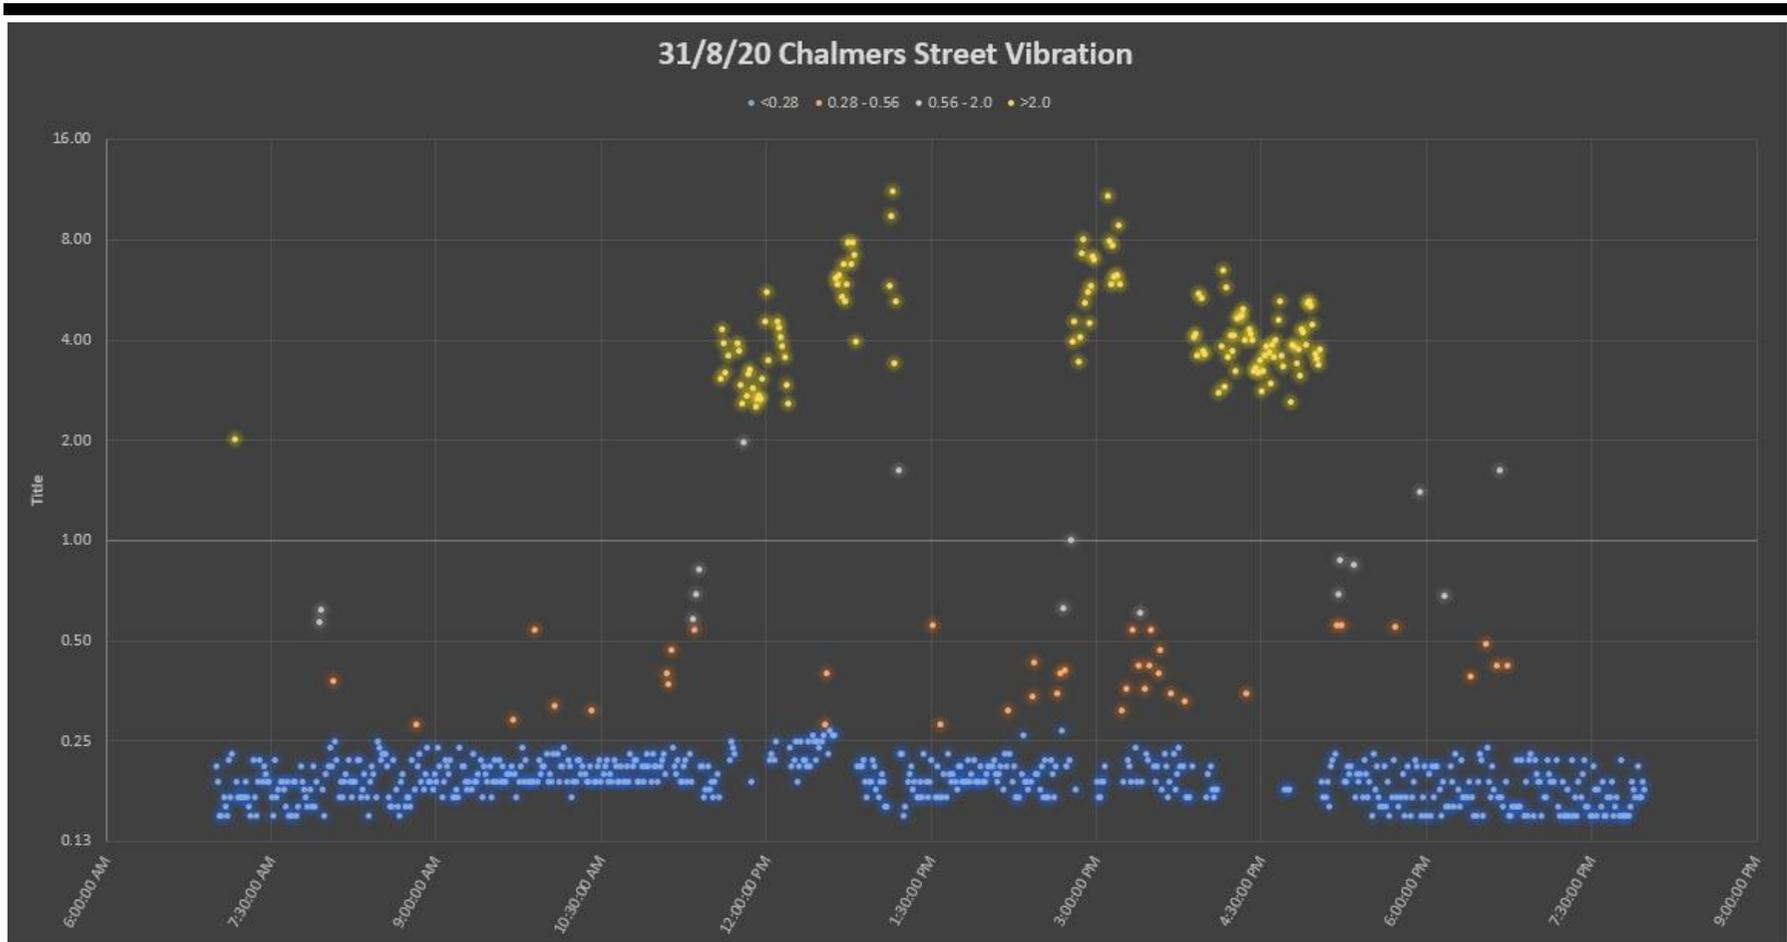
Figure C-1 31st August 2020

Typical activities that occurred on this day included canopy tube drilling and material load out using a crane, into a tipper truck parked in Randle Lane. These activities are not high vibration generating. The increase in vibration detected was attributed to renovation works occurring within Shop 1 on the ground floor of the 30-34 Chalmers St building.

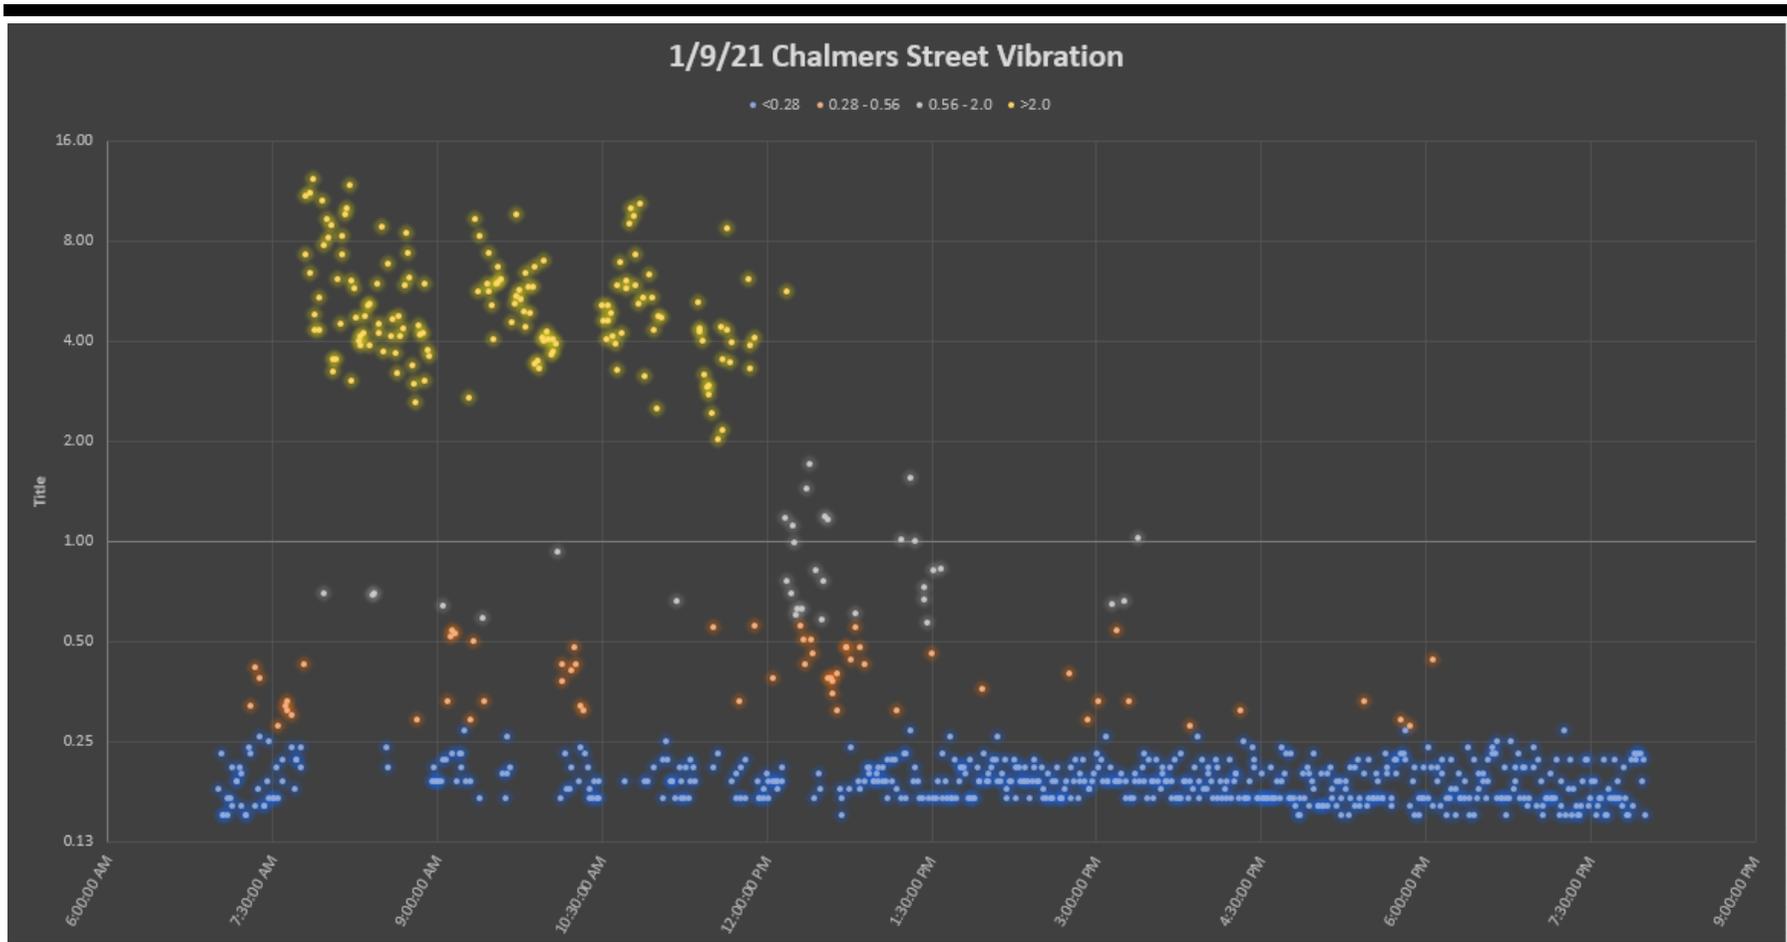
Figure C-2 1st September 2020

Typical activities on this day included crantage of small material and supplies, as well as general site works (maintenance etc). The peak in vibration occurred between 07:50 and 11:50 and ranged from 0.17 and 12.27mm/s. Based on field notes, video surveillance and an understanding of other non-CSM construction works, the peaks in vibration were attributed to the renovation works within the former Haven Café (shop 01, Ground Floor, 30-34 Chalmers Street).

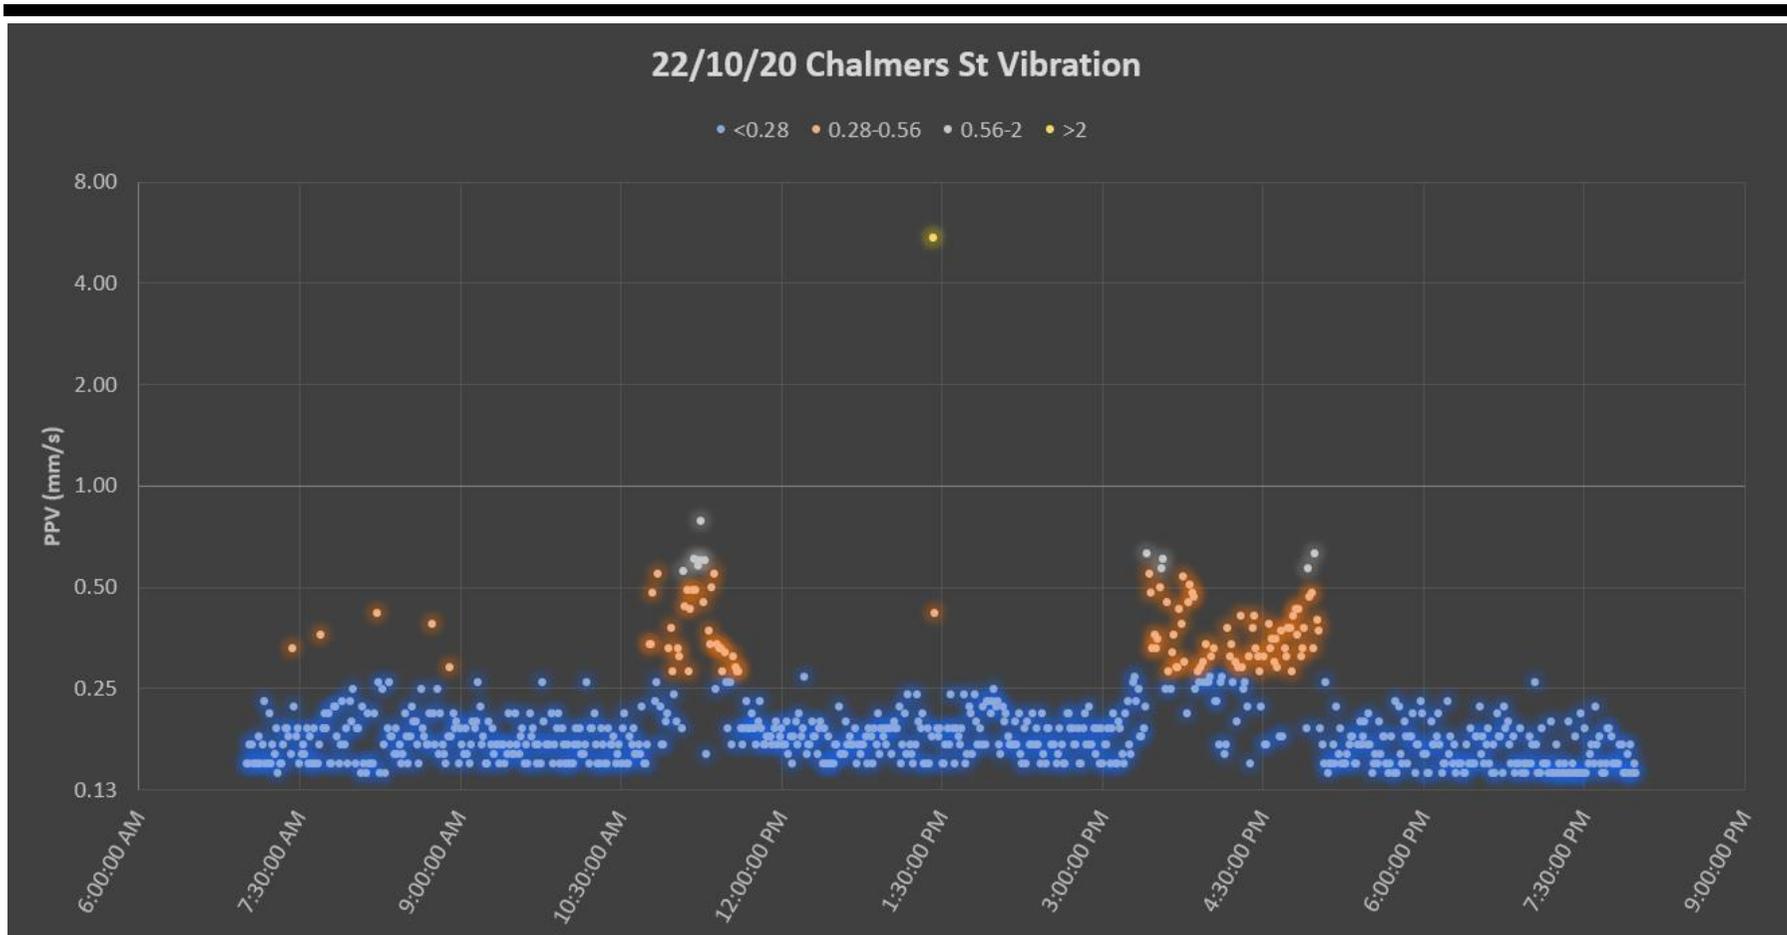
Figure C-3 22nd October 2020

Typical activities that occurred on this day included material delivery and unloading using a crane, as well as formwork and scaffold preparation. A single peak in vibration was observed. It was confirmed that the peaks in vibration occurred due to CSM construction personnel sitting and standing adjacent to the logger.

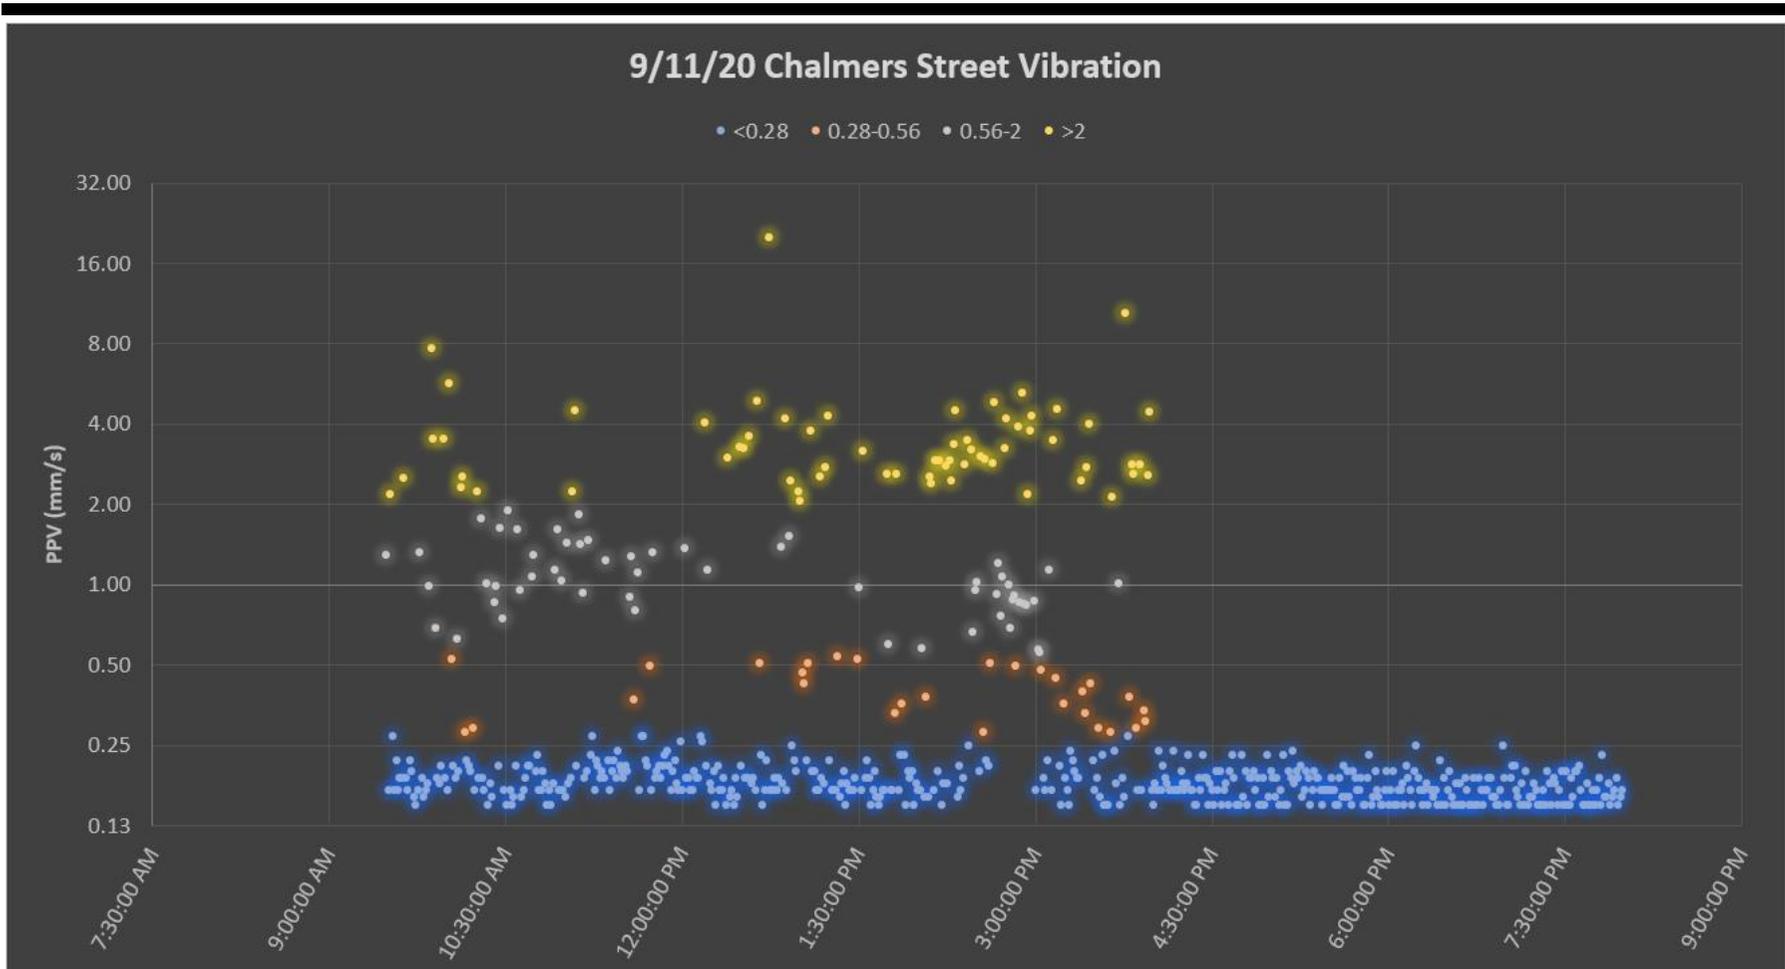
Figure C-4 9th November 2020

The main activity on site that resulted in elevated vibration levels was the localised scabbling work occurring in November 2020.

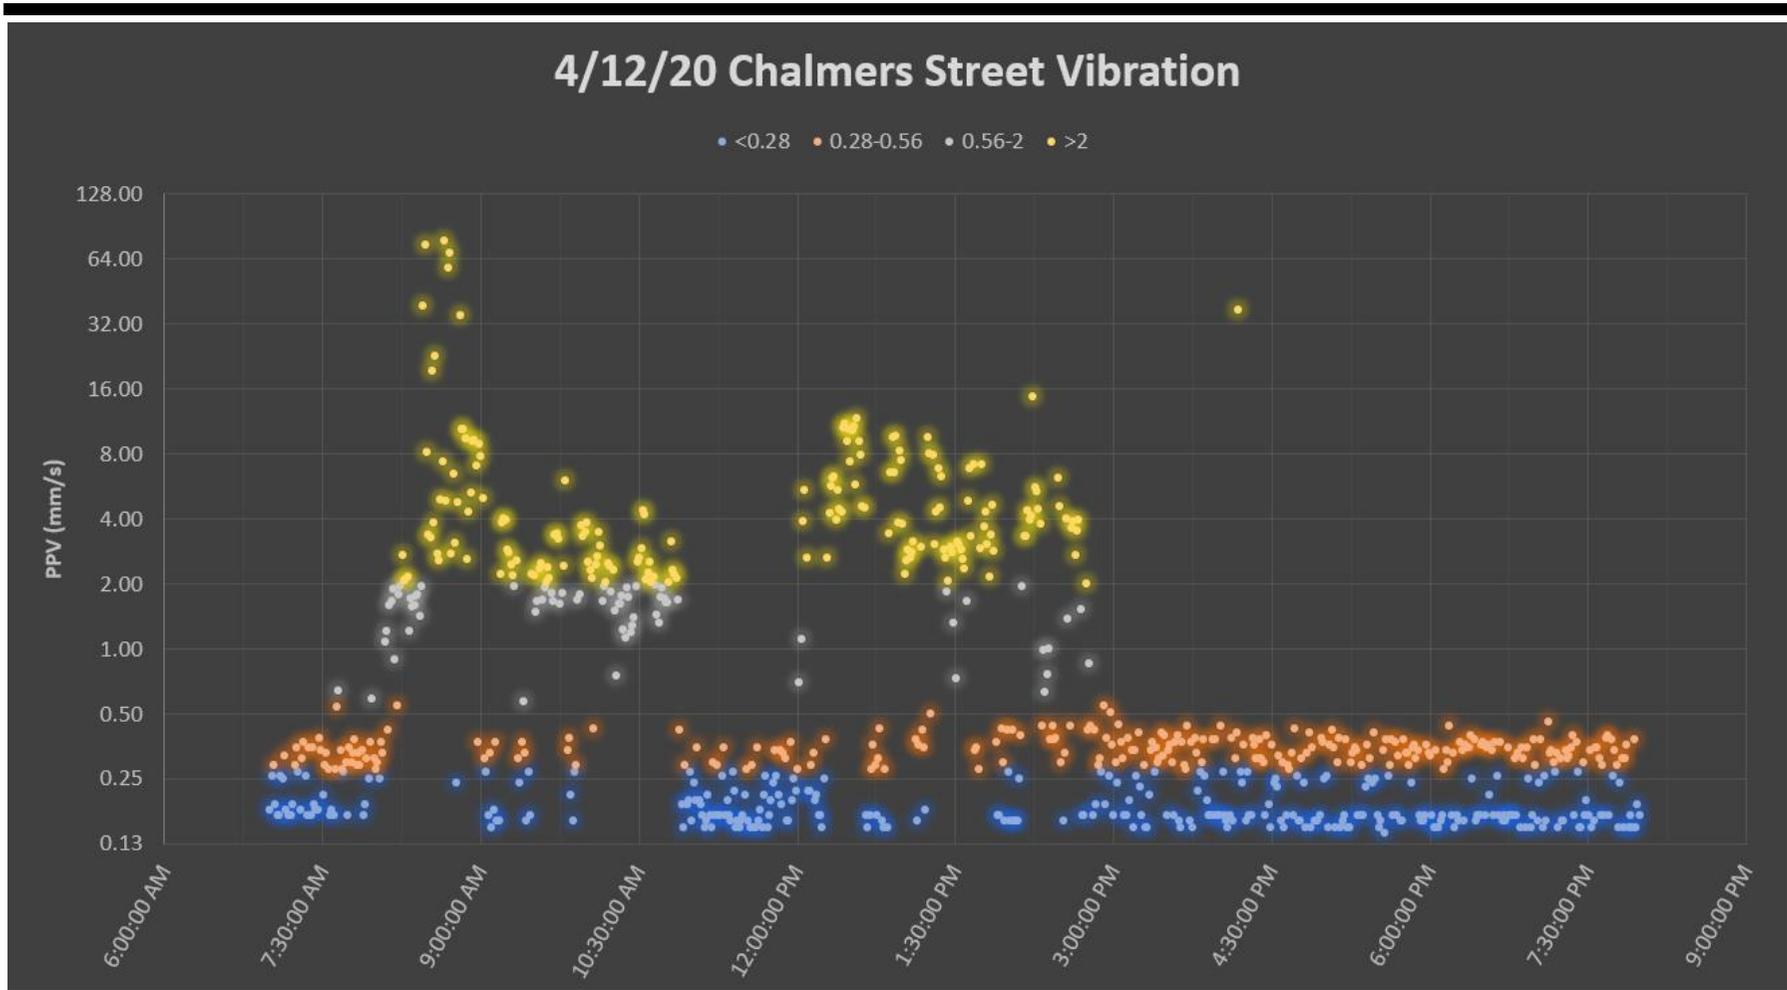
Figure C-5 4th December 2020

Main activity on site that resulted in elevated vibration levels was rock breaking and craneage into trucks occurring during December 2020.

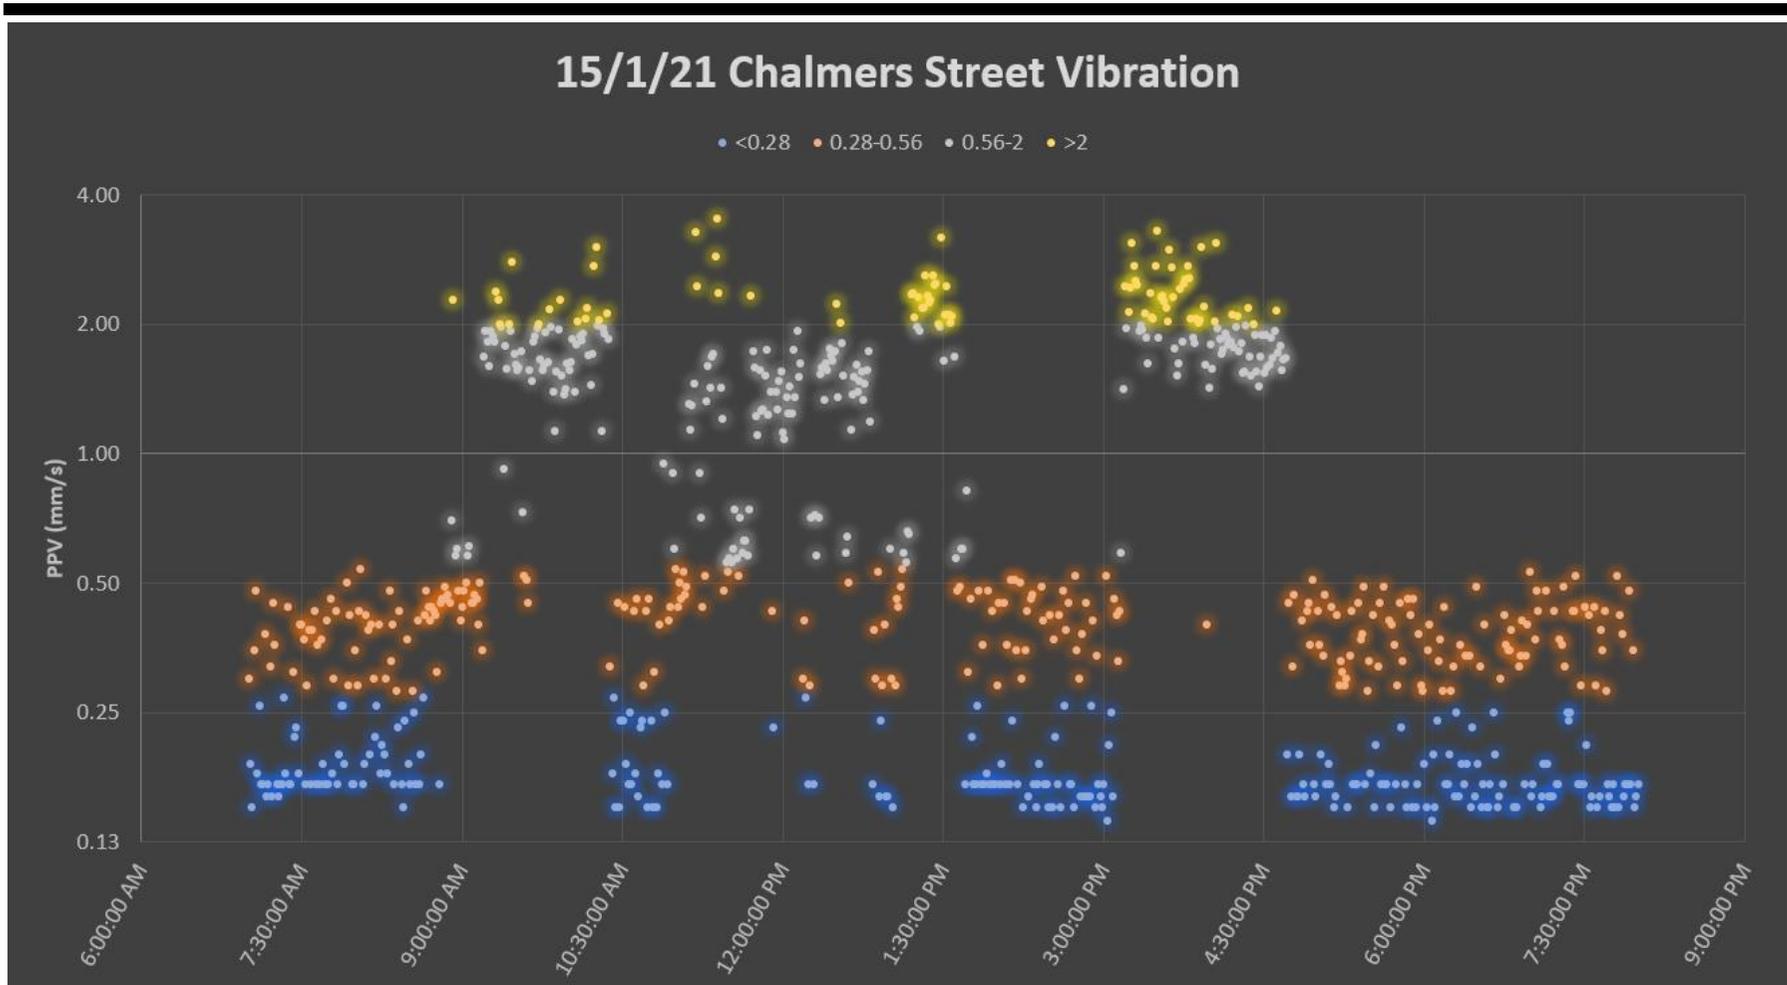
Figure C-6 15th January 2021

Main activity on site that resulted in elevated vibration levels was rock breaking and crange into materials occurring during January 2021.
