**GREATER PARRAMATTA AND OLYMPIC PENINSULA (GPOP)
WATER CYCLE MANAGEMENT PROJECT**

Aboriginal Cultural Heritage Assessment Report

Prepared for Sydney Water

October 2025

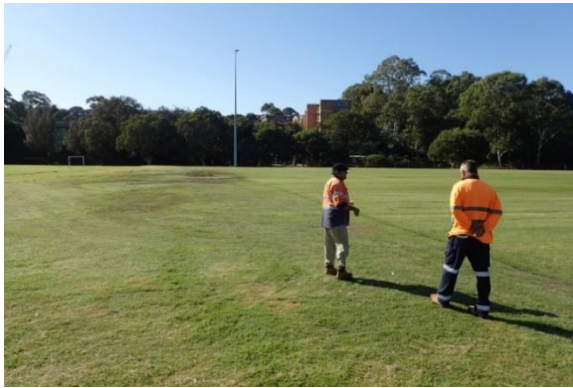
Plate 1. View to east. Meadowbank Park No.7. Open trench alignment runs across this levelled playing field to Charity Creek, now a cement lined drain.

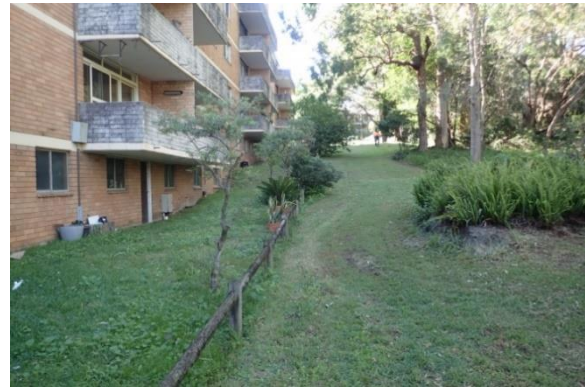
Plate 2. View to southeast at boundary of Memorial Park. Study area alignments runs upslope to Meadow Crescent, between Memorial Park (right) and a block of units, No.12 Meadow Crescent (left).

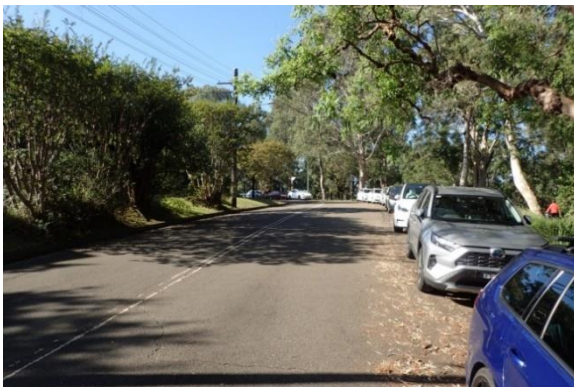
Plate 3. View to east. Meadow Crescent. This section would run in the road, towards Bank Street. At right is Memorial Park.

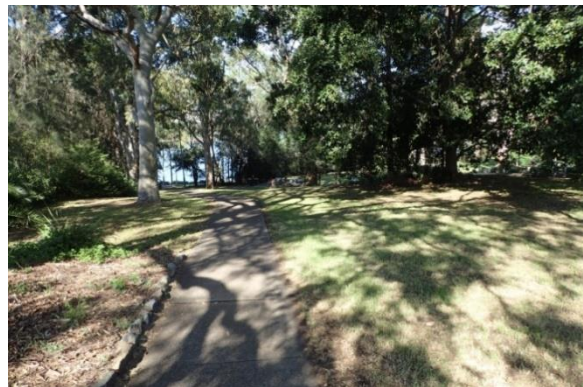
Plate 4. View to south at Memorial Park. The study area alignment proceeds into park, down moderate slopes to the northern foreshores of Parramatta River.

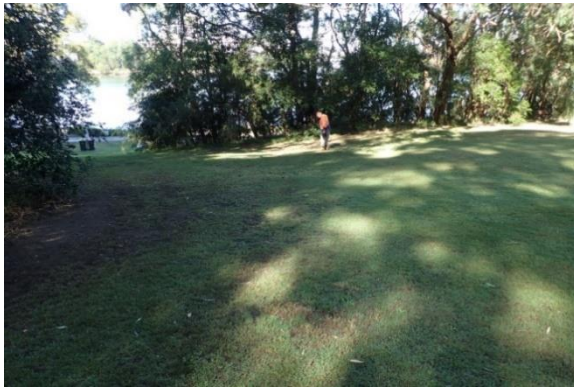
Plate 5. View to south at Memorial Park. Study area crosses moderate slopes leading down to the Parramatta River. Occasional patches of sandstone were inspected between grassed areas.

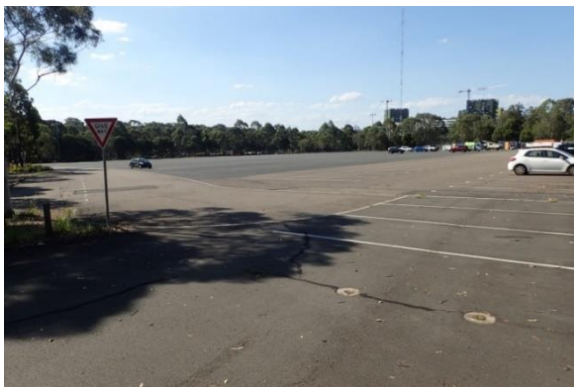
Plate 7. View to north. Photo shows disturbed URBNSURF carpark and proposed compound area.

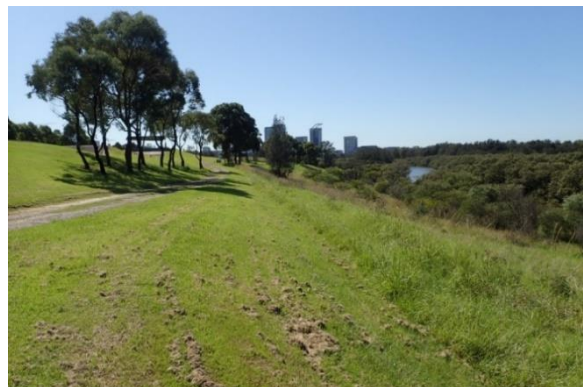
Plate 8. View to north-east. Grass covered slopes south of the Monster BMX complex (at left). At right run is the mangrove lined Haslams Creek.

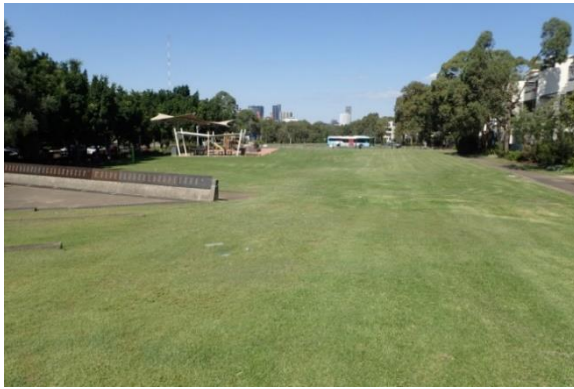
Plate 9. View to south-east at Pierre de Courbetin Park, Newington. Park area had been extensively landscaped.

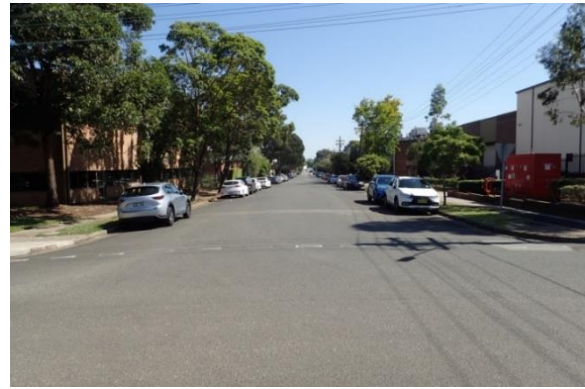
Plate 10. View to west of Derby Street from Day Street intersection. Photo shows typical disturbed conditions of study area alignment in Survey Unit 2.

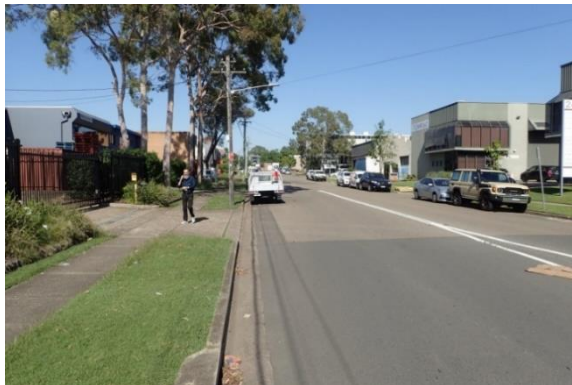
Plate 11. View to south-west at Vore Street. Photo shows typical disturbed conditions of study area alignment in Survey Unit 3.

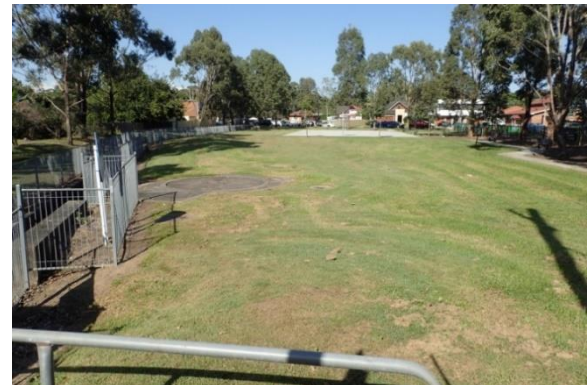
Plate 12. View to south-west at Hume Park. Park displayed disturbance from cement drains, buried sewer infrastructure, sealed paths and landscaping.

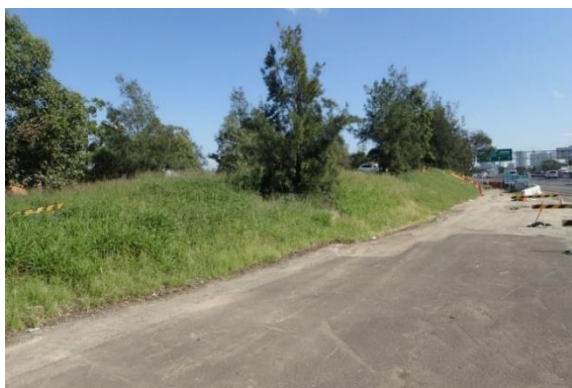
Plate 13. View to north-west. Proposed compound area adjacent to M4 Motorway. Area comprised disturbed mounded soil and appeared to already be in use as a compound area.

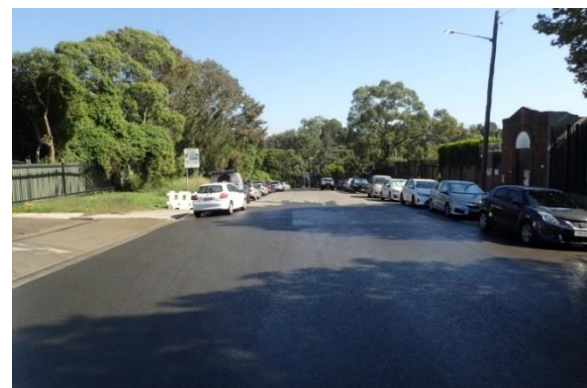
Plate 14. View to north-west at western end of Carnarvon Street. Photo shows typical disturbed conditions of study area alignment in Survey Unit 3.

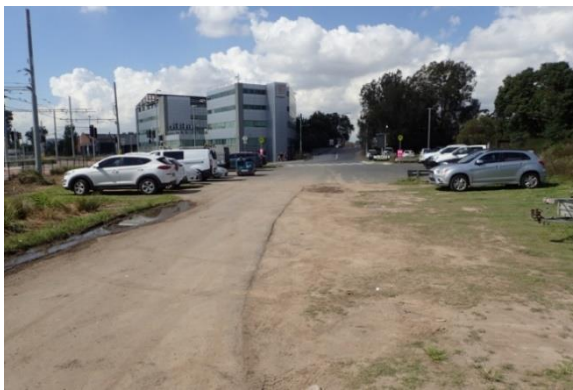
Plate 15. View to southeast. Photo shows proposed compound area at existing disturbed sealed carpark next to Grand Avenue North.

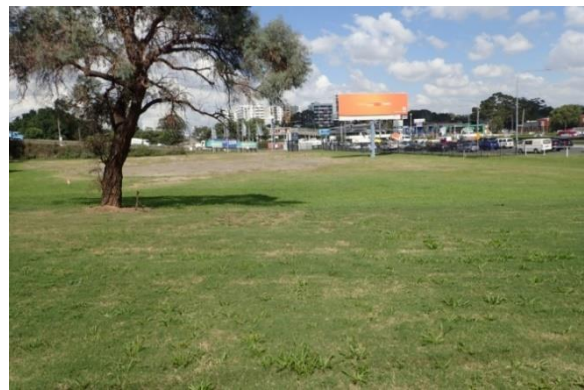
Plate 16. View to south. Proposed compound area and launch/retrieval site. Ground surface was levelled and disturbed.

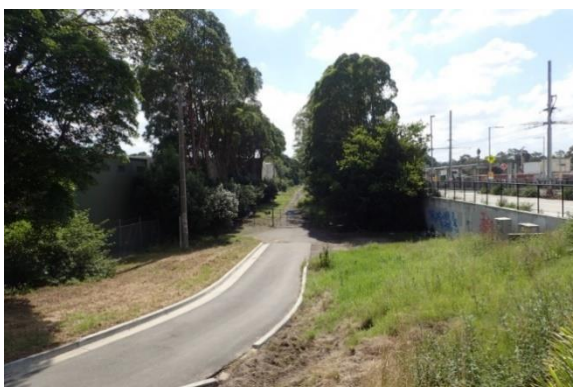
Plate 17. View to north. Photo shows existing bitumen road, running towards Parramatta River and study area alignment. Light Rail at right of photo.

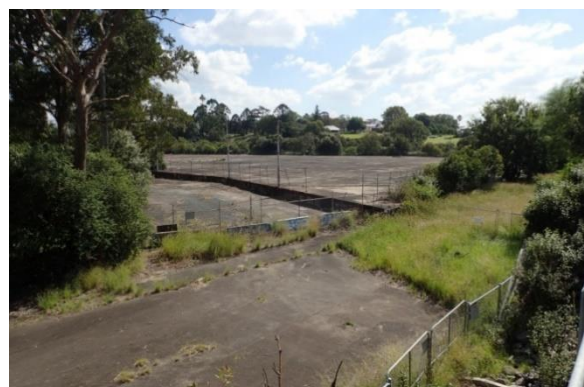
Plate 18. View to north-west. Proposed compound area. This level and sealed block is on the south bank of the Parramatta River.

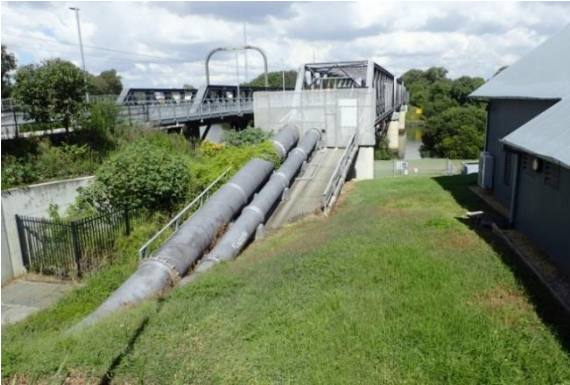
Plate 19. View to south-west. Parramatta campus of Western Sydney University. Existing water pipelines on northern side of the Parramatta River. Highly disturbed ground.

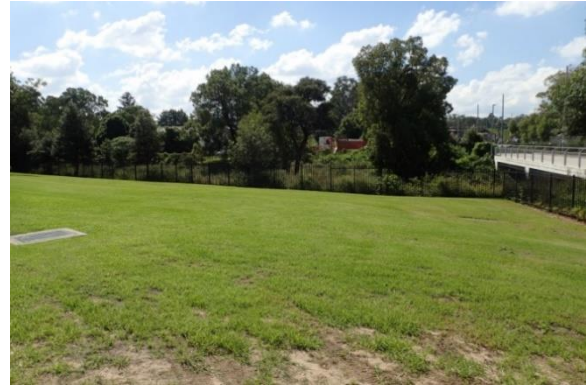
Plate 20. View to north-east. Parramatta campus of Western Sydney University. Proposed compound, from bend in Railway Street. Looking down to modified Vineyard Creek at treeline. At right is Parramatta Light Rail. In foreground are existing sewer and stormwater.

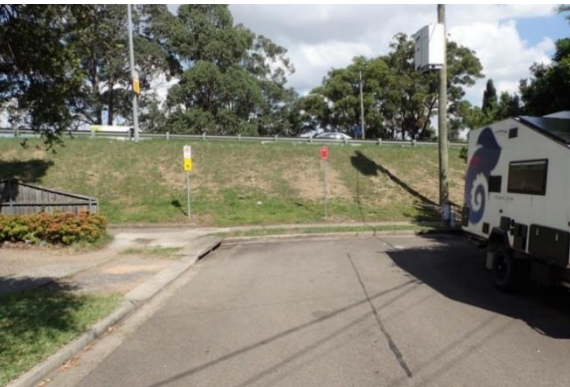
Plate 21. View to south. Southern end of Rippon Avenue. Proposed compound is located on this steep embankment next to Victoria Road.

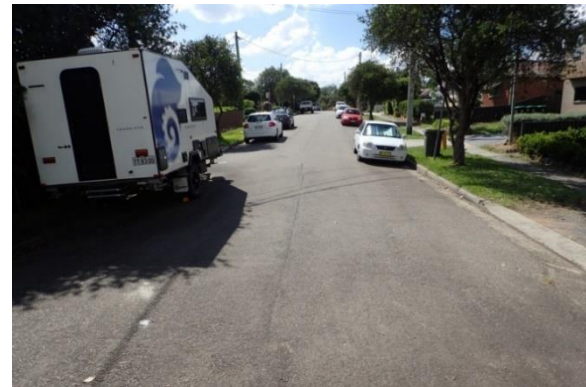
Plate 22. View to north-east along Rippon Avenue. Study area alignment runs in the road to Kissing Point Road.

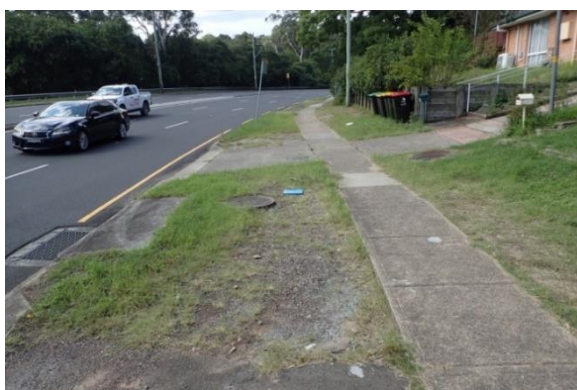
Plate 23. View to north-east on south side of Kissing Point Road. Natural silcrete fragments were identified on this patch of gravel covered ground, between two driveways.

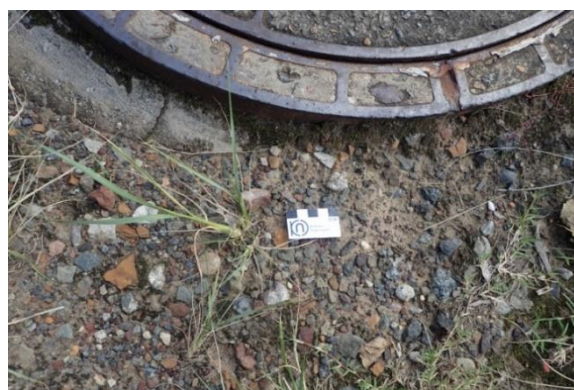
Plate 24. View to north. Dundas. Fragments of silcrete amongst road base gravels next to sewer access point.
