INLAND RAIL – NARRABRI TO NORTH STAR – SSI 7474

ER MONTHLY REPORT

DECEMBER | 2021

ENVIRONMENTAL REPRESENTATIVE'S INSPECTION REPORT

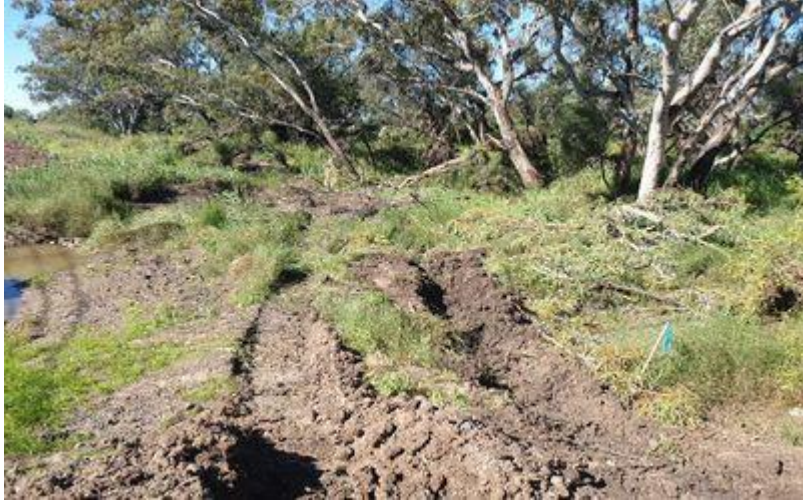
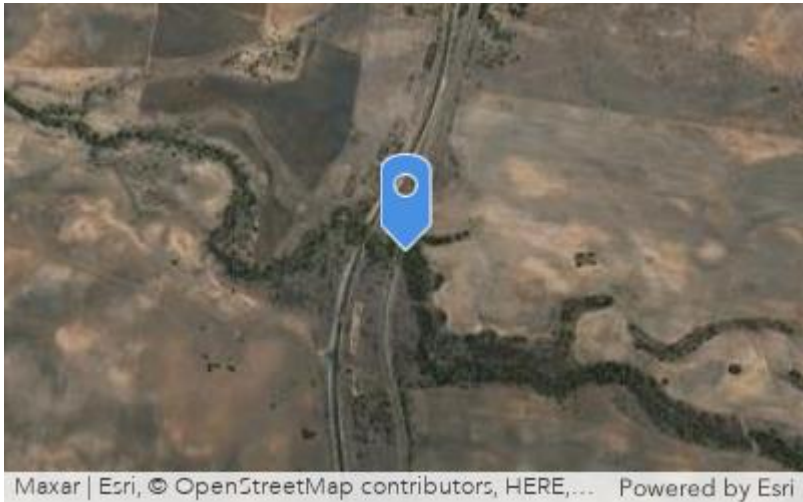
Ref	Photo / Location	Finding	Priority	Status
<p>20211020-157</p> <p>Lon:149.806</p> <p>Lat:-29.684</p> <p>Gurley Creek</p>

<p>Maxar Esri, © OpenStreetMap contributors, HERE, ... Powered by Esri</p>	<p>Excavator has tracked onto creek bed during vegetation removal associated with creation of sight lines for nearby level crossing.</p> <p>Work is to cease until alternative methods (eg chainsaw) or bog matting or similar utilized to reduce impact on creek bed and underlying Telstra Cable</p>	<p>High</p>	<p>Sight line clearing work has been ceased until 2022.</p> <p>Status of rehabilitation of damage to be advised</p> <p>To be reviewed at 15/12 ER inspection</p>

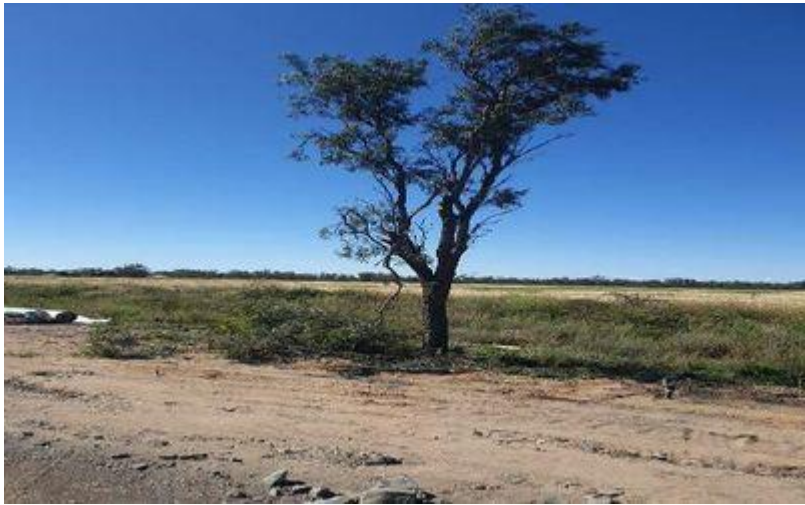
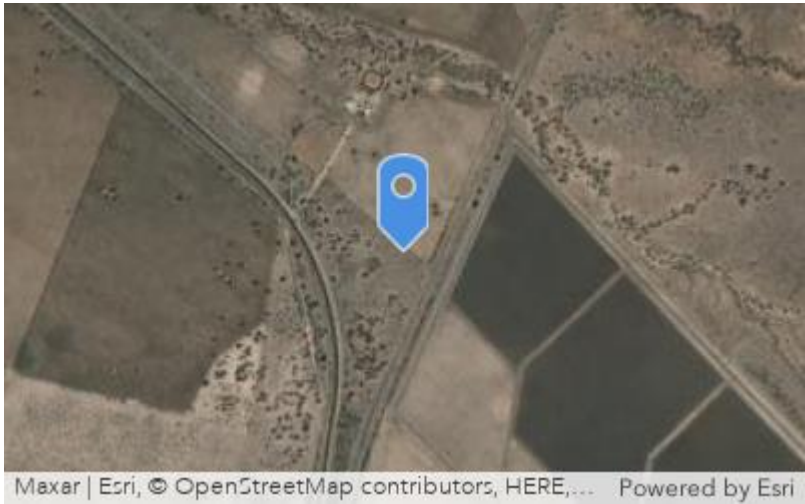
20211020-152

Damaged tree

No Go signage to be relocated to provide tree with greater buffer zone to better ensure its protection

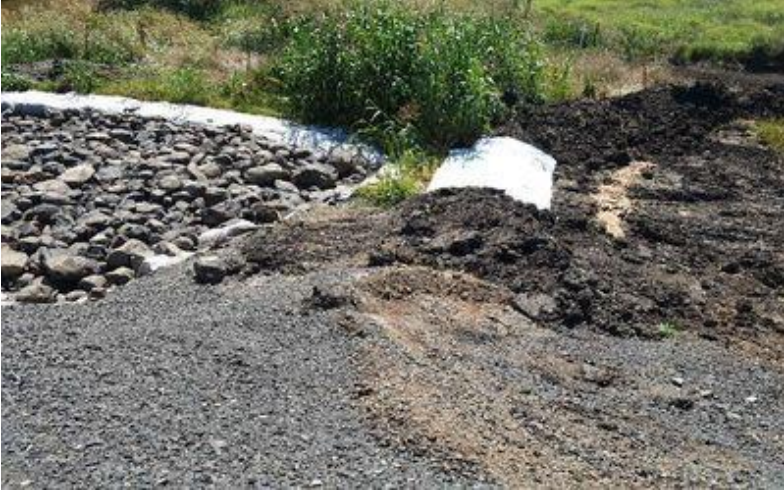
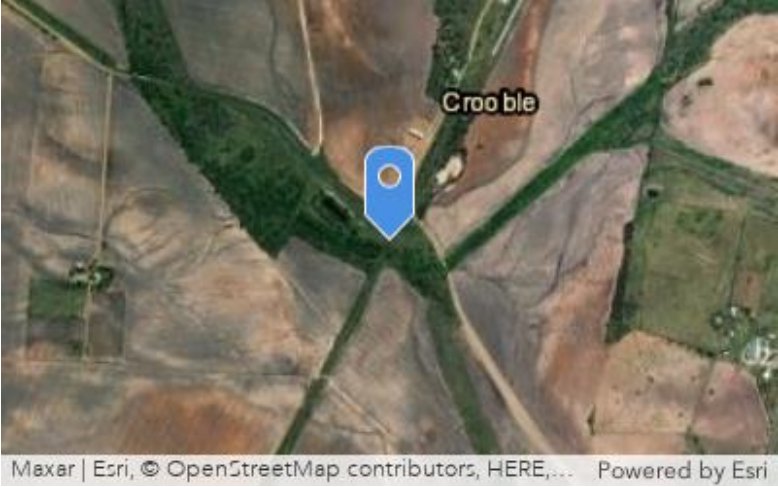
Ref	Photo / Location	Finding	Priority	Status
INLAND RAIL PROJECT – NARRABRI TO NORTH STAR				heritage
<p>20211215-185</p> <p>Lon:150.252</p> <p>Lat:-29.271</p> <p>Gil Gil Creek</p>

<p>Maxar Esri, © OpenStreetMap contributors, HERE, ... Powered by Esri</p>	<p>Geofabric lined earth bund overflow point with gypsum placed on upstream toe of chute</p>

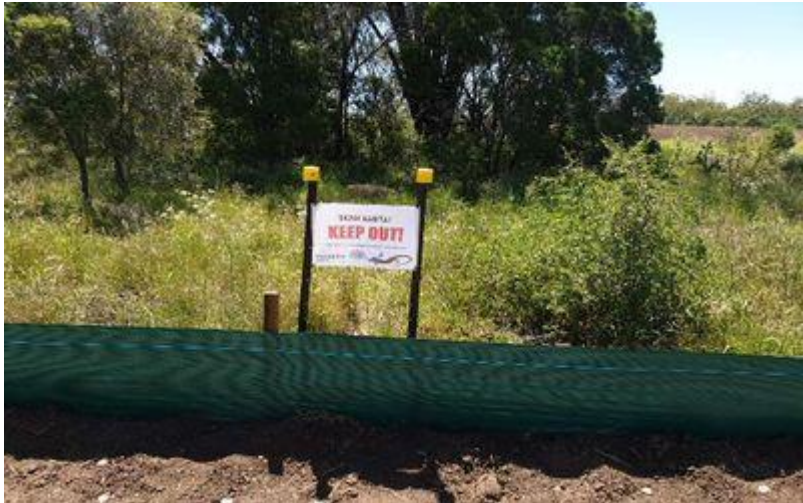
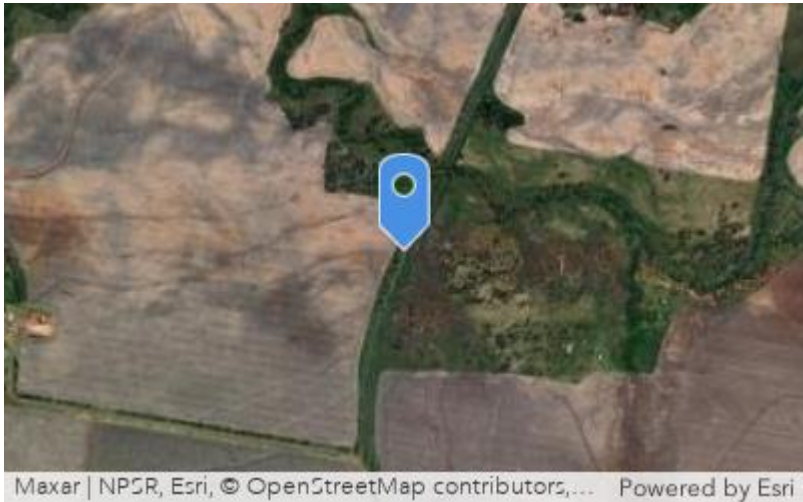
20211215-184
Lon:150.308
Lat:-29.068
Yallaro

Five Clawed Worm Skink refuge
area with signage and silt fence
separating refuge area from work
site

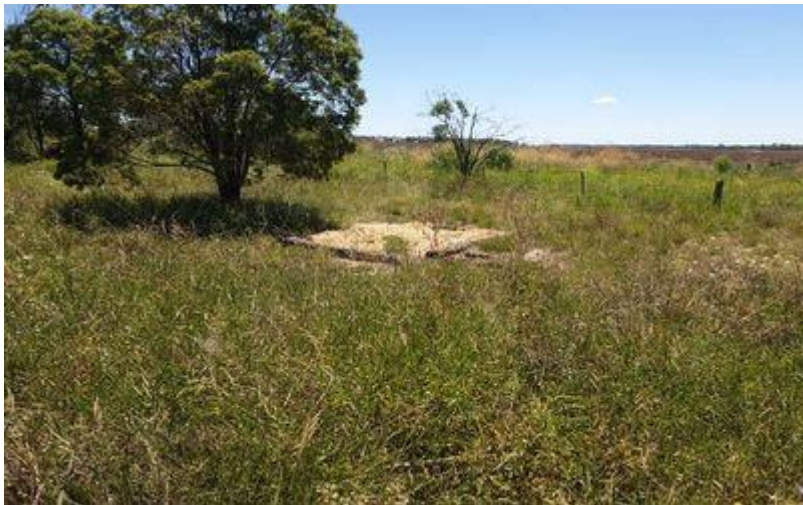
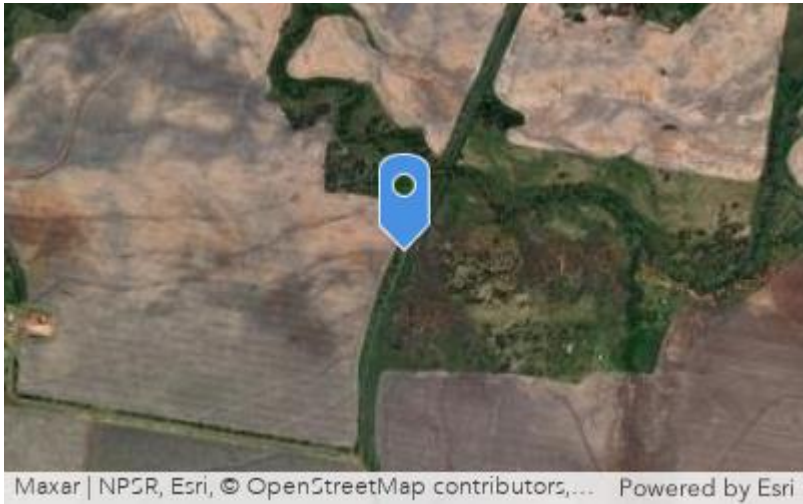
Yallaroi

Skink 'hotel' constructed within
refuge area

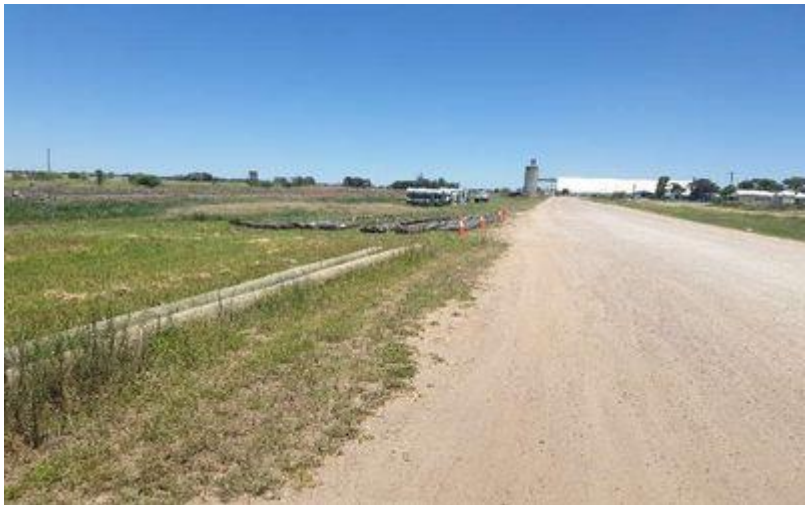
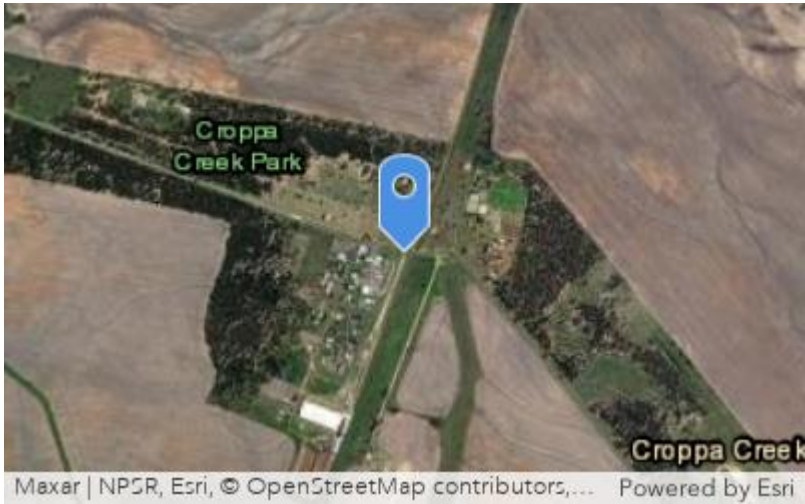
Construction materials laid down adjacent to access road near Croppa Creek Level Crossing need to be relocated to an approved laydown area to avoid this area being classified as a MAF and requiring ER approval

Observation

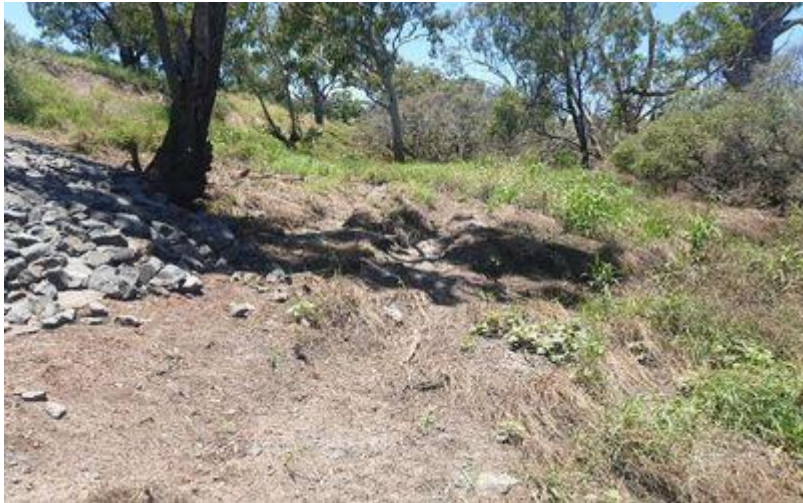
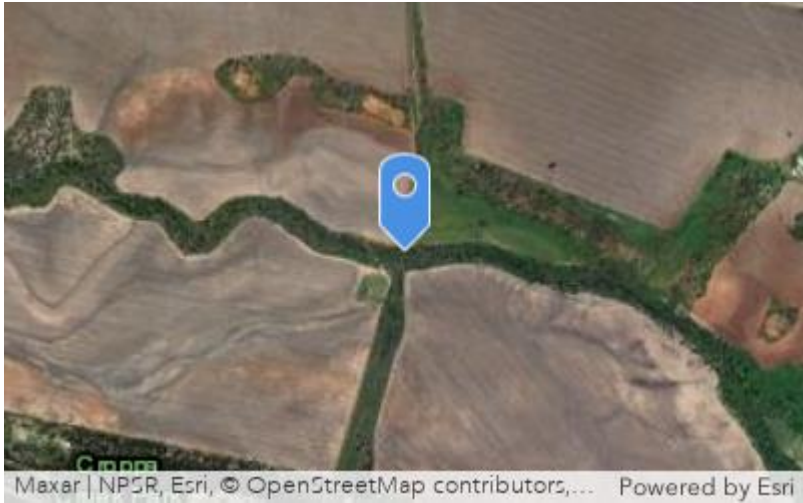
Croppa Creek

Access track used to place boulder rock on north embankment needs to be hydromulched or seeded to better stabilize this area

Low

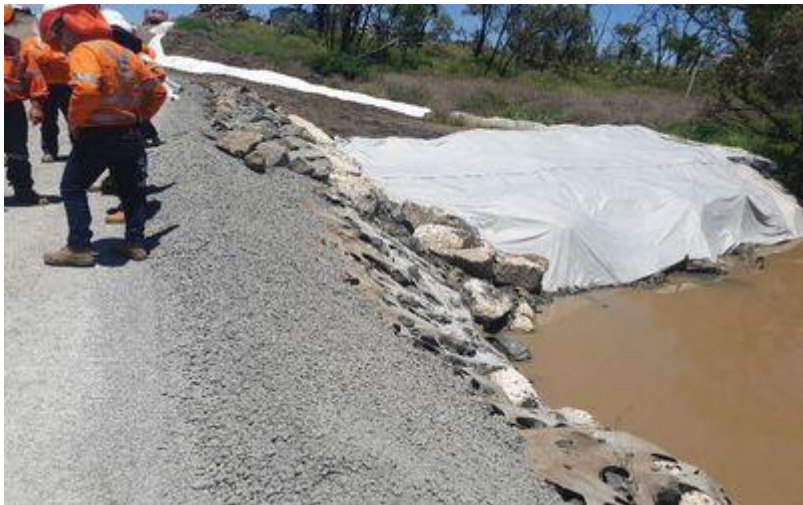
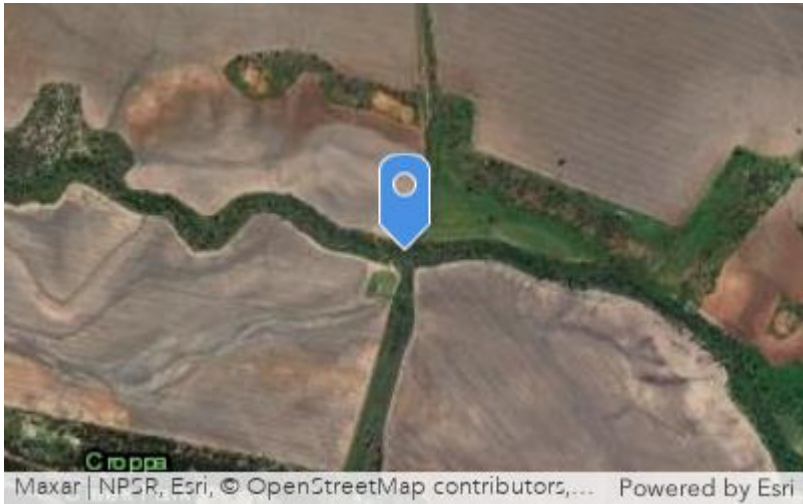
Croppa Creek

Loose ballast on downstream face
of piling pad needs to be wrapped
in geofabric prior to Christmas
closedown

Low

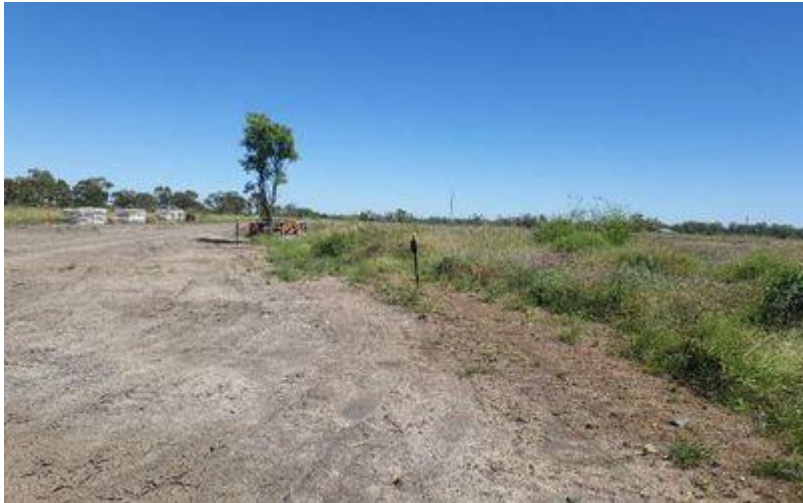
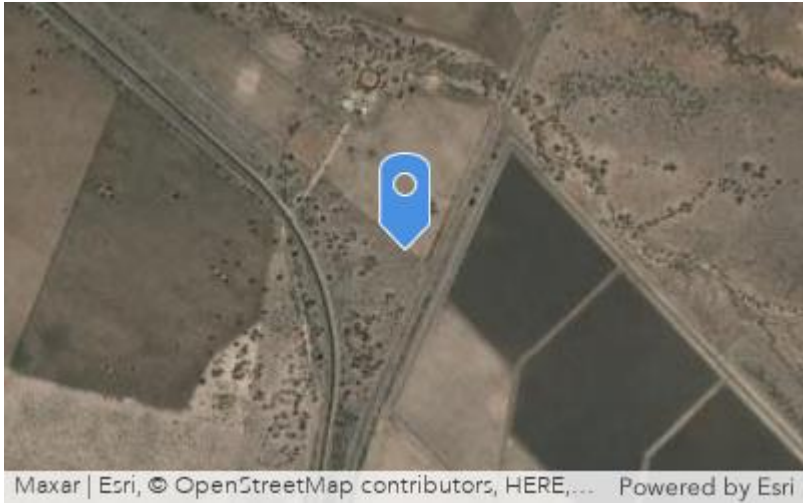
Mardell

Telstra rope being used to demarcate No Go Zone.

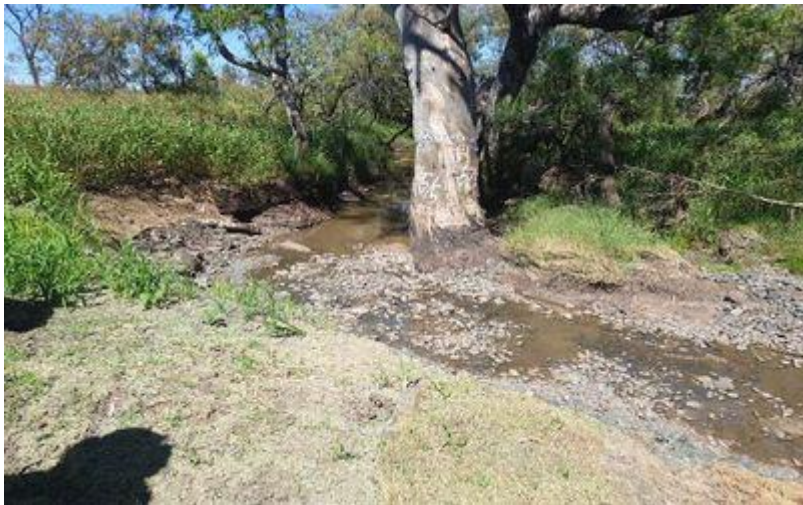
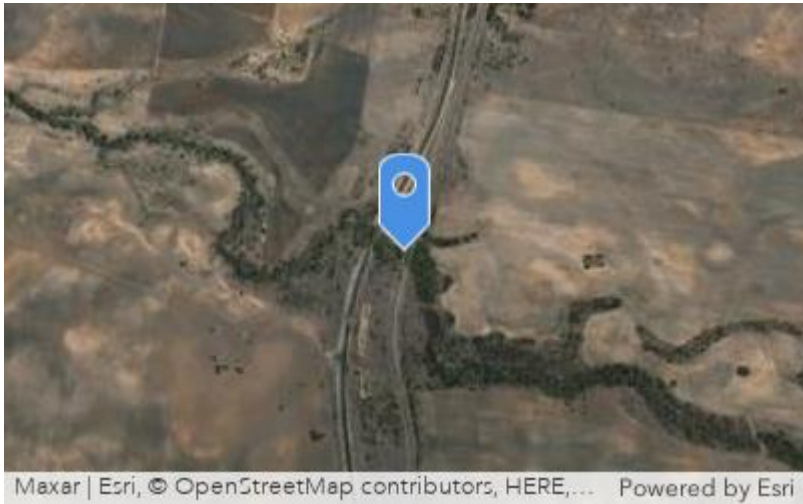
Rehabilitation work at Gurley Creek is progressing well. Ballast material has been removed from Creek without damaging surrounding riparian area to any significant extent.

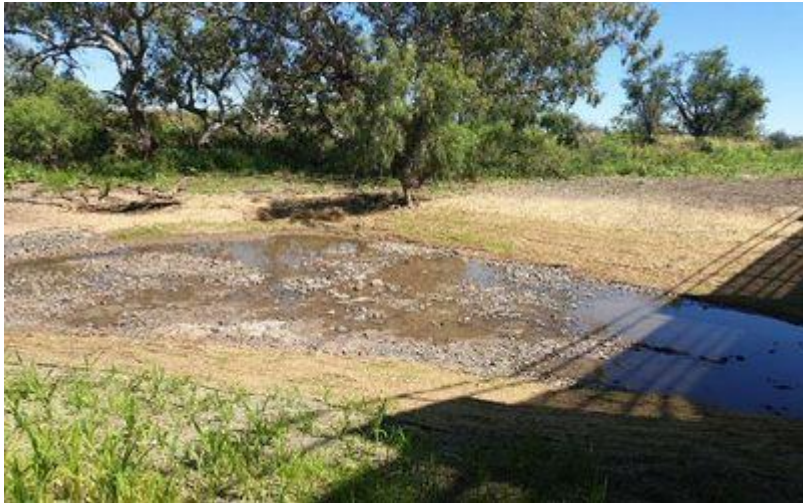
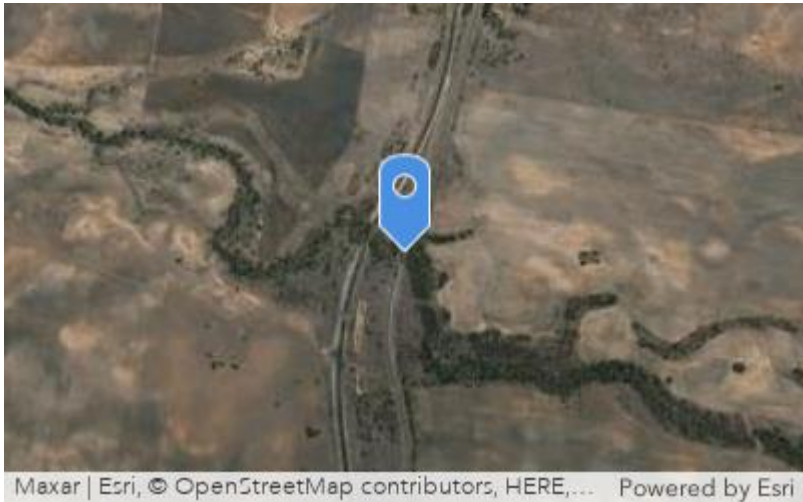
Rehabilitation work on banks of Gurley Creek underneath rail bridge progressing well

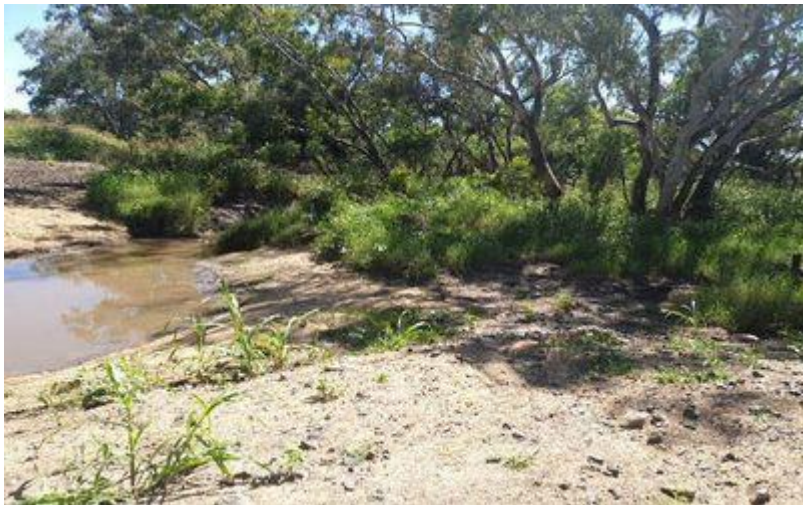
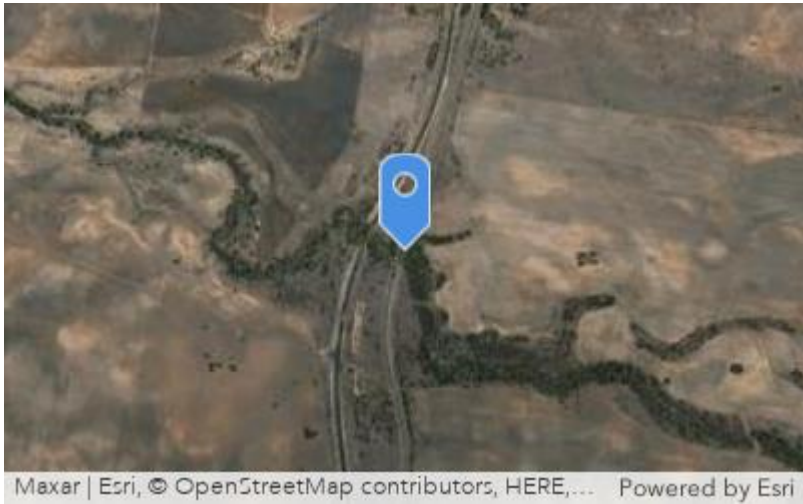
Gurley Creek

Area impacted by excavator in October has been rehabilitated and shows no signs of any long lasting damage.

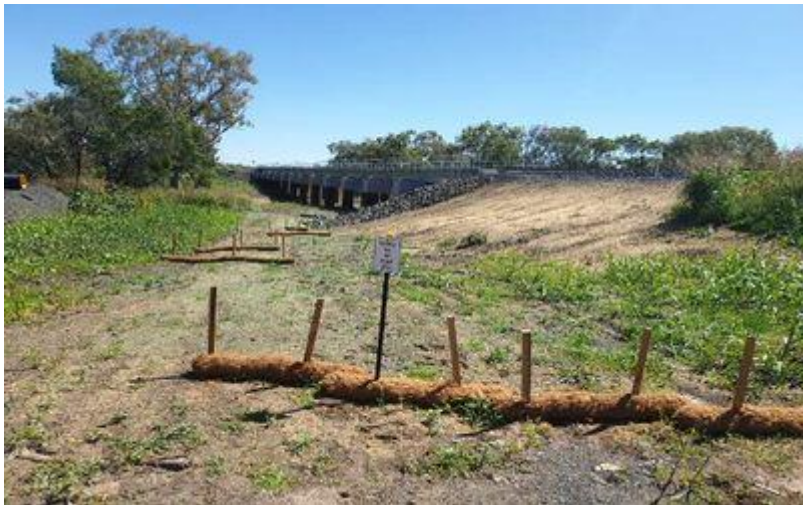
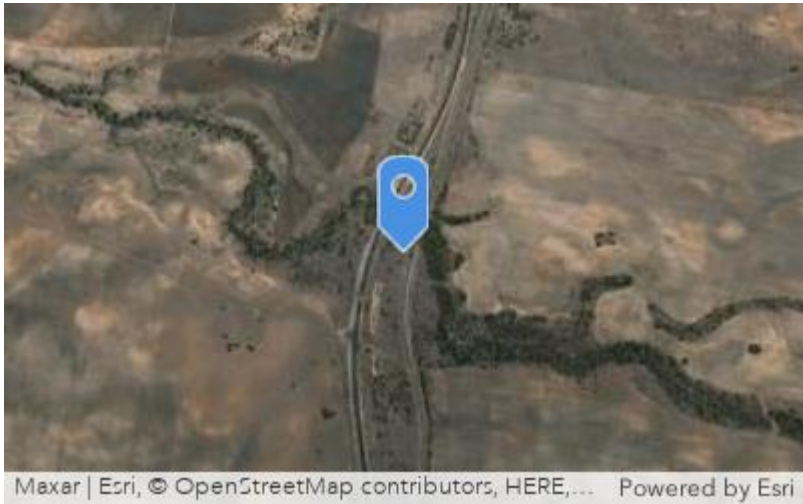
Gurley Creek

Sediment and erosion controls and revegetation on south side rail bridge well advanced prior to Christmas closedown.

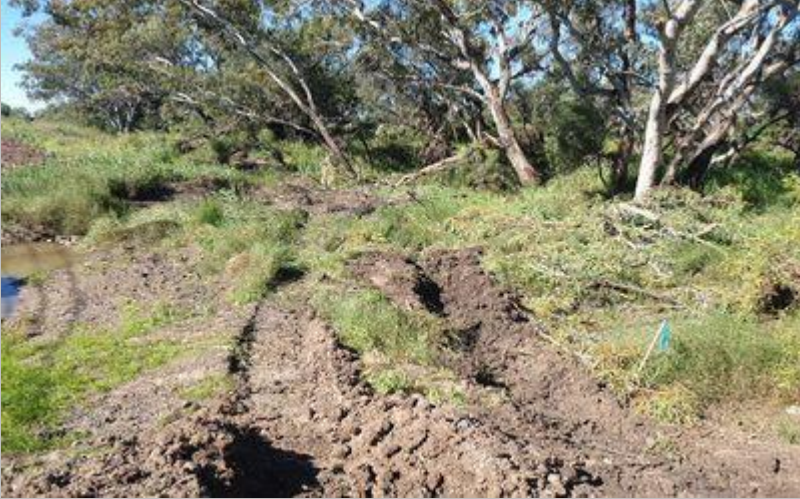
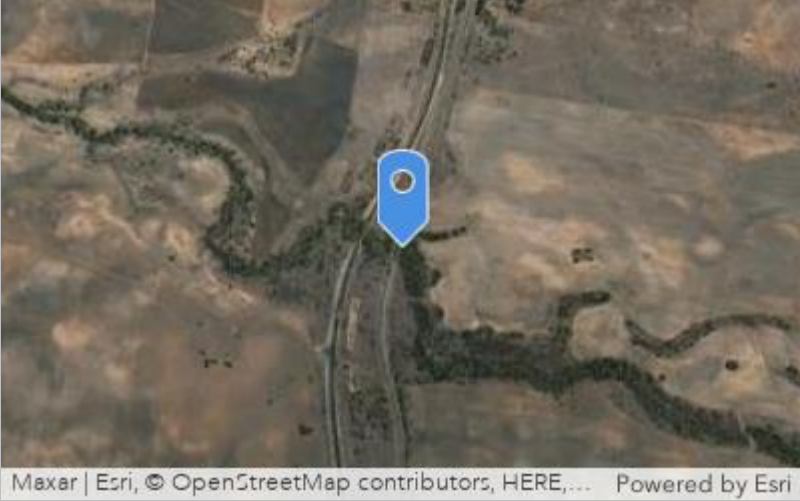
Ref	Photo / Location	Finding	Priority	Status
<p>20211020-157</p> <p>Lon:149.806</p> <p>Lat:-29.684</p> <p>Gurley Creek</p>

<p>Excavator has tracked onto creek bed during vegetation removal associated with creation of sight lines for nearby level crossing.</p> <p>Work is to cease until alternative methods (eg chainsaw) or bog matting or similar utilized to reduce impact on creek bed and underlying Telstra Cable</p>	<p>High</p>	<p>CLOSED</p> <p>Sight line clearing work has been ceased until 2022.</p> <p>Status of rehabilitation of damage to be advised</p> <p>To be reviewed at 15/12 ER inspection</p> <p>15/12: Area has been rehabilitated and no signs of long lasting damage were noted</p>

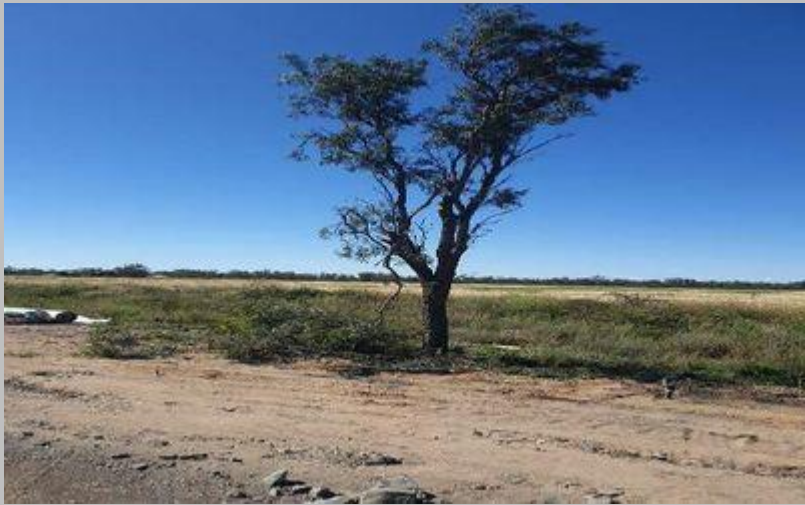
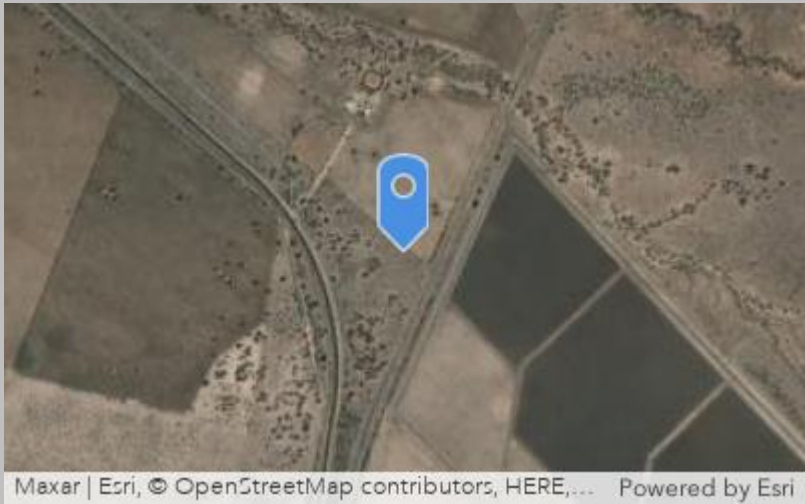
20211020-152

Damaged tree

No Go signage to be relocated to provide tree with greater buffer zone to better ensure its protection
