# INLAND RAIL – NARRABRI TO NORTH STAR – SSI 7474

ER MONTHLY REPORT

FEBRUARY | 2022

**Report Name:** Inland Rail N2NS – SSI 7474 – ER Monthly Report – February 2022

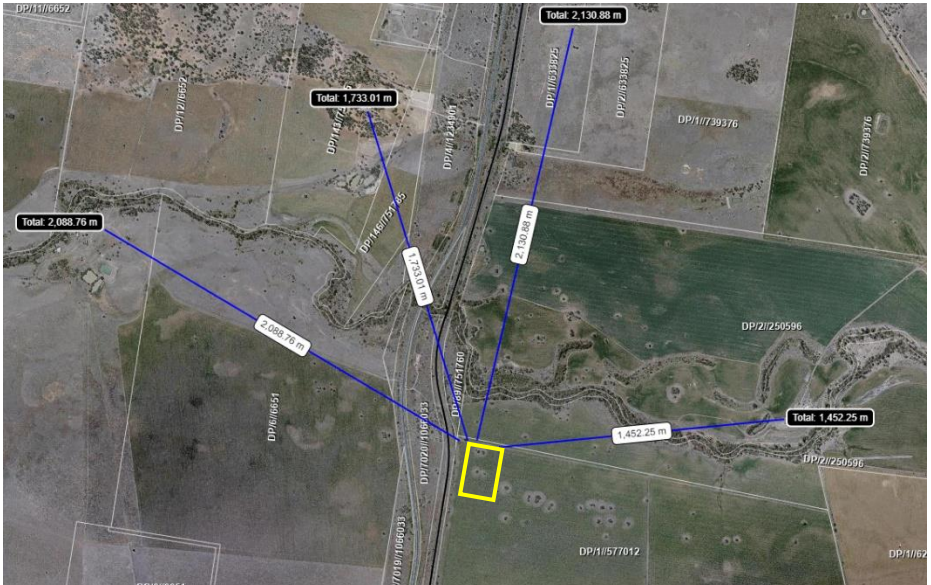
| Criteria | Compliant<br>(Y) Yes<br>(N) No | Comments |
|--|---|--|
| Compliance with the Interim Construction Noise Guideline (CoA A21(b)(i)) | Y | <p>Four sensitive (residential) receivers have been identified within 2.5km of the proposed MAF (Stage 2 / Site 2) site. These have been identified to be:</p> <ul style="list-style-type: none"> <li>▪ 1.4km to the east</li> <li>▪ 1.7km to the north</li> <li>▪ 2.1km to the west</li> <li>▪ 2.1km to the north</li> </ul> <p>The locations of these receivers are shown in the image below:</p> |

| Criteria | Compliant<br>(Y) Yes<br>(N) No | Comments |
|---|---|--|
| | | <p>Prior to site establishment works commencing, all potentially impacted landholders will be consulted regarding potential noise impacts associated with the construction and operation of MAF (Stage 2 / Site 2).</p> <p>The noise impacts to these sensitive receivers will be managed using the mitigation measures detailed in Section 2 of this document.</p> |

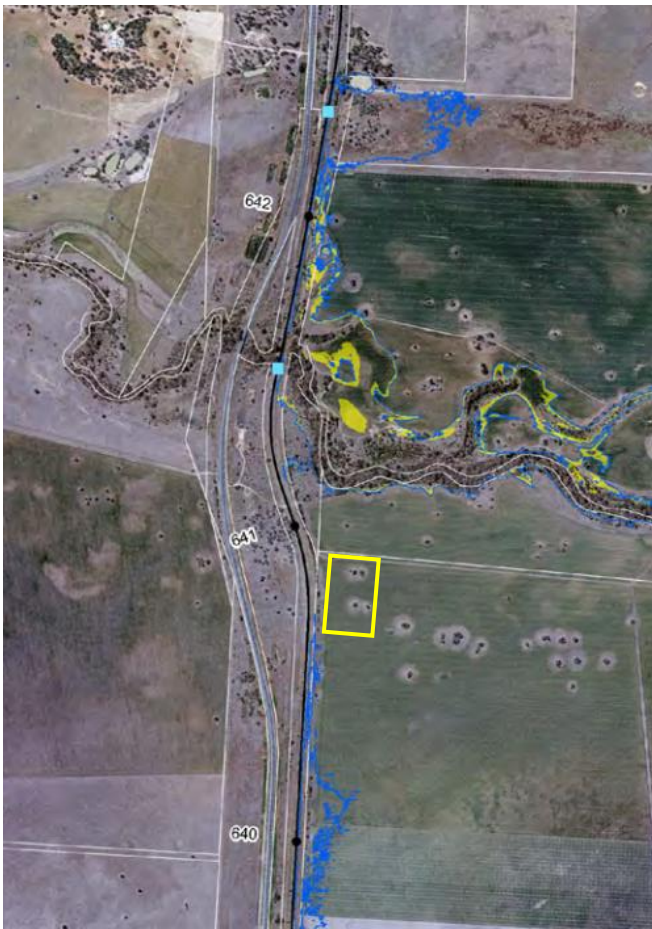
| Criteria | Compliant<br>(Y) Yes<br>(N) No | Comments |
|---|---|--|
| At least 50m from watercourses and outside the 5% AEP flood zone (CoA A21(b)(ii)) | Y | <p>The proposed MAF (Stage 2 / Site 2) site gently falls to the north to Gurley Creek, approx. 200m away.</p> <p>The proposed MAF (Stage 2 / Site 2) site is outside the area impacted by the existing 1% AEP local (blue highlighted in below image) and / or regional flood extent (not shown in image below).</p> <p>NOTE:<br/>Yellow – Reduction in local flood extent.<br/>Blue - Existing 1% AEP local flood extent</p> <p>The anticipated (modelled) increase in the local and / or regional flood extent does not impact the proposed MAF (Stage 2 / Site 2) site.</p> |

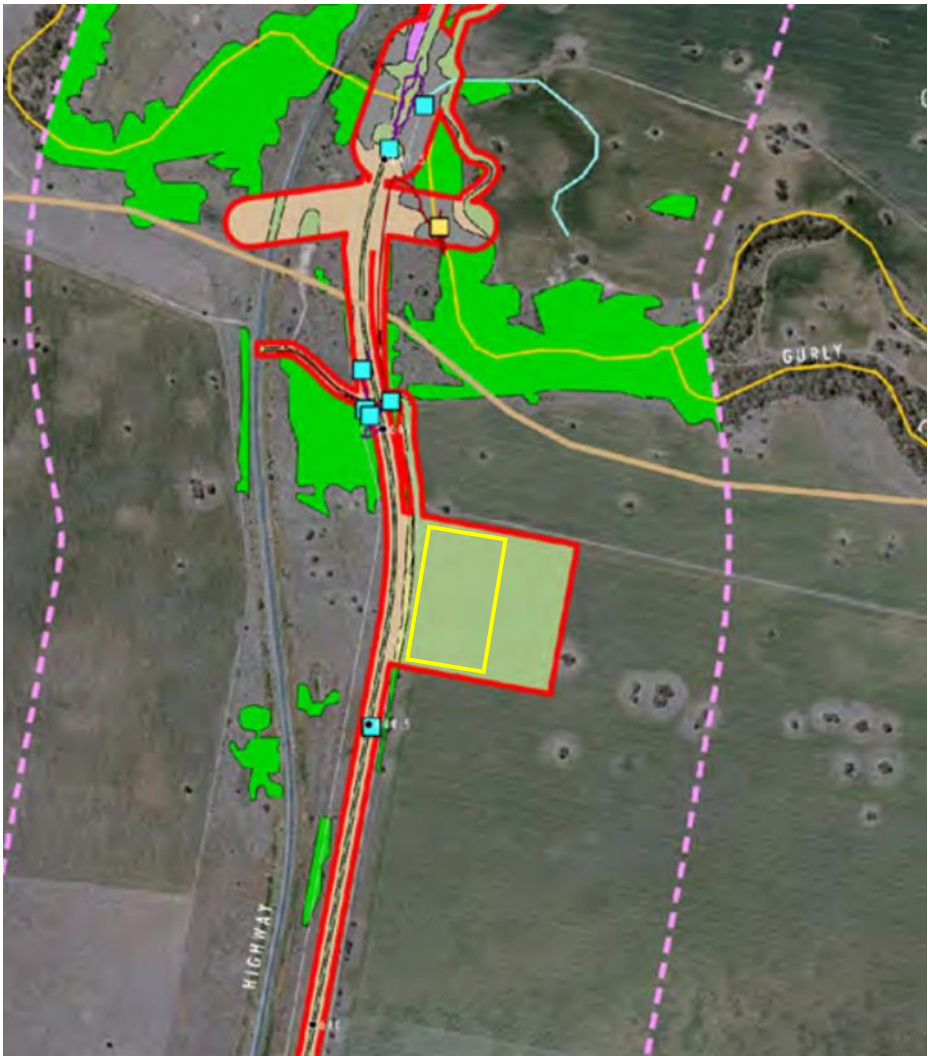
| Criteria | Compliant<br>(Y) Yes<br>(N) No | Comments |
|---|---|--|
| Not within areas identified as threatened communities or species habitats (CoA A21(b)(iii)) | Y | <p>The site of the proposed MAF (Stage 2 / Site 2) is cleared and previously utilised for extensive agriculture. No Plant Community Type/s, Threatened Ecological Community/s, threatened flora, threatened fauna or suitable habitat were mapped or recorded within the area directly impacted by the proposed MAF during the Biodiversity Assessment undertaken for the Project EIS.</p> <p>The closest mapped native vegetation (yellow polygon in below image) is immediately (&lt;20m) to the west of the proposed MAF (Stage 2 / Site 2) site.</p> |

| Criteria | Compliant<br>(Y) Yes<br>(N) No | Comments |
|--|---|---|
| | | <p>This mapped vegetation is outside the development footprint and will not be impacted by the establishment and operation of the MAF.</p> <p>NOTE:</p> <p>Pale Green - Cleared / Non-native Vegetation.</p> <p>Bright Green – Mapped vegetation (BVT / PCT Unknown)</p> <p>Yellow – Zone 1 – PCT-27 BVT-BR233, NA219-Weeping Myall open woodland of the Darling Riverine Plains Bioregion and Brigalow Belt South Bioregion</p> <p>Pale Brown / Beige – Zone 4 – PCT-52 BVT-BR191, NA187 – Queensland Bluegrass +/- Mitchell Grass grassland on cracking clay floodplains and alluvial plains mainly the northern-eastern Darling Riverine Plains Bioregion – Native Grassland</p> |

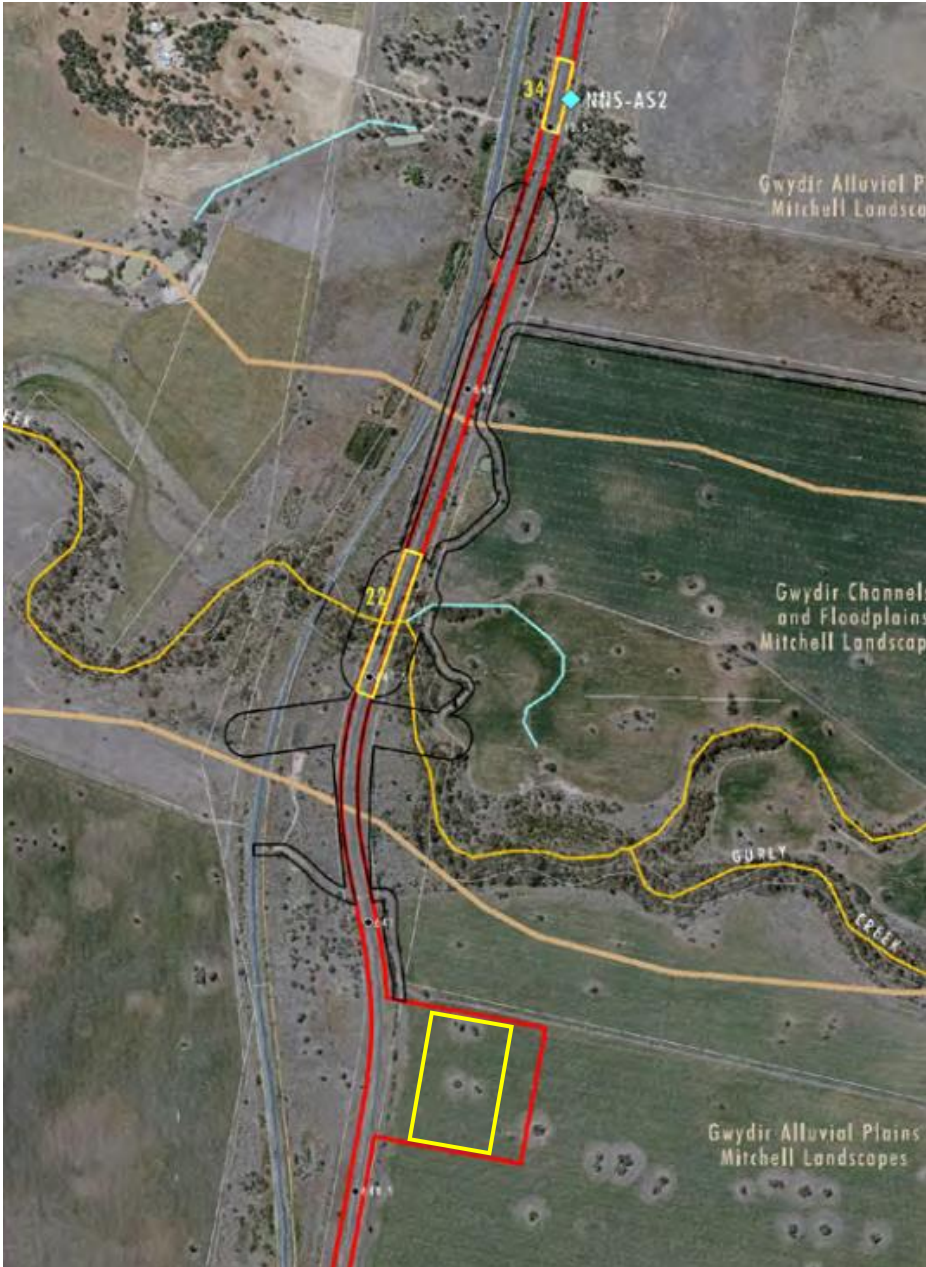
| Criteria | Compliant<br>(Y) Yes<br>(N) No | Comments |
|---|---|---|
| heritage (CoA A21(b)(iii)) | | <p>The closest item or area of heritage significance is an Artifact Scatter located &gt;1.6km to the north (NNS-AS2). This will not be impacted by the establishment of operation of the MAF (Stage 2 / Site 2).</p> |

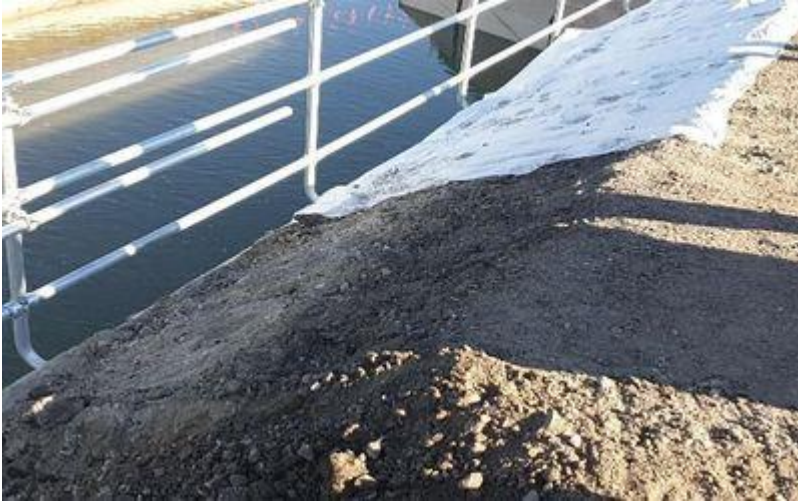
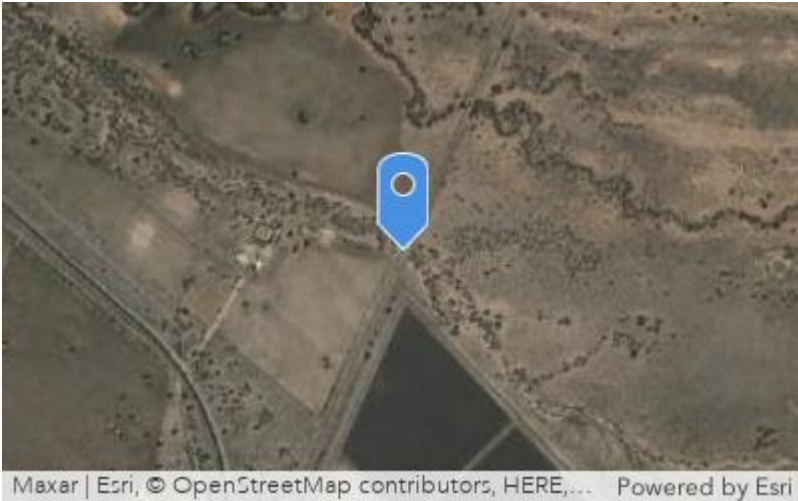
| Ref | Photo / Location | Finding | Priority | Status (including close out evidence) |
|--|---|---|---|--|
| <b>INLAND RAIL PROJECT – NARRABRI TO NORTH STAR</b><br><br><b>20210908-119</b><br><br>Lon:149.819<br><br>Lat:-29.636<br><br>Tycannah Creek | <br><br> | <br><br>Geofabric covering embankment batter to prevent material washing over edge of bridge prior to being cut back to final shape<br><br><i>Finding: Design process to be reviewed to understand how constructability factored in (or not) &amp; any lessons learned arising</i> | <div>Low</div> | <br><b>PROGRESSING</b><br><br>Batter slope cut back from edge (MR to send photos).<br><br>12 & 19/9 Engineers and Site Supervisors and Superintendents meetings the risk of personal \$15K fines for individuals who polluted waters or otherwise breached EPL and CoA conditions was outlined.<br><br>6/10: Meeting with IR DJV representatives scheduled for week of 11/10 to discuss<br><br>20/10: Meeting with IR DJV to be scheduled for week of 25/10 to discuss<br><br>17/11: Further information has been provided to ER by IR DJV for consideration<br><br>1/11: ER provided response to IRDJV email of 3 November concerning fish passage requirements at Tycannah Creek on 26/11. JB to meet |

| Ref | Photo / Location | Finding | Priority | Status (including close out evidence) |
|---|---|---|---|--|
| | | | | <p>with Matt Ross to further discuss and provide response</p> <p>15/12: Meeting between Justin Bate, Grant Brown &amp; IRDJV to take place on 16/12 to discuss issue and provide feedback to ER</p> <p>25/1: ARTC to provide update at 9/2 ER inspection</p> <p>9/2: Wing walls on upstream and downstream top edges of culvert being redesigned to better contain rail embankment material. It is planed to retrofit these during the next Stage 2 possession</p> |

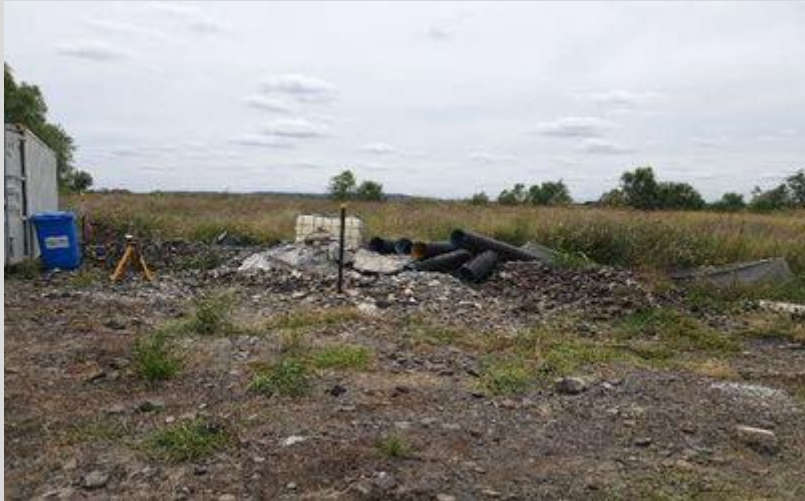
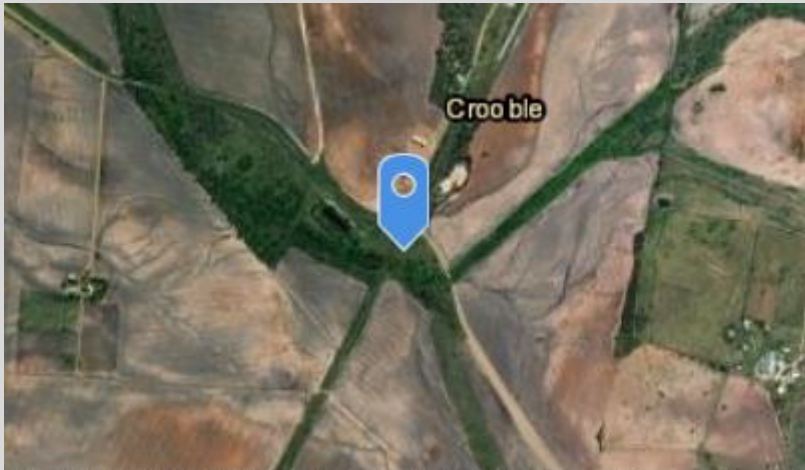
| Ref | Photo / Location | Finding | Priority | Status (including close out evidence) |
|---|---|---|---|--|
| <p><b>20220125-195</b></p> <p>Lon:150.252</p> <p>Lat:-29.271</p> <p>Gil Gil Creek</p> | <p>Maxar Esri, © OpenStreetMap contributors, HERE, ... Powered by Esri</p> | <p>Housekeeping, clean up of waste and other materials and maintenance of silt fence required</p> | <p>Low</p> | <p><b>CLOSED</b></p> <p>Photos sighted evidence of clean up and extension of No Go Zone flagging occurred following inspection</p> |

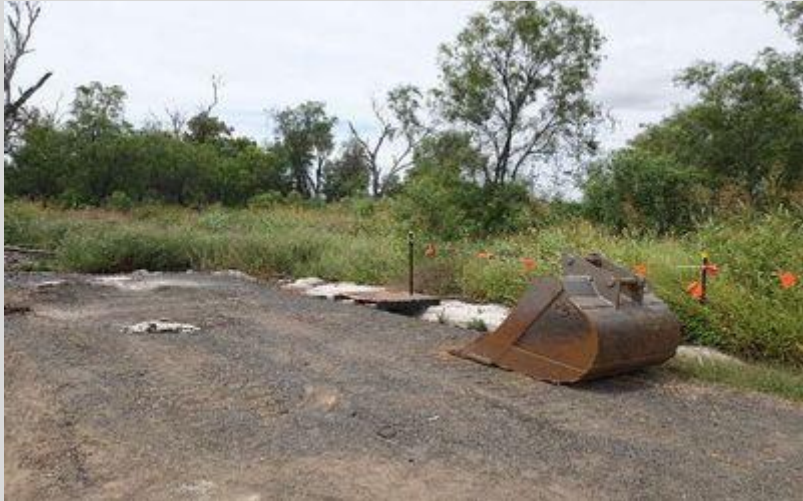
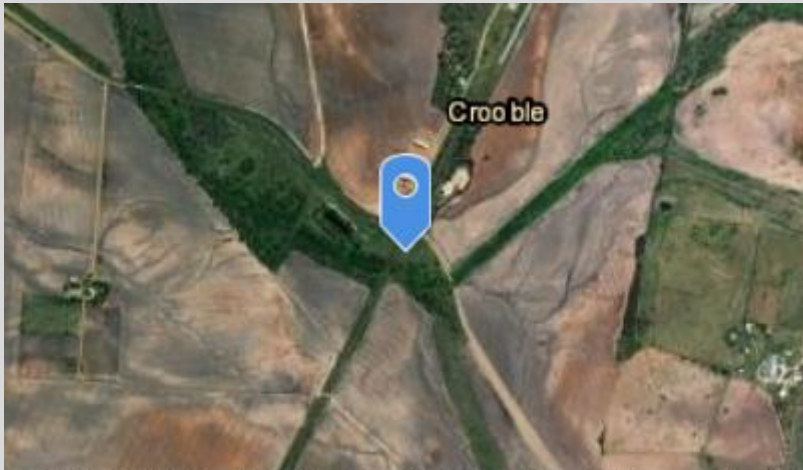
| Ref | Photo / Location | Finding | Priority | Status (including close out evidence) |
|---|---|---|---|--|
| <p><b>20220125-194</b></p> <p>Lon:150.252</p> <p>Lat:-29.270</p> <p>Gil Gil Creek</p> | <p>Maxar Esri, © OpenStreetMap contributors, HERE, ... Powered by Esri</p> | <p>Reinstatement, continuation of No Go flagging tape around perimeter of laydown area required</p> | <p>Low</p> | <p><b>CLOSED</b></p> <p>Photos sighted evidence of clean up and extension of No Go Zone flagging occurred following inspection</p> |

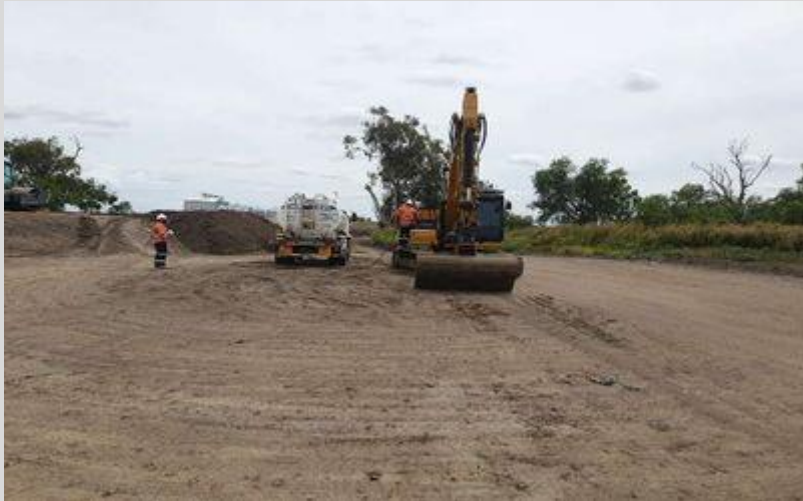
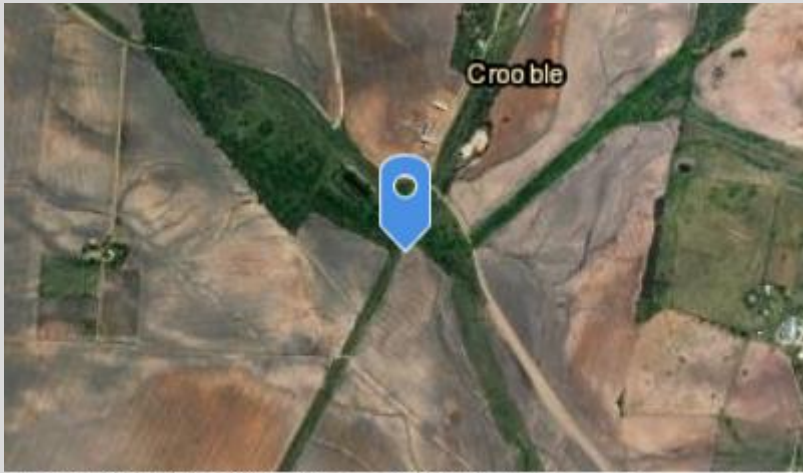
| Ref | Photo / Location | Finding | Priority | Status (including close out evidence) |
|---|---|---|---|---|
| <p><b>20220125-193</b></p> <p>Lon:150.251</p> <p>Lat:-29.272</p> <p>Gil Gil Creek</p> | <p>Maxar Esri, © OpenStreetMap contributors, HERE, ... Powered by Esri</p> | <p>Refueling of excavator observed taking place within 50m of Gil Gil Creek.</p> <p>Refueling activity was ceased at time of inspection. Additional Tool Box, Site Poster and Induction related actions to be implemented</p> | <p>High</p> | <p><b>CLOSED</b></p> <p>Pre start record for Pad 4 (fuel drivers do pre starts here) on 26/1/22 noted refuelling needs to be located greater than 50m from creeks. Daily Briefing Project Wide given on 27/1/22 also covered refuelling issue</p> |

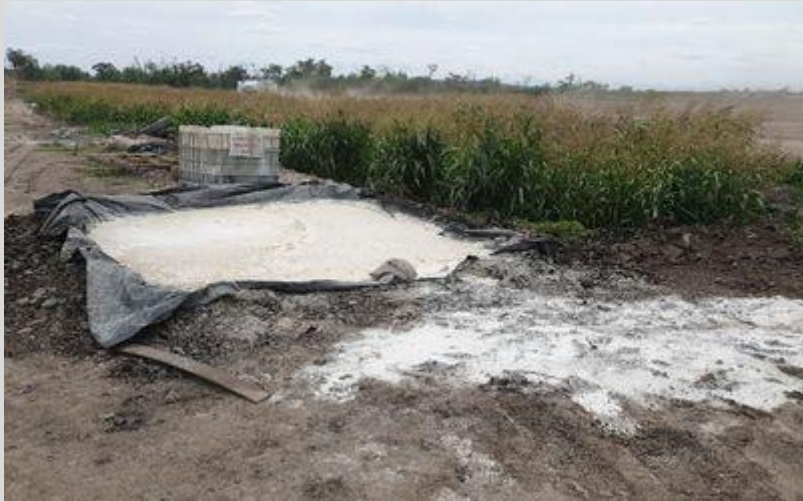
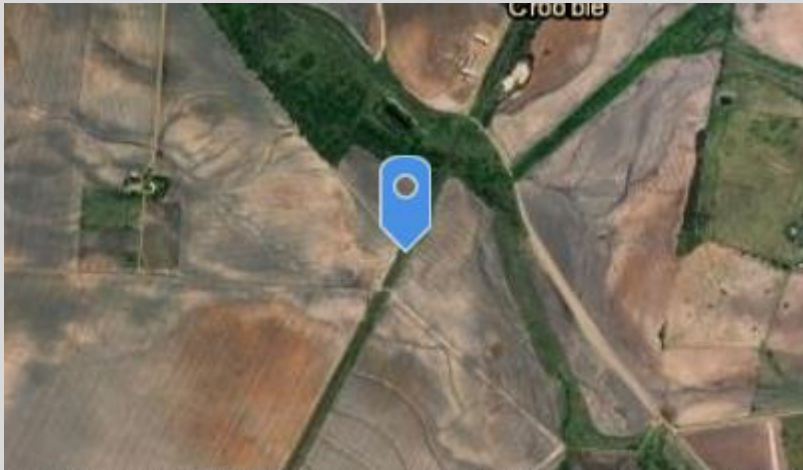
| Ref | Photo / Location | Finding | Priority | Status (including close out evidence) |
|---|---|--|---|---|
| <p><b>20220125-192</b></p> <p>Lon:150.250</p> <p>Lat:-29.274</p> <p>Gil Gil Creek</p> | <p>Maxar Esri, © OpenStreetMap contributors, HERE, ... Powered by Esri</p> | <p>Overflowing concrete washout pit. Concrete was dry at time of inspection.</p> <p>Concrete to be removed and disposed of appropriately and pit reinstated if required.</p> | <p>High</p> | <p><b>CLOSED</b></p> <p>Daily Project Wide Briefing on 27/1/22 also covered concrete washouts and pit has been emptied and reinstated</p> |

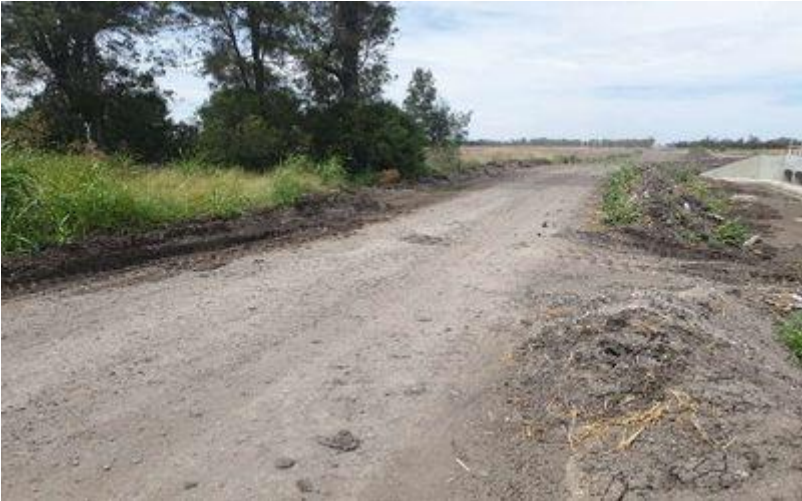
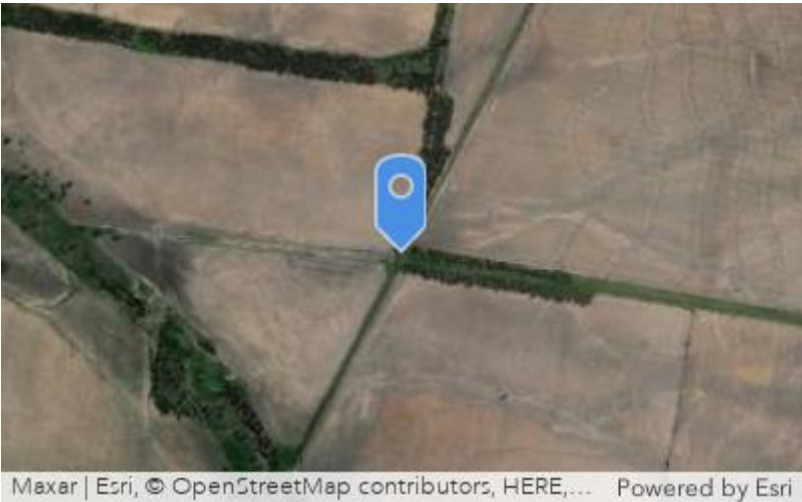
| Ref | Photo / Location | Finding | Priority | Status (including close out evidence) |
|---|---|--|---|---|
| <p><b>20220125-191</b></p> <p>Lon:150.231</p> <p>Lat:-29.305</p> <p>Milguy</p> <p>Chainage 712.58</p> | <p>Maxar Esri, © OpenStreetMap contributors, HERE, ... Powered by Esri</p> | <p>Upstream culvert bund at chainage partially damaged, requires reinstatement</p> | <p>Low</p> | <p><b>OPEN</b></p> <p>To be advised</p> |

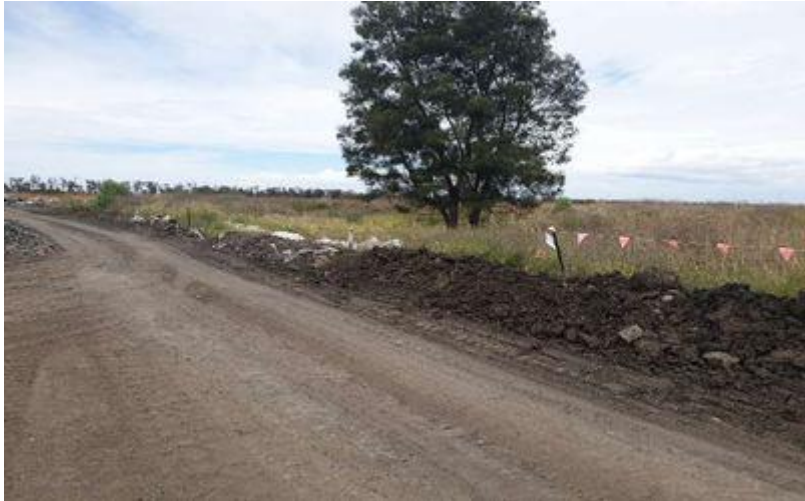
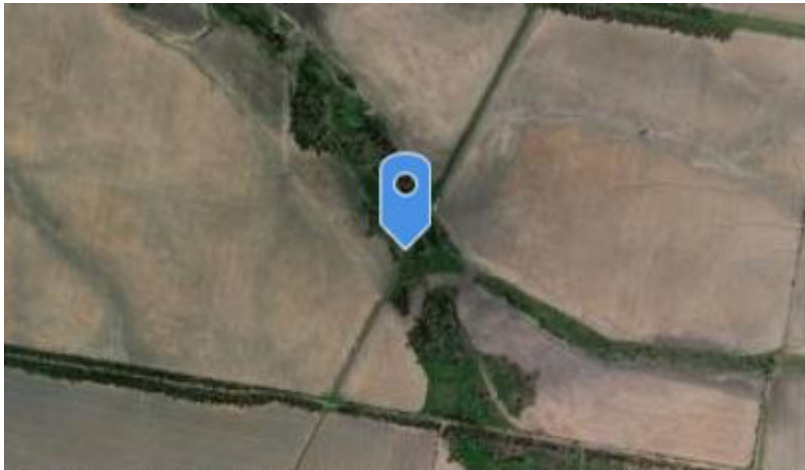
| Ref | Photo / Location | Finding | Priority | Status (including close out evidence) |
|--|---|---|---|---|
| <p><b>20220125-188</b></p> <p>Lon:150.226</p> <p>Lat:-29.313</p> <p>Milguy</p> | <p>Maxar Esri, © OpenStreetMap contributors, HERE, ... Powered by Esri</p> | <p>No Go Zone flagging requires reinstatement</p> | <p>Low</p> | <p><b>OPEN</b></p> <p>TBA</p> |

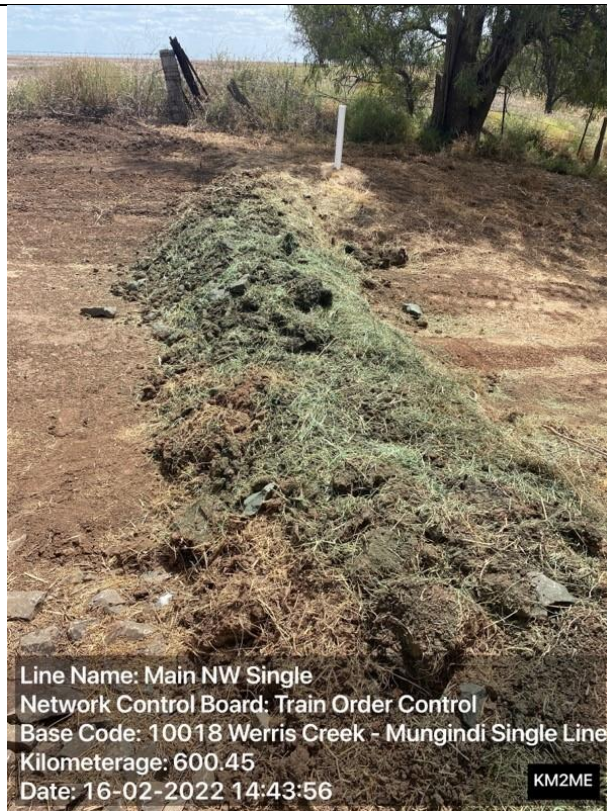
The one finding from the previous ER inspection concerning a rollover needed at northernmost end of the 10 Mile Creek MAF to prevent runoff from leaving site and application of soil binder on exposed soil in lieu of crushed rock placement has been closed out (see photos below).

Rollover at northern end of MAF site

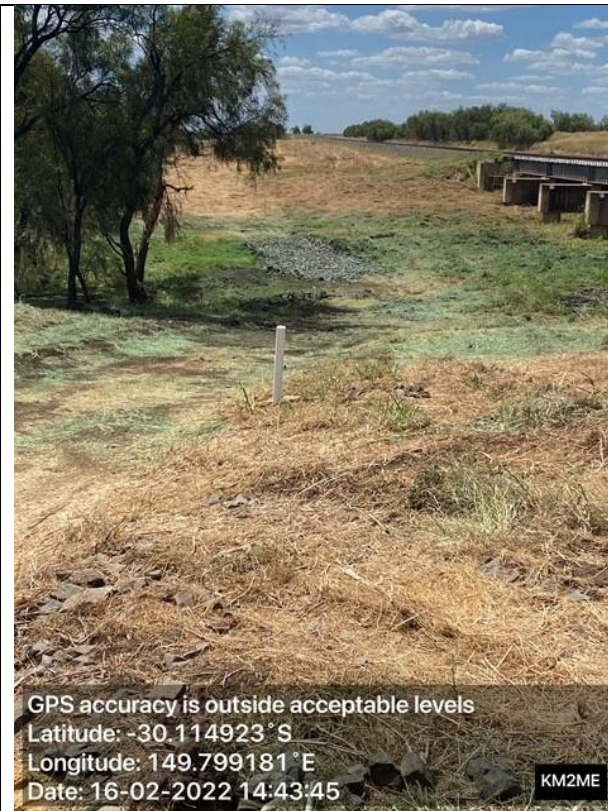
Soil binder applied to track leading down to creek

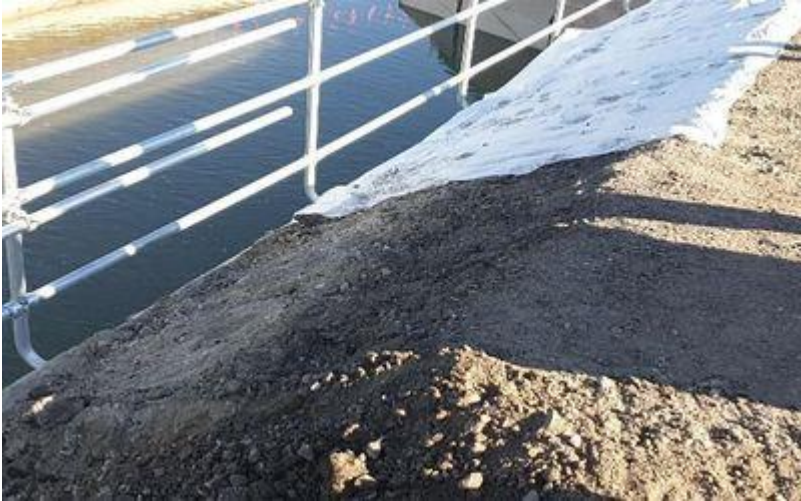
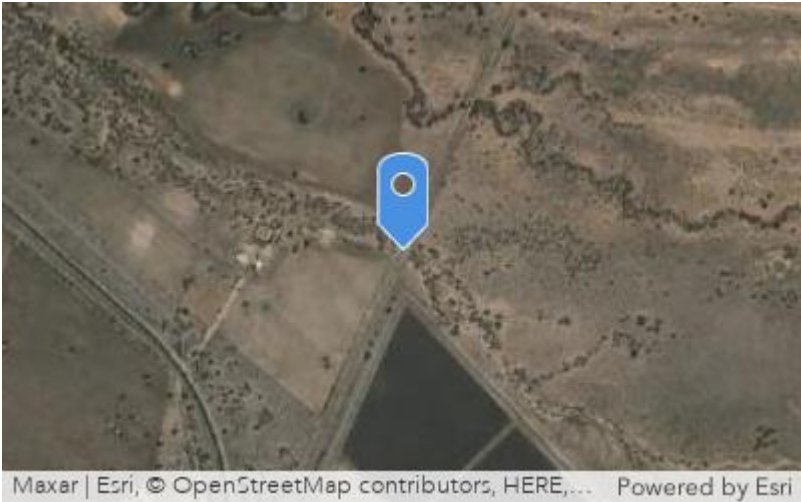
| Ref | Photo / Location | Finding | Priority | Status (including close out evidence) |
|--|---|---|---|--|
| <b>INLAND RAIL PROJECT – NARRABRI TO NORTH STAR</b><br><br><b>20210908-119</b><br><br>Lon:149.819<br><br>Lat:-29.636<br><br>Tycannah Creek | <br><br> | <br><br>Geofabric covering embankment batter to prevent material washing over edge of bridge prior to being cut back to final shape<br><br><i>Finding: Design process to be reviewed to understand how constructability factored in (or not) &amp; any lessons learned arising</i> | <div>Low</div> | <br><b>PROGRESSING</b><br><br>Batter slope cut back from edge (MR to send photos).<br><br>12 & 19/9 Engineers and Site Supervisors and Superintendents meetings the risk of personal \$15K fines for individuals who polluted waters or otherwise breached EPL and CoA conditions was outlined.<br><br>6/10: Meeting with IR DJV representatives scheduled for week of 11/10 to discuss<br><br>20/10: Meeting with IR DJV to be scheduled for week of 25/10 to discuss<br><br>17/11: Further information has been provided to ER by IR DJV for consideration<br><br>1/11: ER provided response to IRDJV email of 3 November concerning fish passage requirements at Tycannah Creek on 26/11. JB to meet |

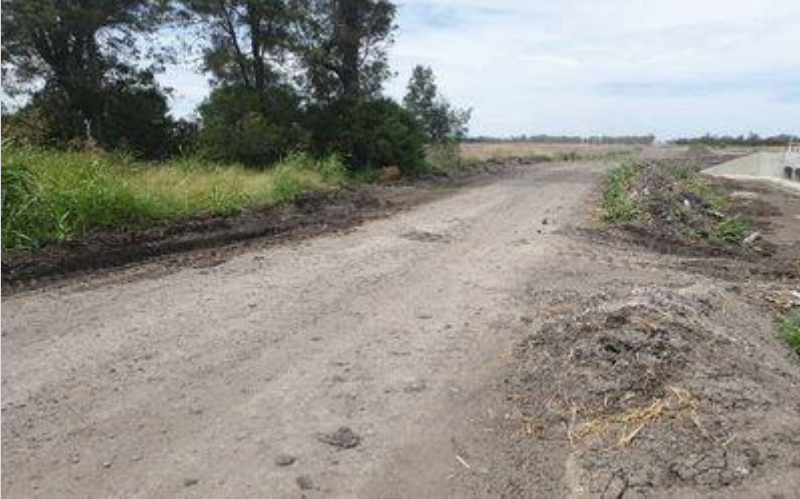
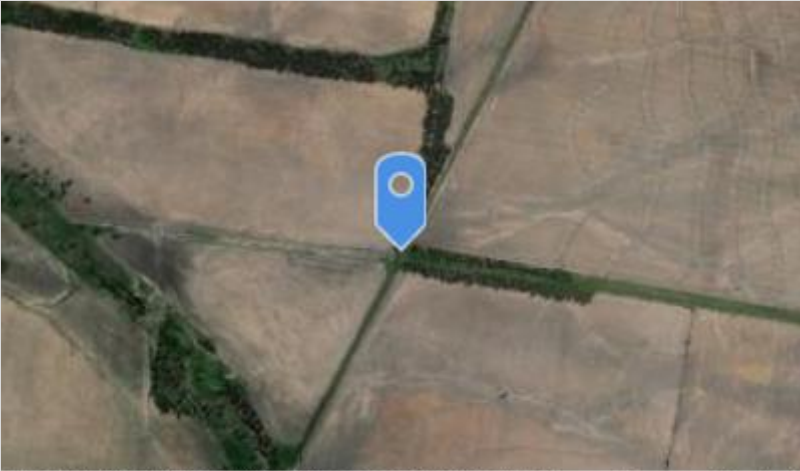
| Ref | Photo / Location | Finding | Priority | Status (including close out evidence) |
|---|---|--|---|--|
| <p><b>20220125-191</b></p> <p>Lon:150.231</p> <p>Lat:-29.305</p> <p>Milguy</p> <p>Chainage 712.58</p> | <p>Maxar Esri, © OpenStreetMap contributors, HERE, ... Powered by Esri</p> | <p>Upstream culvert bund at chainage partially damaged, requires reinstatement</p> | <p>Low</p> | <p><b>CLOSED</b></p> <p><b>Upstream bund has been removed in consultation with CEPSC. Photo sighted.</b></p> |

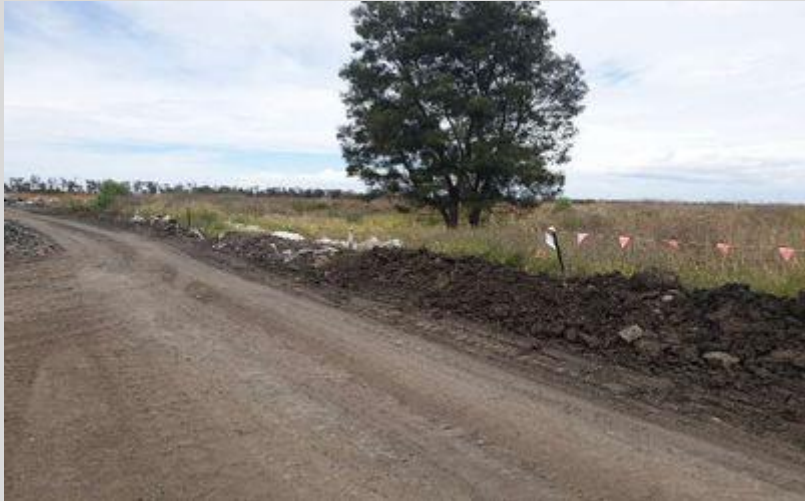
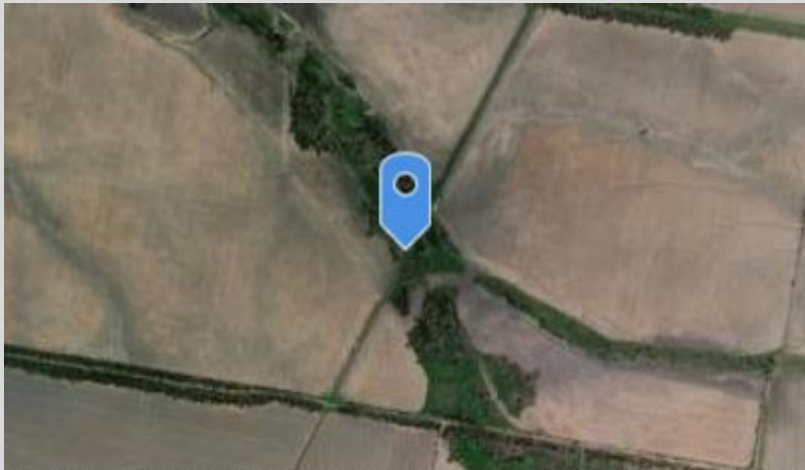
| Ref | Photo / Location | Finding | Priority | Status (including close out evidence) |
|--|---|---|---|---|
| <p><b>20220125-188</b></p> <p>Lon:150.226</p> <p>Lat:-29.313</p> <p>Milguy</p> | <p>Maxar Esri, © OpenStreetMap contributors, HERE, ... Powered by Esri</p> | <p>No Go Zone flagging requires reinstatement</p> | <p>Low</p> | <p><b>CLOSED</b></p> <p><b>Flagging reinstated. Photo sighted</b></p> |
