**INLAND RAIL – NARRABRI TO NORTH STAR PHASE 1:  
FIVE-CLAWED WORM SKINK (*Anomalopus mackayi*)  
CONSTRUCTION SPECIES MANAGEMENT PLAN (Rev 6)**

**August 2024**

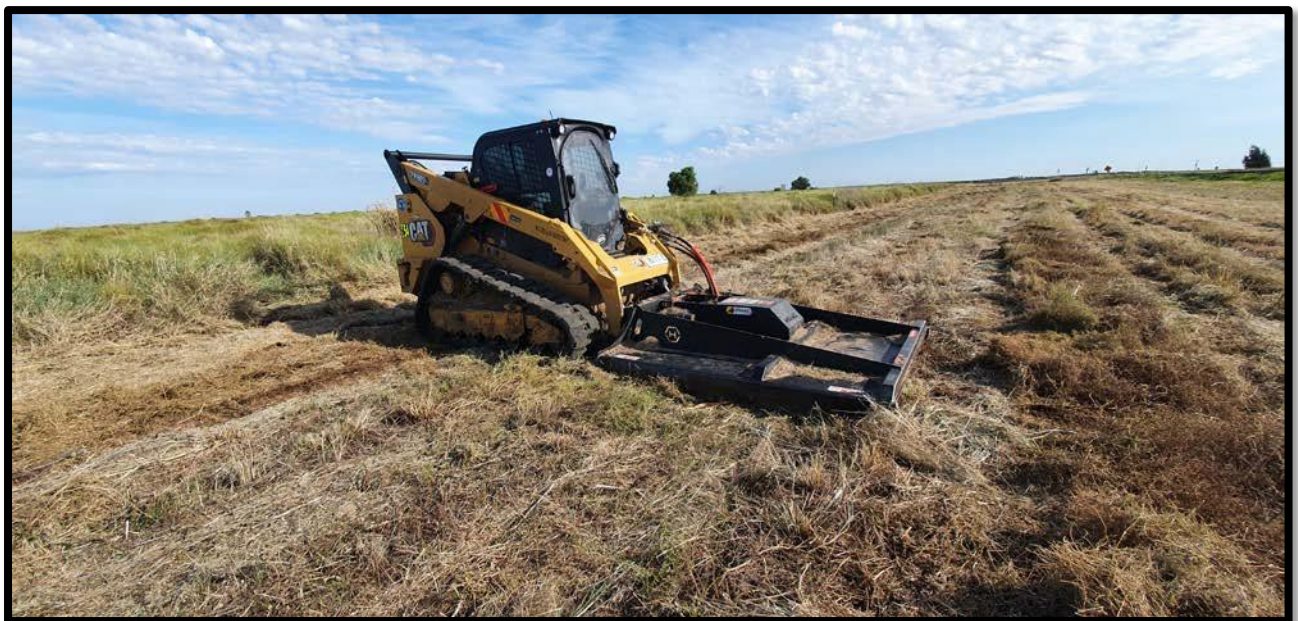
**Plate 5-2.** Slashing on vegetation prior to stripping in Stage 1.

- An ecologist or spotter-catcher to perform clearing supervision when the slasher is mowing vegetation. The slasher should be set at a cutting height that is near to the ground (<100 mm) in order to reduce the suitability of the retained habitat. The ecologist/spotter-catcher would turn suitable materials such as logs, disused sleepers, refuse whilst looking for dispersing skinks. Skinks captured during this stage would need to be retained until such a time the slashing has been completed adjacent to the relocation site noting that a series of measurements and habitat information is to be recorded (see Section 5.2.4).

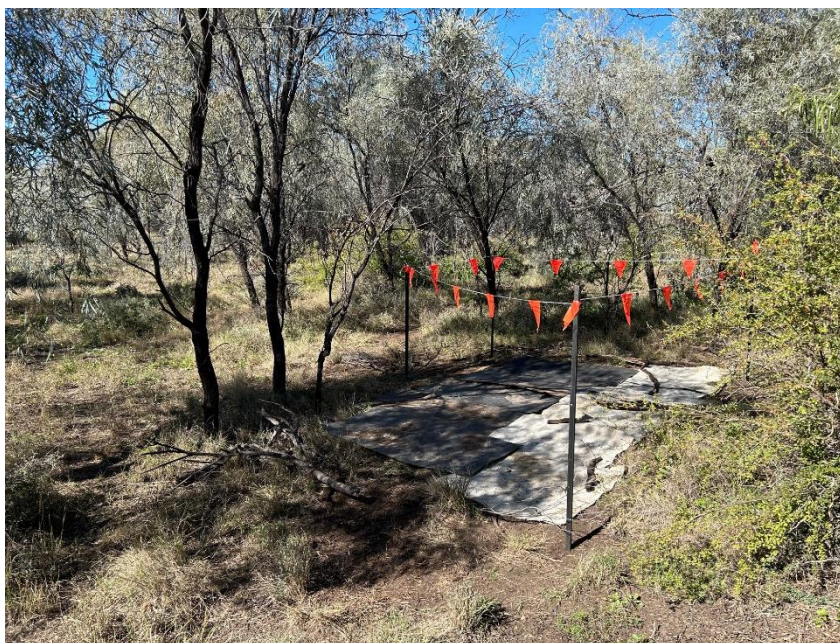
**Plate 6-3.** Treatment Type B (Site 10B) where sites were established in adjacent habitat of the same plant community type.

- **Treatment Type B – Reference.** This type of monitoring site has been located at least 200 m away and at times a number of kilometres from the impact site but within the same PCT and local area (Plate 6-3). As these sites were unaffected by the

project they are considered control or reference sites and are used to measure external factors such as seasonality (i.e. drought/flood) and assist with other abiotic cues (i.e. air temperatures, rainfall).

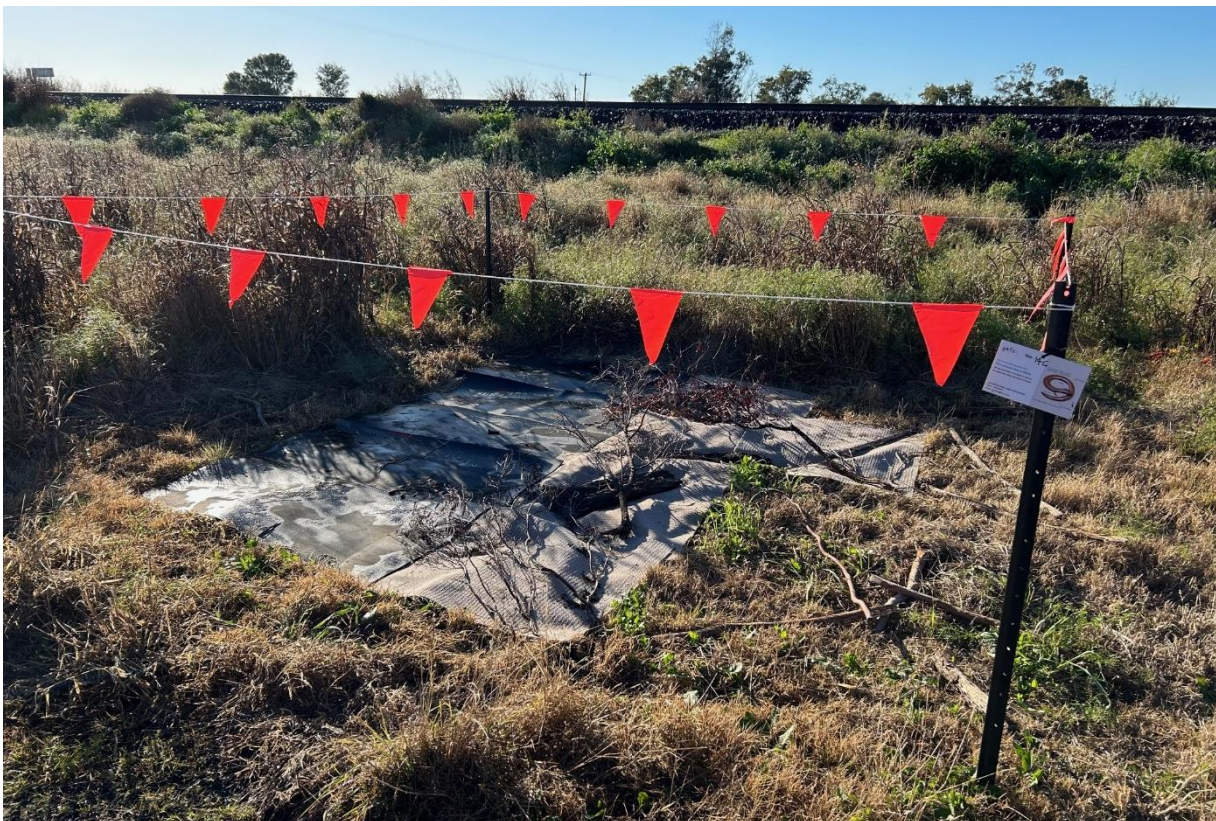
**Figure 6-3.** Artificial shelter site configuration using the clumped configuration as directed by DCCEEW NSW.

The current configuration or arrangement of rubber and carpet tiles is the result of directive from BCS DCCEEW – NSW in 2024, that being to clump the carpet and rubber tiles together in an overlapping nature to create a single continuous covering. (Figure 6-1).
