WestConnex M4-M5 Rozelle Interchange – 264-266 Victoria Road, Rozelle Archival Recording and Salvage Report

Prepared for John Holland CPB Joint Venture

March 2021 – Final

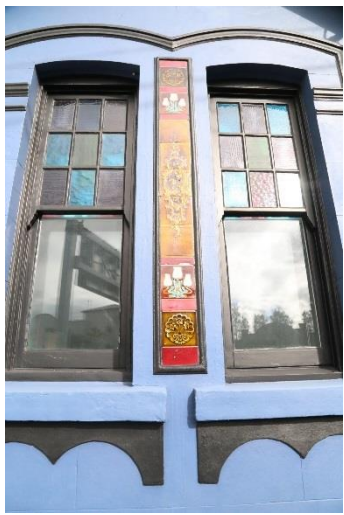
| Image Name. | Direction | Details | Thumbnail |
|---|---|---|--|
| 008_264_VIC_RD_2019 | SW | Detail of sash windows with glass multi-paned lights and sandstone sills. | |

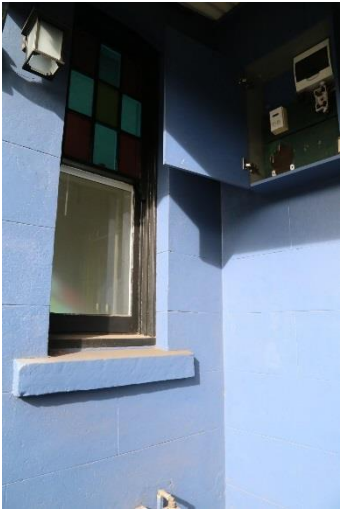
| Image Name. | Direction | Details | Thumbnail |
|---|---|---|--|
| 009_264_VIC_RD_2019 | S | View to sash window at front entrance. | |

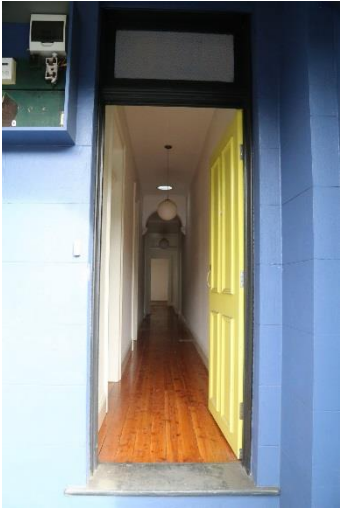
| Image Name. | Direction | Details | Thumbnail |
|---|---|---|--|
| 010_264_VIC_RD_2019 | SW | View of front entrance. | |

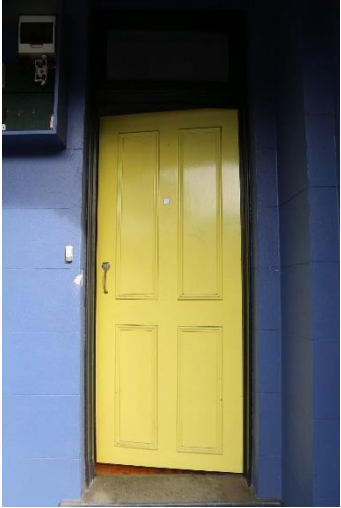
| Image Name. | Direction | Details | Thumbnail |
|---|---|---|--|
| 011_264_VIC_RD_2019 | SW | View of timber panelled front door at front entrance. | |

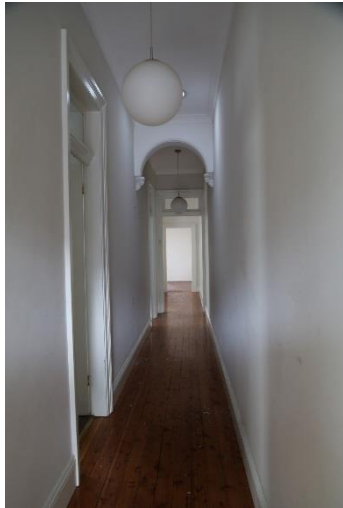
| Image Name. | Direction | Details | Thumbnail |
|---|---|---|--|
| 012_264_VIC_RD_2019 | SW | Overview of hallway of 264 Victoria Road. | |

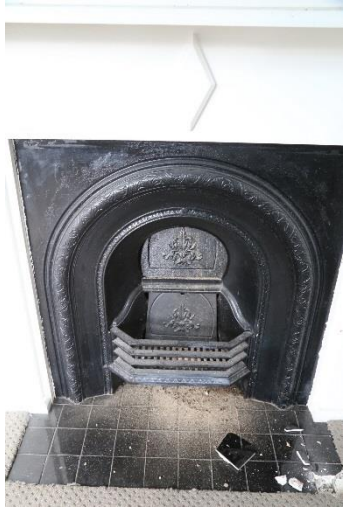
| Image Name. | Direction | Details | Thumbnail |
|---|---|--|--|
| 018_264_VIC_RD_2019 | S | Detail of cast iron fireplace. | |

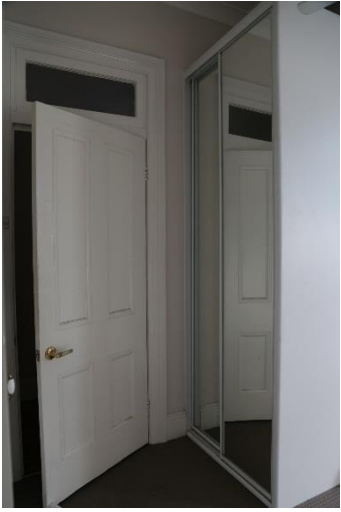
| Image Name. | Direction | Details | Thumbnail |
|---|---|---|--|
| 021_264_VIC_RD_2019 | NE | View of Room 1 with timber panelled door. | |

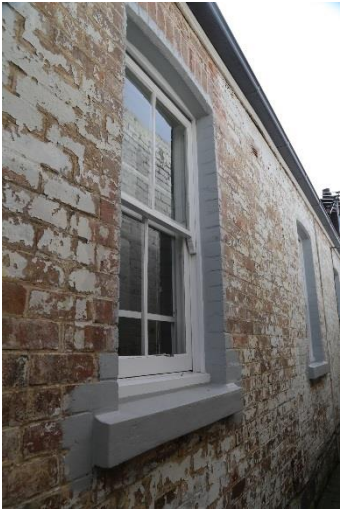
| Image Name. | Direction | Details | Thumbnail |
|---|---|--|--|
| 067_264_VIC_RD_2019 | N | Detail of sash window on side passage closest to rear of property. | |

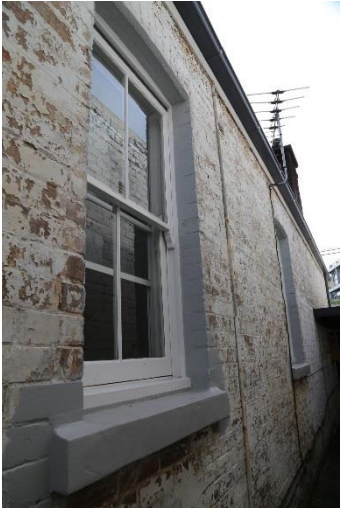
| Image Name. | Direction | Details | Thumbnail |
|---|---|--|--|
| 068_264_VIC_RD_2019 | N | Detail of central sash window on side passage. | |

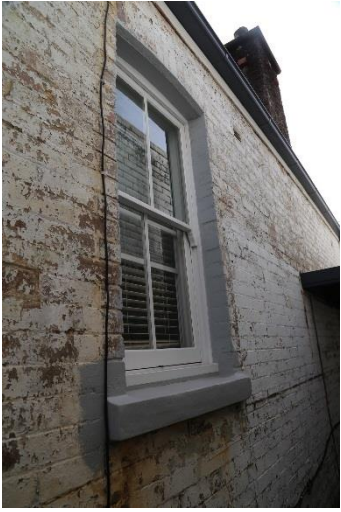
| Image Name. | Direction | Details | Thumbnail |
|---|---|--|--|
| 071_264_VIC_RD_2019 | N | View of sash window and brick chimney from side passage. | |

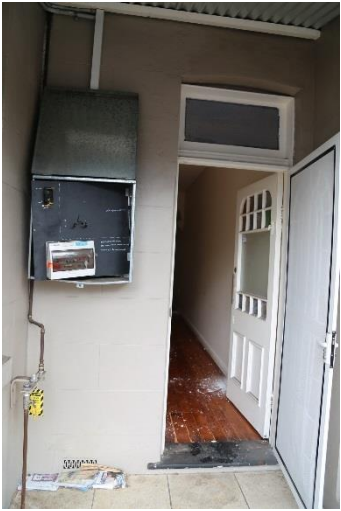
| Image Name. | Direction | Details | Thumbnail |
|---|---|--|---|
| 012_266_VIC_RD_2019 | SW | View of front entrance. | A photograph showing the front entrance of a house from a southwest perspective. The entrance is a white door with a transom window, set into a light-colored stone wall. To the left of the door is a black metal mailbox. The ground is paved with light-colored tiles. |

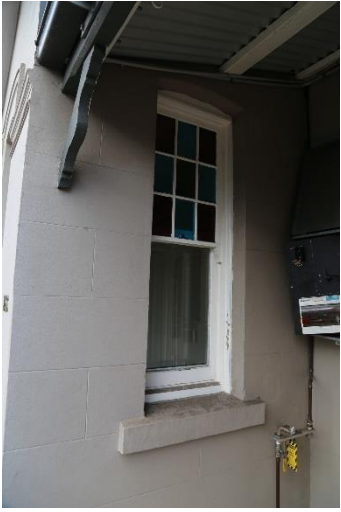
| Image Name. | Direction | Details | Thumbnail |
|---|---|--|---|
| 013_266_VIC_RD_2019 | S | View of sash window at front entrance. | A photograph showing a white sash window with multiple panes, set into a light-colored stone wall. The window is positioned above a small, light-colored stone ledge. To the right of the window is a black metal mailbox. |

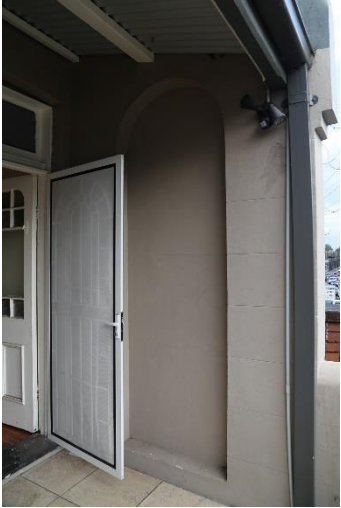
| Image Name. | Direction | Details | Thumbnail |
|---|---|--|---|
| 014_266_VIC_RD_2019 | W | Overview of front entrance. | A photograph showing an overview of the front entrance from a west perspective. The entrance is a white door with a transom window, set into a light-colored stone wall. The door is slightly ajar, revealing the interior. To the right of the door is a black metal mailbox. |

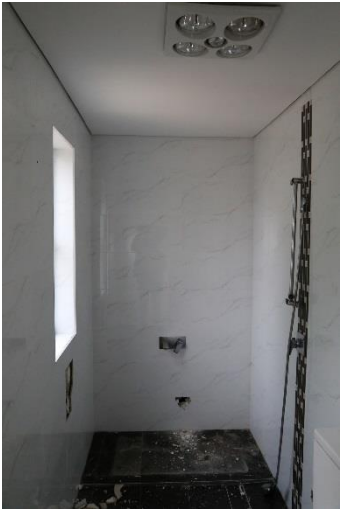
| Image Name. | Direction | Details | Thumbnail |
|---|---|---|--|
| 066_266_VIC_RD_2019 | SW | View of Laundry. | A photograph showing a view of a laundry room from the southwest. The room has white tiled walls, a dark floor, and a shower area with a glass door on the right. A small window is visible on the left wall. |

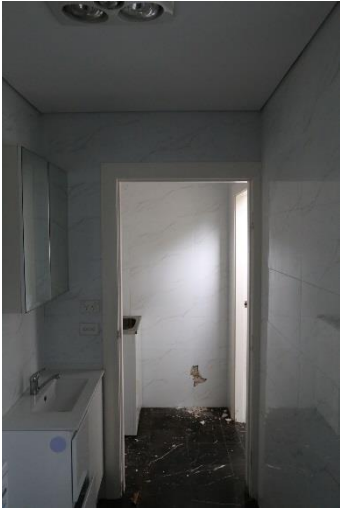
| Image Name. | Direction | Details | Thumbnail |
|---|---|---|--|
| 067_266_VIC_RD_2019 | NE | Overview of Laundry. | A photograph showing an overview of a laundry room from the northeast. The room features white tiled walls, a dark floor, and a doorway leading to another room. A sink and cabinets are visible on the left side. |

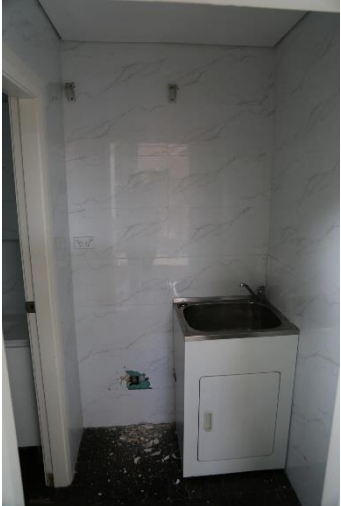
| Image Name. | Direction | Details | Thumbnail |
|---|---|---|--|
| 068_266_VIC_RD_2019 | NW | View of Laundry. | A photograph showing a view of a laundry room from the northwest. The room has white tiled walls, a dark floor, and a sink with a cabinet underneath. A doorway is visible on the left. |

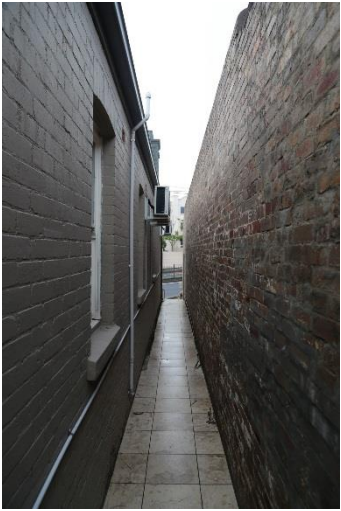
| Image Name. | Direction | Details | Thumbnail |
|---|---|---|--|
| 074_266_VIC_RD_2019 | NE | Overview of side passage towards front of property. | |

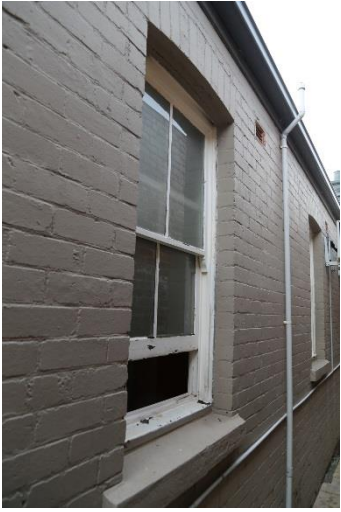
| Image Name. | Direction | Details | Thumbnail |
|---|---|---|--|
| 075_266_VIC_RD_2019 | N | Detail of sash window from side passage. | |

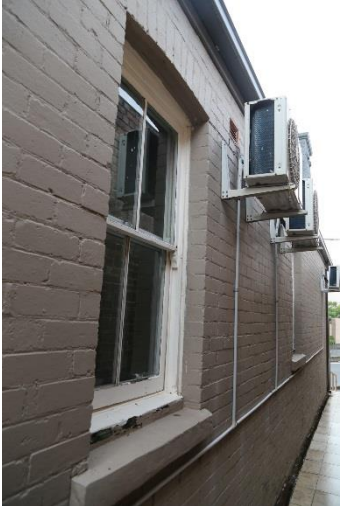
| Image Name. | Direction | Details | Thumbnail |
|---|---|---|--|
| 076_266_VIC_RD_2019 | N | Detail of sash window from side passage. | |

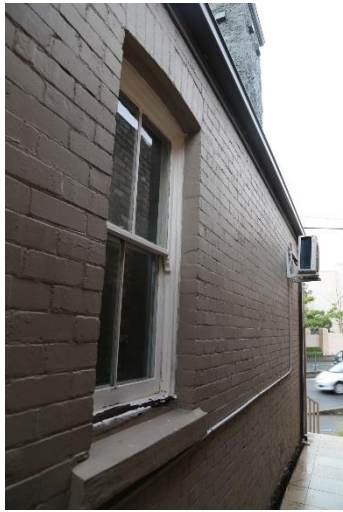
| Image Name. | Direction | Details | Thumbnail |
|---|---|---|--|
| 077_266_VIC_RD_2019 | N | Detail of sash window from side passage. | |

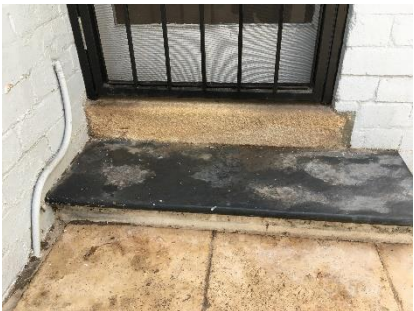
| Ref # | Feature | Quantity | Thumbnail |
|---|---|---|--|
| 6 | Threshold stone | 1 | |

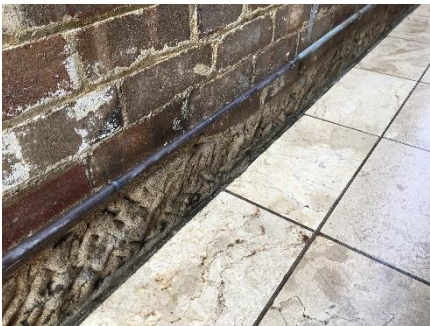
| Ref # | Feature | Quantity | Thumbnail |
|---|---|---|--|
| 7 | Sandstone blocks or bedrock <i>* Visible from 264 Victoria Road. Check for sandstone footings which could be salvaged if present. Salvage will not be viable if it is bedrock.</i> | Unclear, salvage all if viable | |

- If any sandstone blocks are found to be present, either in building courses or foundation stones, where they are in good condition, (i.e. Ashlar blocks, these should be salvaged.
- If highly significant material will need to be physically impacted i.e. cut or damaged, in order to be salvaged, seek the advice of a Heritage Advisor on the most appropriate methodology to minimise the impact.

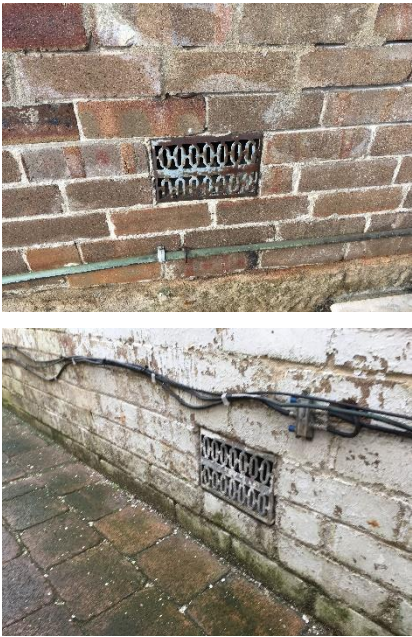
| Ref # | Feature | Quantity | Thumbnail |
|---|--|---|--|
| 11 | Wall vents | 6 | |

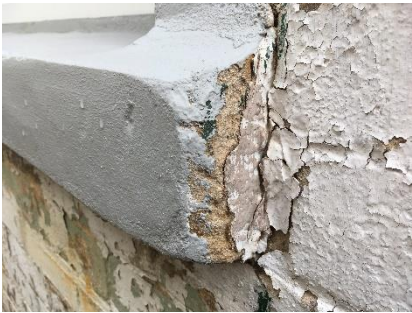
| Ref # | Feature | Quantity | Thumbnail |
|---|--|---|--|
| 14 | Sandstone window sills | 6, if viable | |

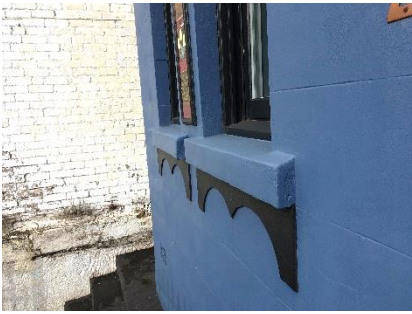
| Ref # | Feature | Quantity | Thumbnail |
|---|--|---|--|
| 15 | Window skirts | 3 | |

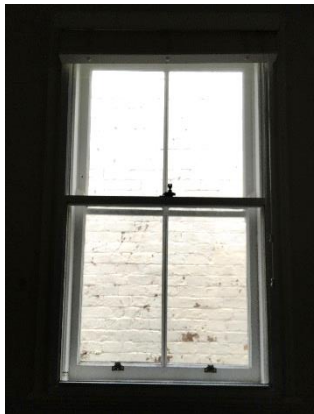
| Ref # | Feature | Quantity | Thumbnail |
|---|--|--|--|
| 1 | Windows <i>* 264 Victoria Road has original windows with modern soundproof glass installed behind. Salvage original windows only.</i> <i>* Salvage windows and timber joinery as set</i> | 6 total 3 sets of single-hung with stained glass 3 sets of double-hung | |

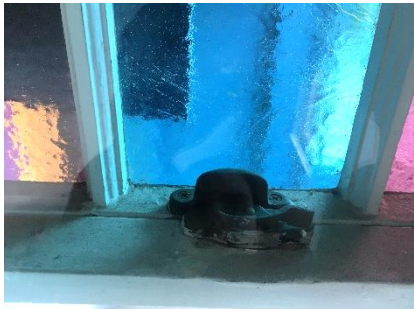
| Ref # | Feature | Quantity | Thumbnail |
|---|---|---|--|
| 2 | Window hardware | 3 locks | |

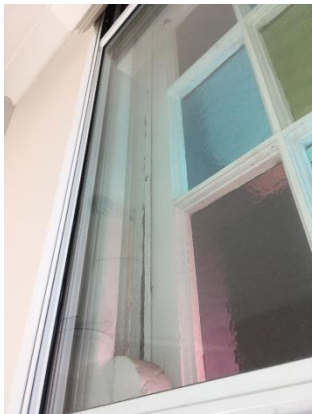
| Ref # | Feature | Quantity | Thumbnail |
|---|---|---|--|
| | Window hardware | 6 sash and pulley wheel sets | |

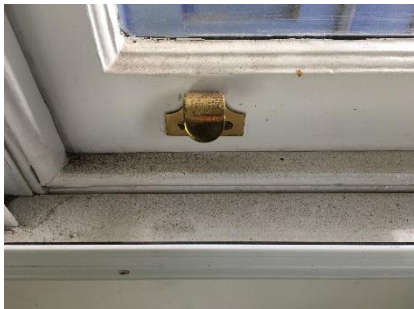
| Ref # | Feature | Quantity | Thumbnail |
|---|---|---|--|
| | Window hardware | 12 finger hooks | |

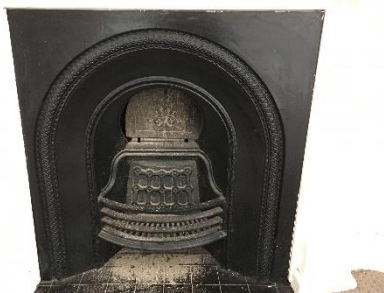
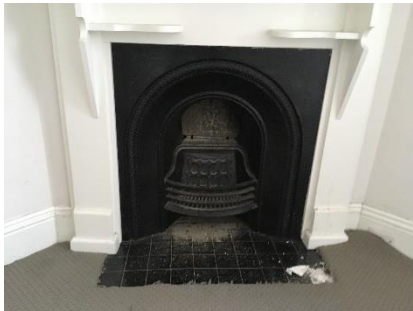
| Ref # | Feature | Quantity | Thumbnail |
|---|--|---|---|
| 12 | Fireplace | 2 | |

- All fabric should be removed carefully to ensure its condition is not compromised.
- Extra care should be taken in the removal and storage of the fireplaces and associated fireplace tiles and tessellated tiles identified in this report to ensure that the condition of the fabric is not compromised or items damaged.

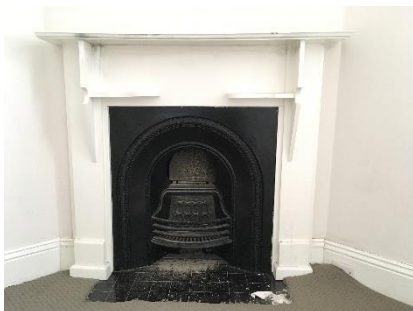
| Ref # | Feature | Quantity | Thumbnail |
|---|--|---|---|
| 13 | Fireplace – mantle | 2 | |

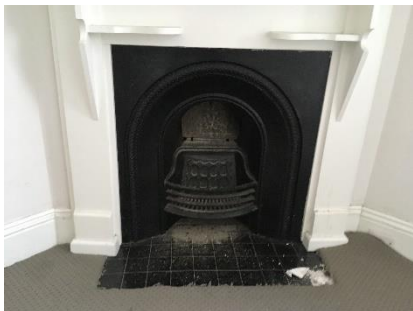
| Ref # | Feature | Quantity | Thumbnail |
|---|--|---|---|
| 14 | Fireplace – tiles <i>* Both fireplaces have been replaced with modern tiles, but historic tiles may be present beneath.</i> | Unknown - check beneath modern tiles, salvage if viable | |

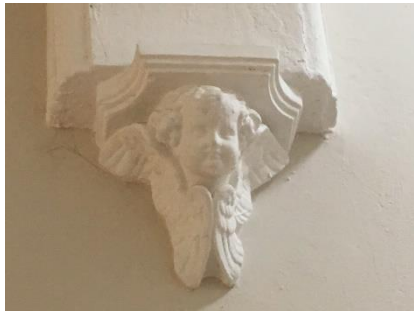
| Ref # | Feature | Quantity | Thumbnail |
|---|---|---|--|
| 20 | Mouldings <i>* Salvage mouldings as a set.</i> | 2, if viable | |

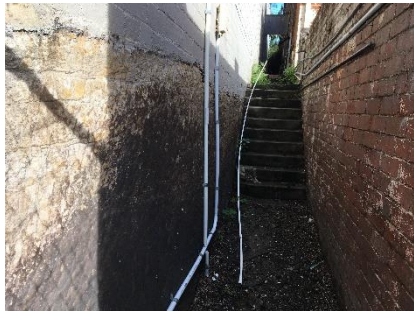
| Ref # | Feature | Quantity | Thumbnail |
|---|---|---|--|
| 7 | Sandstone blocks. <i>* Visible from 266 Victoria Road. Check for sandstone footings which could be salvaged if present. Salvage will not be viable if it is bedrock.</i> | Unknown | |

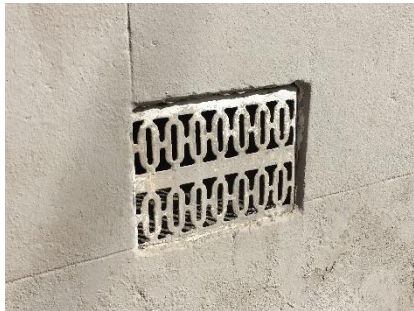
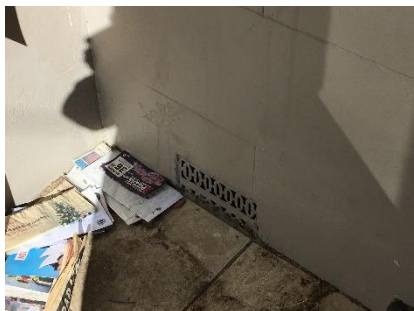
| Ref # | Feature | Quantity | Thumbnail |
|---|---|---|--|
| 11 | Wall vents | 8 | |

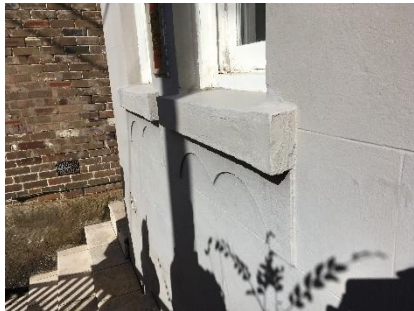
| Ref # | Feature | Quantity | Thumbnail |
|---|---|---|--|
| 14 | Sandstone window sills | 5 | |

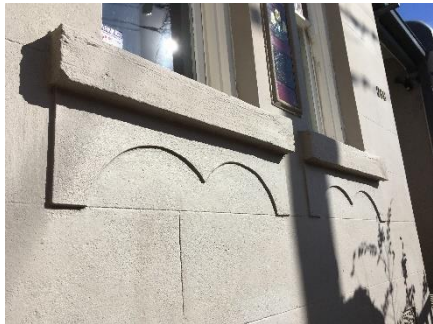
| Ref # | Feature | Quantity | Thumbnail |
|---|---|---|--|
| 15 | Window skirts | 3 | |

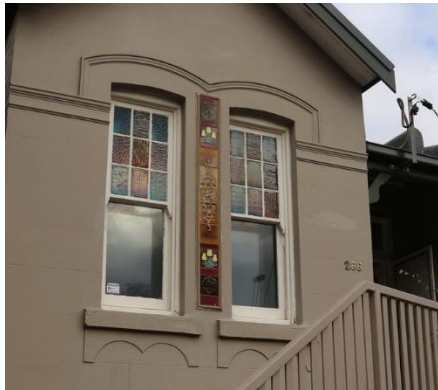
| Ref # | Feature | Quantity | Thumbnail |
|---|---|---|--|
| 16 | Decorative tiles | 1 set, if viable | |

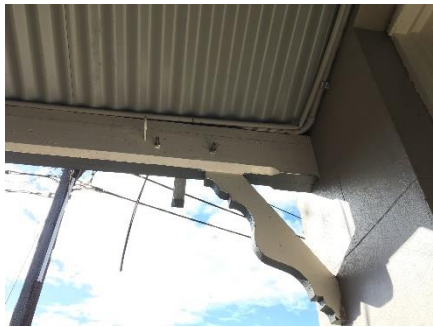
| Ref # | Feature | Quantity | Thumbnail |
|---|---|---|--|
| 19 | Timber brackets <i>* Salvage timber brackets as a set.</i> | 2 | |

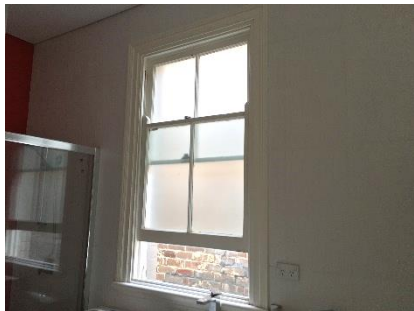
| Ref # | Feature | Quantity | Thumbnail |
|---|--|--|--|
| 1 | Windows <i>* Salvage windows and timber joinery as set.</i> | 6 total 3 sets of single-hung with stained glass 3 sets of double-hung | |

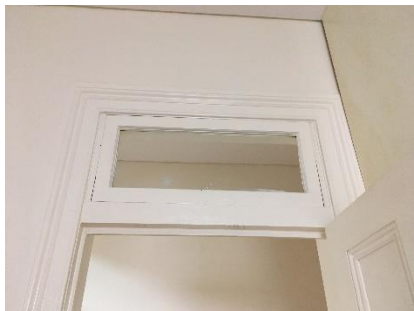
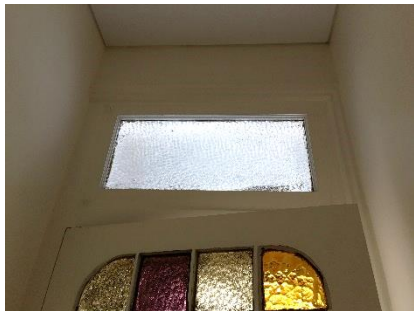
| Ref # | Feature | Quantity | Thumbnail |
|---|---|---|--|
| 6 | Door light and frame | 6 | |

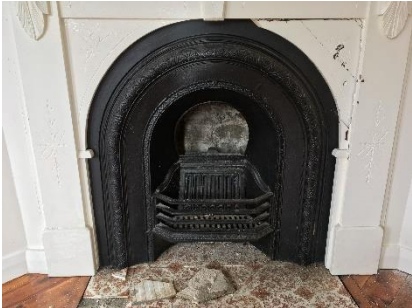
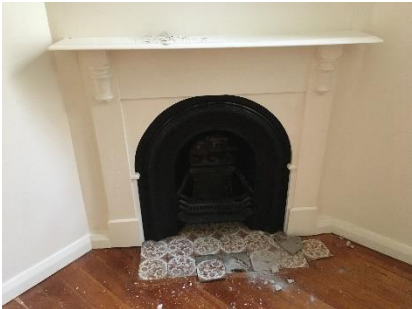
| Ref # | Feature | Quantity | Thumbnail |
|---|--|---|--|
| 12 | Fireplace | 3 | |

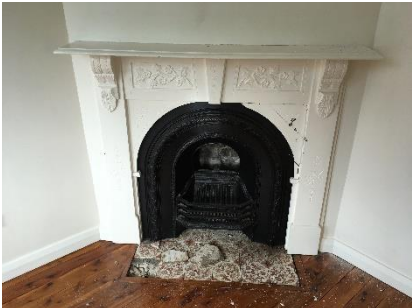
| Ref # | Feature | Quantity | Thumbnail |
|---|--|---|--|
| 13 | Fireplace – mantle | 2 | |

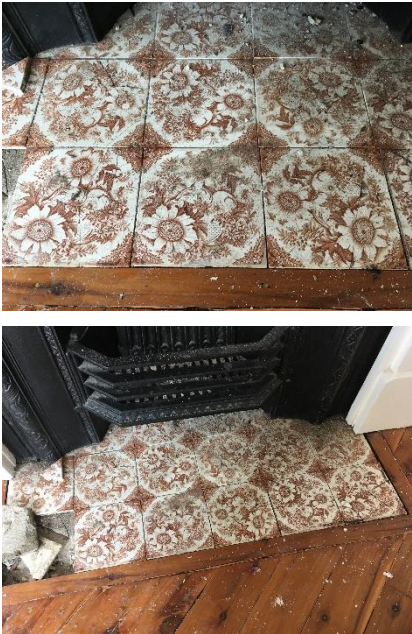
| Ref # | Feature | Quantity | Thumbnail |
|---|---|---|--|
| 14 | Fireplace – tiles | 2 sets, if viable | |

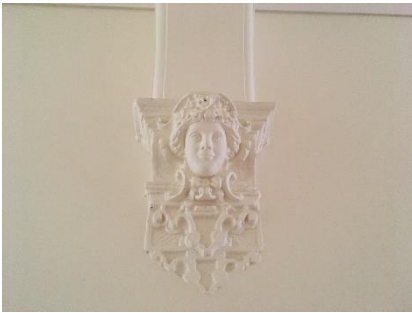
| Ref # | Feature | Quantity | Thumbnail |
|---|---|---|--|
| 20 | Mouldings <i>* Salvage mouldings as a set.</i> | 2, if viable | |

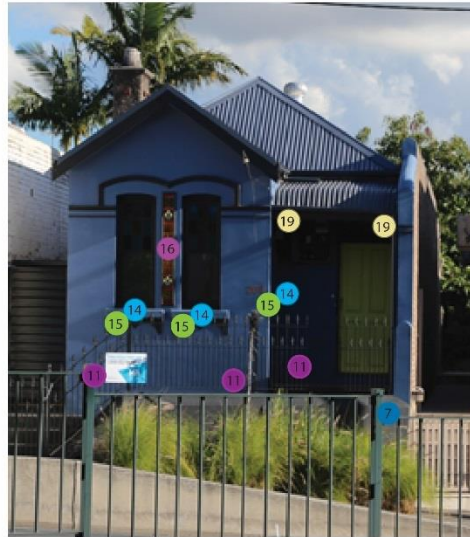
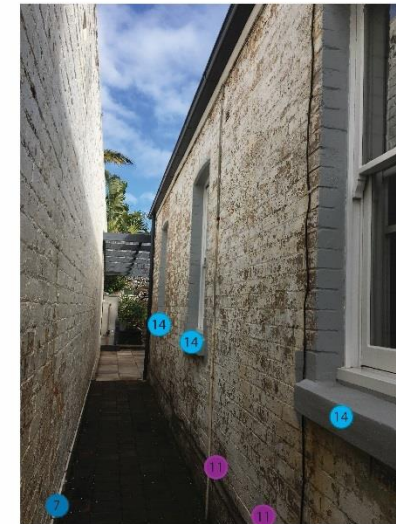
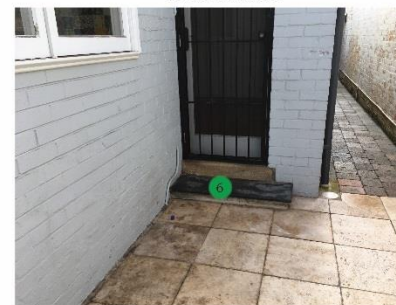
Figure 9. Salvage plan of Exterior of 264 Victoria Road, Rozelle.

| 9 Parapet vase urn | 19 Timber Brackets |
| 10 Corbelled mouldings | |

SIDE PASSAGE

REAR

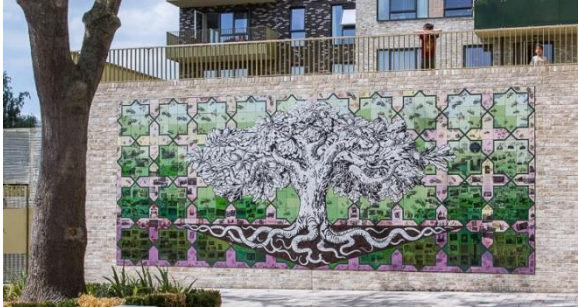
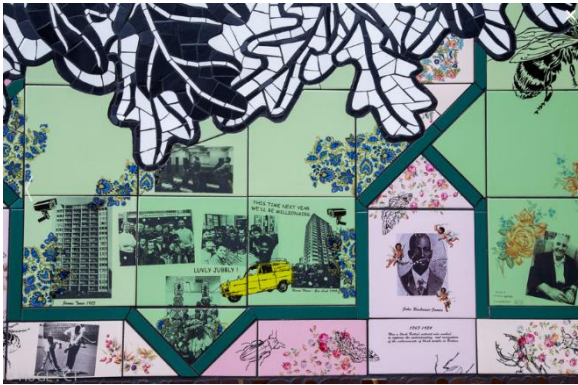
| Fabric | Potential re-use | Example |
|---|---|--|
| <p>Tiles (both exterior and fireplace) (#1-exterior and #14-interior)</p> | <p>Public art</p> | <p>Figure 17. Community tile mosaic (Source: Carrie Reichardt)</p> <p>Figure 18. Community tile mosaic (Source: Carrie Reichardt)</p> |

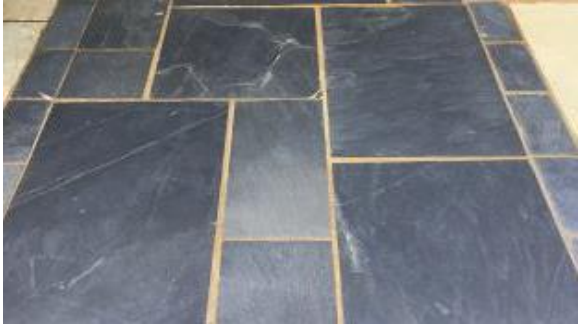
| Fabric | Potential re-use | Example |
|---|---|---|
| Threshold stones (Exterior #6) | Interpretive paving or wall stones | <p data-bbox="1305 687 2054 746">Figure 19. Example of black slate paving that could then be laser cut or etched (Source: Ardosia Slate).</p> |
