# Coffs Harbour Bypass Project

Photographic Archival Recording – Former Coffs Heights Post Office

<b>Author:</b>	Artefact Heritage
<b>Date:</b>	19 August 2021
<b>Version:</b>	Final
<b>Reference:</b>	-
<b>Division:</b>	-
<b>Review date:</b>	19 August 2021

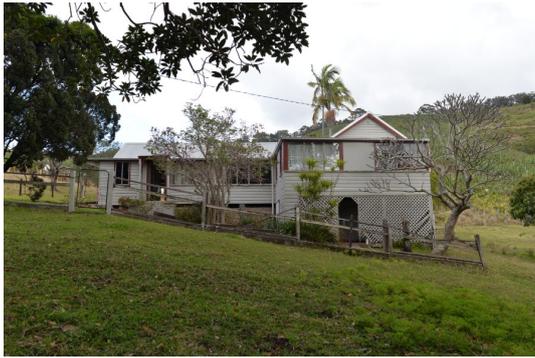
The Former Coffs Heights Post Office is a weatherboard residence constructed in the Inter-War period, with elements of the California Bungalow architectural style (Figure 13). The structure was originally constructed as a post office in 1915. Sometime following the Post Office's closure in 1923, the structure was raised and relocated to its current location and extensively altered from this time.

**Figure 13. South facing view of front façade of Former Coffs Heights Post Office showing weatherboard exterior**

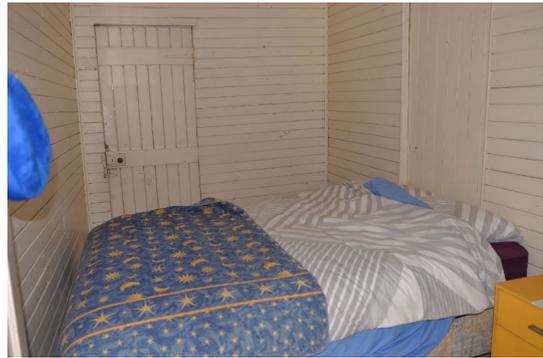
Although the original structure is difficult to identify from the exterior, it comprises the central cabin (comprising four rooms), measuring 12 feet wide and 60 feet long. The four original rooms currently function as a kitchen / dining area, living room, and two bedrooms (Figure 14). Eight rooms have been subsequently added to this central structure, flanking the central cabin to the north and south. This has significantly altered the original layout. These rooms include a kitchen, bathroom, laundry, storage room, sunroom and additional bedrooms (Figure 15).

**Figure 14. Southwest view within one of the original rooms of the Former Coffs Heights Post Office, currently functioning as a bedroom. Note the wooden paneling on walls and door**

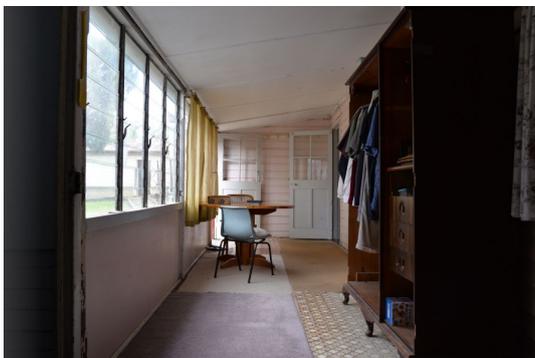
**Figure 15. East facing view within the sunroom of the Former Coffs Heights Post Office. Note the modern building materials including metal frames glass louvre windows and plywood paneling on walls and ceiling**

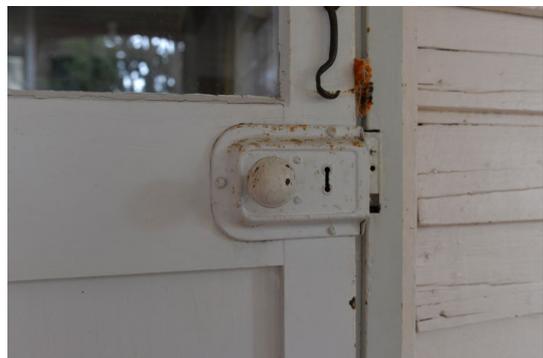
Original fabric is evident internally, including weatherboard walls; wooden framed, four panelled glass windows; wooden panelled doors; and hardware including hinges and doorknobs (Figure 16 - Figure 18). Where extensions and alterations have been made, modern building materials have been utilised including plywood panelling on walls and ceilings and metal framed windows (Figure 15). However, externally, weatherboard and timber skirting have been used in keeping with the original structure.

**Figure 16. South facing view of doorknob and lock on original front door (now internal) of Former Coffs Heights Post Office**

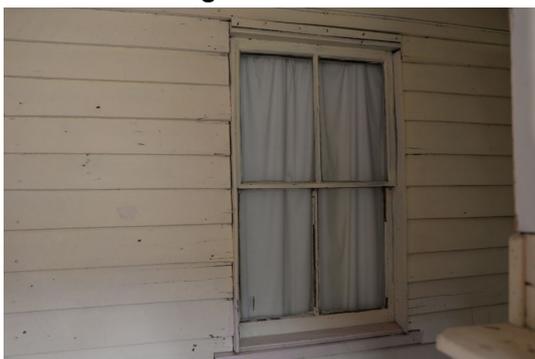
**Figure 17. North facing view of original timber framed four pannelled glass window (now internal) of Former Coffs Heights Post Office**

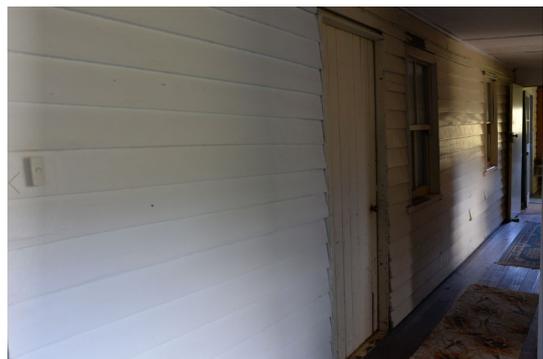
**Figure 18. Northeast facing view within hallway showing original external weatherboard walling, timber panelled door and timber framed four pannelled glass windows (now internal) of Former Coffs Heights Post Office**

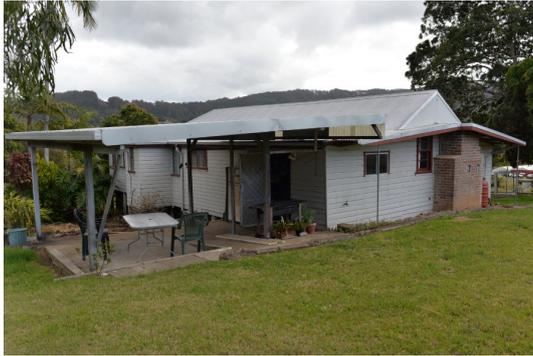
The former post office also comprises a rear covered patio area (Figure 19) and lower-level storage / workshop.

**Figure 19: Northwest facing view of Former Coffs Heights Post Office showing rear covered patio**

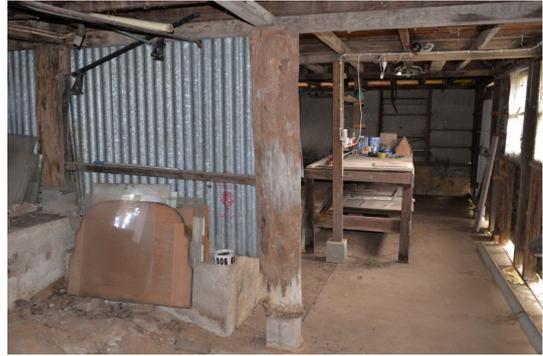
**Figure 20: West facing view within lower-level storage / workshop area of Former Coffs Heights Post Office**

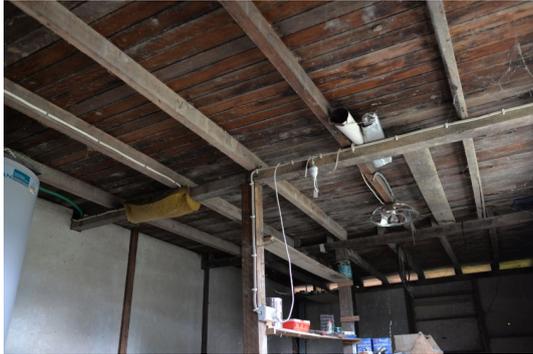
**Figure 21: Southwest facing view within lower-level storage / workshop area of Former Coffs Heights Post Office showing original framework and timber structure**

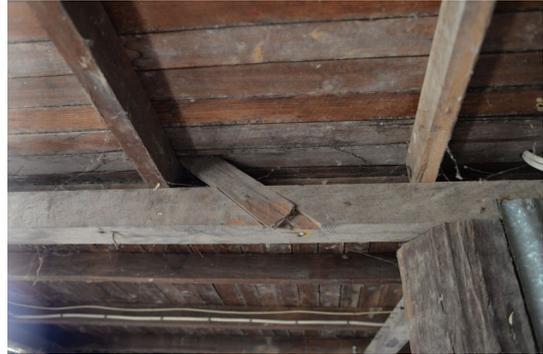
**Figure 22: Southwest facing view within lower-level storage / workshop area of Former Coffs Heights Post Office showing original framework and timber structure**

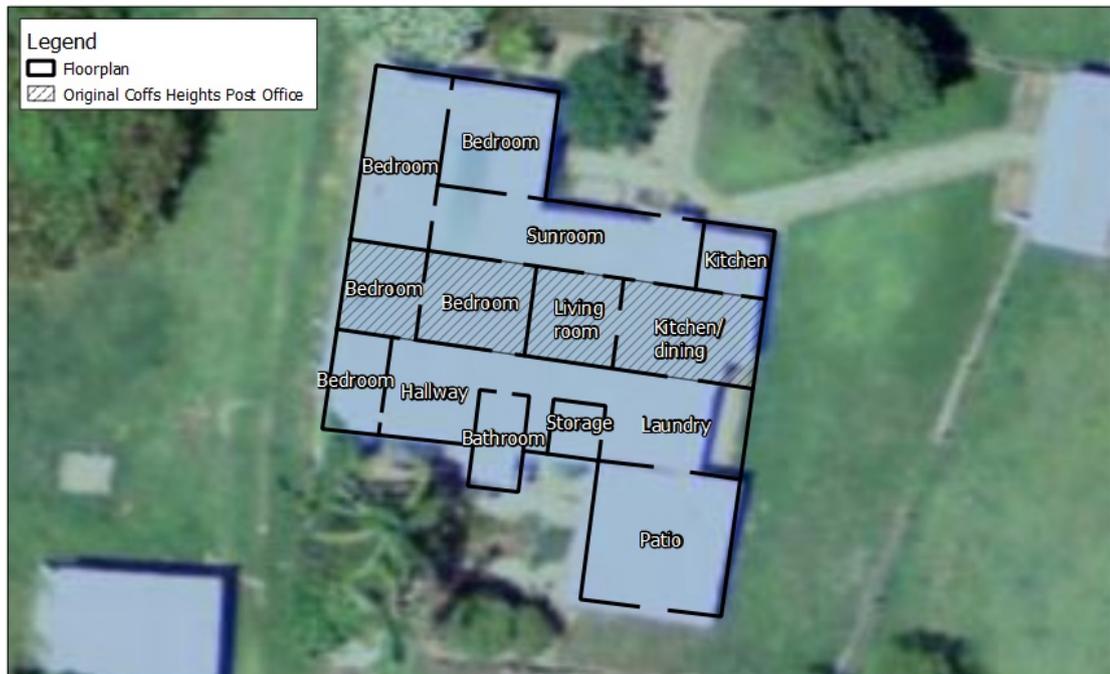
**Figure 23: Former Coffs Heights Post Office floorplan**

**Former Coffs Heights Post Office Floorplan**  
 20105 Coffs Harbour Bypass  
 LGA: Coffs Harbour

Scale: 1:180  
 Size: A4  
 Date: 12-10-2020
