# CONSTRUCTION MONITORING REPORT

NOVEMBER 2021 TO APRIL 2022

## Sydney Metro City & Southwest

### Package 5 & 6

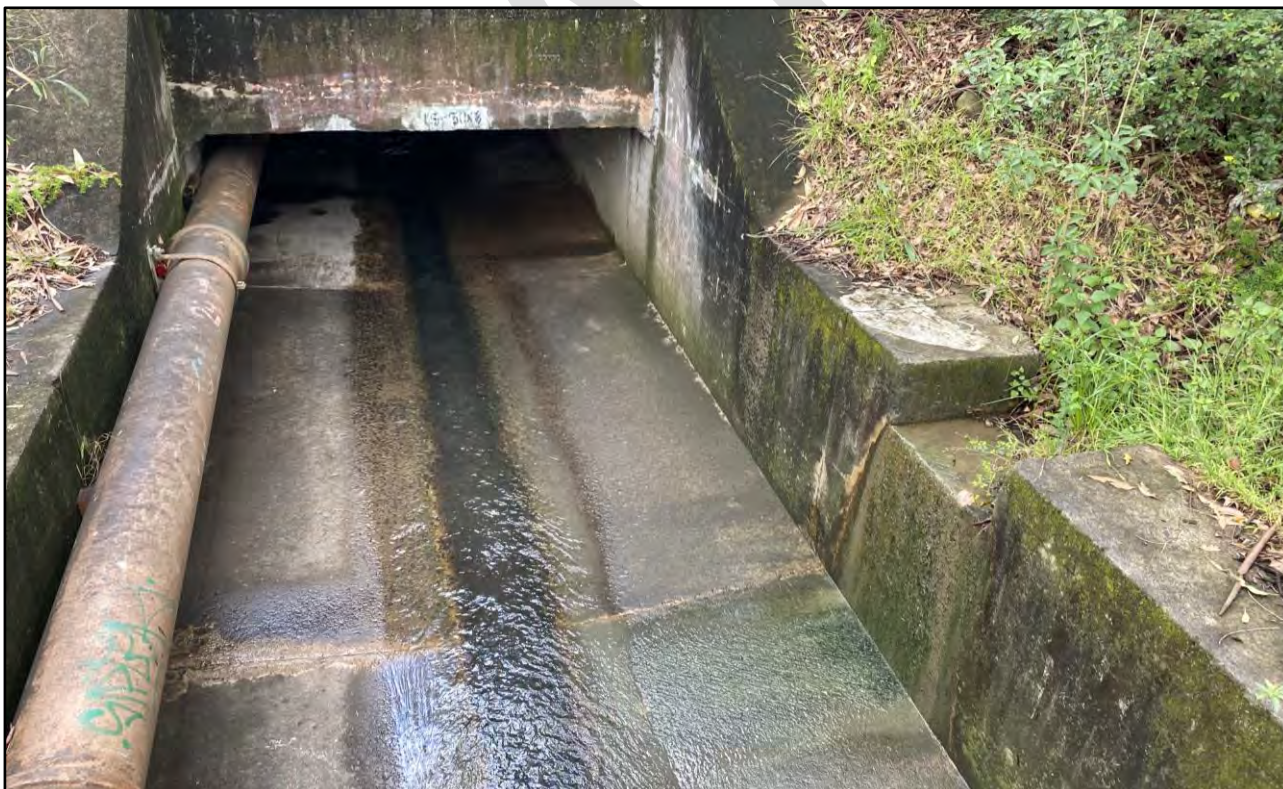
At the time of sampling, minor flow contribution was observed on discharge point (WP1-DP1) immediately downstream / north of WP1. For the downstream of work area, the two discharge points (WP2-DP1 and WP2-DP2) within the rail corridor immediately upstream / south from WP2 were having minor flow contribution.

**Photograph 2.** Discharge point (WP1-DP1) and observed to have contribution to the flow at the time of sampling. Date: 12 November 2021.

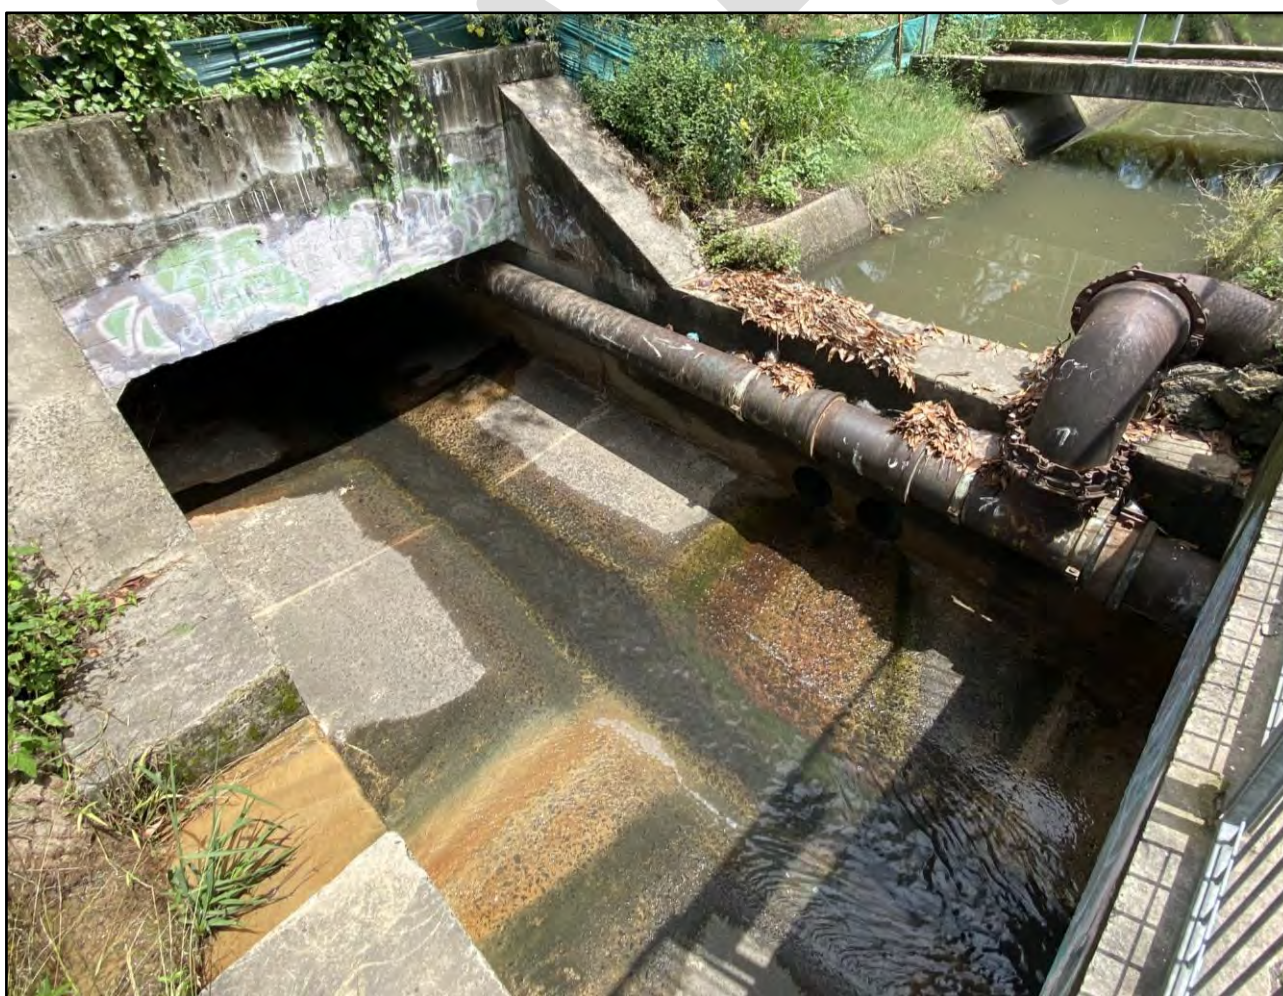
**Photograph 4.** Discharge points (WP2-DP1 and WP2-DP2) and observed to have contribution to the flow at the time of sampling. Date: 12 November 2021.

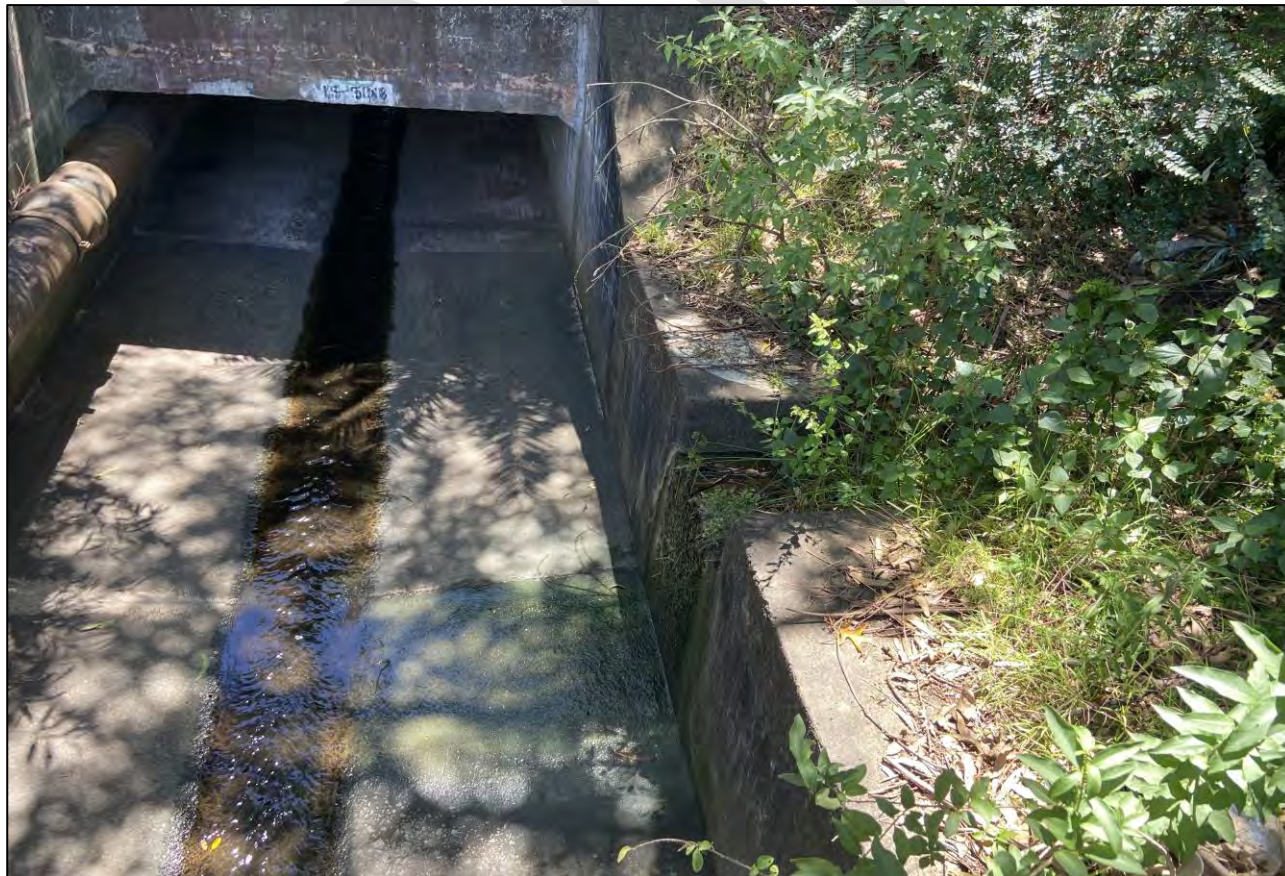
**Photograph 2.** No stormwater in-flow observed from the discharge point WP1-DP1 which was located within the rail corridor and immediately downstream / north from WP1 during the monitoring event – 09.02.2022.

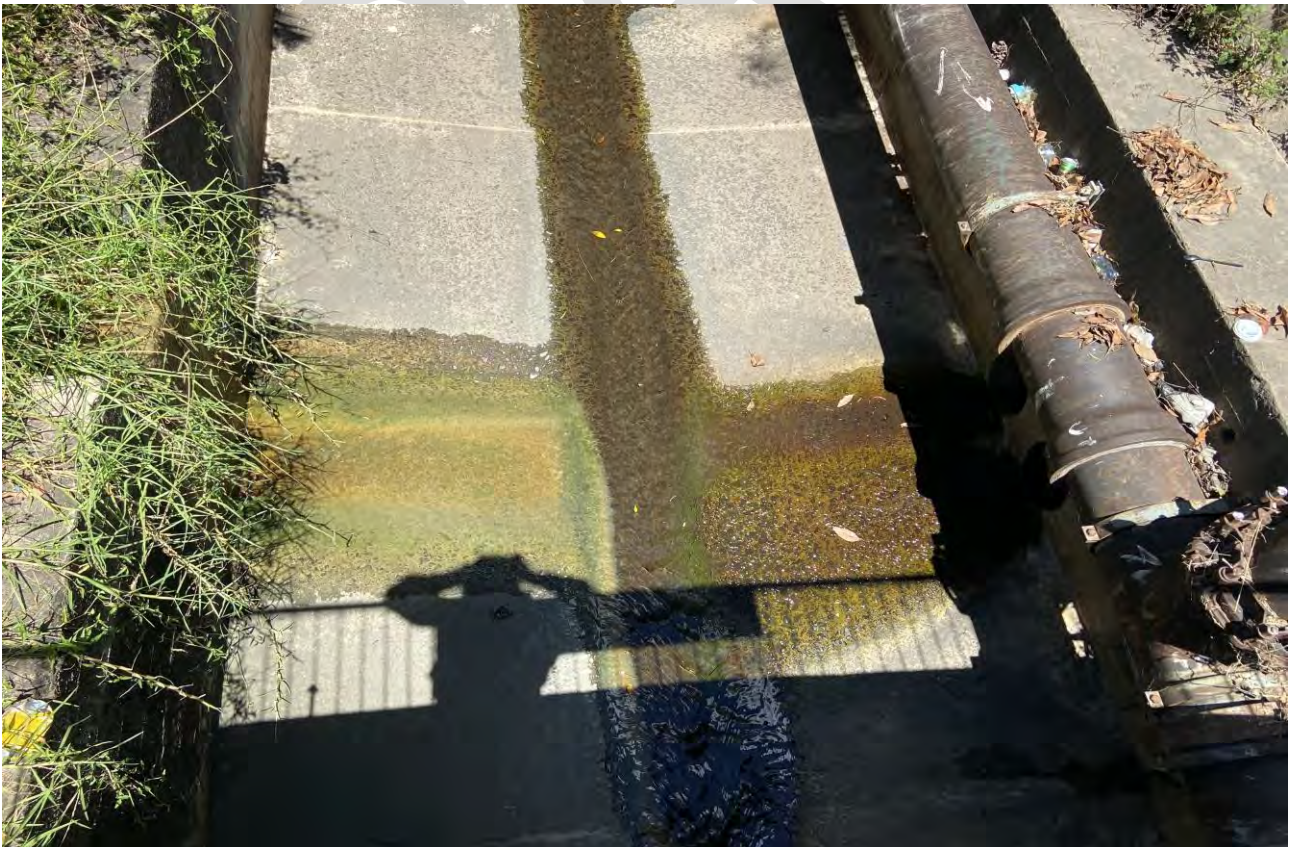
At the time of sampling, flow contribution was observed on discharge point (WP1-DP1) immediately downstream / north of WP1 (upstream of work area). The two discharge points (WP2-DP1 and WP2-DP2) within the rail corridor immediately upstream / south from WP2 also had flow contribution at the time of sampling.

**Photograph 4.** Minor stormwater in-flow observed from both discharge points WP2-DP1 and WP2-DP2 which were located within the rail corridor and immediately upstream / south from WP2 during the monitoring event – 09.02.2022

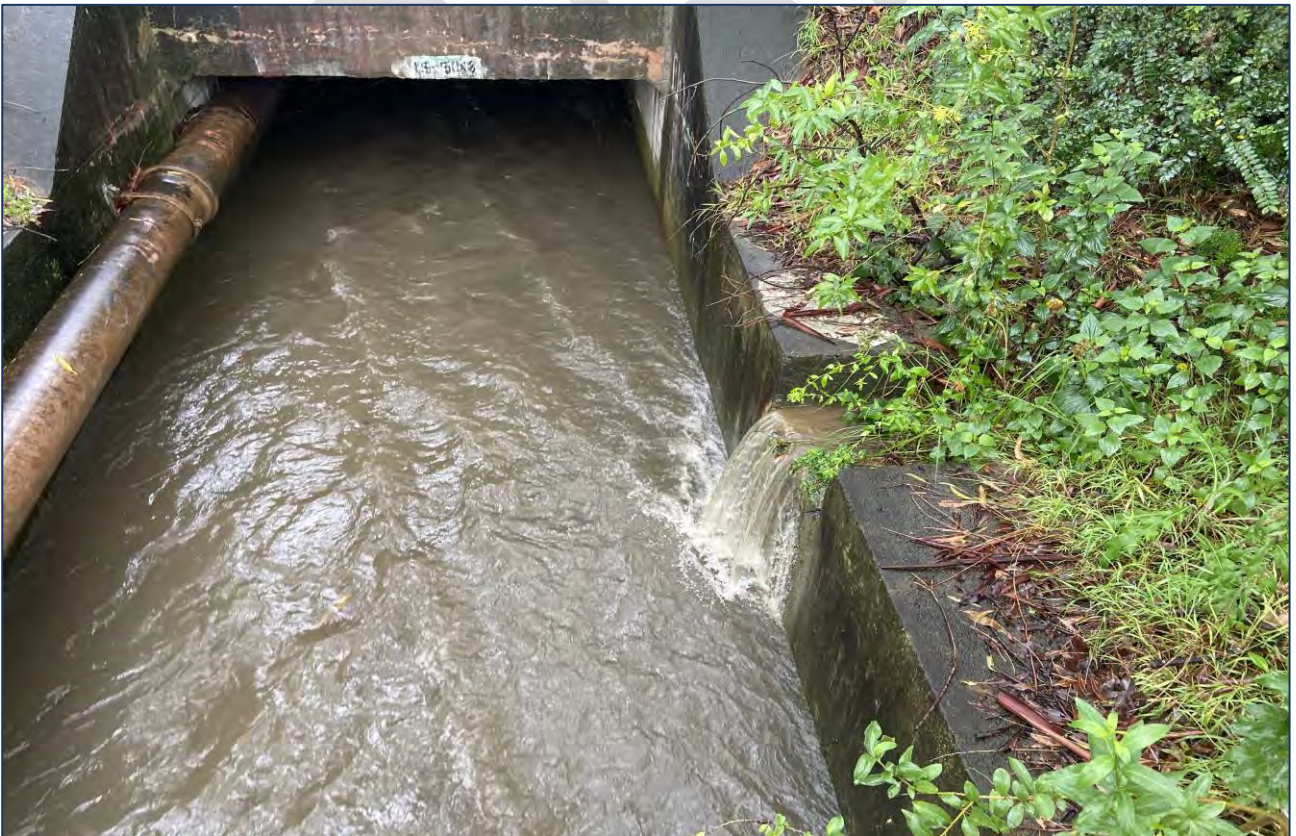
At the time of sampling, one discharge point (WP1-DP1) was observed immediately downstream / north of WP1 with high flow contribution to the stream. During the sampling event, the two discharge points (WP2-DP1 and WP2-DP2) within the rail corridor immediately upstream / south from WP2 were observed. High

**Photograph 2.** High stormwater in-flow observed from the discharge point WP1-DP1 which was located within the rail corridor and immediately downstream/north from WP1. Date: 23 February 2022.

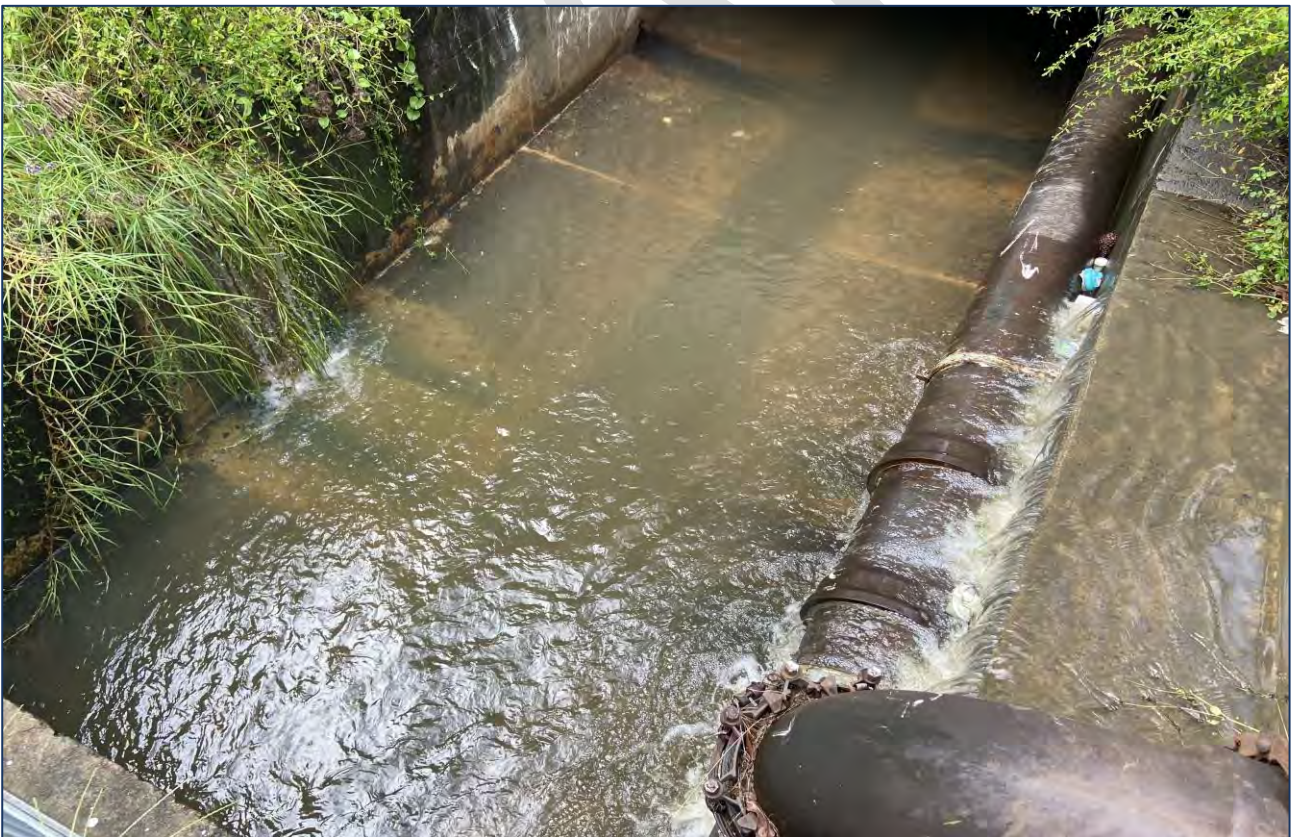
flow contribution from both discharge points were observed at the time of sampling. It is noted that WP2-DP2 was observed to have greater flow contribution than WP2-DP1.

**Photograph 4.** High stormwater in-flow observed from both discharge points WP2-DP1 and WP2-DP2 which were located within the rail corridor and immediately upstream/south from WP2. Date: 23 February 2022.

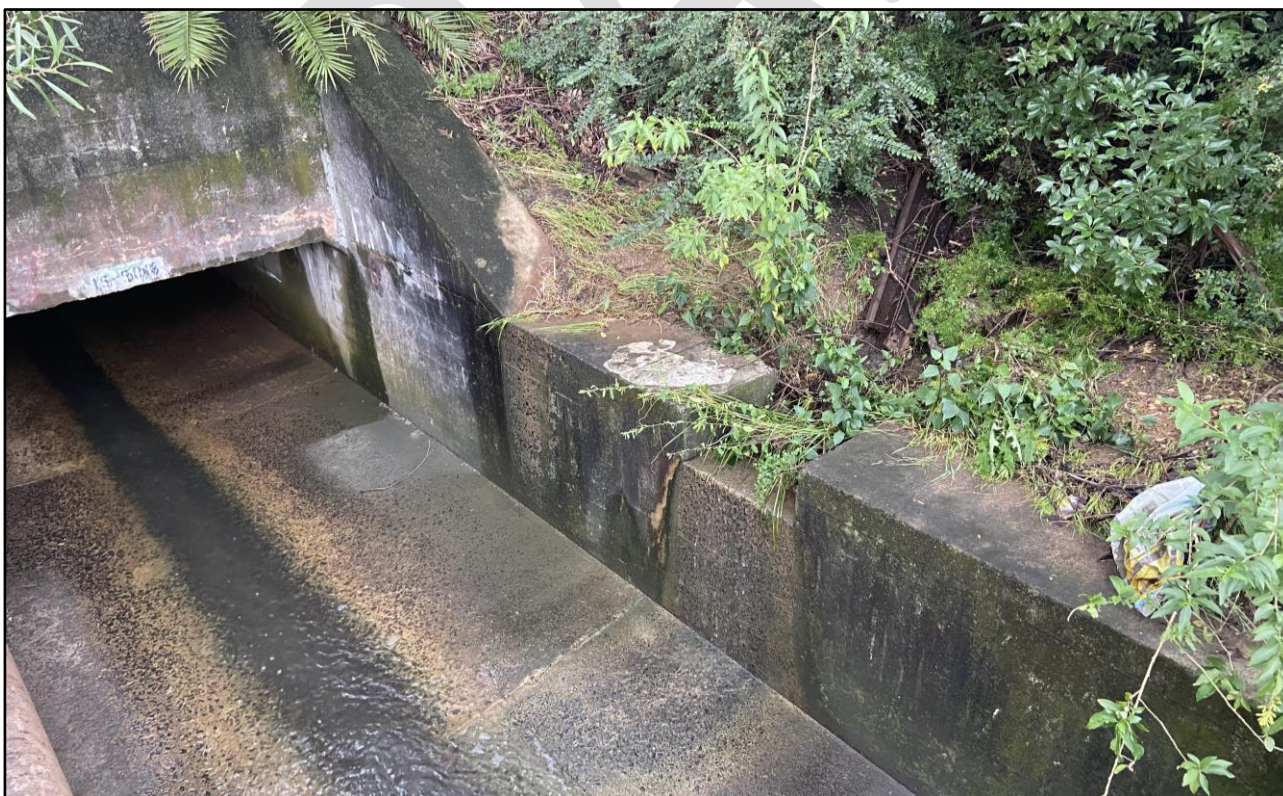
At the time of sampling, WP1 (upstream of work area) contained high flowing clear water with low turbidity, as well as WP2 (downstream of work area). One discharge point (WP1-DP1) was observed immediately downstream/ north of WP1. Medium flow contribution was observed at the time of sampling. For WP2 (downstream of work area), the two discharge points (WP2-DP1 and WP2-DP2) within the rail corridor immediately upstream / south from WP2 were observed. Medium level of flow contribution was observed from discharge point WP2-DP1 and high level of flow contribution was observed from discharge point WP2-DP2.

**Photograph 2.** Medium stormwater in-flow observed from the discharge point WP1-DP1 which was located within the rail corridor and immediately downstream/north from WP1. Date: 9 March 2022.

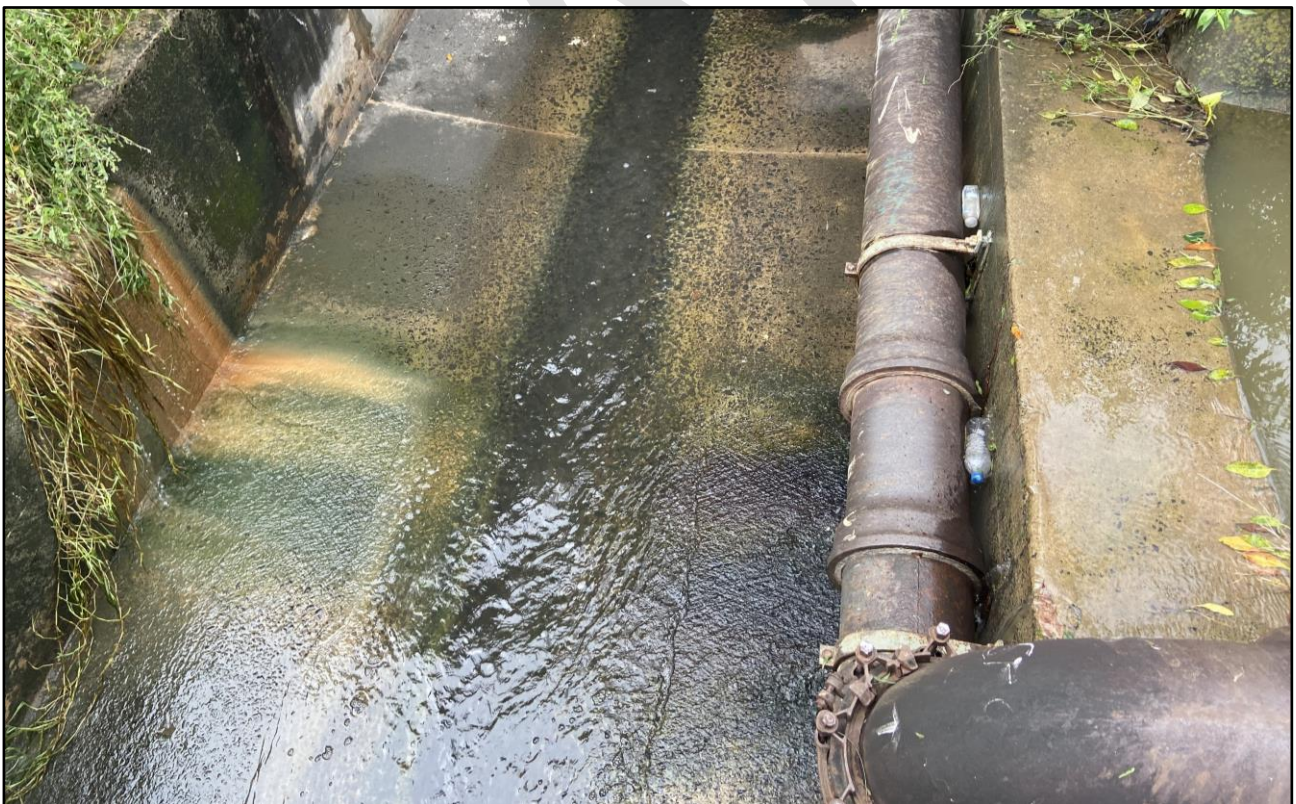
**Photograph 4.** Medium level of flow contribution was observed from discharge point WP2-DP1 and high level of flow contribution was observed from discharge point WP2-DP2. Date: 9 March 2022.

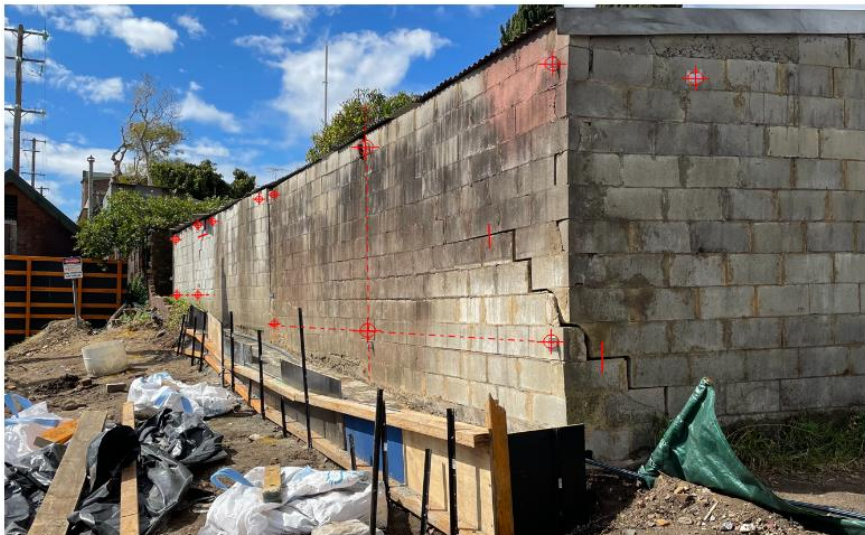
- Visually monitor the condition of the garage wall during construction activities on a daily basis
- Inspect and record results of the survey and crack gauge position on a daily basis during rock breaking activities otherwise weekly
- Should any vertical or translation movement exceed 3mm refer to Lindsay Dynan for review
- Should any crack width increase by 1mm or greater refer to Lindsay Dynan for review (Note: 1mm limit is based on a Very Slight damage category in accordance with AS 2870. Refer appendix A for further details)

— Denotes location and orientation for crack gauge (pack out and bond to blockwork) (3 locations)
