## Environmental Impact Statement – Chapter 22: Soils

# Warragamba Dam Raising

Reference No. 30012078  
Prepared for WaterNSW  
10 September 2021

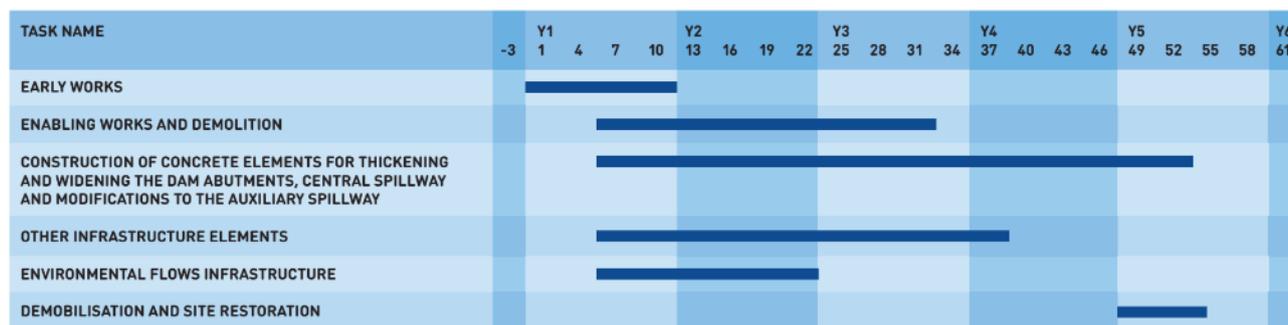
Figure 22-1. Preliminary construction program

A preliminary construction program is presented in Figure 22-1 with construction anticipated to be completed within four to five years.
