Environmental Impact Statement – Chapter 27: Water quality

Warragamba Dam Raising

Reference No. 30012078
Prepared for WaterNSW
10 September 2021

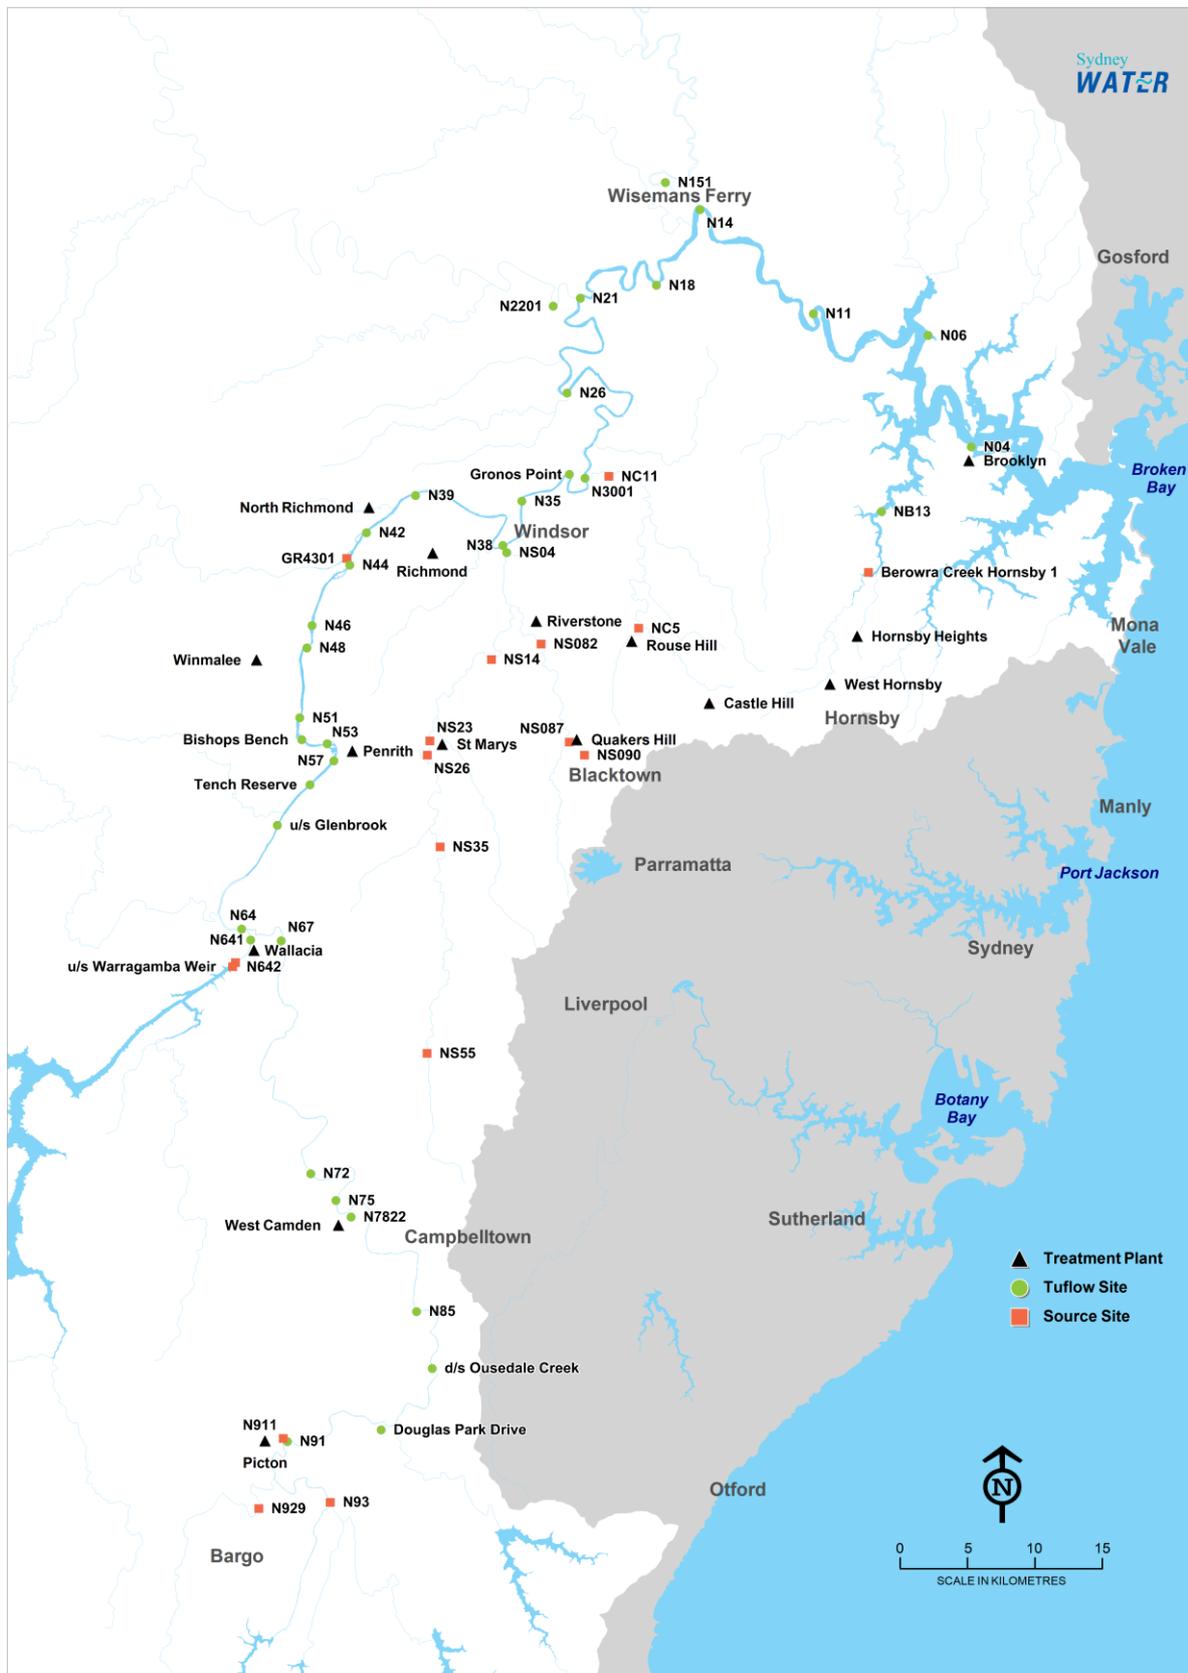
Figure 27-4. Model domain and output points of the NSW Government Hawkesbury Nepean Hydrodynamic Water Quality Model

Note: Tuflow sites are locations on the main river where water quality was modelled

Existing modelled scenarios from Hawkesbury-Nepean Hydrodynamic Water Quality Model were reviewed with the following six scenarios found to be relevant to the Project and were used in the assessment:

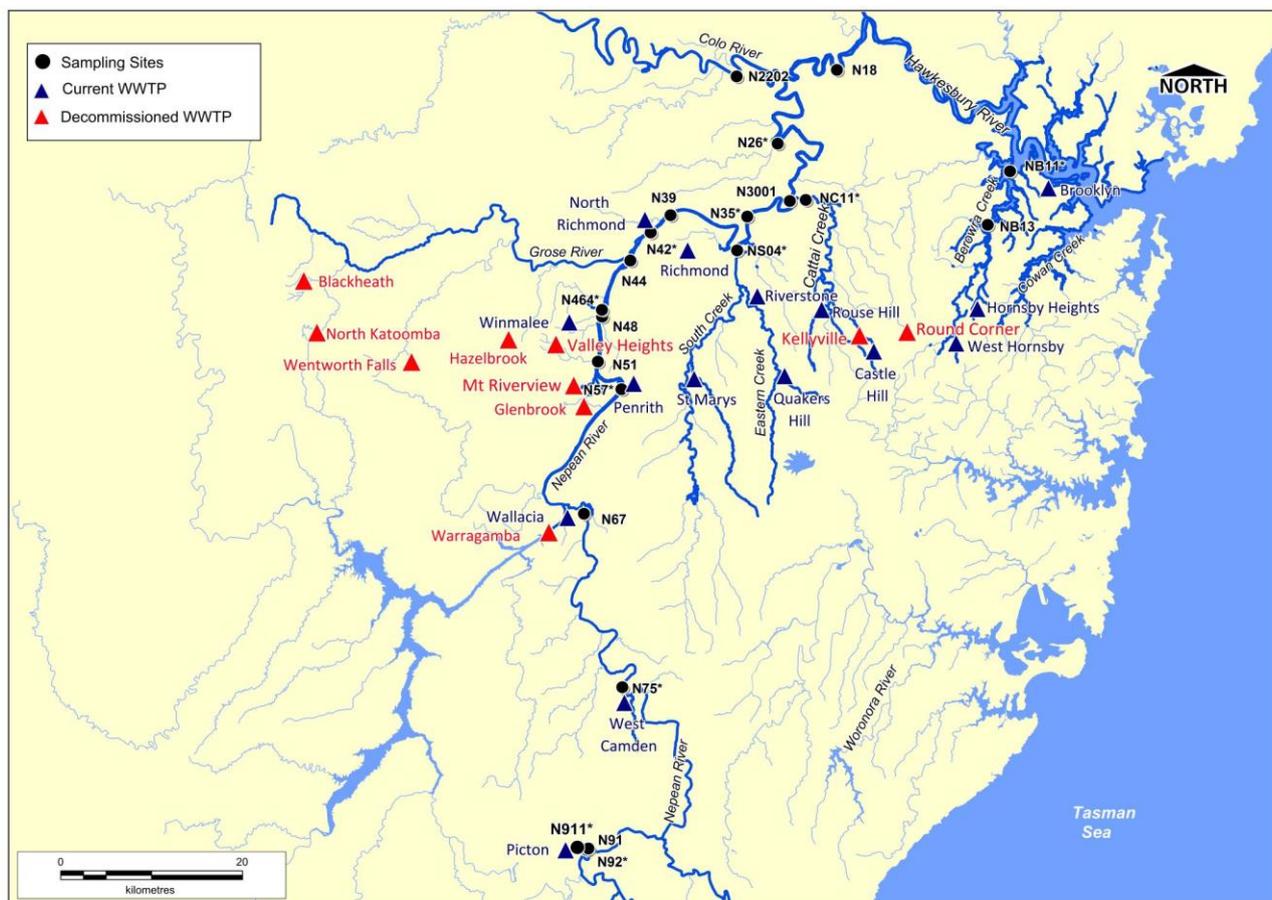
Figure 27-8. Key water quality monitoring sites monitored by Sydney Water as part of its Sewage Treatment System Impact Monitoring Program

Sydney Water undertakes water quality monitoring of the Hawkesbury-Nepean River and some of its tributaries for its Sewage Treatment System Impact Monitoring Program. Results from its Interpretive Report 2016-17 (Sydney Water 2018b) are summarised in the following sections. The sites monitored and the locations of WWTPs are shown in Figure 27-8.
