Environmental Impact Statement – Appendix K: Aboriginal Cultural Heritage Assessment Report

Warragamba Dam Raising

**Archaeological Assessment Report
Warragamba Dam Raising Project
Warragamba NSW**

Prepared by Niche Environment and Heritage | 9 September 2021

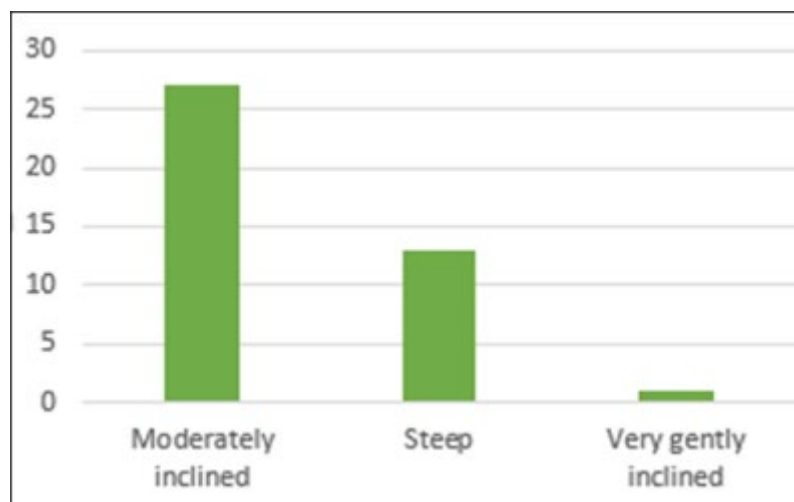
Chart 1. Distribution of sites in Dendrobium Area 5 and 6 (Niche 2018)

Biosis Research (2007) and Niche (2018) conducted extensive surveys of the Metropolitan Special Area for the Dendrobium Area 3 and Dendrobium Areas 5 and 6, a similar landscape to Warragamba Special Area. This study was located within the Avon and Cordeaux Dam catchment areas approximately 67 km south east of the Subject Area. Aboriginal sites within Metropolitan Special Area are mostly located within the moderate to steep slope classes. Niche (2018) lists 33 of the 41 sites located within the AHIMS search area of this project being located on moderate to steep slope classes. In this case moderately inclined slopes are defined as slopes of between 5.75 and 18 degrees, steep is defined as between 18 and 30 degrees. This study suggests that in the Subject Area that high numbers of Aboriginal sites may be present on moderate to steep slope classes, although not many Aboriginal sites have been recorded to date due to the lack of extensive survey. Dendrobium Area 3 and Dendrobium Areas 5 and 6 have been extensively surveyed and do not have a bias in areas surveyed compared to areas not surveyed. This is shown in the histogram below that clearly indicates that Aboriginal sites are found in high frequency on moderate – steep slope classes. Slope analysis and distribution of sites per slope gradient for Dendrobium Area 3 and Dendrobium Areas 5 and 6 are outlined in Chart 1.

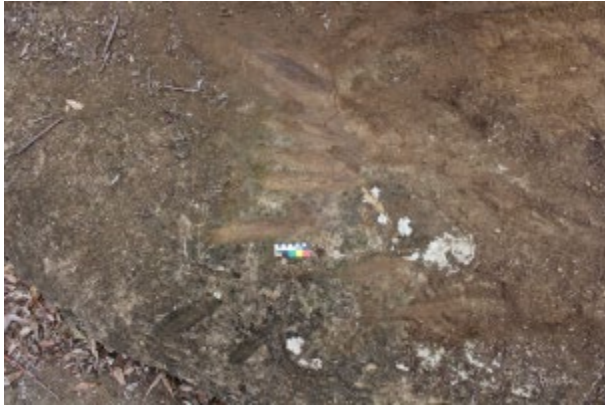
Plate 11: Detail of Axe Grinding Grooves at Joorilan Creek (AHIMS ID#52-1-0045)

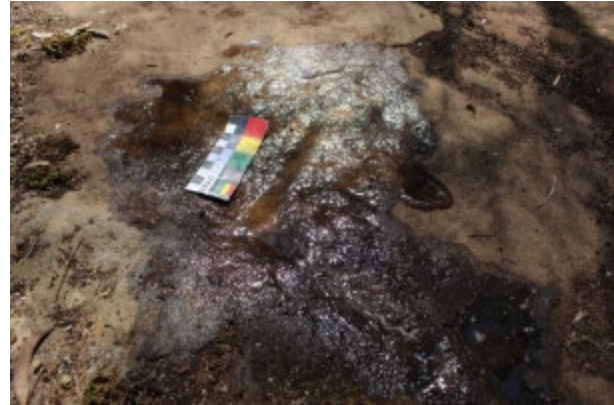
Plate 12: Detail of Axe Grinding Grooves at Warragamba-228

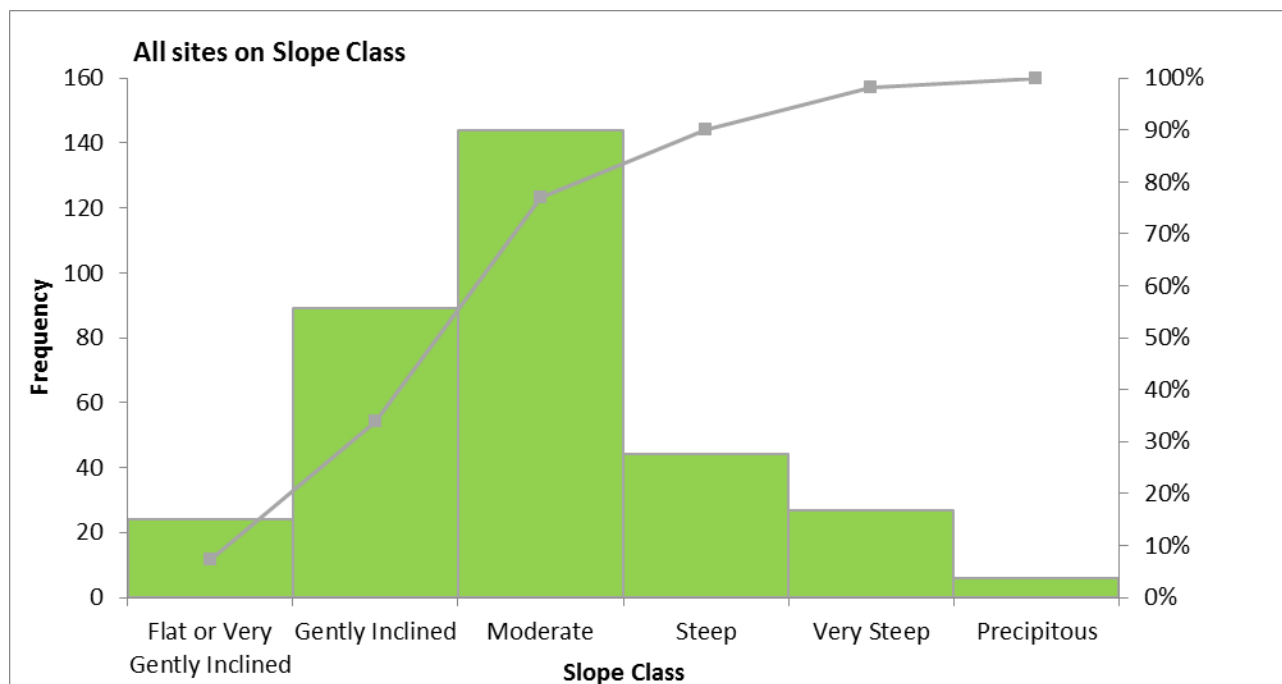
Chart 2: Number of sites per slope gradient class for the Warragamba survey

Chart 2 demonstrates that 144 of the 334 sites located during the assessment (highlighted in Figure 17) are located on the moderately inclined slopes. These moderately inclined slopes represent a slope class where both sandstone rockshelter sites and open artefact sites both occur frequently, and these two site types are the most frequent sites found within the Survey Area (Table 41).

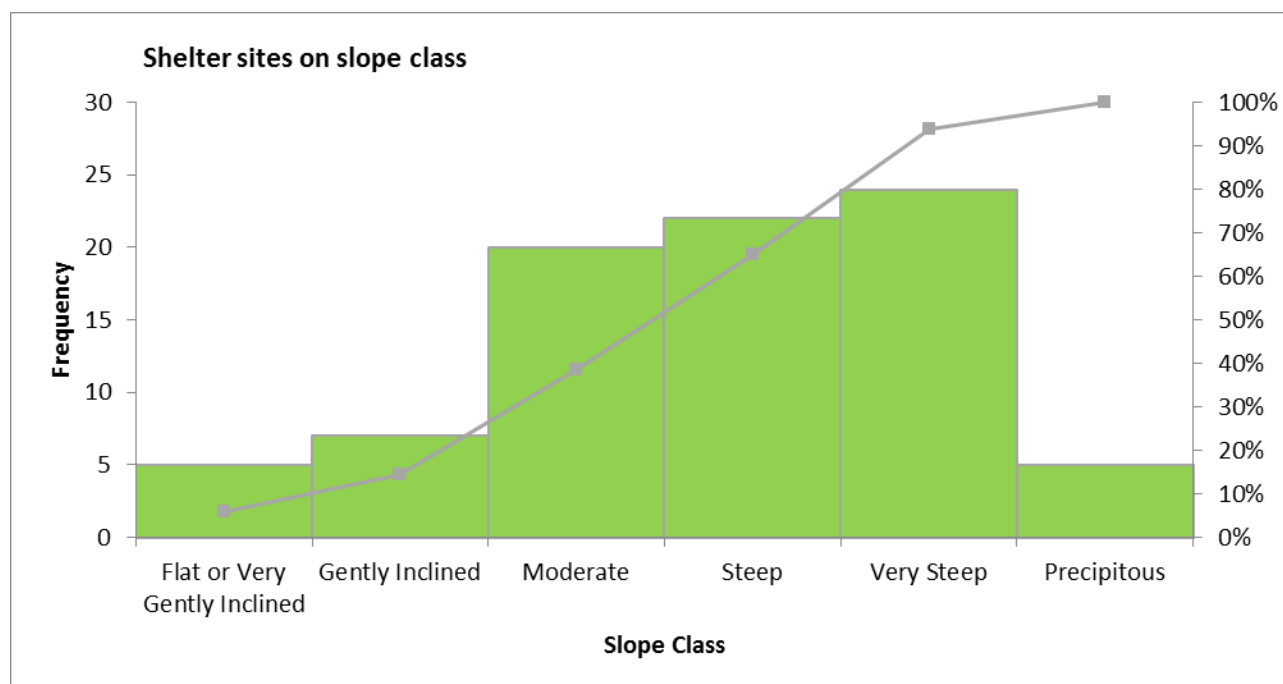
Chart 3: Number of shelter sites per slope gradient class for the Warragamba survey

sites per slope gradient in Chart 3 and Chart 4 supports the predictive model for the project as to where Aboriginal sites are likely to be located based on slope analysis.

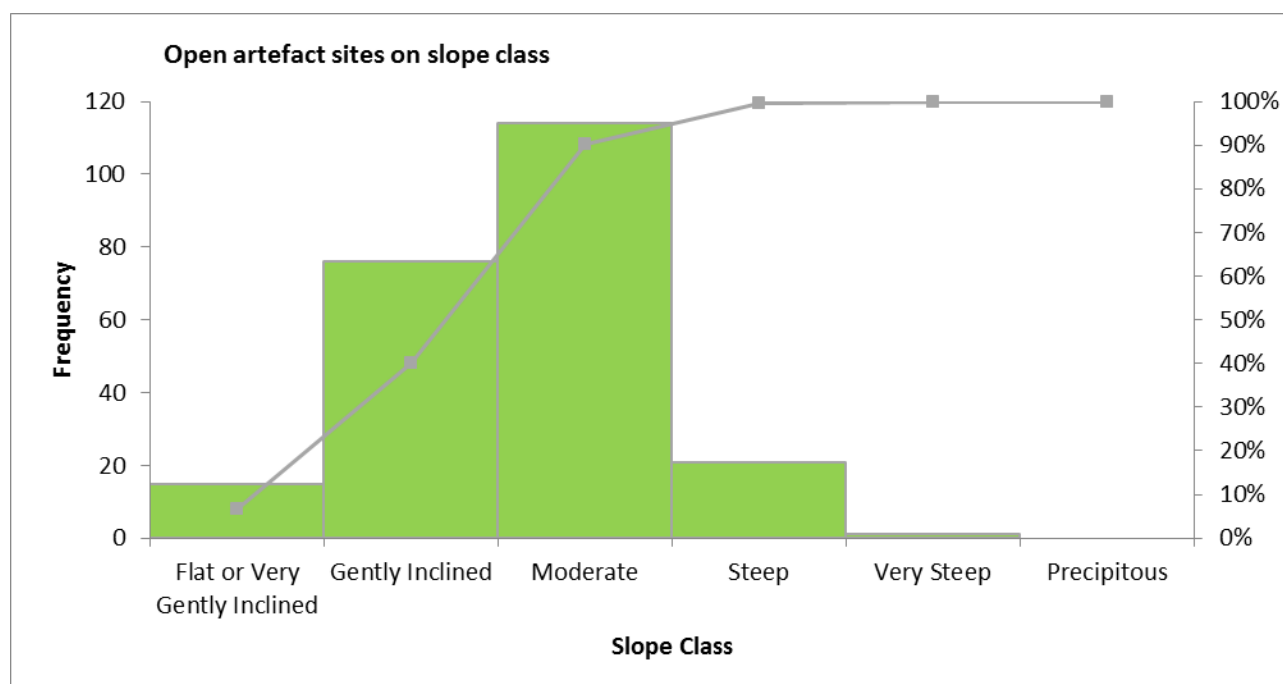
Chart 4: Number of open artefact sites per slope gradient class for the Warragamba survey

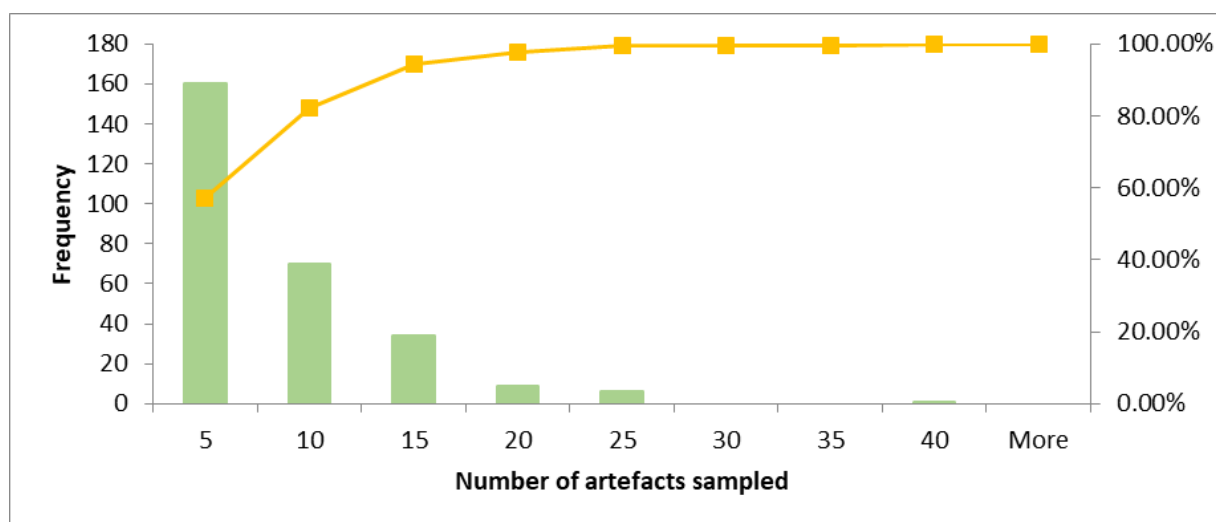
Chart 5: Histogram of the number of artefacts sampled at sites during the surveys.

A total of 1765 artefacts had their attributes recorded during the surveys. Artefacts were sampled from both open sites and rockshelters. The sample represents 1348 artefacts from 217 open sites, and 417 artefacts sampled at 63 rockshelter sites. The sites where artefact attributes were recorded included both new sites, and sites that were already recorded. The highest estimated number of artefacts at a site was greater than 300 and the highest sampled number of artefacts at a site was 38 artefacts at Warragamba-258, while the lowest sampled number at a site was one, with many sites containing only one visible artefact at the time of survey. The average number of artefacts sampled at a site was 6 artefacts, with 80% of sites having 10 artefacts or less sampled, as shown in Chart 5.

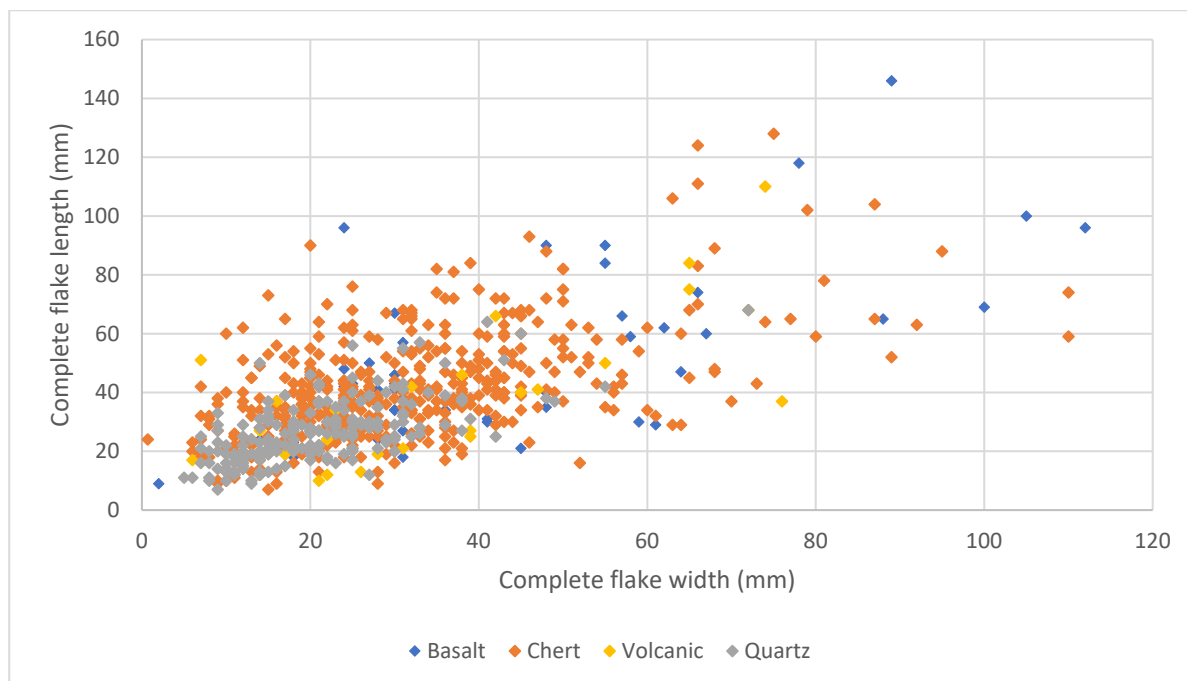
Chart 6. Scatterplot of length versus width for complete flakes of main raw material types

However, one thing that is apparent from Chart 6 is that quartz was used to make smaller artefacts than the other raw materials. This possibly reflects the raw material cobble size of the quartz being smaller, and also possibly that quartz flakes less consistently than fine grained basalts and cherts, so it cannot be worked to flakes consistently larger than 40 mm in either length or width (Table 46).

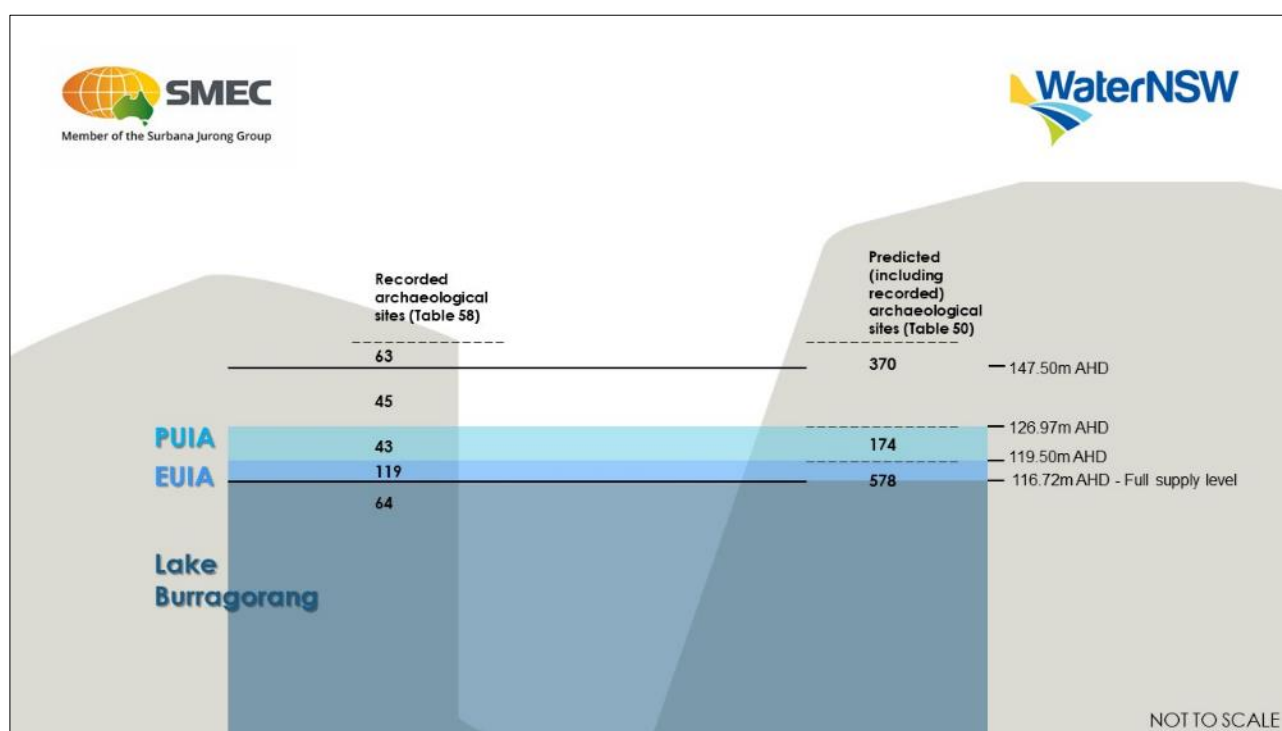
Diagram 2. Distribution of archaeological sites across the Survey Area.

Of the 334 new and previously registered on AHIMS Aboriginal cultural heritage sites identified during this assessment a total of 43 sites are located within the PUIA. In addition to these 43 sites a further 45 sites are within the Subject Area. A further 246 sites were identified as being outside the Subject Area (n=63) or in the EUIA (n=183).

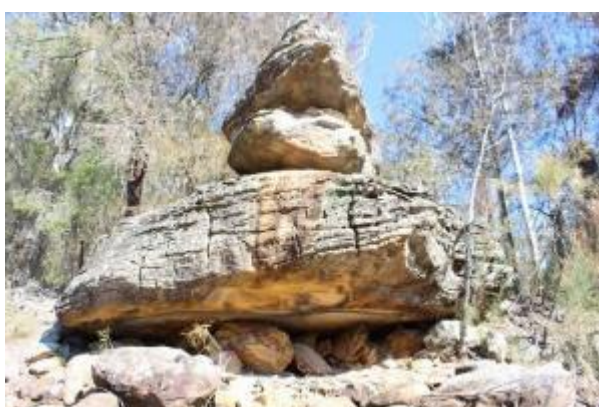
Plate 28: Warragamba 16 this site appears to have been subject to water wash and mineralisation from continuous fluctuations in the water levels of Lake Burragorang, and as such is in a very poor state of preservation.

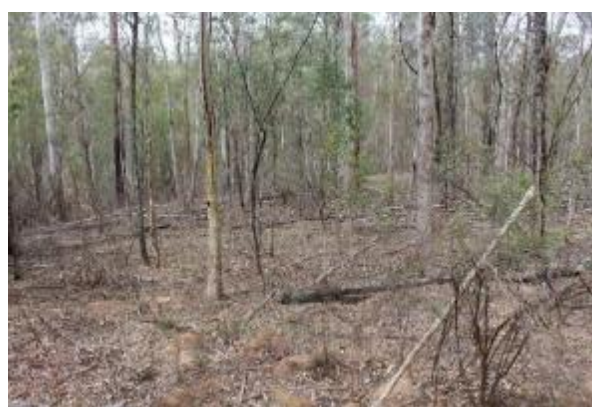
Plate 29: RC 1AHIMS ID# 45-4-0967 demonstrates an example of a previously registered Aboriginal site comprising of an Open Camp Site that falls within the FSL. The original site card listed three areas with numerous artefacts. Only five artefacts were relocated during this assessment.
