Environmental Impact Statement – Chapter 18: Aboriginal Cultural Heritage

Warragamba Dam Raising

Reference No. 30012078 Prepared for WaterNSW 10 September 2021

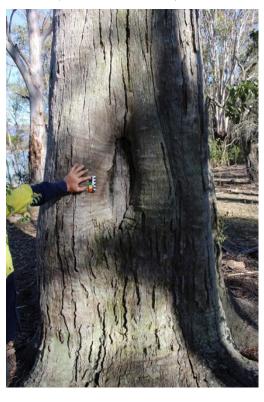
Photo 18-11. General view of scarred tree at Tonalli Cove 2 (AHIMS ID#52-1-0131)

Five (5) sites were recorded that comprised only of scarred trees and were not associated with another feature. There are no sites within the PUIA. Details are provided in Appendix K (ACHA, Appendix 1, Table 32 & 33; and Appendix 5).
