# Preferred Infrastructure Report

Warragamba Dam Raising

Application Number	SSI-8441
EPBC ID Number	2017/7940

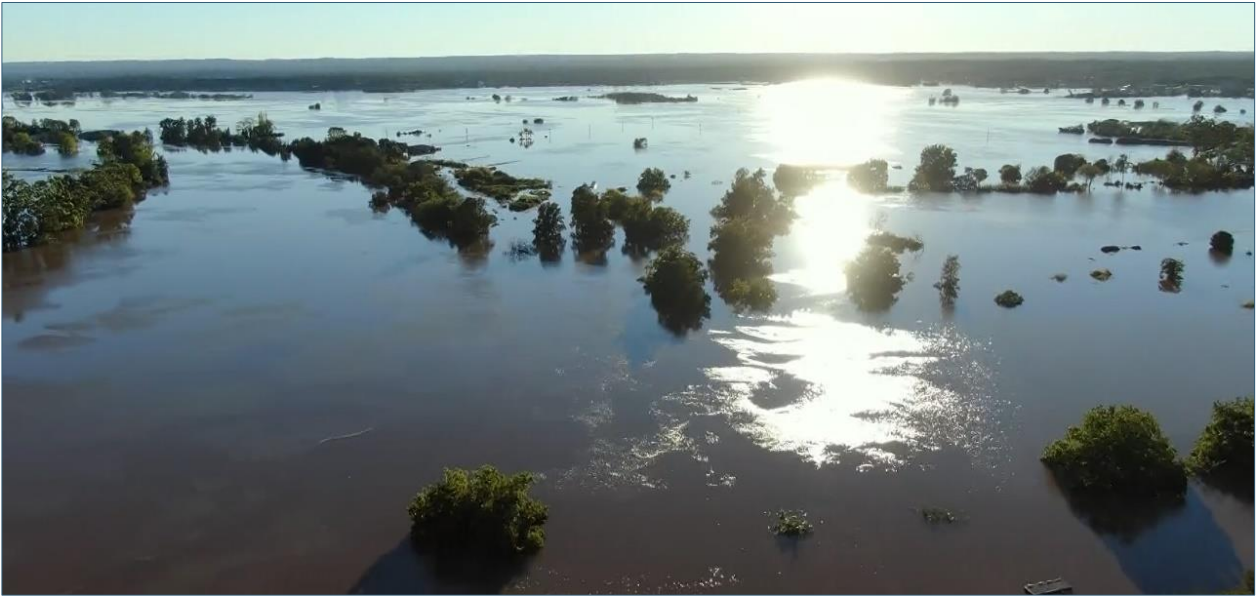
Photo 1 2021 and 2020 (similar to 2021 flood with Project) floods - North Windsor looking north

These changes are shown on Photo 1, Photo 8, Figure 7 and Figure 8.

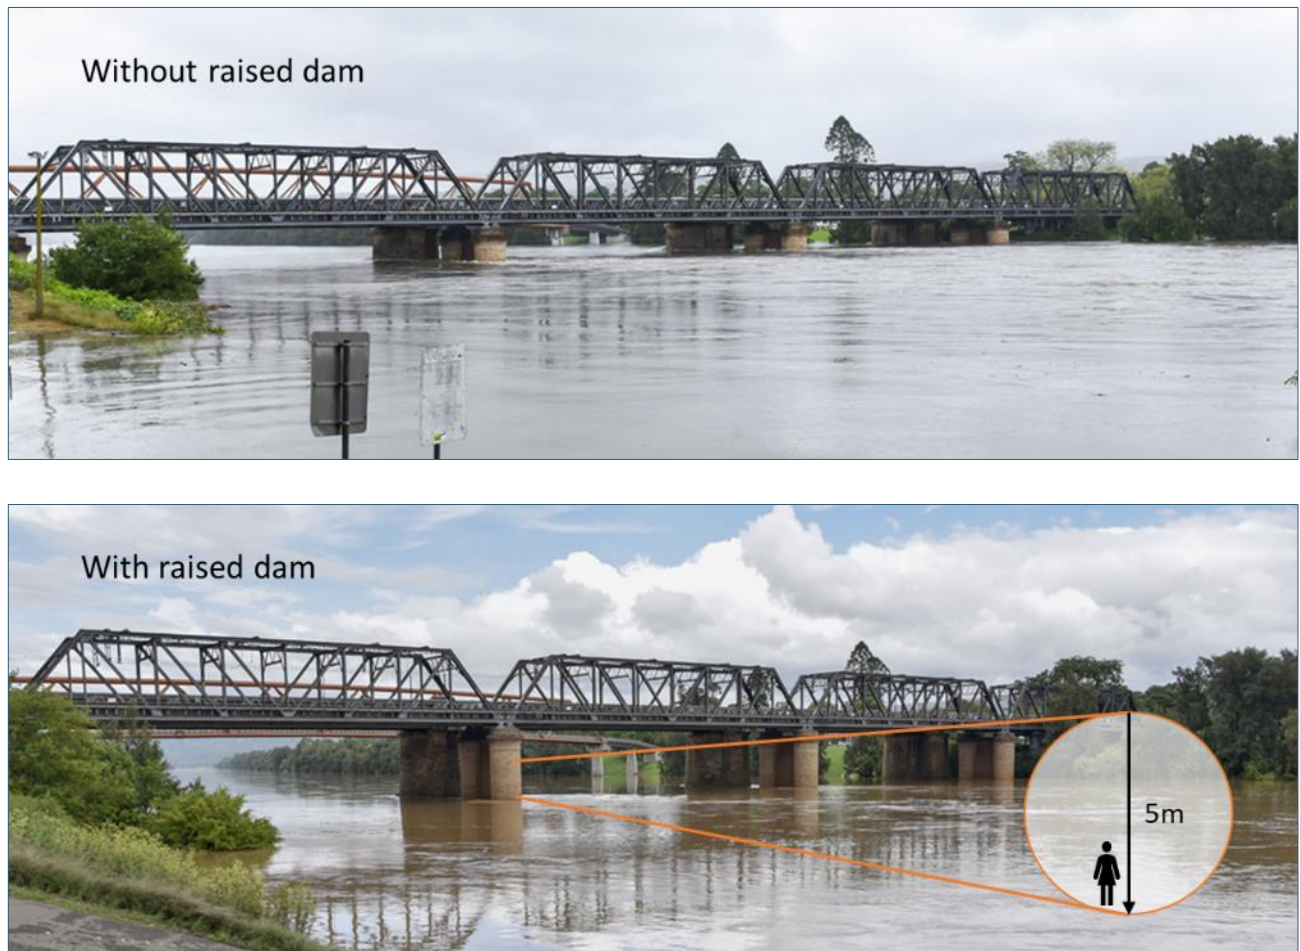
Figure 8 2021 flood - Victoria Bridge at Penrith near the peak of the March 2021 flood

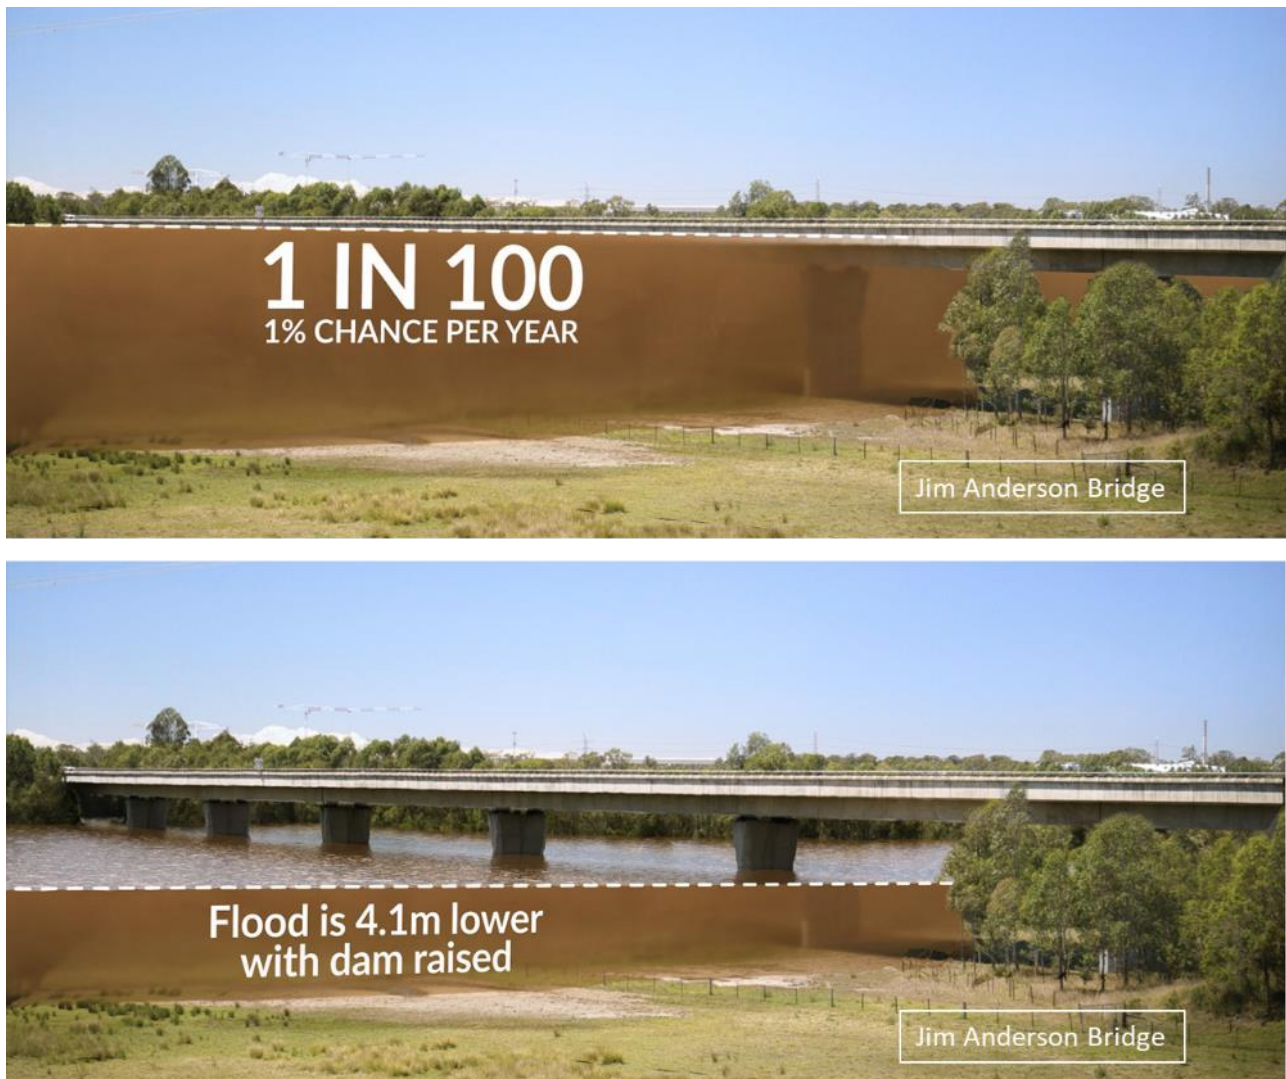
Figure 9 Jim Anderson Bridge (Windsor) 1 in 100 chance in a year flood – without and with raised dam

Note: Modelling of reduction in 1 in 100 chance per year flood level by WMAwater for INSW

Project mitigation is shown on Figure 9 and Figure 10.

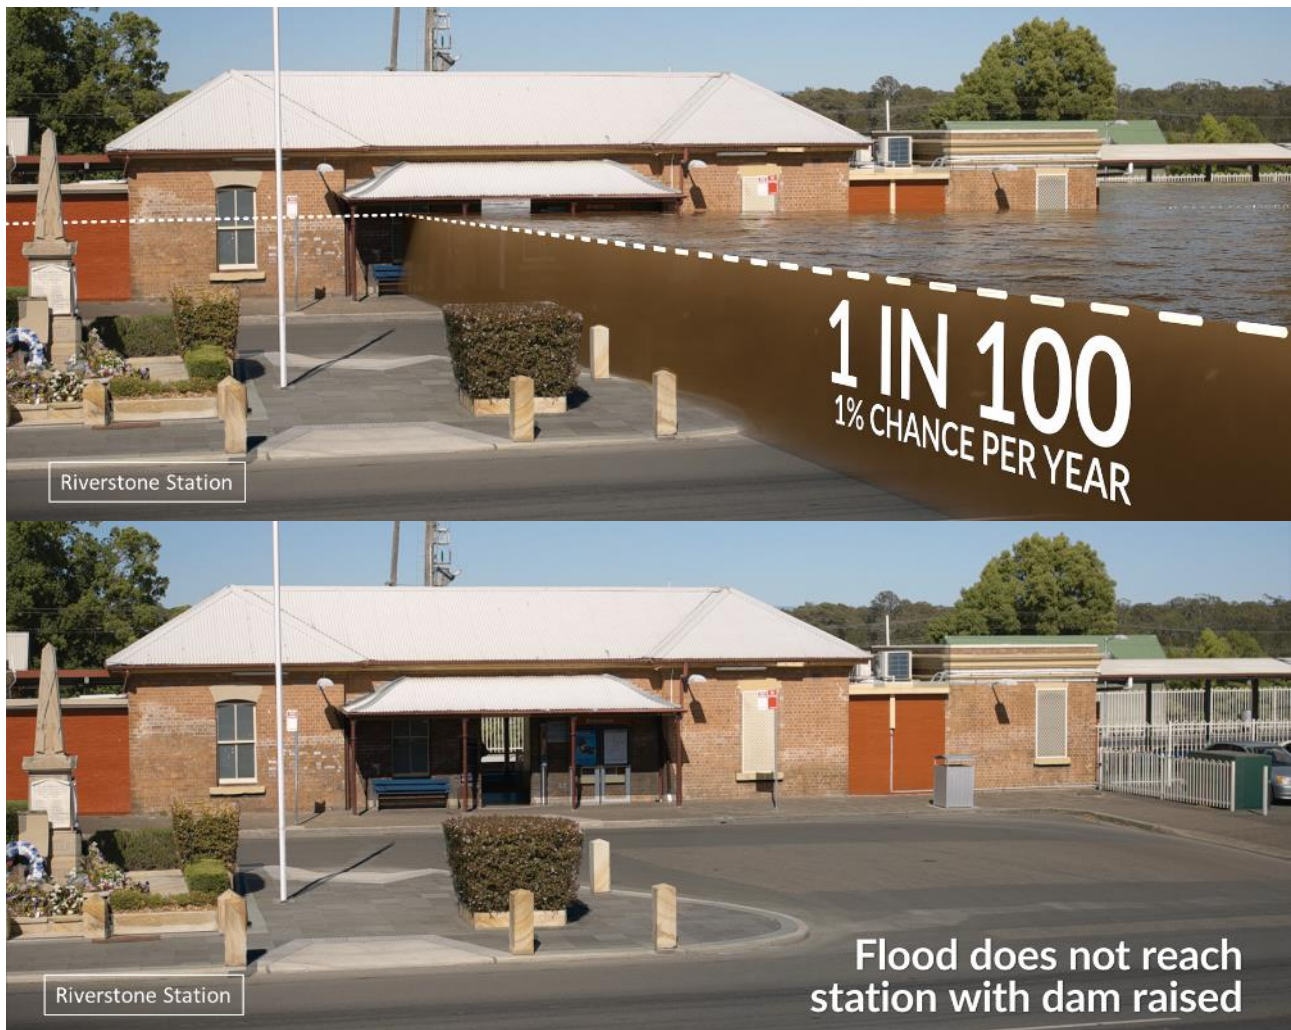
Figure 10 Riverstone Station in a 1 in 100 chance in a year flood – without and with raised dam

Note: Modelling of reduction in 1 in 100 chance per year flood level by WMAwater for INSW

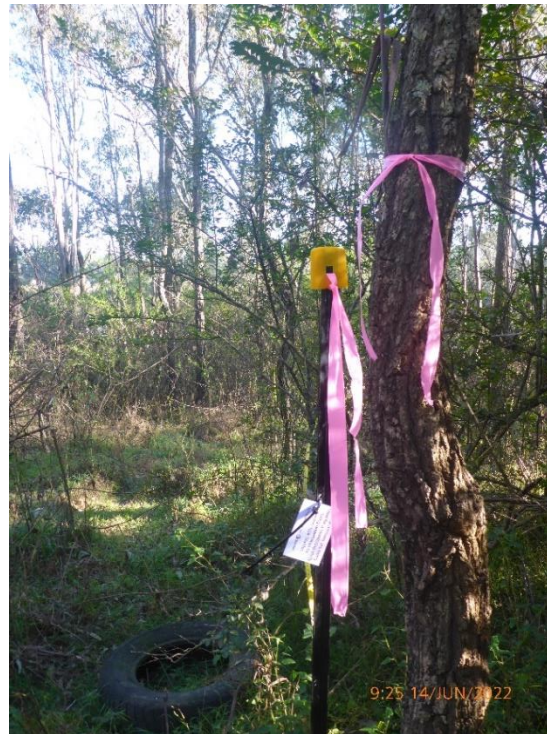
At each plot location any additional observations, such as flood debris height and quantity, and the presence of anthropogenic litter, were also noted. A marker was placed at the start of each vegetation plot to assist in ensuring the repeatability of any future investigations. An example is illustrated below.

**Plate 2-1:** Example marker used for plot identification within the Site

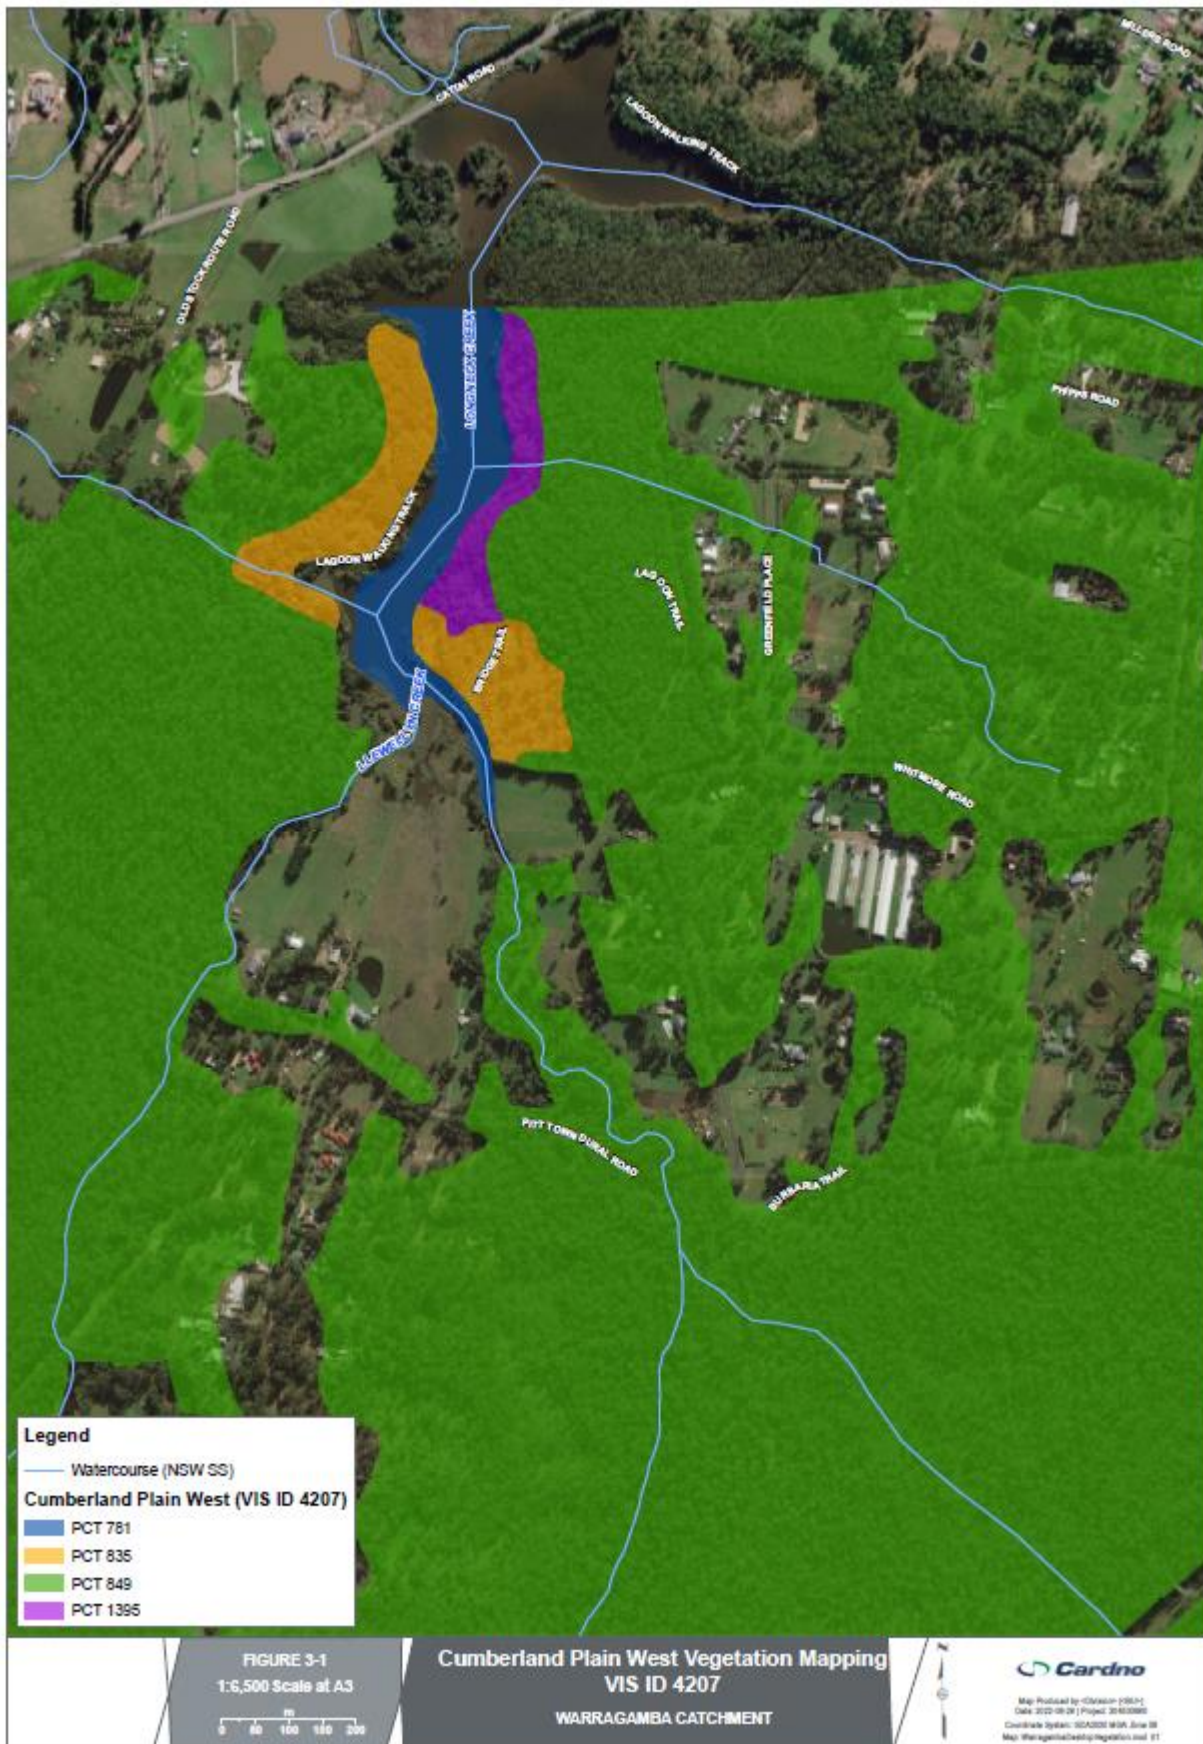
Figure 3-1 Vegetation Mapping – Cumberland Plain West Vegetation Mapping (VIS ID 4207)

The Cumberland Plain West (VIS ID 4207) vegetation mapping indicated that there were four PCTs expected to occur within the Site. The PCTs and associated TECs are defined in **Table 3-1** and illustrated in **Figure 3-1**.

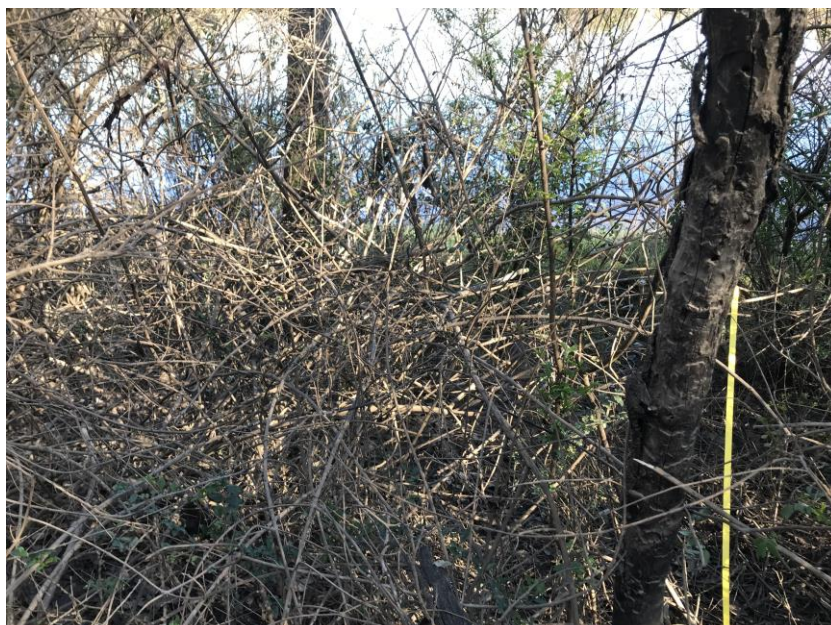
**Plate 3-1** Accumulation of woody debris in Plot 1

- > An increase in leaf litter moving along the 50m transect towards the lagoon, particularly in Plot 1, where leaf litter cover was observed at 100% in litter plot 5, and Plot 3.
- > Abundant flood debris across all affected plots, including woody debris, such as fallen shrubs and branches, and grassy debris accumulated at tree bases.
- > Anthropogenic litter, including bottles, cans, and household items, in Plots 1 and 5.
- > The detection of a pine cone nearby to Plot 5, where no nearby mature pine tree was noted. This observation highlights the potential for exotic weeds to be introduced or spread during periods of inundation.
- > Accumulated debris and silt marks up to 2-3 m in height in Plots 1, 5 and 8.
- > An abundance of dead shrubs, particularly in Plots 1 and 5.

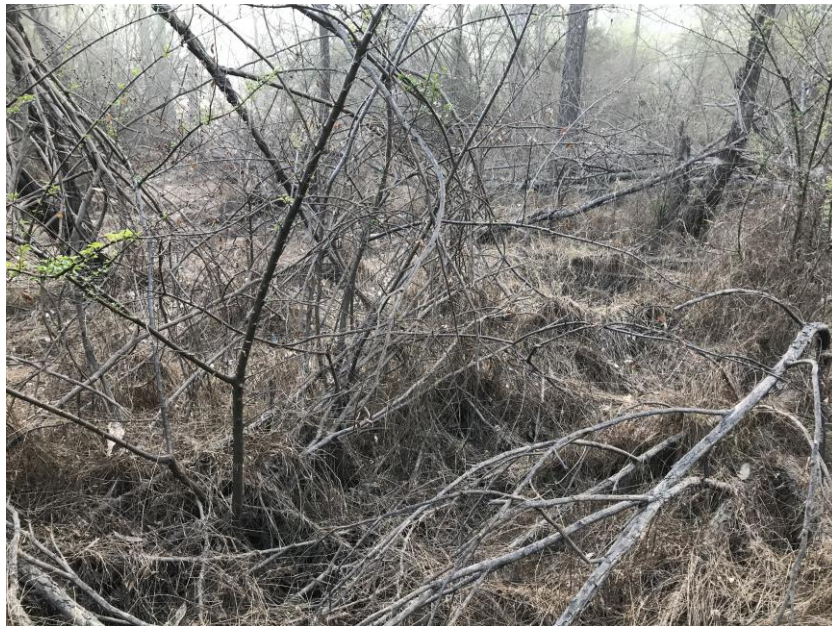
**Plate 3-2** Accumulation of woody debris and grasses in Plot 5

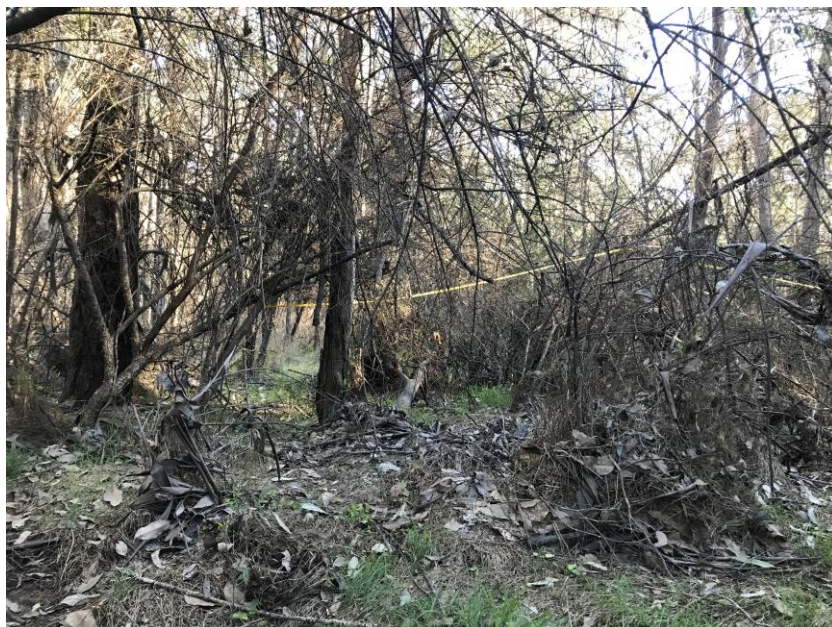
**Plate 3-3** Accumulation of woody debris and grasses in Plot 8

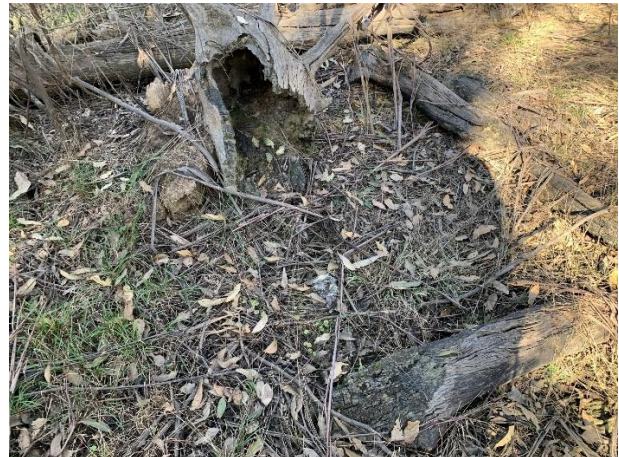
**Plate 8: Example of saturated soils at LN 18 (AHIMS ID# 45-5-0656). Reduced stratigraphic integrity of upper soil horizons due to intermixing of soils during inundation**

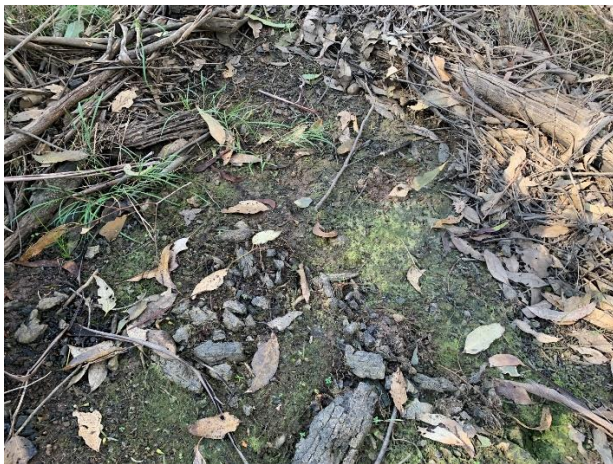
**Plate 10: Example of waterlogged soils and algae growth in the vicinity of LN 12 (AHIMS ID# 45-5-0650)**

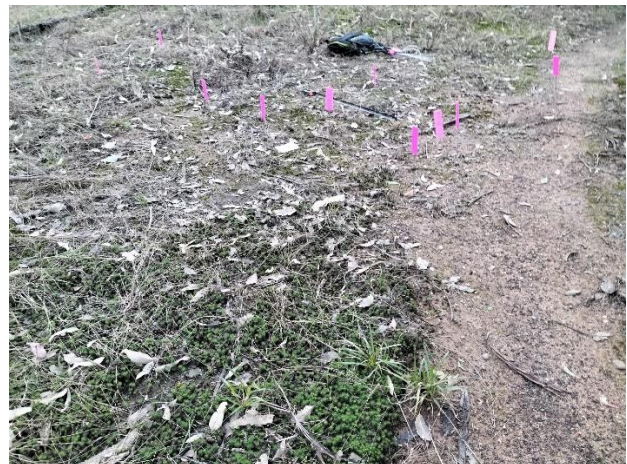
**Plate 11: Example of redeposited soils within western portion of LN 15 (AHIMS ID# 45-5-0653). Note the slight slope downwards towards west side of the track**

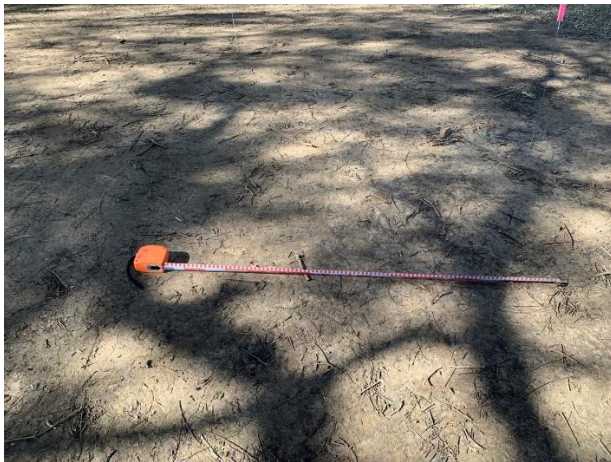
**Plate 12:** Example of sheet wash in an area of exposure at WD 7 (AHIMS ID# 45-5-2739). Artefacts were firmly embedded within the soil deposit

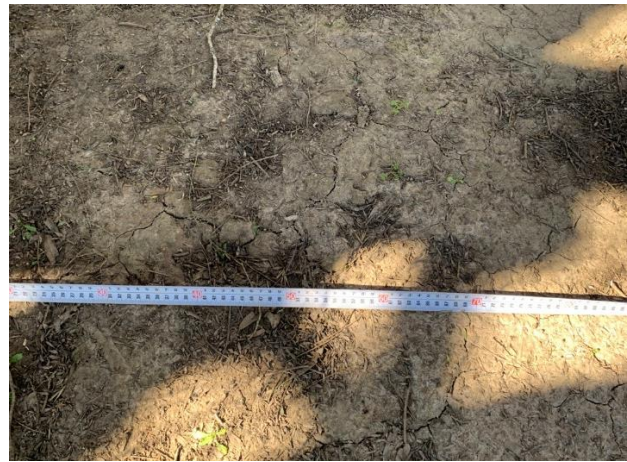
**Plate 13:** Example of surface cracking at WD 7 (AHIMS ID# 45-5-2739). The prolonged suspension of the upper soil horizon has resulted in an intermixing of soils. As flood waters receded, cracking has resulted

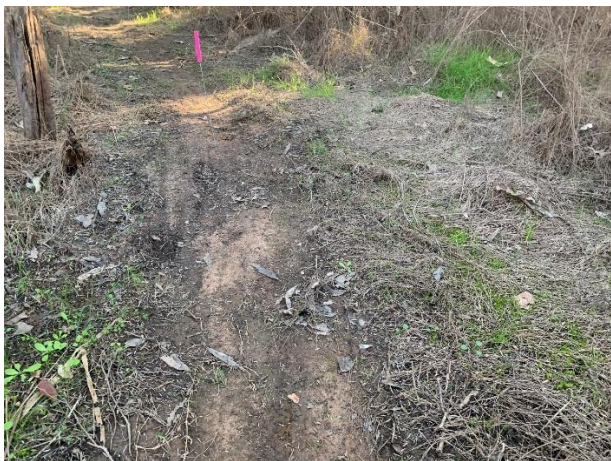
**Plate 14:** Example of minor sheet and rill erosion observed along the access track at LN 17 (AHIMS ID# 45-5-0655). No surface runoff of soils was observed at the boundary of the access track in this area

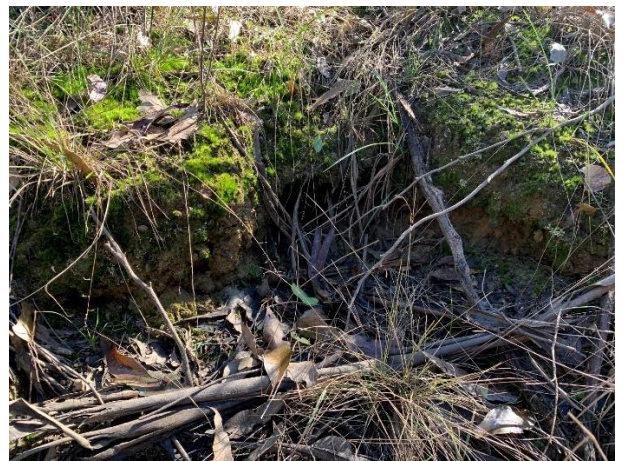
**Plate 15:** Example of bank erosion on the western side of creek at LN 12 (AHIMS ID# 45-5-0650) likely due to local catchment run-off

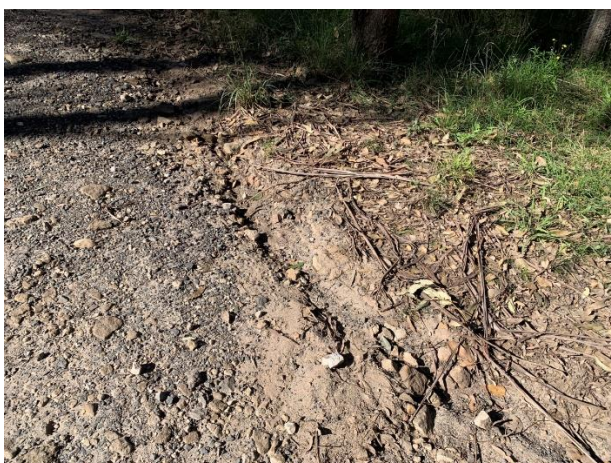
**Plate 16:** Example of rill erosion observed near LL01 (AHIMS ID# 45-5-3708). Larger pebbles have accumulated in distinct areas along the erosion lines

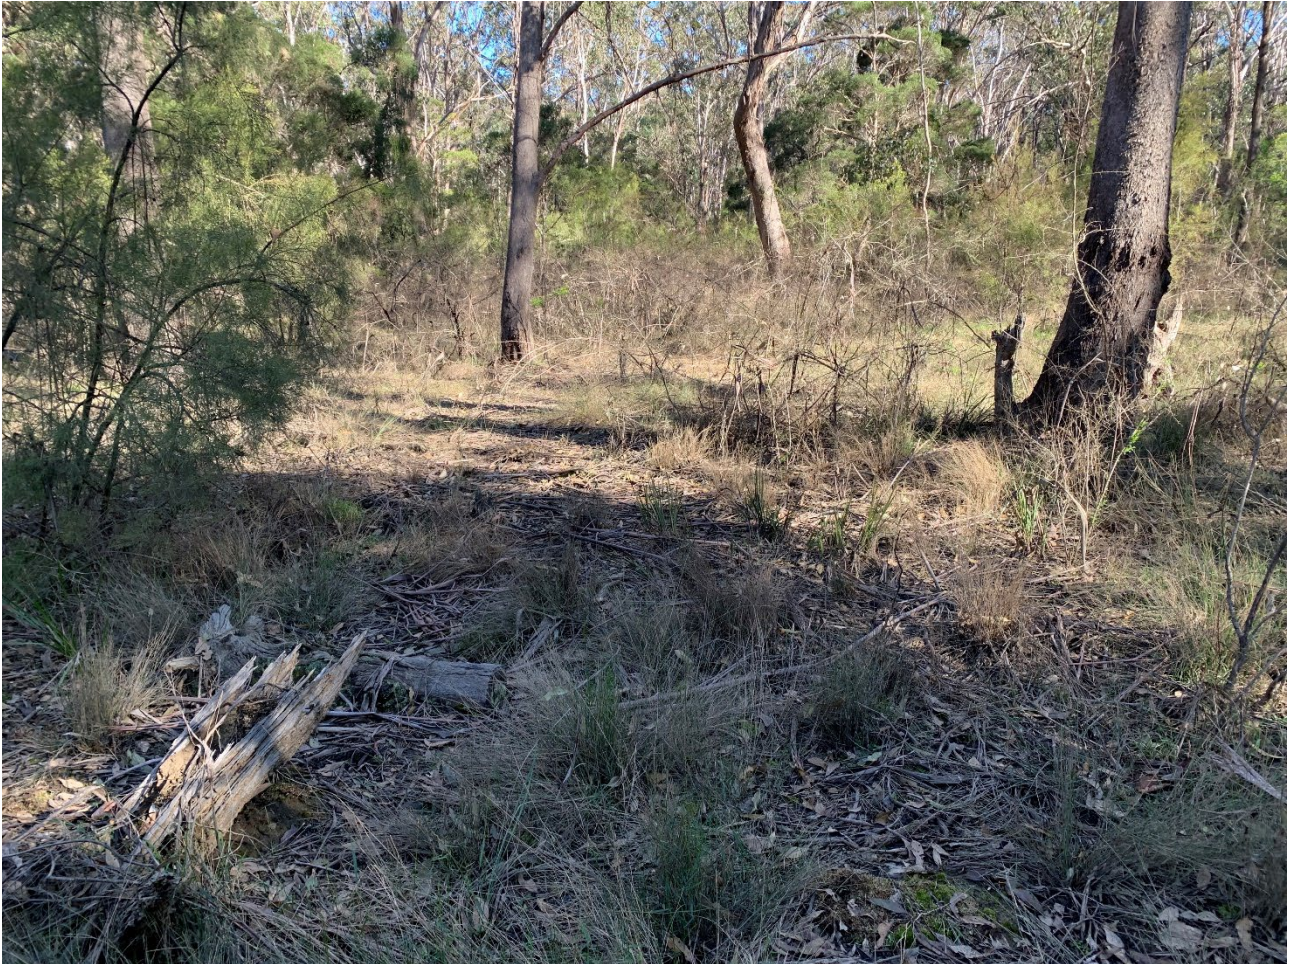
**Plate 20: Photographed approximately 35m back from the creek's edge, this area to the south of LN 12 (AHIMS ID# 45-5-0650) had dried significantly by the time of the site inspection. Evidence of sheet or rill erosion could not be observed on the ground surface in this area.**

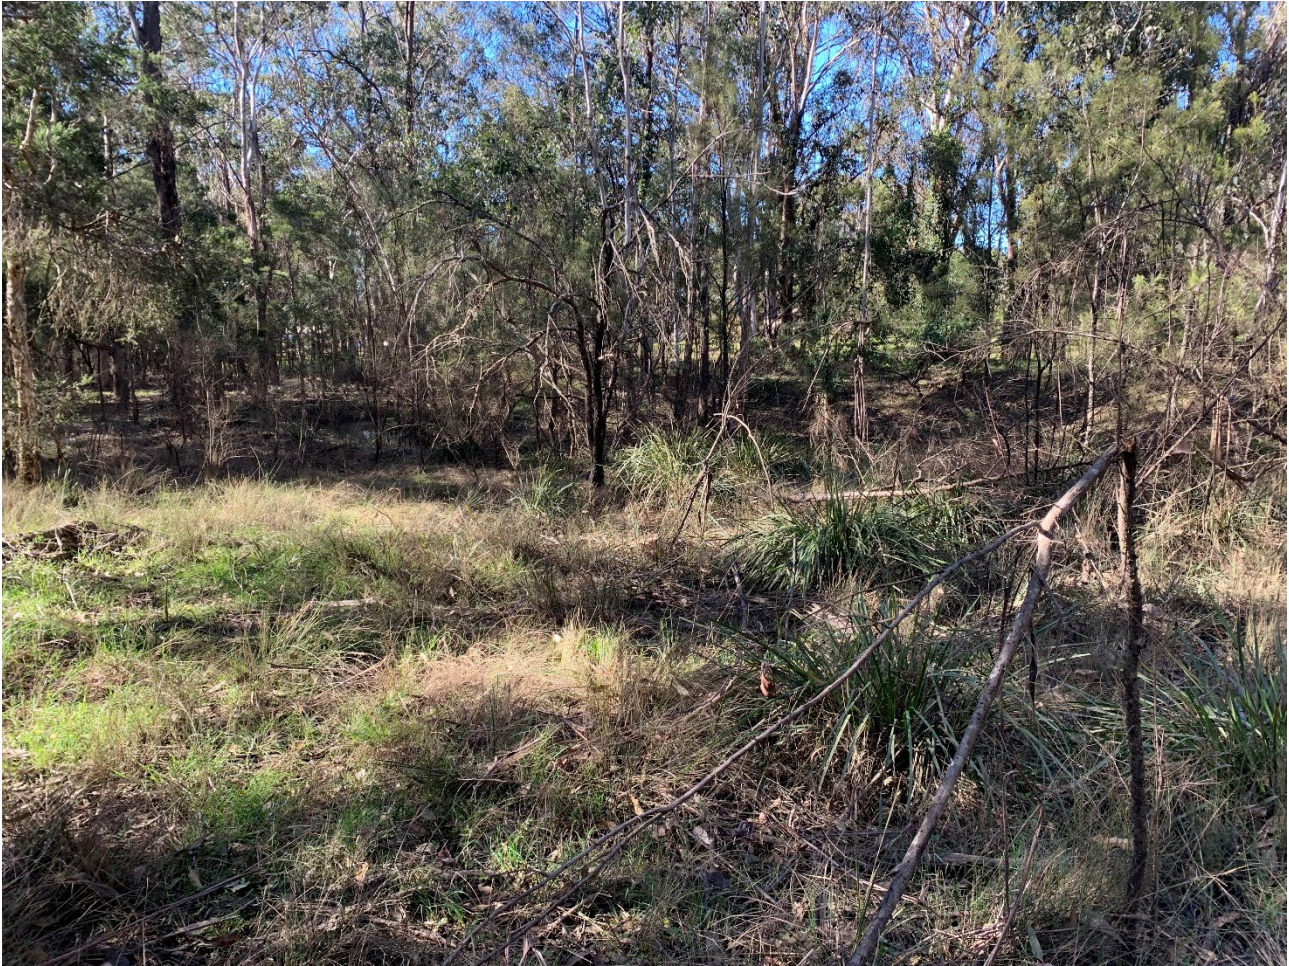
**Plate 21: Well vegetated areas further back from the creek's edge appear less flood affected. Very few exposures with eroded soils were observed in proximity to LN 12 (AHIMS ID# 45-5-0650).**

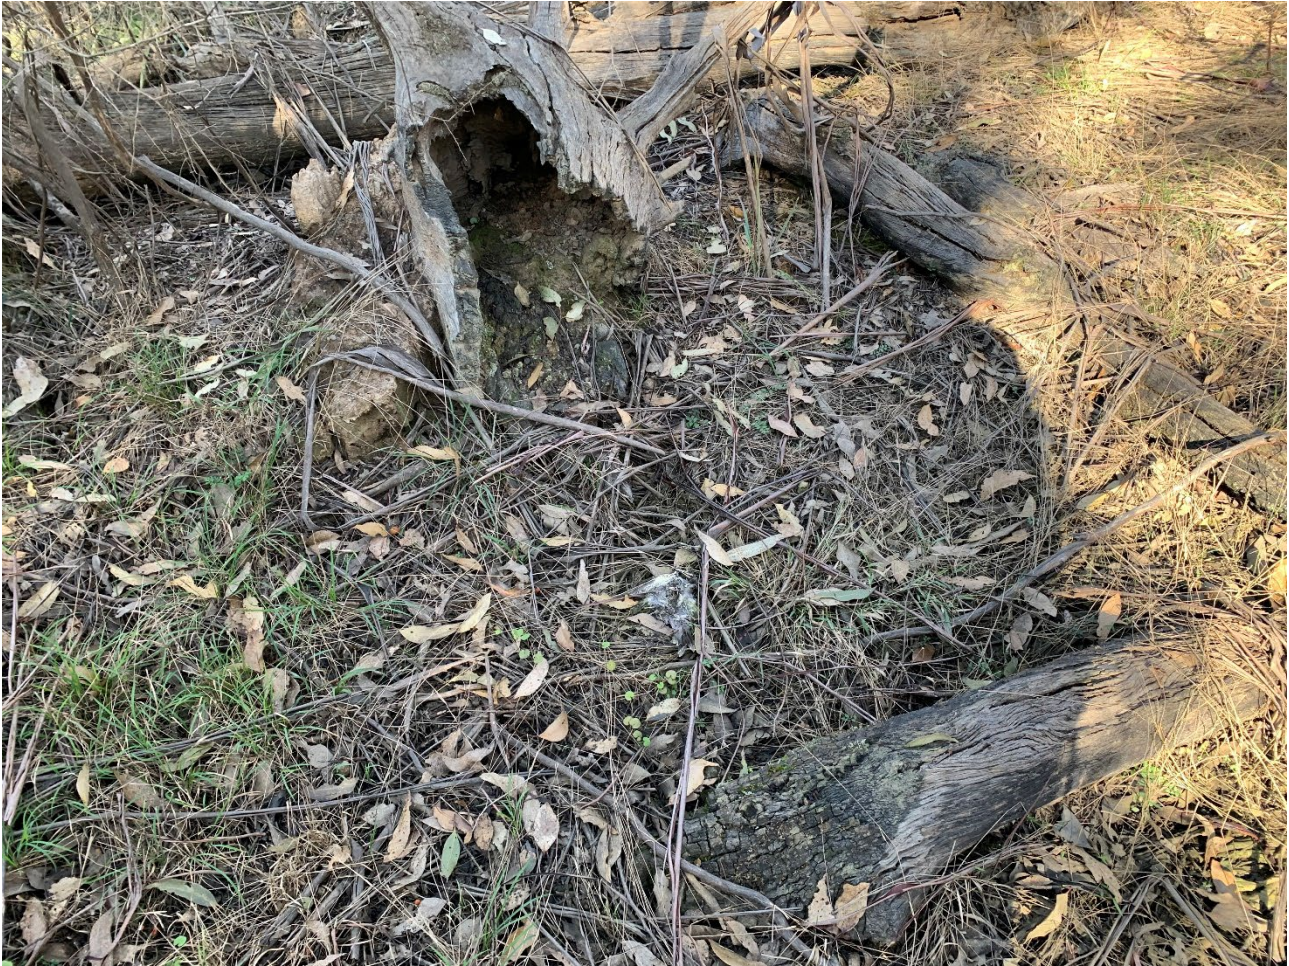
**Plate 22:** In the vicinity of fallen timber laying horizontally on the ground surface, redeposited soils accumulating in a trunk cavity and surrounds was observed. Given the orientation of the trunk cavity (facing the sloped area to the west) and the distance back from the creek's edge (approximately 100 m) it is more likely that this erosion is associated with catchment runoff rather than backwater flooding.

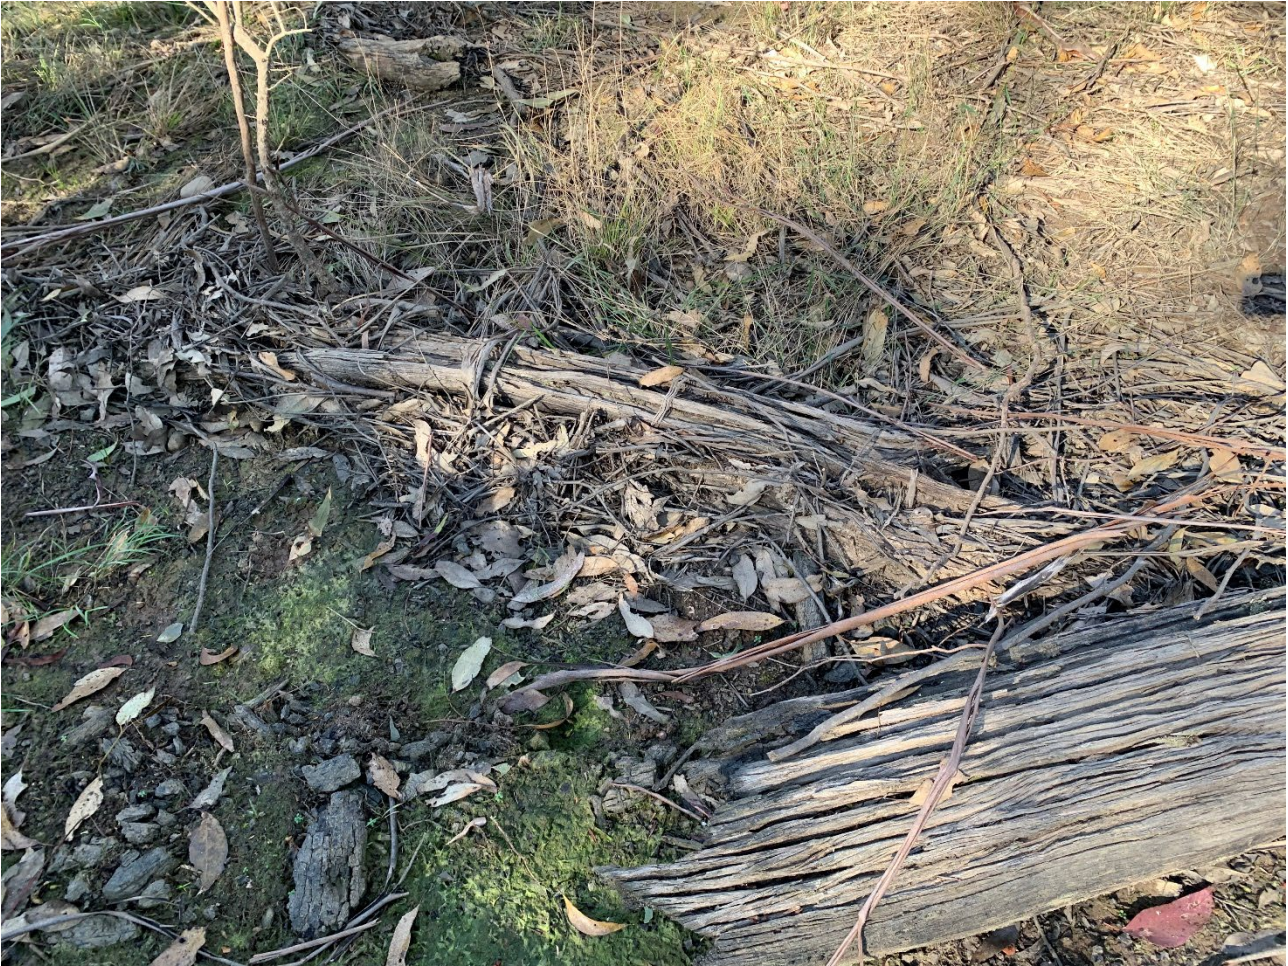
**Plate 23: Evidence of erosion associated with catchment runoff was observed in the vicinity of LN 12 (AHIMS ID# 45-5-0650) including redeposited and intermixed soils on the ground surface. This soil has covered leaf litter present in the surrounding area.**

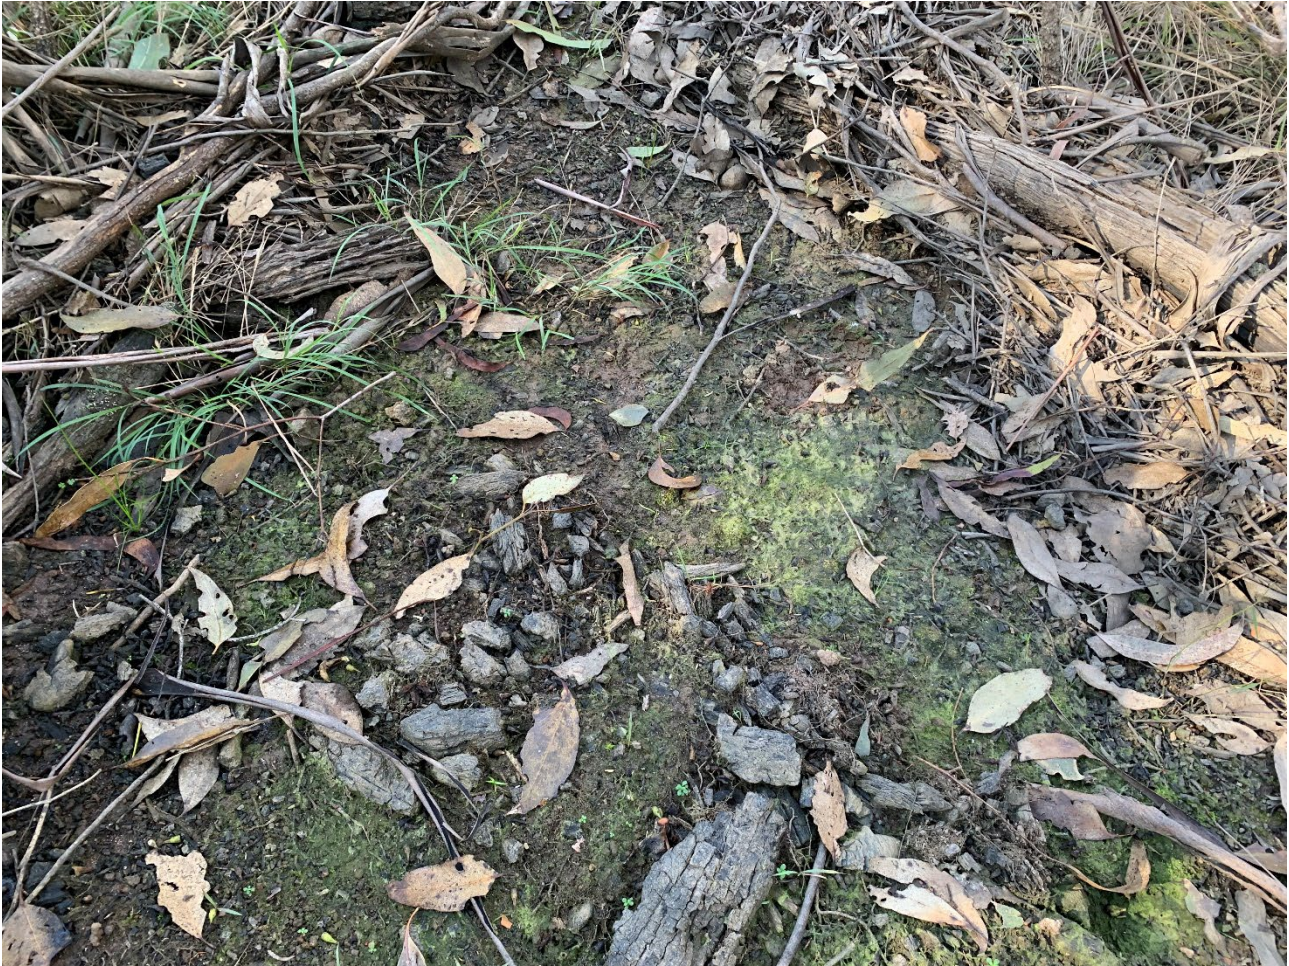
**Plate 24: Close-up of redeposited soils in the vicinity of LN 12 (AHIMS ID# 45-5-0650). Algae had begun to develop on the water-logged soils. Some isolated areas with little to no vegetation cover have been affected, in particular along pronounced rills or along steeper creek banks.**

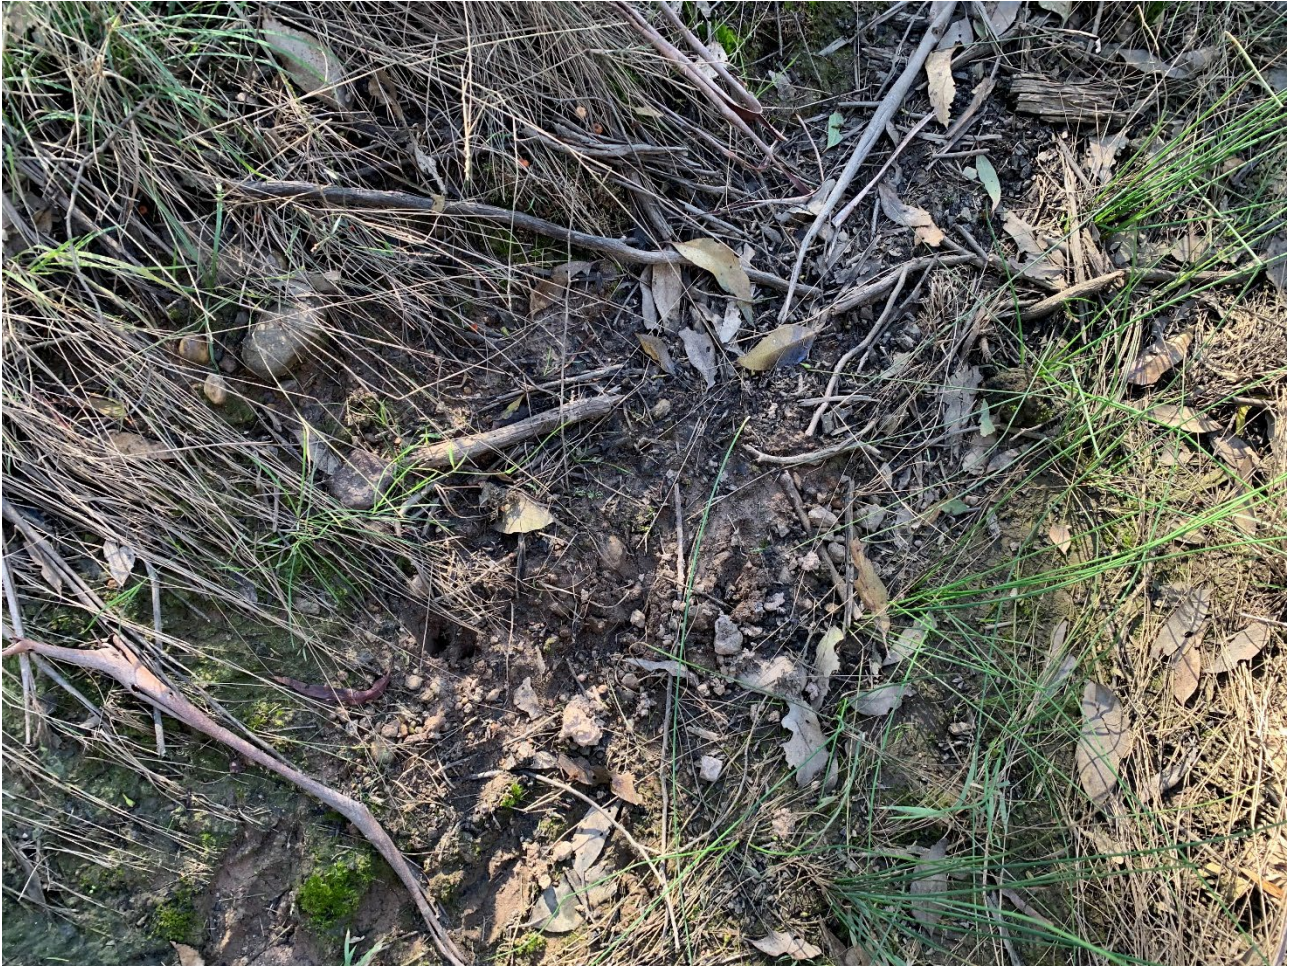
**Plate 25: Minor rill erosion present in the vicinity of LN 12 (AHIMS ID# 45-5-0650) showing the effects of local catchment runoff resulting in the exposure of sub-surface gravels. Waterlogged soils in adjacent areas have also started to experience algae growth.**

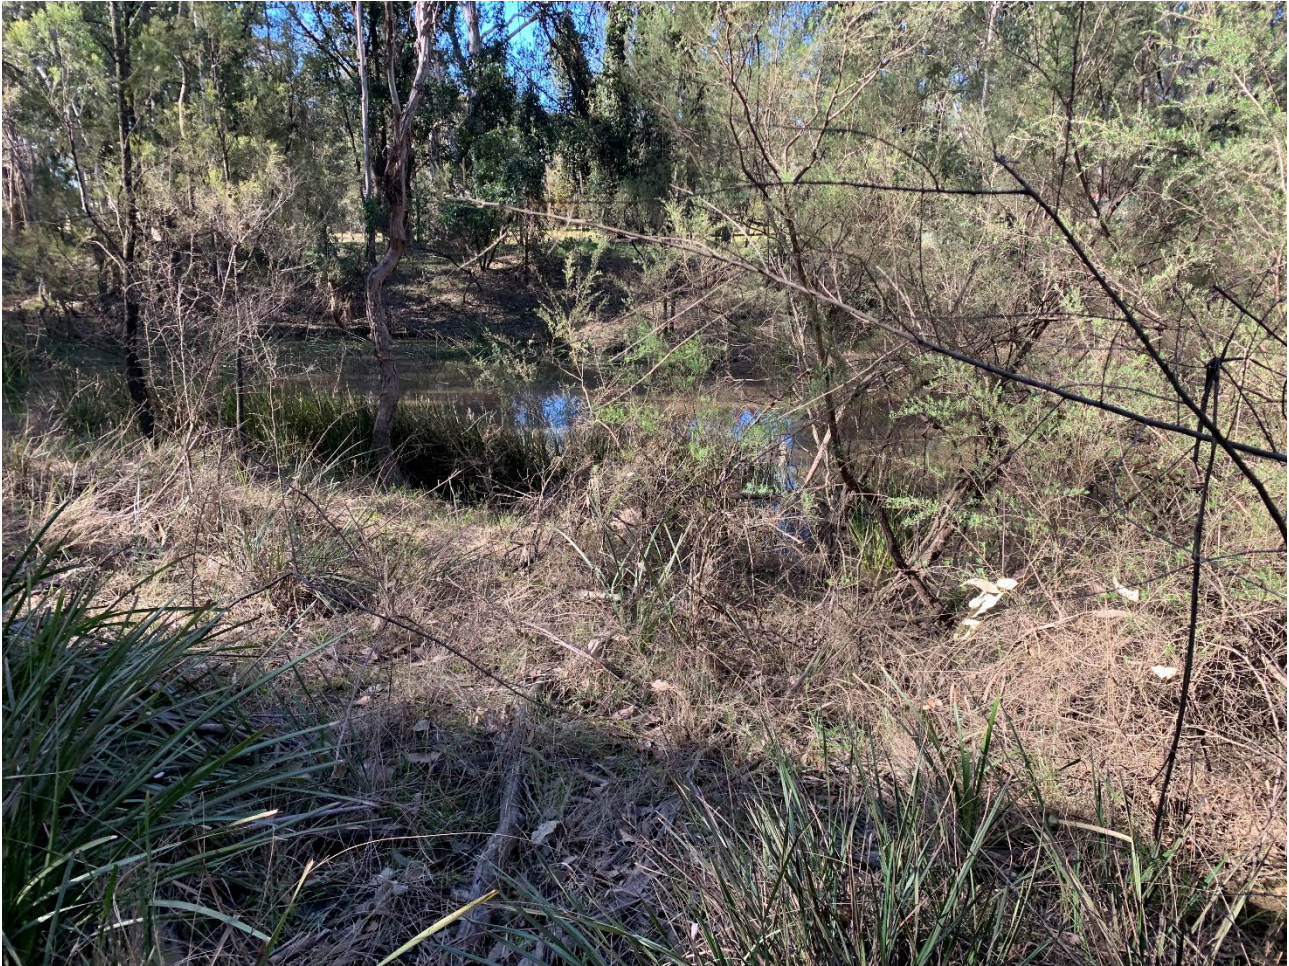
**Plate 26: Vegetation present across the creek banks and flats in the vicinity of LN 12 (AHIMS ID# 45-5-0650) have likely reduced the impact of rising floodwaters by helping to decelerate the force of backwater flooding. In general, it may expected that backwater flooding in this area would only have a low water velocity.**

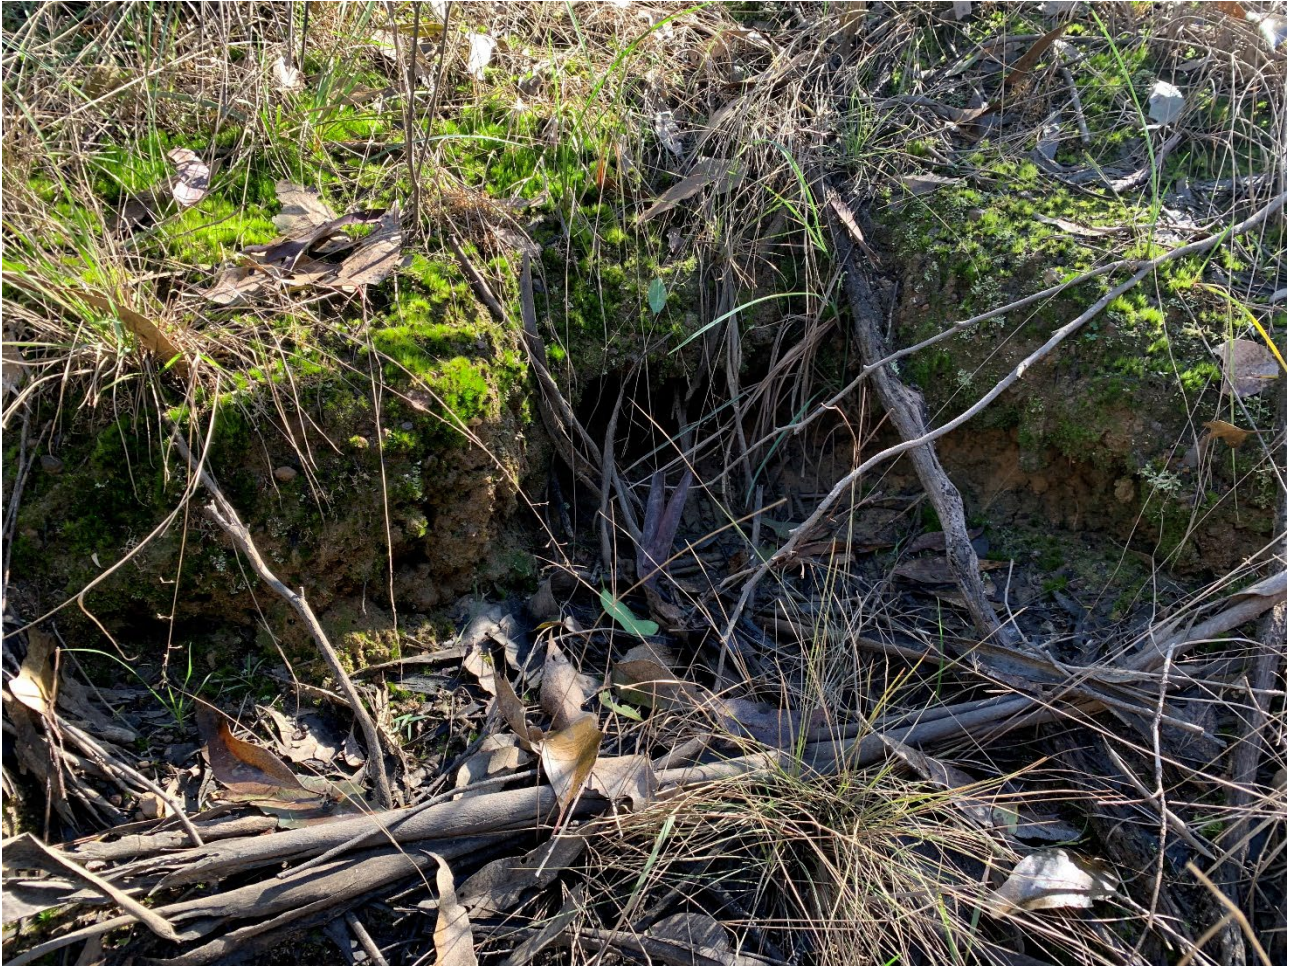
**Plate 27: Eroded location on the upper bank on the western side of the creek at LN 12 (AHIMS ID# 45-5-0650) showing the effects of slumping and subsequent undermining of exposed creek banks in isolated areas within 20 m of the creekline. Temporary backwater flooding have likely saturated the surrounding area, acting to reduce the soil cohesive strength and undermine the bank's structure. Minor volumes of redeposited soils can be observed below this erosion.**
