# Preferred Infrastructure Report

Warragamba Dam Raising

Application Number	SSI-8441
EPBC ID Number	2017/7940

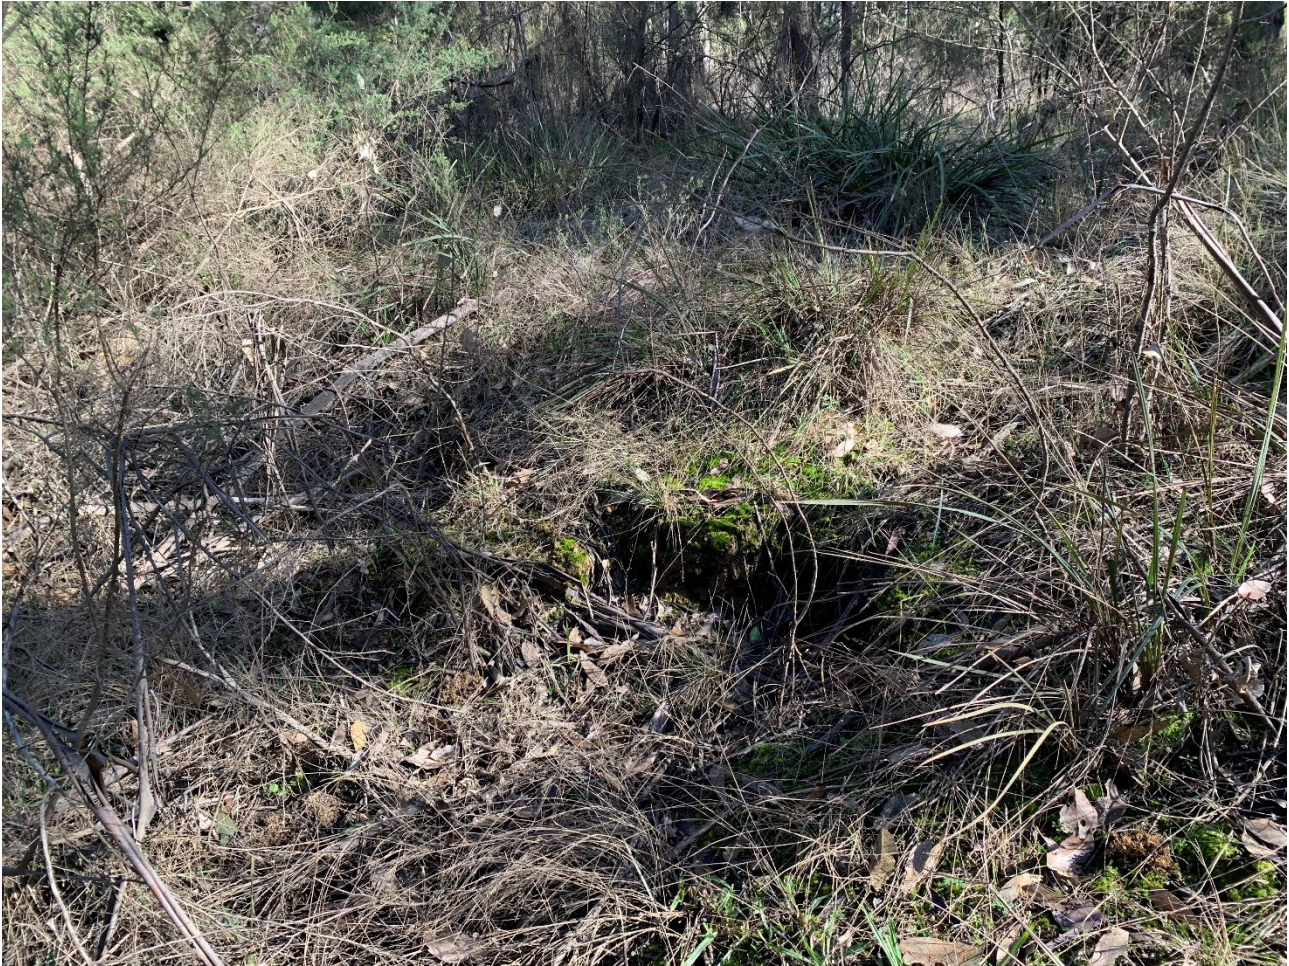
**Plate 28: Rill erosion present in the vicinity of LN 12 (AHIMS ID# 45-5-0650) in an area of mid-slope on the western side of the creek line.**

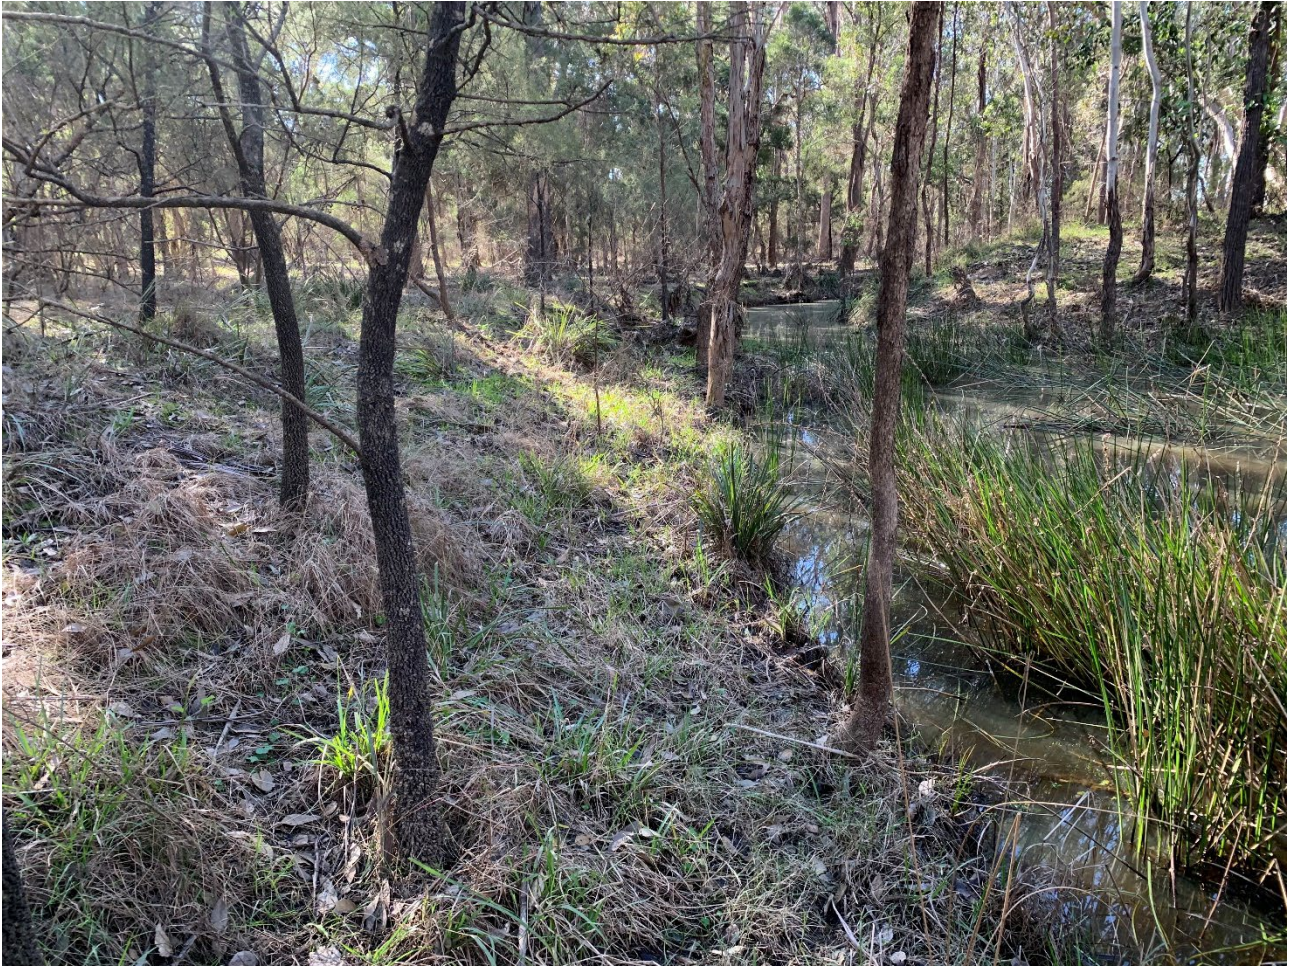
**Plate 29: Vegetated areas along the western bank of the creek line at LN 12 (AHIMS ID# 45-5-0650) have helped to reduce the impact of rising floodwaters on the stratigraphic integrity of adjacent creek banks.**

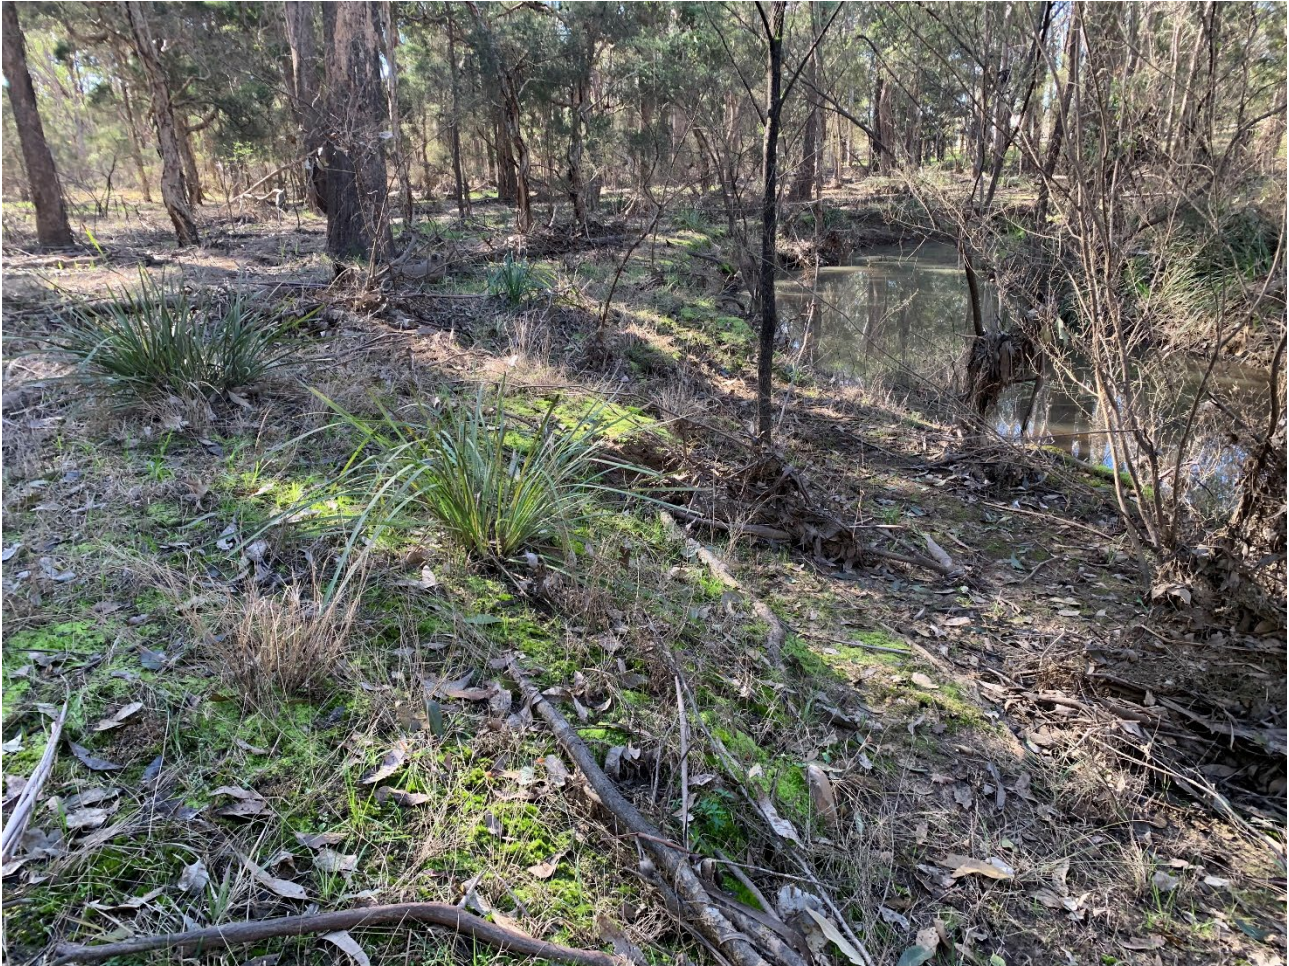
**Plate 30: Minor bank erosion observed on the western banks of creek line at LN 12 (AHIMS ID# 45-5-0650).**

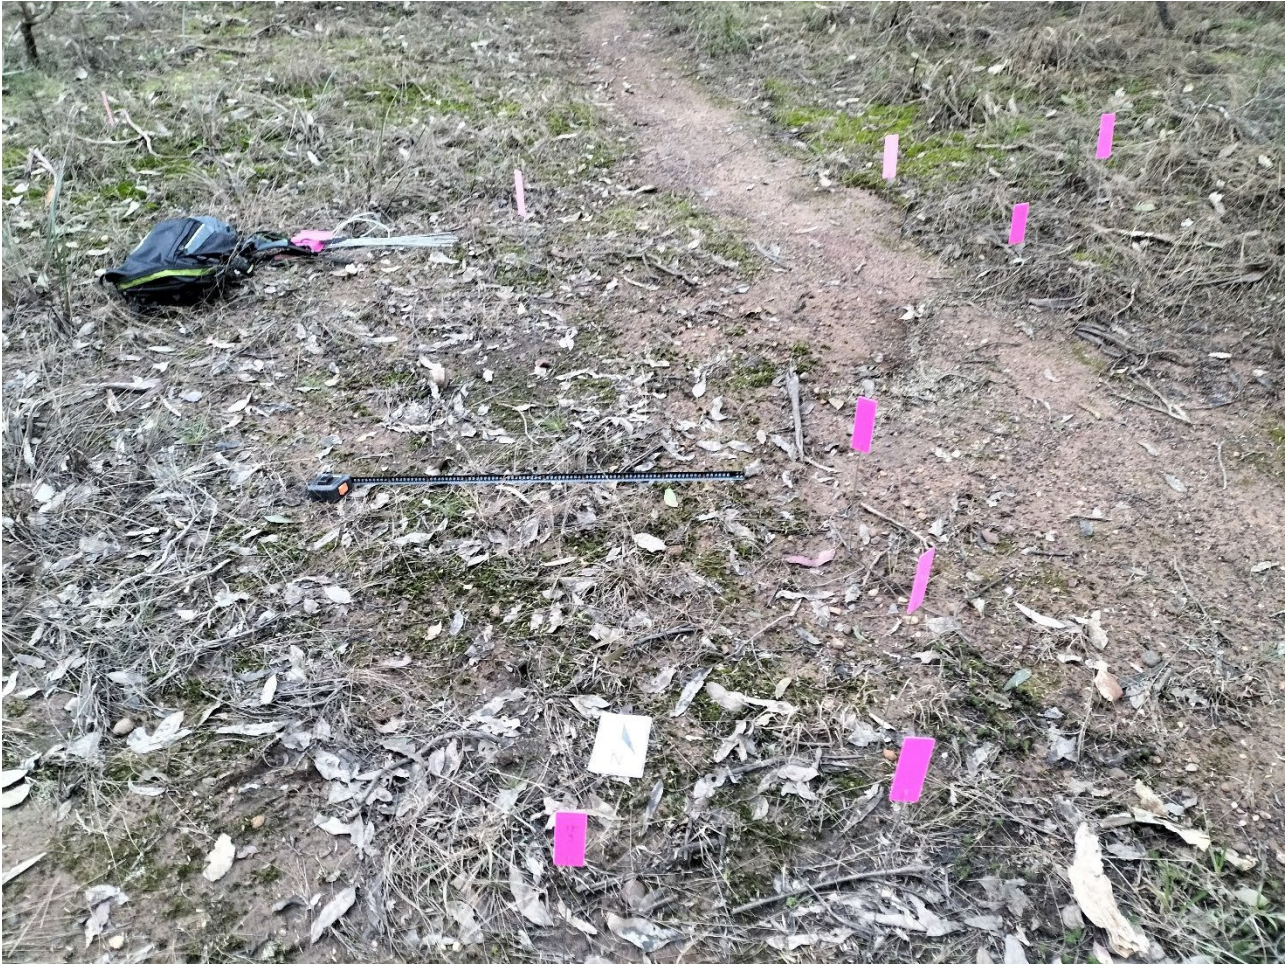
**Plate 32: The spatial distribution of surface artefacts within the western portion of LN 15 (AHIMS ID# 45-5-0653) along a defined path within a clearing of vegetation and slight slope change provide evidence of rill erosion along a natural drainage line cutting across the walking track. On the surface, some redeposited soils have accumulated on the western side of the track (left of the track in the picture) in the vicinity of the identified artefacts. Other artefacts previously identified at the location have likely been covered by the redeposition. Nonetheless, it should be noted that this portion of the site occurs within an area of previous disturbance related to vegetation clearance, track construction/ use and grazing activities and is generally exposed to catchment runoff.**

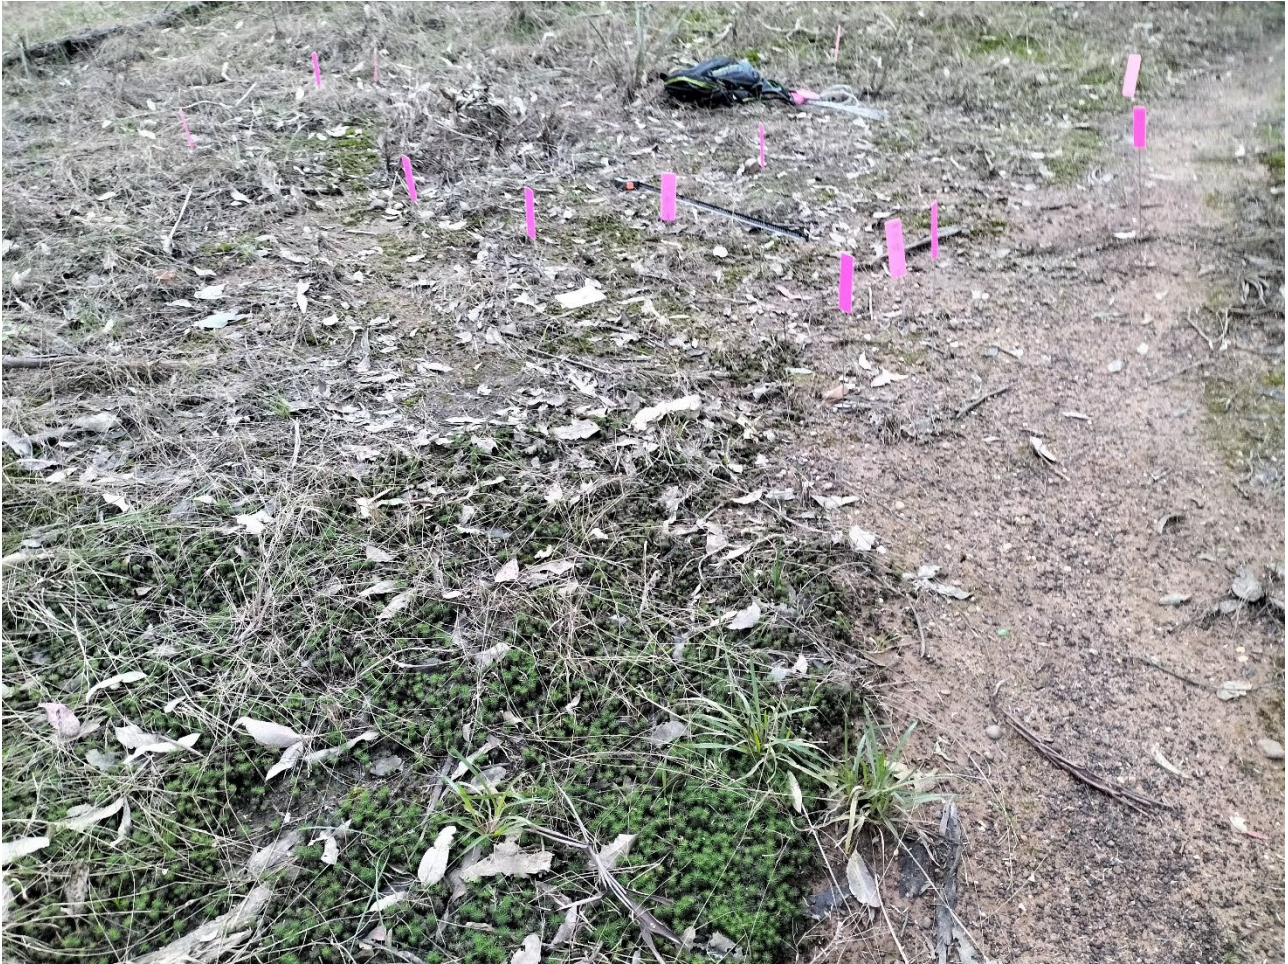
**Plate 33: Close-up of redeposited soils associated with rill and sheet erosion within the western portion of LN 15 (AHIMS ID# 45-5-0653). There is a slight slope leading from the western side towards the track.**

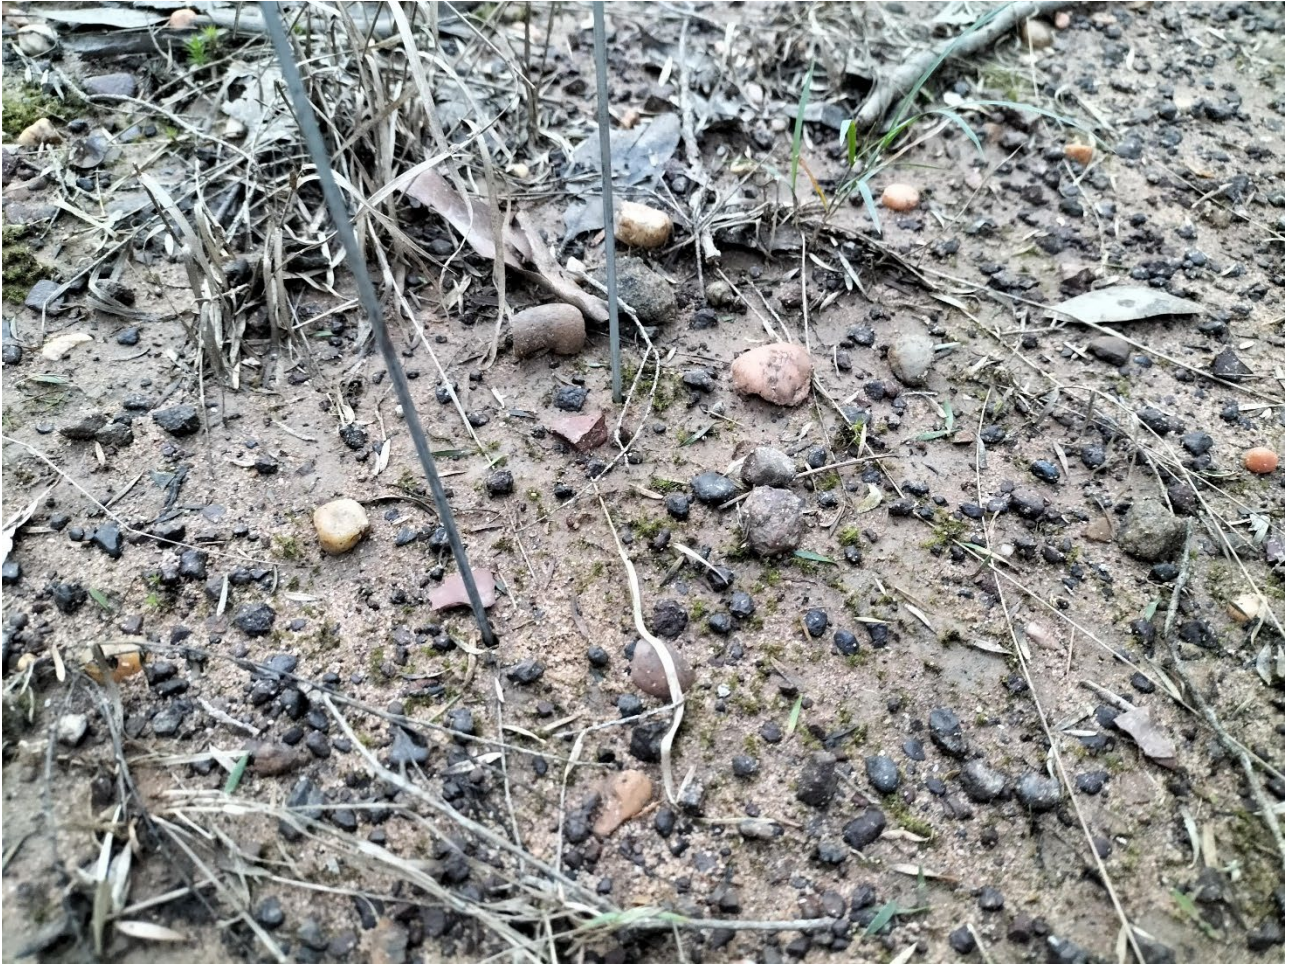
**Plate 34: Ground surface within western portion of LN 15 (AHIMS ID# 45-5-0653) showing the occurrence of sheet and rill erosion in the local area. The high sand and silt content present has increased the erodibility of the deposit, with surface gravels being highly exposed in this area. The artefacts were identified sitting above this deposit and have potentially either been exposed at or transported to this location. Previous moss growth at this location has been inundated by the redeposited soils.**

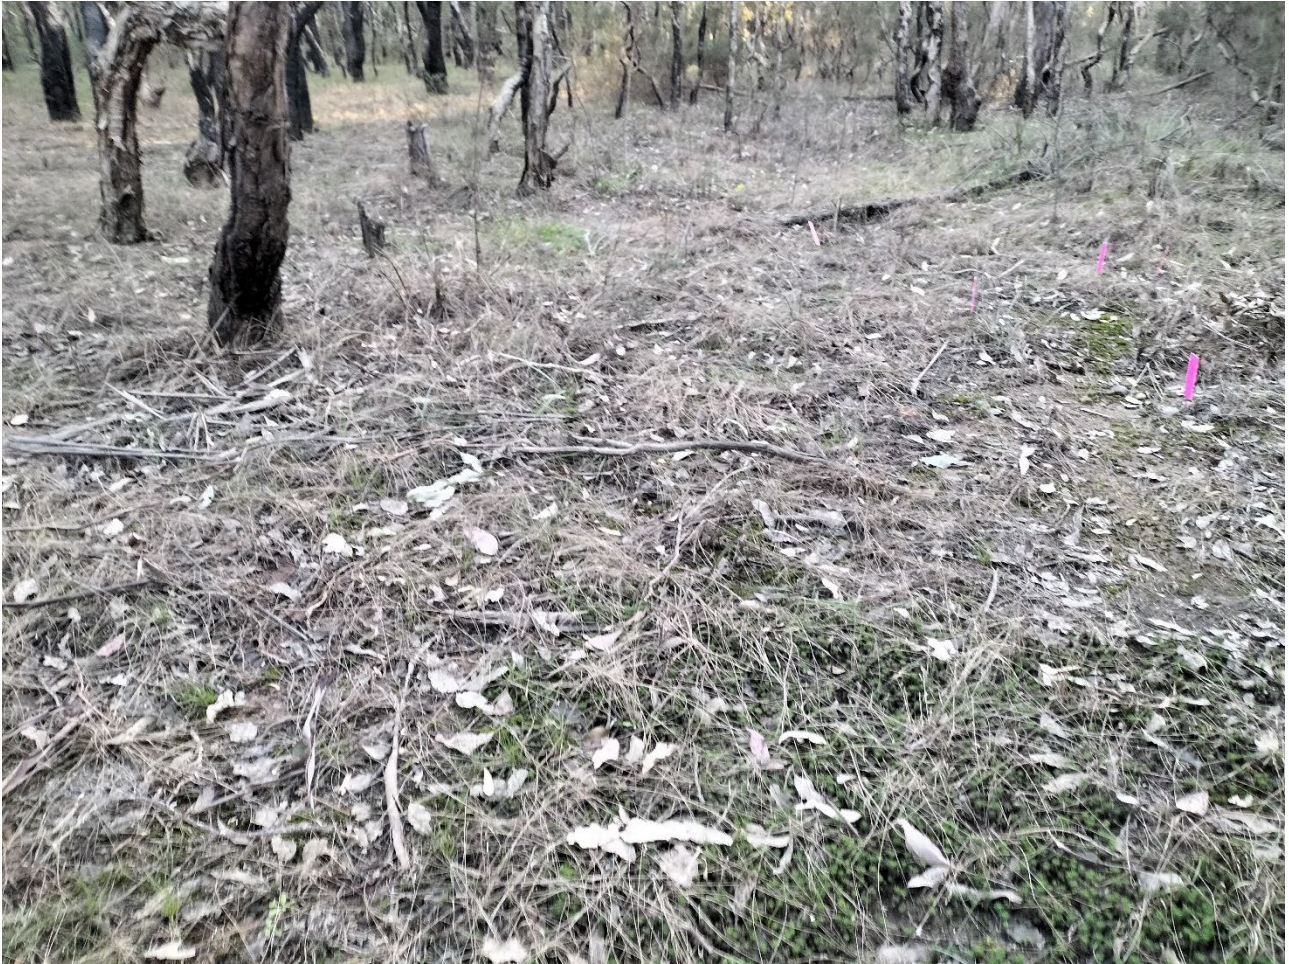
**Plate 35: Ground surface visibility was 0% away from exposures in the western extent of LN 15 due to the presence of thick vegetation cover and leaf litter. It is likely that further surface and sub-surface artefacts are situated within and between the western and eastern portions of this site.**

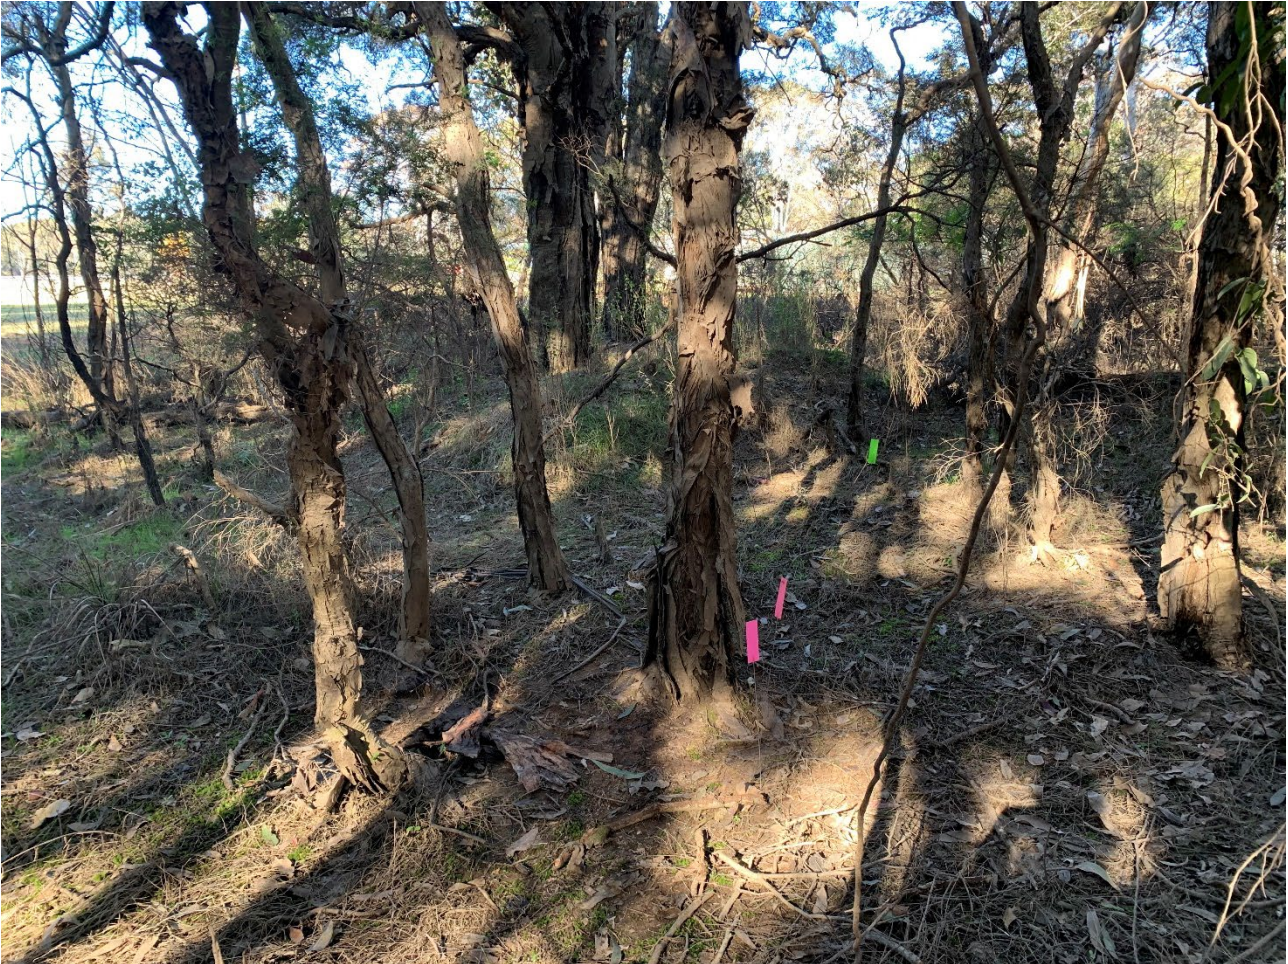
**Plate 36: Three previously unrecorded mudstone artefacts were identified during the site inspection sitting loosely on the ground surface in proximity to the recorded location for LN 15 (AHIMS ID# 45-5-0653). These three artefacts were therefore treated as occurring within the eastern extent of a broader site extent for LN 15 (AHIMS ID# 45-5-0653). The three artefacts are situated only a few metres above the creek level and this has resulted in some localised evidence of inundation and erosion. Due to their exposed context (within 15m of the creek line), they are unlikely to occur in-situ. No eroded soils were found to have built up in the immediate surroundings, nor was any sorting of gravels observed. The ground surface of the soil displayed evidence of intermixing and small cracks and moss growth were observed.**

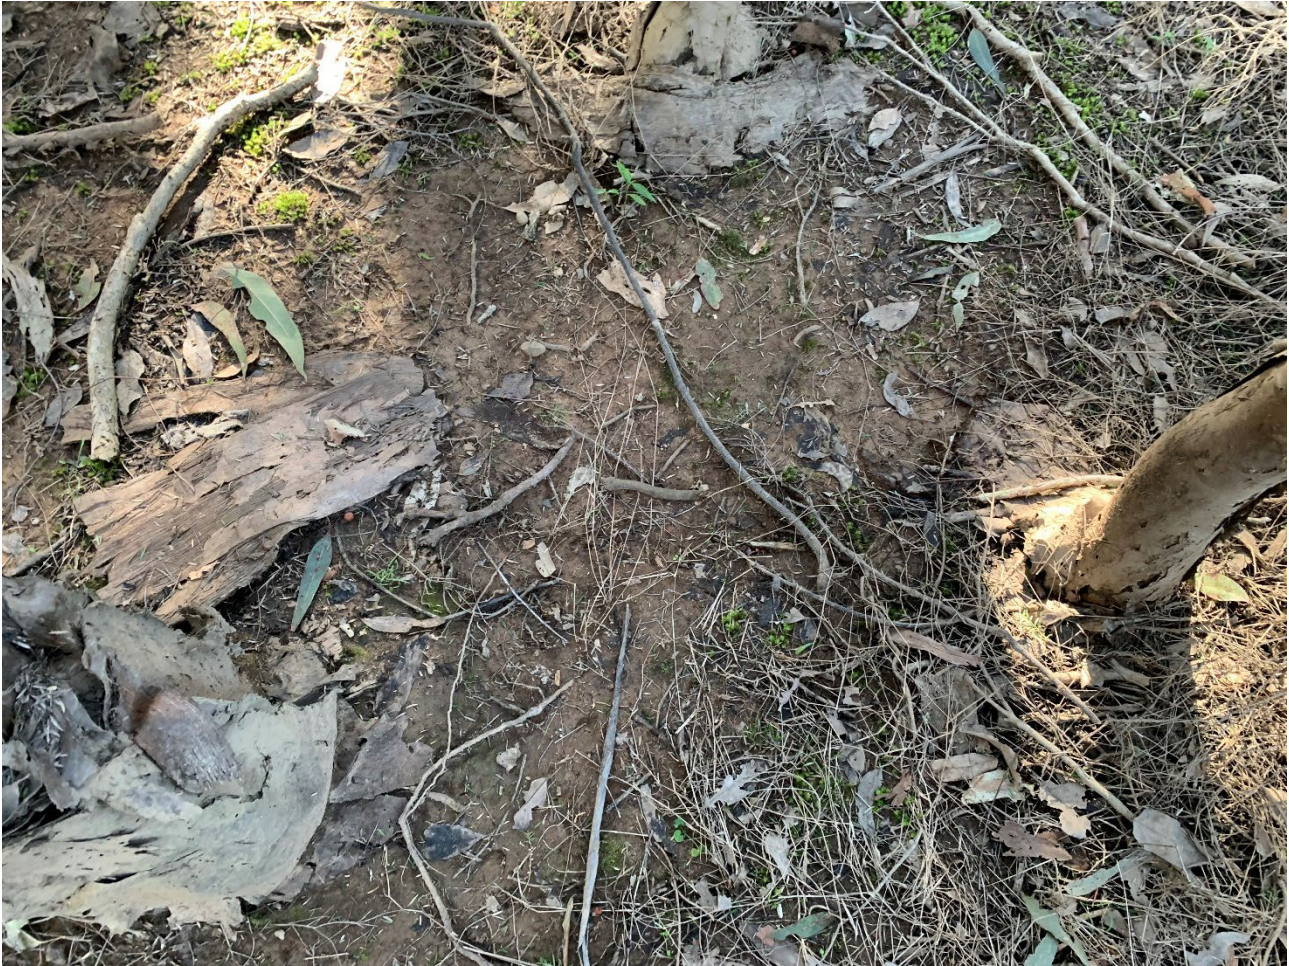
**Plate 37: An isolated area of sheet erosion observed east of LN 15 (AHIMS ID# 45-5-0653). Small cracks in the ground surface were observed during the site inspection, likely associated with the fall in the groundwater level after heavy inundation events.**

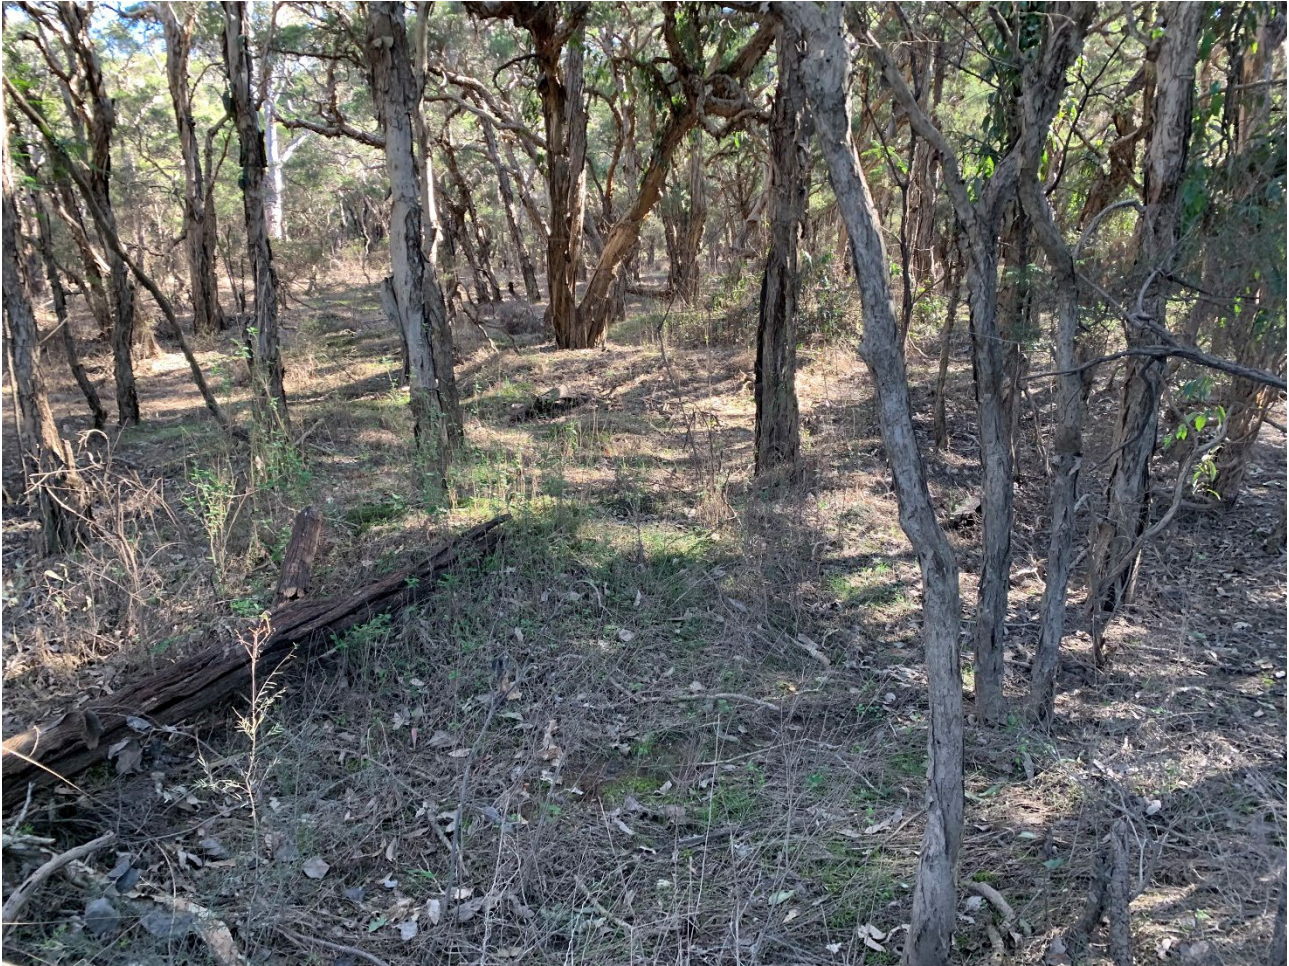
**Plate 38: Thick vegetation and leaf litter cover at eastern boundary of LN 15 (AHIMS ID# 45-5-0653) reduced the ground surface visibility to approximately 0%. Further surface and sub-surface artefacts may occur at the site.**

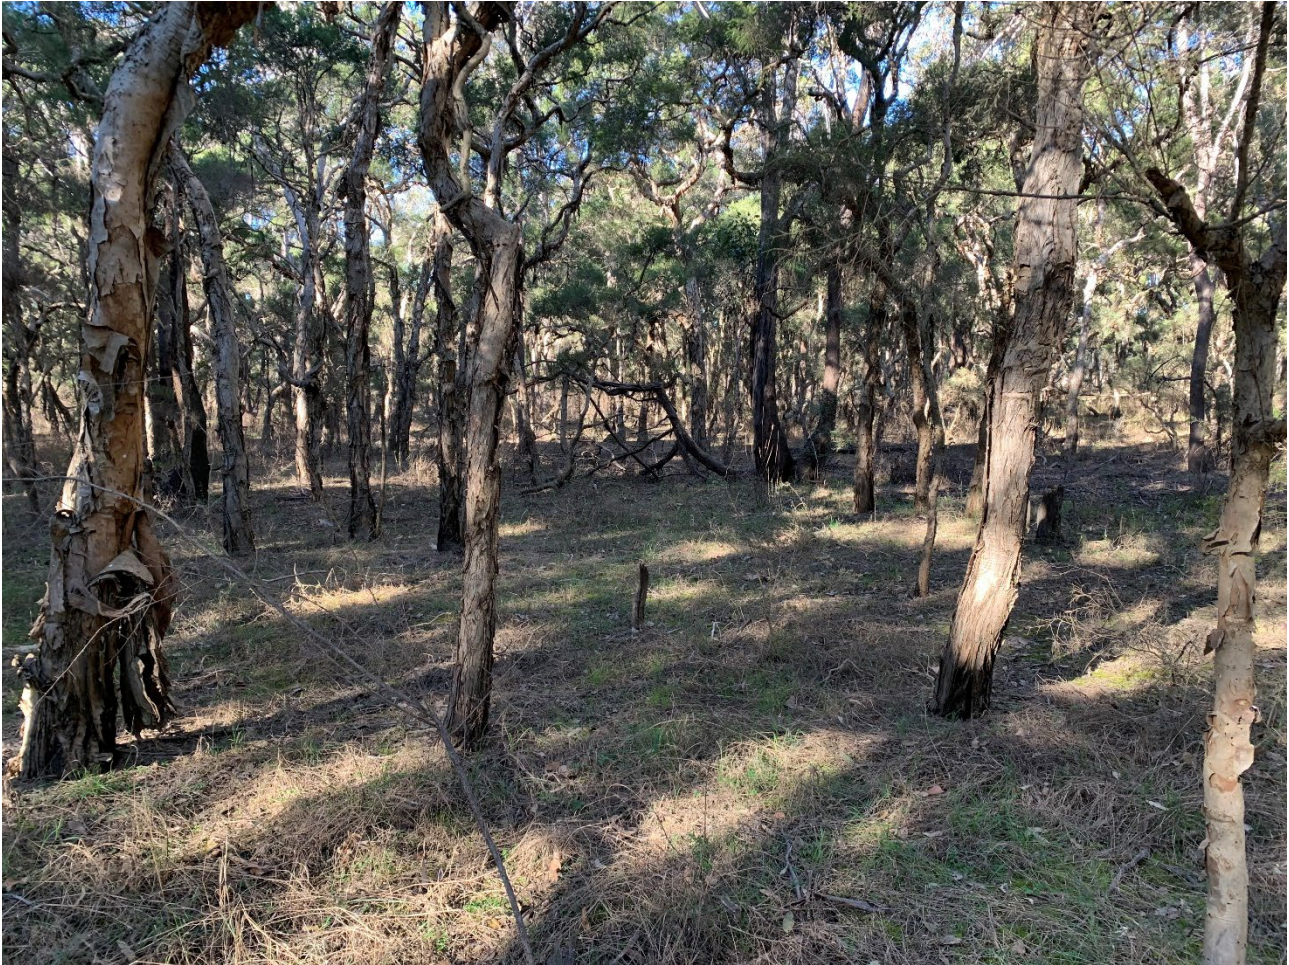
**Plate 39: The impact of flooding at the recorded location of LN 16 (AHIMS ID# 45-5-0654) has been relatively limited, though no artefacts could be identified during the present site inspection. The site is situated on an old vehicle track. The soil present is a brown sandy loamy silt and was compact and wet at the time of the site inspection. Thick moss growth potentially predating the most recent floods covers large parts of the surrounding area suggesting that soils present are frequently waterlogged. Ground surface visibility was 5%.**

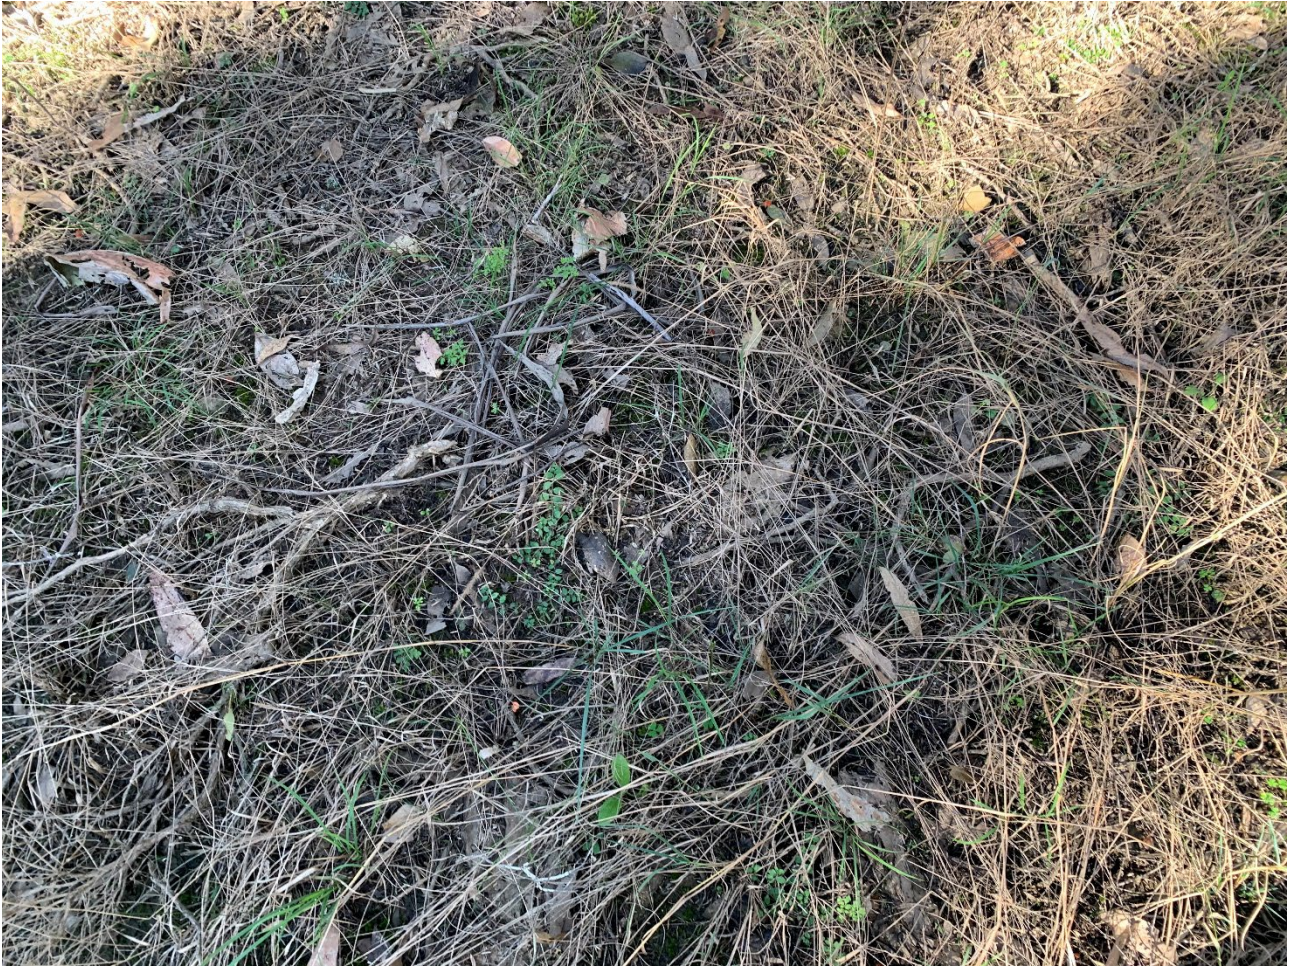
**Plate 40: Ground surface visibility at LN 16 (AHIMS ID# 45-5-0654) was generally 5% due to extensive leaf litter and vegetation cover.**

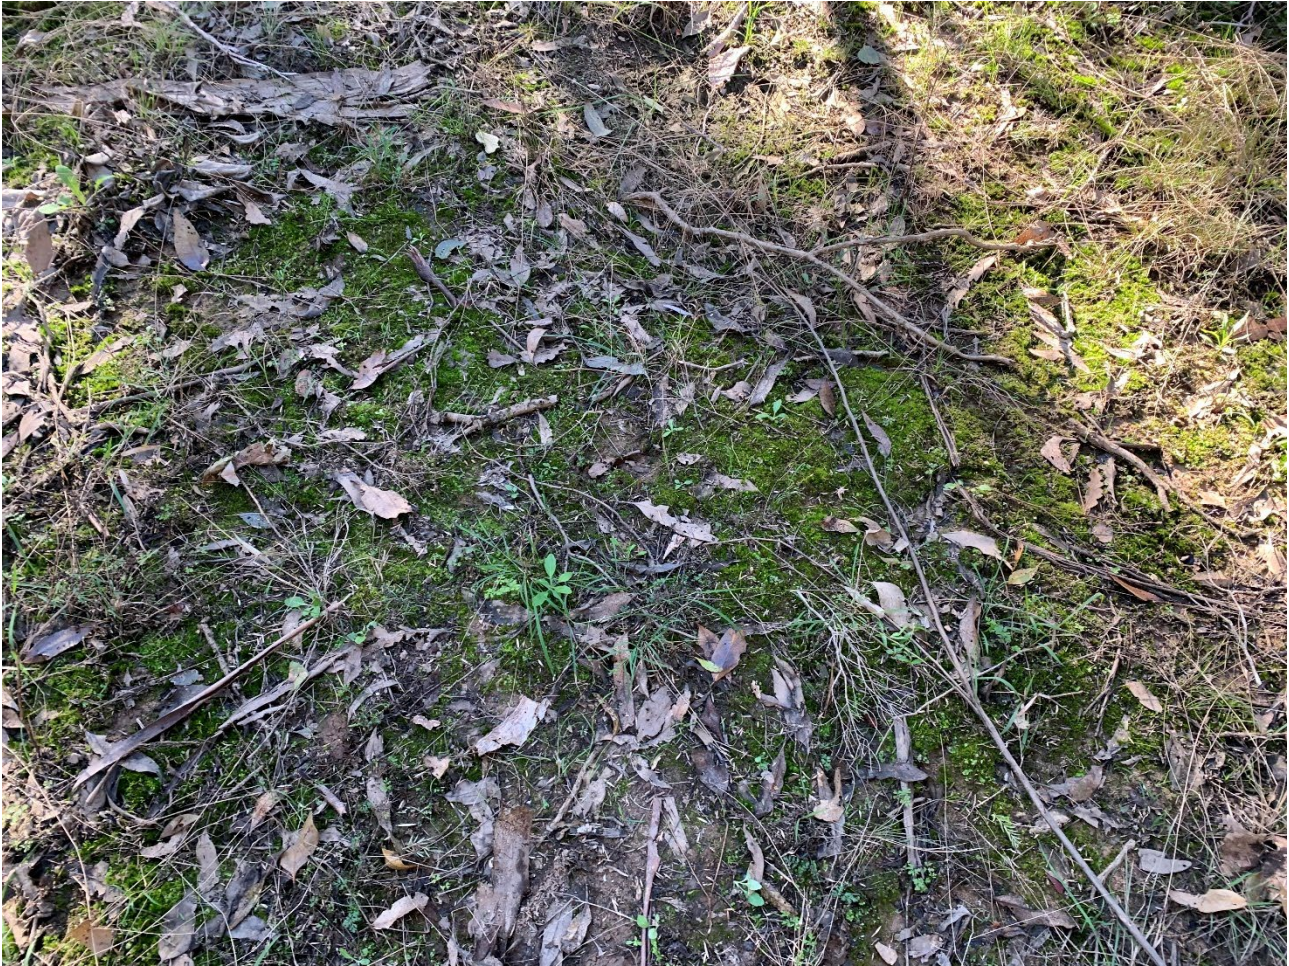
**Plate 41: Thick moss growth observed across some large areas of exposed dirt in proximity to the recorded location for LN 16 (AHIMS ID# 45-5-0654). This moss growth has potentially obscured the identification of artefacts previously recorded on the ground surface.**

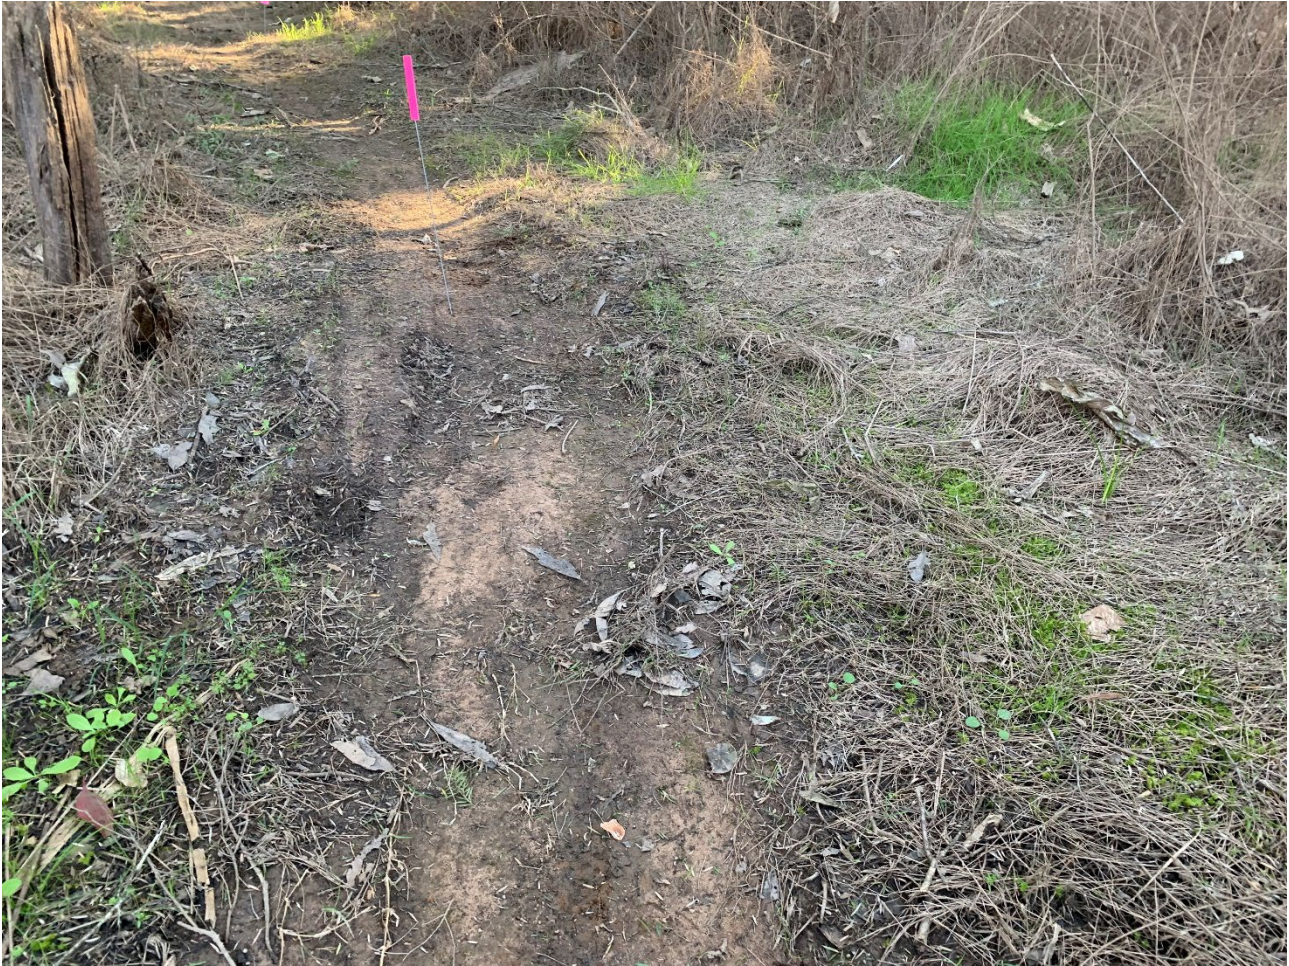
**Plate 43: Minor sheet and rill erosion observed along the access track at LN 17 (AHIMS ID# 45-5-0655) with some intermixing observed. A few footprints and bike tracks were observed during the site inspection and have formed whilst the track was wet. No surface runoff of soils was observed at the boundary of the access track in this area.**

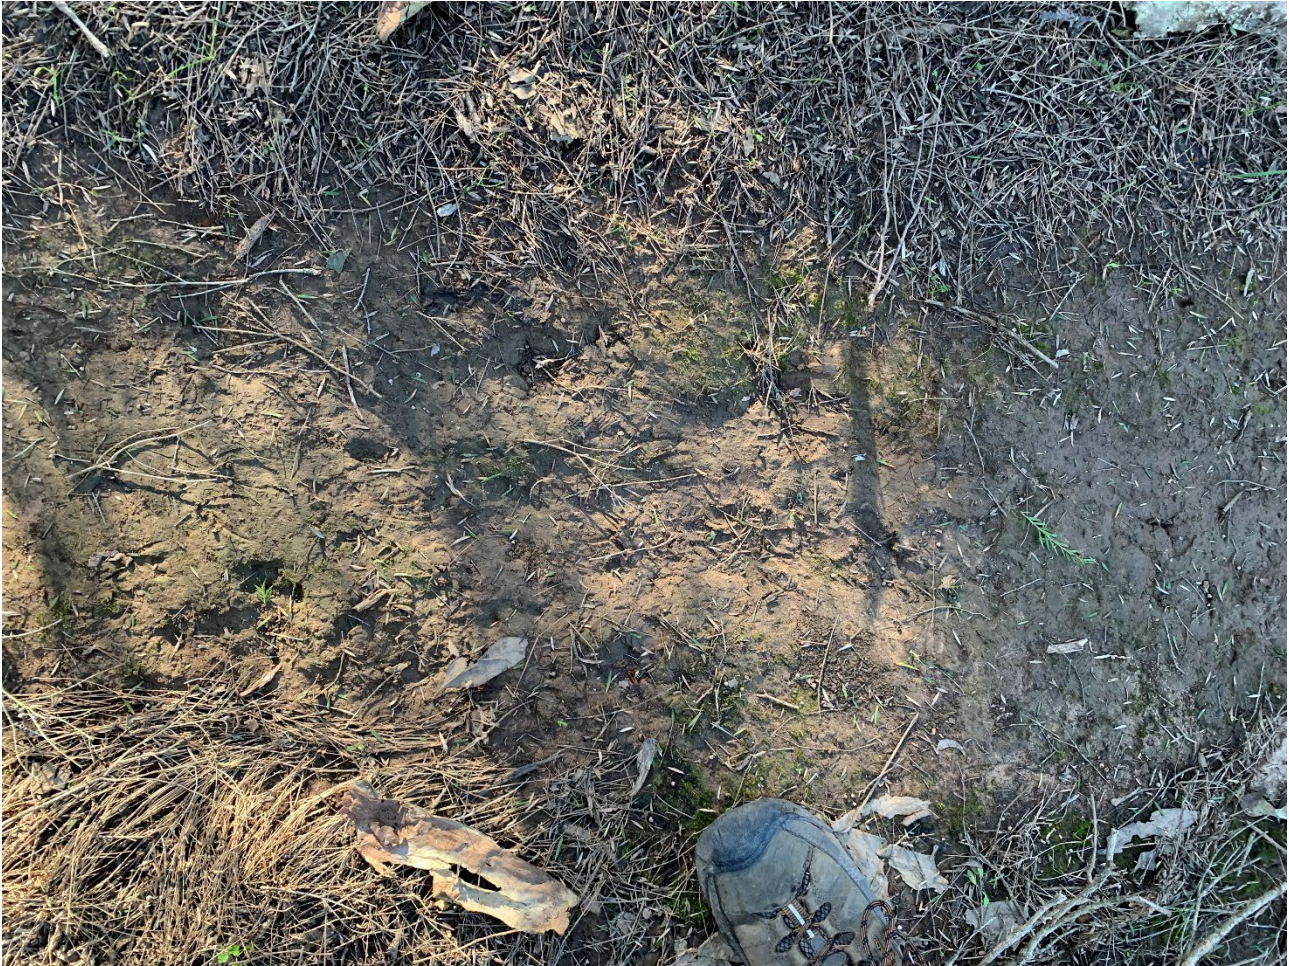
**Plate 44: Redeposited soil along access track at LN 17 (AHIMS ID# 45-5-0655) showing the extent of intermixing and some limited cracking. Overall, the level of erosion observed was not extensive.**

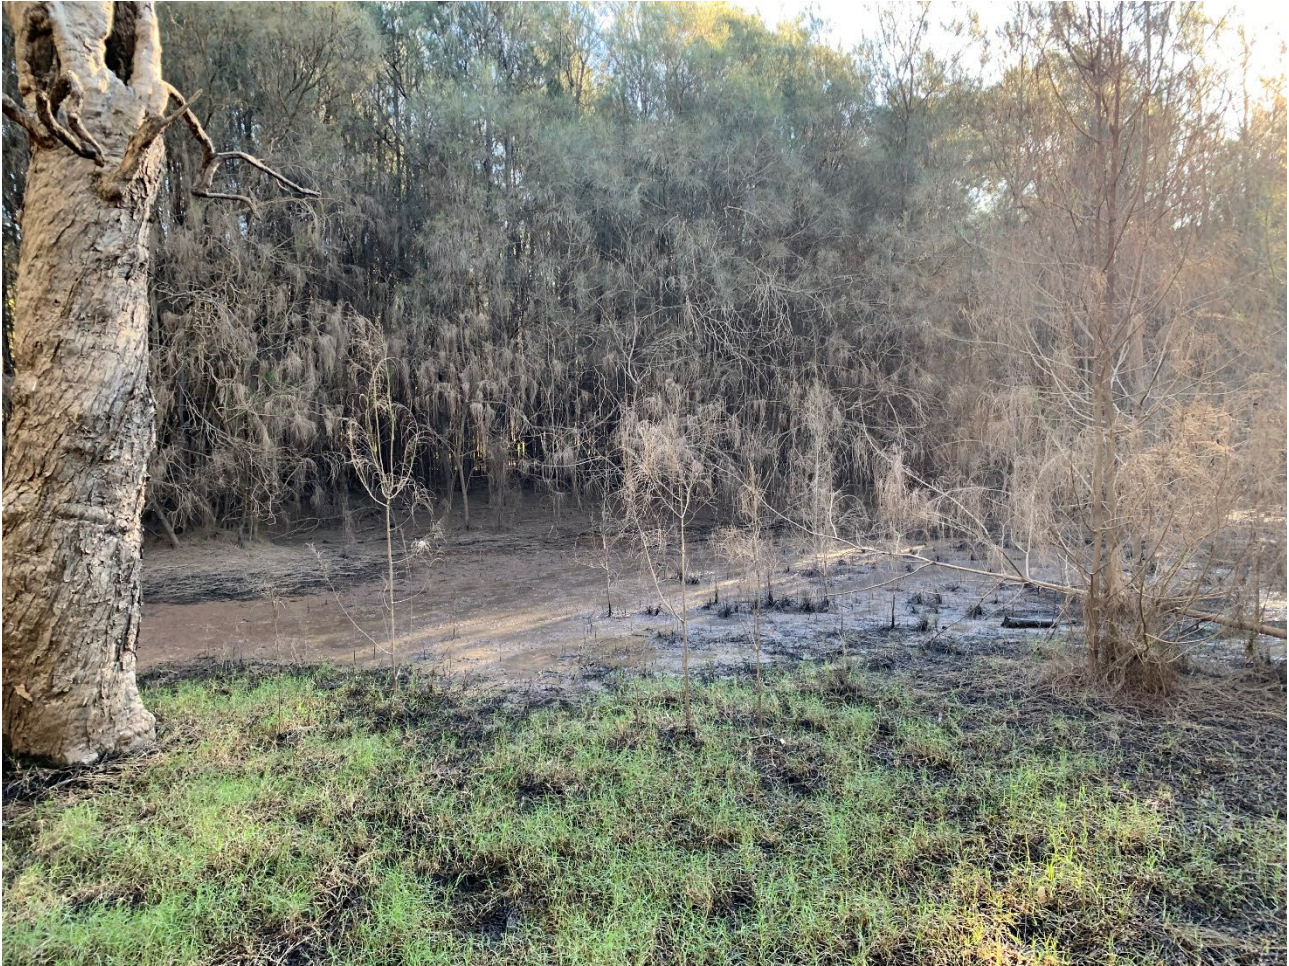
**Plate 47: Saturated soils at LN 18 (AHIMS ID# 45-5-0656) showing the temporary impact on vegetation following prolonged submersion. Very few debris from fallen trees have been transported into this area despite the large inundations, suggesting the inundation event has been more gradual.**

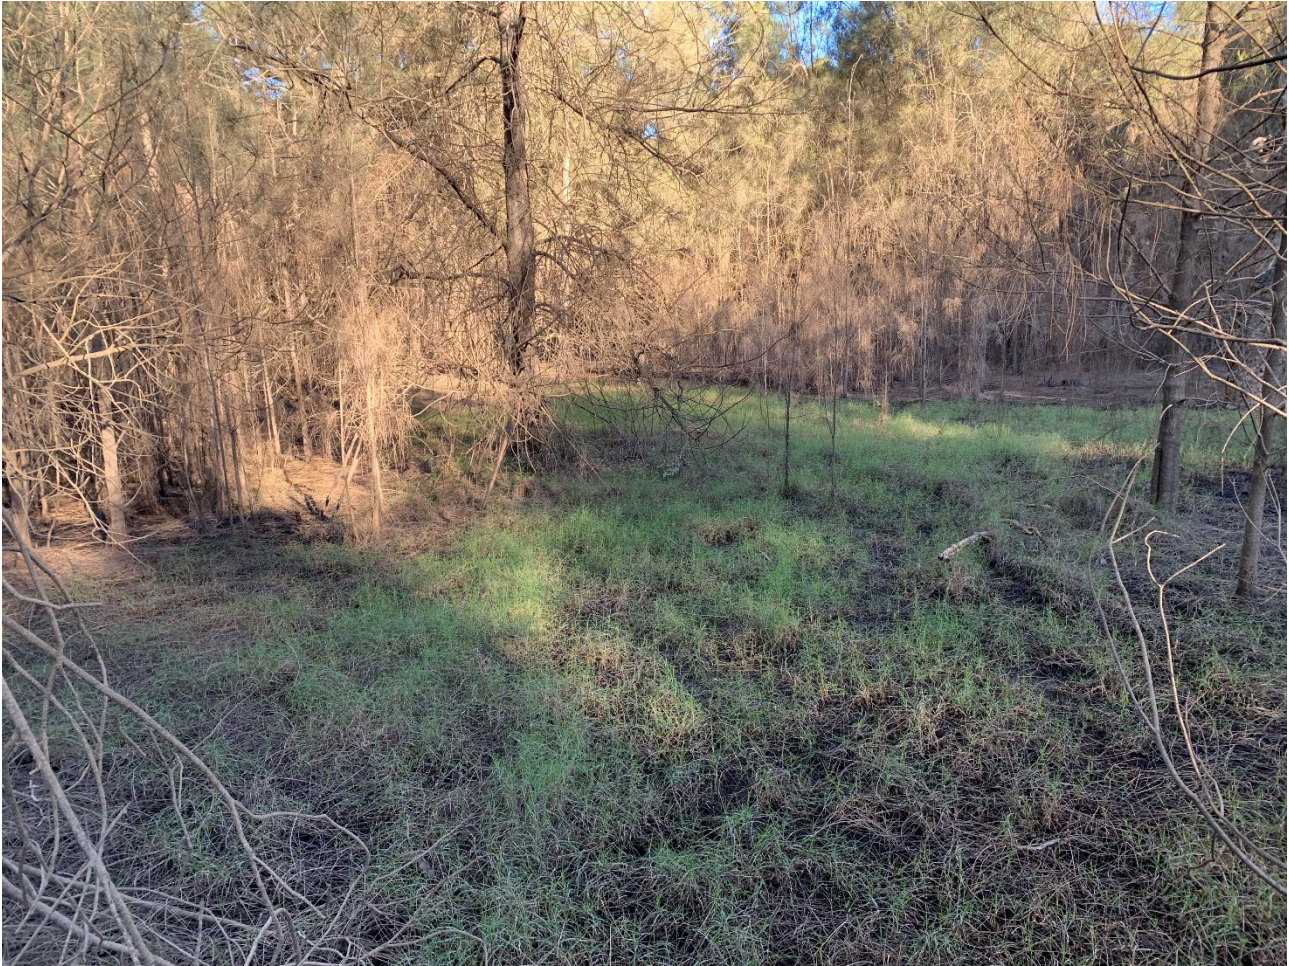
**Plate 48: Thinly vegetated areas covered by fallen pine needles and grass in areas adjacent to the standing water at LN 18 (AHIMS ID# 45-5-0656) appear to have fared better. These grass-covered areas were heavily saturated at the time of the survey and were wet underfoot. No channelling or bank scouring was observed in the surrounding area.**
