# Preferred Infrastructure Report

Warragamba Dam Raising

Application Number	SSI-8441
EPBC ID Number	2017/7940

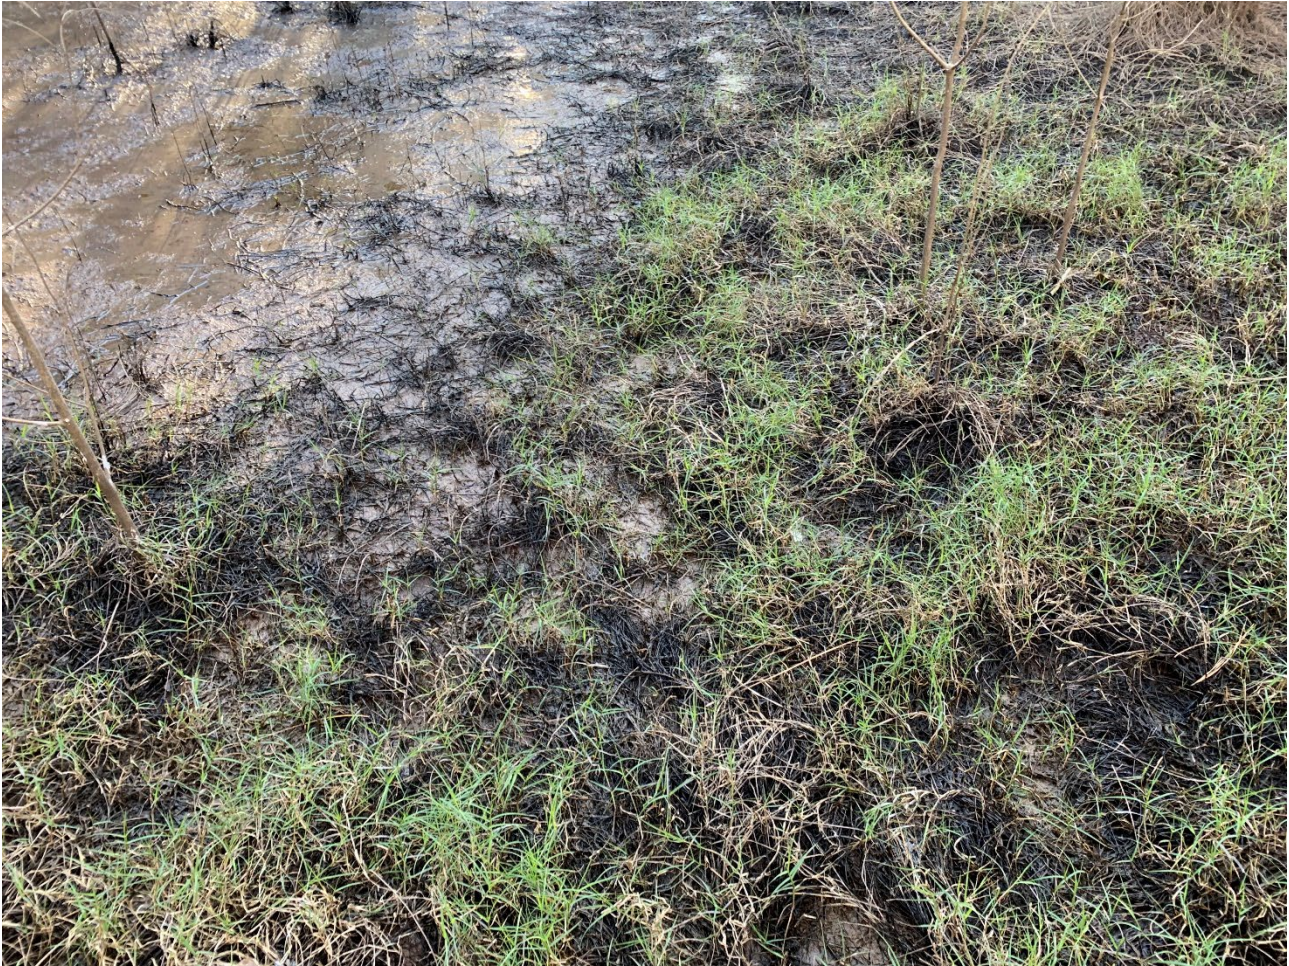
**Plate 49: Inundated soils at LN 18 (AHIMS ID# 45-5-0656) showing the impact of rising groundwater in this flood-prone area. At the time of the survey and in spite of broad-scale saturation, redeposited soils associated with rill or sheet erosion could be observed on the ground surface at this location.**

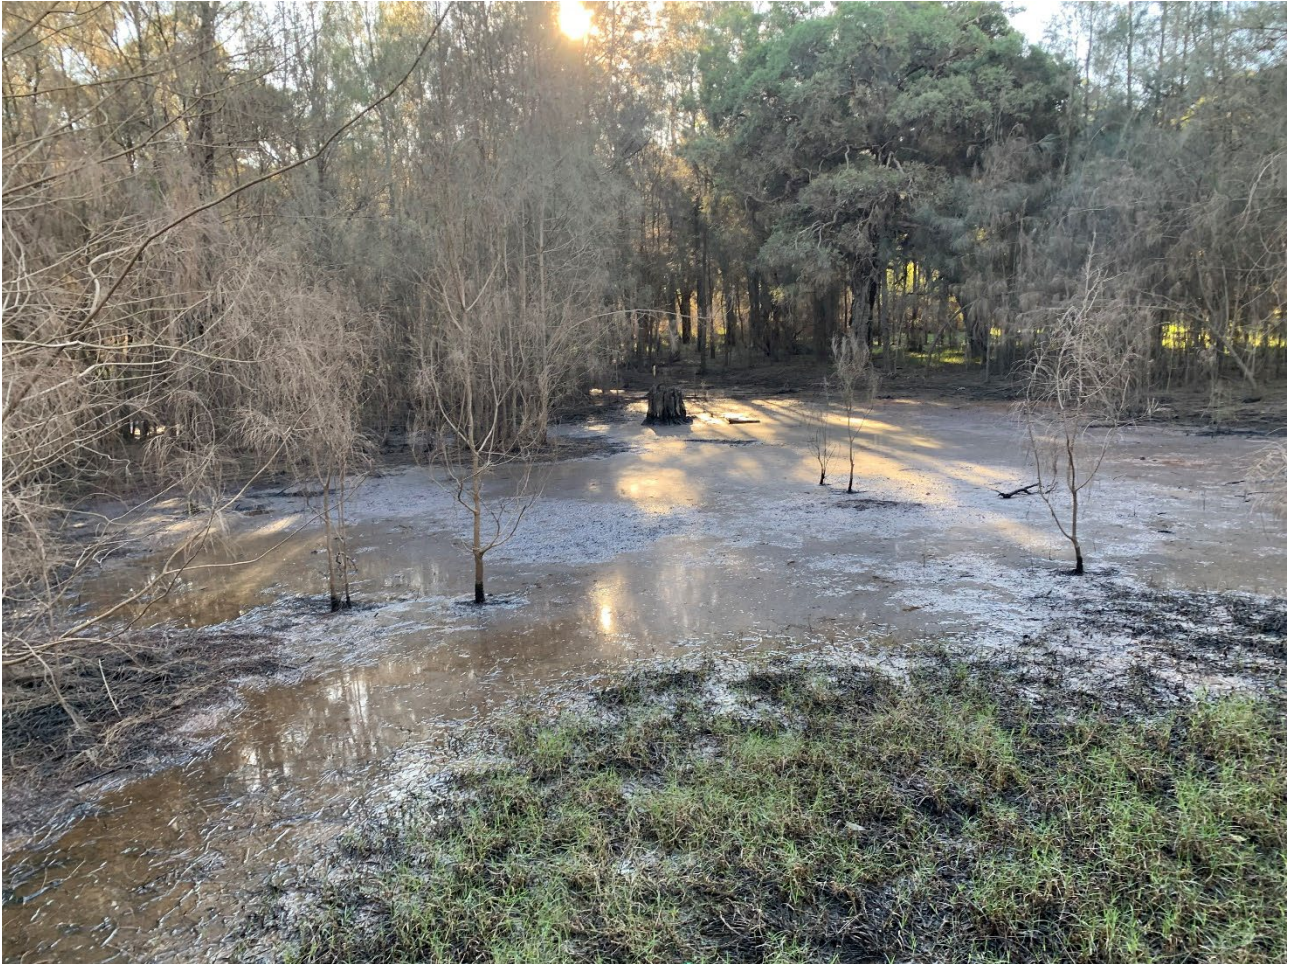
**Plate 50: Saturated soils at LN 18 (AHIMS ID# 45-5-0656) showing the prolonged impact of floodwaters in low-lying areas in proximity to the lagoon. The stratigraphic integrity of this area has been impacted by the prolonged presence of standing water, with upper soil horizons likely experiencing some intermixing.**

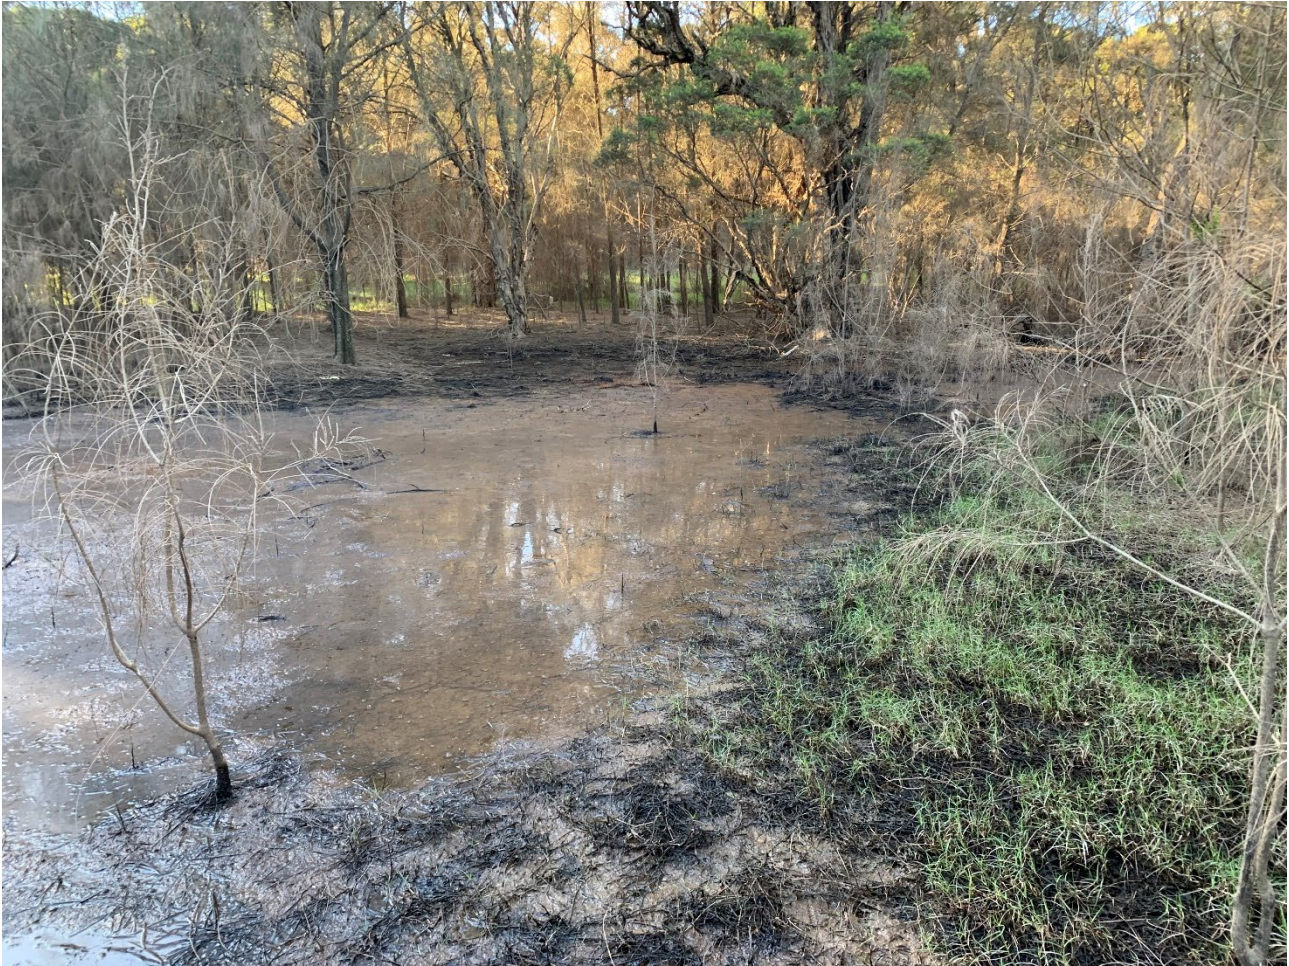
**Plate 51: Saturated soils at LN 18 (AHIMS ID# 45-5-0656) showing the prolonged impact of the heavy rainfall event in low-lying areas in proximity to the lagoon.**

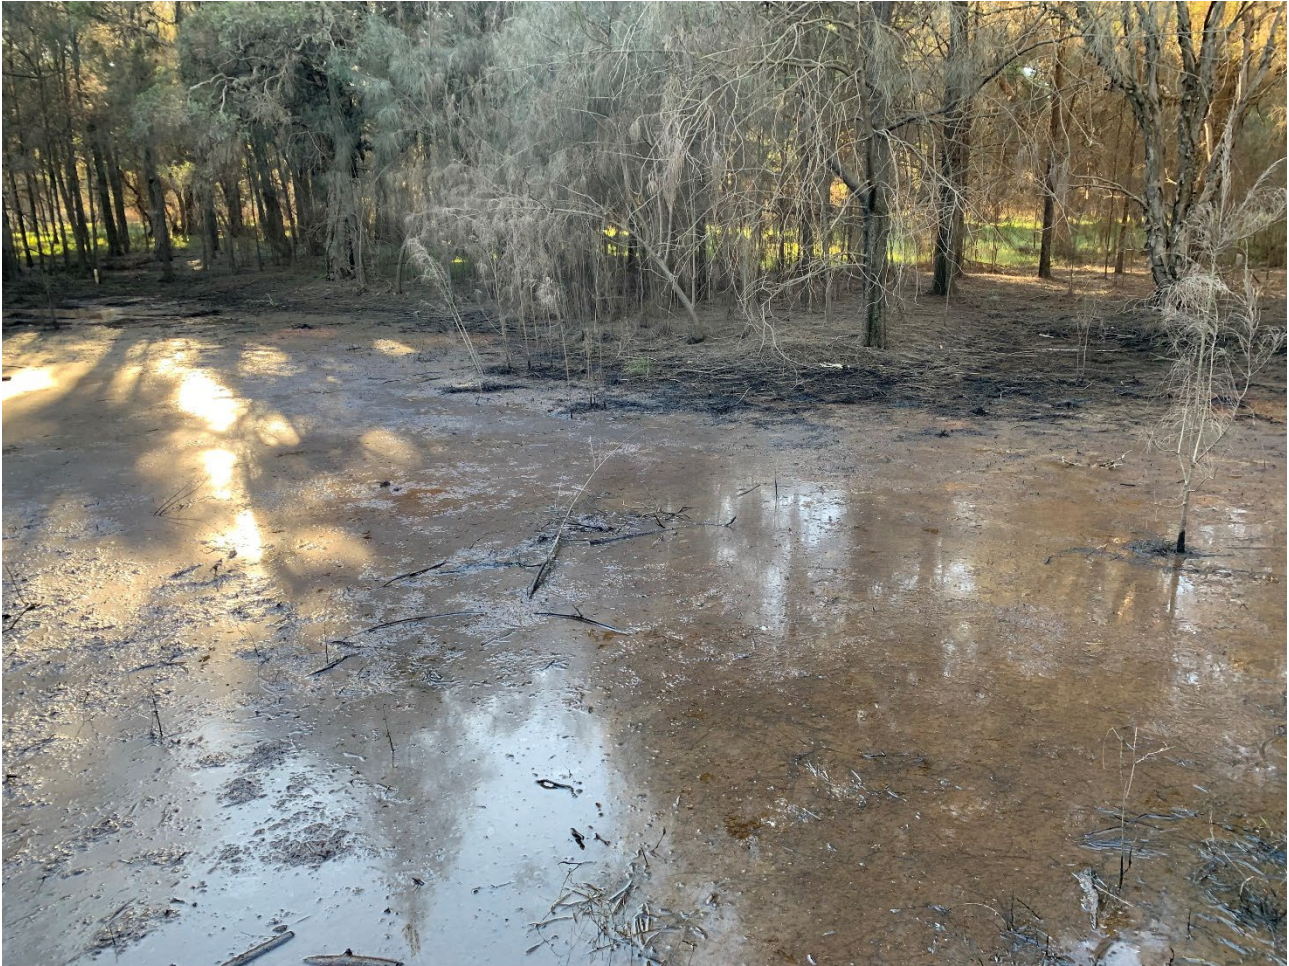
**Plate 52: Saturated soils at LN 18 (AHIMS ID# 45-5-0656) showing the prolonged impact of the heavy rainfall event in low-lying areas in proximity to the lagoon.**

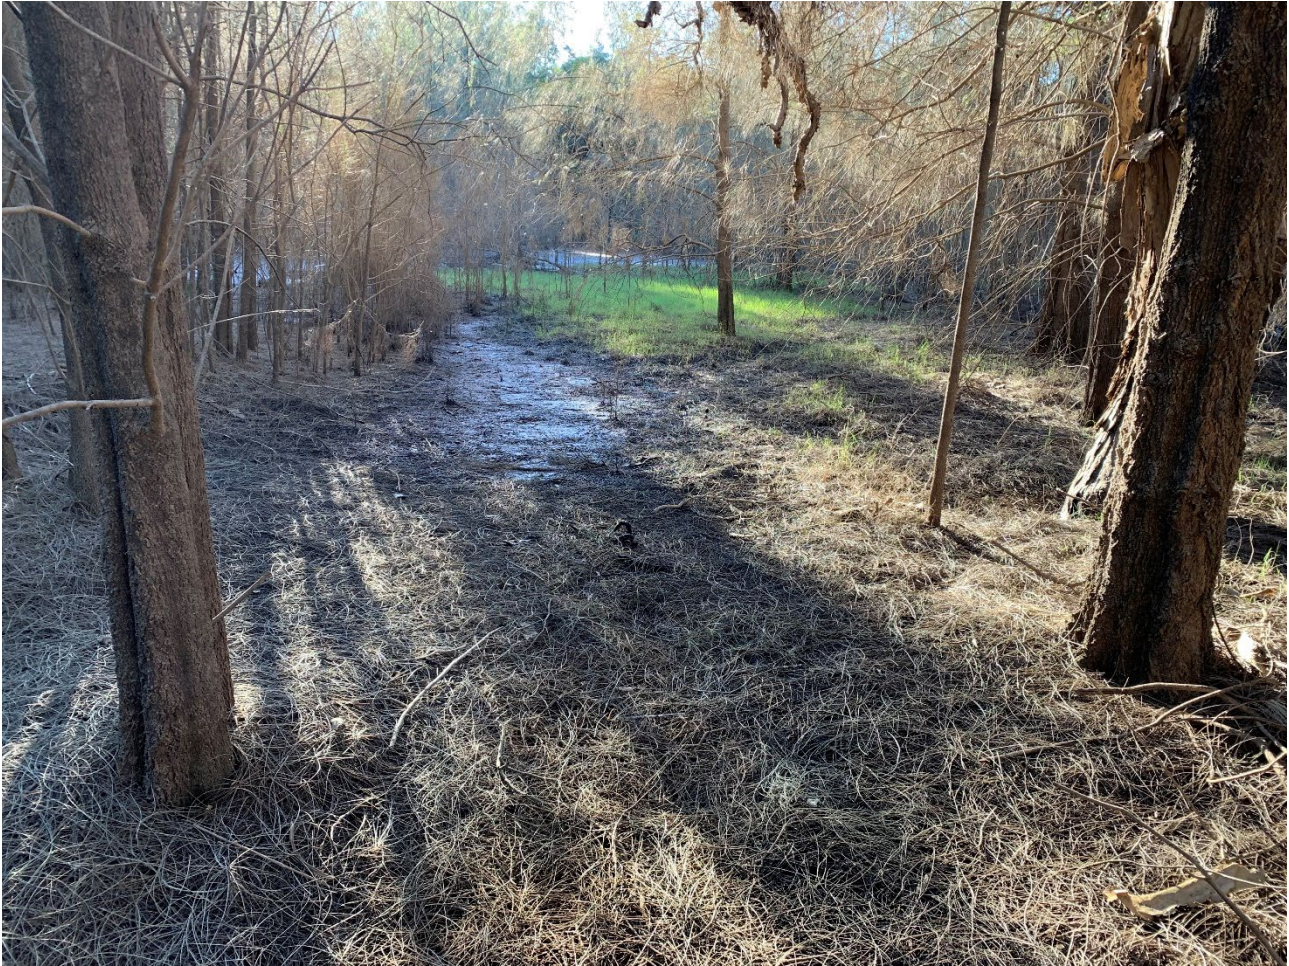
**Plate 53: Saturated soils at LN 18 (AHIMS ID# 45-5-0656) showing the prolonged impact of heavy rainfall in low-lying areas in proximity to the lagoon. A narrow channel has formed along a shallow drainage line.**

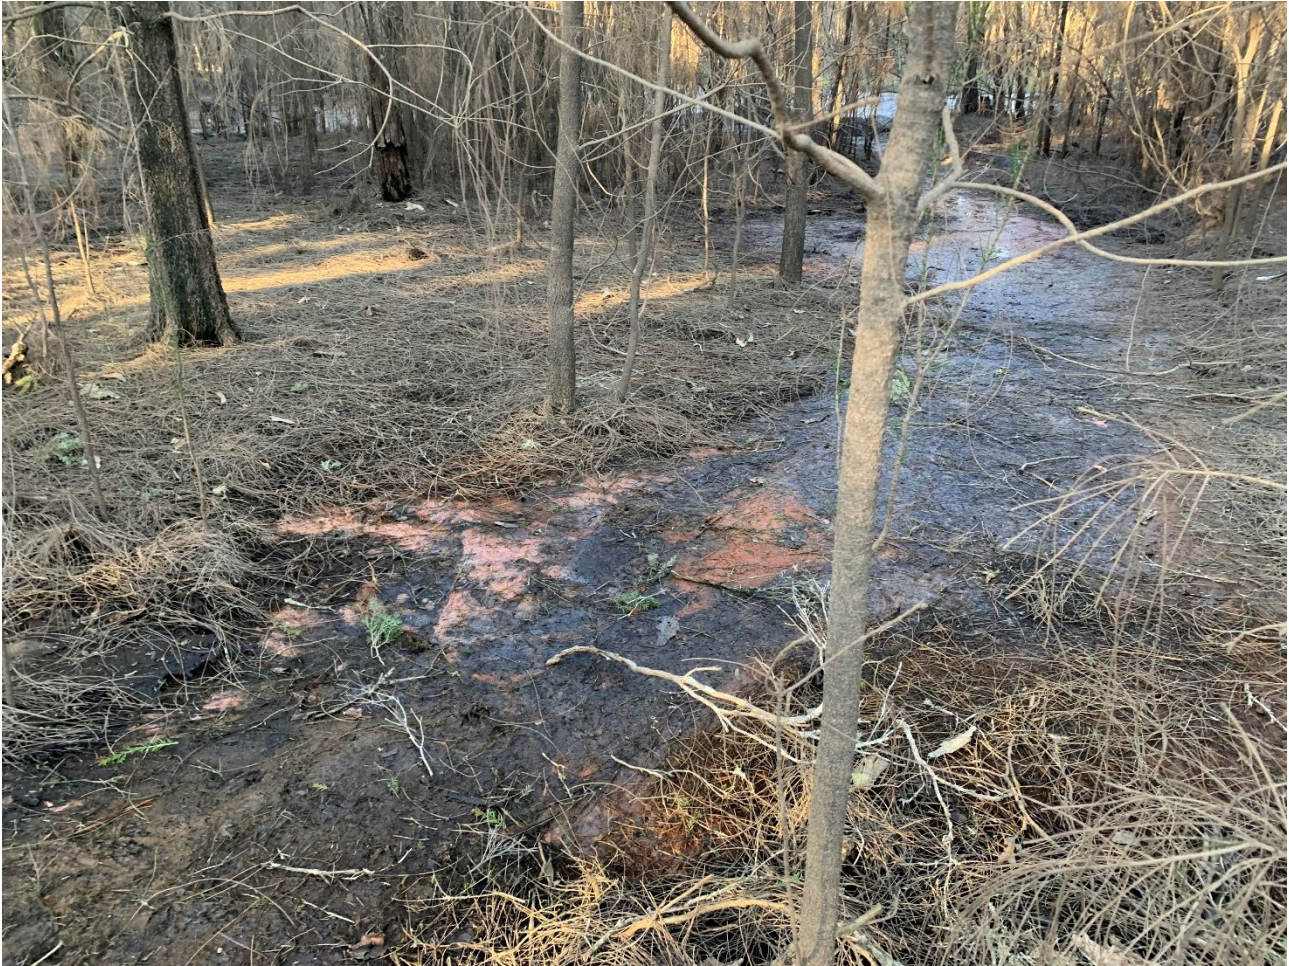
**Plate 54: Saturated soils at LN 18 (AHIMS ID# 45-5-0656) showing the prolonged impact of heavy rainfall in low-lying areas in proximity to the lagoon. A narrow channel formed along a drainage line stemming out from the area of saturation has likely experienced rill erosion. Soil appears to have been deposited along the left bank though the extent of this rill erosion and redeposition could not be readily ascertained.**

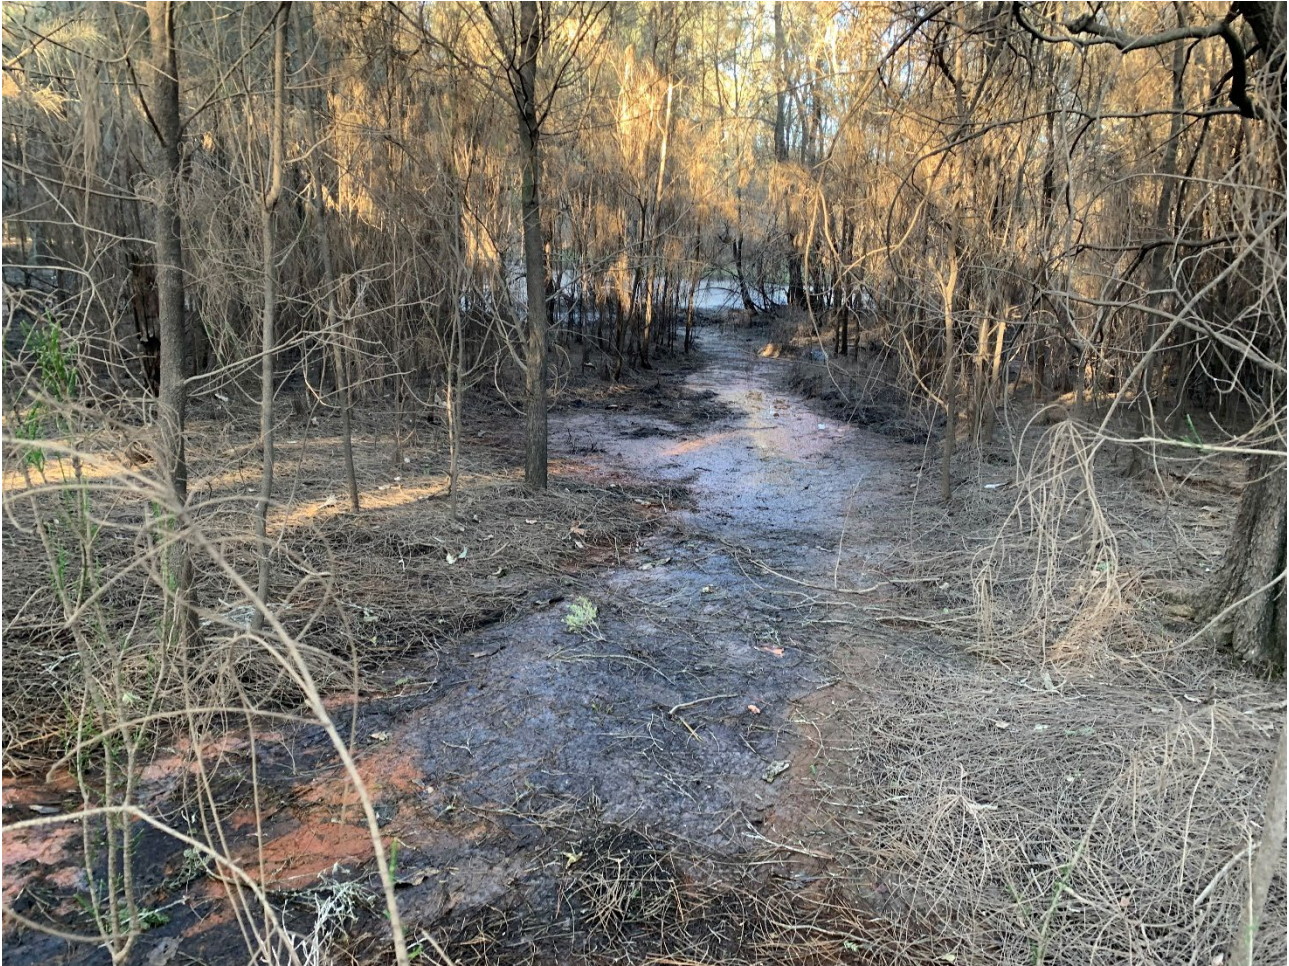
**Plate 55: Saturated soils at LN 18 (AHIMS ID# 45-5-0656) showing the prolonged impact of heavy rainfall in low-lying areas in proximity to the lagoon. Rill erosion is present in this sensitive area (situated further north-east along the same channel as Plate 54).**

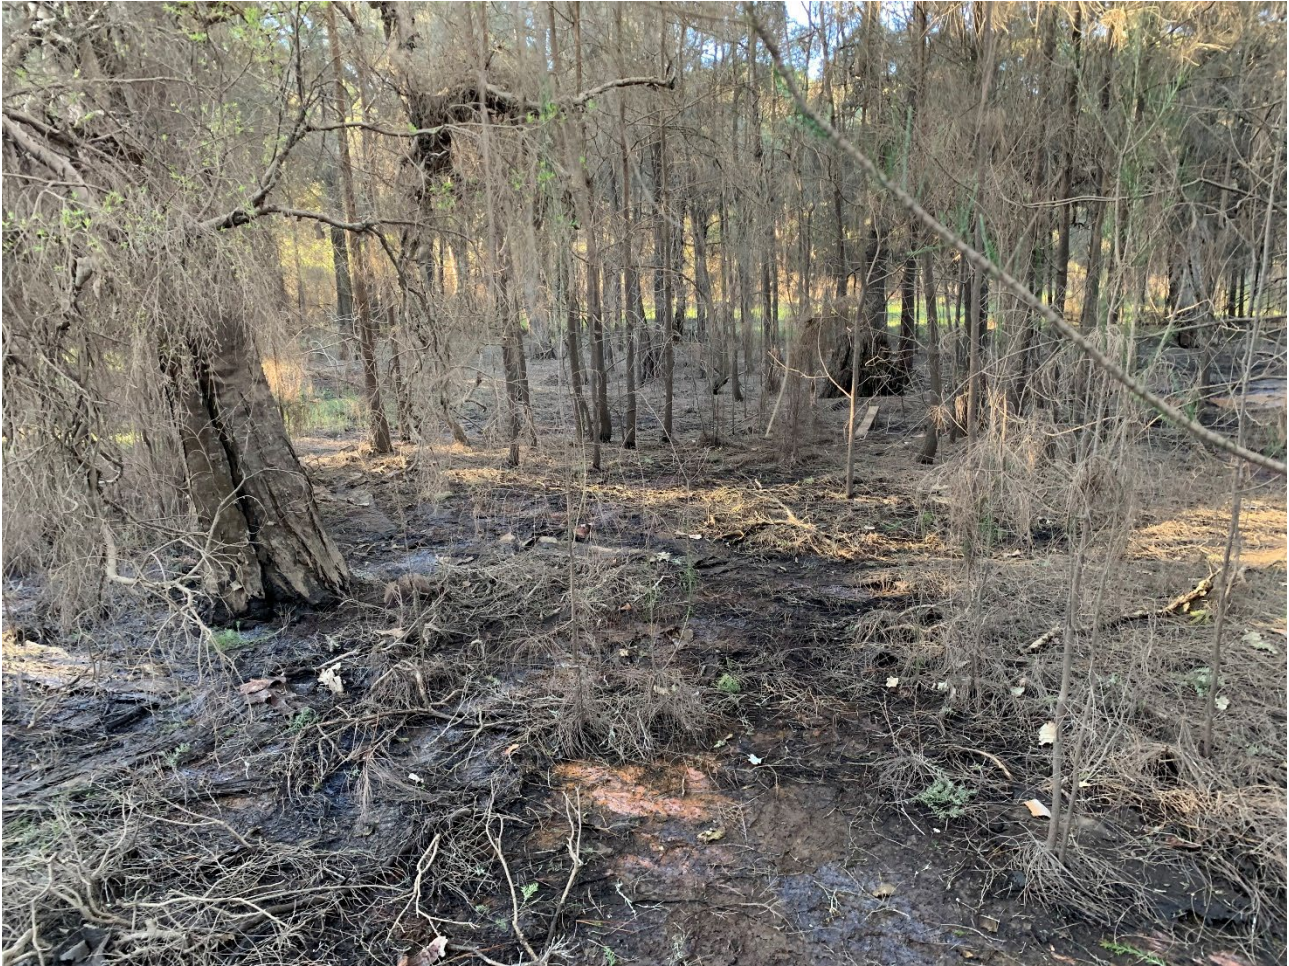
**Plate 56: Upstream of this channel the surrounding area has been heavily saturated. No accumulation of soil that has been transported by the floodwaters was observed at the base of the large tree suggesting low velocity flows through this area. Limited sheet and gully erosion were observed at this location.**

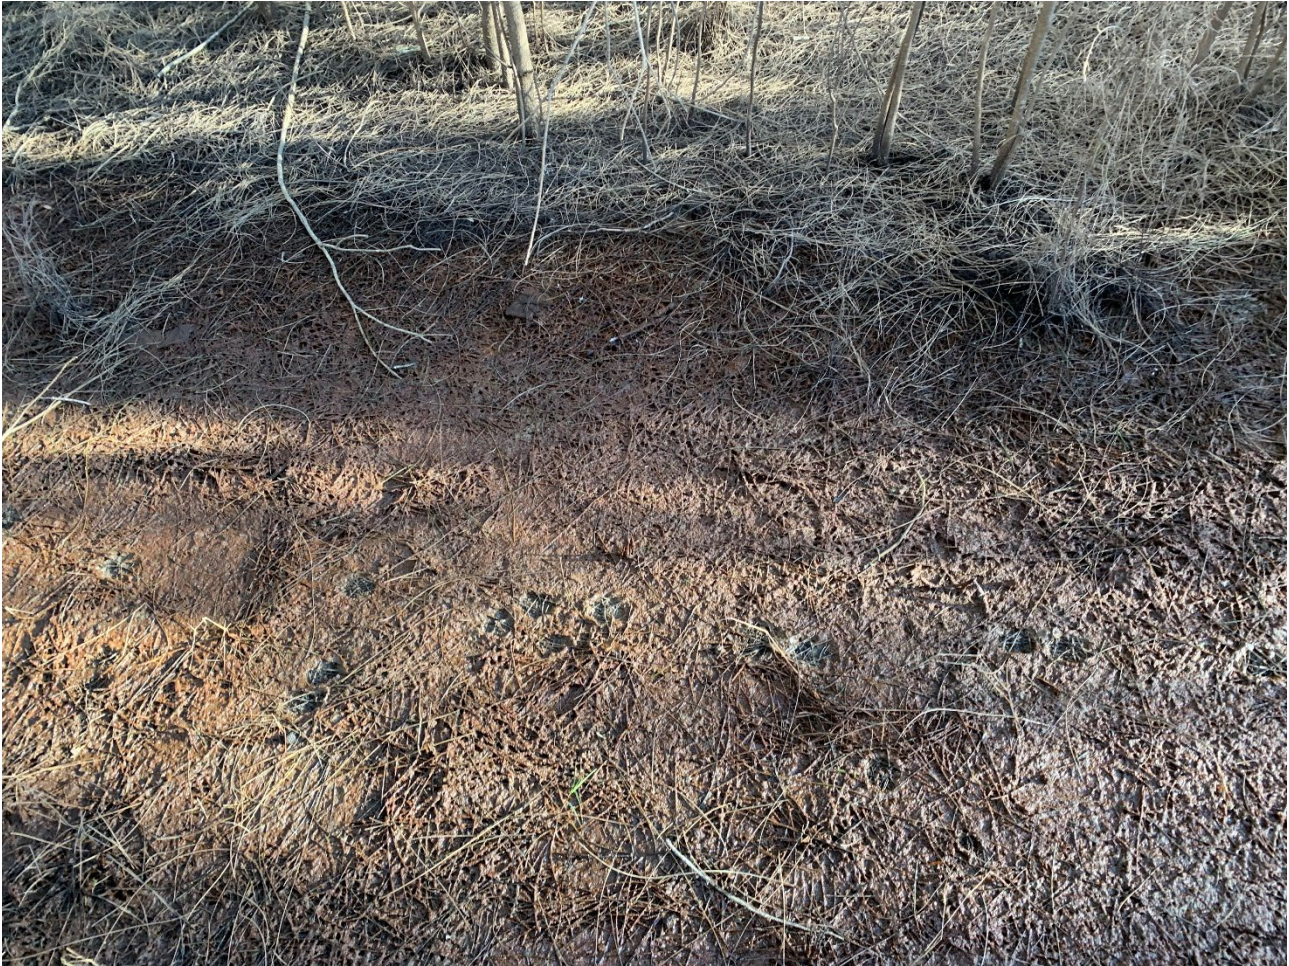
**Plate 57: As the groundwaters have receded they have left a mark on the soils present on the ground surface of the surrounding area to LN 18 (AHIMS ID# 45-5-0656). The upper soil horizon appears to have been intermixed.**

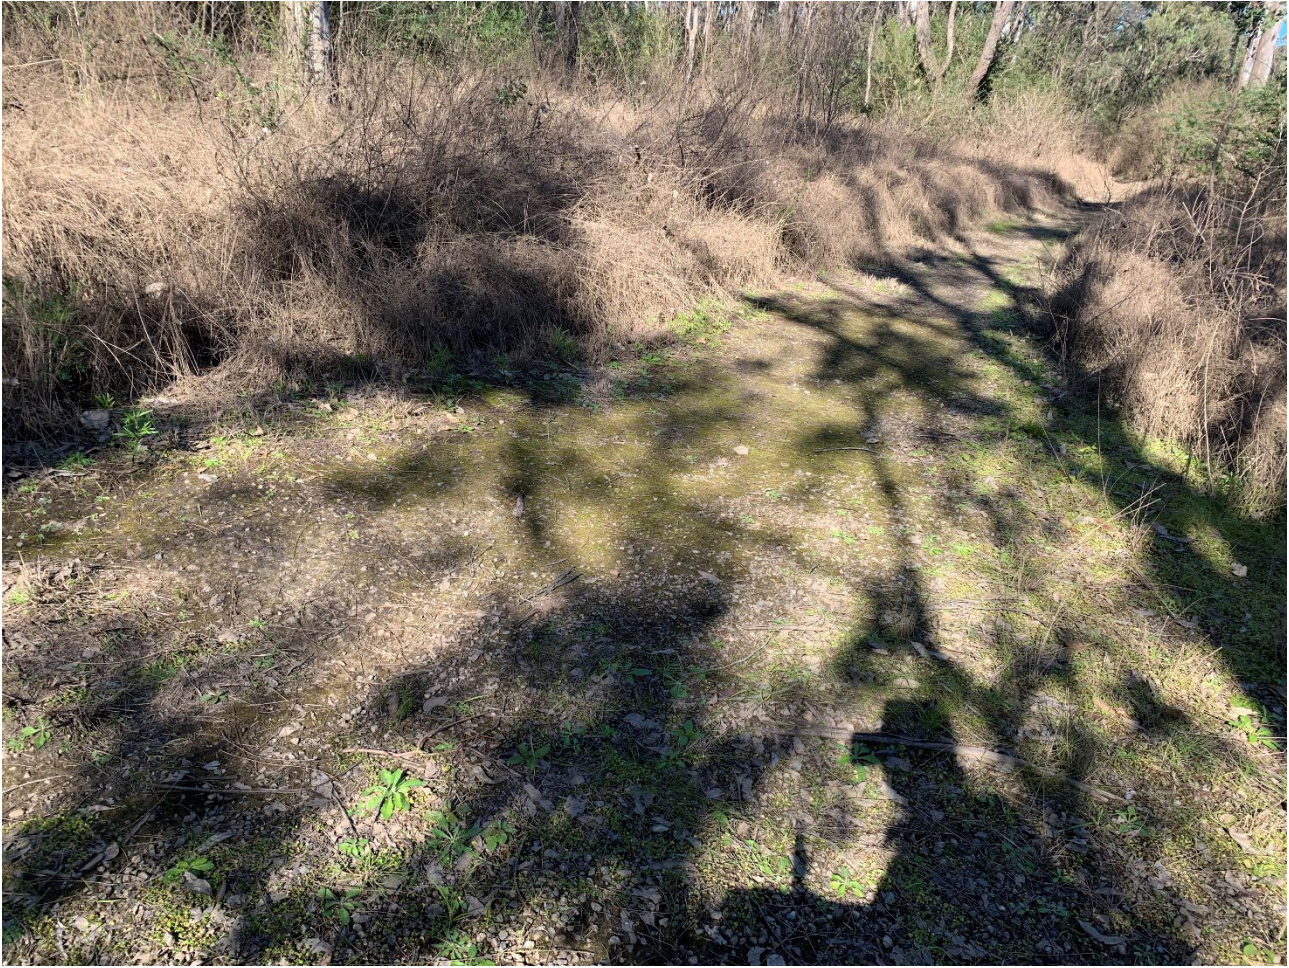
**Plate 58: Moss growth on track at WD 6 (AHIMS ID# 45-5-2738) and grass dieback in adjoining areas. Surface gravels have accumulated on the western side of the track (situated lower on the slope). Some isolated, low-lying areas within the vegetated area adjoining the access track were covered by standing water at the time of the survey. Sheet erosion in a southerly and westerly direction across the exposed track may be expected in this area. The small scatter of red silcrete artefacts which have been recorded at the site in February 1995 could not be relocated during the present site inspection. It is unclear whether the artefacts have been transported elsewhere due to erosion or obscured by sheet erosion as the level of ground surface visibility (GSV) in the area adjacent and downslope to the track was 0%.**

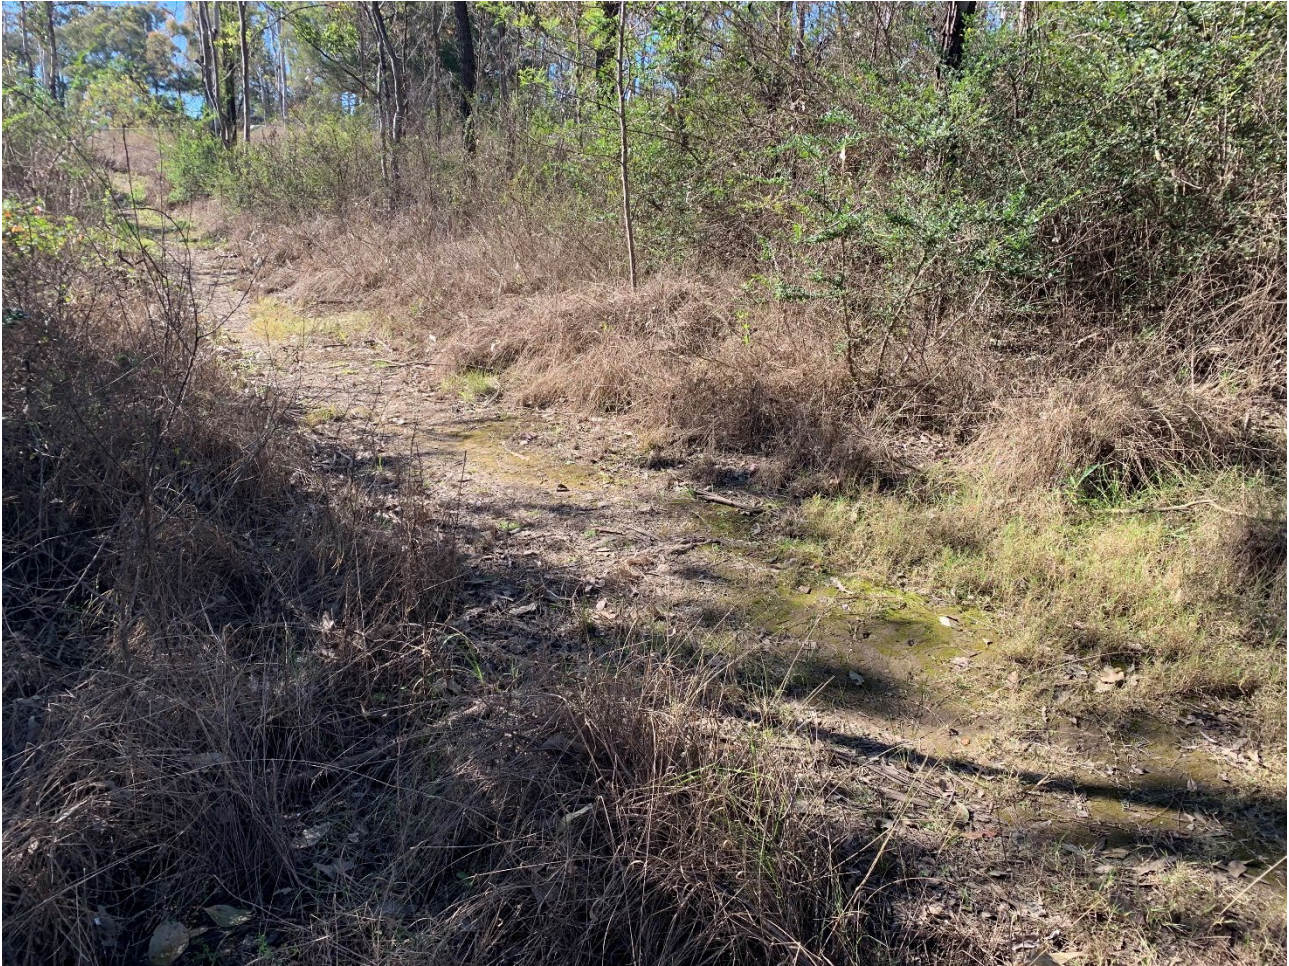
**Plate 59: Eroded access track situated in the north-eastern corner of the lagoon at the approximate location of WD 6 (AHIMS ID# 45-5-2738). Gravel has accumulated on the westernmost side of the track (sitting lower topographically) confirming sheet erosion has occurred in the area. The track surface contains a combination of natural gravels as well as introduced fill material (crushed brick). Ground surface visibility was poor across the exposed track, with moss cover obscuring some of the surface. The soil is a compact sandy clay loam and no exposures with visible stratigraphy were observed during the site inspection.**

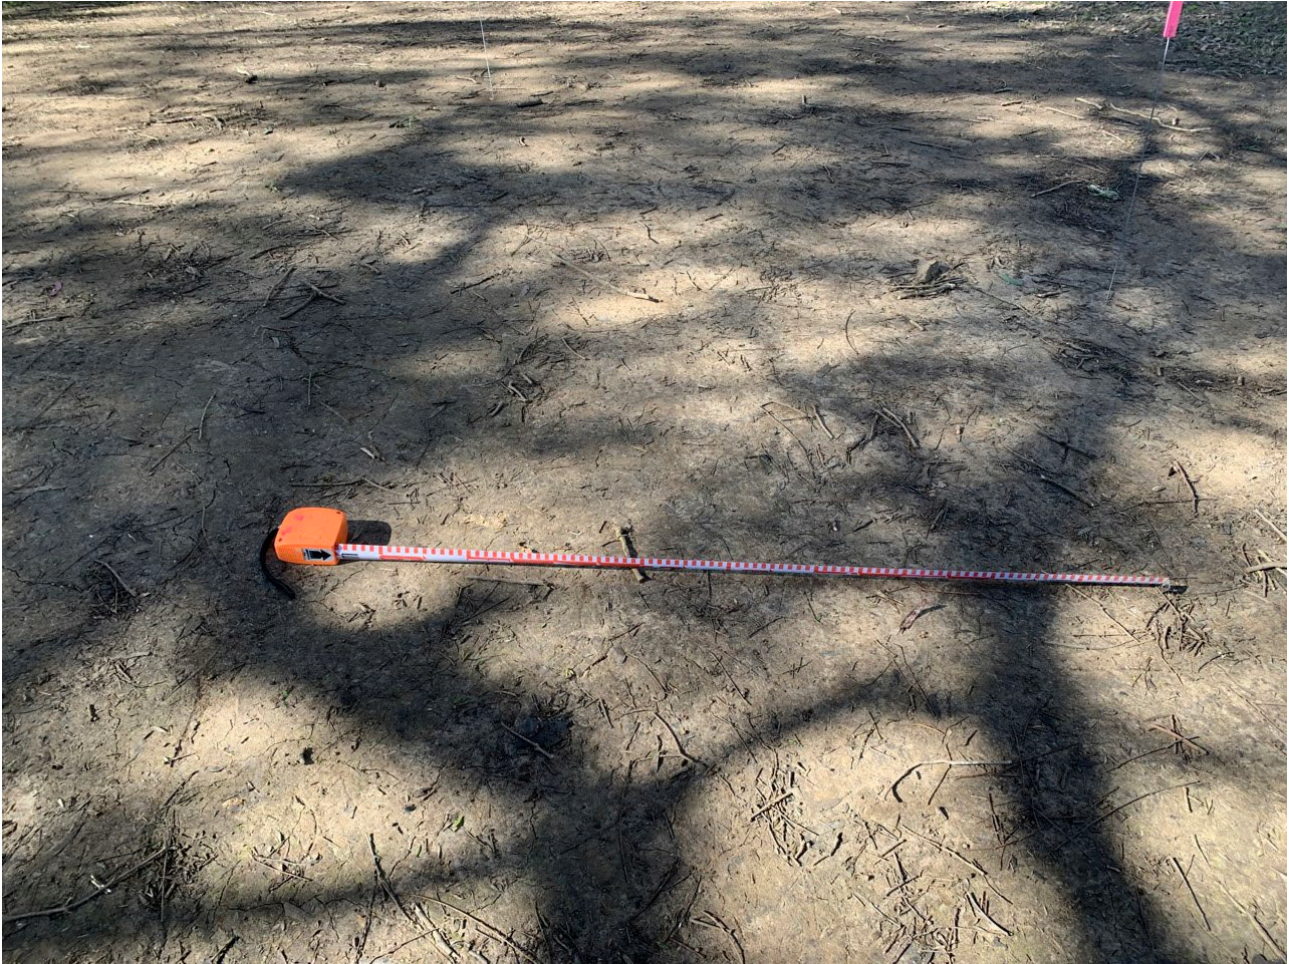
**Plate 62: Close-up of impacted soils within the exposure at WD 7 (AHIMS ID# 45-5-2739). Artefacts that were identified on the surface in the vicinity of this location were firmly embedded within the soil deposit. This aggrading soil has built up with sediments transported downslope to form a sediment fan.**

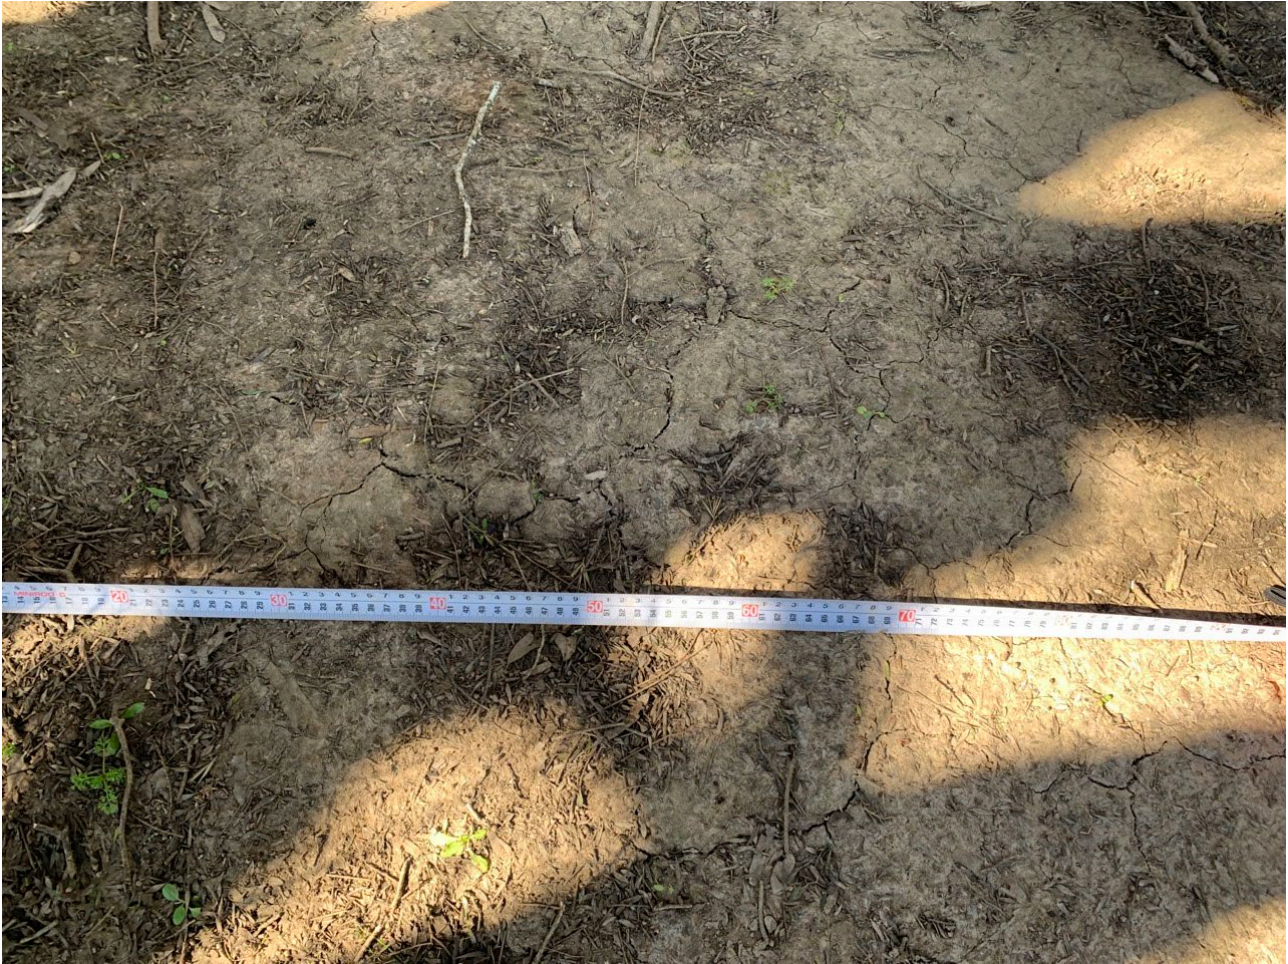
**Plate 63: Cracking present on ground surface at WD 7 (AHIMS ID# 45-5-2739) associated with intermittent flooding events. The prolonged suspension of the upper soil horizon has resulted in an intermixing of soils, though the depth of this impact could not be verified in the field. After the surge and as flood waters receded, cracking has resulted. The inundation has also likely contributed to some minor slumping of the bank and the subsequent hardening of reconsolidated soils. The absence of vegetation in this area has made the site more susceptible to bank scouring.**

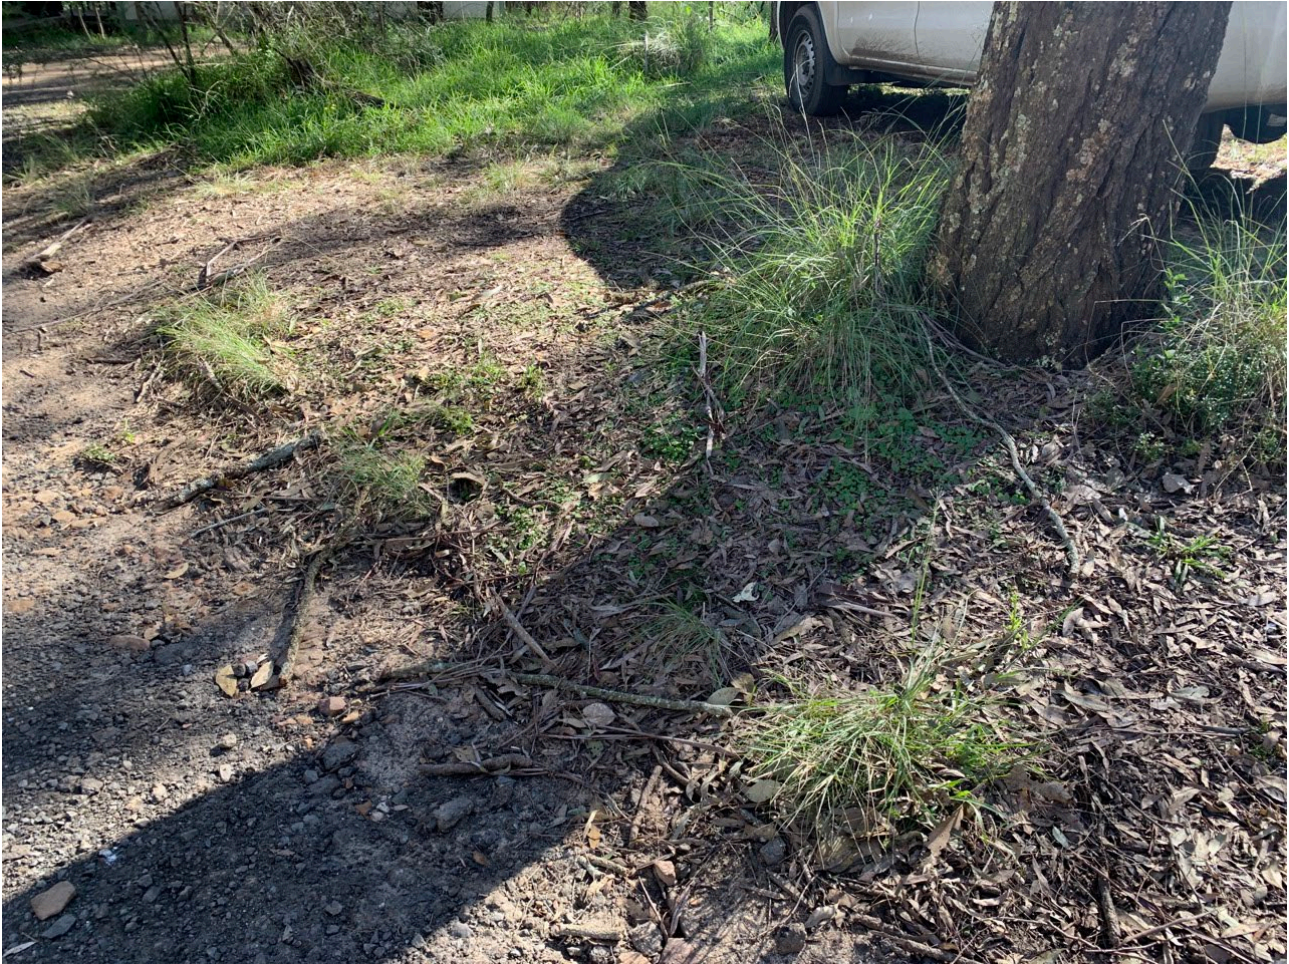
**Plate 67: At the edges of the track in the vicinity of LL01 Coordinates in AMG 66 (AHIMS ID# 45-5-3708) evidence of rill erosion was observed in a limited capacity during the site inspection. Rill erosion has likely exposed sub-surface gravels present.**

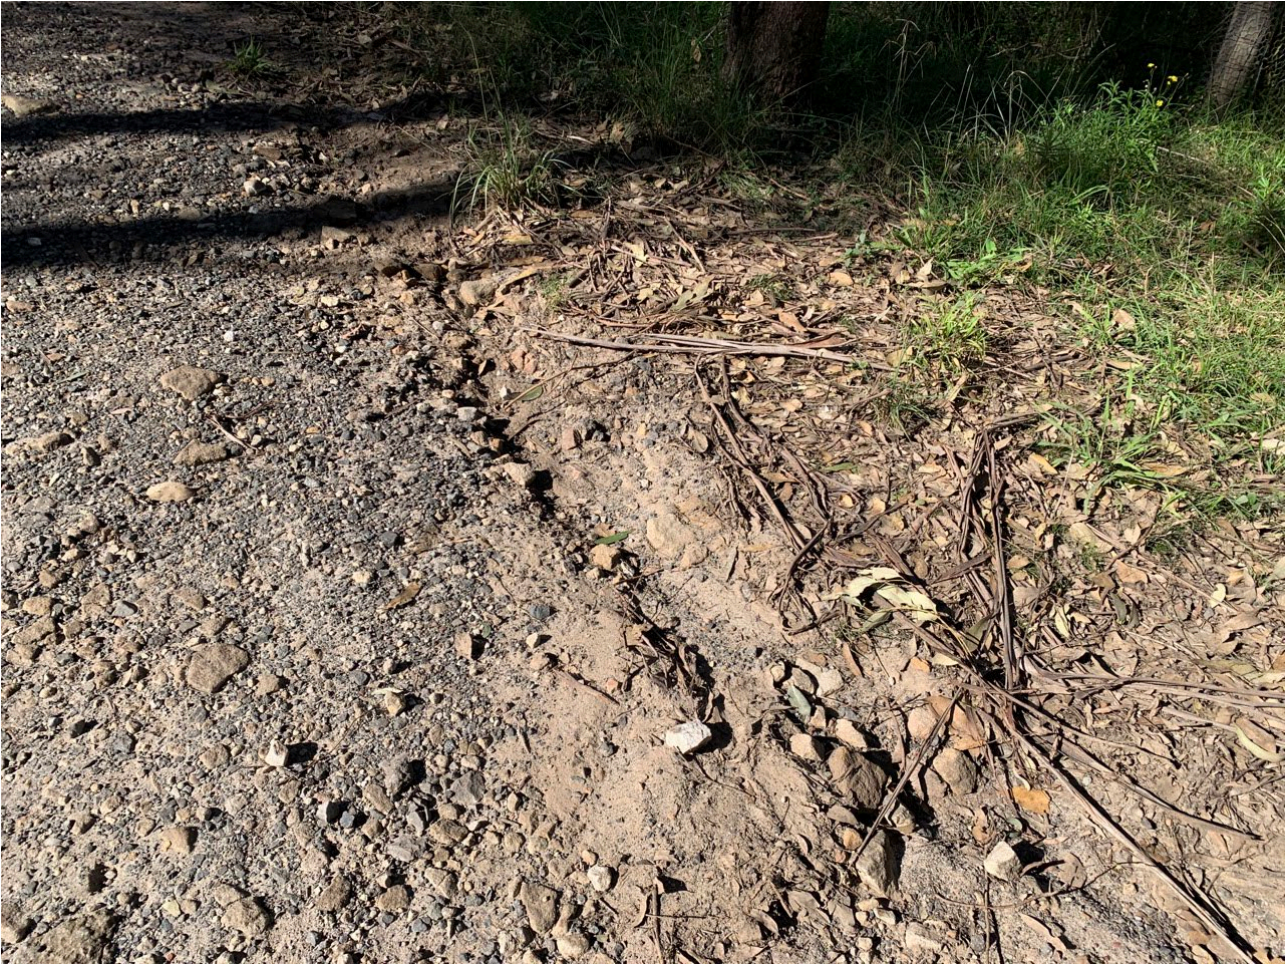
**Plate 68: Limited rill erosion was observed along the edges of the track at LL01 Coordinates in AMG 66 (AHIMS ID# 45-5-3708) with infilled sand having covered some of the surface gravels. Larger pebbles have accumulated in distinct areas along the erosion lines. No artefacts were observed on the ground surface during the site inspection following community collection in 2010 (AHIP # 1121342).**

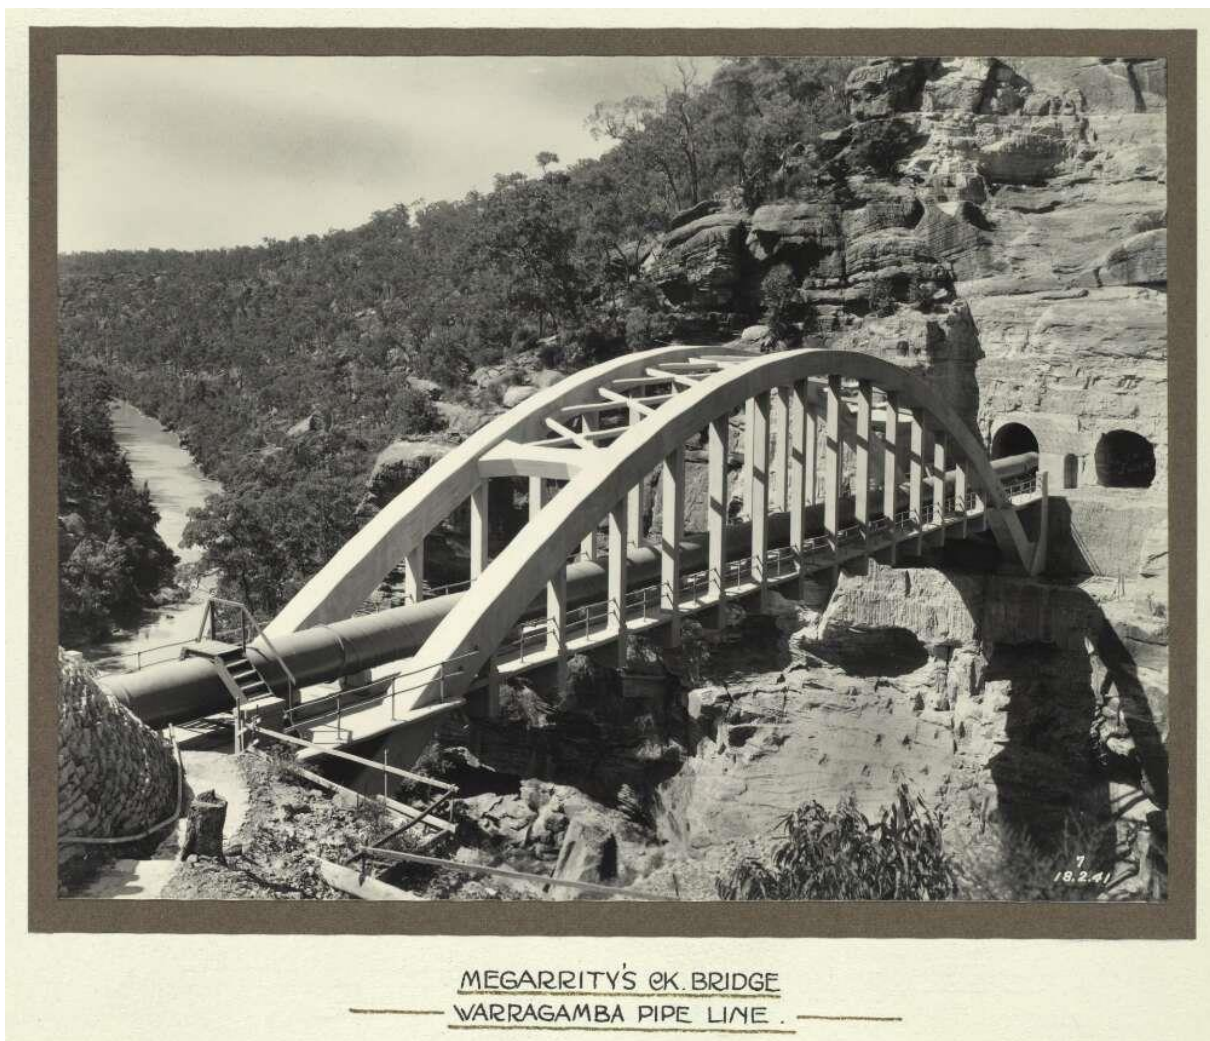
**Figure 3-21: Photograph of Megarrity's Bridge, c. 1941. (Source: NLA, PIC/8732/17 LOC Album 562)**

*Megarrity's Creek Bridge is a concrete arch bridge spanning Megarrity's Creek. The construction of the bridge provided a vital link across the Creek for the operation of the Warragamba Emergency Scheme. While it was designed eventually to carry the No. 1 106" outlet main from Warragamba Dam, for the Emergency Scheme it carried the 48" main from the weir to Prospect Reservoir.<sup>14</sup>*

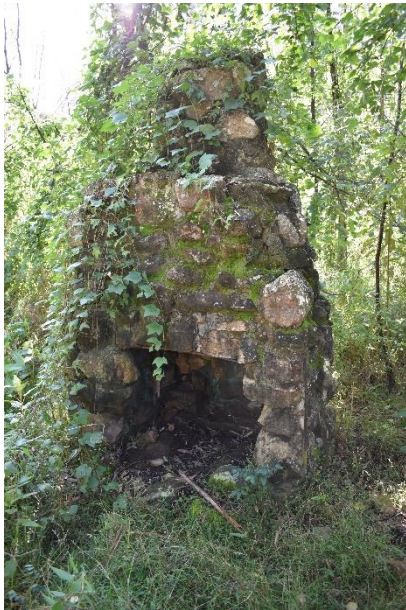
Figure 4-1: Frontal view of the extant stone chimney and fireplace, facing north-east.

The remains of the Orange Tree Flat House primarily consist of an extant, free-standing bluestone chimney and fireplace (see Figure 4-1). The chimney is about 2.5 metres in height with the opening of the fireplace measuring 0.8 metres in height (see Figure 4-6 and Figure 4-9). The structure is located roughly 5 metres west of the Orange Tree Flat trail, and about 10 metres from the water's edge of Little River, up on a steep embankment. The structure is situated in a clearing within relatively thick vegetation and has impeded views towards the Little River and the Orange Tree Flat trail.

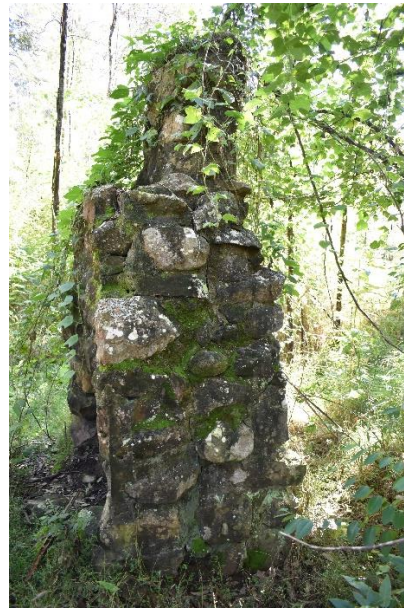
Figure 4-2: Side view of the stone chimney, facing north.

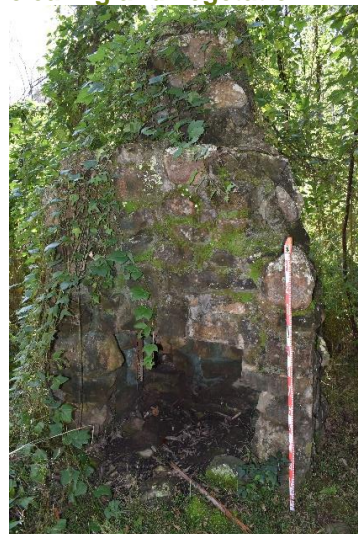
Figure 4-6: The chimney structure with scale (1.3 m).

The structure is constructed of bluestone with a lime mortar aggregate. It is a typical chimney design, with a wide fire base which narrows to a chimney flue. There is some vegetation growing over the structure but there is no evidence of the vines compromising the chimney (see Figure 4-8). The internal structure of the chimney is clear of vegetation and there is no evidence of collapse. There are areas at the back of the structure which are experiencing cracking or breaking of the lime mortar.

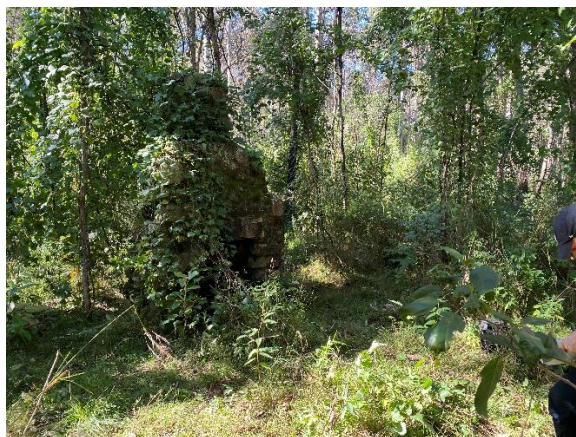
Figure 4-8: View of the chimney showing vegetation growing over the structure.

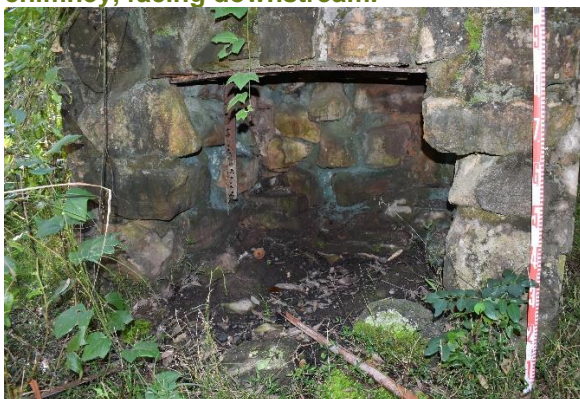
Figure 4-9: View of the fireplace with scale.
