# Preferred Infrastructure Report

Warragamba Dam Raising

Application Number	SSI-8441
EPBC ID Number	2017/7940

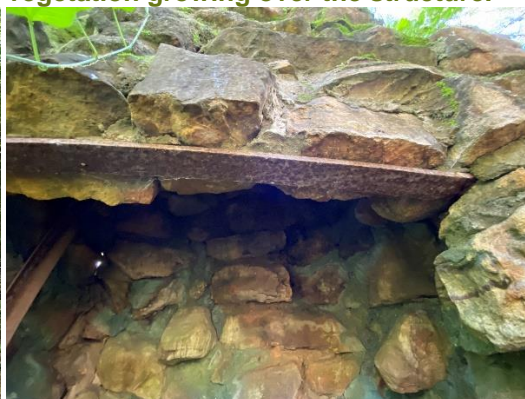
Figure 4-10: Image of the iron lintel above the fireplace.

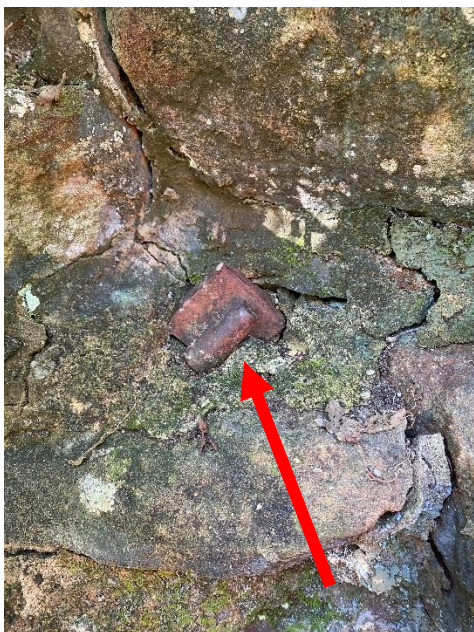
Figure 4-11: Image of one of the steel bolts protruding from the side of the chimney.

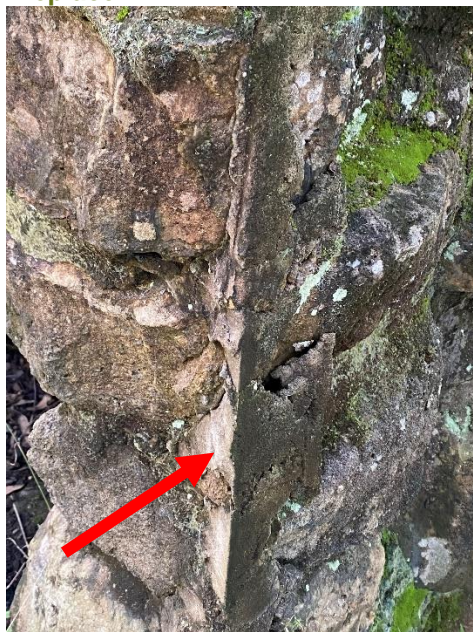
Figure 4-12: Image of one of the external sides of the chimney, showing possible former joint or wall.

Externally on the chimney structure, on both sides, is evidence of the affixing of former walls with lime, which suggests the fireplace and chimney were formally attached to a structure (see Figure 4-12).

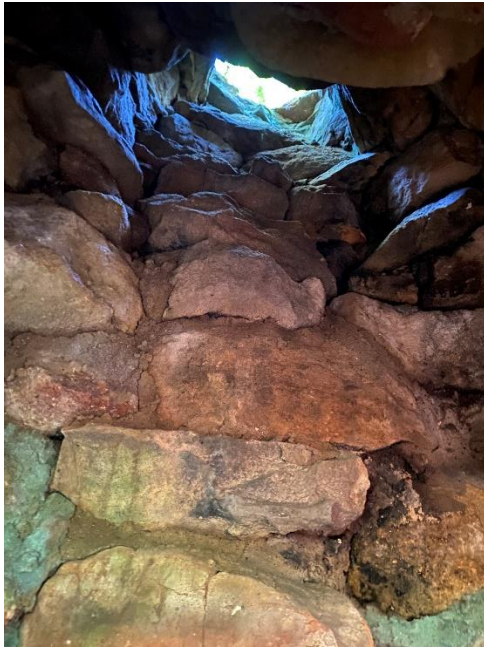
**Figure 4-13: View inside the chimney flue.**

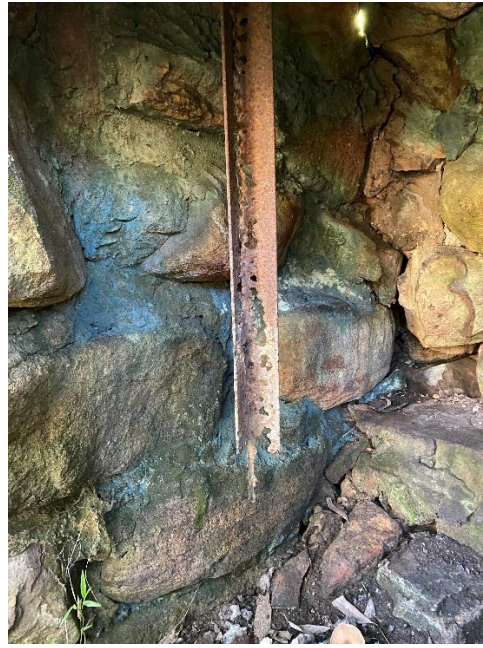
**Figure 4-14: Closer image of the iron bar vertically hanging within the fireplace.**

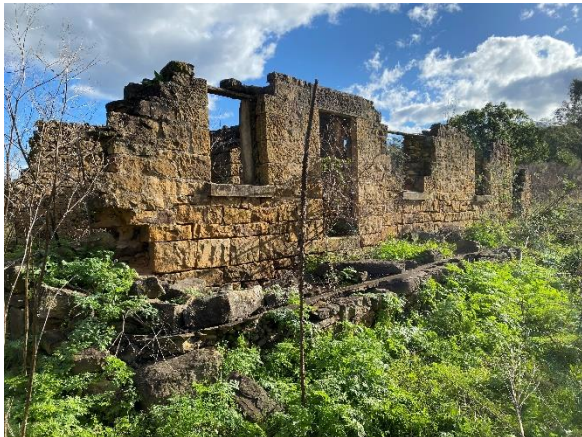
**Figure 4-15: View of the northern façade of the stone hut ruins, showing the collapsed veranda and eastern wall.**

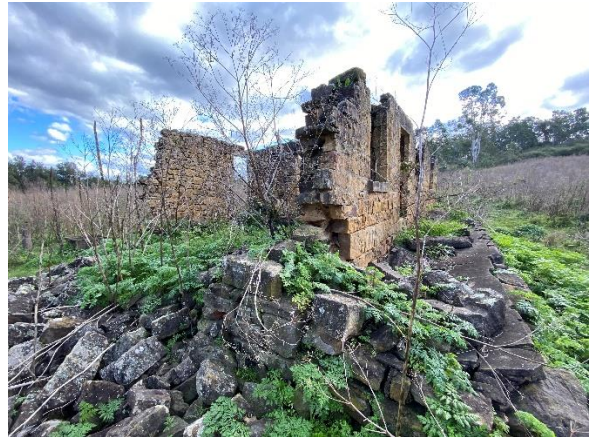
**Figure 4-16: View of the collapse eastern wall.**

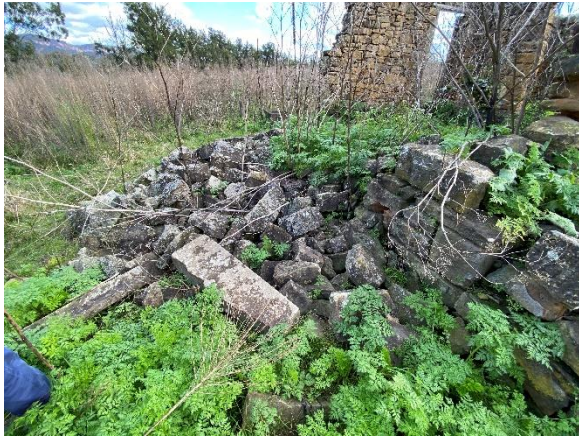
**Figure 4-17: View of the collapsed easterly wall.**

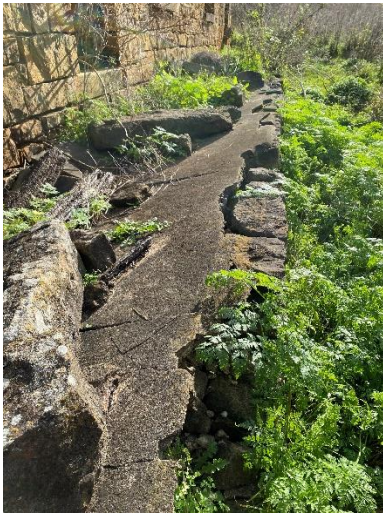
**Figure 4-19: View of the subsided veranda.**

There is evidence of shaped stone around the doorways where former door jams would have been inserted (see Figure 4-20). The house consists of four rooms in a traditional linear layout. The most westerly room is the smallest (see Figure 4-22), which adjoins two moderate sized rooms (see Figure 4-23) which lead into the largest room to the east (see Figure 4-26). The walls of the largest room on the eastern side of the house have collapsed, mostly in a uniform fall (see Figure 4-17). On the northern face of the house, there is evidence of a former veranda, with a mixed stone foundation and

possibly concrete surface (see Figure 4-19). This has all subsided inwards. Extant sections of lime are evident on the internal walls of the structure, indicating the internal rooms were finished with a wash (see Figure 4-25, Figure 4-33 and Figure 4-34).

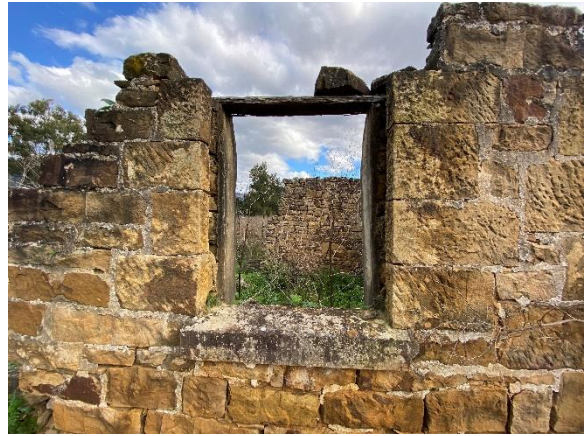
**Figure 4-18: Example of a window with timber and sandstone lintels.**

The stone house is constructed of sandstone with a lime aggregate, with larger blocks used as lintels and doorsteps (see Figure 4-18). It is very likely this house is an example of the continuation of the Old Colonial Georgian style into the Victorian era, which is characterised by symmetrical facades, simple rectangular shapes, and general orderliness. This is evidenced in a historic image found of the stone house (see Figure 3-7), which is likely dated to the late 1920s to early 1930s based on the woman's attire on the veranda. This would be before the Hunt family vacated the property in 1933. In this image the house's corrugated iron roof is well intact with a modest veranda held up by timber posts and smaller fencing in the foreground. In the background a structure is held up by four tall timber posts, which may have been a shelter or a platform. What is also illustrated in this photograph is that the room on the righthand side of the image is possibly a later extension to the main house, likely the smallest room on the most westerly side (see Figure 4-22). The image also shows evidence of a timber door and possibly 6-paned glazed windows. On the left hand side of the picture there appears to be a mature tree and possible fencing in the form of a small paddock adjacent to the house. This tree is perhaps the snag shown leaning towards the house, surrounded by younger trees growing inside and around the house, in an image of the site taken in 1990 (see Figure 3-7).

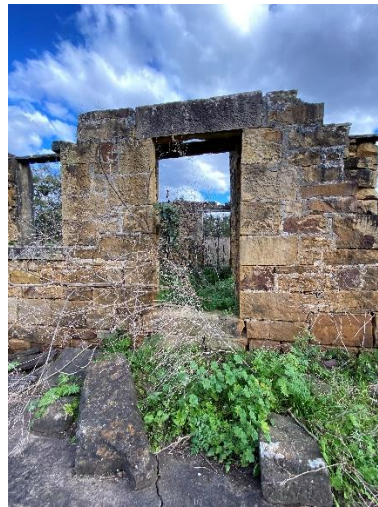
**Figure 4-20: Example of a doorway with sandstone and timber lintels.**

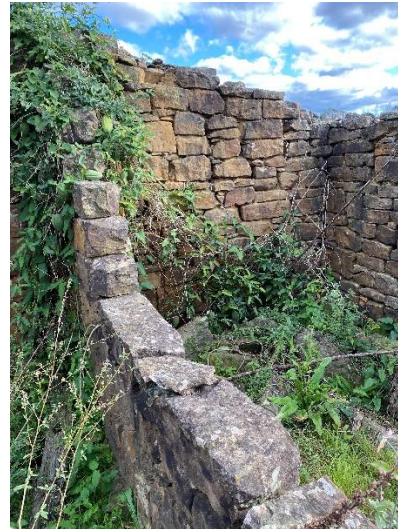
**Figure 4-22: View of the first, smallest room, facing south west.**

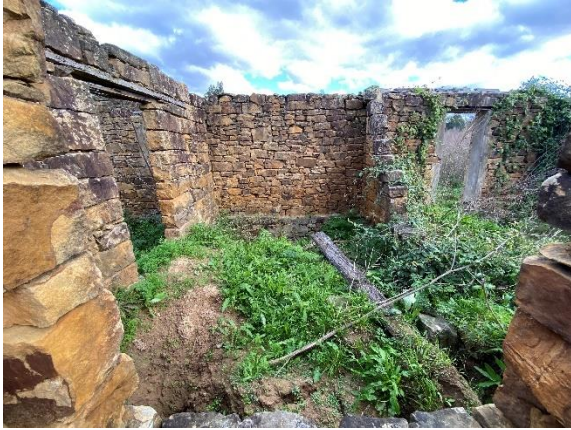
**Figure 4-23:** View of the two middle rooms, facing south.

Timber lintels line all six windows, and four external and one internal doorway, which all appear in poor condition (see Figure 4-27). One of the internal timber lintels between the second room and the third room is on the ground having likely fallen when the internal wall collapsed (see Figure 4-23).

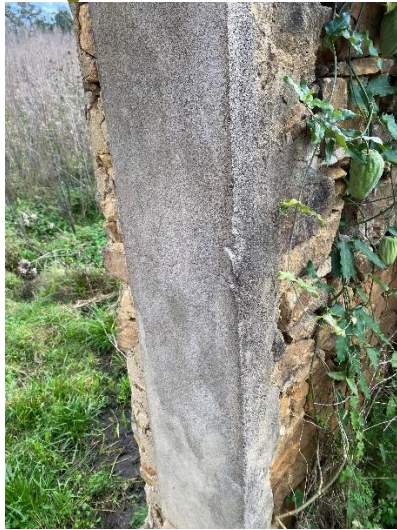
**Figure 4-25:** Example of lime wash on the interior walls and doorways.

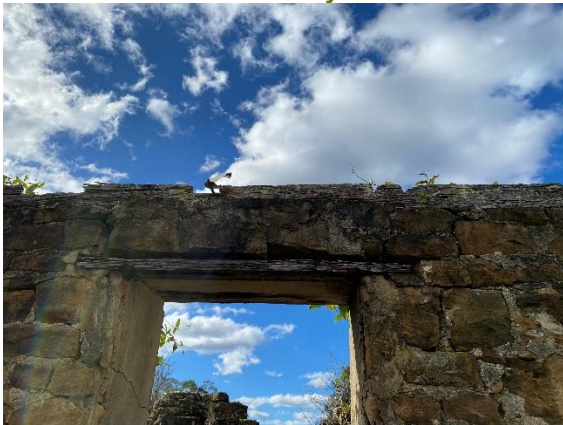
**Figure 4-27:** Example of timber lintel and timber framing to former roof with evidence of metal bracket nailed to the beam.

The entire house is currently exposed with the roof no longer extant. There is some evidence of the former corrugated iron roof with some metal brackets still nailed (with handcrafted nails) to timber lintels framing the most western doorway (see Figure 4-27, Figure 4-35 and Figure 4-36).

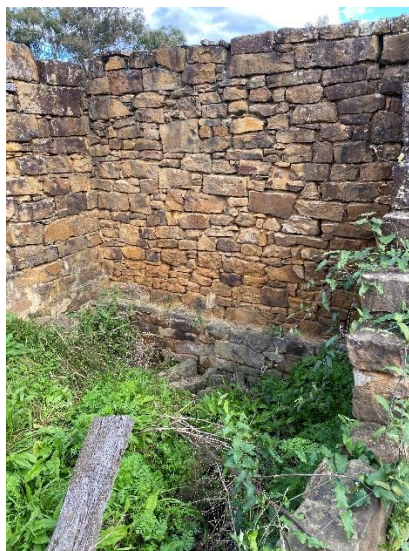
Figure 4-30: View of the third room showing the former floor level and the subfloor level, shown through colour differentiation in the sandstone.

There is no longer evidence of the former flooring in the house with the subfloor completely exposed however there is a clear differentiation between the structure's foundations and where the former flooring would have been located (see Figure 4-30). Internally and externally the ground is experiencing a moderate level of visible moisture in the lower stones and foundations of the walls (see Figure 4-39).

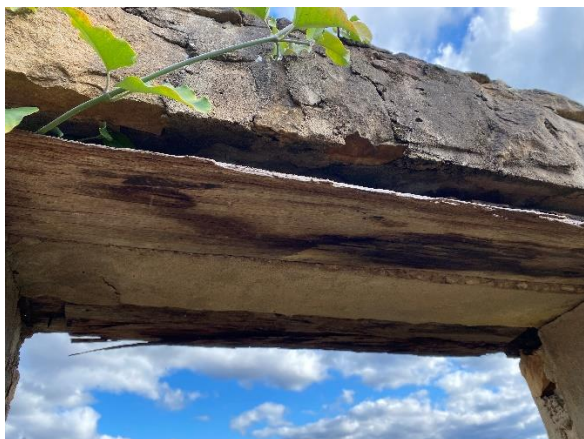
Figure 4-31: Example of the condition of timber lintels.

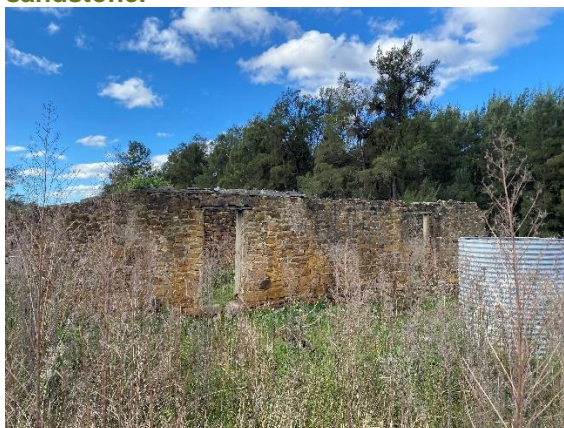
Figure 4-32: View of the tank and southern wall, facing north.

To the west of the stone house is an extant corrugated iron water tank (see Figure 4-32). This appears to be in fair condition. To the west of the tank are remnant timber fence posts, which were found to run along the extent of the property around the house. Separate from the fencing is a larger timber post which has a metal nail or bolt protruding from the top (see Figure 4-37). In the general vicinity of these structures are scattered sandstone blocks completely covered by ground cover and grasses (Figure 4-38). These were likely from smaller stone structures associated with the main house.

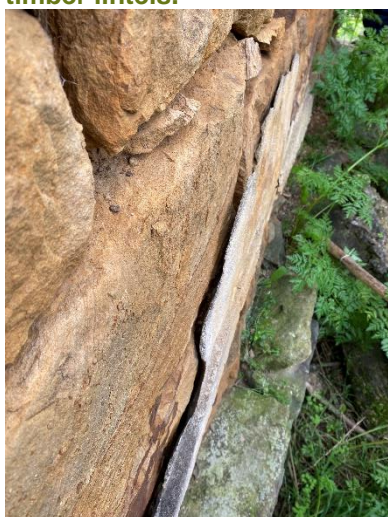
Figure 4-33: Another example of lime wash on the interior walls.

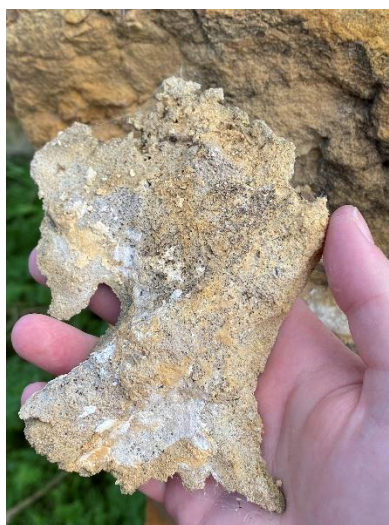
Figure 4-34: Flaked lime wash from the walls, showing sand aggregate.

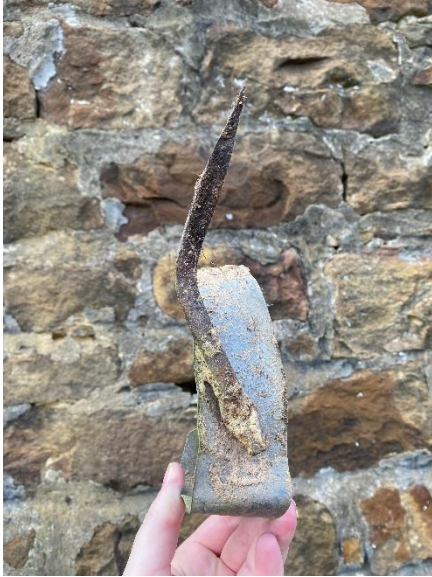
**Figure 4-35:** Example of metal bracket from timber beams with a long, handmade nail.

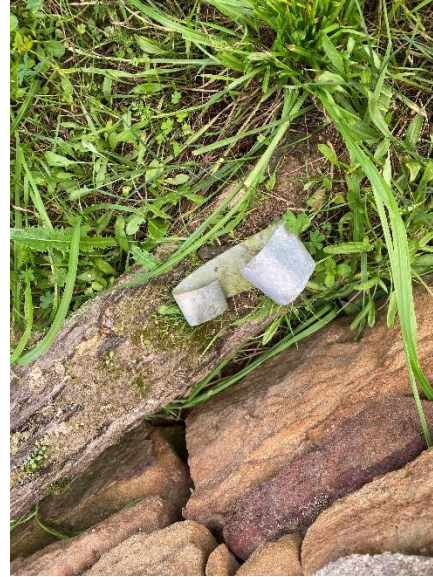
**Figure 4-36:** Metal bracket nailed into a timber beam.

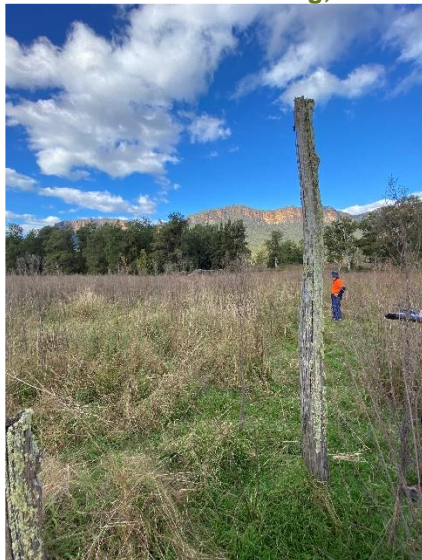
**Figure 4-37:** Large timber post and remnant fencing, a few metres beyond the water tank.

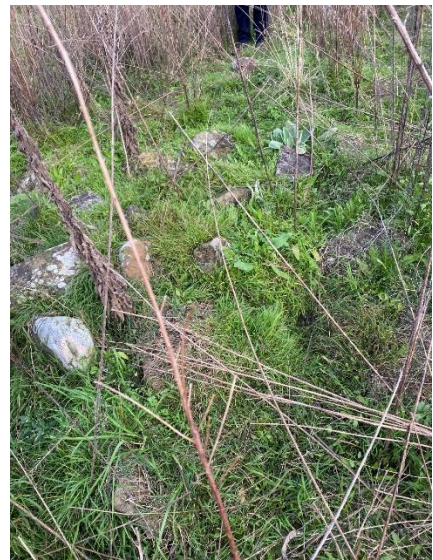
**Figure 4-38:** Example of scattered sandstones in the grass nearby to the stone house.

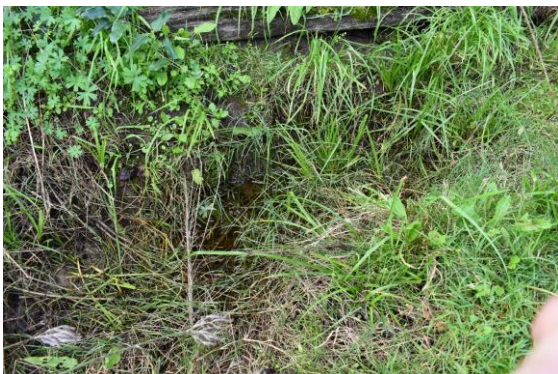
**Figure 4-39:** Example of damp ground beneath the foundations.

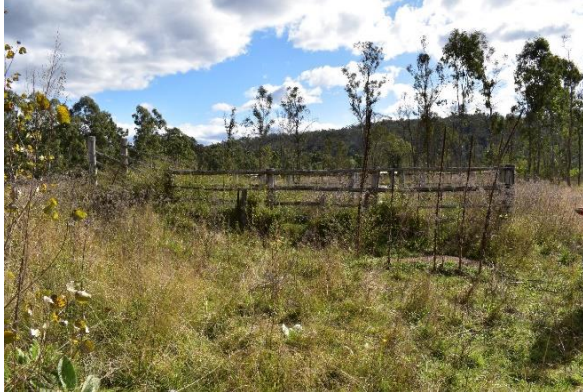
**Figure 4-42: Former livestock ramp and yard, with extant fencing, facing west.**

The former cattle or sheep ramp, yard and remnant fencing are in poor condition but are largely legible as a sorting and holding yard (see Figure 4-42 and Figure 4-43). The construction is primarily a timber post and rail arrangement with rails tied to the posts with high tensile wire or bolted to the end posts (see Figure 4-47 and Figure 4-48). Some of the fencing also consists of timber posts with belly wire fencing, suggesting rabbit or kangaroo proof fencing was used on the property (see Figure 4-50). There is evidence of both kinds of fencing throughout the general area of these structures, which suggest majority of the property was fenced into paddocks.

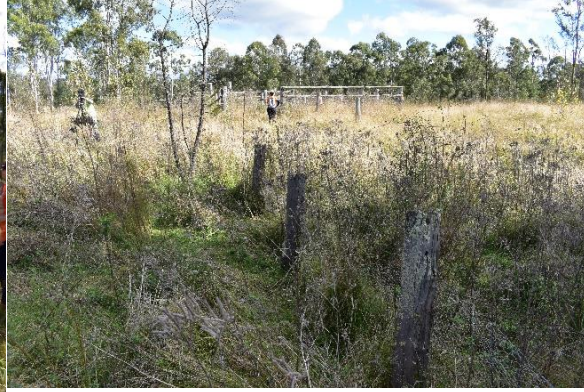
**Figure 4-43: View of the livestock ramp and yard, with extant fencing, facing south.**

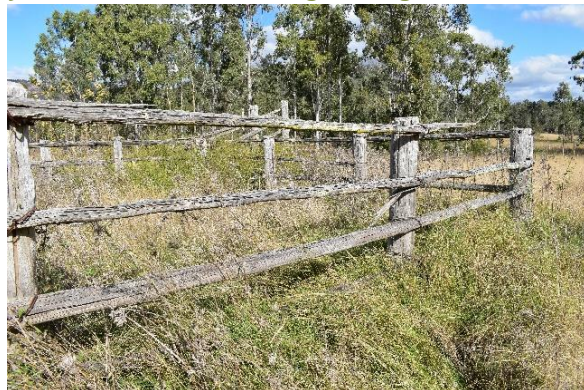
**Figure 4-45: Former sorting yard fencing.**

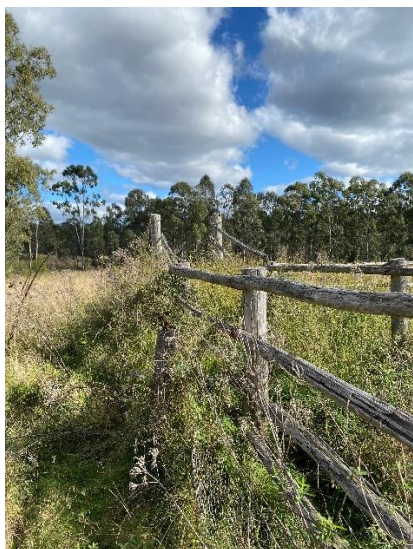
Figure 4-46: Former livestock ramp.

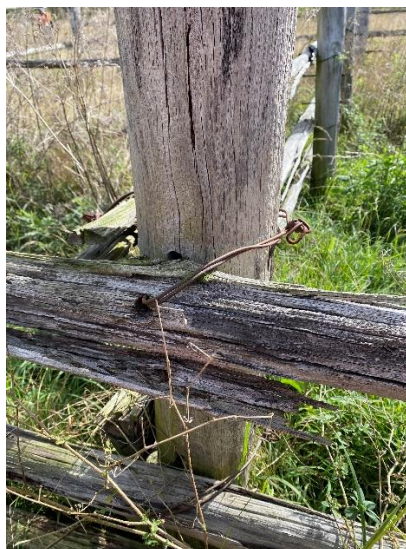
Figure 4-47: Example of the high tensile fencing wire used to tie the rails to the posts at the yard.

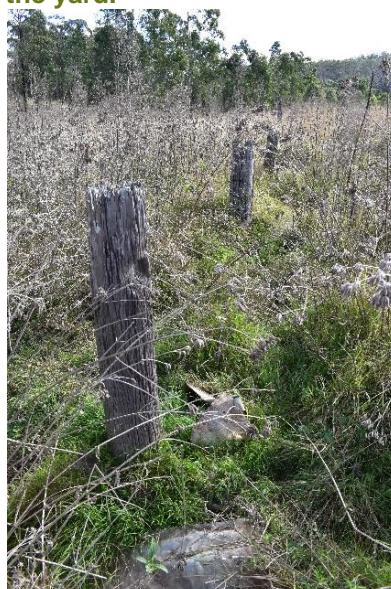
Figure 4-48: Example of bolted rails to end posts at the yard.

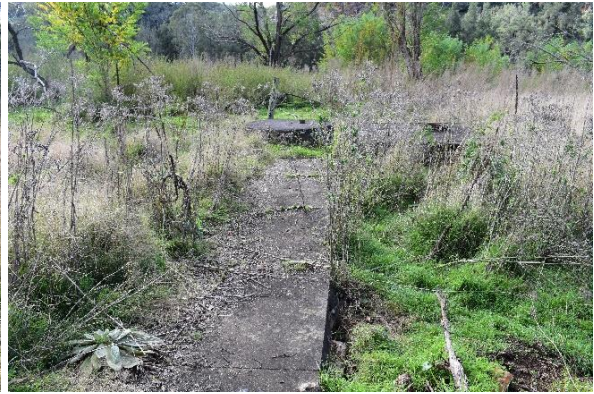
**Figure 4-58: View of former structure foundations, facing west.**

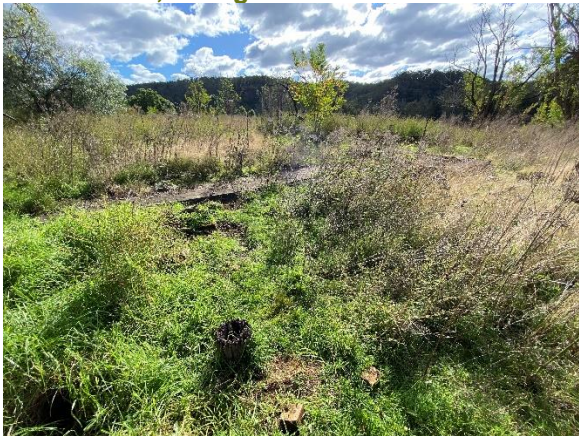
**Figure 4-59: View of former structure foundations, facing north.**

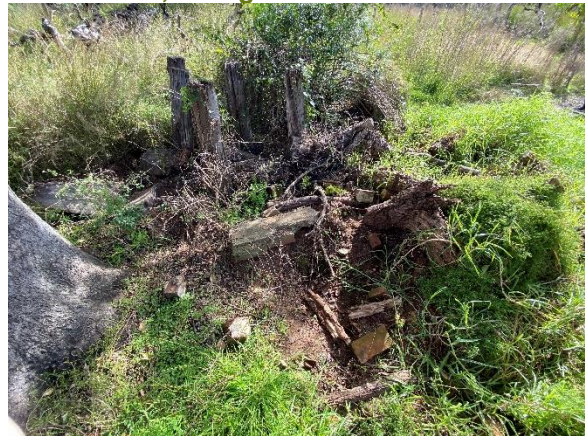
**Figure 4-60: Another view of former structure foundations, facing west.**

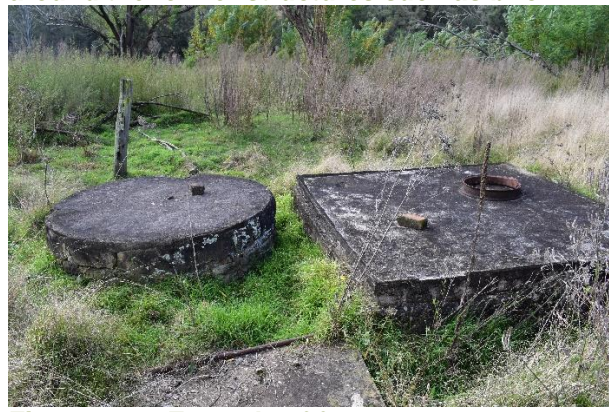
**Figure 4-63: Example of former structures, one with stone foundations and one with concrete foundations.**

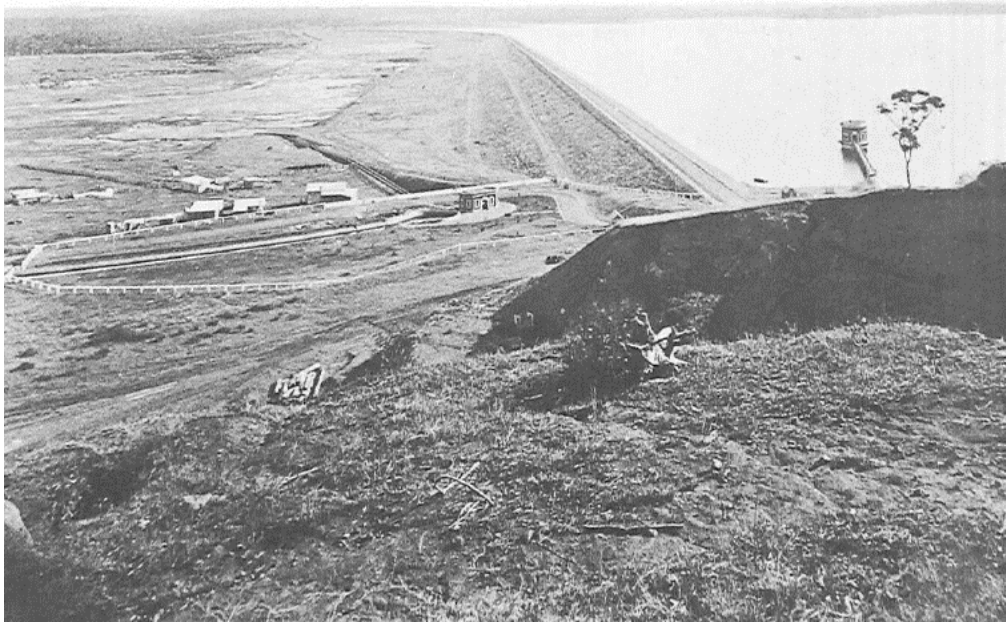
**Figure 6: Historic photograph of Prospect Reservoir at the time of completion, 1888**  
(Source: Reproduced in Besley, M. 'The Sweat of their Brows' Water Board, 1988)
