Upper South Creek Advanced Water Recycling Centre **DSI**

Figure 6-2a Pipelines Contamination AECs

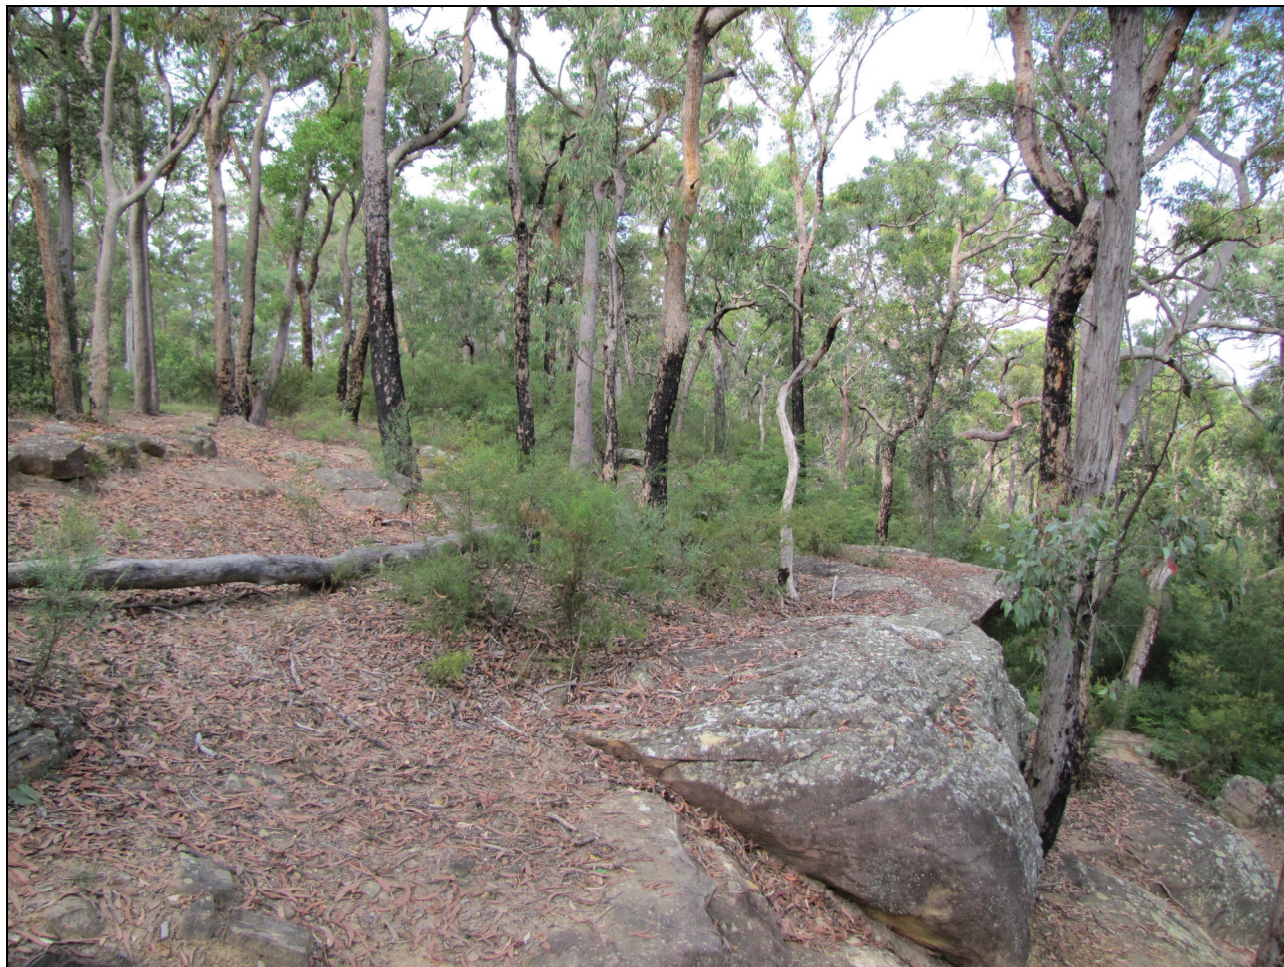
**Landscape**—undulating to rolling rises and low hills on Hawkesbury Sandstone. Local relief 20–80 m, slopes 10–25%. Rock outcrop <25%. Broad convex crests, moderately inclined side slopes with wide benches, localised rock outcrop on low broken scarps. Extensively cleared open forest (dry sclerophyll forest) and eucalypt woodland.

**Soils**—shallow to moderately deep (30–100 cm) yellow earths (Gn2.24) and earthy sands (Uc5.11, Uc5.2) on crests and insides of benches; shallow (<20 cm) siliceous sands (Uc1.21) on leading edges of benches; localised gleyed podzolic soils (Dg4.21) and yellow podzolic soils (Dy4.11, Dy5.11, Dy5.41) on shale lenses; shallow to moderately deep (<100 cm) siliceous sands (Uc1.2) and leached sands (Uc2.21) along drainage lines.

**Limitations**—steep slopes, water erosion hazard, rock outcrop, localised rockfall hazard, localised non-cohesive soils, shallow highly permeable soil, very low soil fertility.

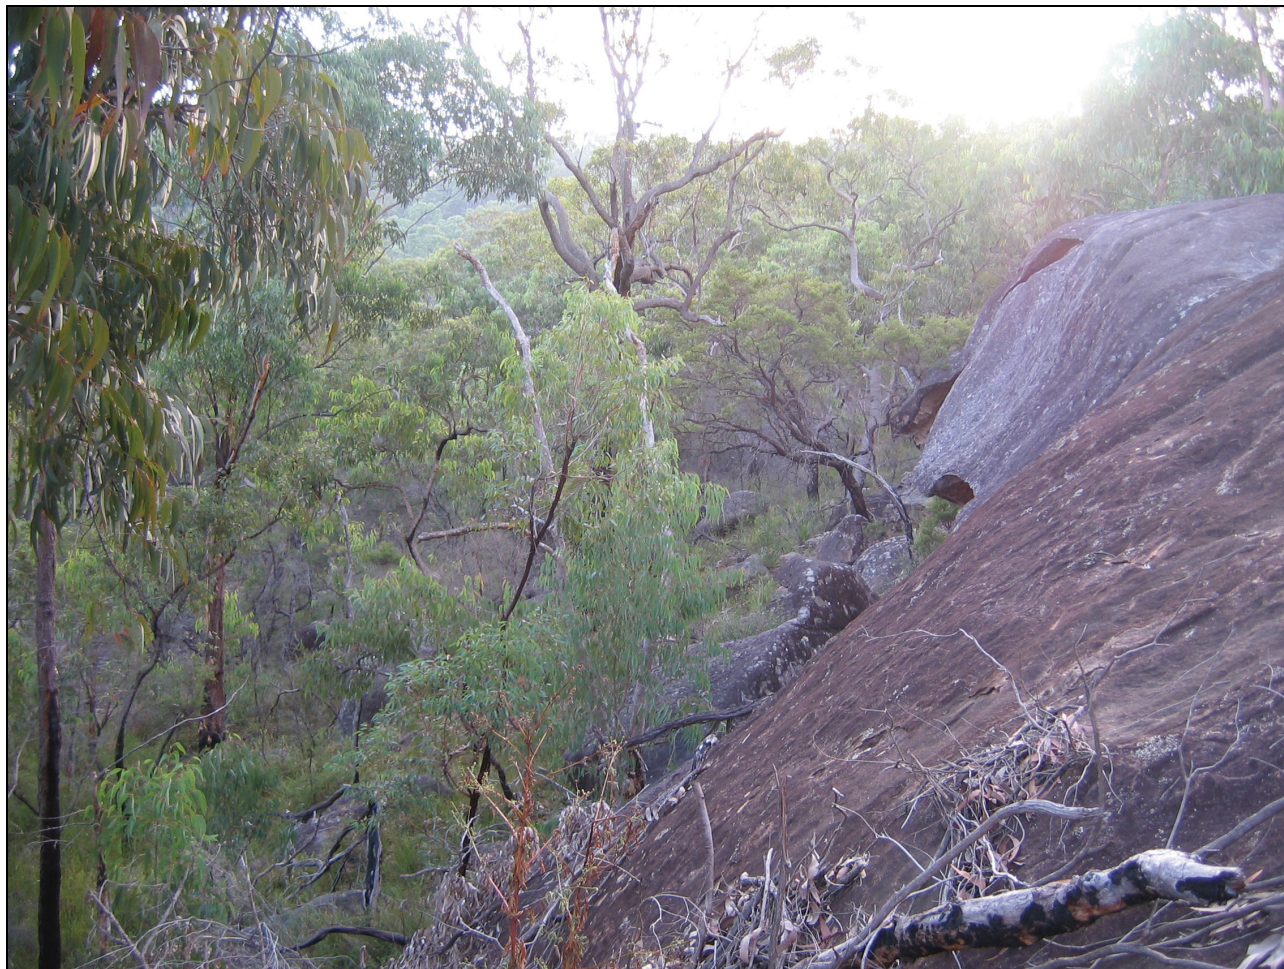
**Landscape**—rugged, rolling to very steep hills on Hawkesbury Sandstone. Local relief 40–200 m, slopes >25%. Rock outcrop >50%. Narrow crests and ridges, narrow incised valleys, steep sideslopes with rocky benches, broken scarps and boulders. Mostly uncleared Eucalypt open-woodland (dry sclerophyll forest) and tall open-forest (wet sclerophyll forest).

**Soils**—shallow (<50 cm), discontinuous lithosols/siliceous sands (Uc1.21) associated with rock outcrop; earthy sands (Uc5.11, Uc5.23), yellow earths (Gn2.24) and some locally deep sands on inside of benches and along joints and fractures; localised yellow and red podzolic soils (Dy4.11, Dy5.21, Dr5.11, Dr5.21) associated with shale lenses; siliceous sands (Uc1.2) and secondary yellow earths (Gn2.41) along drainage lines.

**Limitations**—steep slopes, mass movement hazard, rockfall hazard, water erosion hazard, shallow soils, rock outcrop, non-cohesive soils (localised), stony, highly permeable soils of low fertility.

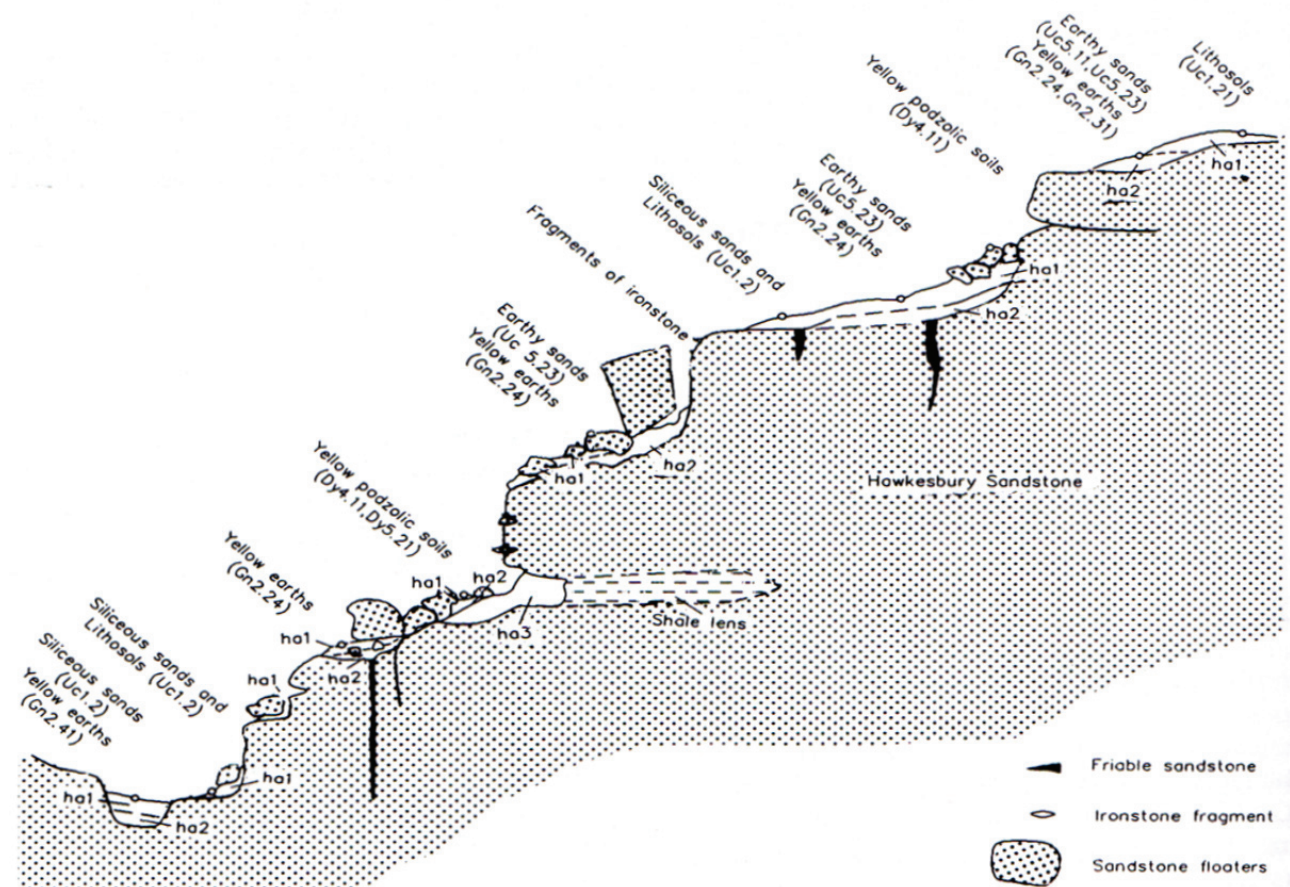
*Distribution diagram of the Hawkesbury soil landscape showing the occurrence and relationship of dominant soil materials.*

**Crests and ridges.** Up to 20 cm of loose, coarse quartz sand (**ha1**) overlies either bedrock [lithosols Uc1.21] or <30 cm of earthy, yellowish brown sandy clay loam subsoil (**ha2**) [earthy sands Uc5.11], yellow earths (Gn2.24, Gn2.31)]. Total soil depth is <50 cm. The boundary between soil materials is usually gradational. Texture often increases gradually with depth.

**Sideslopes and benches.** Soils are discontinuous. Sandstone outcrop and boulders may cover >50% of the ground surface. Usually 10–30 cm of **ha1** overlies bedrock [lithosols and siliceous sands (Uc1.22)] on outsides of benches whilst on higher sides of benches 5–15 cm of **ha1** overlies up to 50 cm of **ha2** [yellow earths (Gn2.24)] or locally deep sands. Boundaries between soil materials are either gradual or clear and total soil depth, although variable, is usually <70 cm. In some instances, especially along joint lines, soil depth may exceed 200 cm. Often **ha2** is found along bedding planes in the sandstone.

**Drainage lines.** Drainage lines are either on exposed bedrock or have deposits of gravel or loose quartz sand (**ha1**) [siliceous sands (Uc1.2)] which occasionally overlie **ha2** [yellow earths (Gn2.41)]. Total soil depth is usually <100 cm.

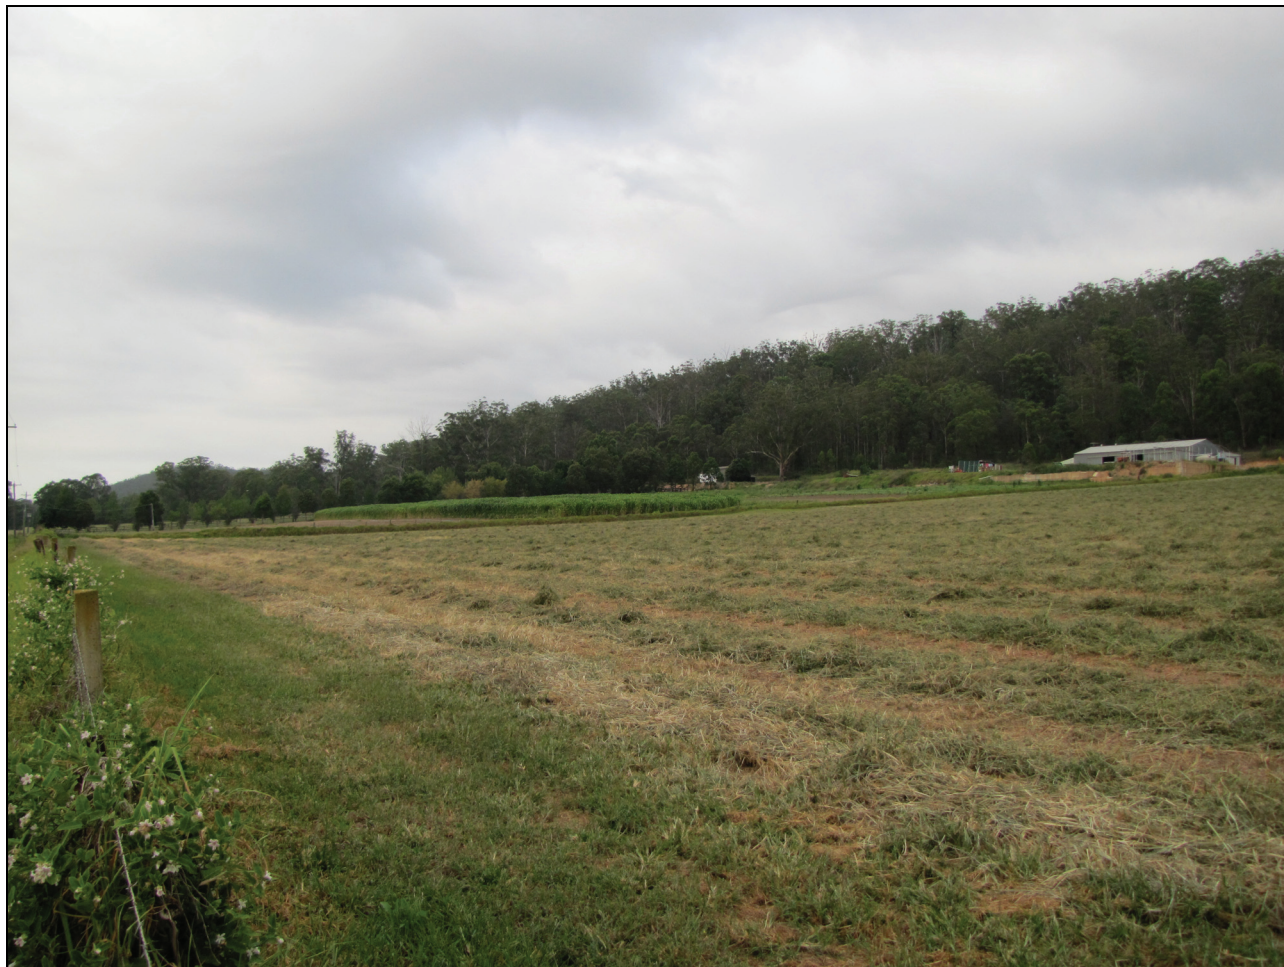
**Landscape**—a very narrow unit of steep concave east facing slopes intersected by parallel drainage lines. Local relief to 100 m; sideslope >60% with undulating colluvial footslopes >10%.

**Soils**—highly variable soils due to the nature of the colluvial parent material. Yellow solodic soils (Dy5.42), chocolate soils (Dr4.11, Db3.2) and earthy sands (Uc4.21). Lithosols (Uc4.21) occur on upper slopes and occasionally elsewhere.

**Limitations**—localised steep slopes, localised mass movement hazard as minor slipping on midslopes, localised water erosion hazard, localised non-cohesive soils as relatively unconsolidated materials on lower slopes; low fertility, sodic subsoil.

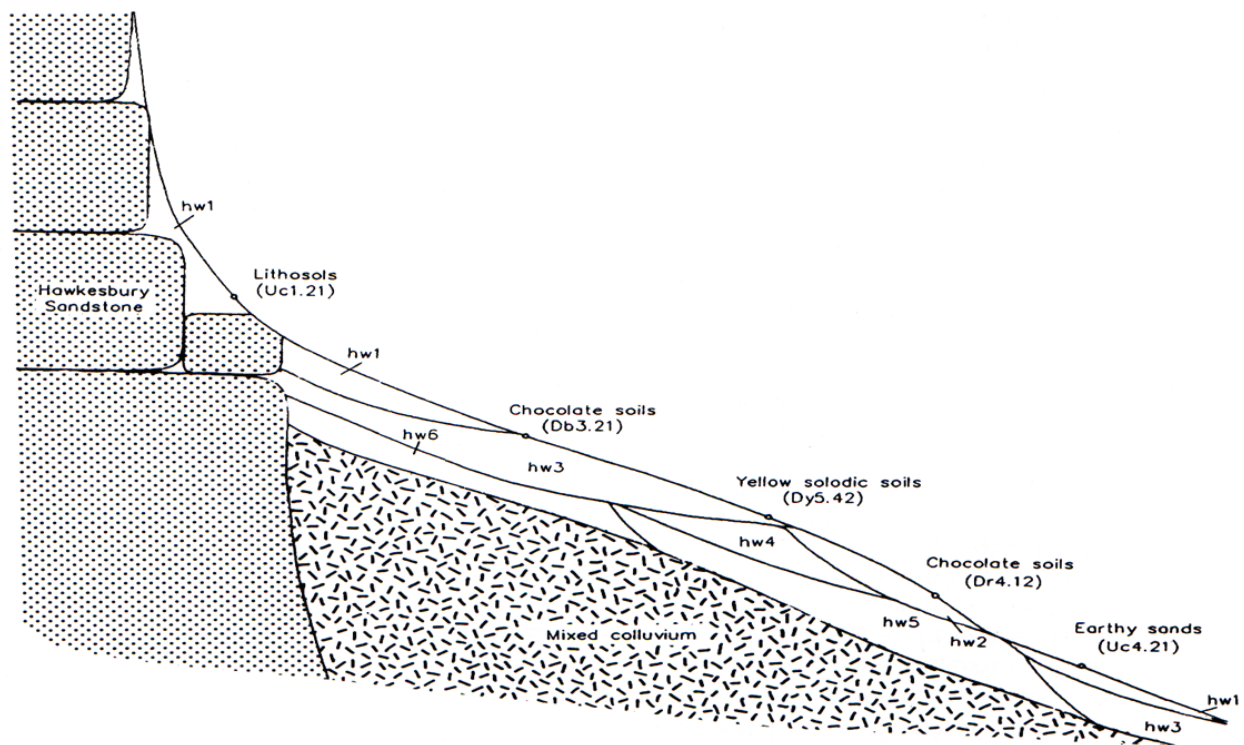
*Distribution diagram of the Hazelwood soil landscape showing the occurrence and relationship of dominant soil materials.*

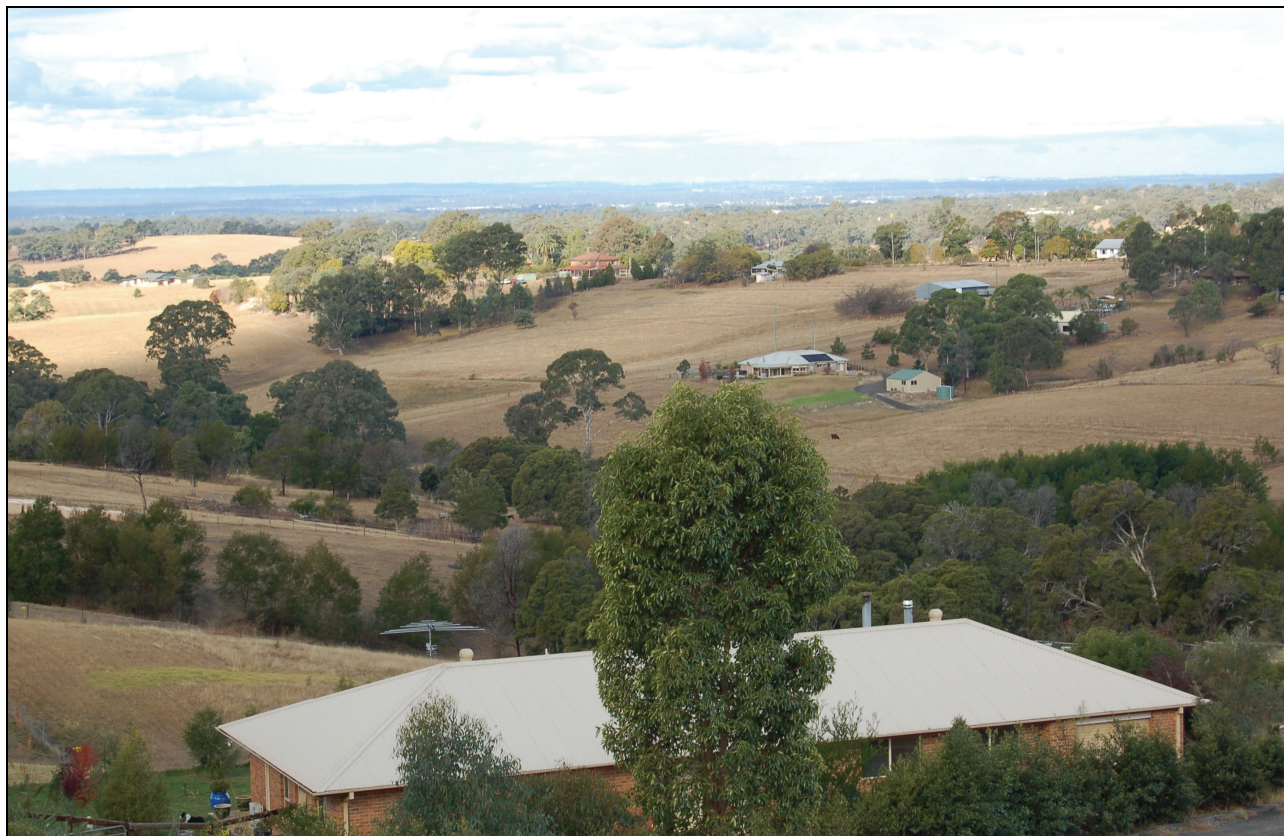
**Landscape**—undulating to rolling low hills on Wianamatta Group shales, often associated with Minchinbury Sandstone. Local relief 50–80 m, slopes 5–20%. Narrow ridges, hillcrests and valleys. Extensively cleared tall open forest (wet sclerophyll forest).

**Soils**—shallow (<100 cm) dark podzolic soils (Dd3.51) or massive earthy clays (Uf6.71) on crests; moderately deep (70–150 cm) red podzolic soils (Dr2.11, Dr2.41, Dr3.11) on upper slopes; moderately deep (<150 cm) yellow podzolic soils (Dy4.22) and prairie soils (Gn3.26) on lower slopes and drainage lines.

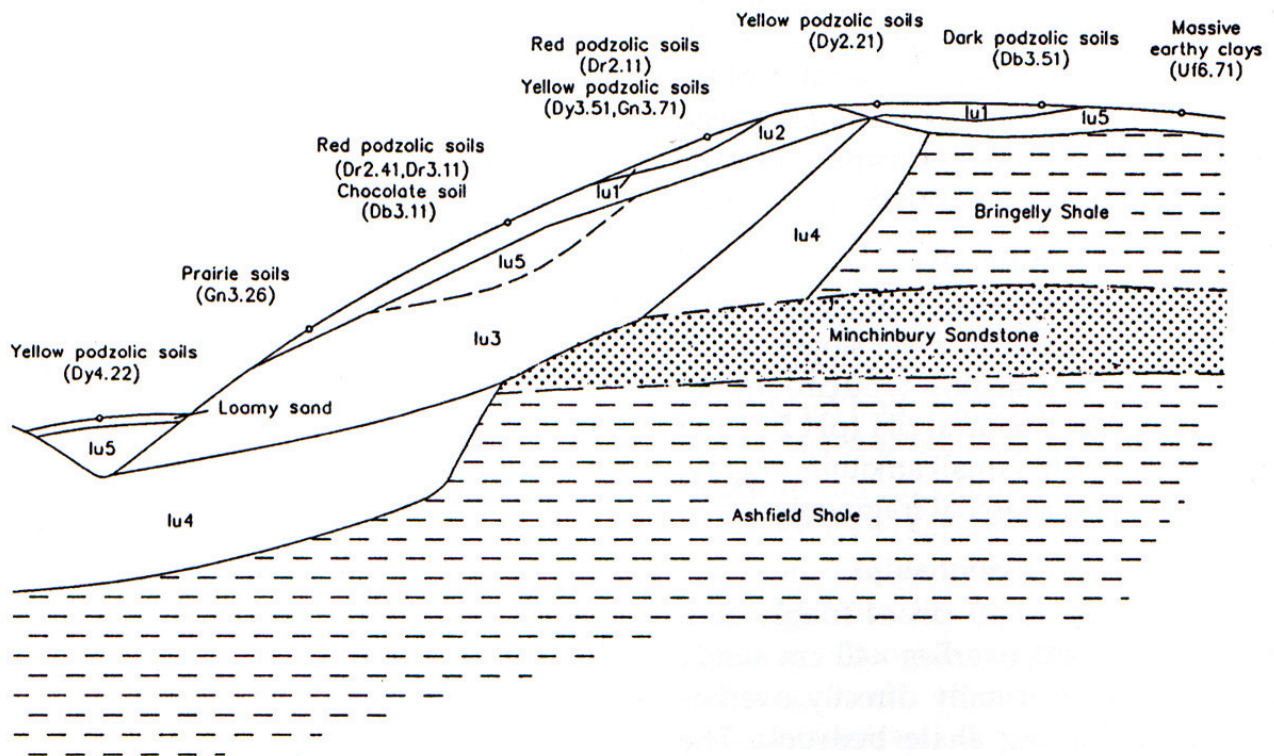
*Distribution diagram of the Luddenham soil landscape showing the occurrence and relationship of dominant soil materials.*

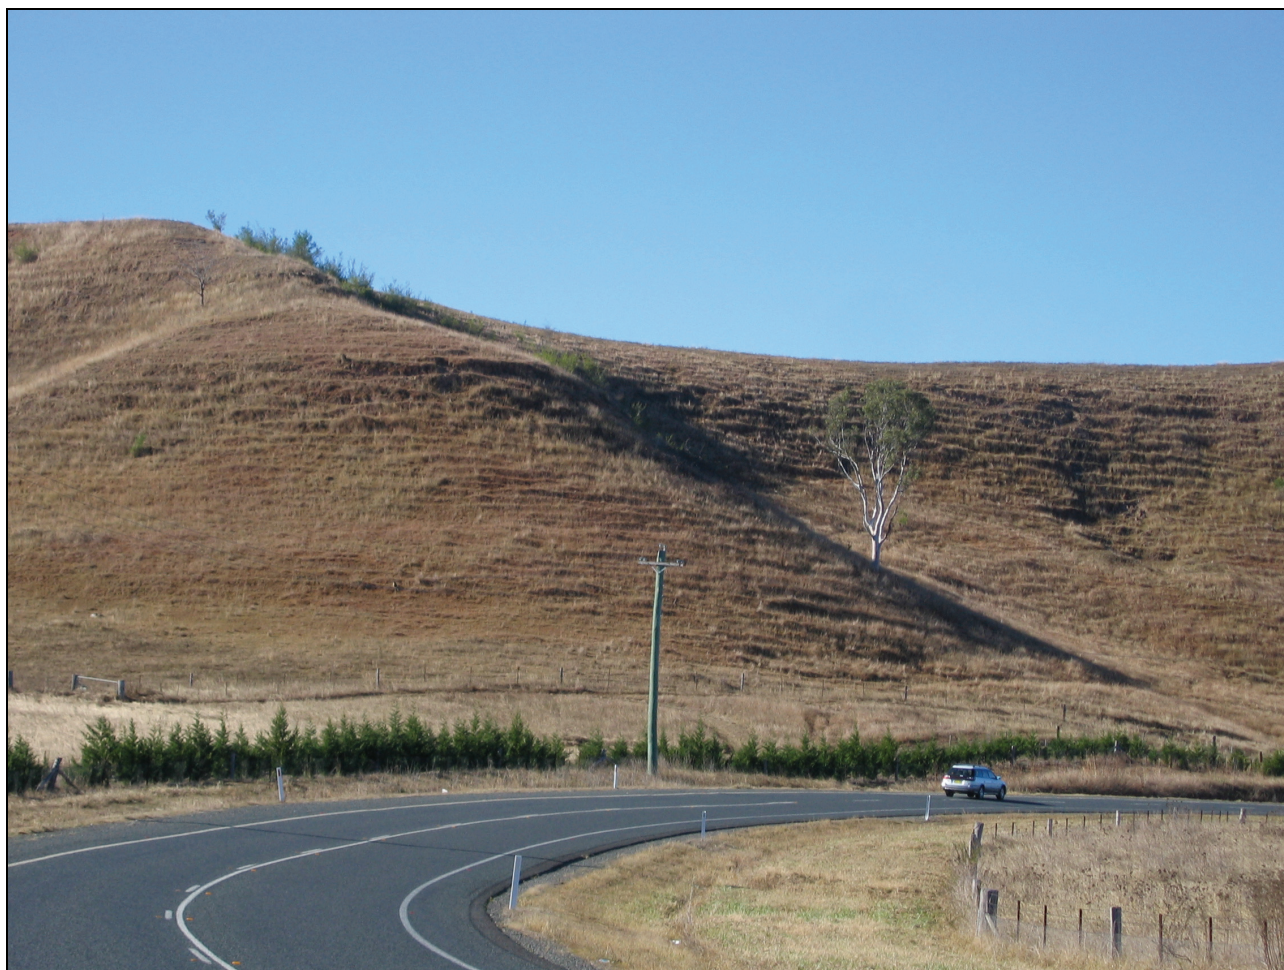
**Landscape**—steep sideslopes, Wianamatta Group shale and shale colluvial materials usually with a southerly aspect. Local relief 90–300 m, slope gradients >20%. Extensively cleared tall open-forest.

**Soils**—shallow to deep (50–200 cm) red and brown podzolic soils (Dr2.11, Dr3.11, Db1.11) on upper slopes. Brown and yellow podzolic soils on colluvial material (Db1.11, Dy4.11, Dy5.11). Yellow podzolic soils (Dy3.11) on lower slopes and in drainage lines.

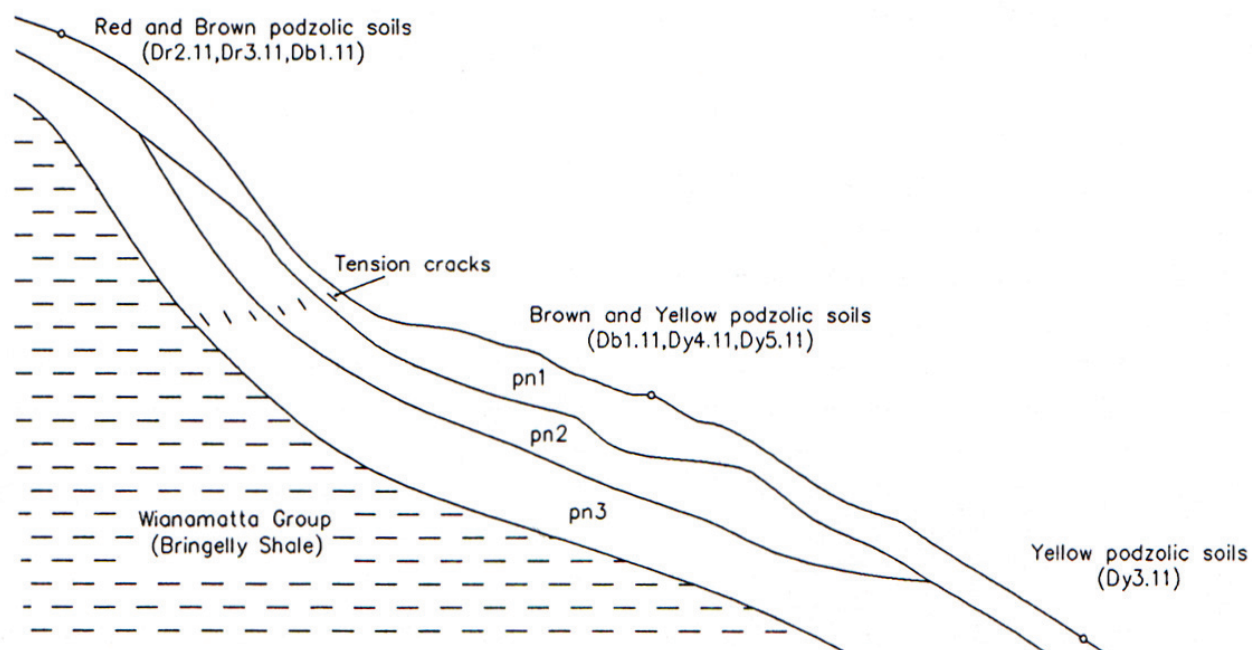
*Distribution diagram of the Picton soil landscape showing the occurrence and relationship of dominant soil materials.*

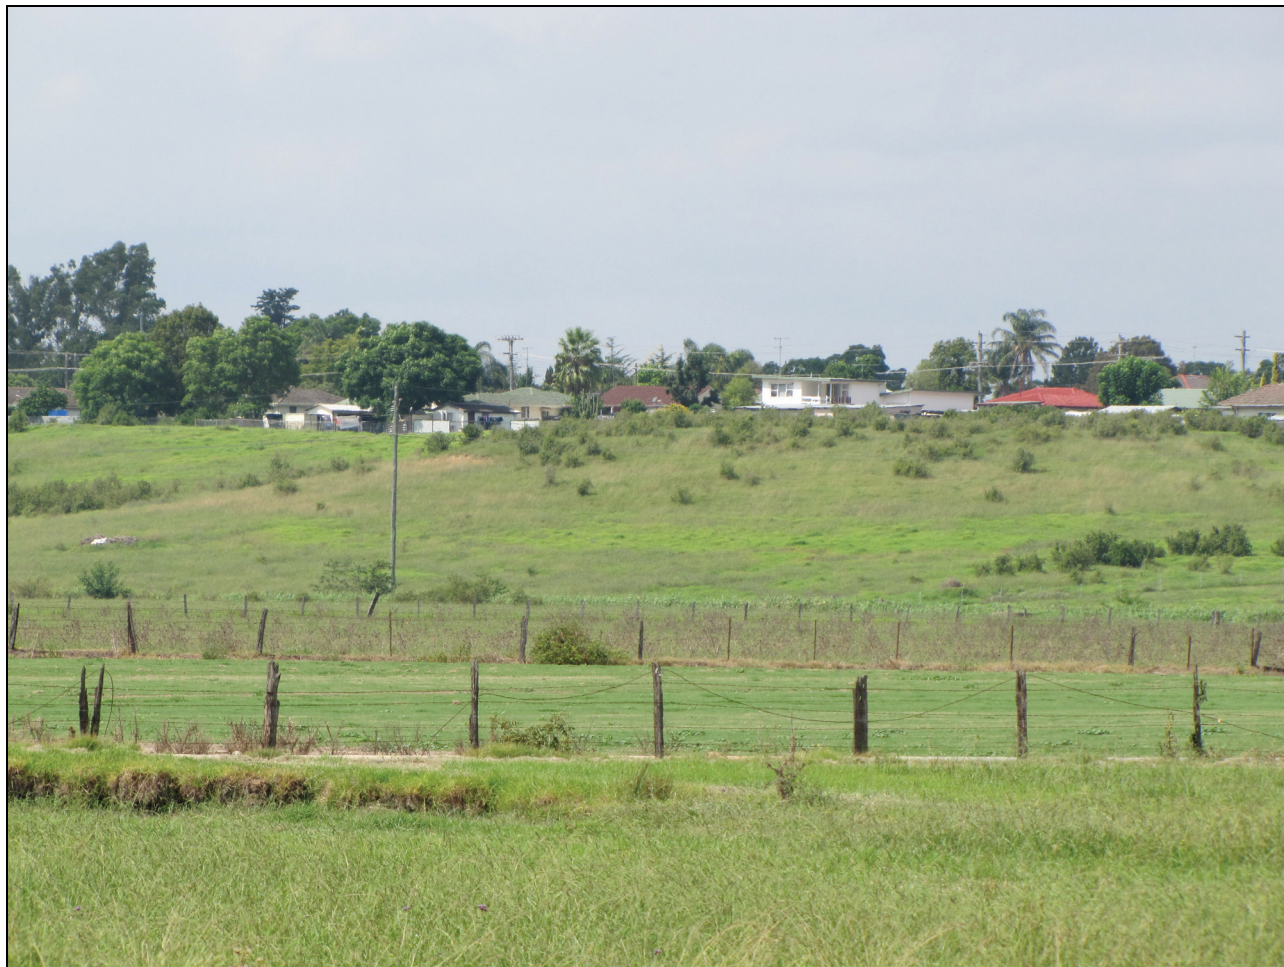
**Landscape**—Quaternary terraces of the Nepean and Georges Rivers. Mainly flat (slopes <1%). Splays and levees provide local relief (<3 m). Tree cover, now almost completely cleared, was formerly a low open-woodland (dry sclerophyll).

**Soils**—poorly structured orange to red clay loams, clays and sands. Texture may increase with depth. Ironstone nodules may be present. Plastic clays (U46.12) in drainage lines. Deep acid non-calcic brown soils (Gn3.14, Gn4.34), red earths (Gn2.11) and red podzolic soils (Dr2.41), occur on terrace surfaces with earthy sands (Uc5.21, Uc1.23) on terrace edges.

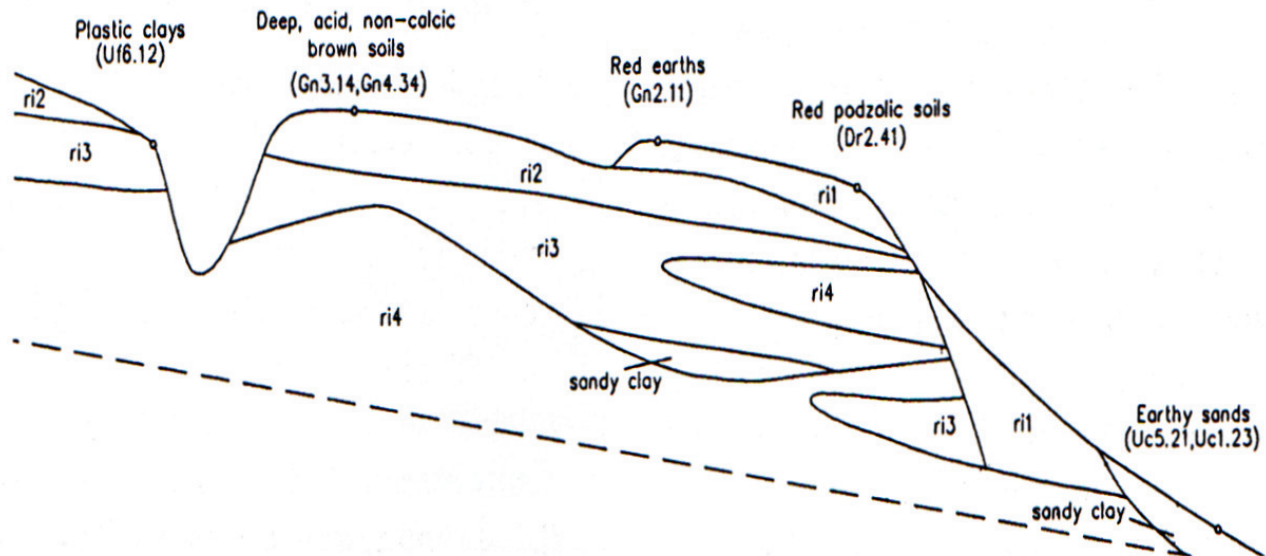
*Distribution diagram of the Richmond soil landscape showing the occurrence and relationship of dominant soil materials.*

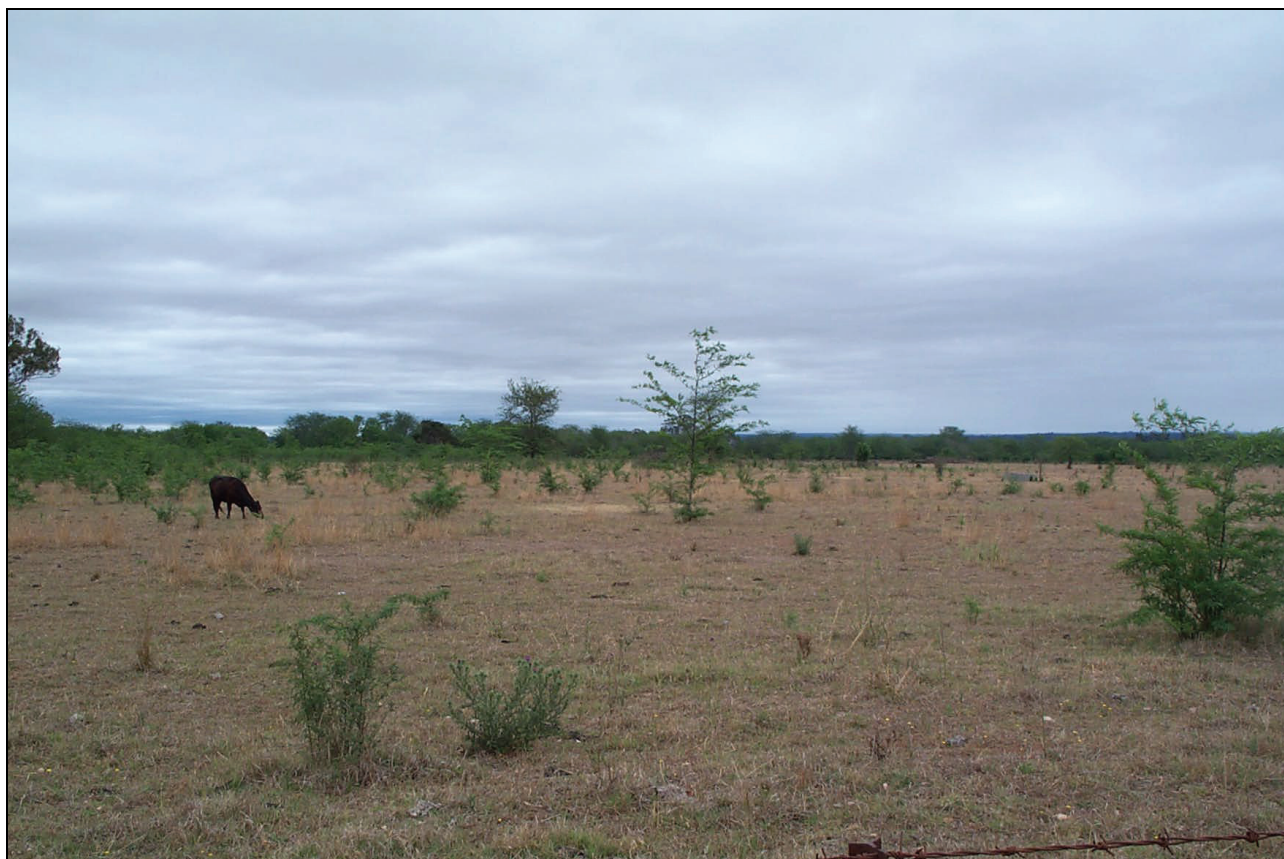
**Landscape**—floodplains, valley flats and drainage depressions of the channels on the Cumberland Plain. Usually flat with incised channels; mainly cleared.

**Soils**—often very deep layered sediments over bedrock or relict soils. Where pedogenesis has occurred structured plastic clays (Uf6.13) or structured loams (Um6.1) in and immediately adjacent to drainage lines; red and yellow podzolic soils (Dr5.11, Dy2.41, Dr2.21) are most common terraces with small areas of structured grey clays (Gn4.54), leached clay (Uf4.42) and yellow solodic soils (Dy4.42, Dy5.23).

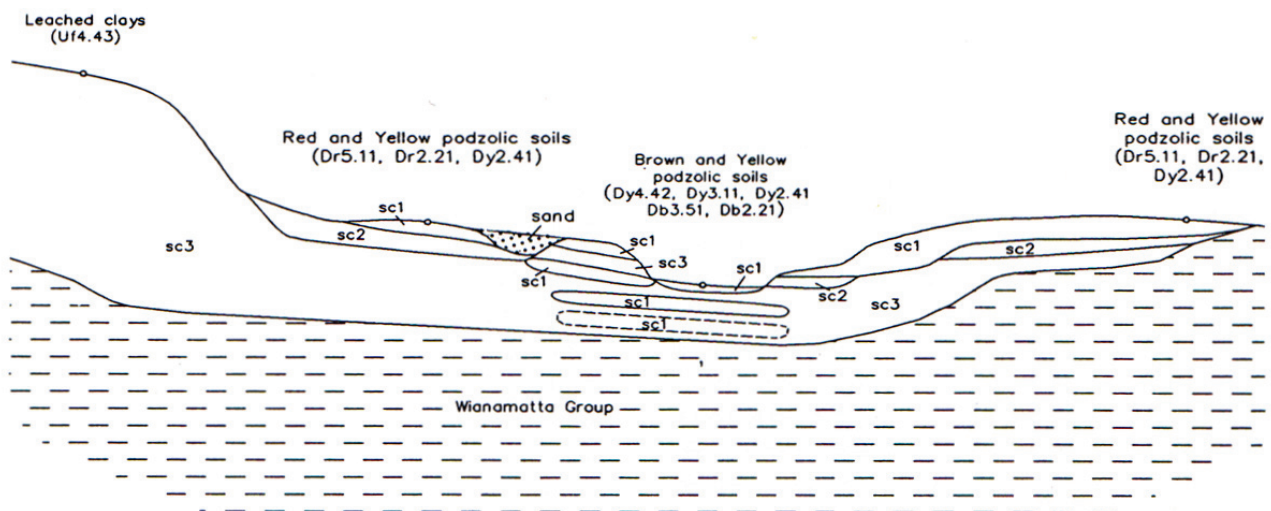
*Distribution diagram of the South Creek soil landscape showing the occurrence and relationship of dominant soil materials.*

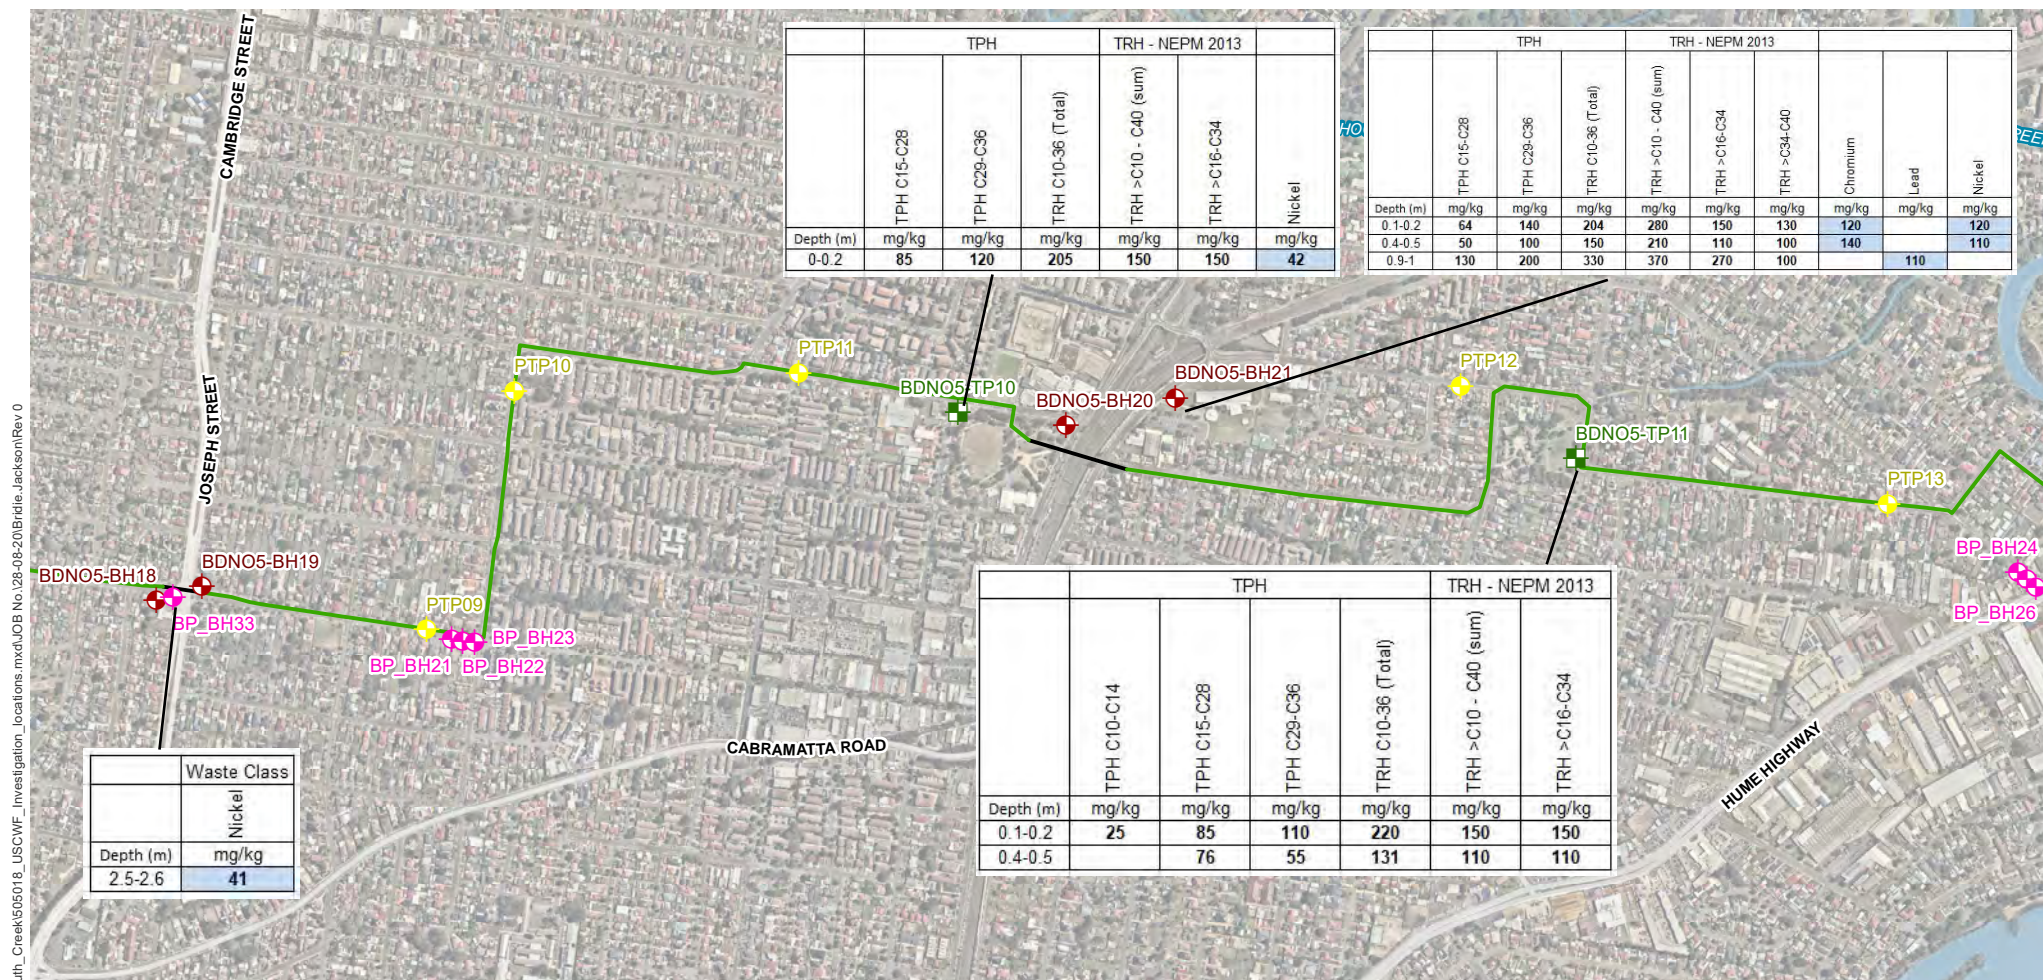
**Figure 21:** Investigation locations and exceedances

- Brine Pipeline
- Underbore
- Borehole (Brine Discharge – NRGS - Option 5)
- Test Pit (Brine Discharge – NRGS - Option 5)
