## Aquatic Ecology Impact Assessment

Upper South Creek Advanced Water Recycling Centre

Prepared for: Sydney Water Corporation

September 2021

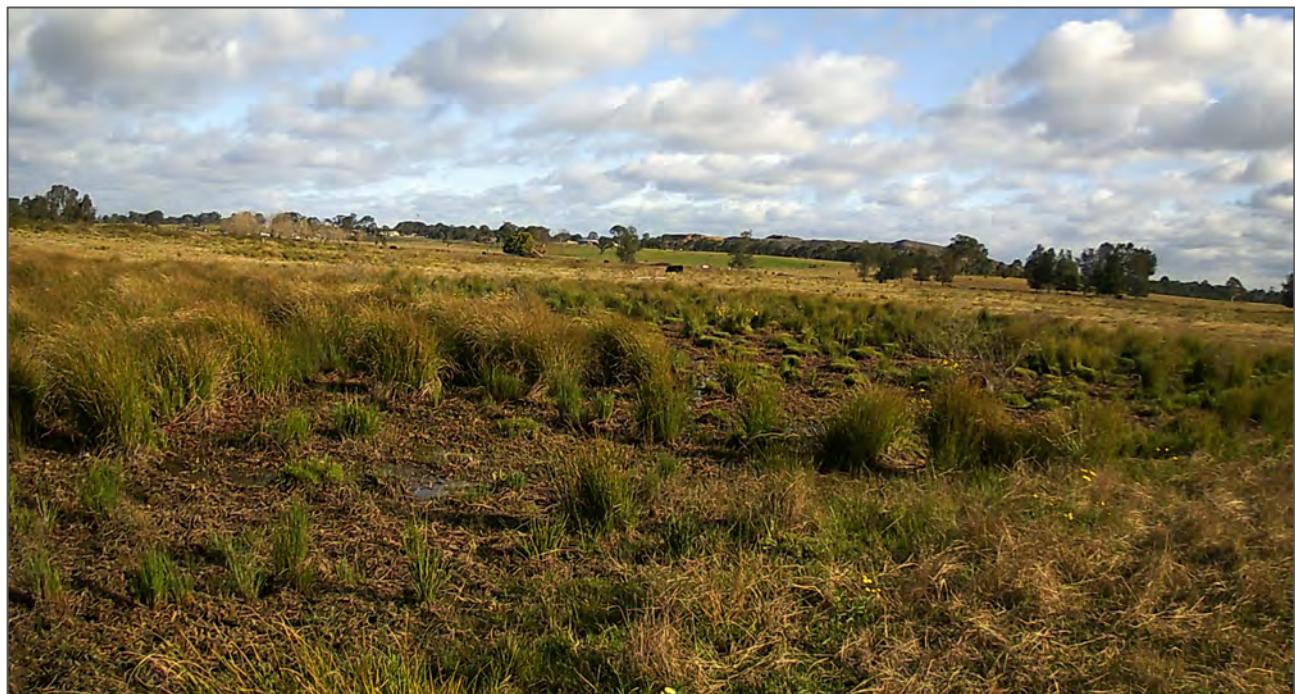
Figure 10 Historical anabranch of South Creek, now wetland ecosystem on the AWRC site (photo – Jan 2020).

Review of aerial photos of the AWRC site shows an anabranch/oxbow of South Creek is present in the western portion of the site. Field based inspection confirmed this feature as a historical flow path of South Creek which is now separated from South Creek and forms a wetland ecosystem which is likely maintained by rainfall, shallow groundwater and bankfull flows in South Creek (Figure 10 and Figure 11).

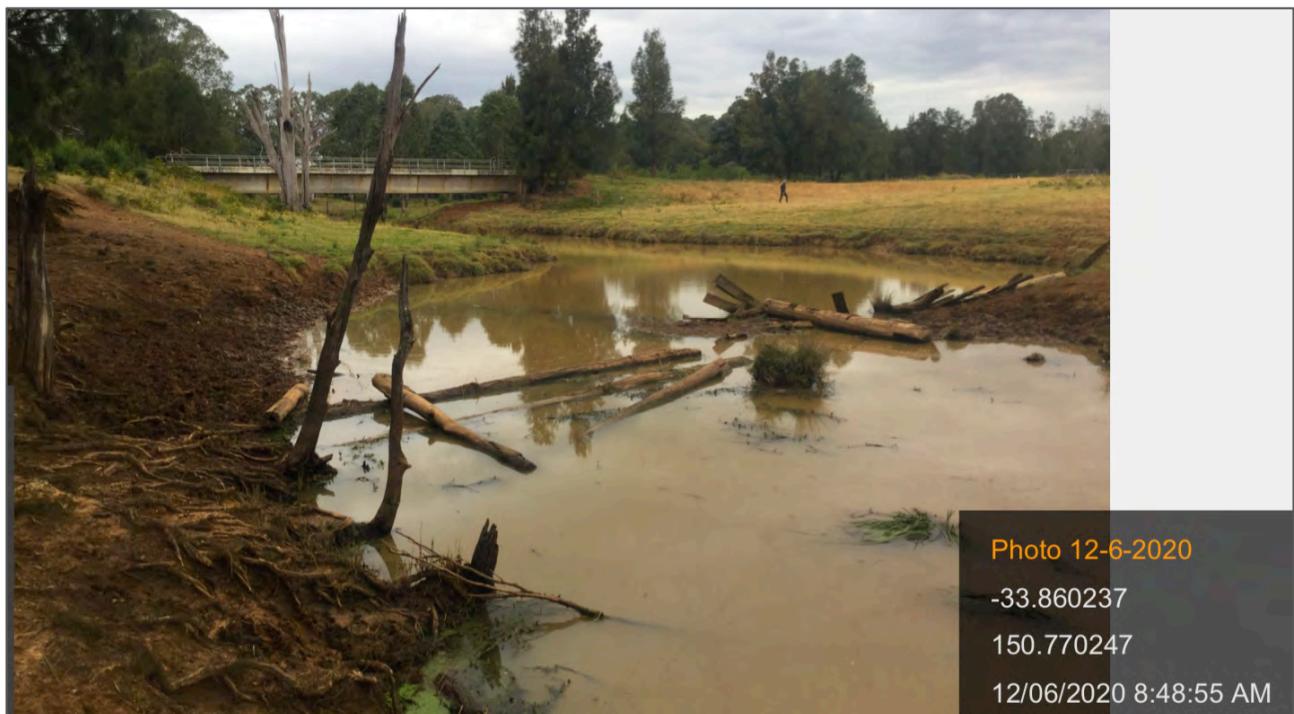
Figure 12 South Creek at the AWRC site – Type 1, Class 1 Key Fish Habitat.

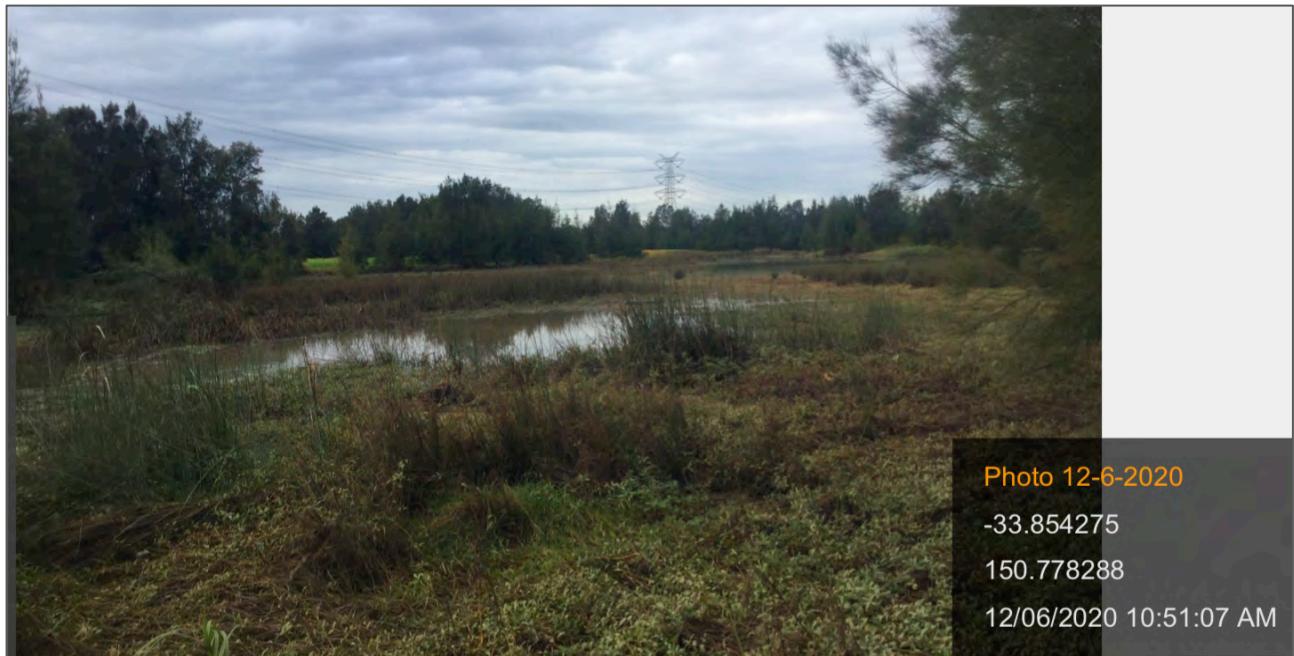
Figure 13 Kemps Creek adjacent to the AWRC site – Type 1, Class 1 Key Fish Habitat.

Kemps Creek was assessed as a Type 1, Class 1 waterway due to the presence of overhanging vegetation, natural bed detritus, snags greater than 300 mm in diameter or 3 m in length, the presence of native aquatic plants and the permanency of water along this reach, particularly in and upstream of Kemps Creek Dam (Figure 13).

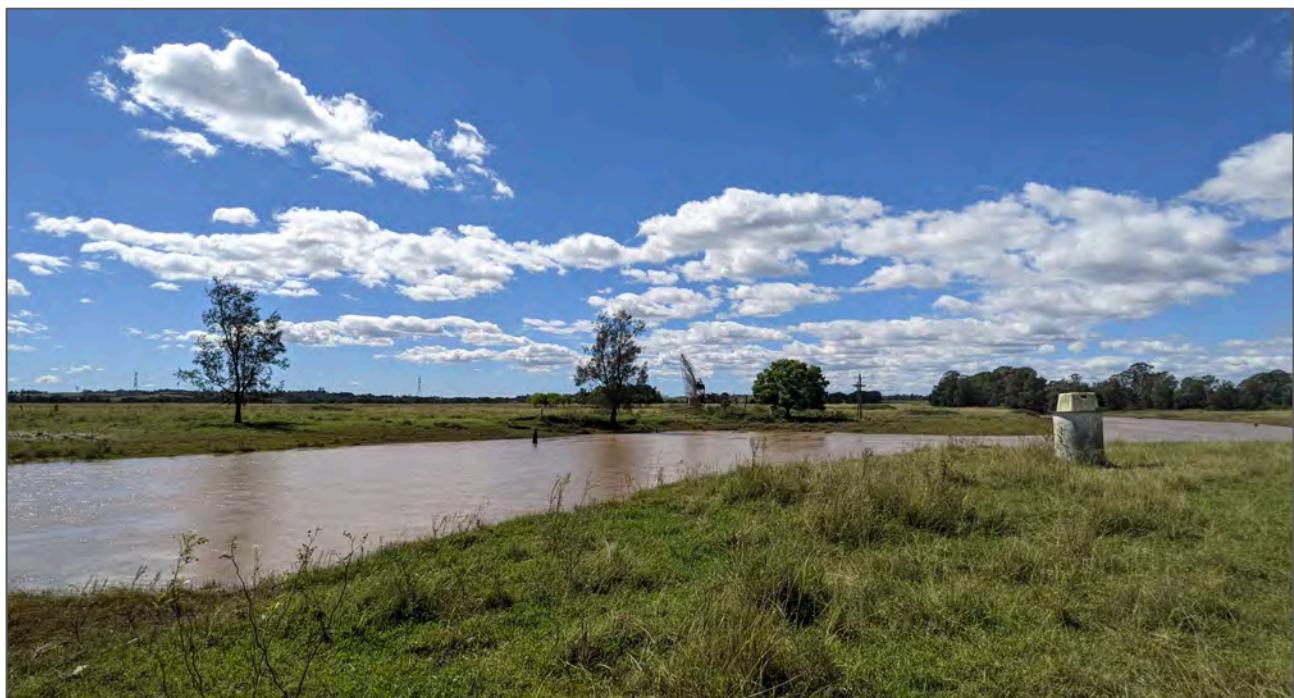
Figure 15 South Creek looking southeast over the AWRC site (photo – April 2021).

Field validation of GDEs confirmed no terrestrial GDEs are within the AWRC site boundary and South Creek is highly likely connected to groundwater which is indicated by the permanency of water in this reach of the creek (Figure 15).

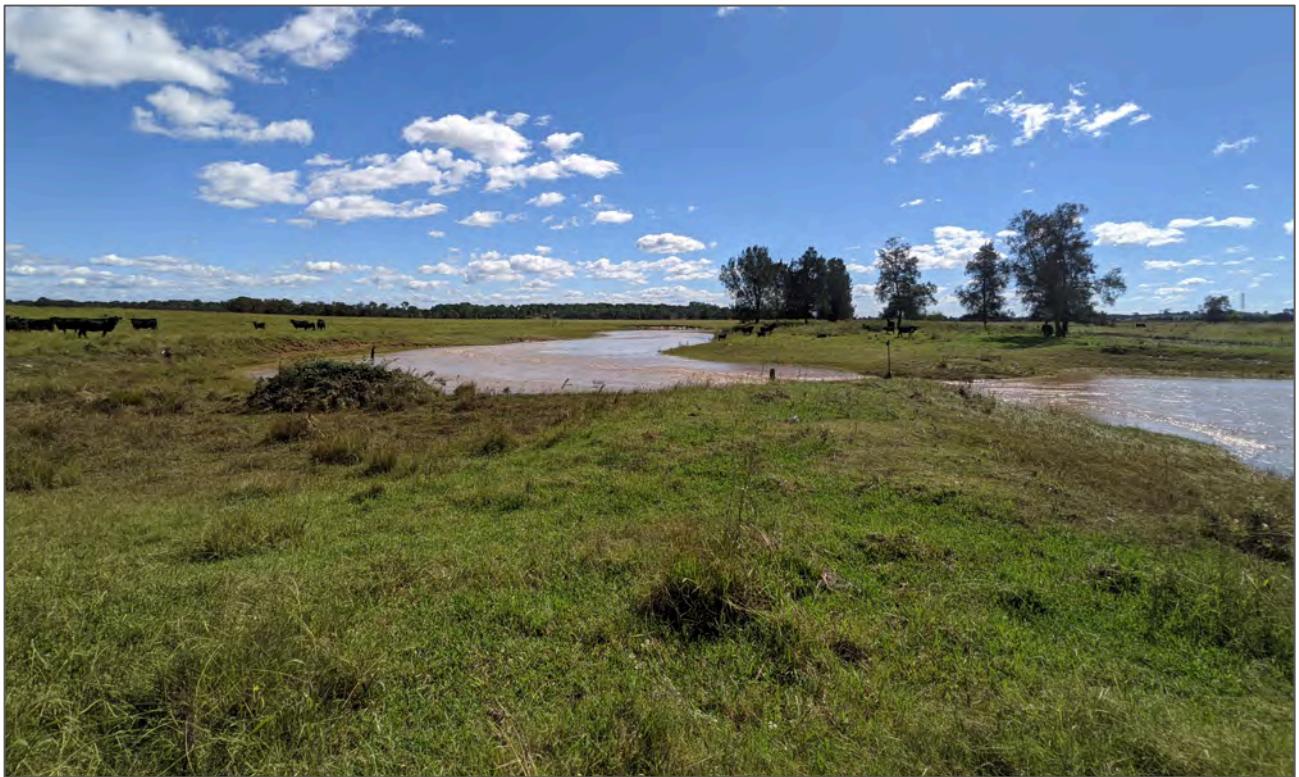
Figure 20 Approximate location (trees in middle ground) of proposed AWRC stormwater release outlet to South Creek.

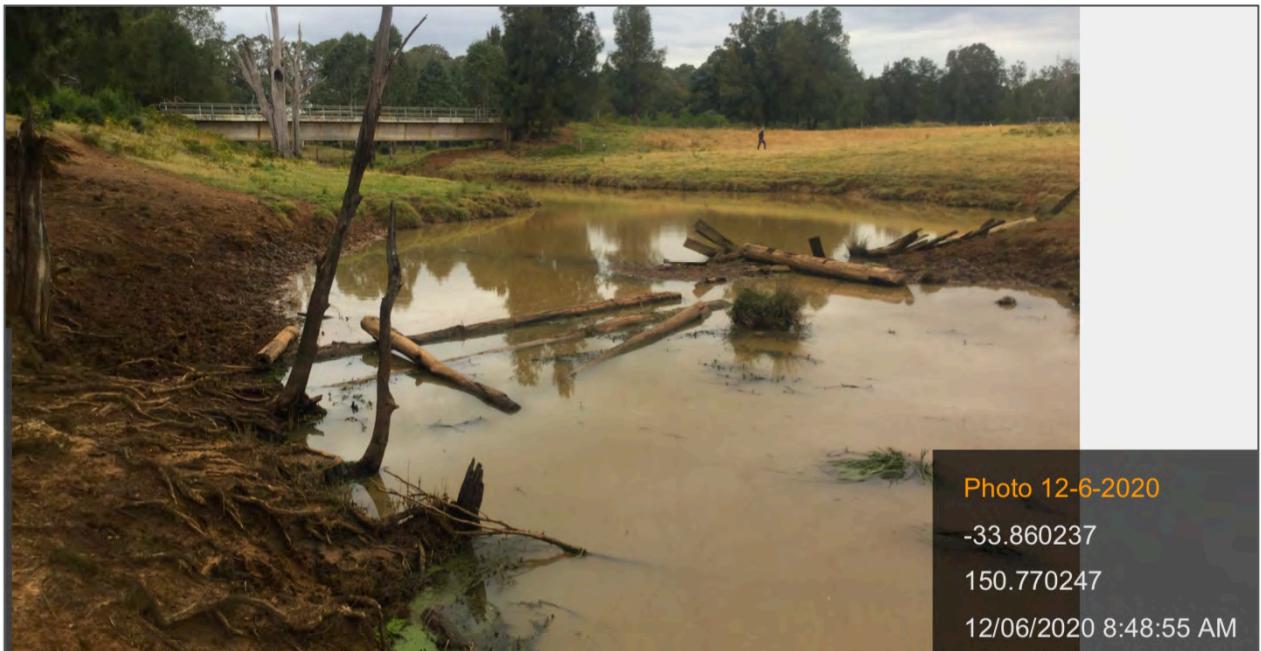
Figure 39 South Creek at the AWRC site – Type 1, Class 1 Key Fish Habitat.

Field validation of Key Fish Habitat (KFH) Type and Class following the framework outlined by Policy and Guidelines for Fish Habitat Conservation and Management (update 2013) (DPIE Fisheries, 2013) across Study Area 3 included assessment of South Creek and results show South Creek is considered Type 1 (highly sensitive Key Fish Habitat) and Class 1 (major Key Fish Habitat).

This result was due to the presence of overhanging vegetation, natural bed detritus, snags greater than 300 mm in diameter or 3 m in length, the presence of native aquatic plants and the permanency of water along this reach (Figure 39).

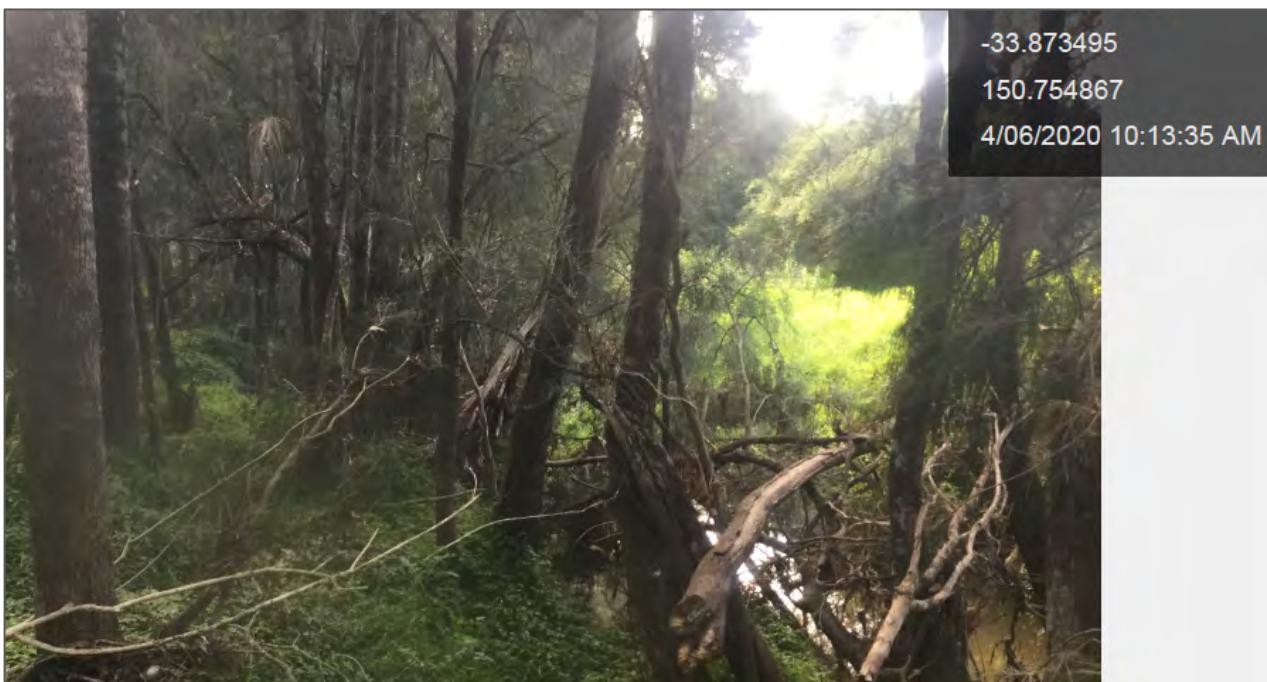
Figure 40 Badgerys Creek at the site of the proposed Treated Water Pipeline.

The reach of Badgerys Creek subject to potential impact was mapped as KFH and field validated as Type 2 (moderately sensitive Key Fish Habitat) and Class 2 (moderate Key Fish Habitat).

This classification was awarded due to the presence of overhanging vegetation and snags greater than 300 mm in diameter or 3 m in length. This reach of Badgerys has an intermittent flow regime with clearly defined bed and bank, which supports permanent pools (Figure 40).

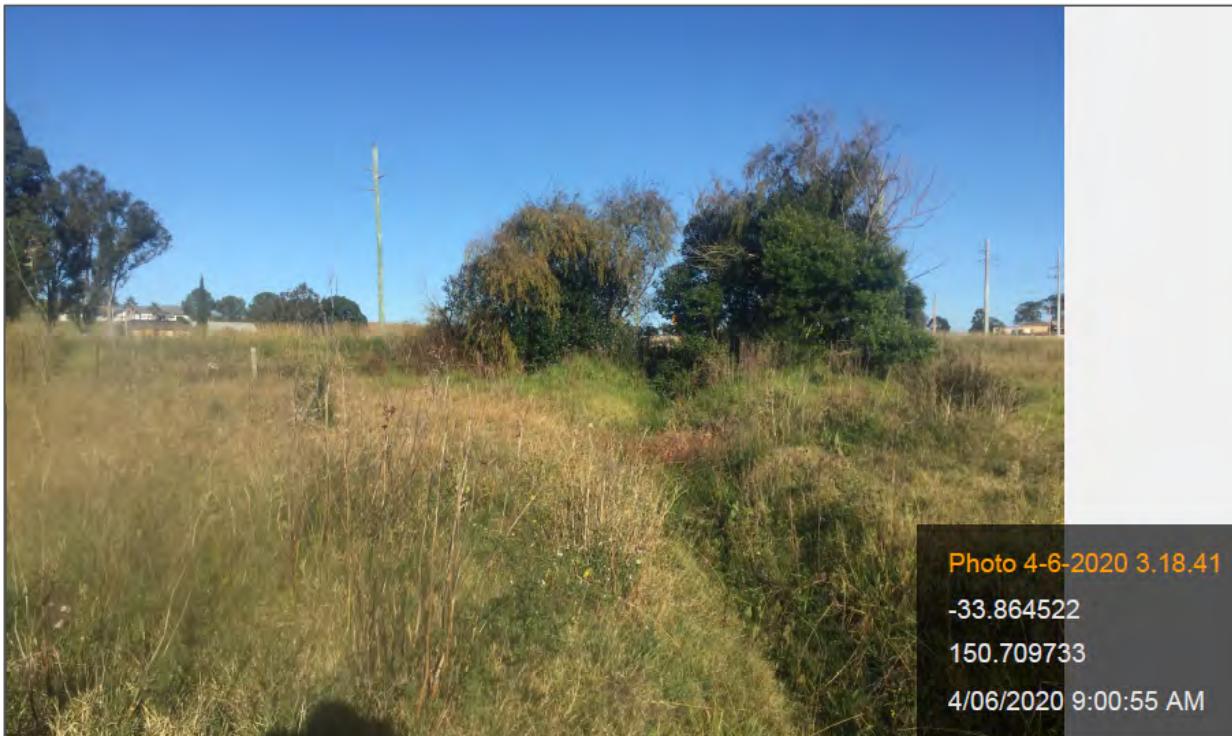
Figure 42 Jerry's Creek at the site of the proposed Treated Water Pipeline.

The reach of Jerrys Creek with potential to be affected by the Treated Water Pipeline was not mapped as KFH and field validated as Type 3 (minimally sensitive Key Fish Habitat) and Class 3 (minimal Key Fish Habitat). This was due to the ephemerality of the creek with sparse refugia and the lack of native aquatic vegetation or other habitat features such as overhanging vegetation and snags (Figure 42).

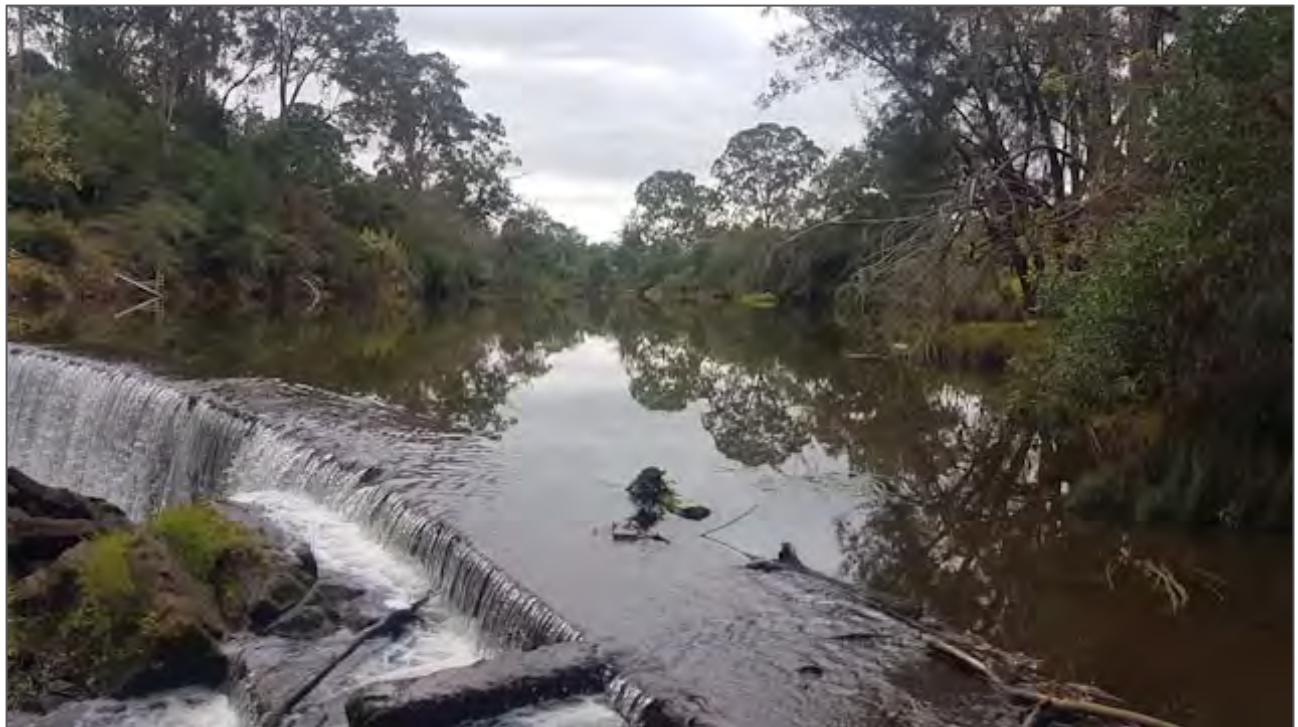
Figure 57 Study Area 5 – Nepean River Upstream of Wallacia Weir. Weir can be seen in foreground.

Review of aerial photos of Study Area 5 shows the area is a long weir pool that stretches for approximately 12 km upriver from Wallacia Weir to Bents Basin. The River along this reach is confined to the channel by high, steep banks, which contain high flows, restricting the floodplain engagement (Figure 57).

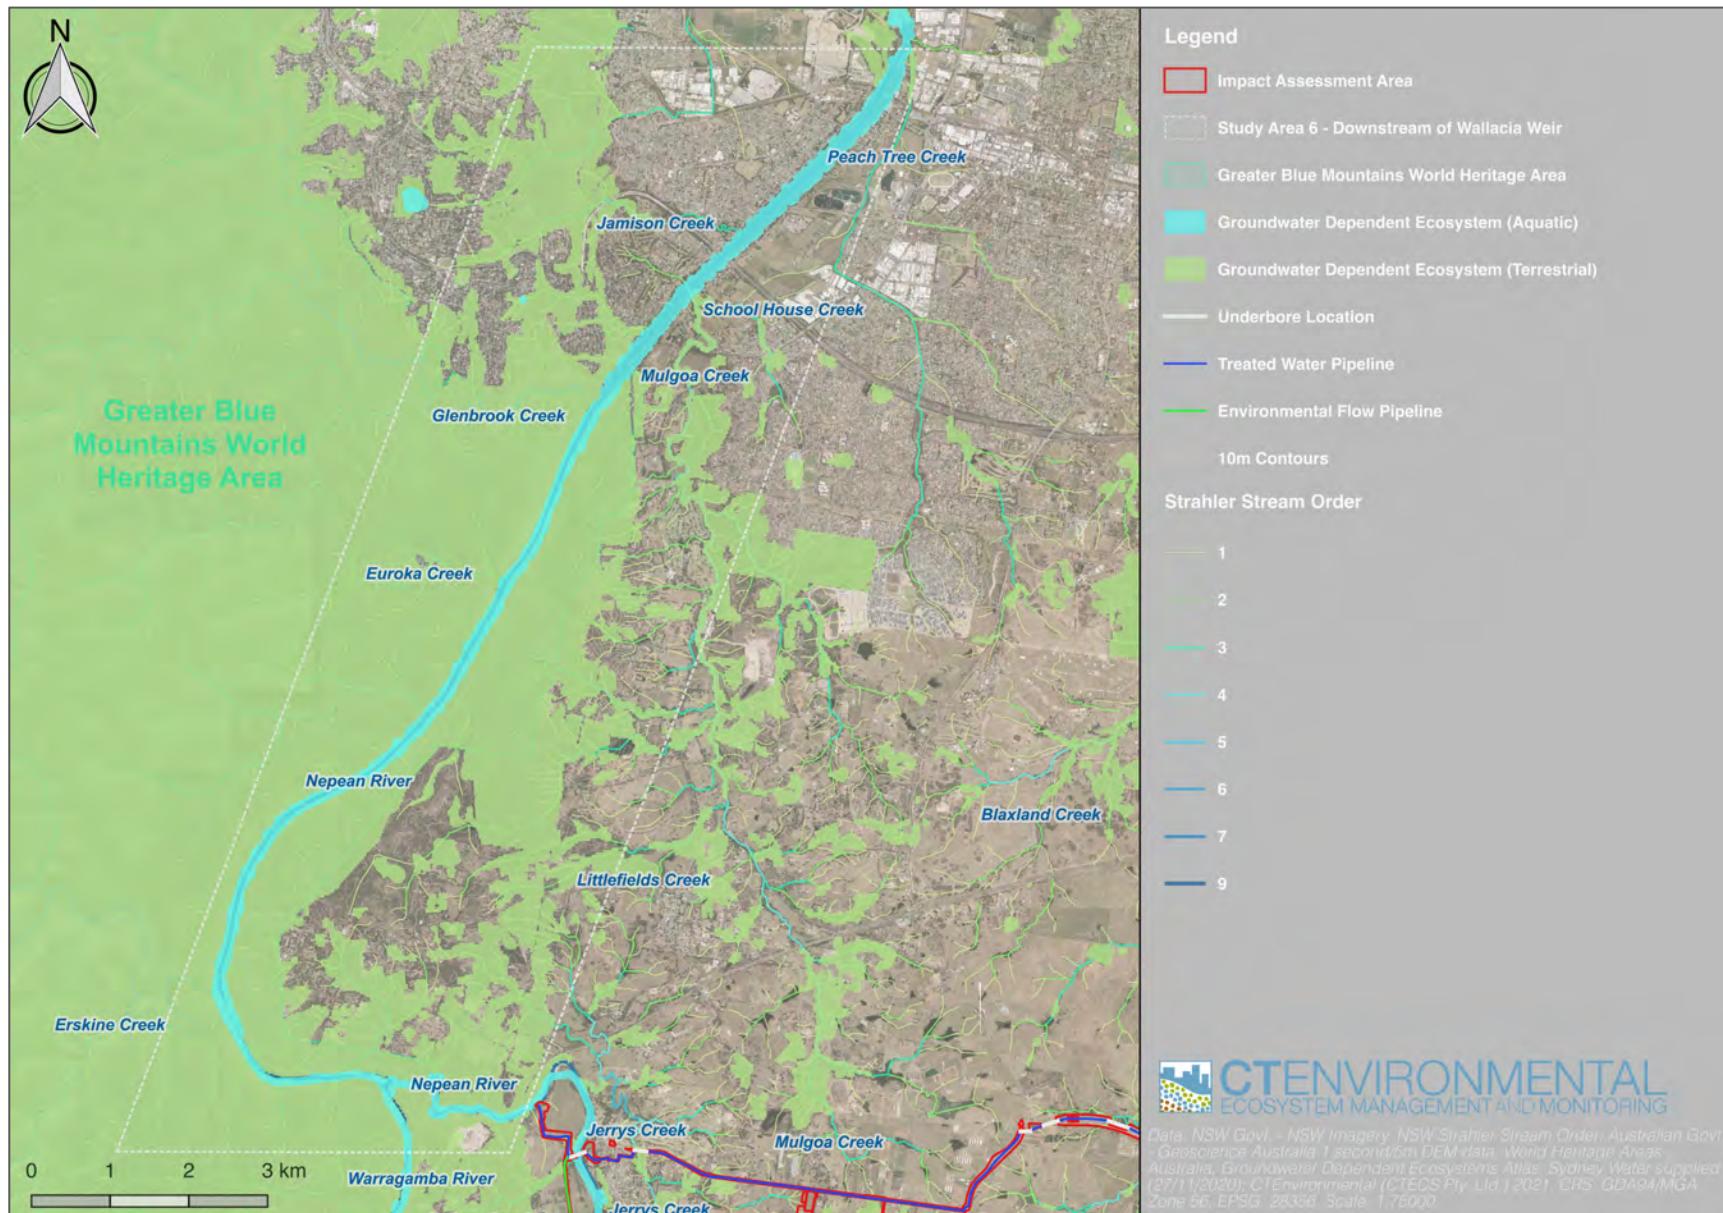
Figure 65 Mapped GDEs within and adjacent to Study Area 6 – Nepean River Downstream of Wallacia Weir.

Review of the Atlas of Groundwater Dependent Ecosystems (BOM, 2021) shows the Nepean River is considered an aquatic GDE and terrestrial GDEs are mapped along the banks of the river (Figure 65).

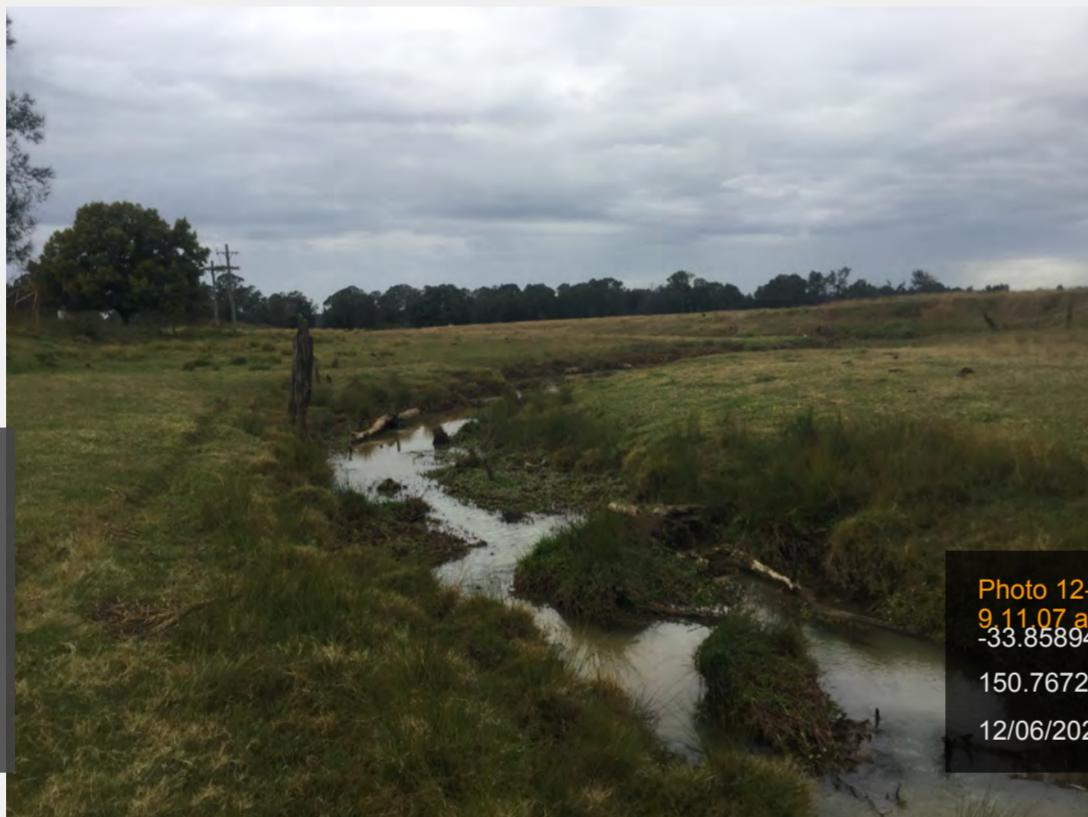
Photo 12-6-2020  
9.11.07 am.jpg  
-33.858947

The site is in fair condition, with a raw score of 19.85 (69%) overall. The bed type is natural bed (invert) - Nv. The bank type is grass - G.

Weed species observed at the site include Blackberry, Fireweed, Solanum spp., Thistle.

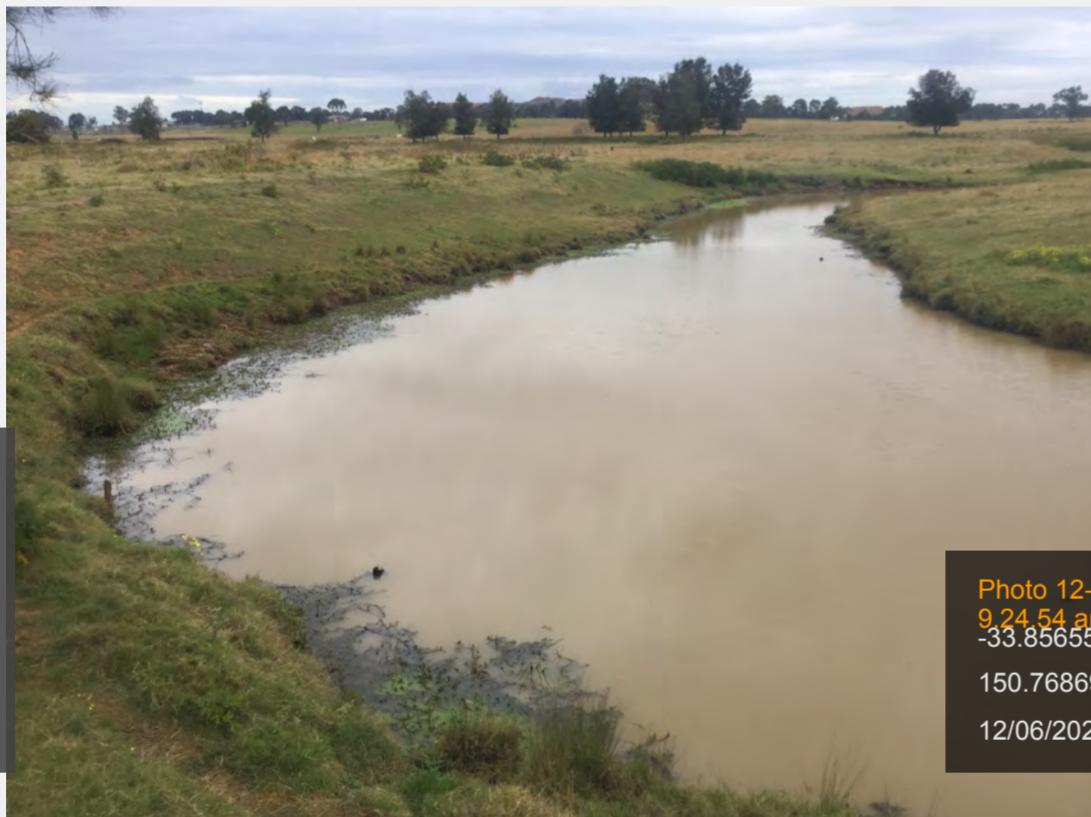
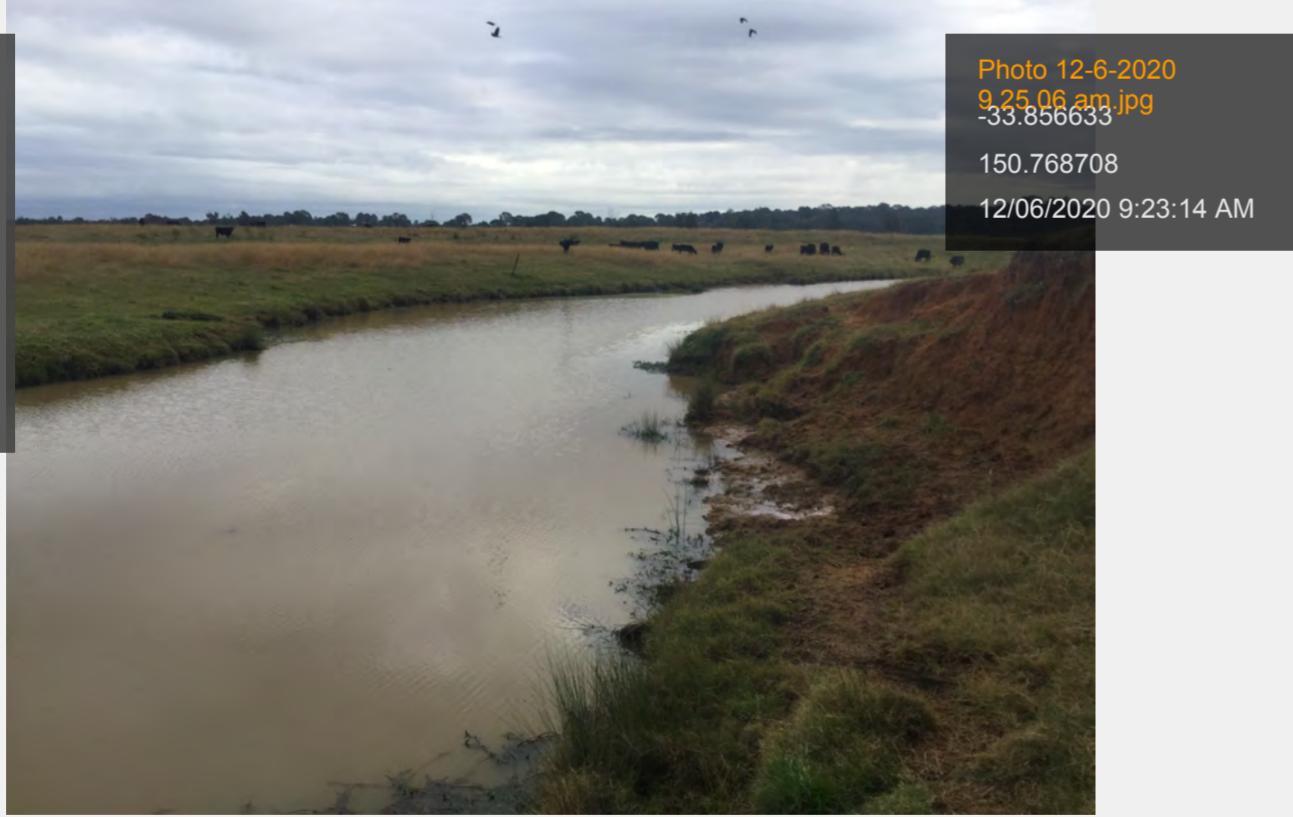
The site is in poor condition, with a raw score of 6 (64%) overall. The bed type is natural bed (invert) - Nv. The bank type is grass - G.

Weed species observed at the site include Blackberry, Fireweed, Solanum spp..

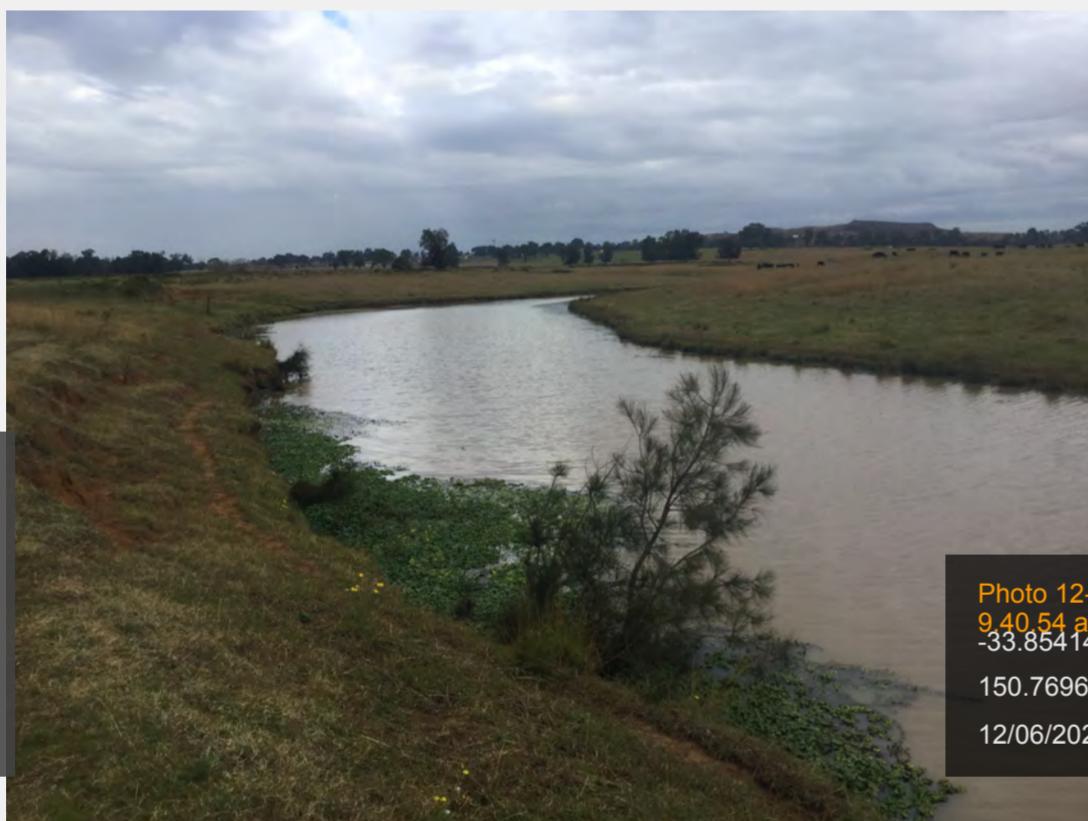
Photo 12-6-2020  
9.40.54 am.jpg  
-33.854145

The site is in poor condition, with a raw score of 6.4 (64%) overall. The bed type is natural bed (invert) - Nv. The bank type is grass - G.

Weed species observed at the site include Fireweed, Solanum spp..

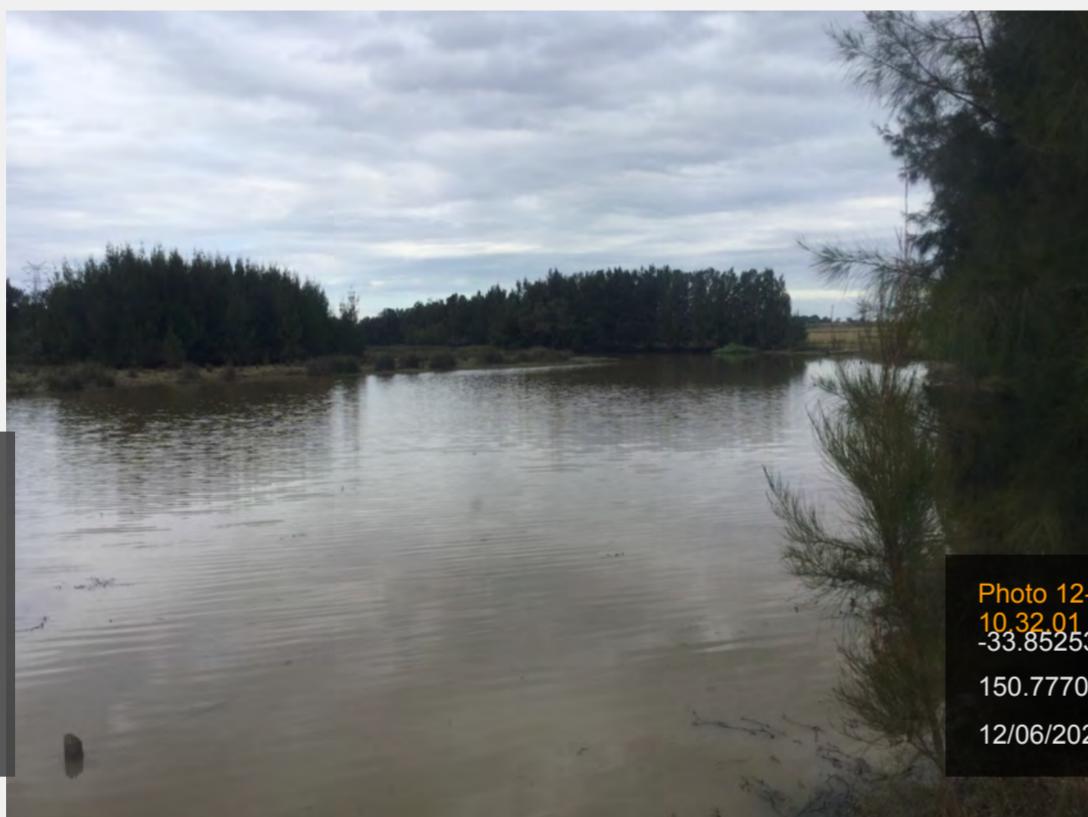
### Kemps-45

The site is in good condition, with a raw score of 29.4 (73%) overall. The bed type is natural bed (invert) - Nv. The bank type is natural vegetation - Nveg.

Weed species observed at the site include Balloon vine, Blackberry, Purpletop verbena, Thistle.

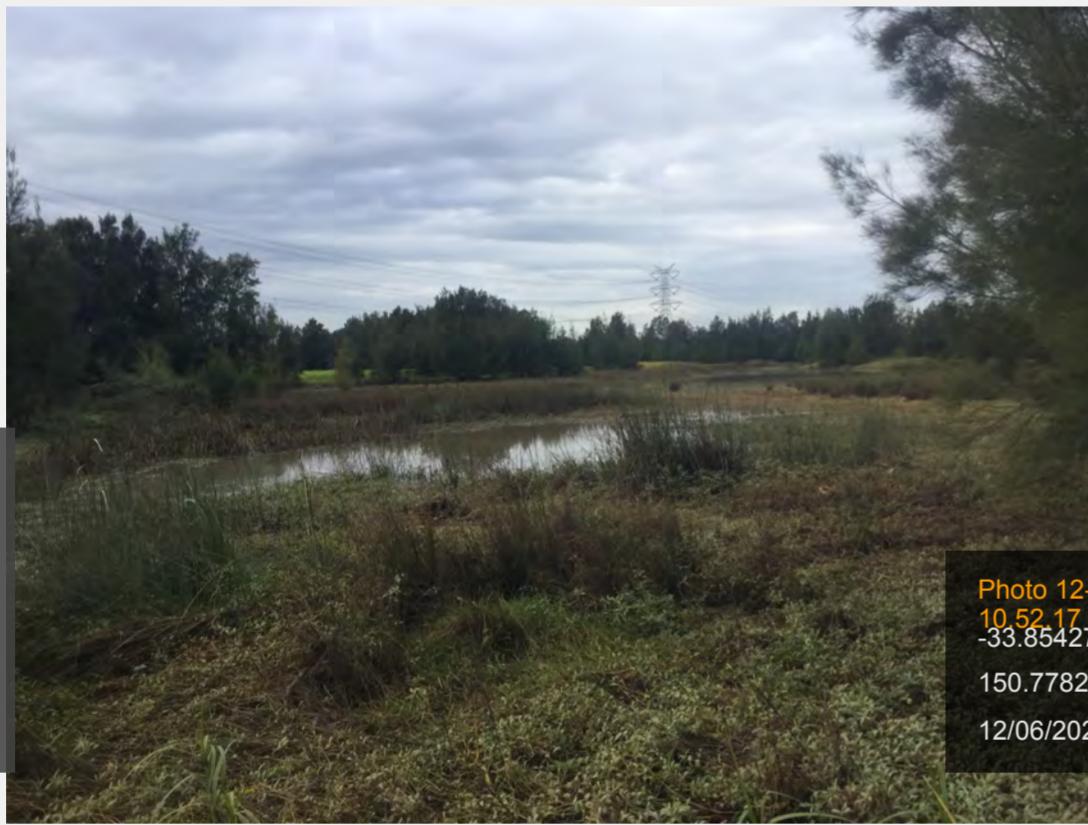
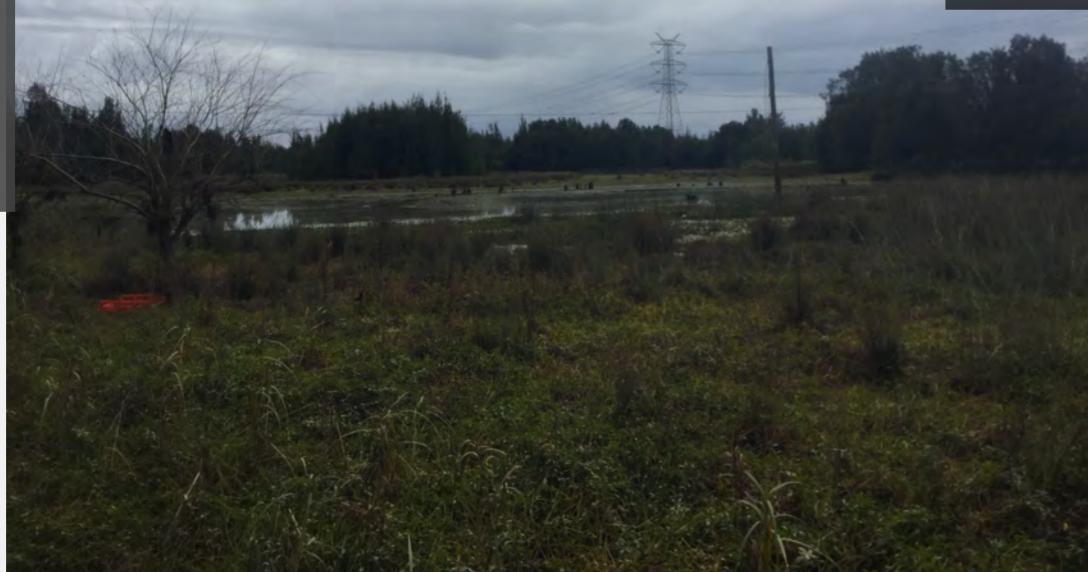
### Kemps-47

The site is in good condition, with a raw score of 32.8 (75%) overall. The bed type is natural bed (invert) - Nv. The bank type is natural vegetation - Nveg.

Weed species observed at the site include Balloon vine, Blackberry, Narrow leaved privet , Patty's Lucerne , Tacoma stands.

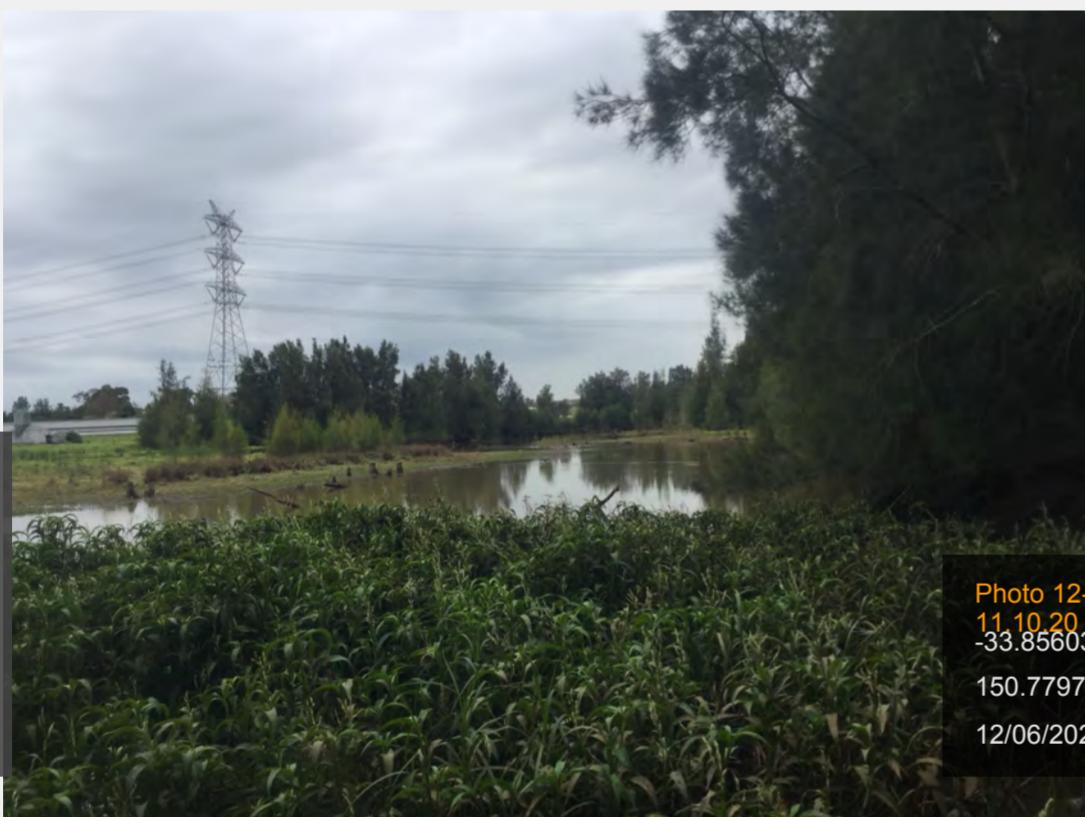
Photo 12-6-2020  
11:10:20 am.jpg  
-33.856030  
150.779725  
12/06/2020 11:09:46 AM

The site is in good condition, with a raw score of 30.65 (74%) overall. The bed type is natural bed (invert) - Nv. The bank type is natural vegetation - Nveg.

Weed species observed at the site include Narrow leaved privet.

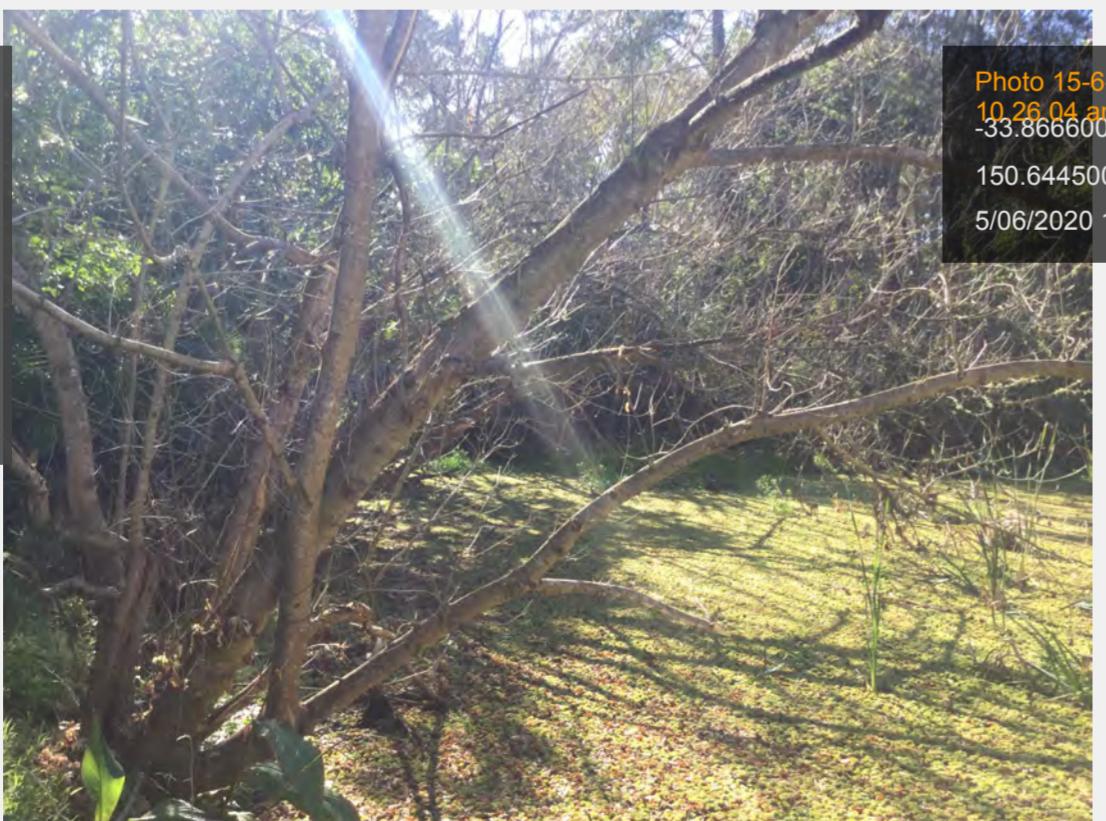
The site is in poor condition, with a raw score of -9.4 (58%) overall. The bed type is natural bed (invert) - Nv. The bank type is natural earth - Ne.

Weed species observed at the site include African olive, Black willow, Broad leaved privet , Narrow leaved privet , Salvinia.

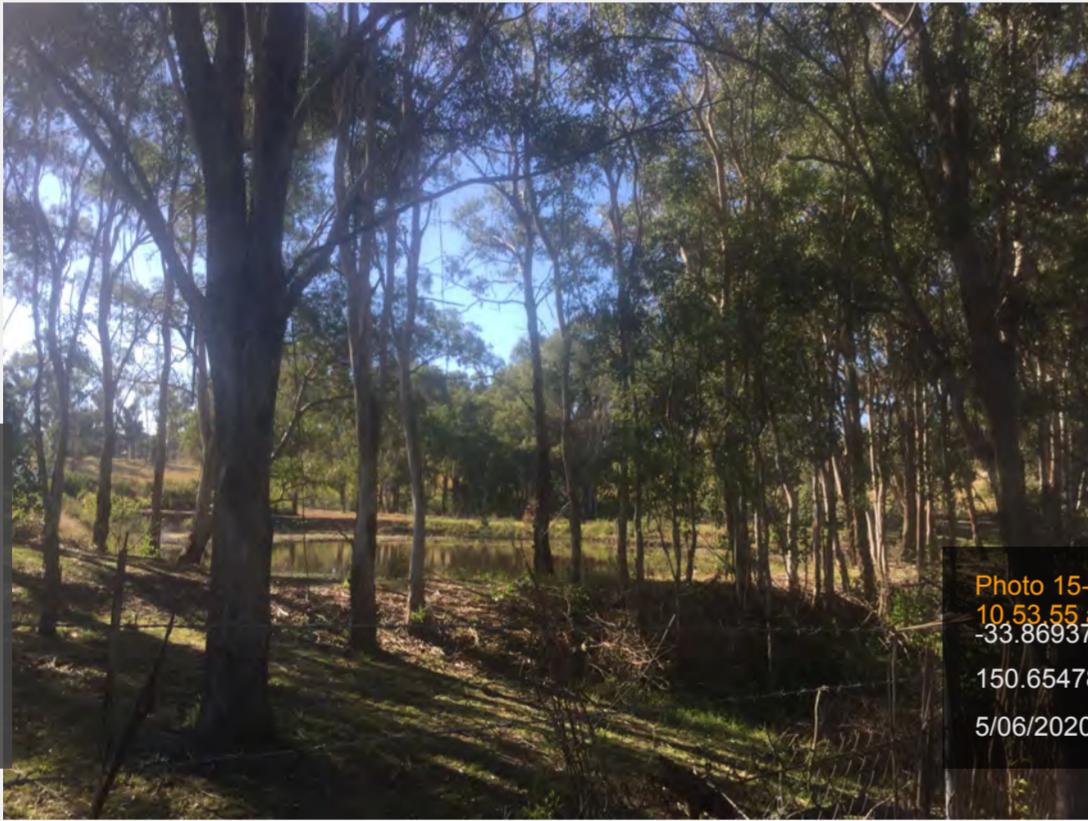
The site is in poor condition, with a raw score of -21.8 (53%) overall. The bed type is natural bed (invert) - Nv. The bank type is natural earth - Ne.

Weed species observed at the site include African olive, Narrow leaved privet .

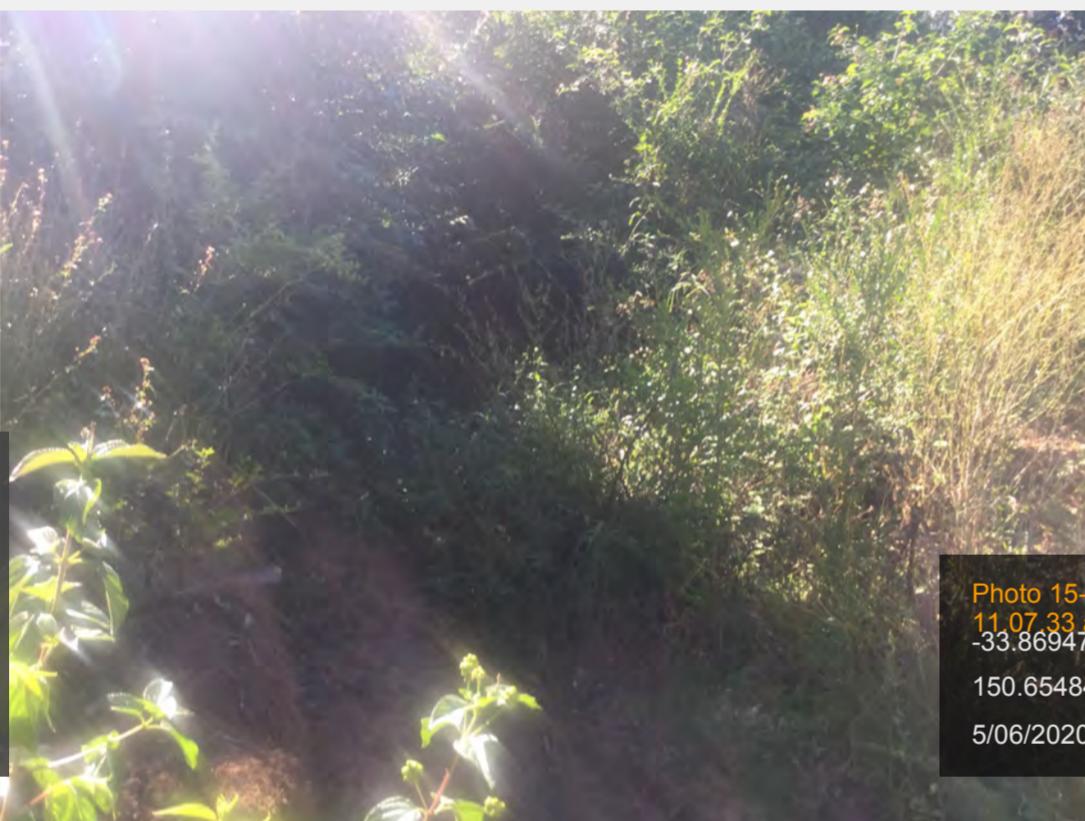
Photo 15-6-2020  
11:07:33 am.jpg  
-33.869475

The site is in poor condition, with a raw score of -15.3 (55%) overall. The bed type is natural bed (invert) - Nv. The bank type is natural earth - Ne.

Weed species observed at the site include Blackberry, Narrow leaved privet .
