## Aquatic Ecology Impact Assessment

Upper South Creek Advanced Water Recycling Centre

Prepared for: Sydney Water Corporation

September 2021

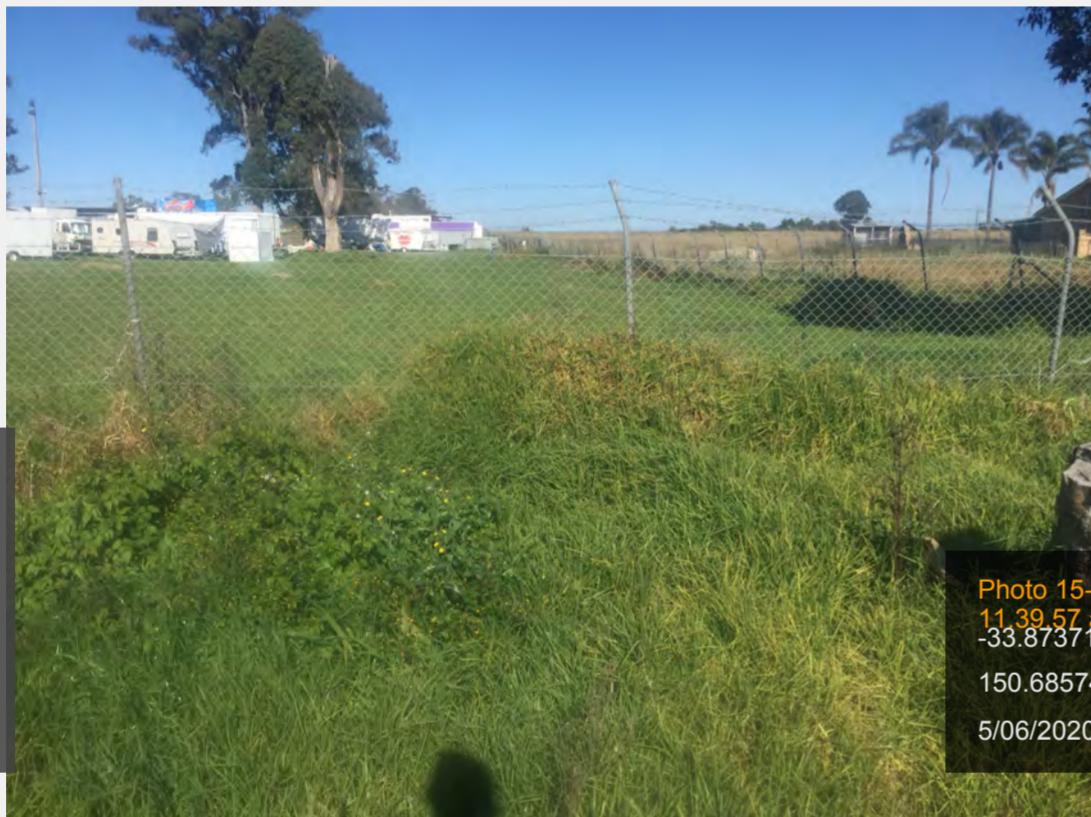
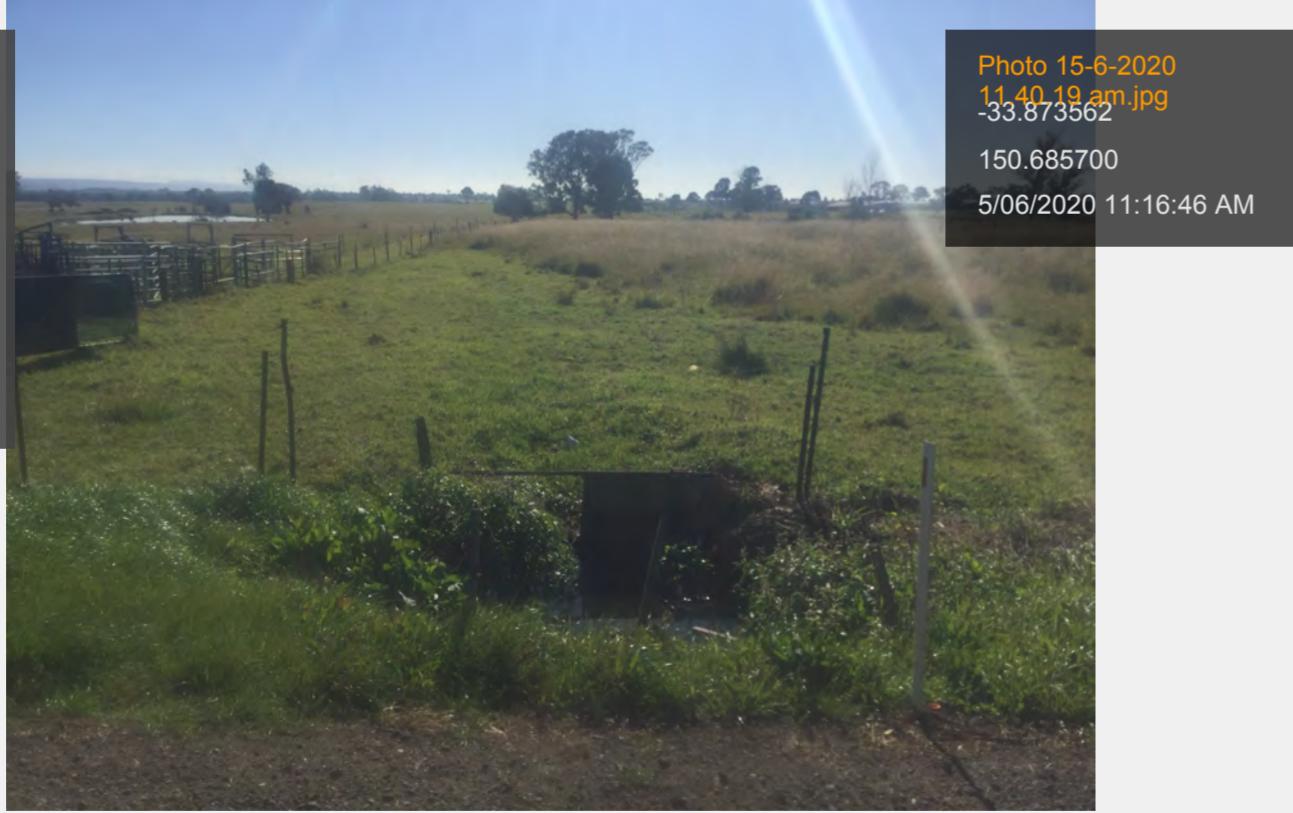
The site is in poor condition, with a raw score of -16.2 (55%) overall. The bed type is grass invert - Gv. The bank type is grass - G.

Weed species observed at the site include Castor plant .

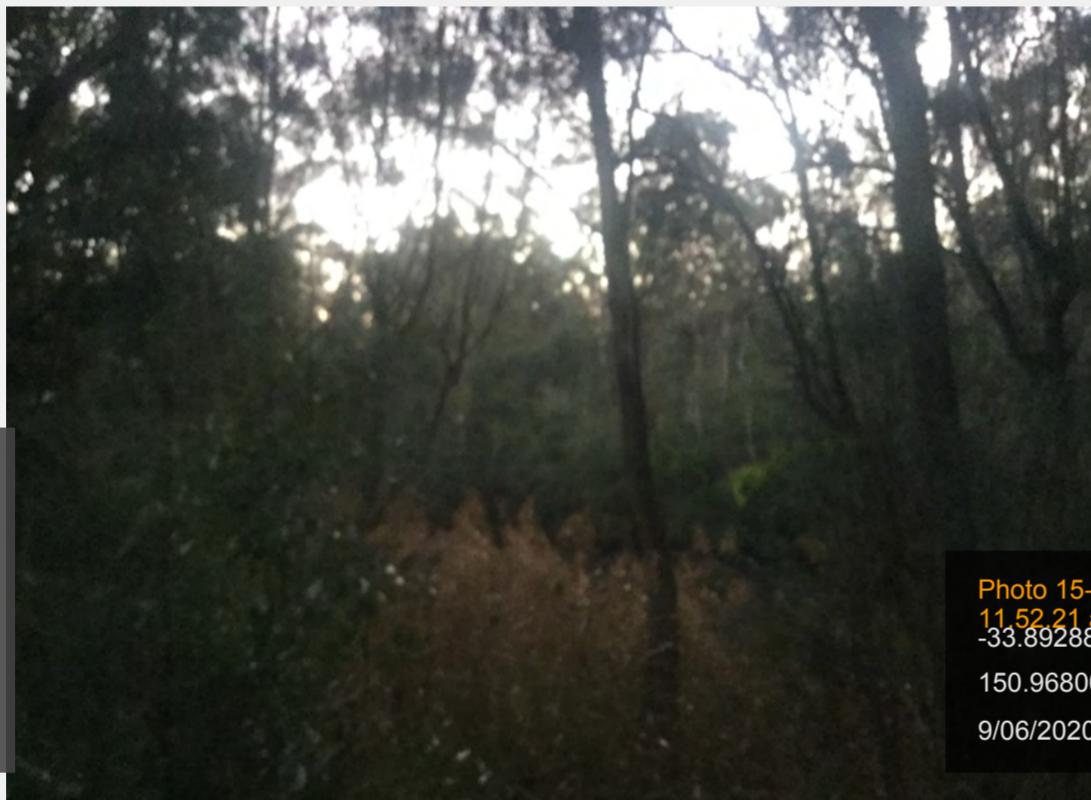
Photo 15-6-2020  
11:52:21 am.jpg  
-33.892887  
150.968003  
9/06/2020 6:56:11 AM

The site is in good condition, with a raw score of 41.2 (78%) overall. The bed type is natural bed (invert) - Nv. The bank type is natural vegetation - Nveg.

Weed species observed at the site include Balloon vine .

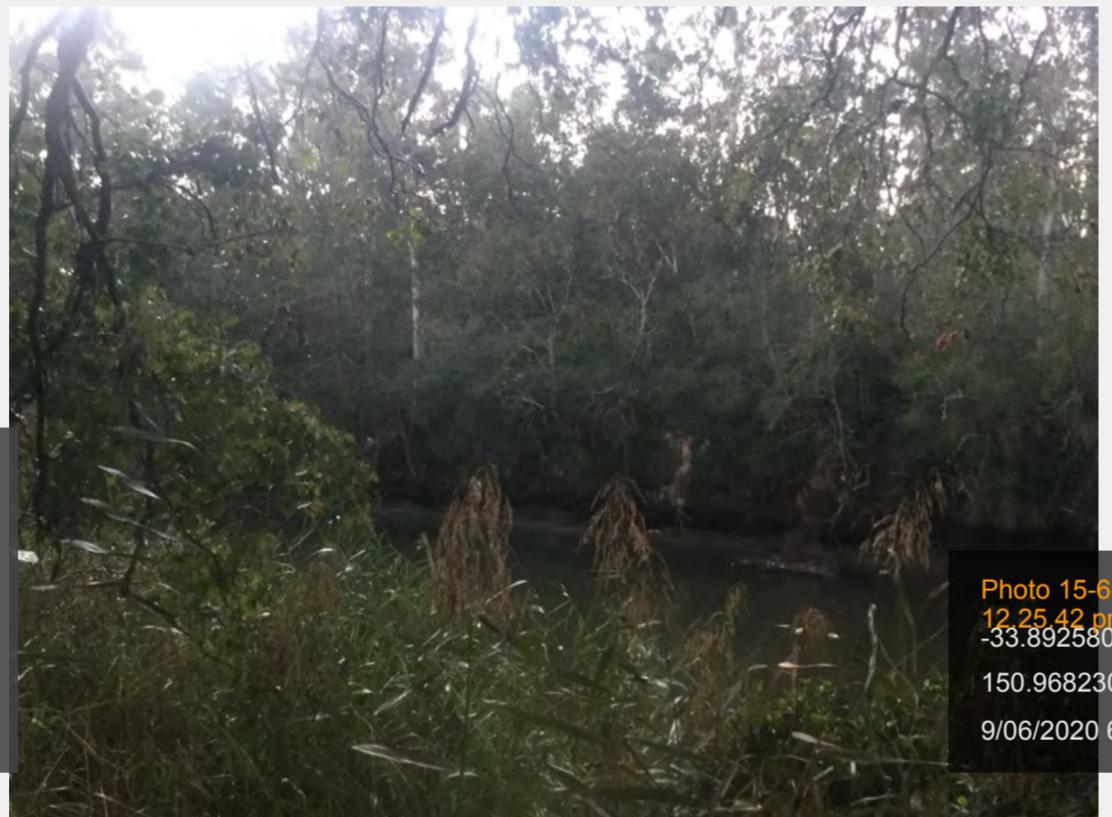
Photo 15-6-2020  
12:25:42 pm.jpg  
-33.892580  
150.968230  
9/06/2020 6:57:38 AM

The site is in good condition, with a raw score of 41.2 (78%) overall. The bed type is natural bed (invert) - Nv. The bank type is natural vegetation - Nveg.

Weed species observed at the site include Narrow leaved privet .

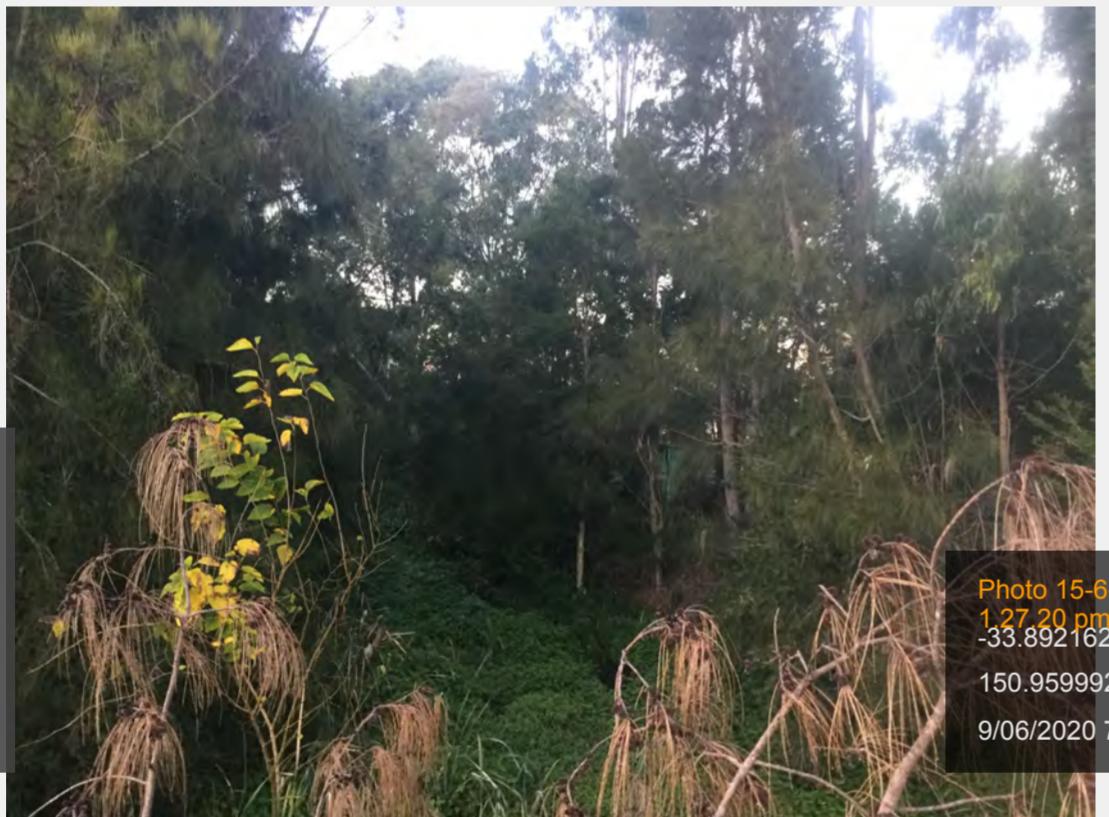
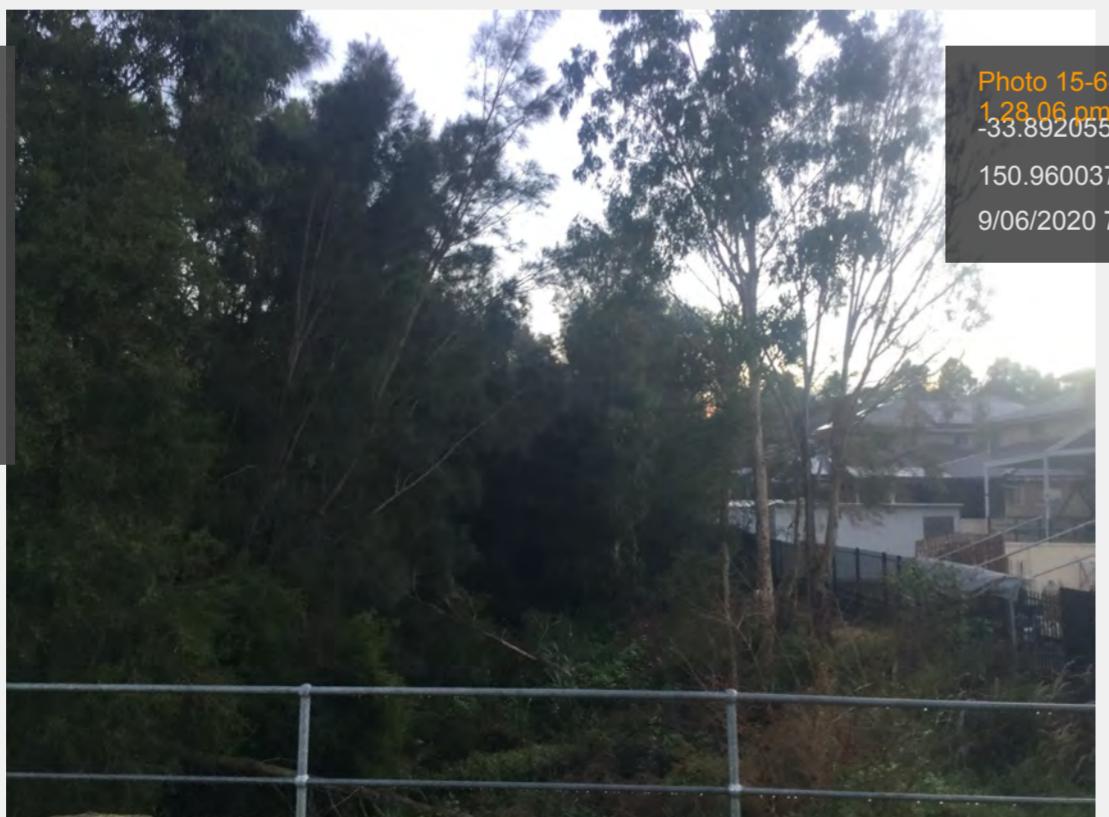
The site is in very poor condition, with a raw score of -54 (40%) overall. The bed type is natural bed (invert) - Nv. The bank type is natural earth - Ne.

Weed species observed at the site include Narrow leaved privet .

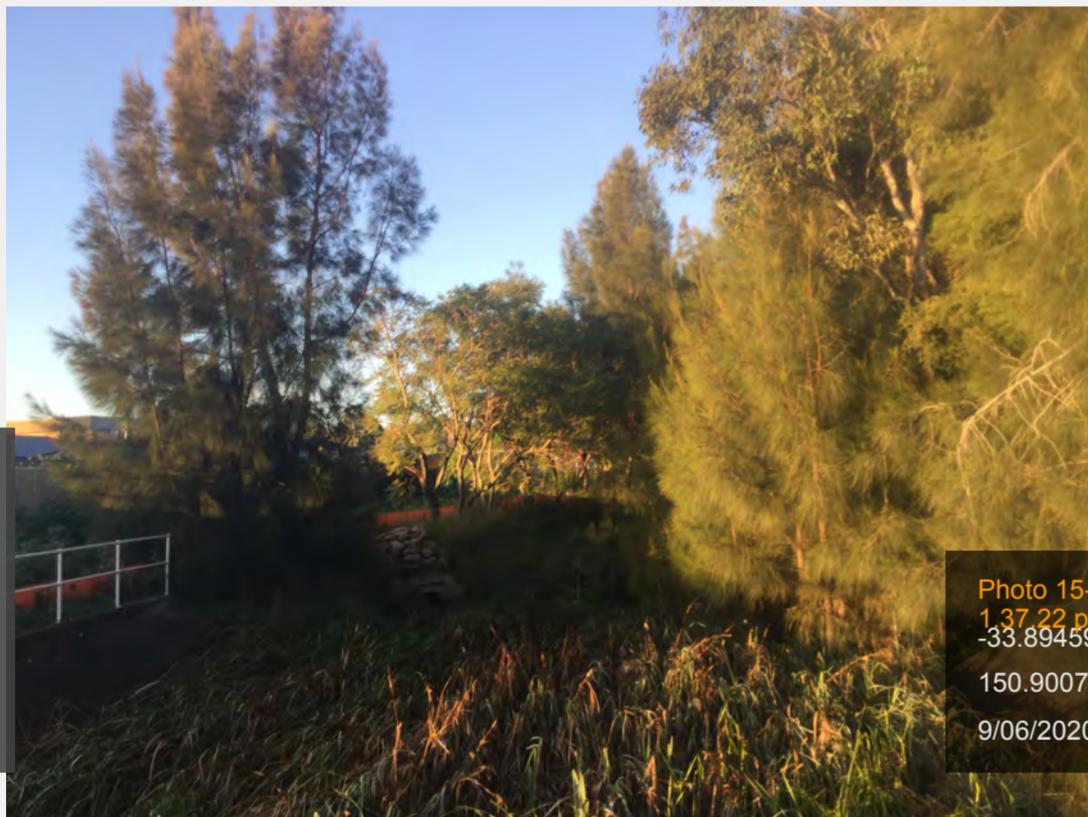
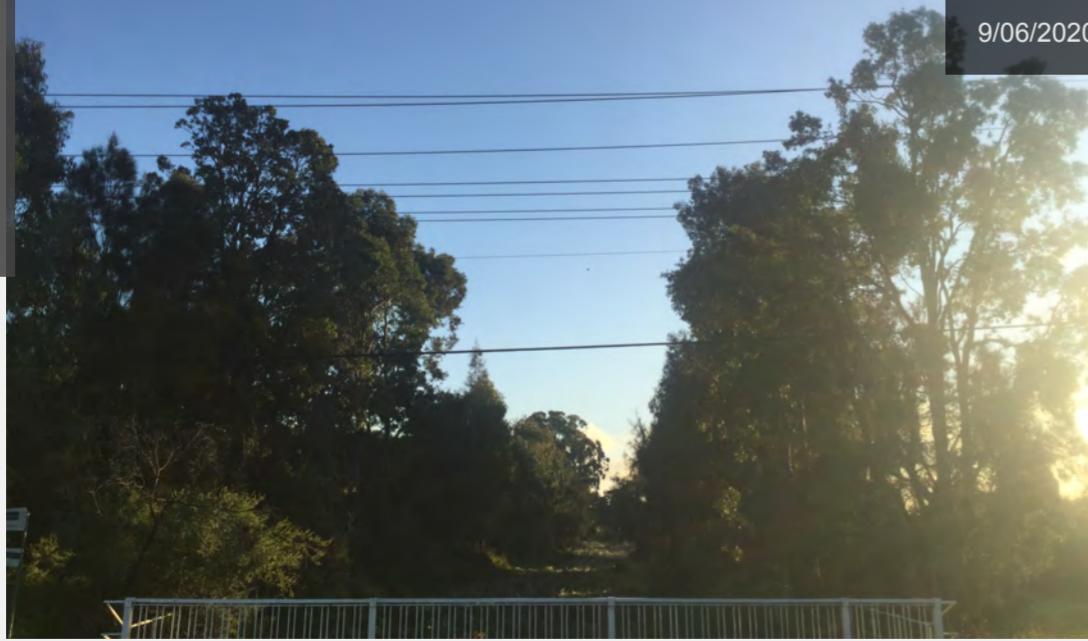
The site is in very poor condition, with a raw score of -60 (37%) overall. The bed type is concrete invert - Cv. The bank type is concrete trapezoidal wall- Ctrap.

Weed species observed at the site include Trad.

extraction	absent
excavation	absent
litter	high 20-50
sewer	absent
stormwater	present
odour	normal/none
turbidity	medium

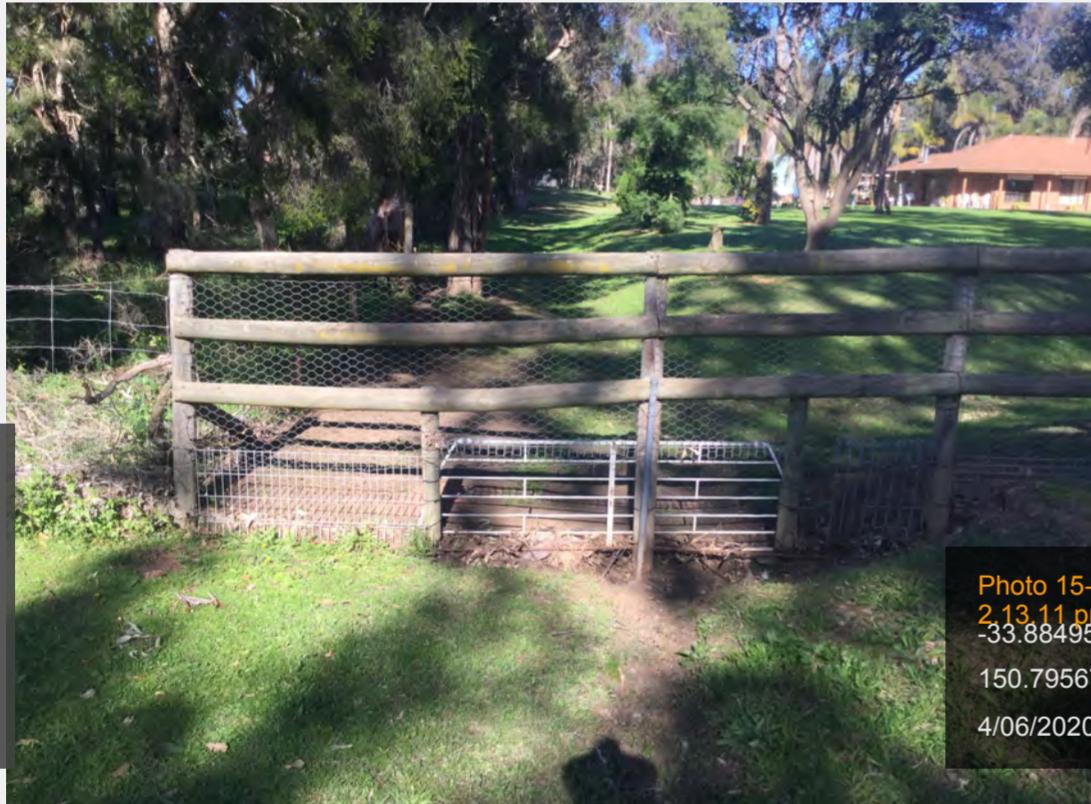
Photo 15-6-2020  
2,13,11 pm.jpg  
-33.884955  
150.795670  
4/06/2020 11:07:44 AM

The site is in fair condition, with a raw score of 12.6 (66%) overall. The bed type is natural bed (invert) - Nv. The bank type is natural vegetation - Nveg.

Weed species observed at the site include Narrow leaved privet .

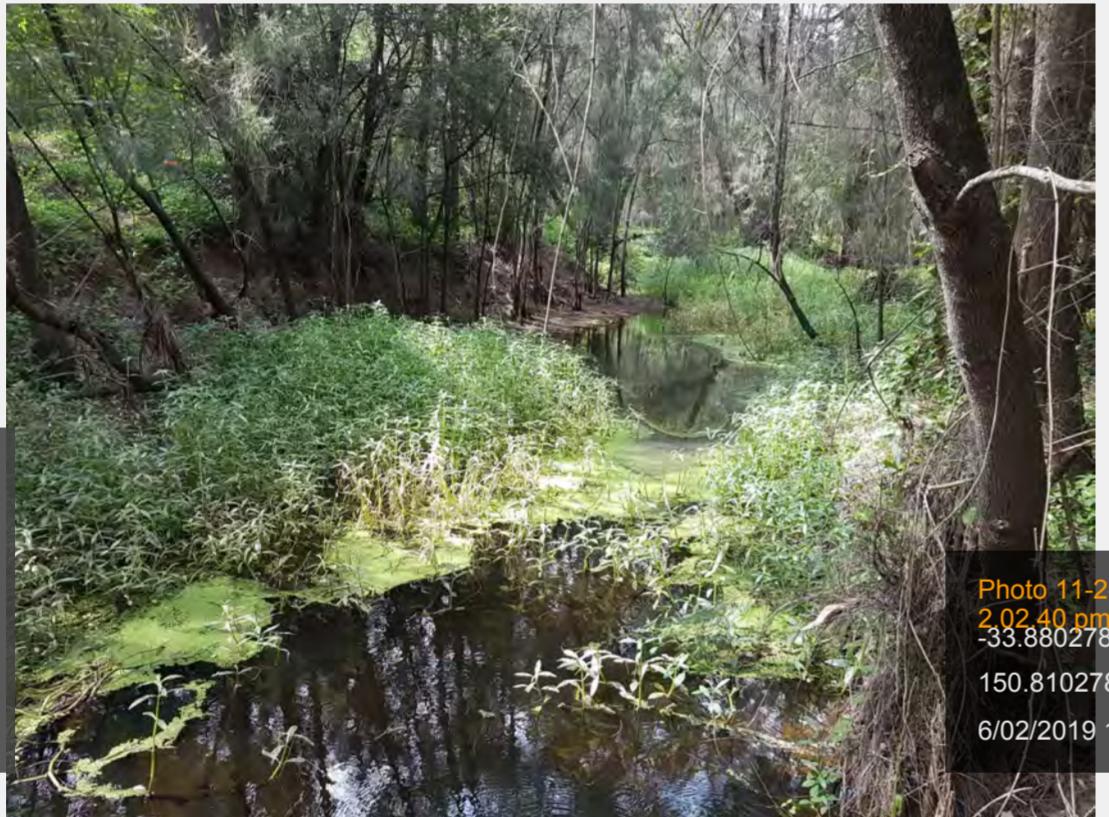
### Kemps-49

The site is in fair condition, with a raw score of 23.6 (71%) overall. The bed type is natural bed clay - Nvc. The bank type is natural vegetation - Nveg.

Within the 50 metre assessment radius, left bank vegetation structure is 20% under-scrubbed forest/woodland, 80% weed/exotic, approximately. Right bank vegetation structure is 100% forest/woodland, approximately. This is reflected in the vegetation structure subtotal.

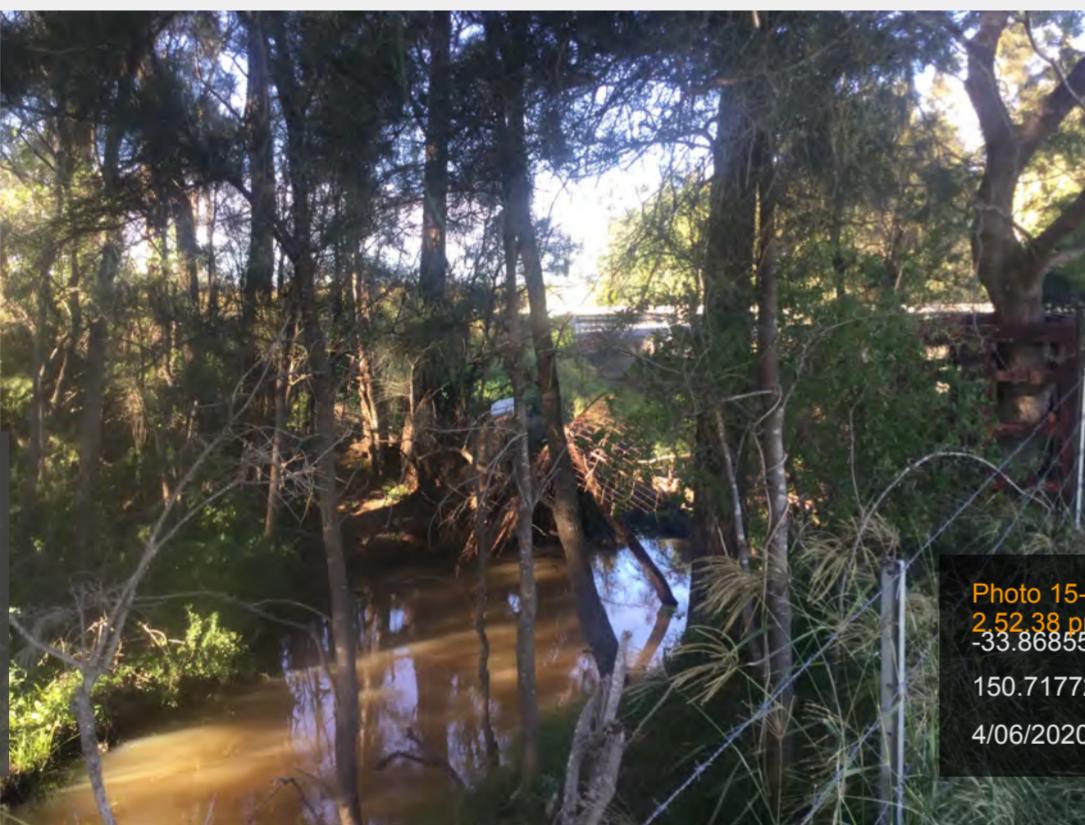
The site is in fair condition, with a raw score of 14.8 (67%) overall. The bed type is natural bed (invert) - Nv. The bank type is natural vegetation - Nveg.

Weed species observed at the site include Trad.

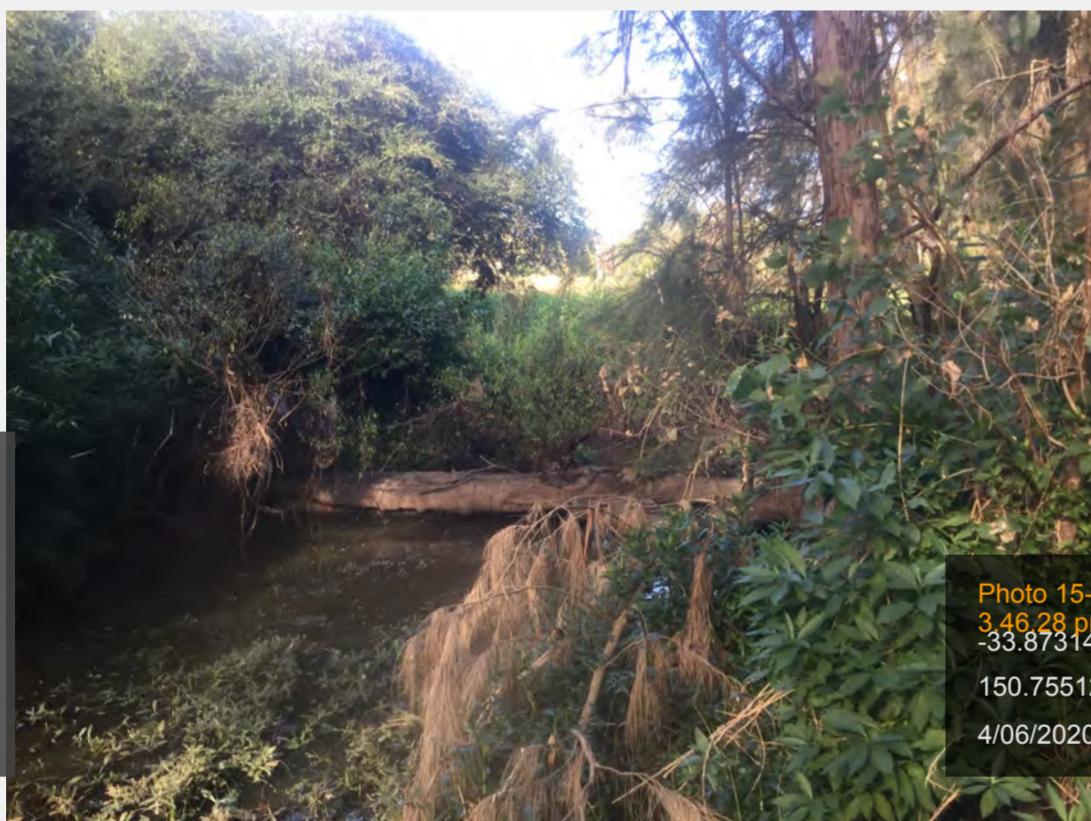
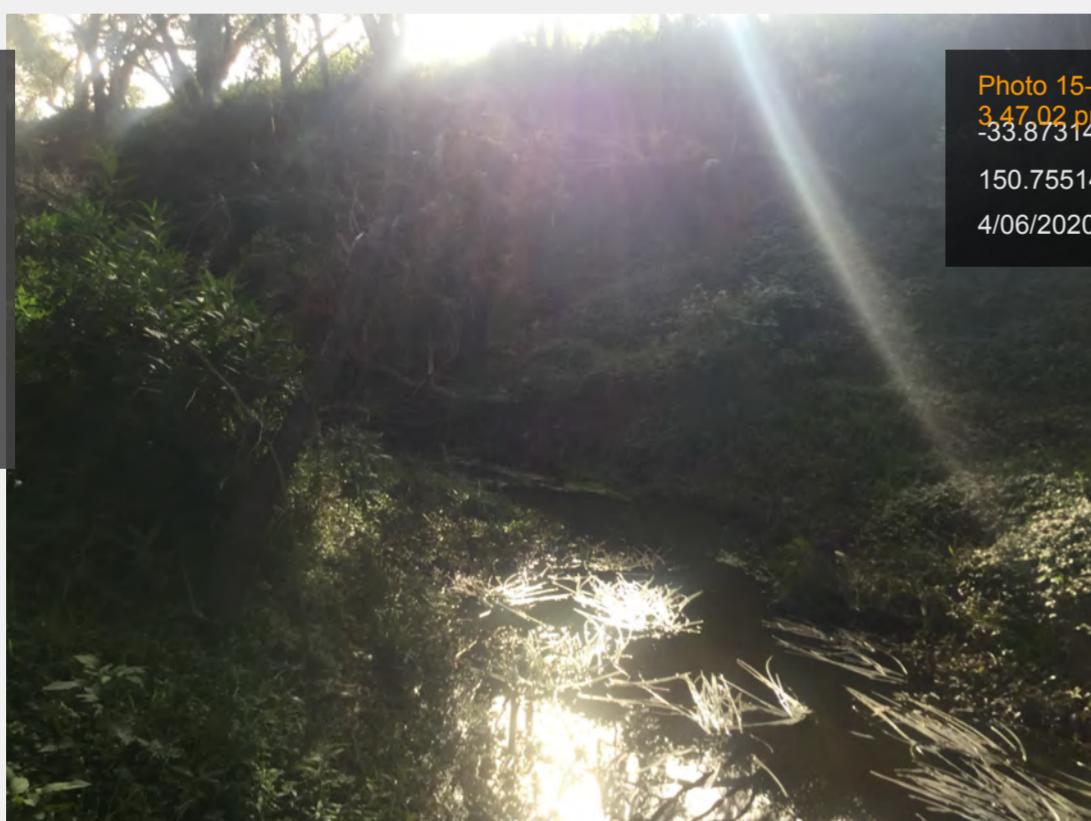
The site is in good condition, with a raw score of 35 (75%) overall. The bed type is natural bed (invert) - Nv. The bank type is natural vegetation - Nveg.

Weed species observed at the site include African boxthorn, Green cestrum.

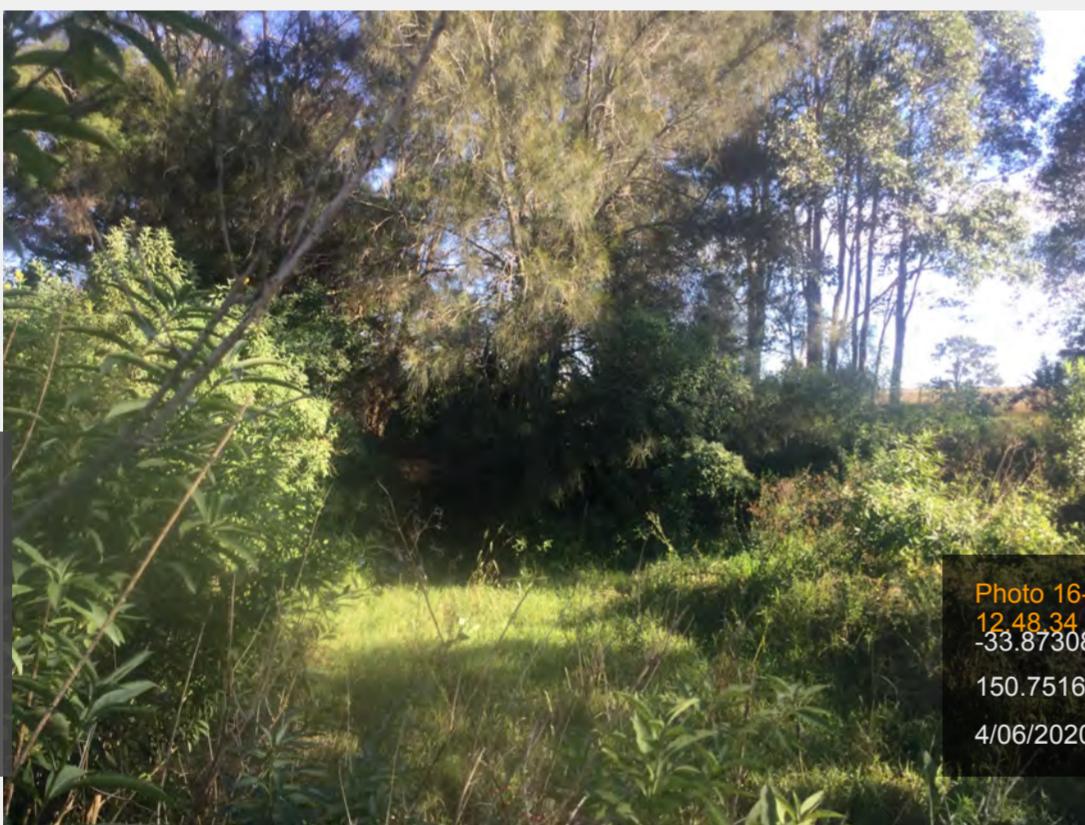
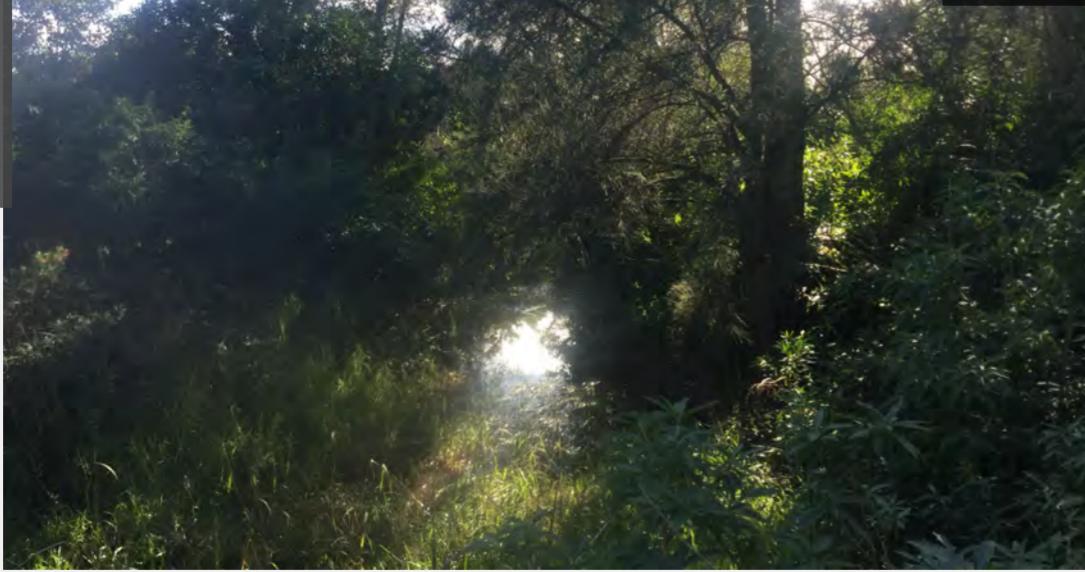
The site is in good condition, with a raw score of 32.8 (75%) overall. The bed type is natural bed (invert) - Nv. The bank type is natural vegetation - Nveg.

Weed species observed at the site include Green cestrum.

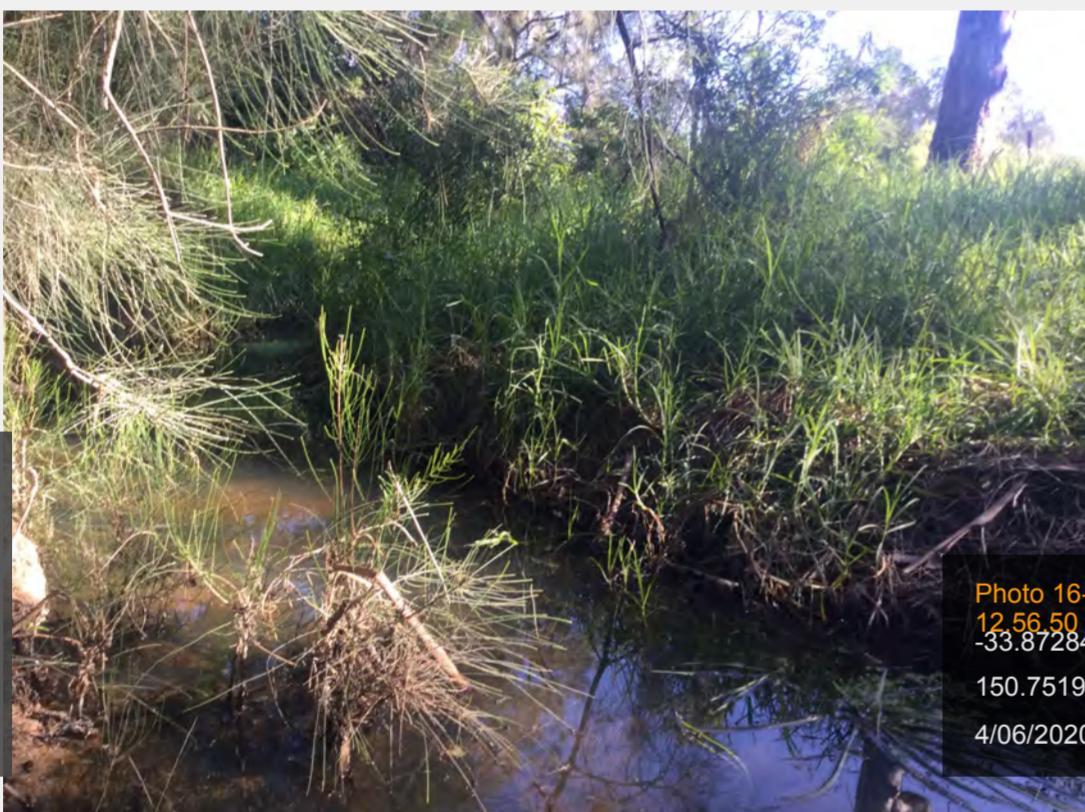
The site is in good condition, with a raw score of 28.8 (73%) overall. The bed type is natural bed (invert) - Nv. The bank type is natural vegetation - Nveg.

Weed species observed at the site include Green cestrum.

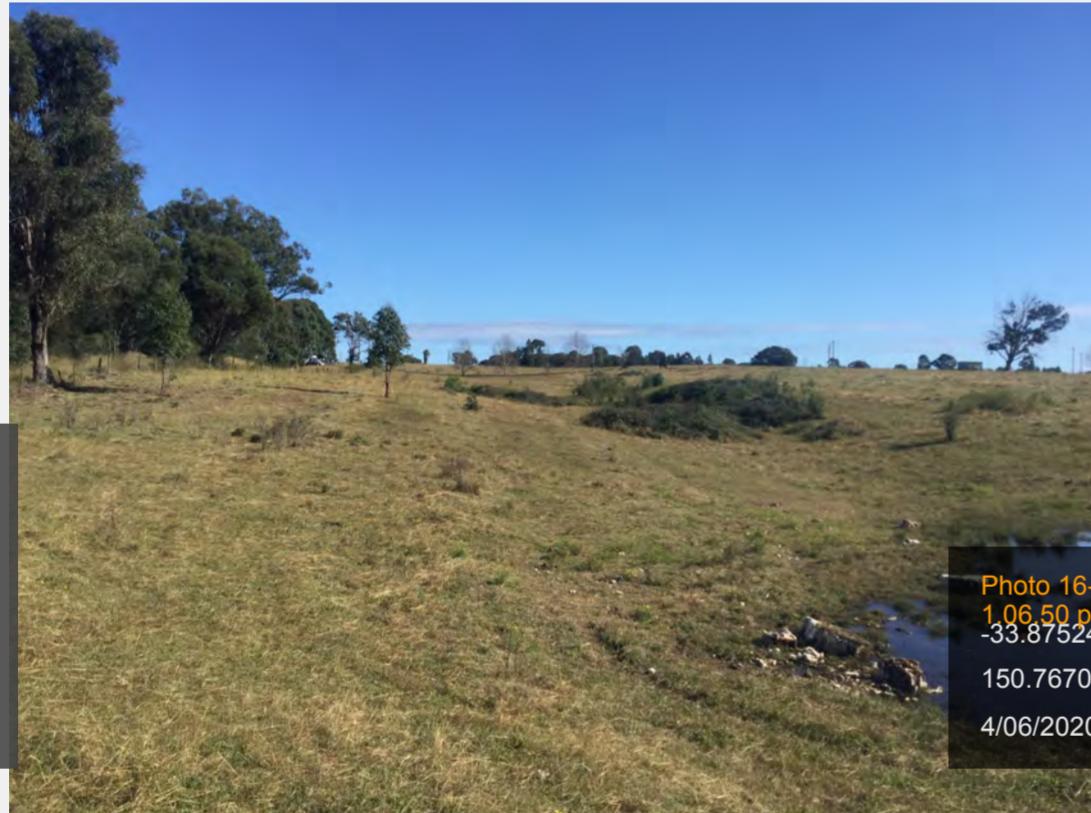
The site is in poor condition, with a raw score of -15 (55%) overall. The bed type is natural bed mud - Nvm. The bank type is natural earth - Ne.

Weed species observed at the site include African boxthorn.

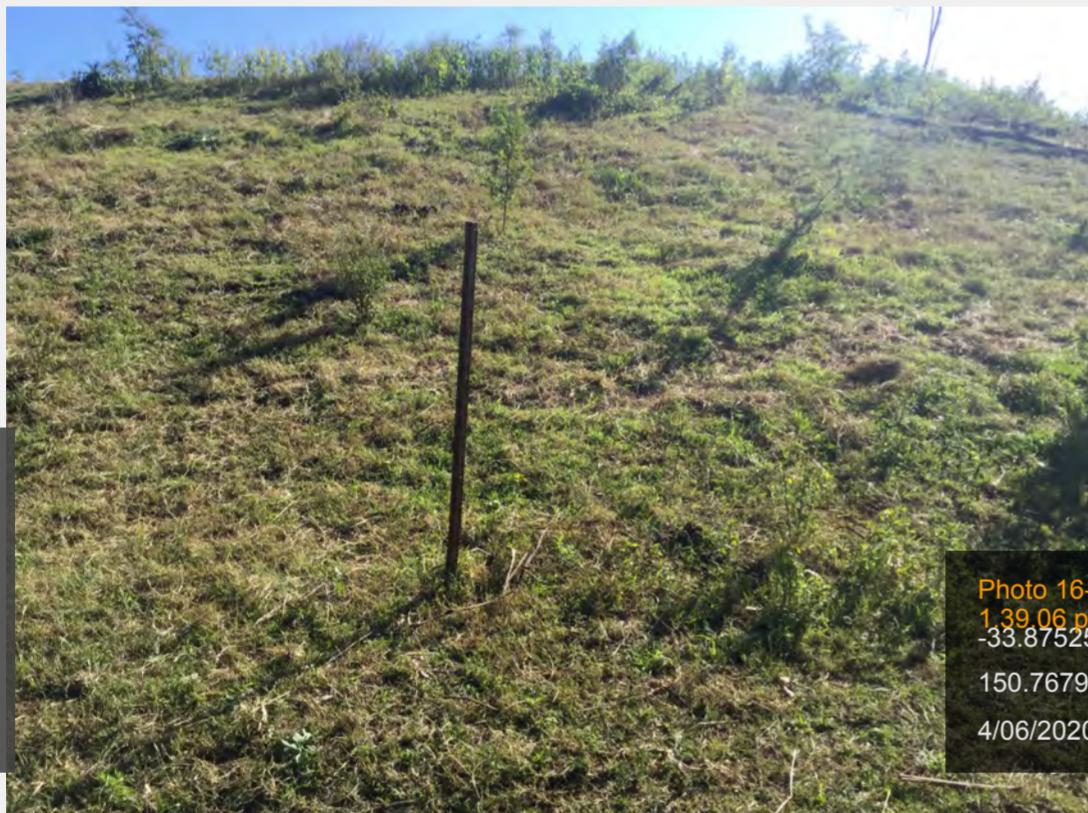
The site is in poor condition, with a raw score of -11.7 (57%) overall. The bed type is natural bed clay - Nvc. The bank type is natural earth - Ne.

Weed species observed at the site include Green cestrum .

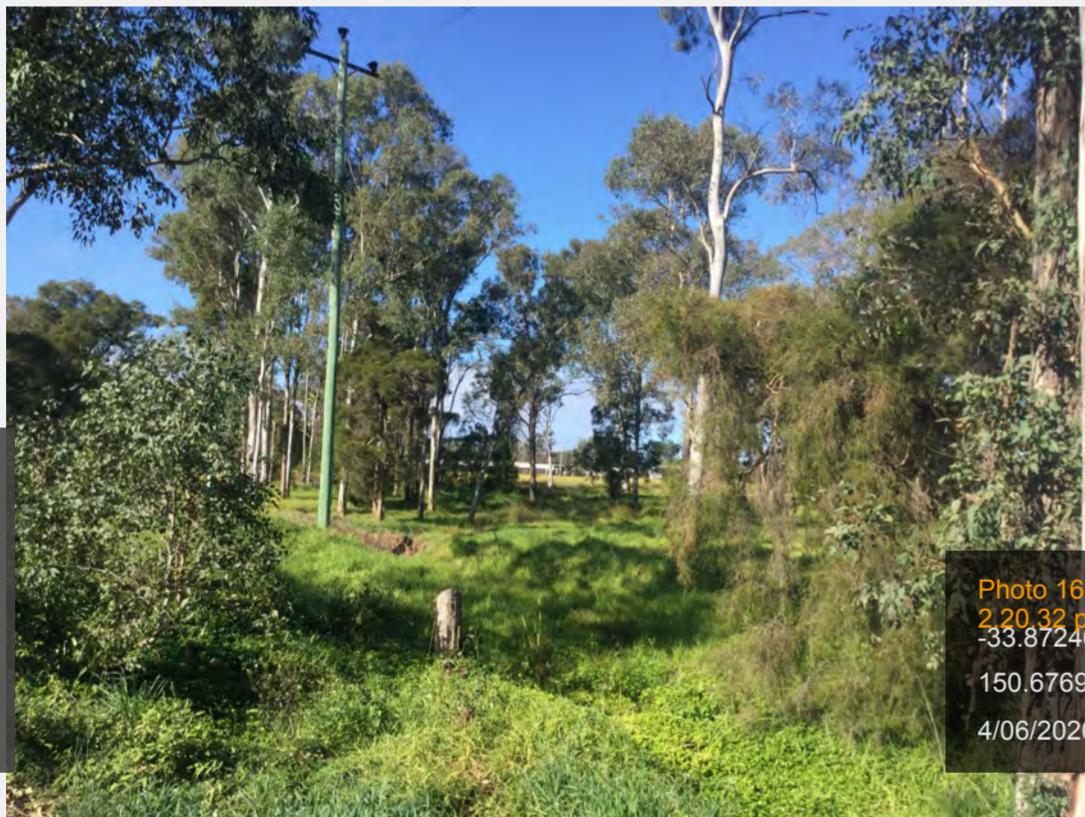
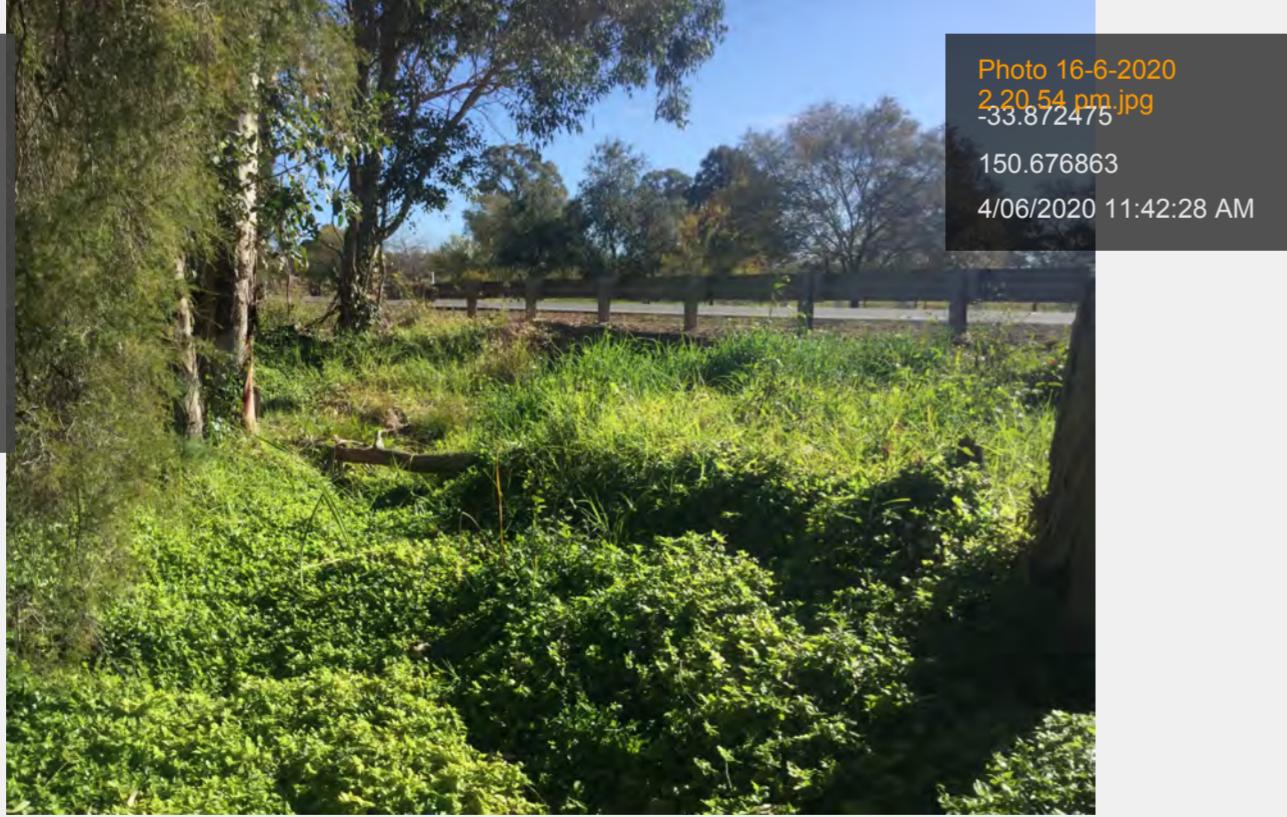
The site is in poor condition, with a raw score of 4.9 (63%) overall. The bed type is natural bed (invert) - Nv. The bank type is natural vegetation - Nveg.

Weed species observed at the site include Narrow leaved privet , Trad.

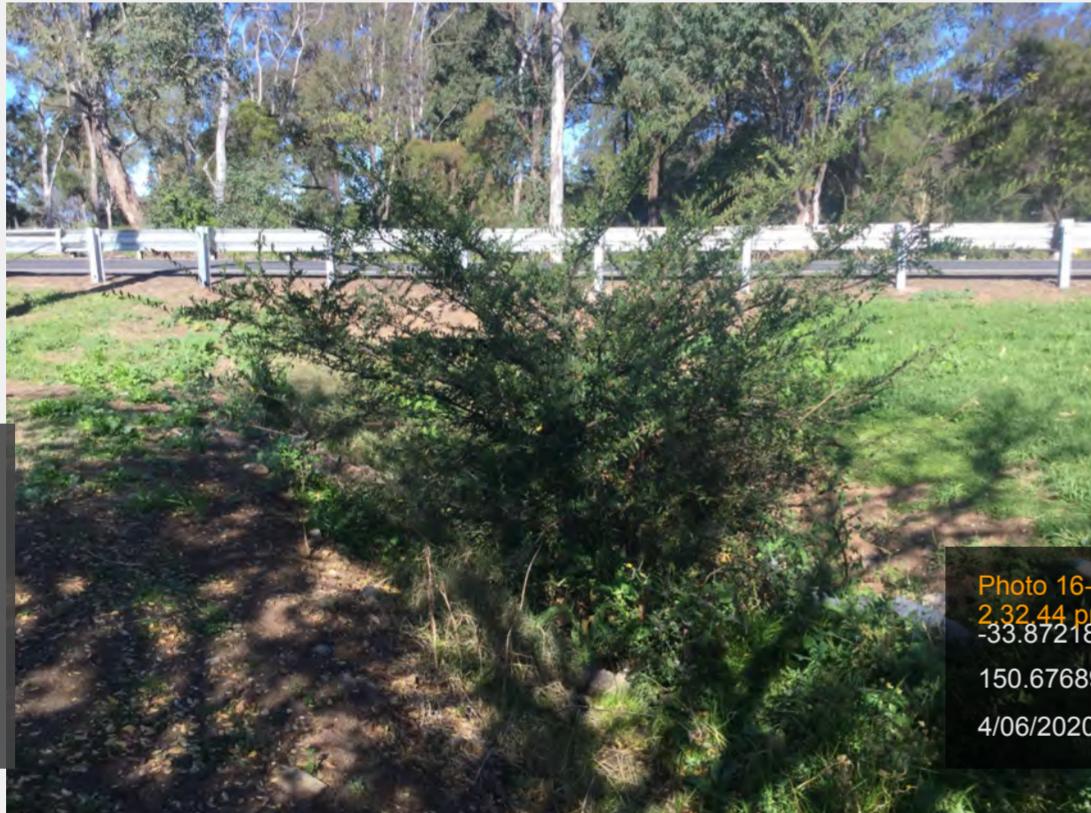
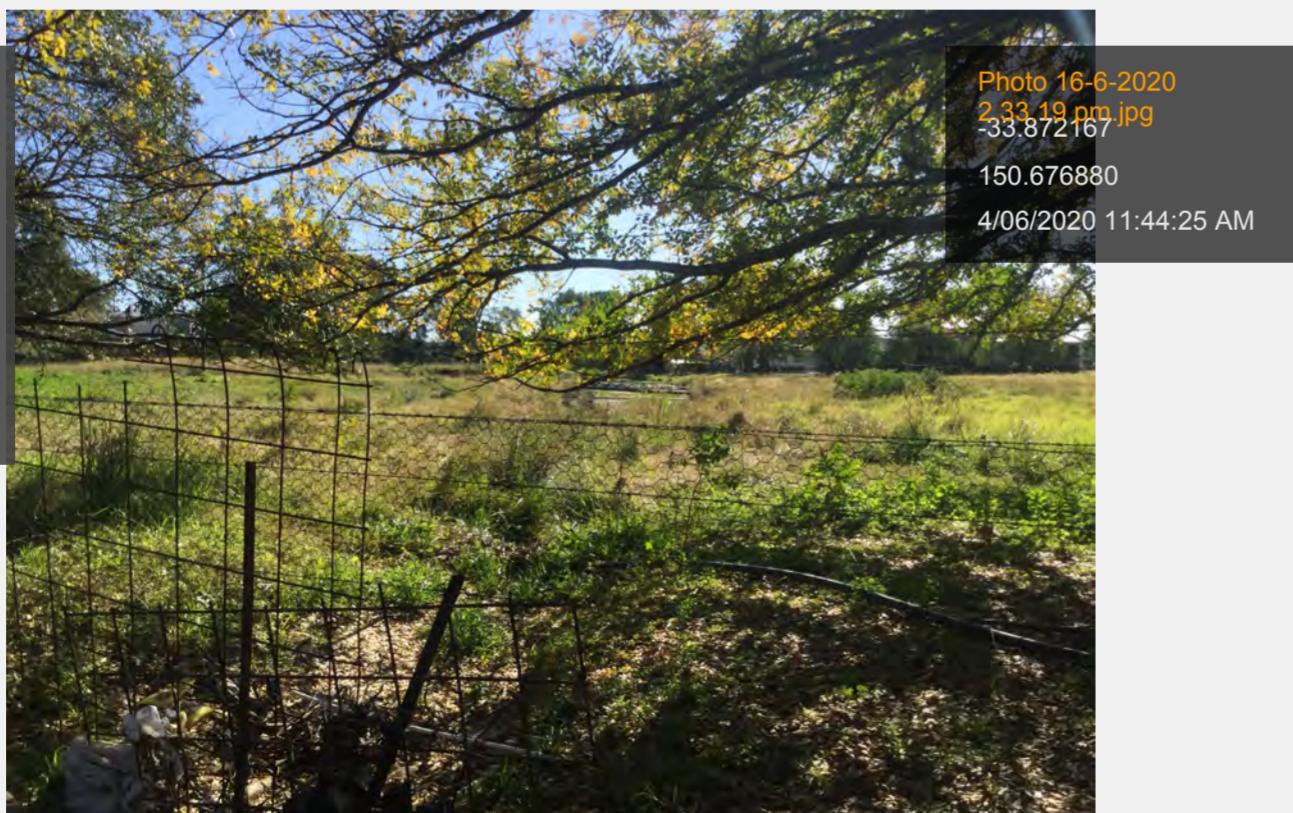
The site is in poor condition, with a raw score of -11.2 (57%) overall. The bed type is natural bed (invert) - Nv. The bank type is natural earth - Ne.

Weed species observed at the site include Blackberry.

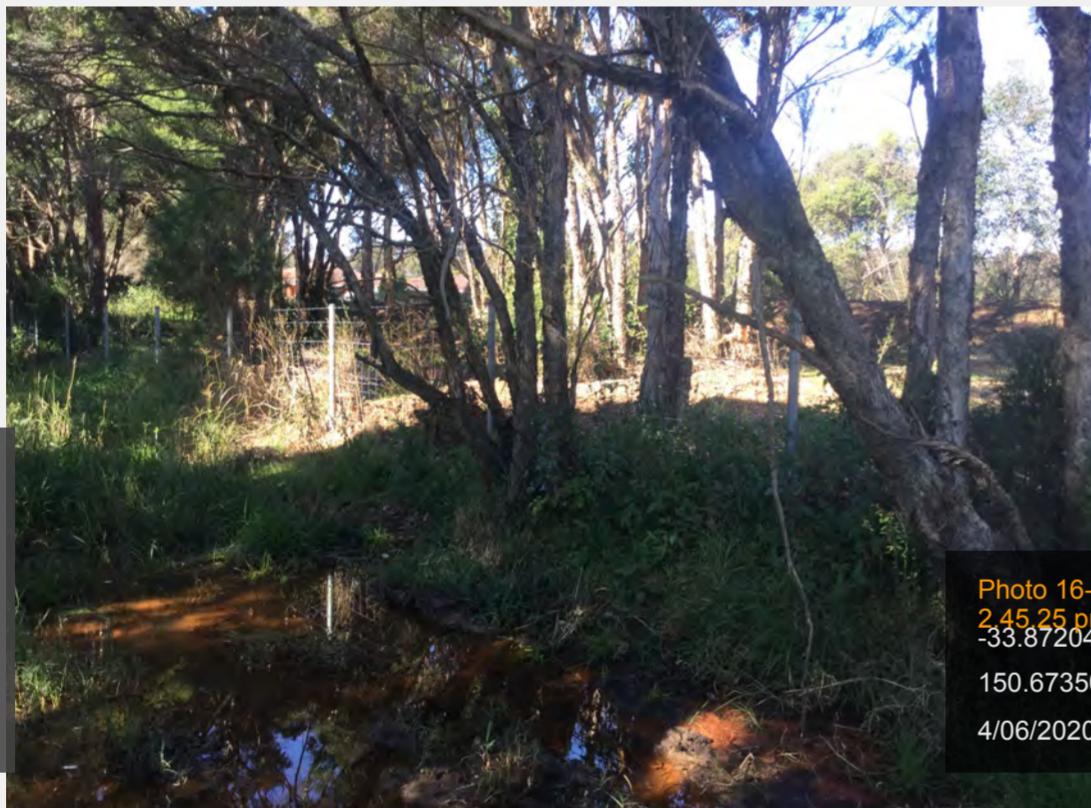
The site is in poor condition, with a raw score of -30.4 (49%) overall. The bed type is natural bed (invert) - Nv. The bank type is natural earth - Ne.

Weed species observed at the site include Blackberry.

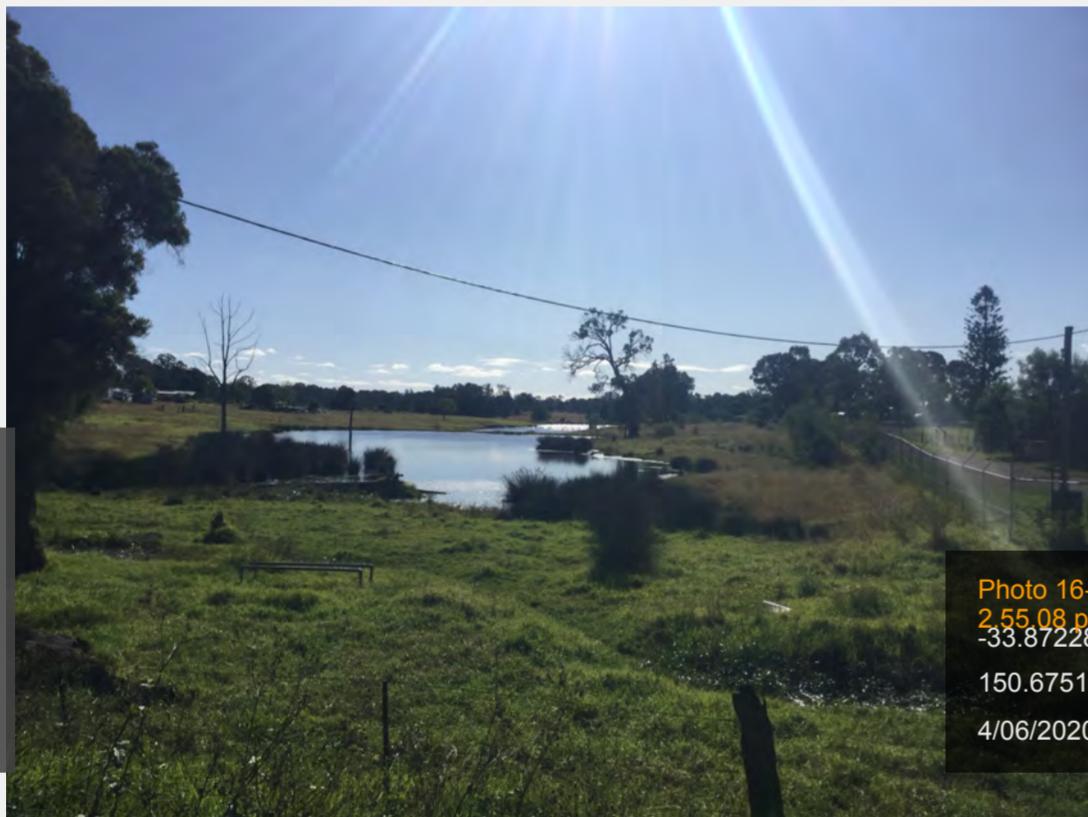
The site is in very poor condition, with a raw score of -40.2 (45%) overall. The bed type is natural bed (invert) - Nv. The bank type is natural earth - Ne.

Weed species observed at the site include Blackberry.
