## Aquatic Ecology Impact Assessment

Upper South Creek Advanced Water Recycling Centre

Prepared for: Sydney Water Corporation

September 2021

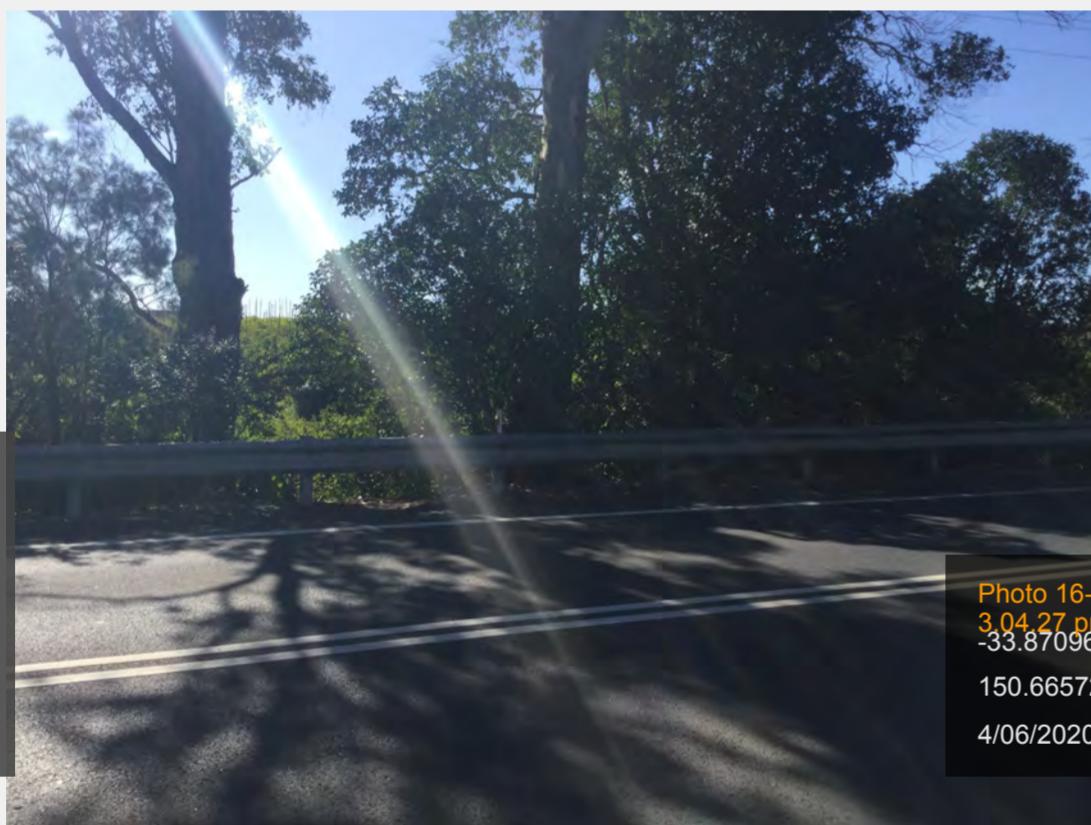
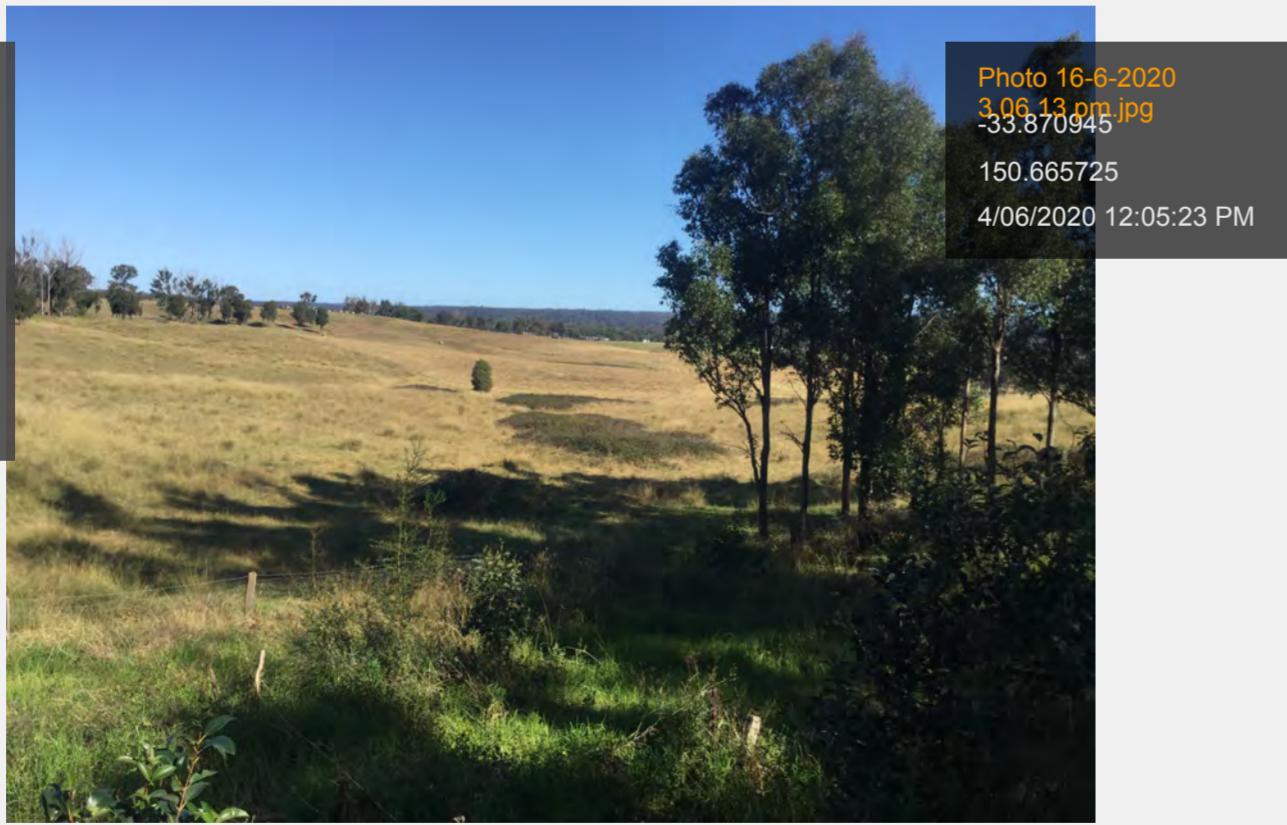
The site is in poor condition, with a raw score of -13.2 (56%) overall. The bed type is natural bed (invert) - Nv. The bank type is natural earth - Ne.

Within the 50 metre assessment radius, left bank vegetation structure is 80% pasture grassland, 20% absent/concrete/earth, approximately. Right bank vegetation structure is 80% pasture grassland, 20% absent/concrete/earth, approximately. This is reflected in the vegetation structure subtotal.

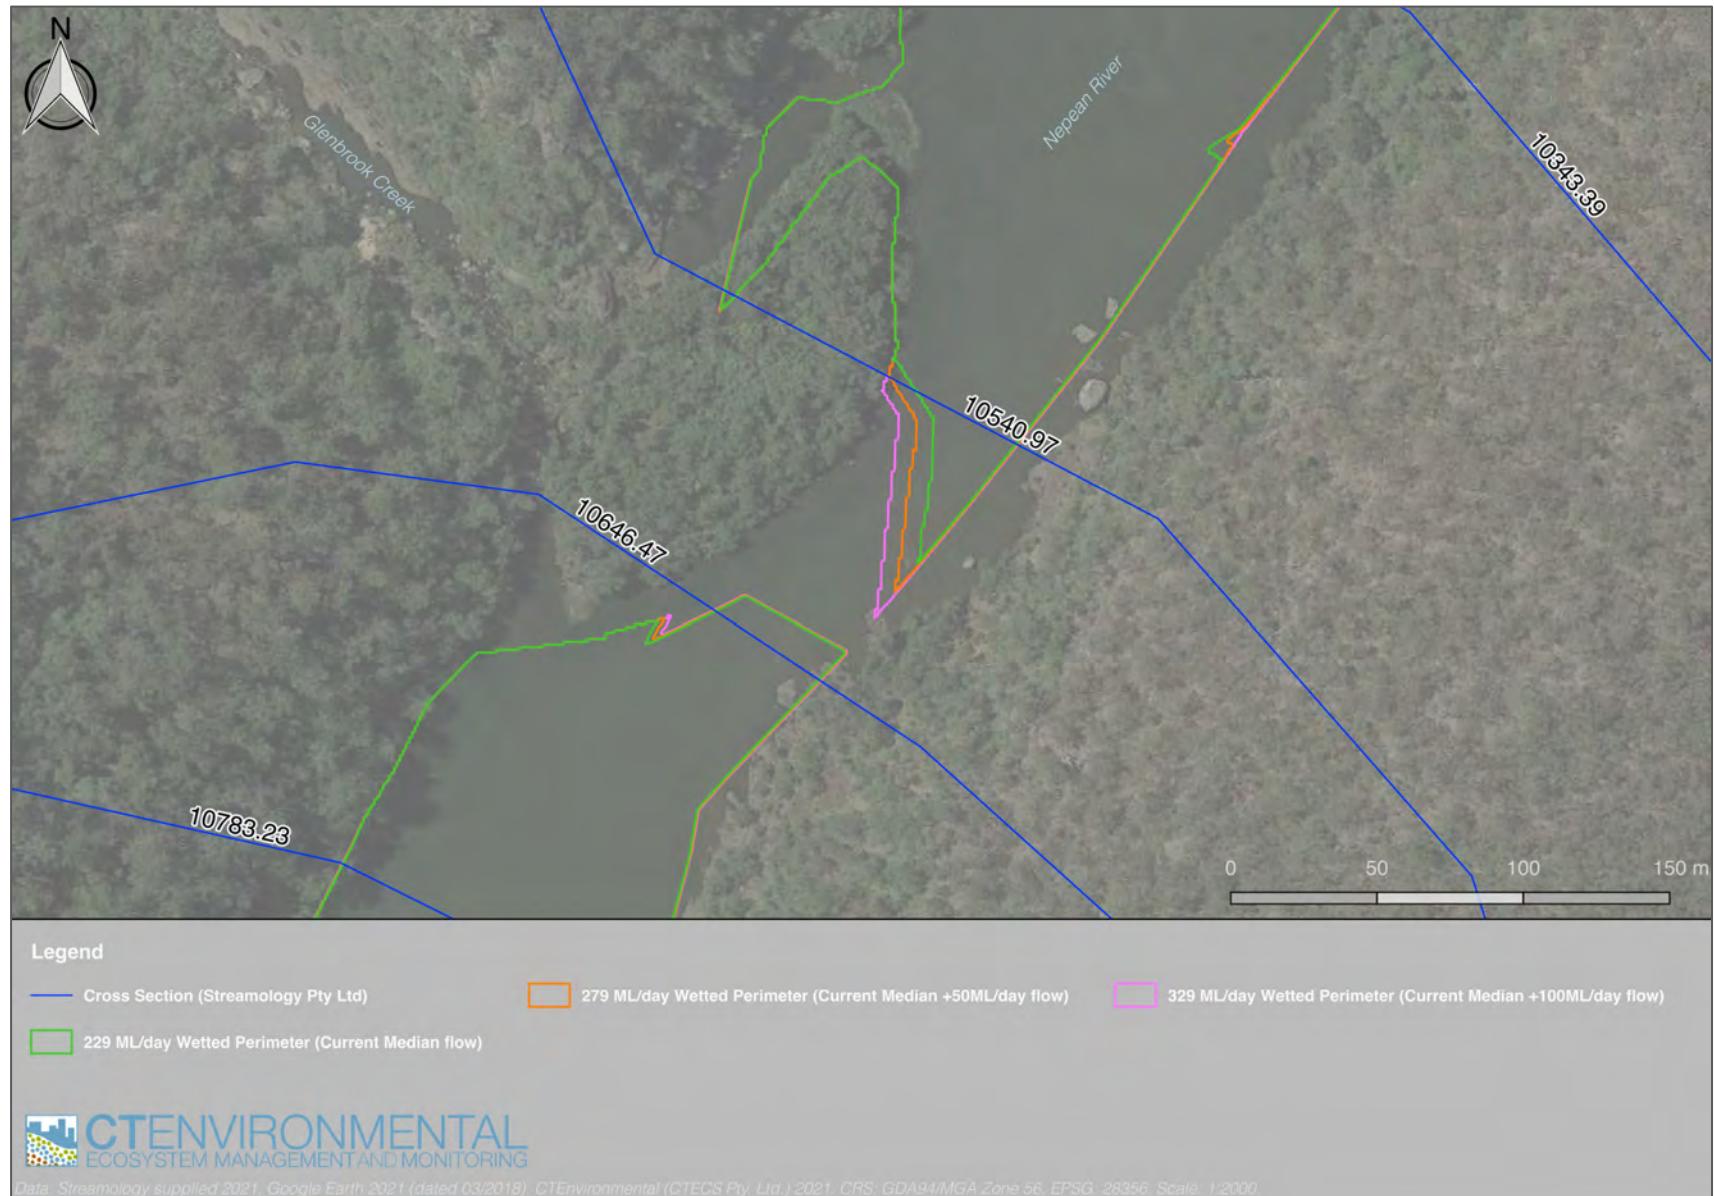
Figure 77 Identified anomaly at the Glenbrook Creek-Nepean River confluence. Cross section 10540.97 dissects the baseline Median and baseline Median +50ML /day wetted perimeter polygons, resulting in an over-expression of wetted perimeter extent within the wetted channel (approximately adjacent to the western bank).

It is considered that the magnitude and consequence of this over-expression relative to the scale of wetted perimeter analysis conducted from Bents Basin to Penrith Weir is negligible, and in no way detracts or under-represents the impact of wetted perimeter from increased flow events. Wetted perimeter calculations presented by this assessment for both baseline median and 90<sup>th</sup> percentile flow scenarios would therefore be considered conservative.

Examples of these isolated anomalies are displayed with accompanying commentary where relevant (Figures 1-5). All effort has been taken to draw upon a range of relevant ecohydraulic metrics and field survey data to inform inferences and mitigations proposed by this assessment.

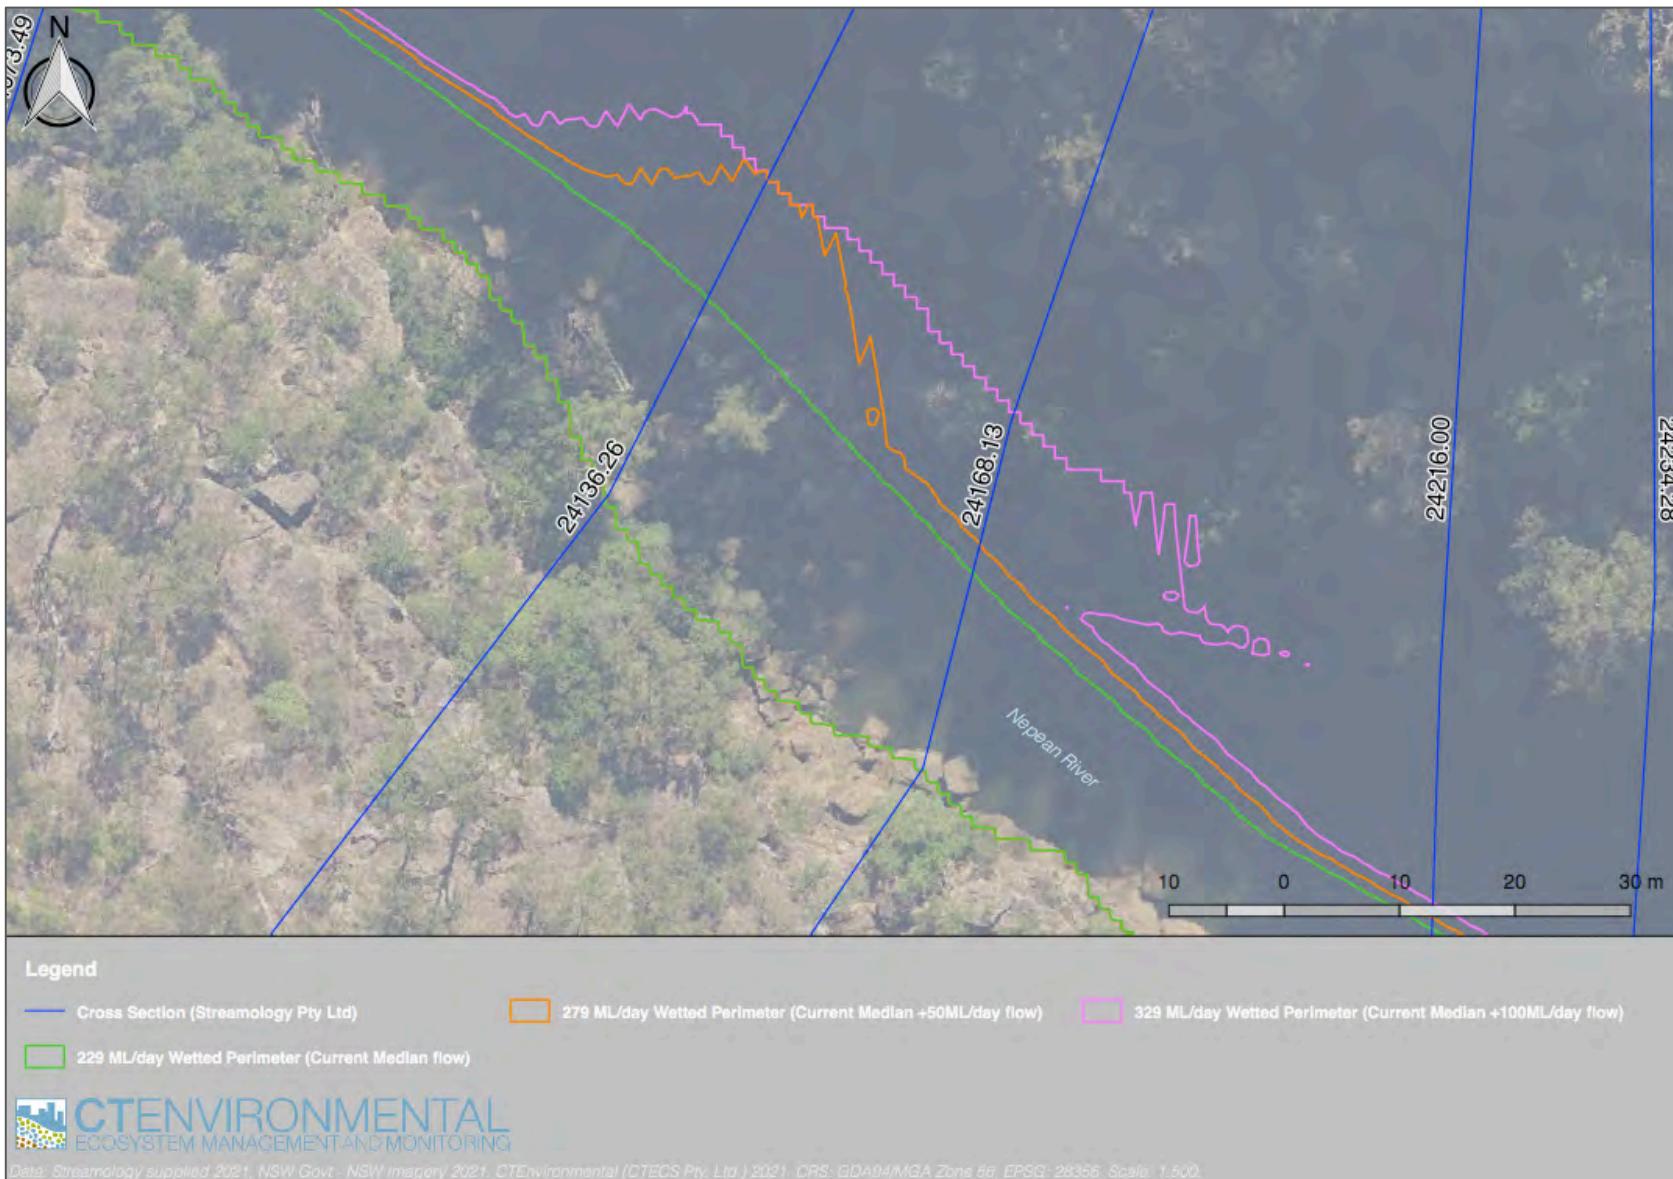
Figure 80 Close up of cross section 24136.26 (selected example discussed only) dissecting baseline Median, baseline Median +50ML /day and baseline Median +100ML /day wetted perimeter extents.
