Beaches Link and Gore Hill Freeway Connection

Technical working paper: Aboriginal cultural heritage assessment report

December 2020

Jacobs Group (Australia) Pty Ltd.

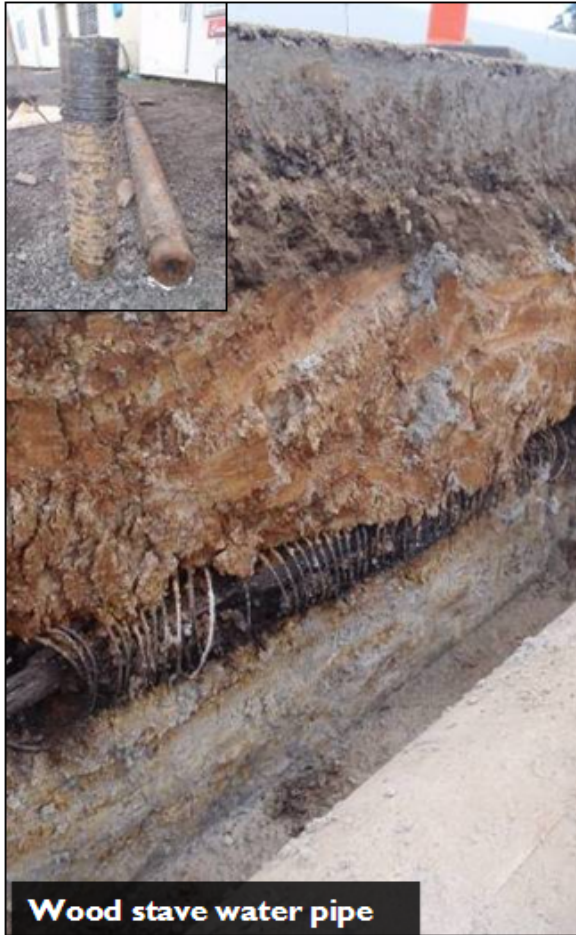
Wood stave water pipe

Top left hand picture continuing clockwise: Woodstave water pipe with tar and wire sealing (Horsley Drive); Tram tracks (Sydney); Brick lined cistern (Clyde); Retaining wall (Great Western Highway, Leura).

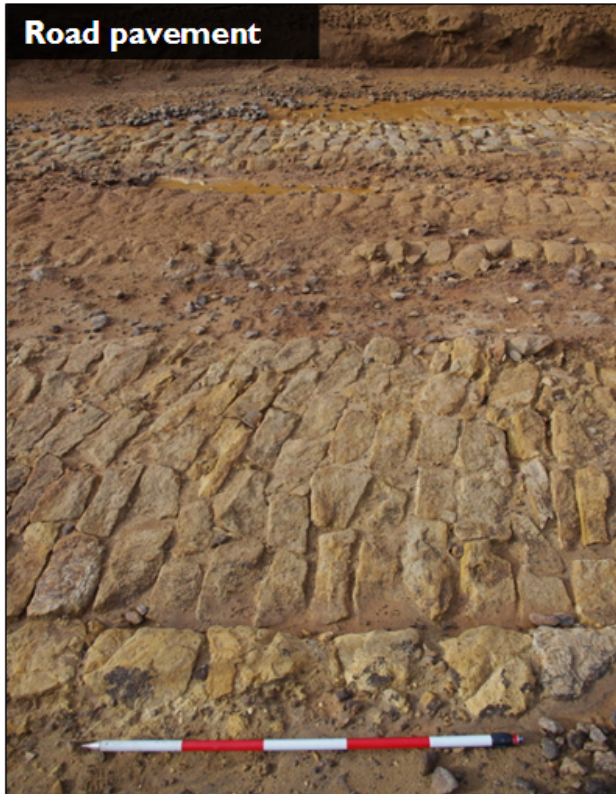
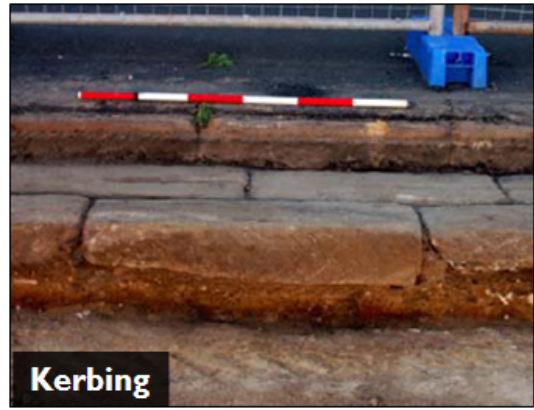
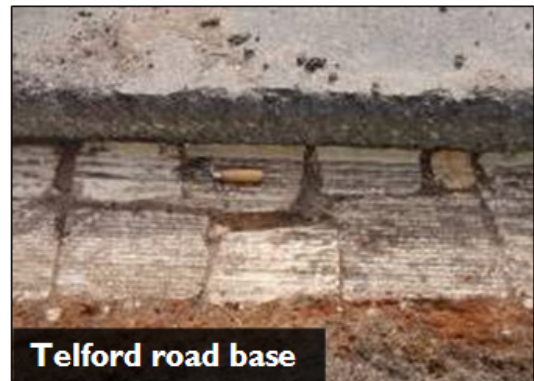
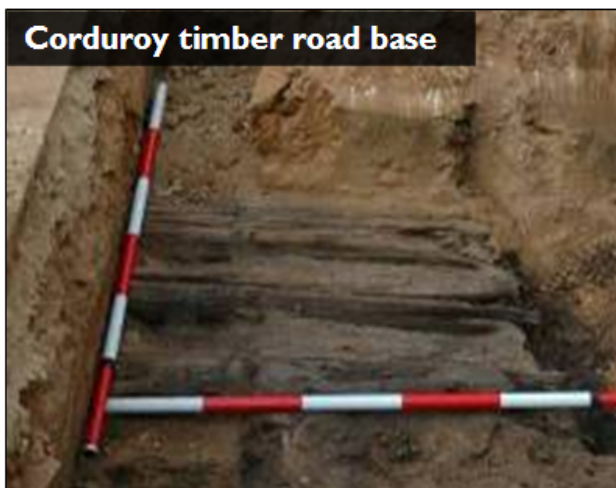
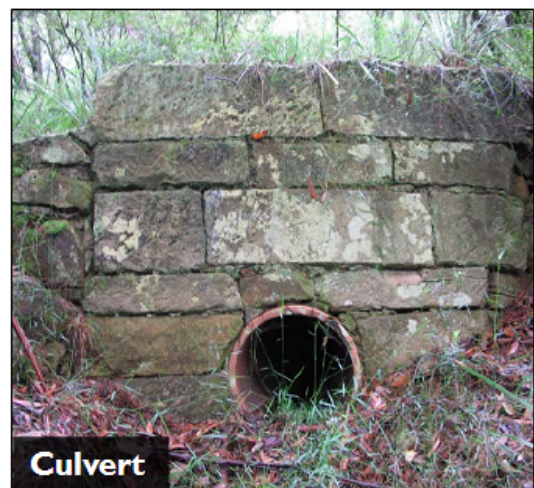
Top left hand picture continuing clockwise: Road pavement (Great Western Highway, Lawson); Sandstone kerbing and guttering (Parramatta Road, Mays Hill); Telford road (sandstone road base, Great Western Highway, Leura); Ceramic conduit and sandstone culvert headwall (Blue Mountains, NSW); Corduroy road (timber road base, Entrance Road, Wamberai).

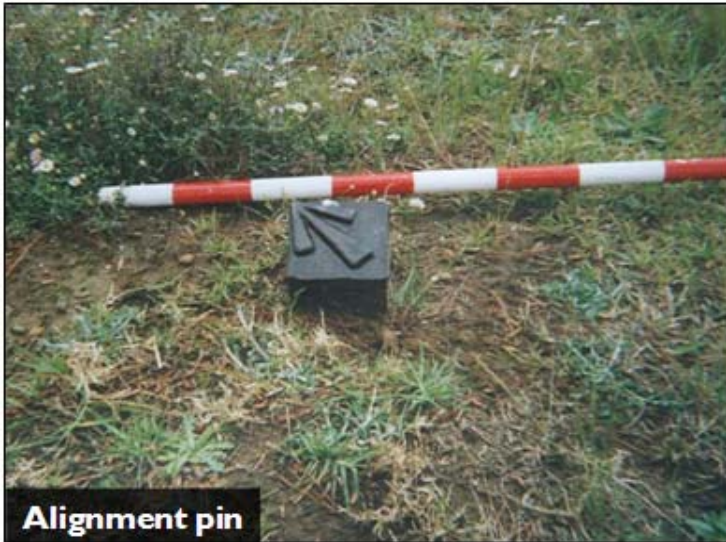
Alignment pin

Top left hand corner continuing clockwise: Alignment Pin (Great Western Highway, Wentworth Falls); Survey tree (MR7, Albury); Survey tree (Kidman Way, Darlington Point, Murrumbidgee); Survey tree (Cobb Highway, Deniliquin); Milestone (Great Western Highway, Kingswood, Penrith); Alignment Stone (near Guntawong Road, Riverstone). Please note survey marks may have additional statutory protection under the *Surveying and Spatial Information Act 2002*.

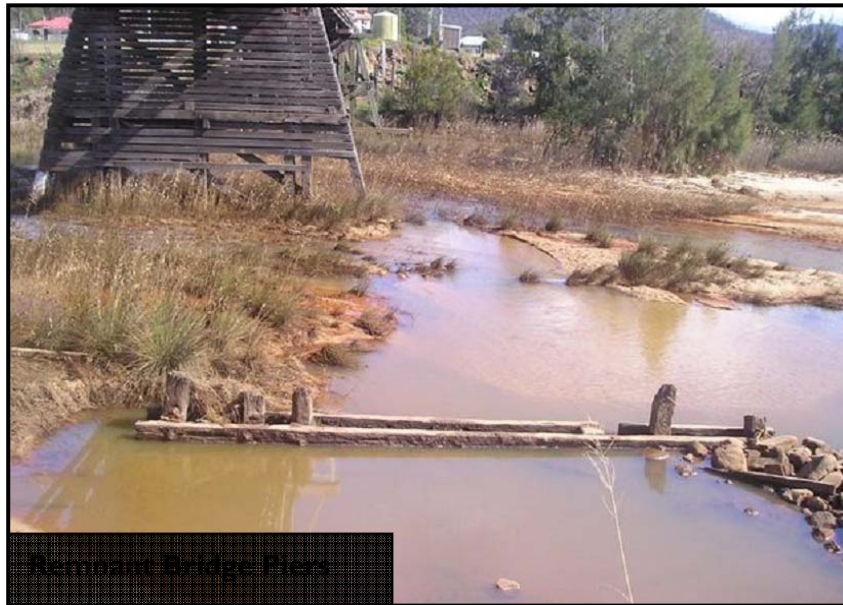
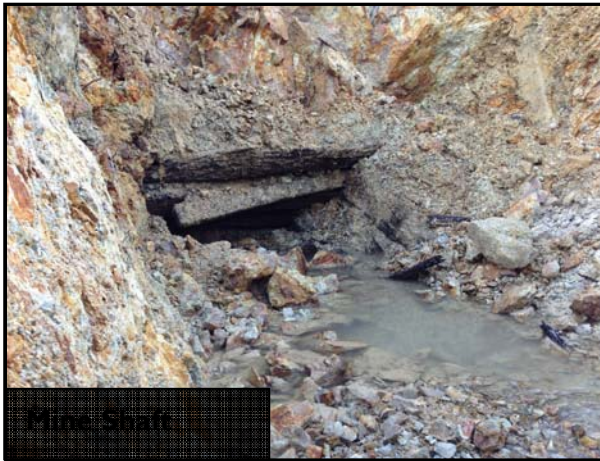
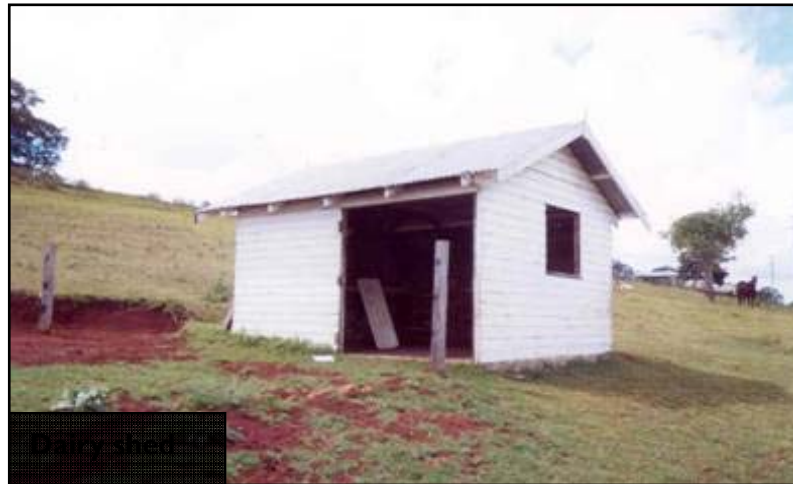
Top left hand corner continuing clockwise: Remnant bridge piers (Putty Road, Bulga); Wooden boundary fence (Campbelltown Road, Denham Court); Dairy shed (Ballina); Golden Arrow Mine Shaft.

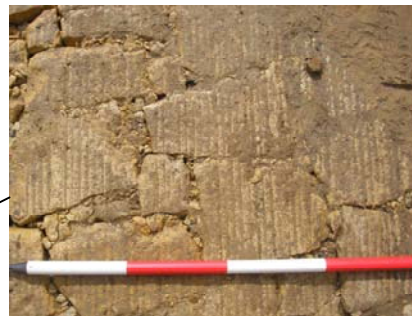
Figure 2: Close up detail of the sandstone surface showing material type, formation and construction detail. This is essential for establishing date of the feature.

It is important to take a general photograph (Figure 1) to convey the location and setting of the item. This will add much value to the subsequent detailed photographs also required (Figure 2).

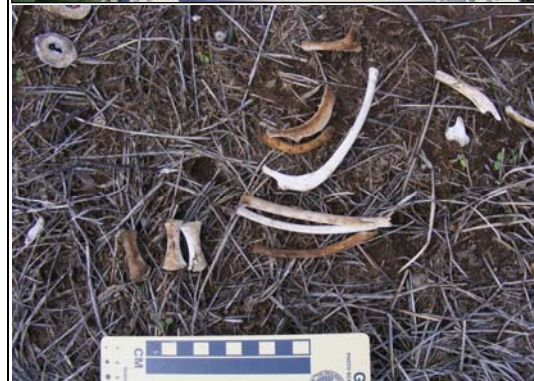
Figure 2: Disarticulated bones that require assessment to determine species.

Where it is not 'obvious' that the bones are human (in the majority of cases, illustrated by Figure 2), specialist assessment is required to establish the species of the bones. Photographs of the bones can assist this assessment if they are clear and taken in accordance with guidance provided in Appendix C. Good photographs often result in the bones being identified by a specialist without requiring a site visit; noting they are nearly always non-human. In these cases, non-human skeletal remains must be treated like any other unexpected archaeological find.

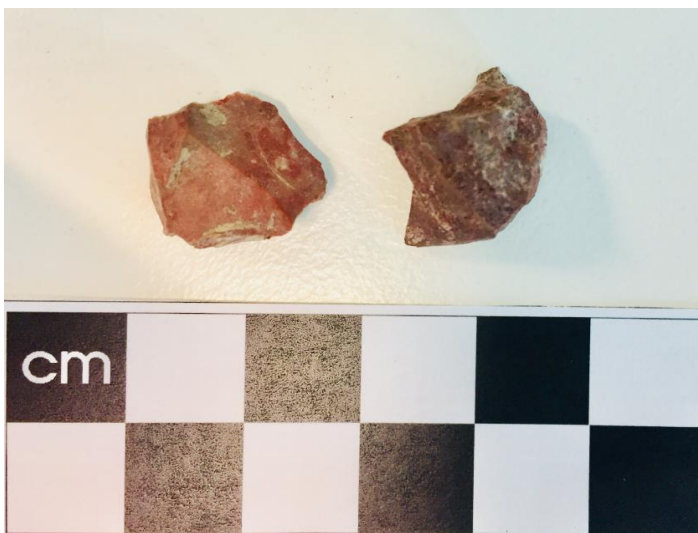
Figure 6-1 Red silcrete artefacts located at Artarmon Park artefact scatter

Figure 6-1 to Figure 6-4 show artefacts found at Artarmon Park PAD.

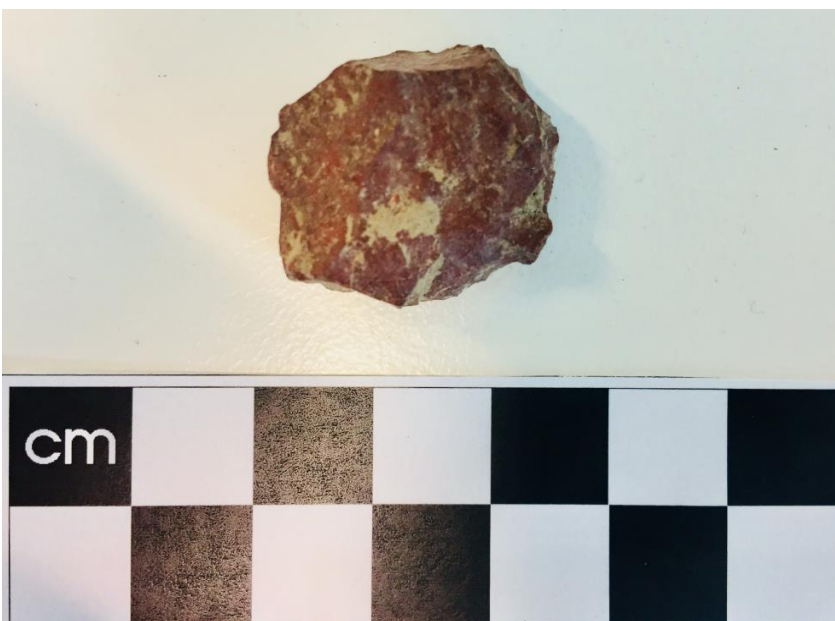
Figure 6-4 Red silcrete core located at Artarmon Park artefact scatter

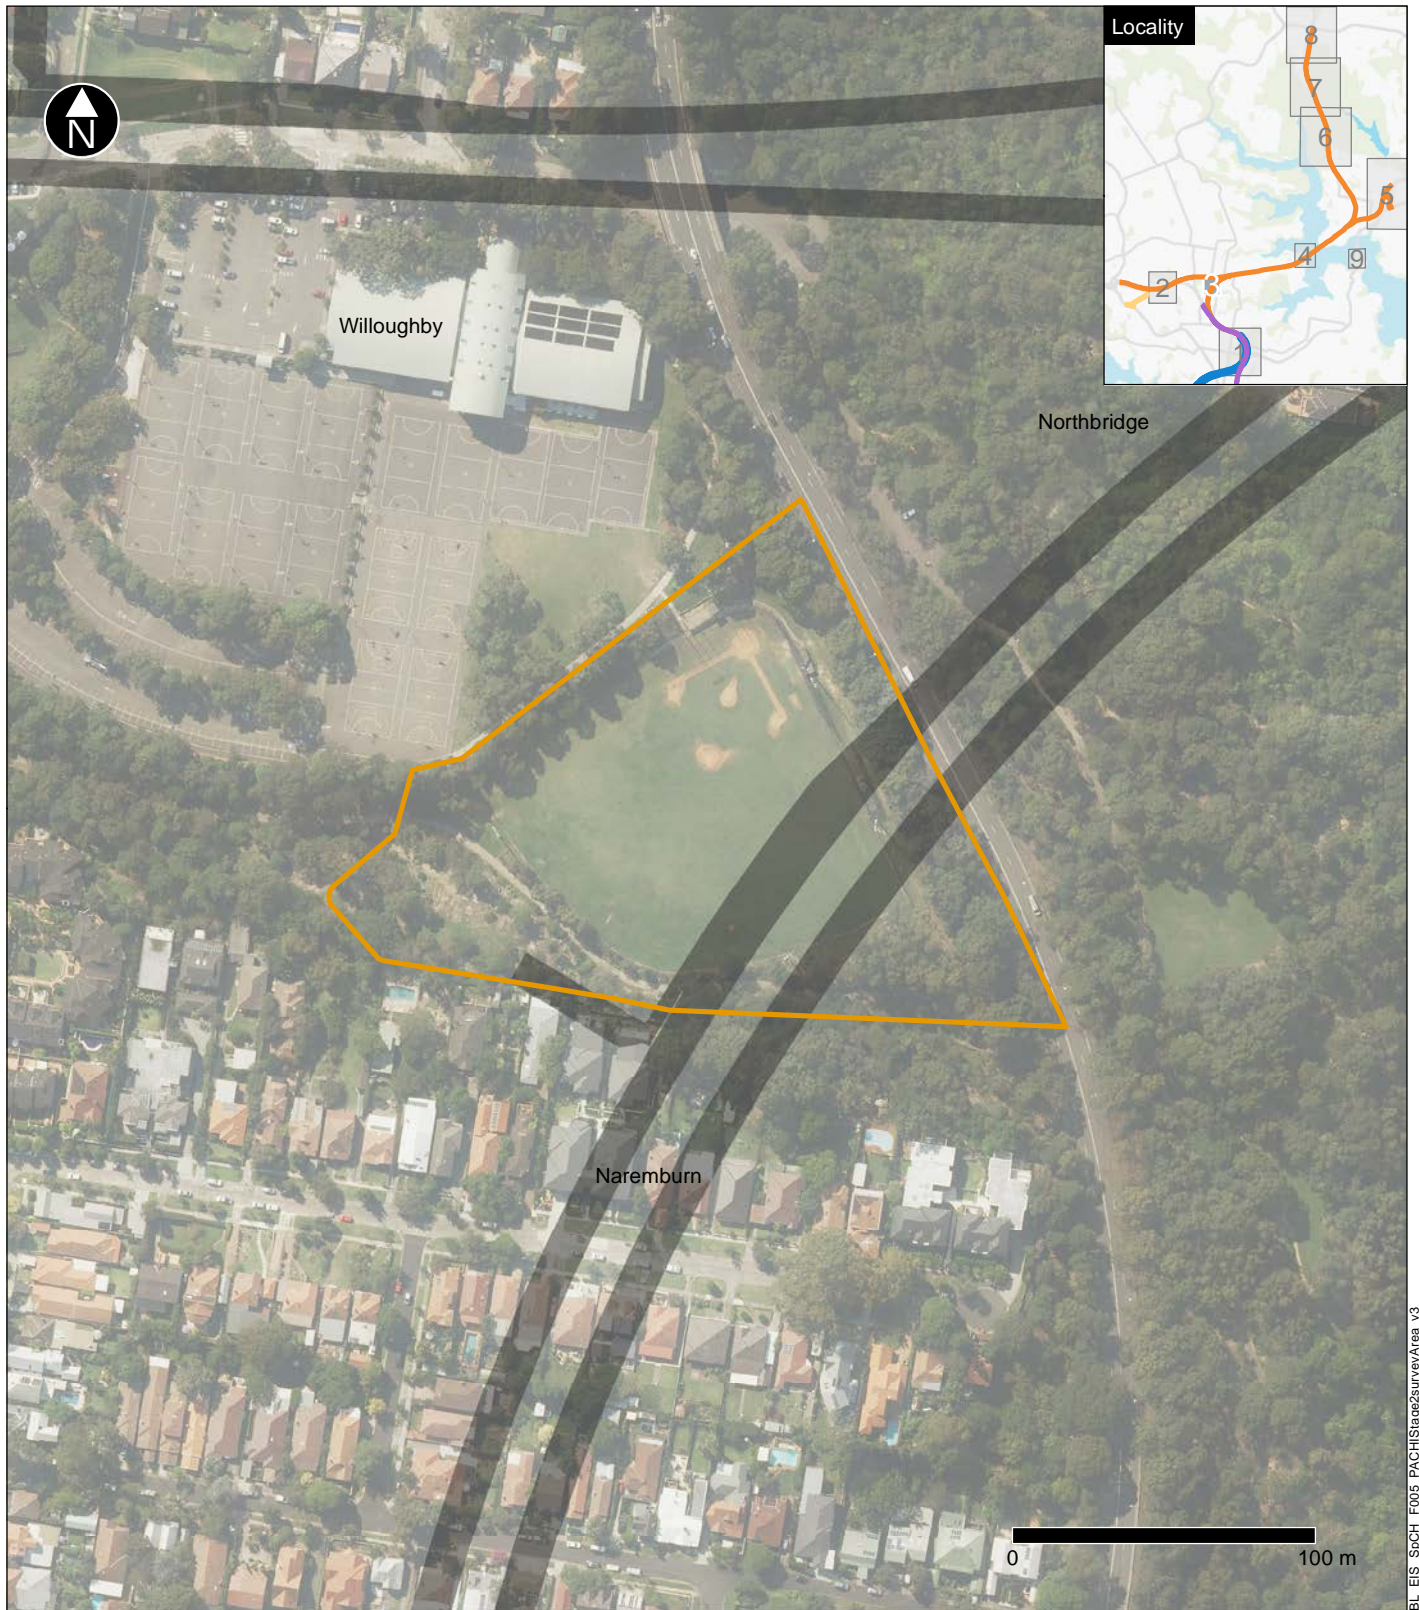
Figure A-2 Archaeological survey areas

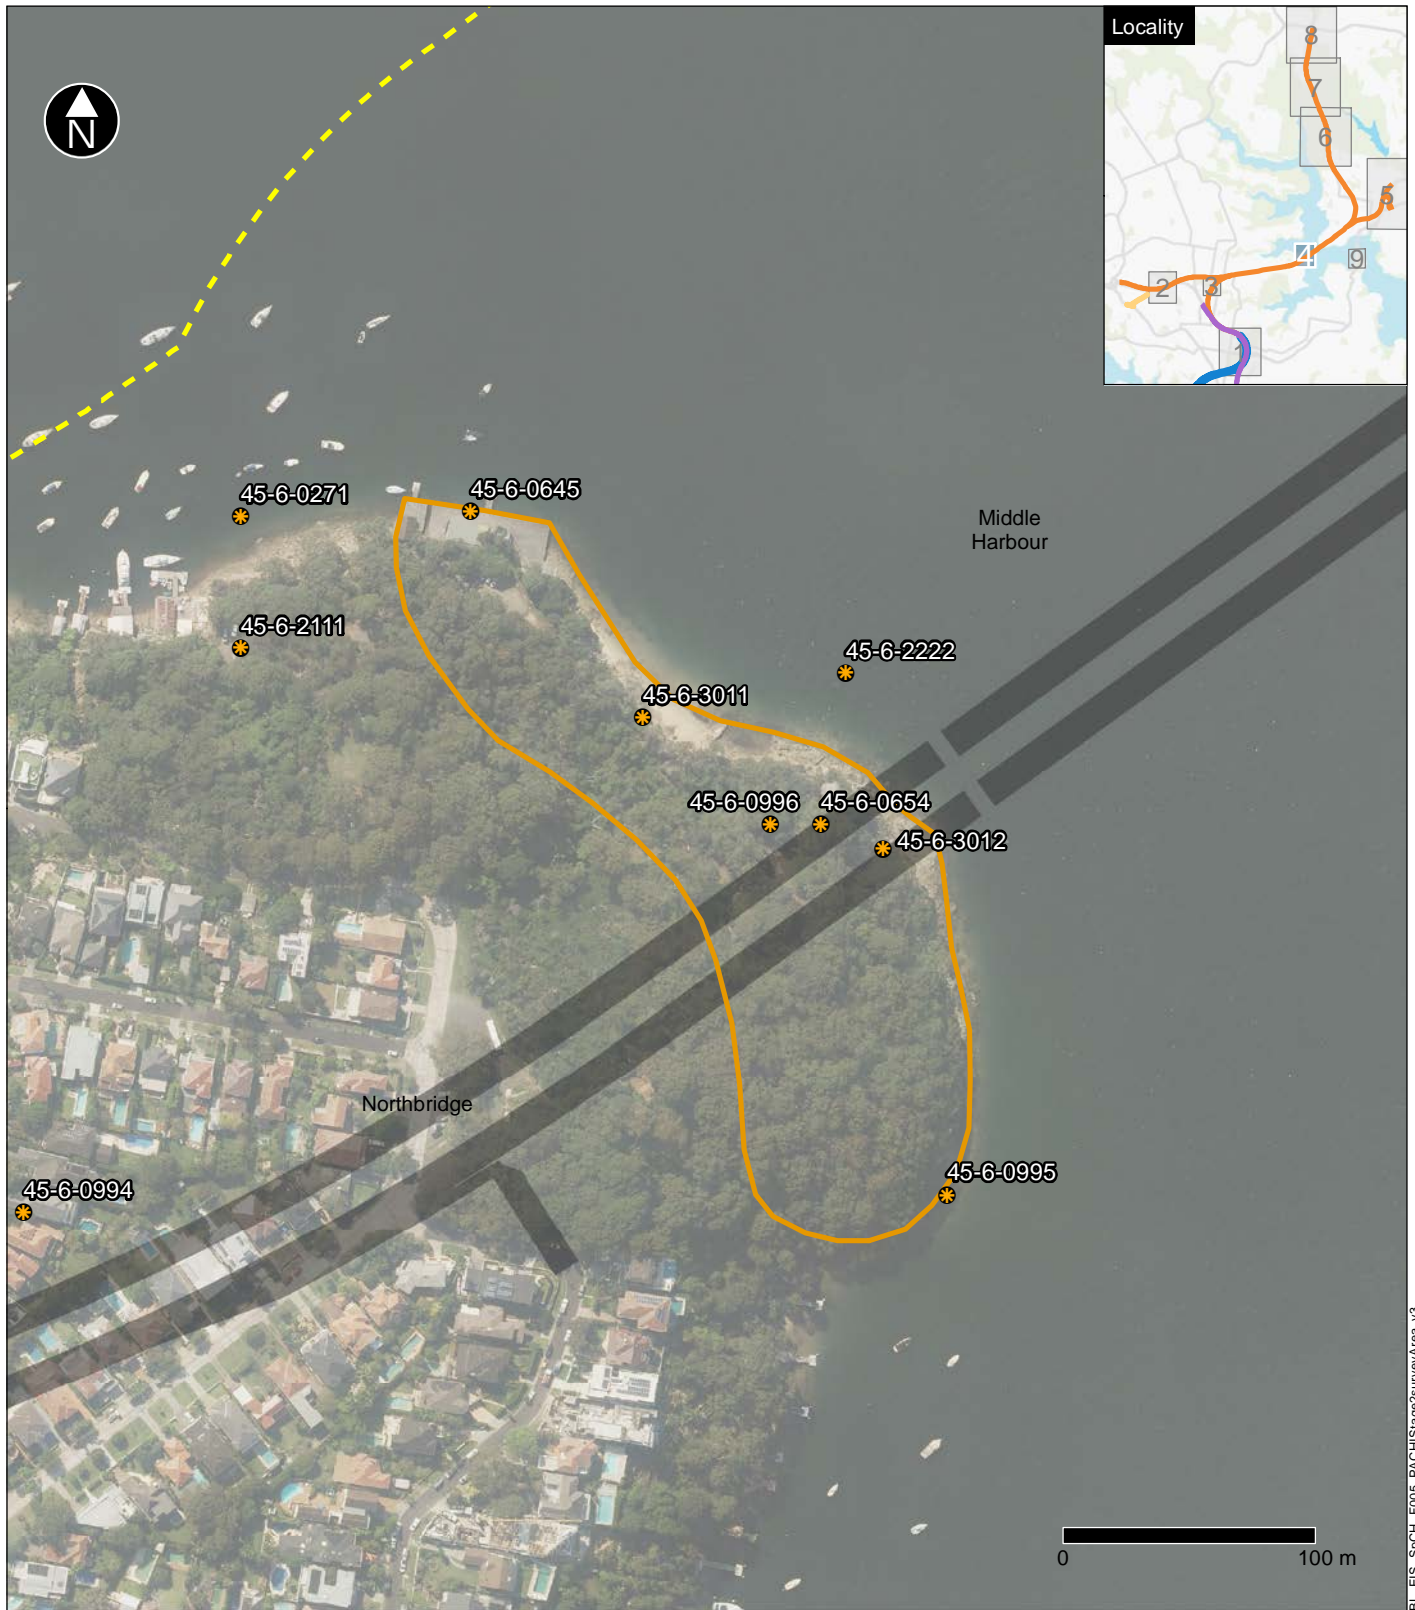
Figure A-3 Archaeological survey areas

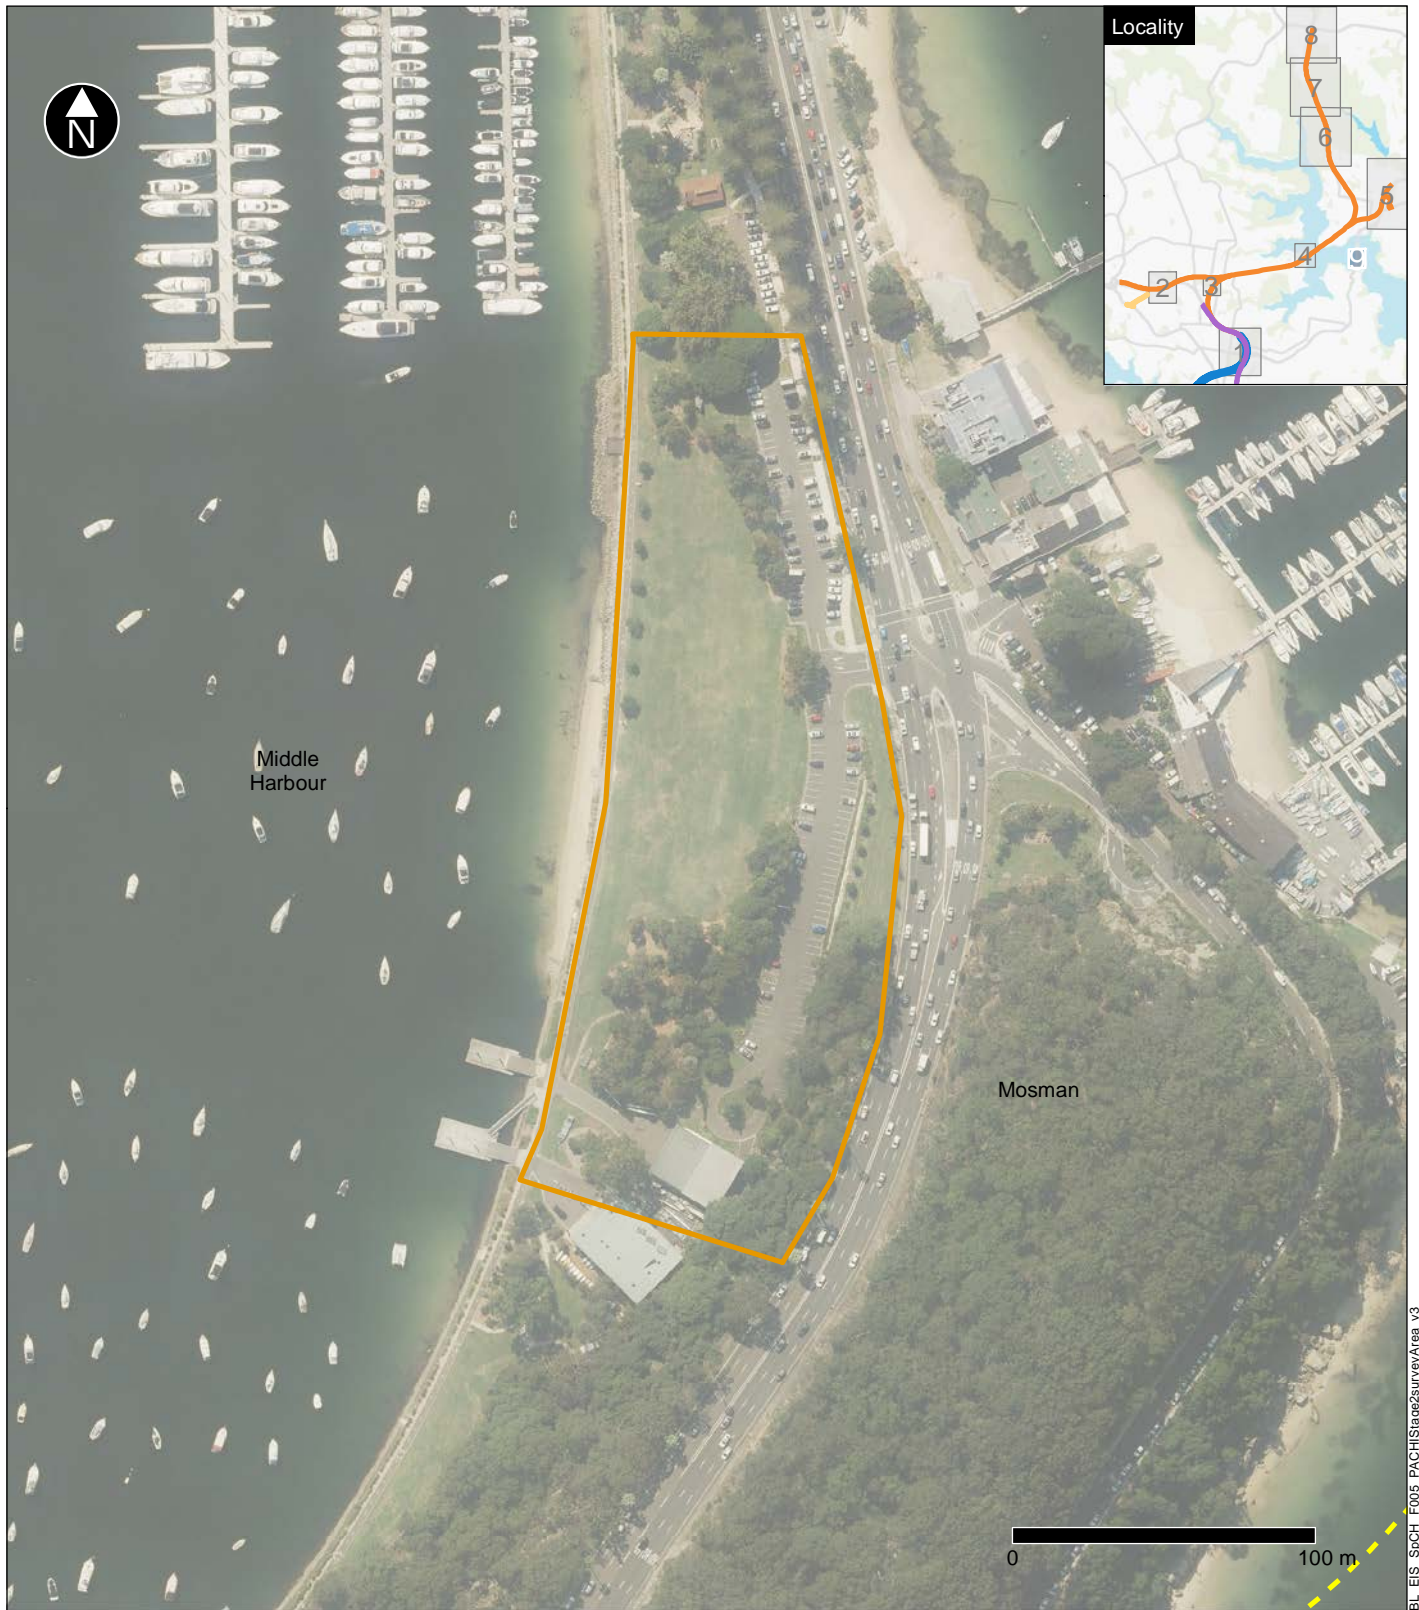
Figure A-8 Archaeological survey areas

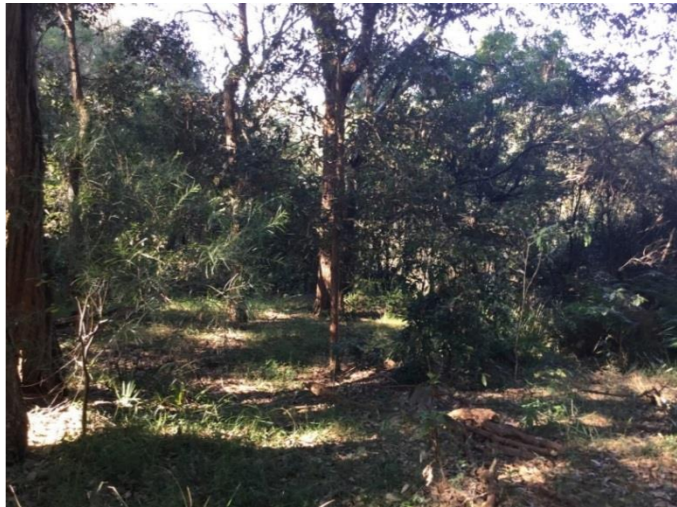
<p>Photo by A Costello 17/5/17 looking south – S Timothy in foreground</p>
North Shore	17/5/17	Artarmon Park (Parkes Road)	PAD	Selina Timothy (Metro LALC) Mark Lester (RMS)	The sensitivity of Artarmon Park is associated with the sandstone outcrops and potential for archaeological deposit. Generally, the western end and eastern extreme ends have been heavily modified and there are no Aboriginal heritage constraints Where the soils and rock formations have been retained there is moderate potential for engravings, grinding grooves or Aboriginal artefacts. Difficult to determine if area has been modified/disturbed through landscaping/freeway construction. Further research, archival photographs would assist.

<p>Photo by A Costello 17/5/17 looking east across PAD and thick bush</p>

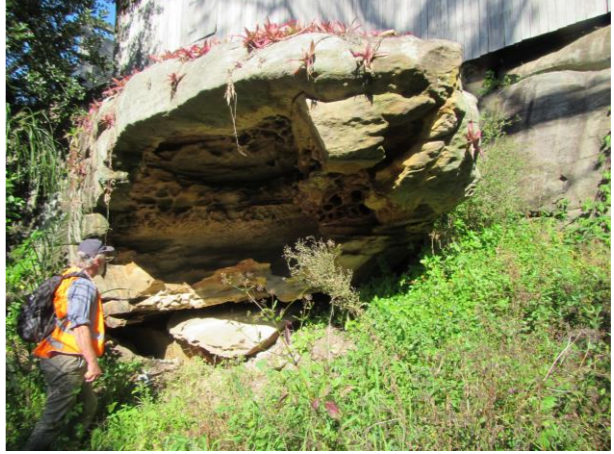
<p>Photo by A Costello 17/5/17 showing A Roberts looking at rock shelter above bike track at Flat Rock Creek Gully</p>
Middle Harbour	17/5/17	Clive Park	N/A	Selina Timothy (Metro LALC) Mark Lester (RMS)	<p>Clive Park is a high Aboriginal heritage sensitivity on the foreshore and littoral zone with highly significant Aboriginal cultural heritage sites close to the water. High risk is associated with impacts through shore-wash and vibration during construction.</p>

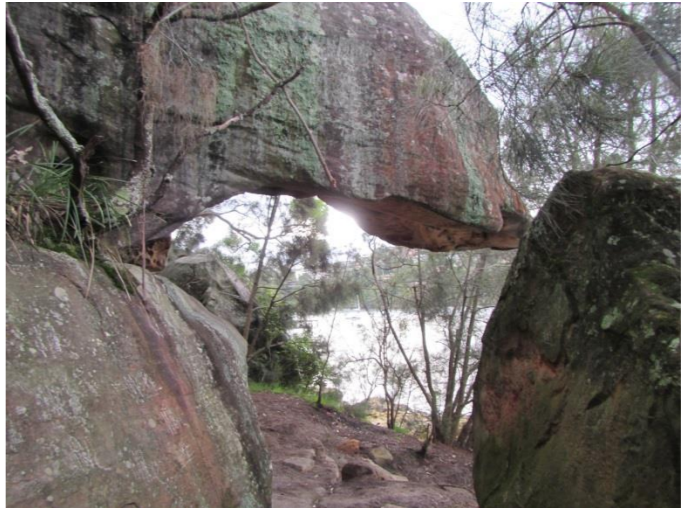
<p>Photo by A Costello 17/5/17 looking west across rock shelter</p>

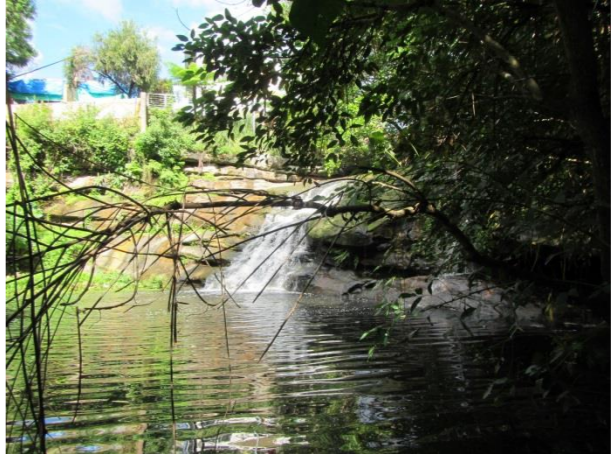
<p>Photo by A Costello 18/5/17 photo across creek showing waterfall</p>

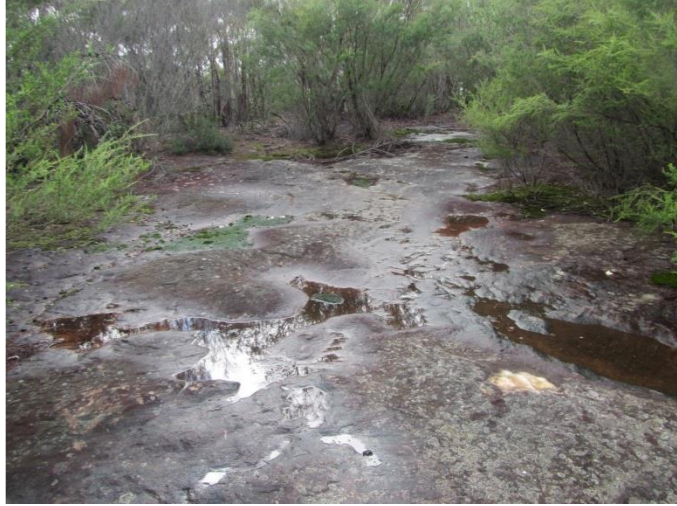
<p>Photo by A Costello 18/5/17 looking across engraving site</p>

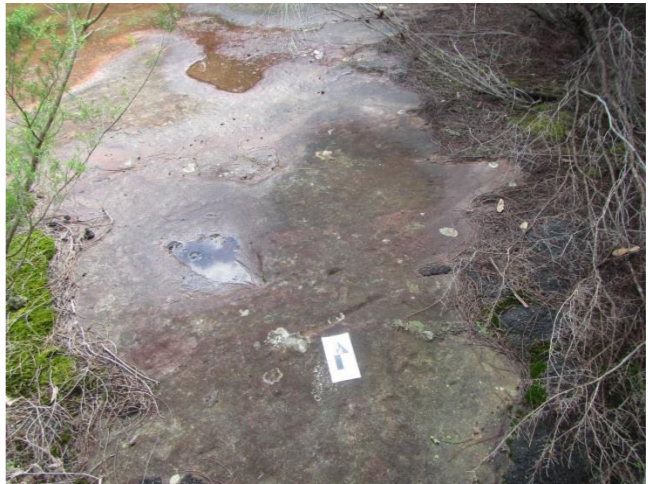
<p>Photo by A Costello 18/5/17 showing engraving site at AHIMS 45-6-0655</p>

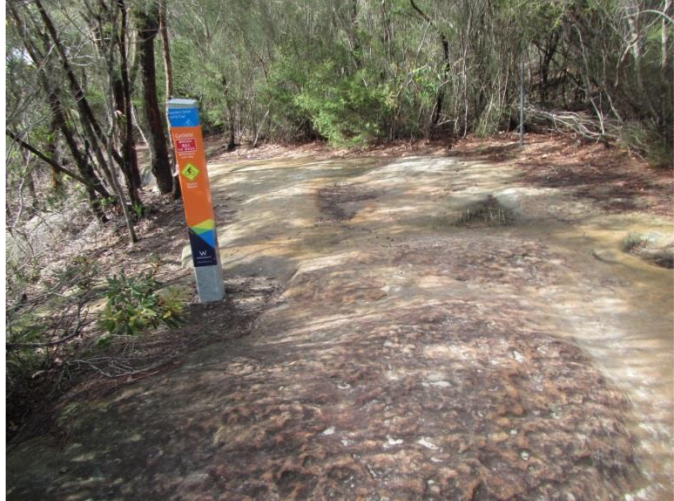
<p>Photo by A Costello 18/5/17 looking across sandstone bedrock</p>
Wakehurst Parkway	18/5/17 & 1/6/17	Warringah Road End	N/A	Mark Lester (RMS)	Some areas are heavily modified and there are no Aboriginal heritage constraints - where the actual roadway and verges are, where the development of the Northern beaches hospital has modified the landscape and where urban and industrial developments have removed the potential for Aboriginal heritage to be present.

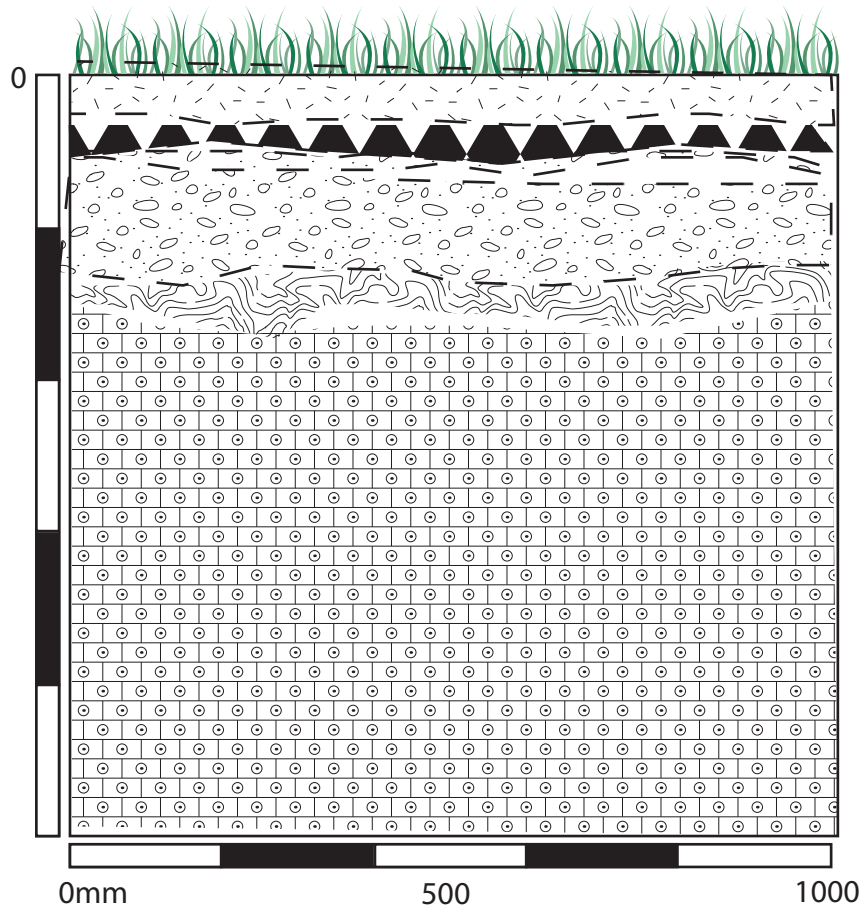
Attachment F Artarmon Park PAD Stratigraphic Profile

1	0-50mm: Silty loose humic soil. Munsell: 10 YR 5/2.
2	50-75mm: Thin layer of decomposing foliage
3	75-275mm: Compact grey/brown silt. Munsell: 10 YR 5/2.
4	275-300mm: Compact yellow orange clay. Munsell: 10YR 6/4.

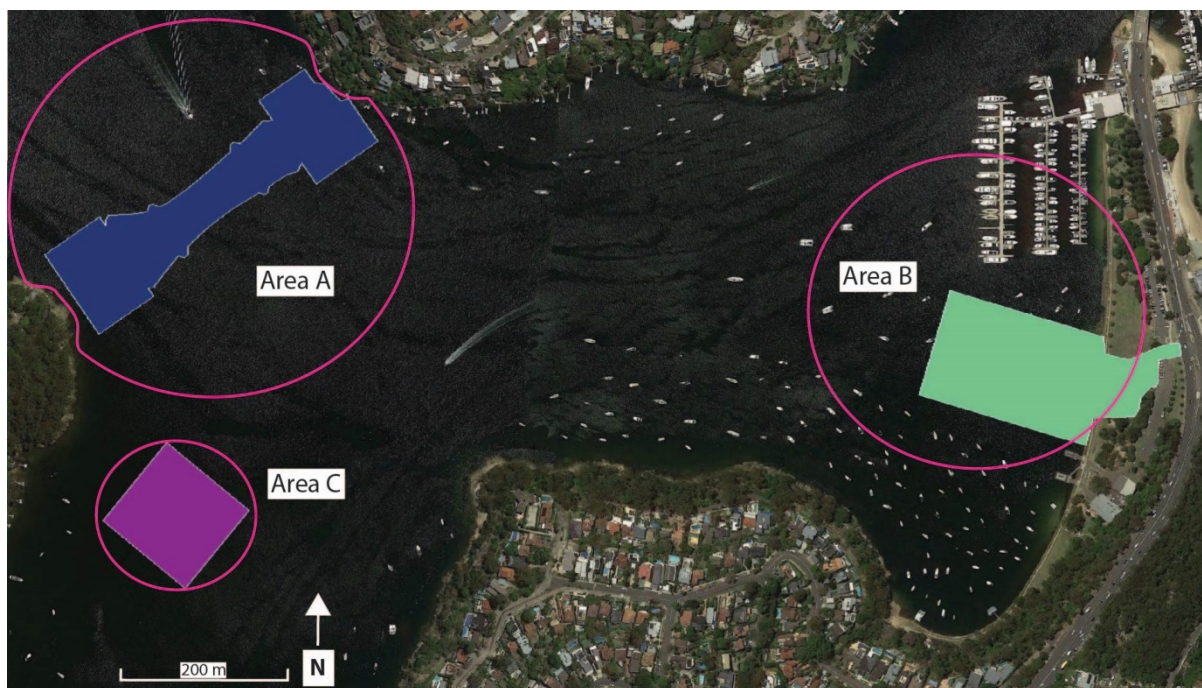
Figure 1: Study area separated into Area A – Northbridge to Seaforth; Area B – Pearl Bay, including the western side of The Spit and Area C at the entrance to Long Bay (Base image: Google Earth)

The study area for this potential submerged Aboriginal archaeological sites assessment is separated into three areas. These areas have been defined according to where construction activities related to the project will occur over water or over former bed of the harbour (Figure 1).

The study areas primarily cover the bed of the harbour but also include adequate buffers to account for areas of the foreshore that have been reclaimed as part of previous development. Area B is confined to the eastern portion of the proposed disturbance footprint for the project (see Figure 1).

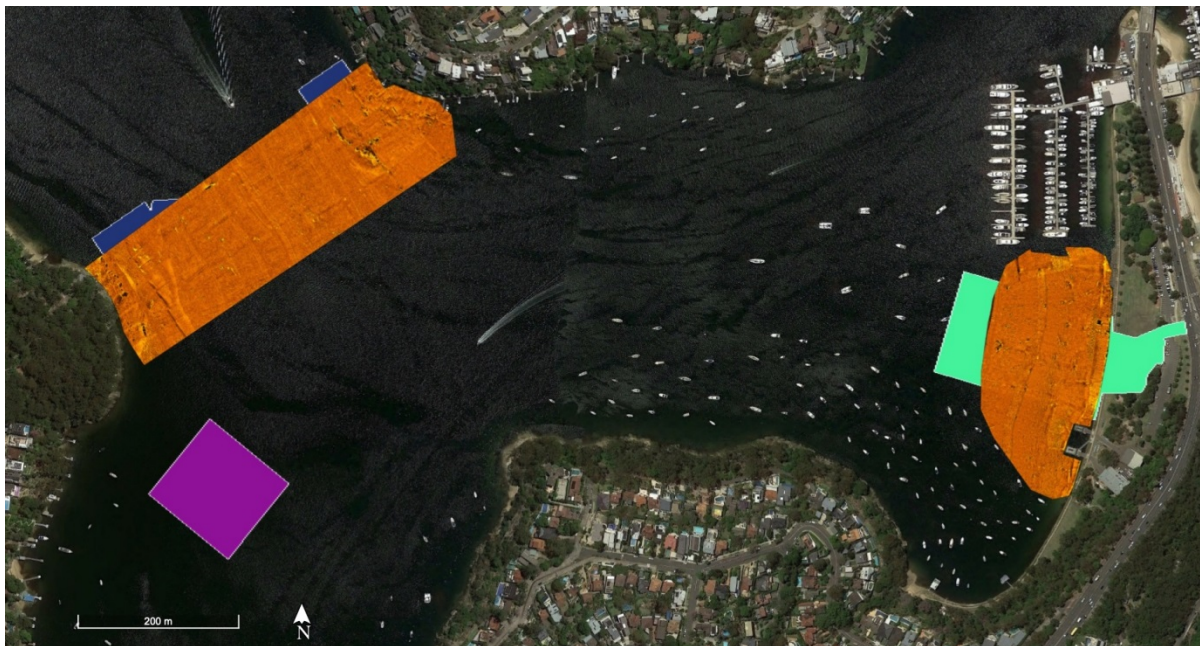
Figure 2: Extent of side scan sonar survey in relation to proposed extent of disturbance footprint (in solid blue and solid orange) (Base image: Google Earth). Side scan sonar data provided as .shp files by Podnar, A. Geotechnical Engineer, Douglas Partners, 5 December 2017.

Apart from identifying anomalies such as shipwrecks, side scan sonar can identify natural features and landform units of Aboriginal archaeological potential, such as rock outcrops or protruding ledges. These could once have been rock overhangs on the slopes of a hill and as such the floors of such features may contain physical evidence of Aboriginal occupation (see Section 5.4 for a discussion of the Aboriginal archaeological predictive model devised for the study area).

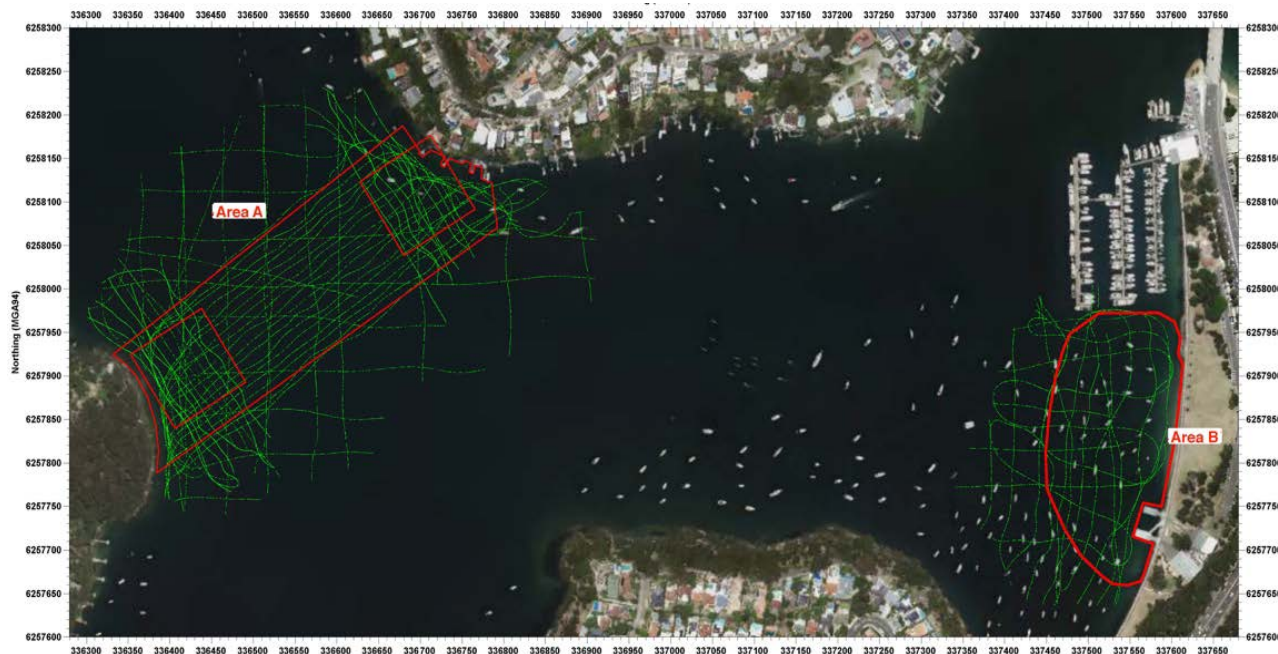
Figure 3 Vessel track plot showing extent of seismic reflection survey in Areas A and B (Earth Technology Solution Pty Ltd, July 2017a: Figure MH 4). The green lines show where the survey collected the data. The red boxes show the area of interest around the proposed cofferdams.

The initial survey was carried out in May and June 2017 with the objective to ‘map subsurface layers across the site to assess geological conditions for tunnel alignment assessment including the depth to top of rock and significant sediment layers, and provide sufficient spatial coverage to allow production of contour plans of these layers’ (Figure 3) (Earth Technology Solution, 2017a). An additional survey was carried out in late October 2017 along the tunnel alignment next to Seaforth (Marine and Earth Sciences, 2017).

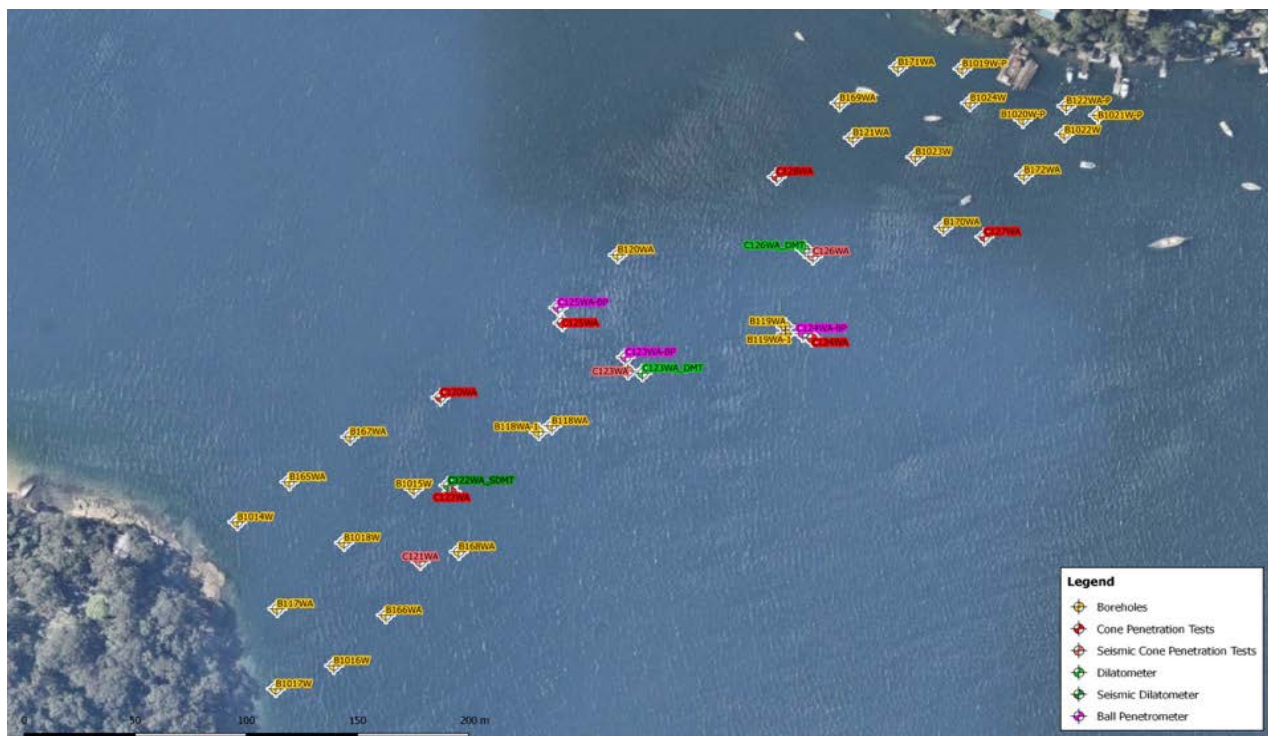
Figure 4 Drilling sites within Area A (Golder Associates and Douglas Partners, October 2017 Test Locations; Western Harbour Tunnel and Beaches Link; Middle Harbour. Drawing No. 2, Revision 1, drawn 19 October 2017).

Geotechnical drilling took place within Area A throughout May and June 2017. A variety of techniques were deployed amounting to 74 locations where drilling took place (Figure 4). The data collected from the drilling is informative on the presence or otherwise of residual (ie pre-inundation) soil deposits which may contain evidence of Pleistocene Aboriginal occupation.

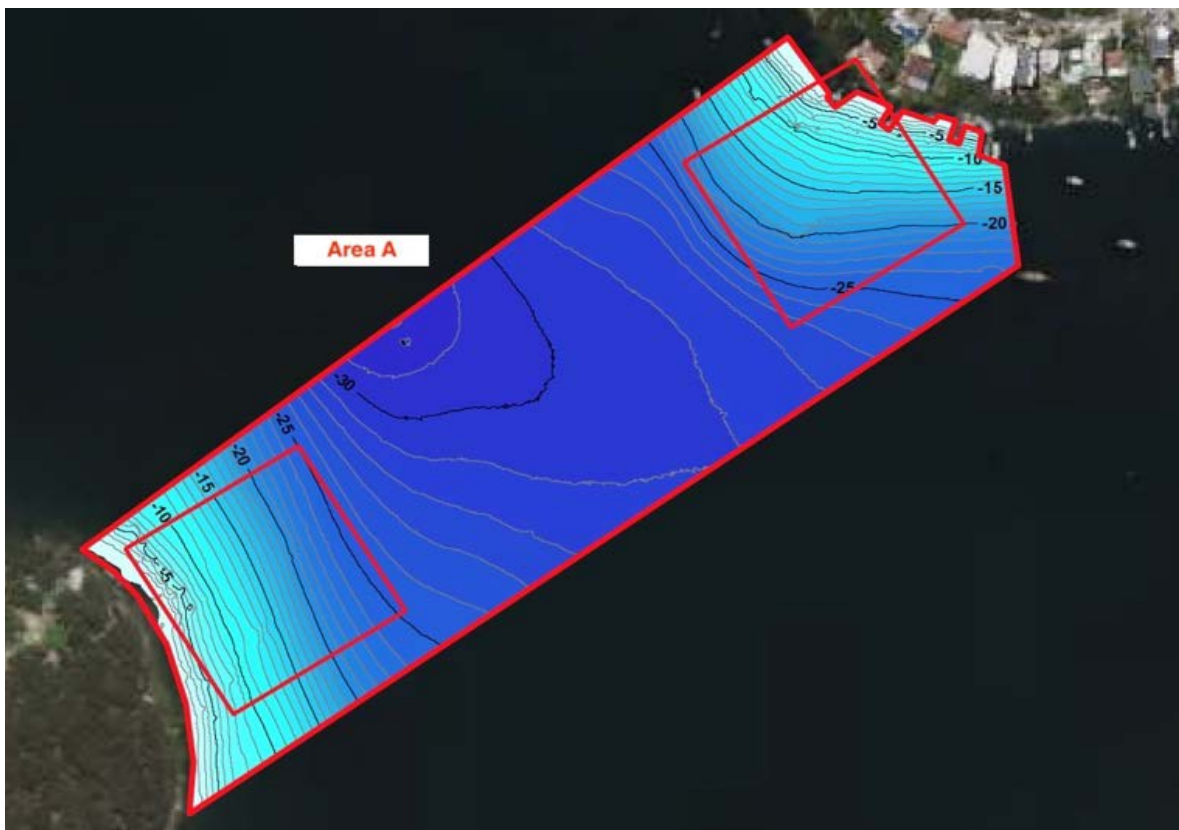
Figure 7: Bathymetric contour plan within Area A between Clive Park at Northbridge and Seaforth Bluff at Seaforth, Middle Harbour. The red boxes show the area of interest around the proposed cofferdams. Depths are in metres AHD (Earth Technology Solution Pty Ltd, July 2017a: Figure MH2)

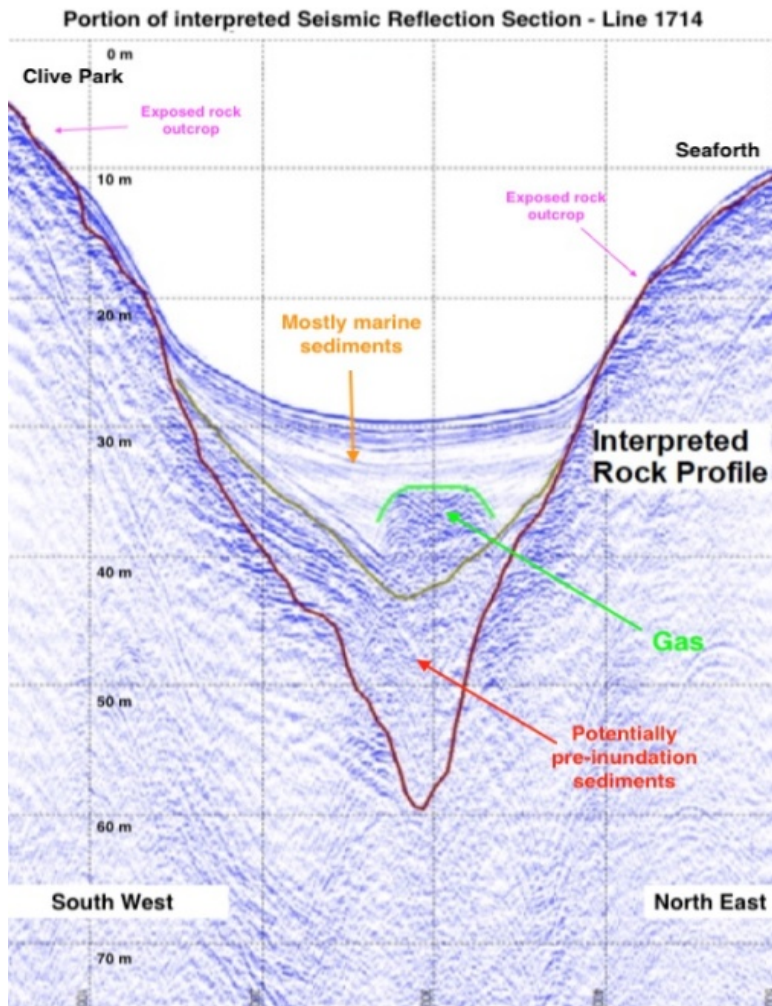
Figure 10: Seismic reflection profiles – Line 1714 (Earth Technology Solution, 2017a). The pink arrows point to locations on the profile where there is little or no sediment overlaying the sandstone bedrock and this corresponds to the areas where rock outcrops and ledges are protruding from the bed of the harbour (see Figure 8 and Figure 12). Interpretation of the sediments on the figure provided by authors of this report by correlating borehole data..
