Beaches Link and Gore Hill Freeway Connection

Technical working paper: Aboriginal cultural heritage assessment report

December 2020

Jacobs Group (Australia) Pty Ltd.

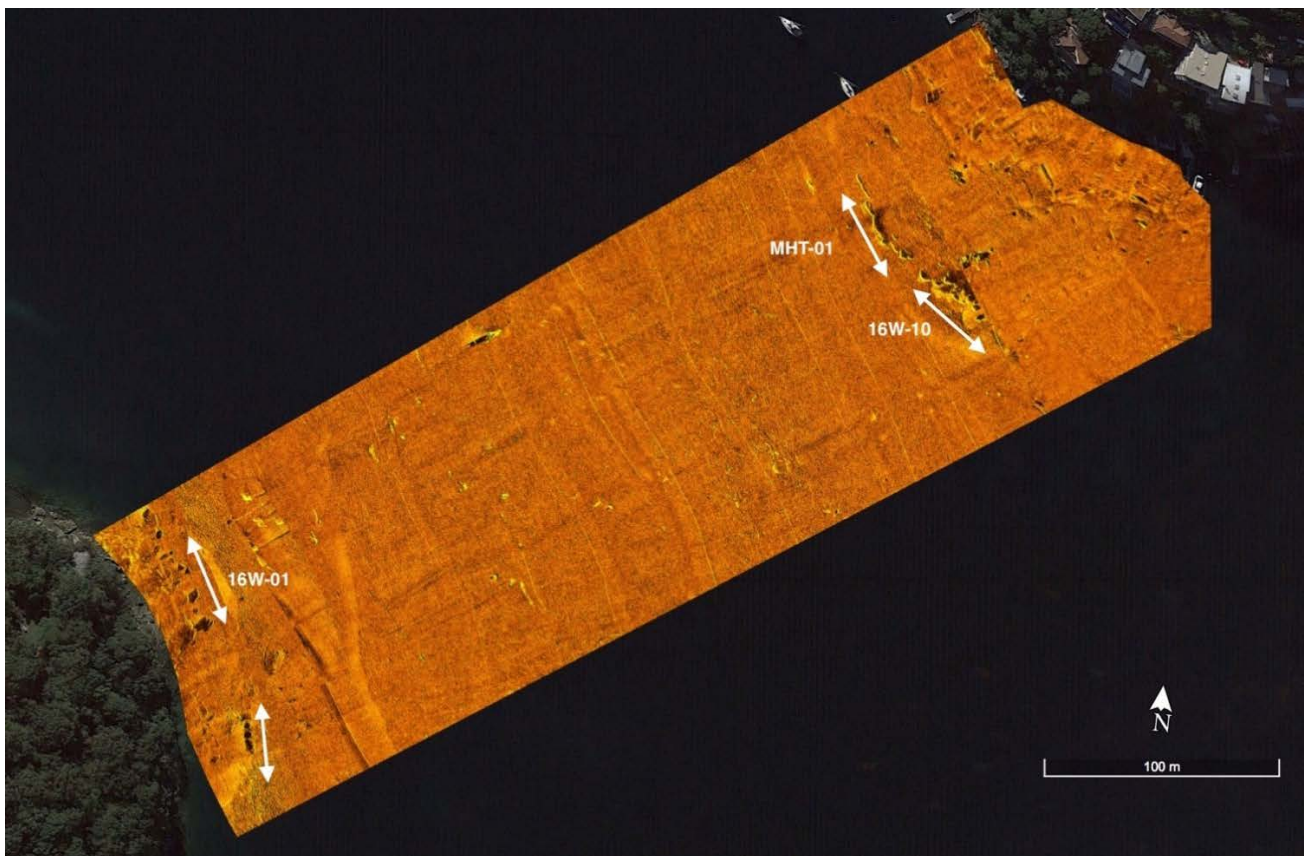
Figure 12: Side scan sonar image showing location of rock outcropping visible (blue arrows) above the marine sediments in Area A (Base image: Google Earth). Side scan sonar data provided as .shp file by Podnar, A. Geotechnical Engineer, Douglas Partners, 5 December 2017.

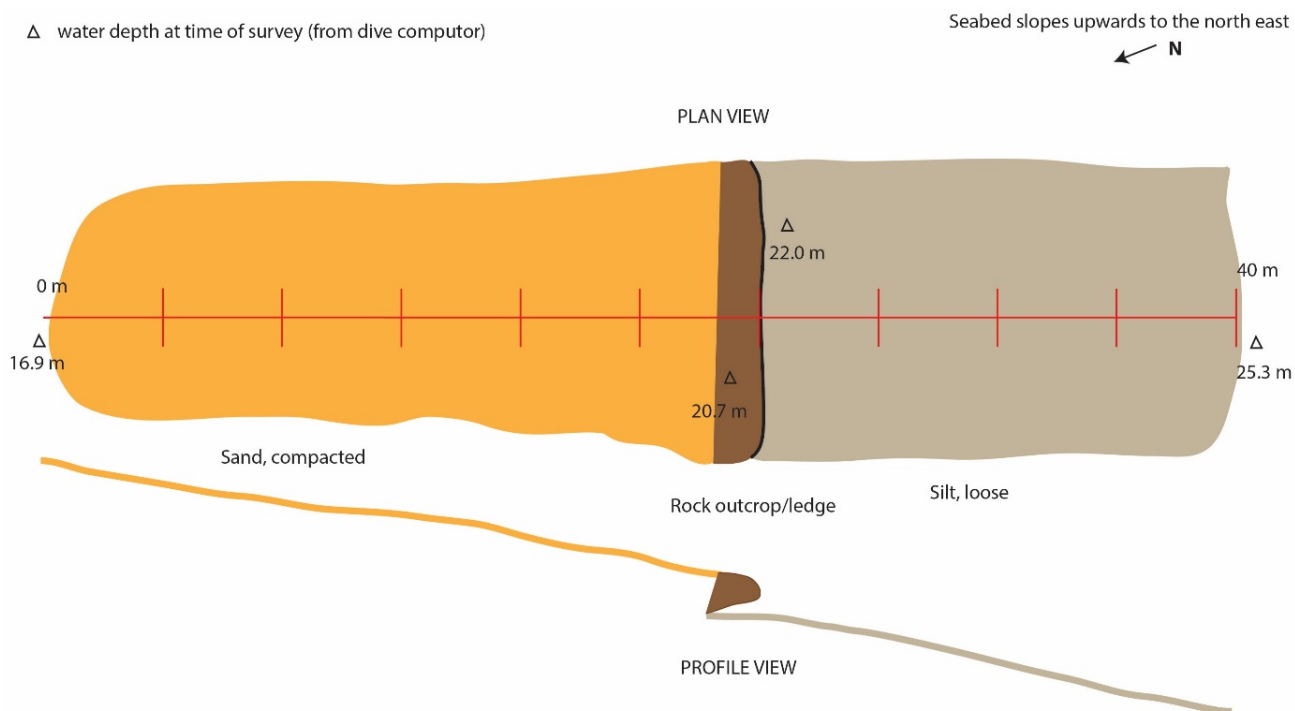
Figure 13: Plan and profile view of MHT-01 showing rock ledge and overhang

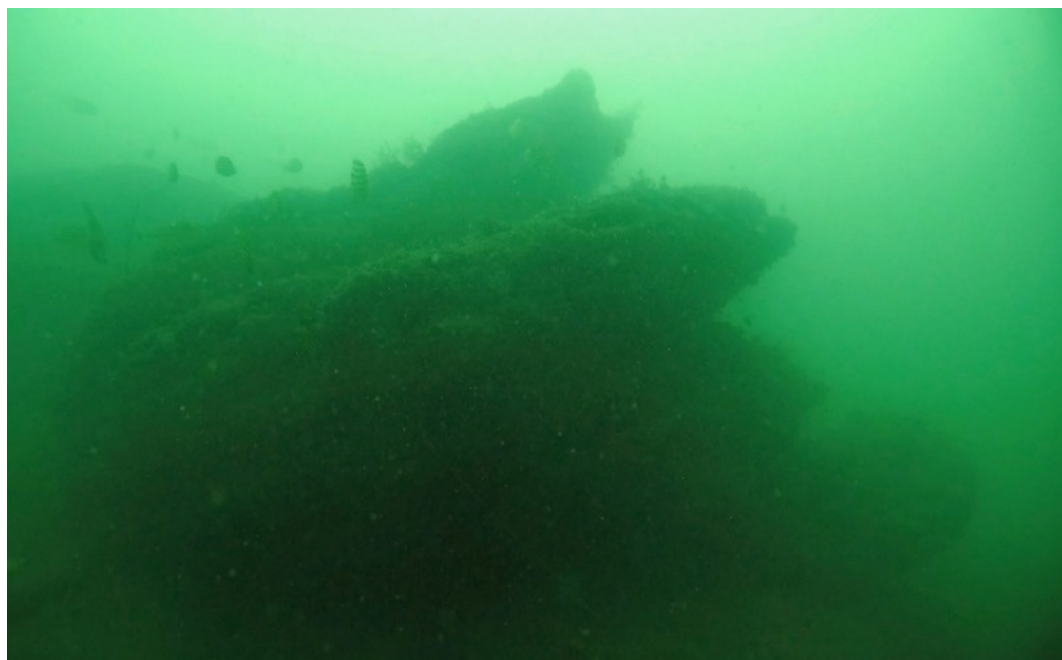
Figure 14: Sandstone outcrop observed at site 16W-10

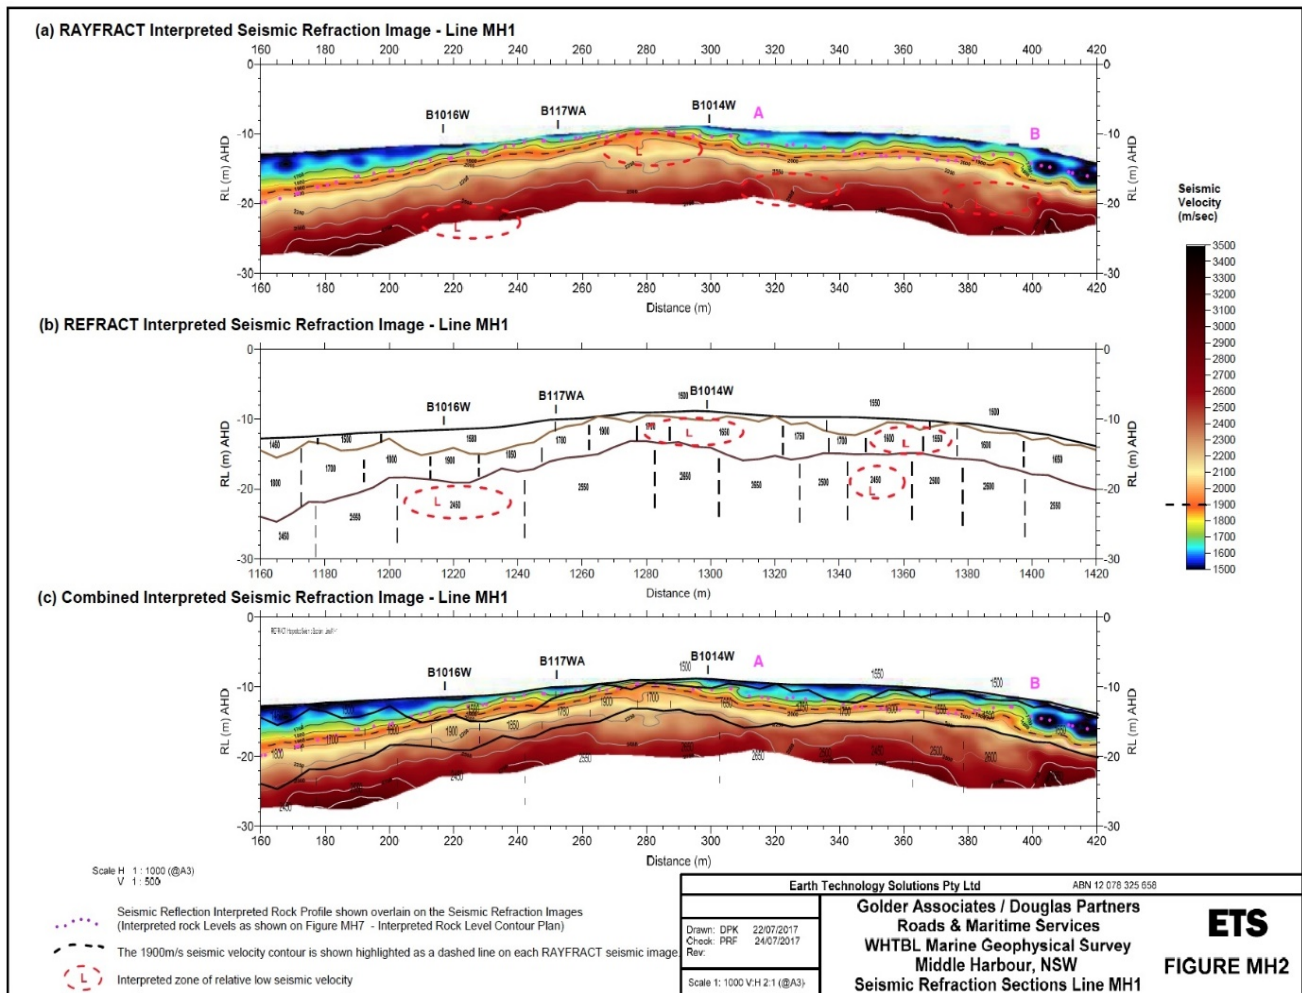
Figure 16: Seismic refraction sections line MH 1 (Earth Technology Solution, 2017b). This cross section – from the SE (left of image) to NW – taken close to Clive Park shows the varying density of bedrock (brown hues) overlain by marine sediments (blue to green hues)

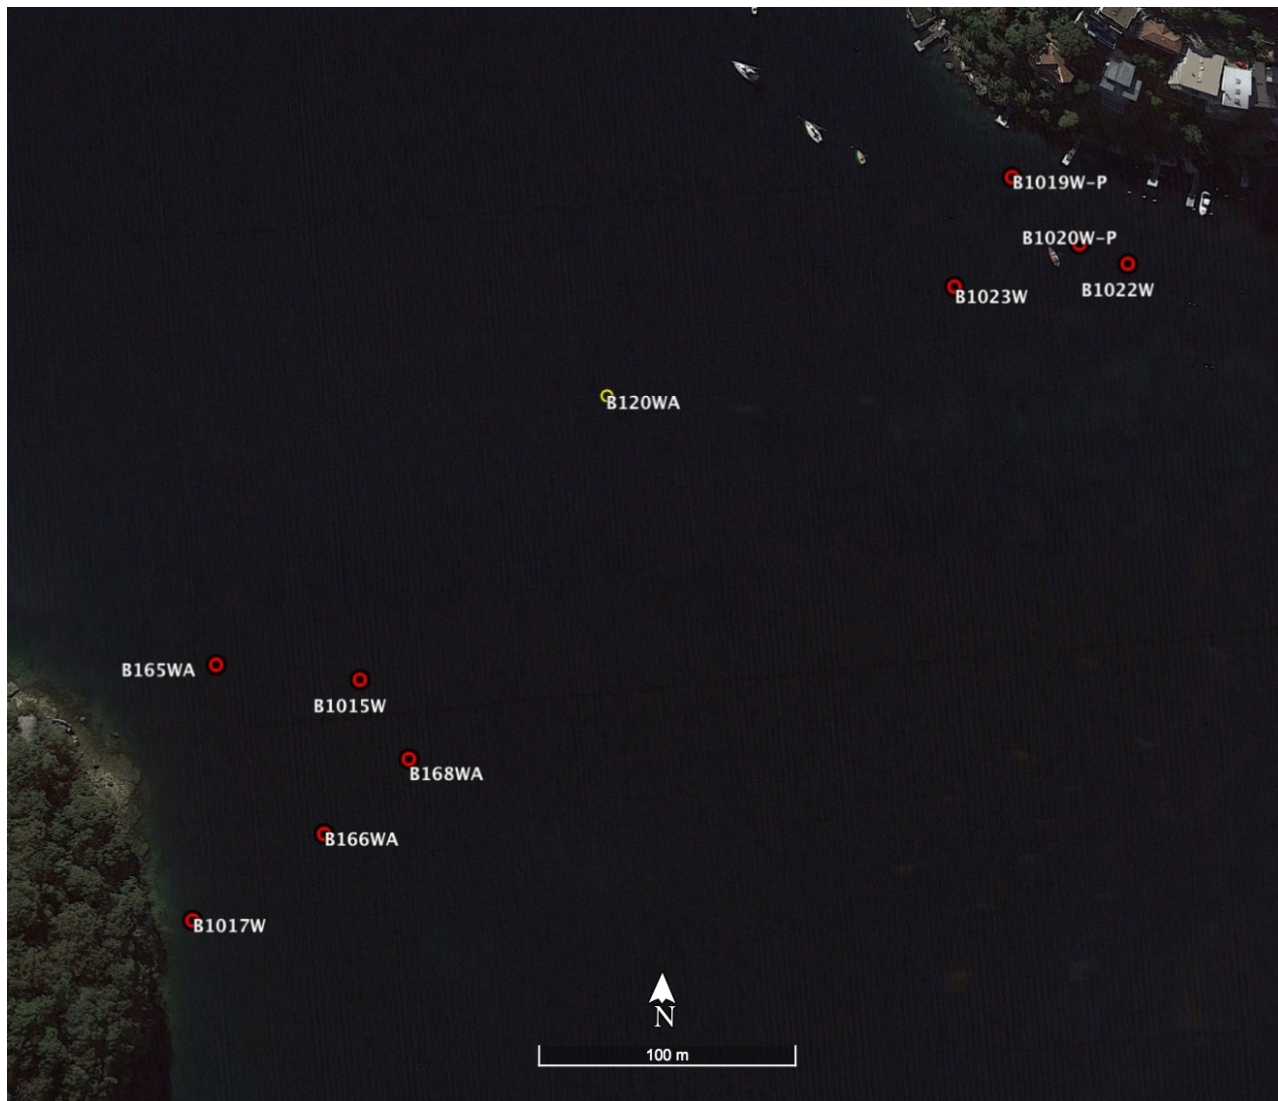
Figure 17: Location of boreholes in Area A where residual soils (red) and peat (yellow symbol) were identified. (Base image: Google Earth)

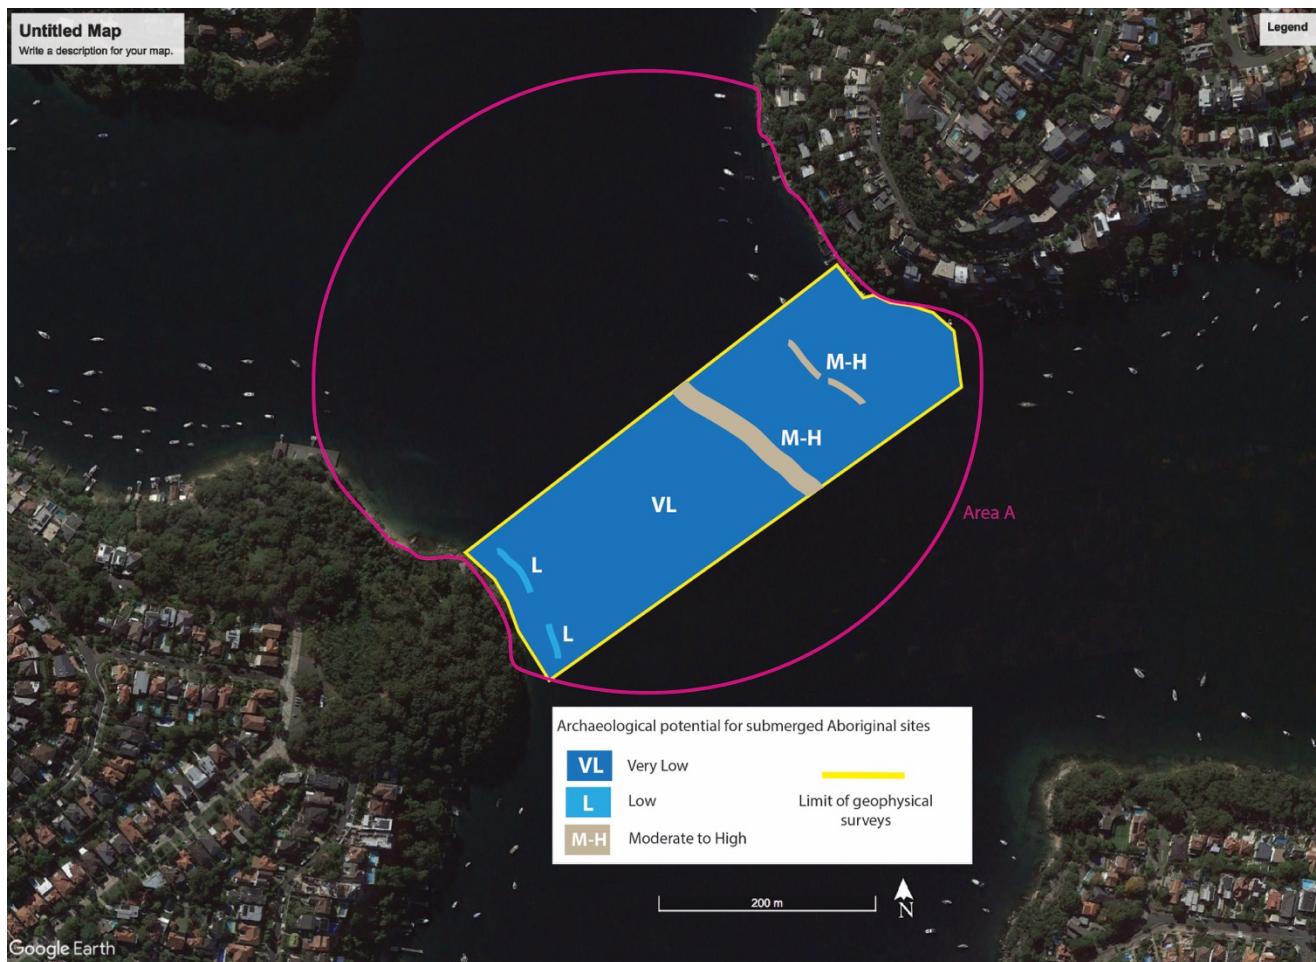
Figure 18: Likelihood for presence of Aboriginal cultural heritage associated with submerged archaeological sites

The pronounced rock outcrops at the -20 m depth interval close Seaforth Bluff are considered to have Moderate to High potential for the presence and survival of inundated rock shelters; more so than the seemingly submerged smaller rock overhangs closer to Clive Park which have been assessed as having Low potential (Figure 18 and Table 5). At 30 metres below the current bed of the harbour peat deposits present along the ancient watercourse that formed the Middle Harbour River have better potential to contain well preserved cultural material. Elsewhere within the area where geotechnical data is available the archaeological potential is much reduced on account of the seemingly thin residual soils and the absence of detectable substantial rock overhangs buried under marine sediments.

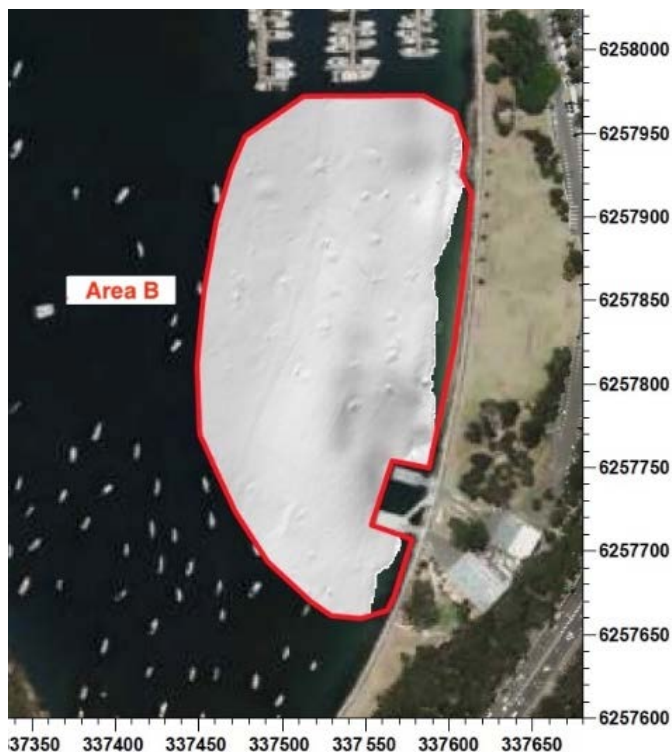
Figure 21 (left): Bed of the harbour features derived from bathymetric survey within Area B (Earth Technology Solution Pty Ltd, July 2017a: Figure MH2A). Low circular mounds are moorings for recreational craft.

There are numerous moorings across the bed of the harbour south of the existing marina (Figure 21). Some of these moorings are located at water depths of about 20 metres.

Seismic reflection data from within Area B shows the thickness of the Holocene marine sediments ranging from 10 metres at the southern end to over 50 metres towards the north (Figure 21).

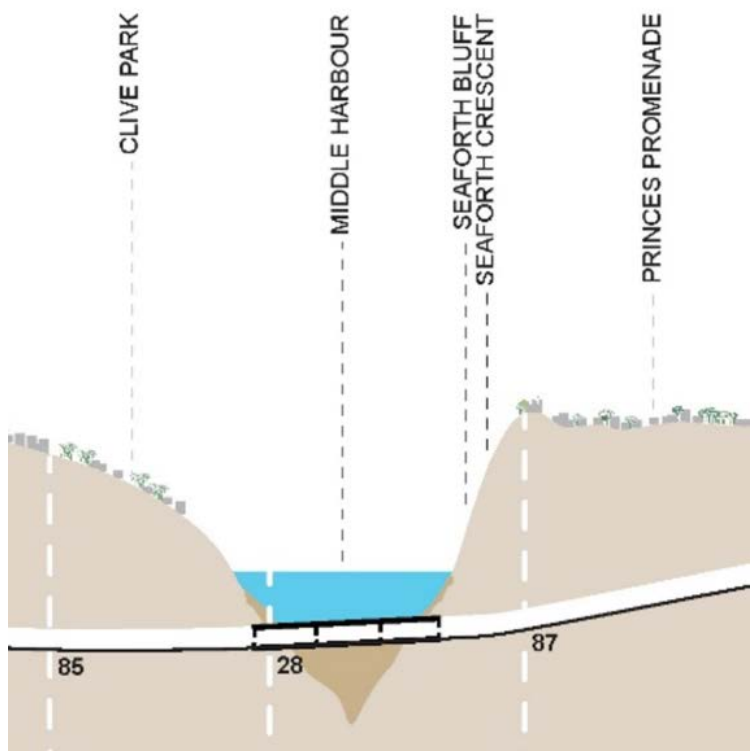
Figure 28: Indicative vertical alignment of the mainline tunnel crossing of Middle Harbour

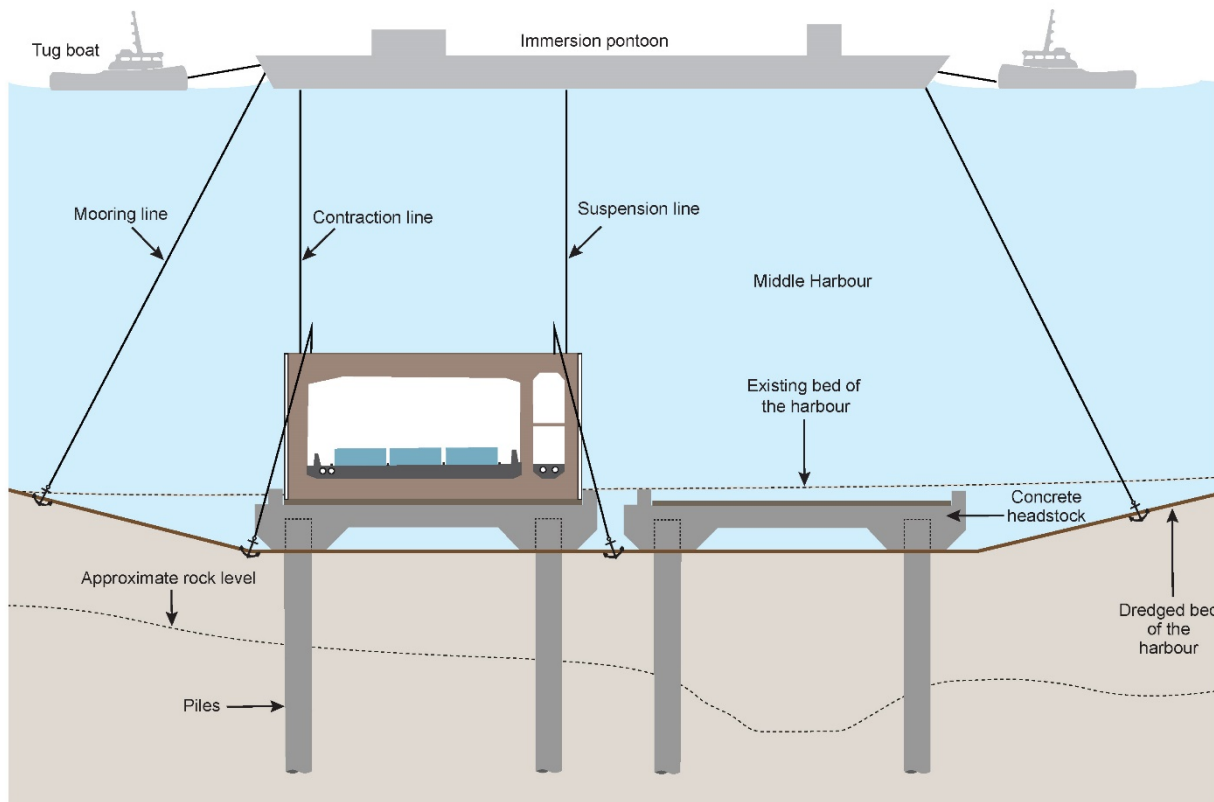
Figure 29: Typical immersion configuration – immersion pontoon
