Beaches Link and Gore Hill Freeway Connection

Technical working paper: Maritime heritage

December 2020

Cosmos Archaeology

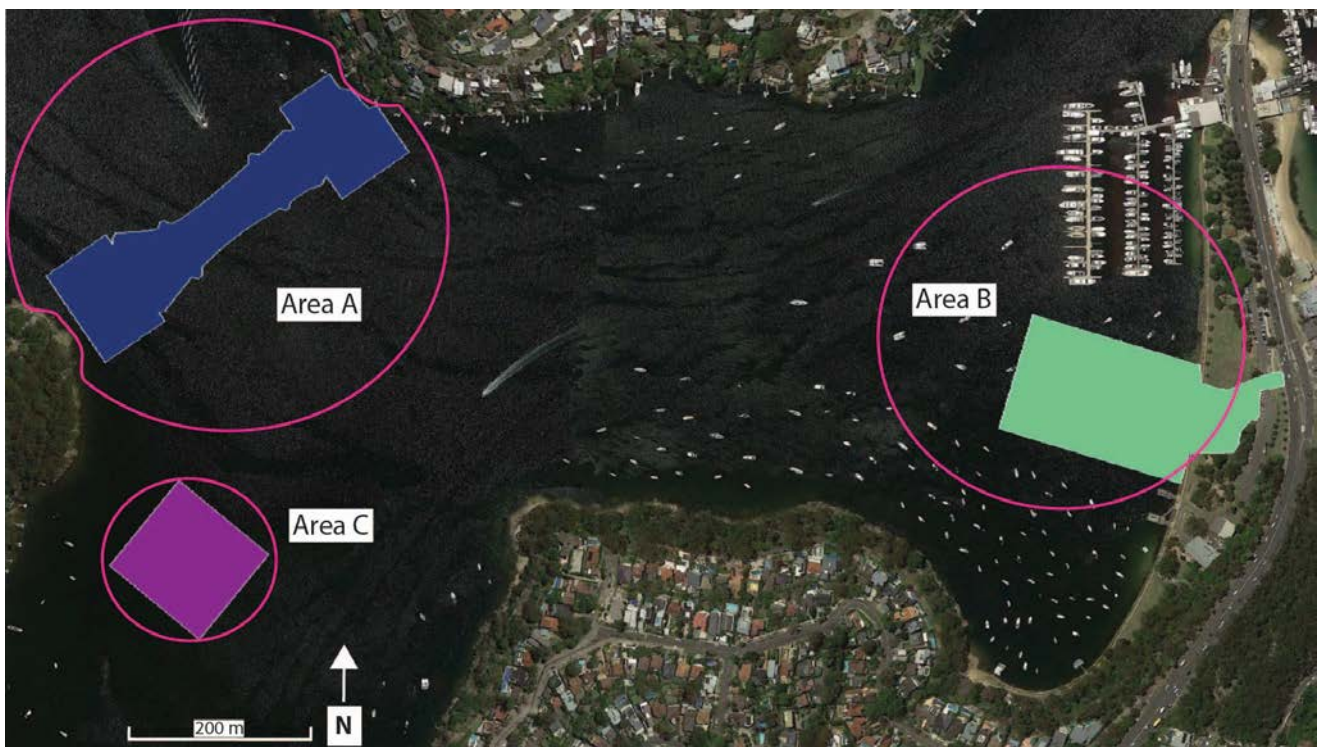
Figure 2-1: Study area for the maritime heritage assessment separated into Area A – Northbridge to Seaforth, Area B – Pearl Bay, including the western side of The Spit, and Area C at the entrance to Long Bay (Base image: Google Earth)

- Area A – the proposed tunnel alignment and cofferdams between Northbridge (Middle Harbour south cofferdam (BL7) and Seaforth Middle Harbour north cofferdam (BL8))
- Area B – the proposed construction support site in Pearl Bay and the western side of The Spit (Spit West Reserve (BL9))
- Area C – the proposed temporary mooring facility east of Clive Park in Middle Harbour.

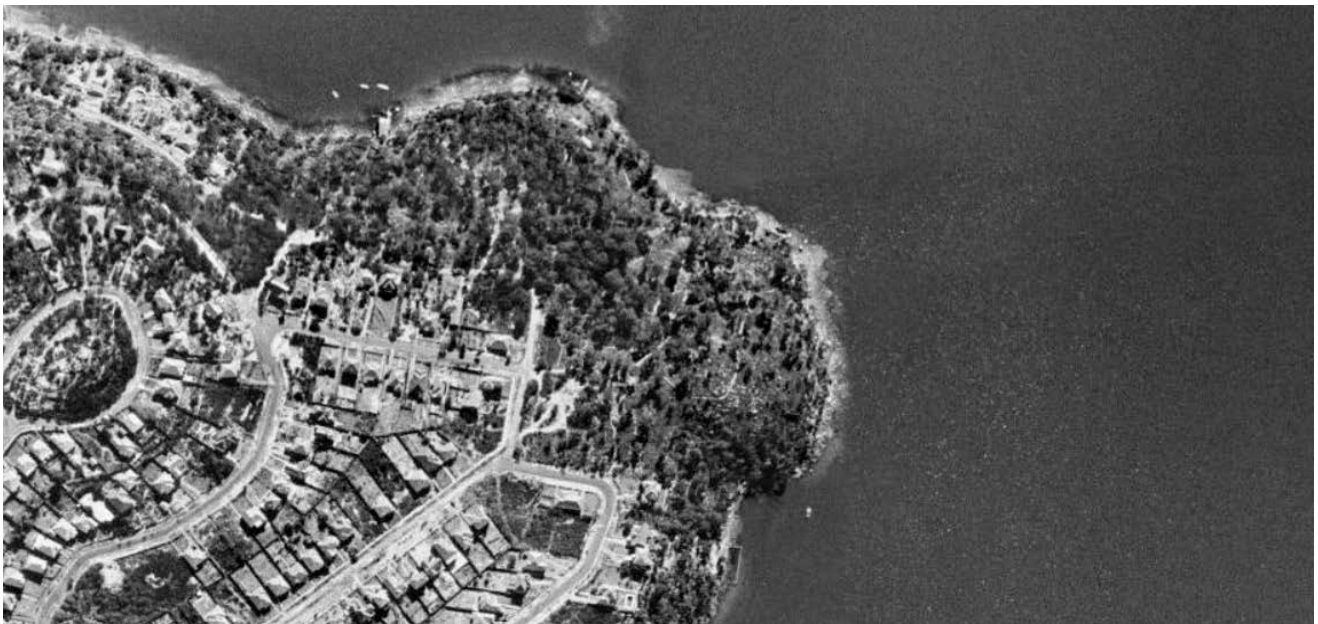
Figure 4-6: 1943 aerial photograph showing Clive Park (RTA photography 1943).

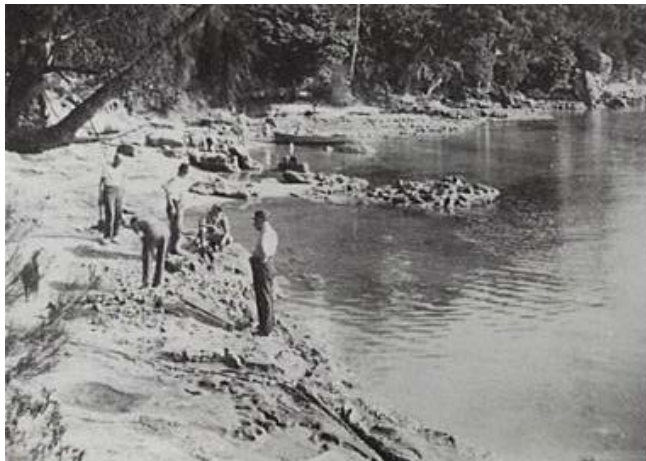
Figure 4-7: ca.1980s Crown plan showing layout of Clive Park tidal pool (left) (Crown Plan, ca.1980s)

In 1945, a recreational tidal pool was constructed at Clive Park by the Northbridge Volunteer Defence Corps Association. The pool was formed of two seawalls of large rocks topped with concrete and connected by a screen made of galvanised pipe and steel mesh (NSW Office of Environment and Heritage 2013) (Figure 4-7 to Figure 4-10). The Clive Park foreshore has continued to be used for recreational purposes with no further development since the mid 20th century, with the structural features of the tidal pool surviving largely intact (see Section 4.3).

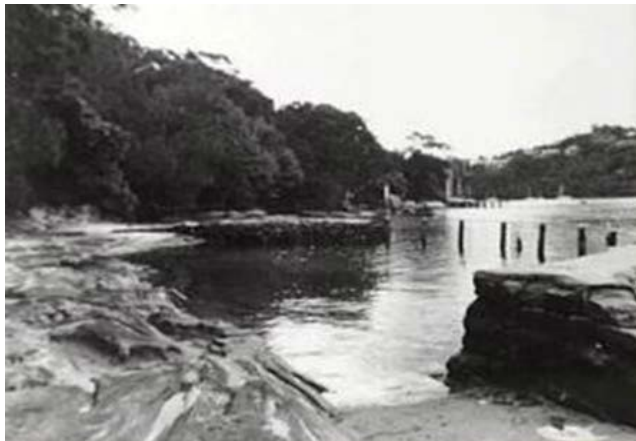
Figure 4-9: 1994 photograph of remains of Clive Park pool (Anon 1994) (left)

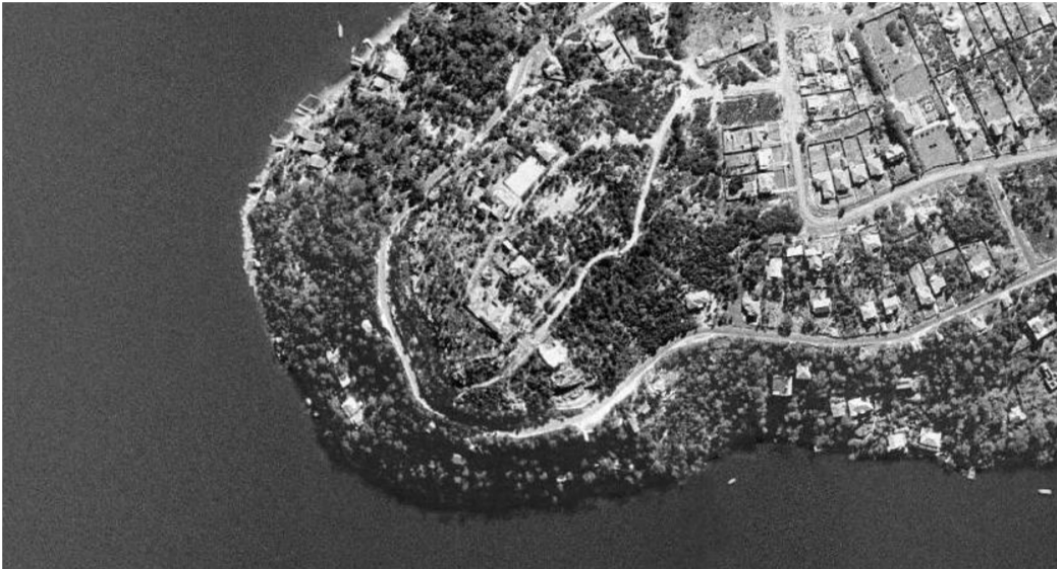
Figure 4-13: 1943 aerial photograph of Seaforth Bluff (RTA Photography 1943)

Scattered residential development ensued around Seaforth Bluff over the following decades. By the early 1940s, half a dozen private residences had been constructed on the clifftop at the south-western tip of Seaforth Bluff, with associated private waterfront facilities including seawalls, small jetties, boat landings and sheds (Figure 4-13).

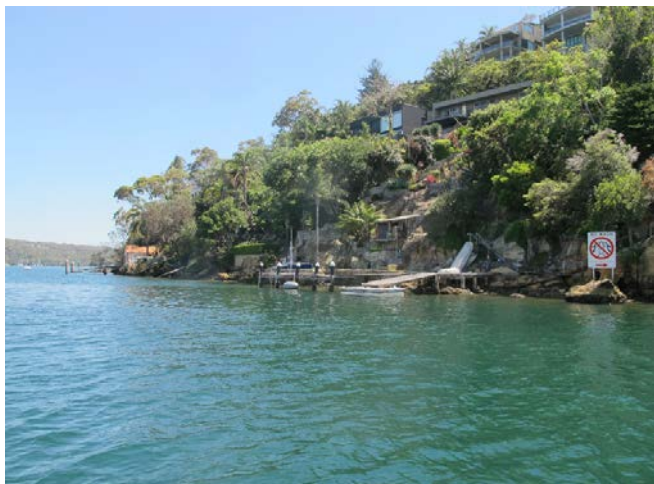
Figure 4-16: Foreshore at Seaforth looking north-west (left) (Image: Cosmos Archaeology, 14 December 2017)

The Seaforth foreshore is listed as an item of local heritage significance on the *Manly Local Environmental Plan 2013* (Item No. 11). The foreshore within Area A contains a mixture of small timber or concrete-piled private jetties, sandstone block retaining walls and small slipways for hauling up boats (Figure 4-16). Along the foreshore are sections of exposed sandstone cliffs of low height, which have been shaped by seawater movement in the form of tides and wave action for around 8,000 years (Figure 4-17).

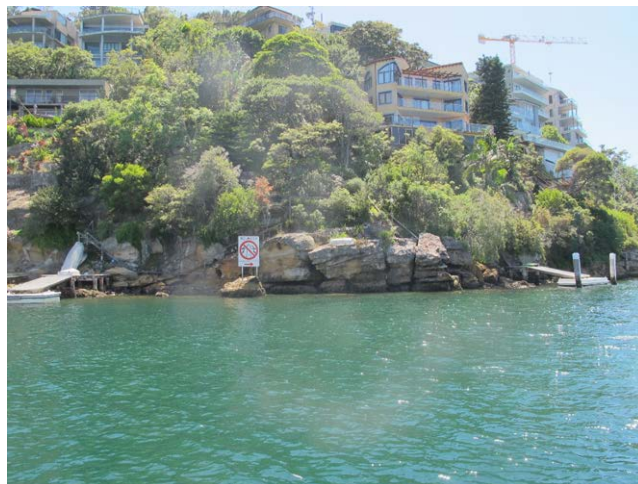
Figure 4-17: Foreshore at Seaforth looking north-east (right) (Image: Cosmos Archaeology, 14 December 2017)

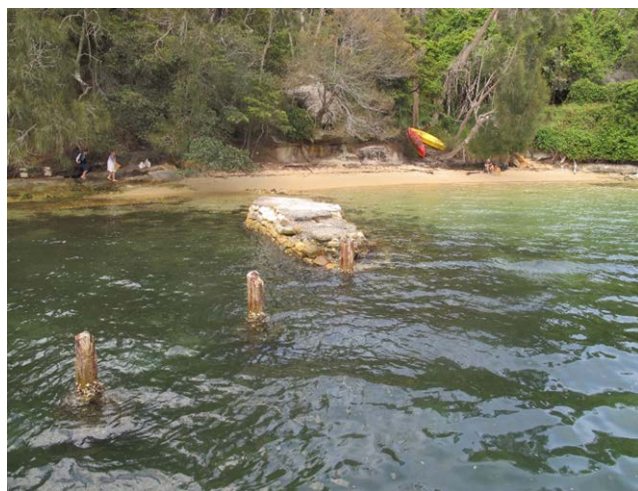
Figure 4-18: Clive Park Tidal Pool looking south-east towards the shore (left) (Cosmos Archaeology 18 December 2017)

Clive Park Tidal Pool, constructed in 1945, is listed as an item of heritage significance in the *Willoughby Local Environmental Plan 2012* (Item 179). The pool is located in a shallow bay on the northern side of Clive Park. It is a semi-circular enclosure about 20 metres wide and 12 metres across that incorporates natural sandstone outcropping on its eastern side (Figure 4-18). Immediately to the west of the tidal pool is a small sandy beach (Figure 4-19). The depth of the pool was not measured but it would appear to be a few metres at most at high tide. The bed of the harbour is a mix of rock platform, rubble and sand.

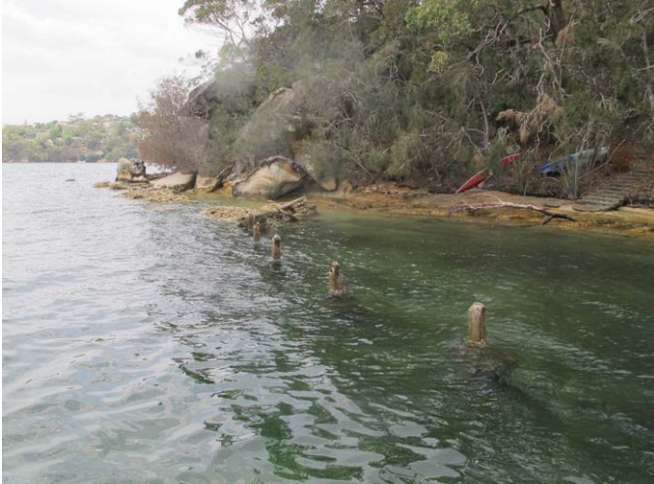
Figure 4-19: West end of Clive Park Tidal Pool looking south towards shore (right) (Cosmos Archaeology 18 December 2017)

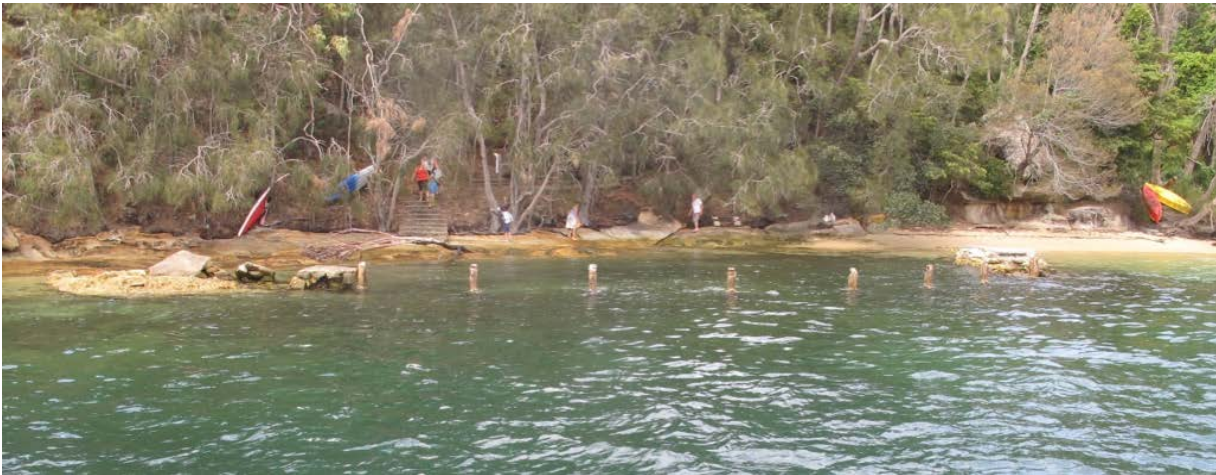
Figure 4-20: Clive Park Tidal Pool looking south towards shore. Row of eight reinforced concrete piles in the centre flanked by low sandstone walls bonded with cement. (Cosmos Archaeology 18 December 2017)

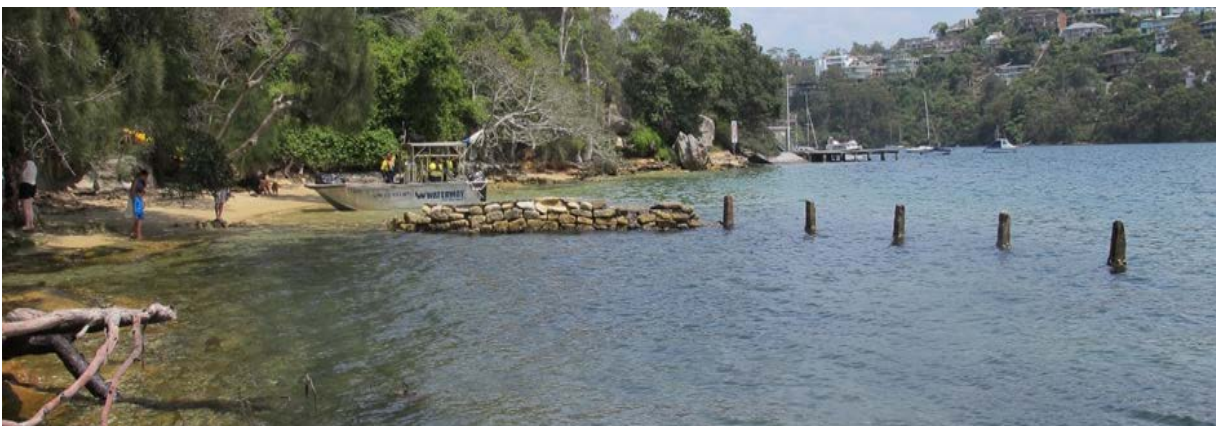
Figure 4-21: West end of Clive Park Tidal Pool showing coarsely stacked sandstone blocks (Cosmos Archaeology 18 December 2017)

The western sandstone wall is the better preserved of the two. It is about 10 metres long, 1.5 metres wide and about one metre high (Figure 4-21). The eastern wall is poorly preserved and has collapsed in places (Figure 4-22). As of December 2017 the condition of the Clive Park Tidal Pool could generally be considered to be poor, with sections having collapsed or collapsing and the pylons in the process of breaking apart as the steel reinforcing corrodes.

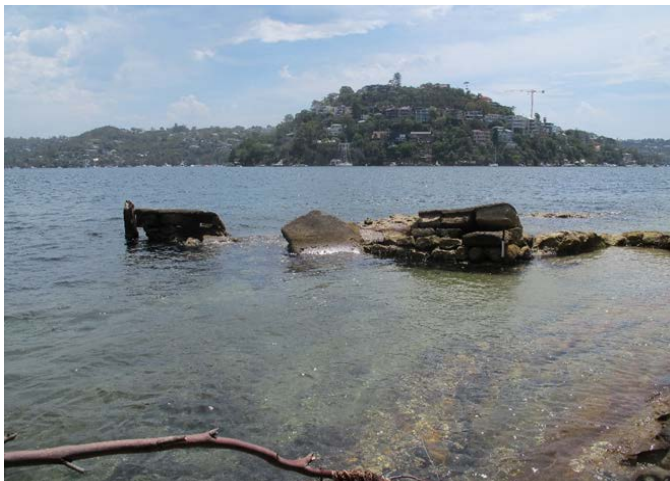
Figure 4-22: Eastern end of Clive Park Tidal Pool showing collapsed wall. Seaforth Bluff is in the background
 (Image: Cosmos Archaeology, 18 December 2017)

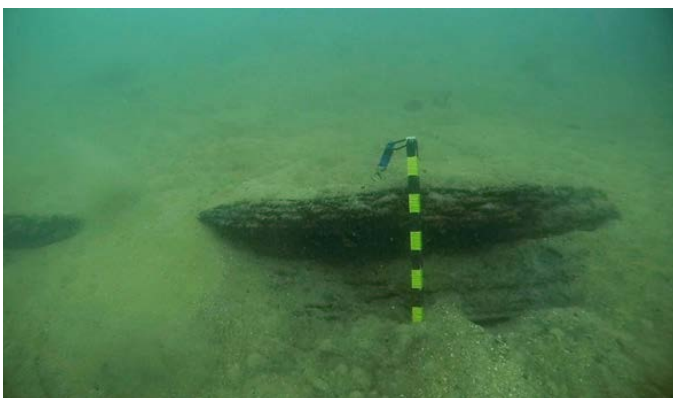
Figure 4-23 Target 16W-004 – timber pile (left) (Cosmos Archaeology, 18 December 2017)

Target ID	Description
16W-004	Timber pile lying on bed of the harbour. About 0.5 metre diameter with remnant length about 7 metres
16W-005	Large plastic mooring buoy 1 metre high and one metre across
16W-008	Timber pile lying on bed of the harbour. About 0.3 metres diameter with remnant length about 7 metres

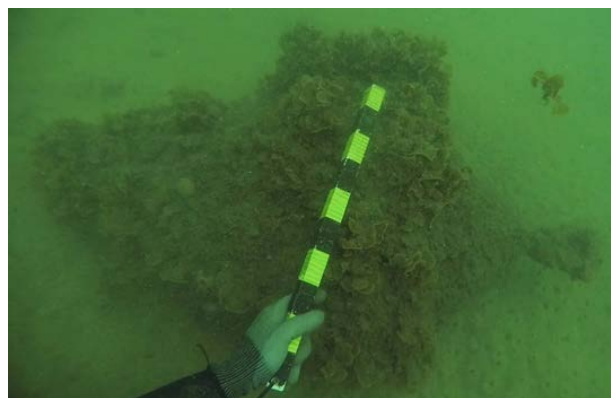
Figure 4-24 Target 16W-005 – mooring buoy (right) (Cosmos Archaeology, 18 December 2017)

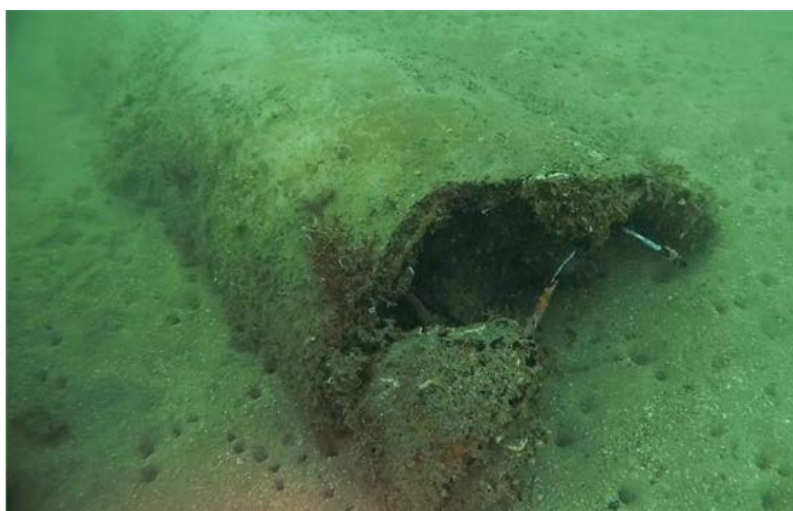
Figure 4-29 Target 16W-002 – concrete pipe (Cosmos Archaeology, 18 December 2017)

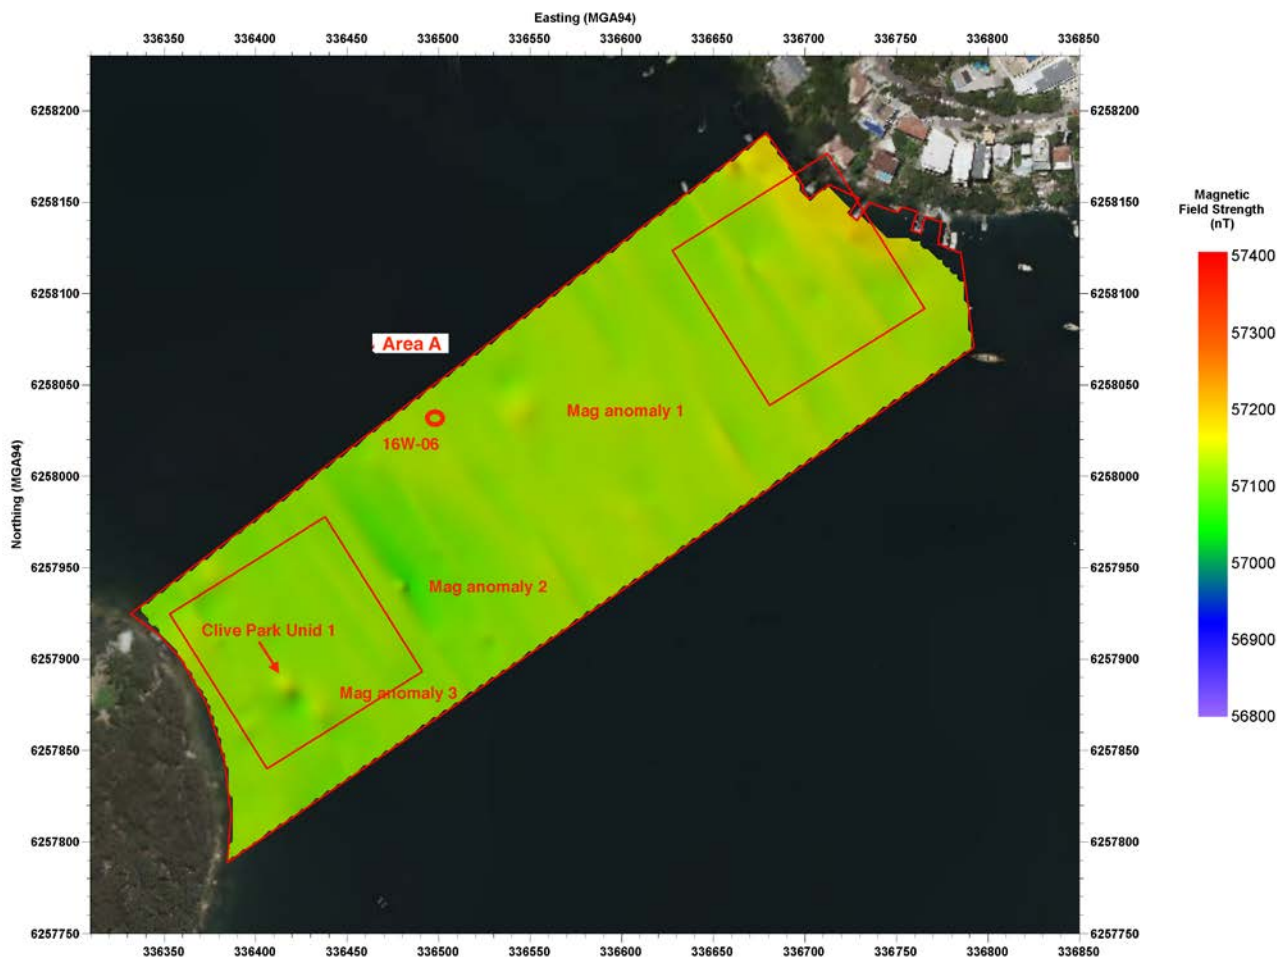
Figure 4-31: Magnetic anomalies in Area A (Earth Technology Solution Pty Ltd, July 2017b: Figure MH9A). Target 16W-06 has been included to show that it displayed no magnetic signature, which means there is little ferrous content associated with it. The red boxes show the area of interest around the proposed cofferdams.

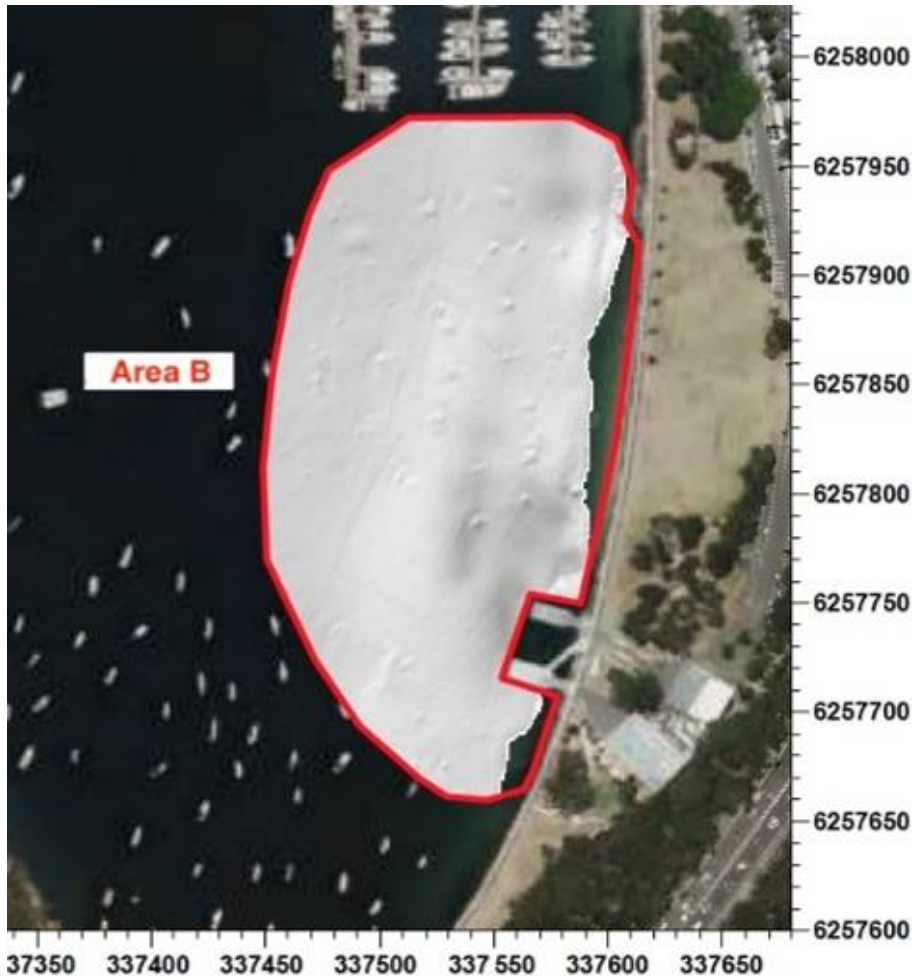
Figure 5-3: Bed of the harbour features derived from bathymetric survey within Area B (Earth Technology Solution Pty Ltd, July 2017a: Figure MH2A). Low circular mounds are moorings for recreational craft

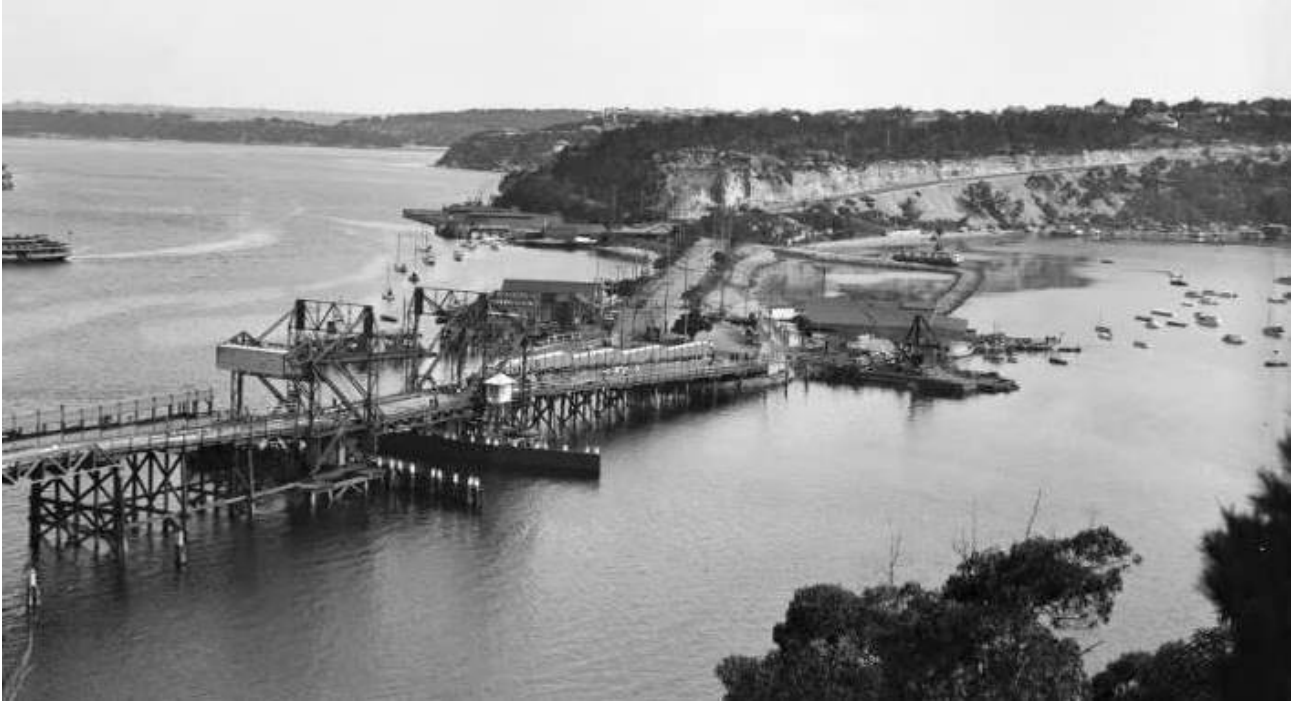
Figure 5-9: ca. early 1930s photograph of Spit Bridge showing reclamation works being carried out on the western side of The Spit (Foster ca. 1930s)

In the late 1920s, the construction of the Northern Suburbs Ocean Outfall Sewer at Bluefish Point, North Head, resulted in large excavations at Clontarf. Spoil from these works was used to reclaim sections of the tidal flats along the western side of The Spit to provide additional public parkland and recreational facilities surrounding the bridge. The reclamation works were carried out in the early to mid 1930s and resulted in the creation of a 12-acre park retained by concrete seawalls and vested in the Sydney Harbour Trust Commissioners (Mosman Municipal Library) (Figure 5-9 to Figure 5-12). This reclamation created the current western shoreline of The Spit – within and adjacent to Area B.

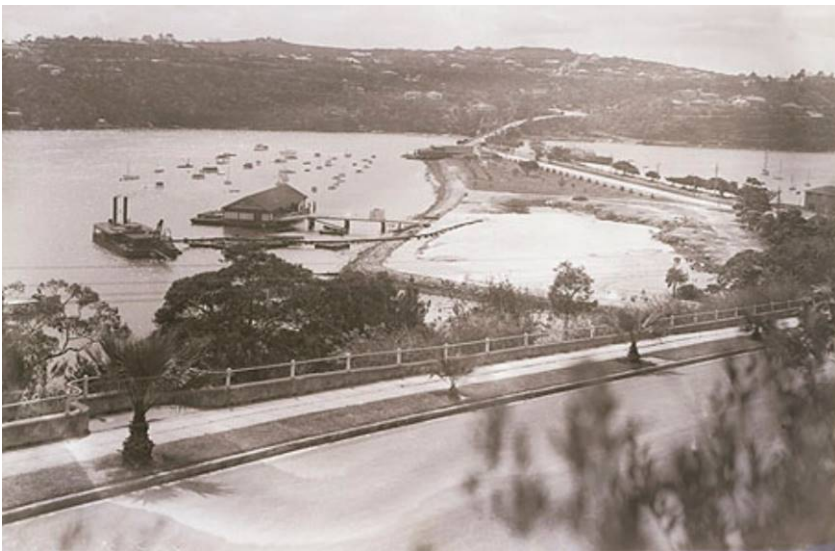
Figure 5-10: Reclamation being carried out at Pearl Bay, 1935 (Anon 1935)

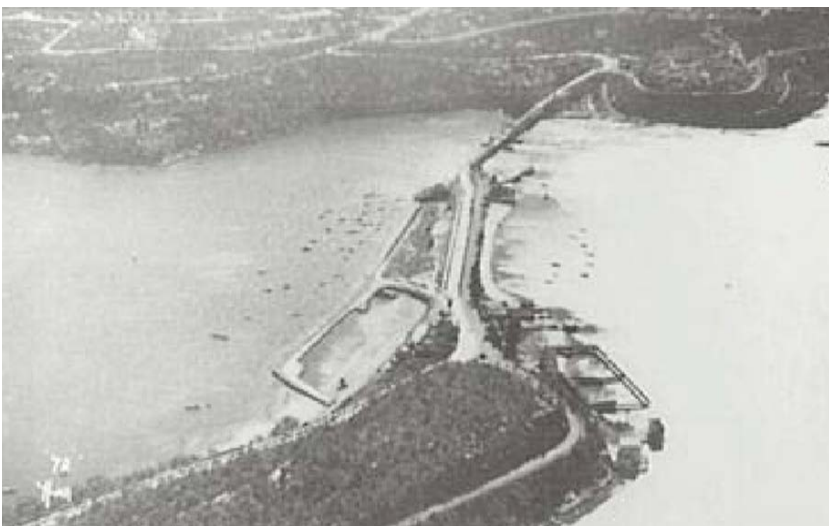
Figure 5-11: Spit Bridge, 1932, showing reclamation (John Hall & Co. 1932)

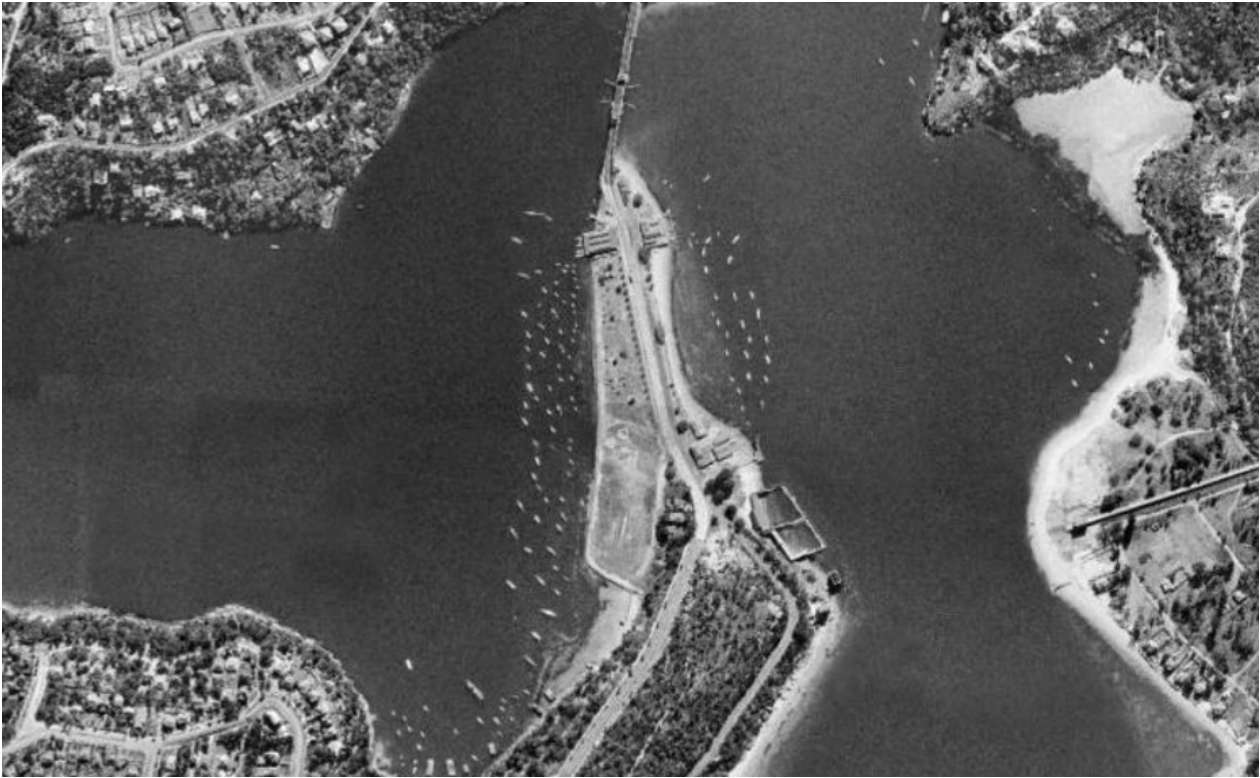
Figure 5-12: 1943 aerial photograph showing the reclaimed land and seawall on the western side of The Spit (RTA Photography 1943). Note the number of moored vessels in Pearl Bay

Concrete seawalls were constructed to retain the most recent phase of reclamation, along with the creation of a 12 acre park. The curved northern end of the seawall and its western edge can be discerned in a 1943 aerial photograph of The Spit, abutting the eastern edge of Area B (Figure 5-12). The current seawall is concrete, faced for the most part with rock armour rubble. There may also be remains of the earlier retaining walls within the reclamation.

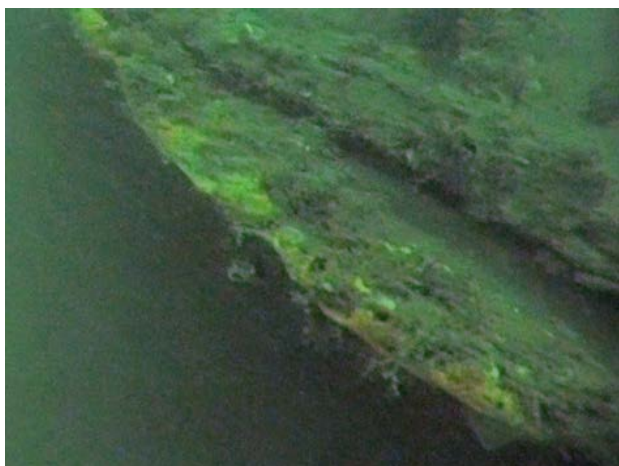
Figure 5-14: Close-up of copper/copper alloy sheathing (left) (Cosmos Archaeology Pty Ltd 19 December 2017)

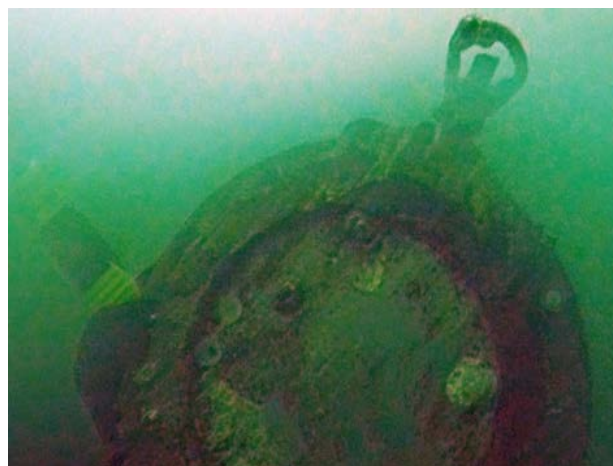
Figure 5-15: Port hole found in the interior of the wreck (right) (Cosmos Archaeology Pty Ltd 19 December 2017)

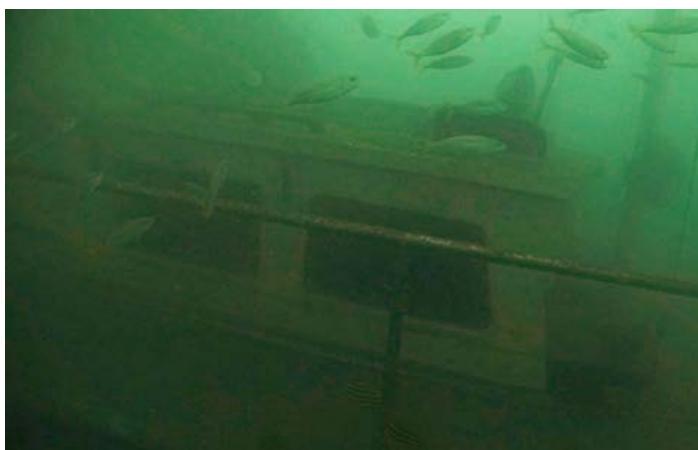
Figure 5-17: Large intact wooden yacht (Cosmos Archaeology Pty Ltd 19 December 2017)

Within 10 metres of the Pearl Bay Unidentified No. 1 shipwreck is the wreck of a 12 metre timber yacht (Figure 5-17). This vessel is known to have sunk sometime during the six months preceding the December 2017 dive inspection, because it did not appear on the side scan sonar imagery obtained earlier in the year and the registration numbers and vessel name were clearly visible. (This information has been withheld from this report on the basis that the vessel may be the subject of an enquiry or investigation). The vessel is not listed on the Australian Register of Historic Vessels (Australian National Maritime Museum).

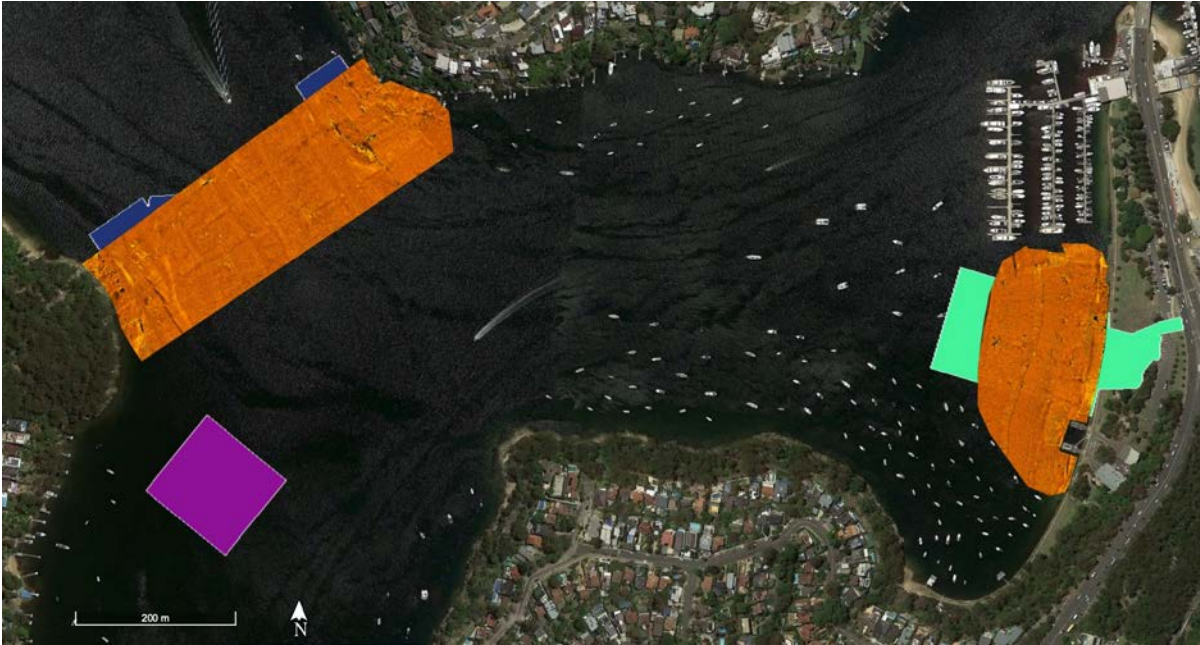
Figure 8-5: Extent of side scan sonar survey in relation to proposed extent of disturbance footprint (Base image: Google Earth; Side scan sonar data provided as .shp files by Adam Podnar, Geotechnical Engineer, Douglas Partners, 5 December 2017)

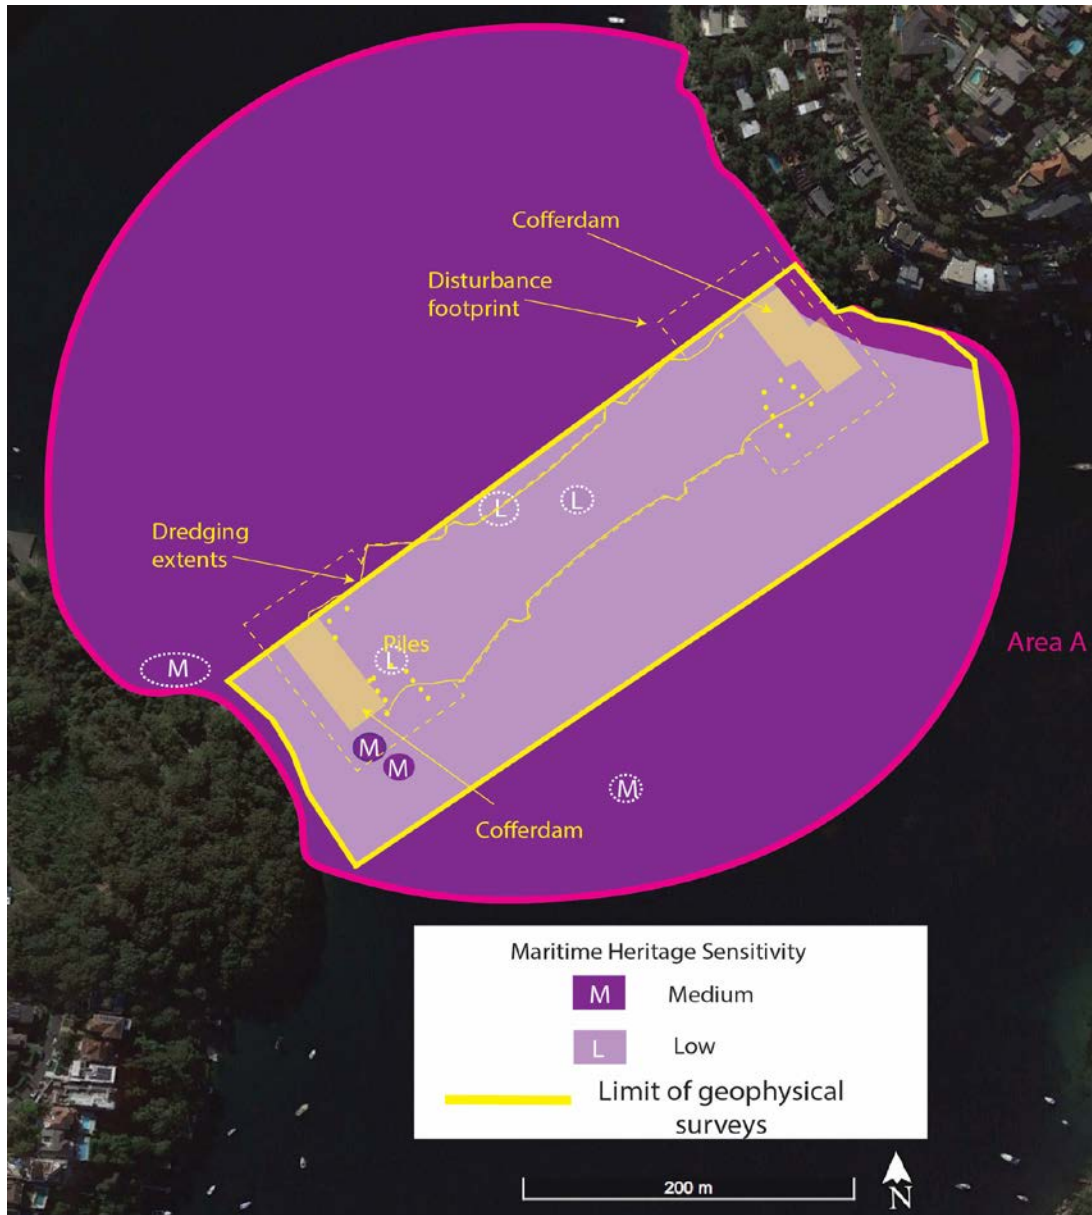
Figure 8-6: Potential impact on maritime heritage sites in Area A (Proposed works outlined in yellow)
