Roads and Maritime Services

F6 Extension Stage 1

New M5 Motorway at Arncliffe to
President Avenue at Kogarah

Environmental Impact Statement

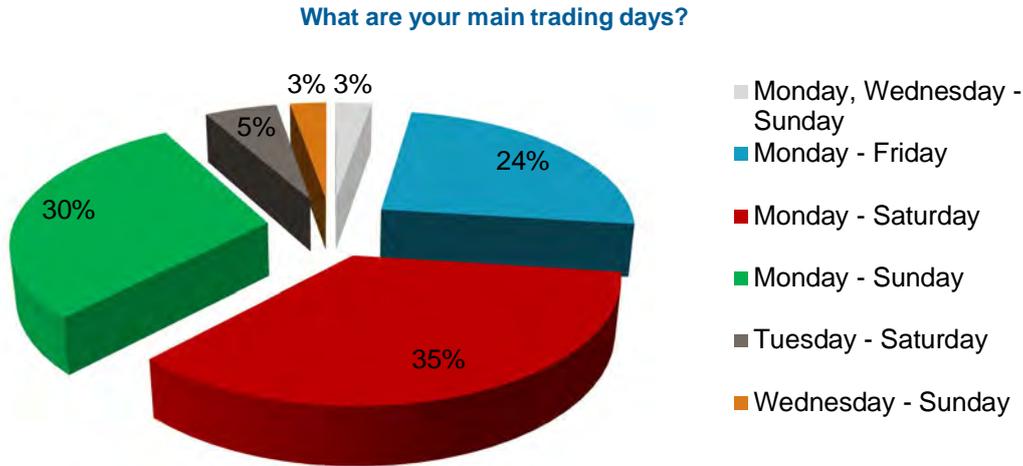
What are your main trading days?

Of the businesses that participated in the survey, 35 per cent are open Monday to Saturday and 30 per cent are open Monday to Sunday. Twenty-four per cent are open Monday to Friday.

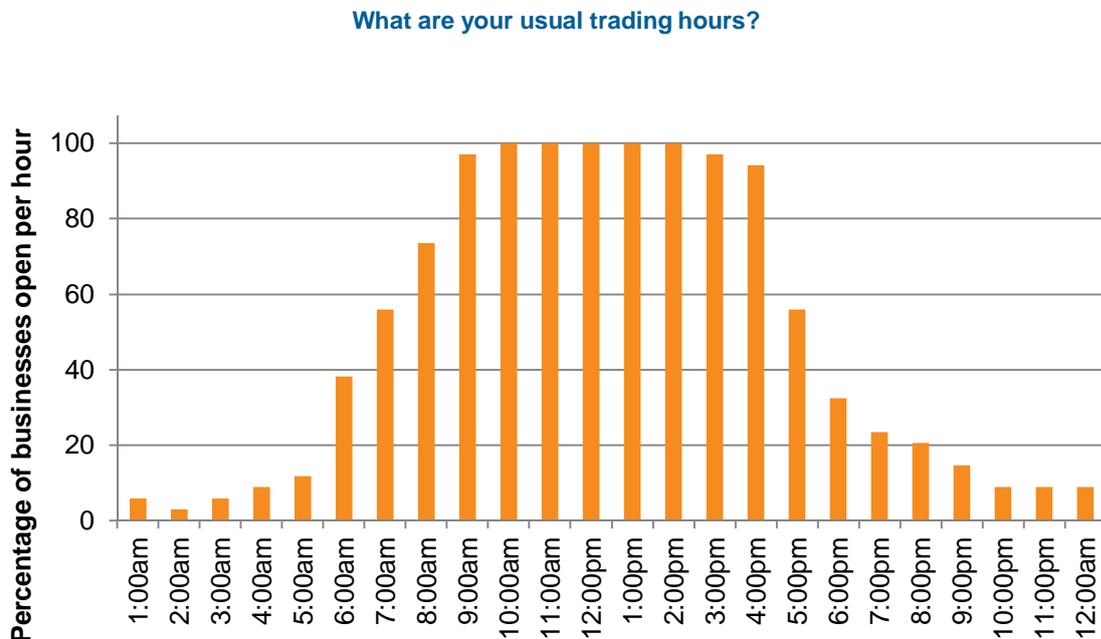
What are your usual trading hours?

Three businesses did not provide their usual trading hours and have not been included in this discussion or the data represented in the graph.

All the businesses that participated in the survey indicated that their business is open between 11:00am and 4:00pm (100 per cent), and up to around eight per cent are operational overnight between 11:00pm and 5:00am.

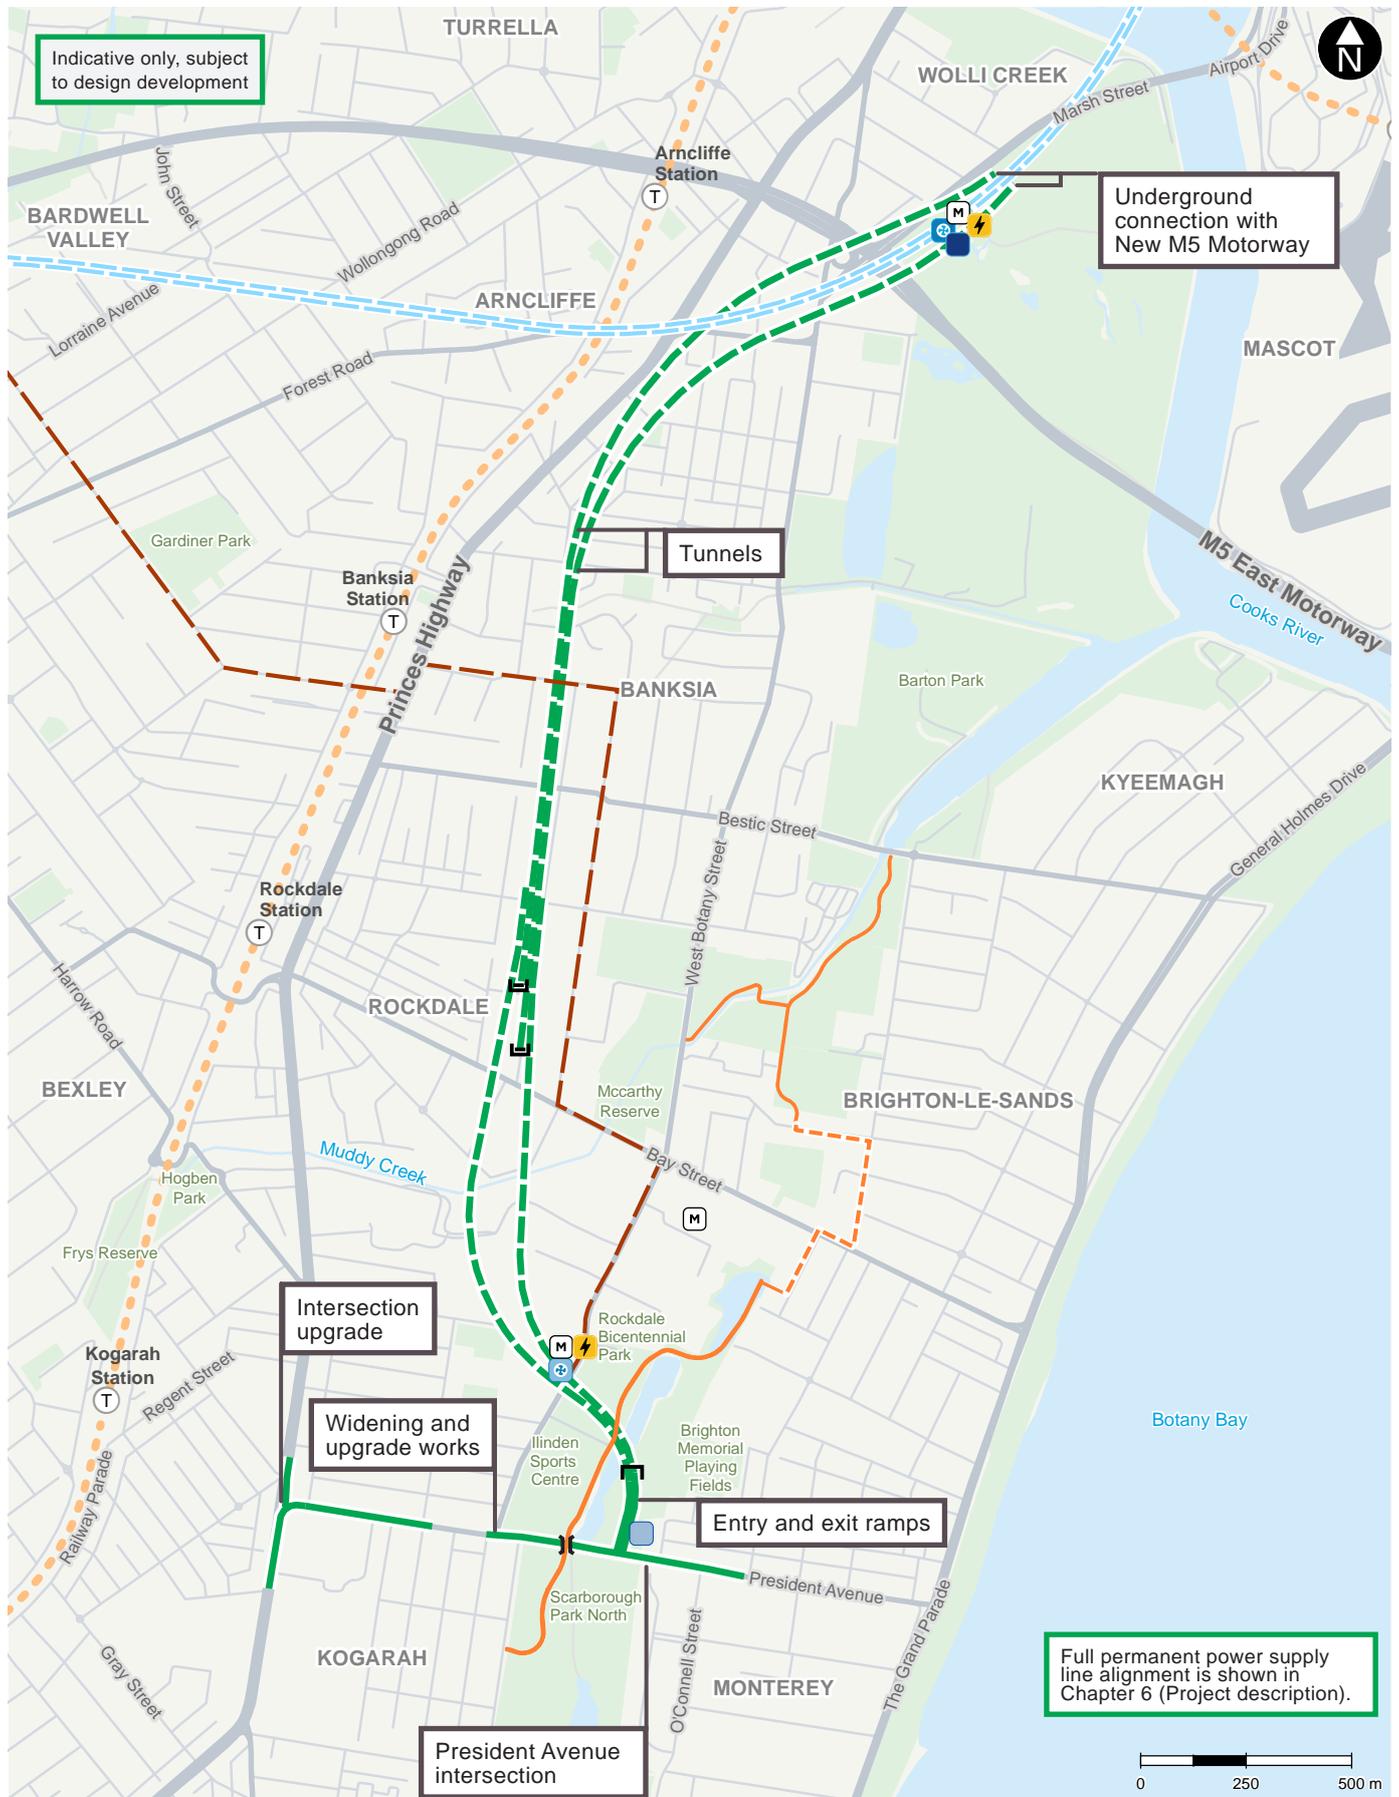
The key features of the project are shown on **Figure 2-1**.

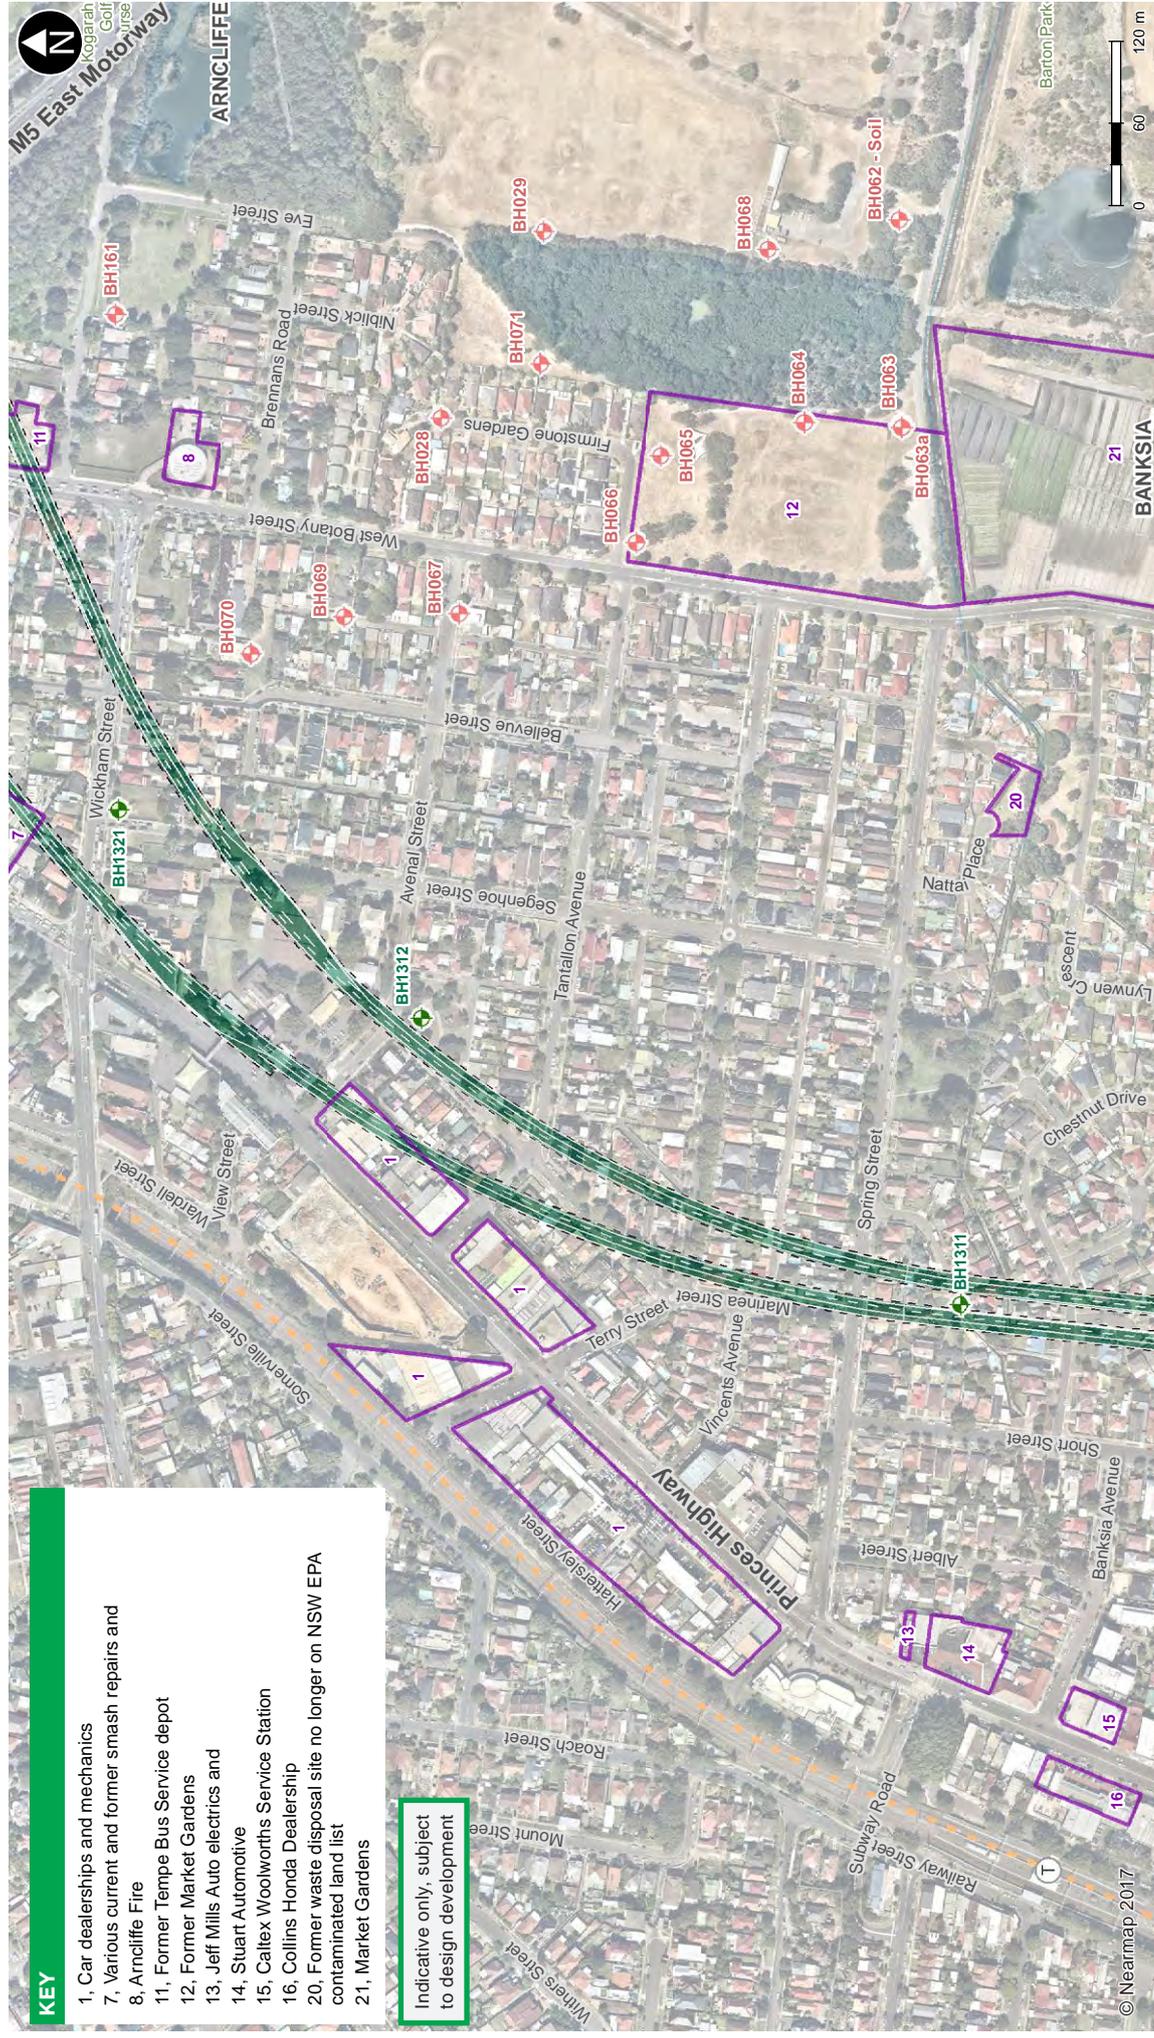
Figure 4-5 New M5 Motorway to Forest Road, Arncliffe

- KEY**
- 1, Car dealerships and mechanics
 - 7, Various current and former smash repairs and Arncliffe Fire
 - 11, Former Tempe Bus Service depot
 - 12, Former Market Gardens
 - 13, Jeff Mills Auto electrics and Stuart Automotive
 - 15, Callex Woolworths Service Station
 - 16, Collins Honda Dealership
 - 20, Former waste disposal site no longer on NSW EPA contaminated land list
 - 21, Market Gardens

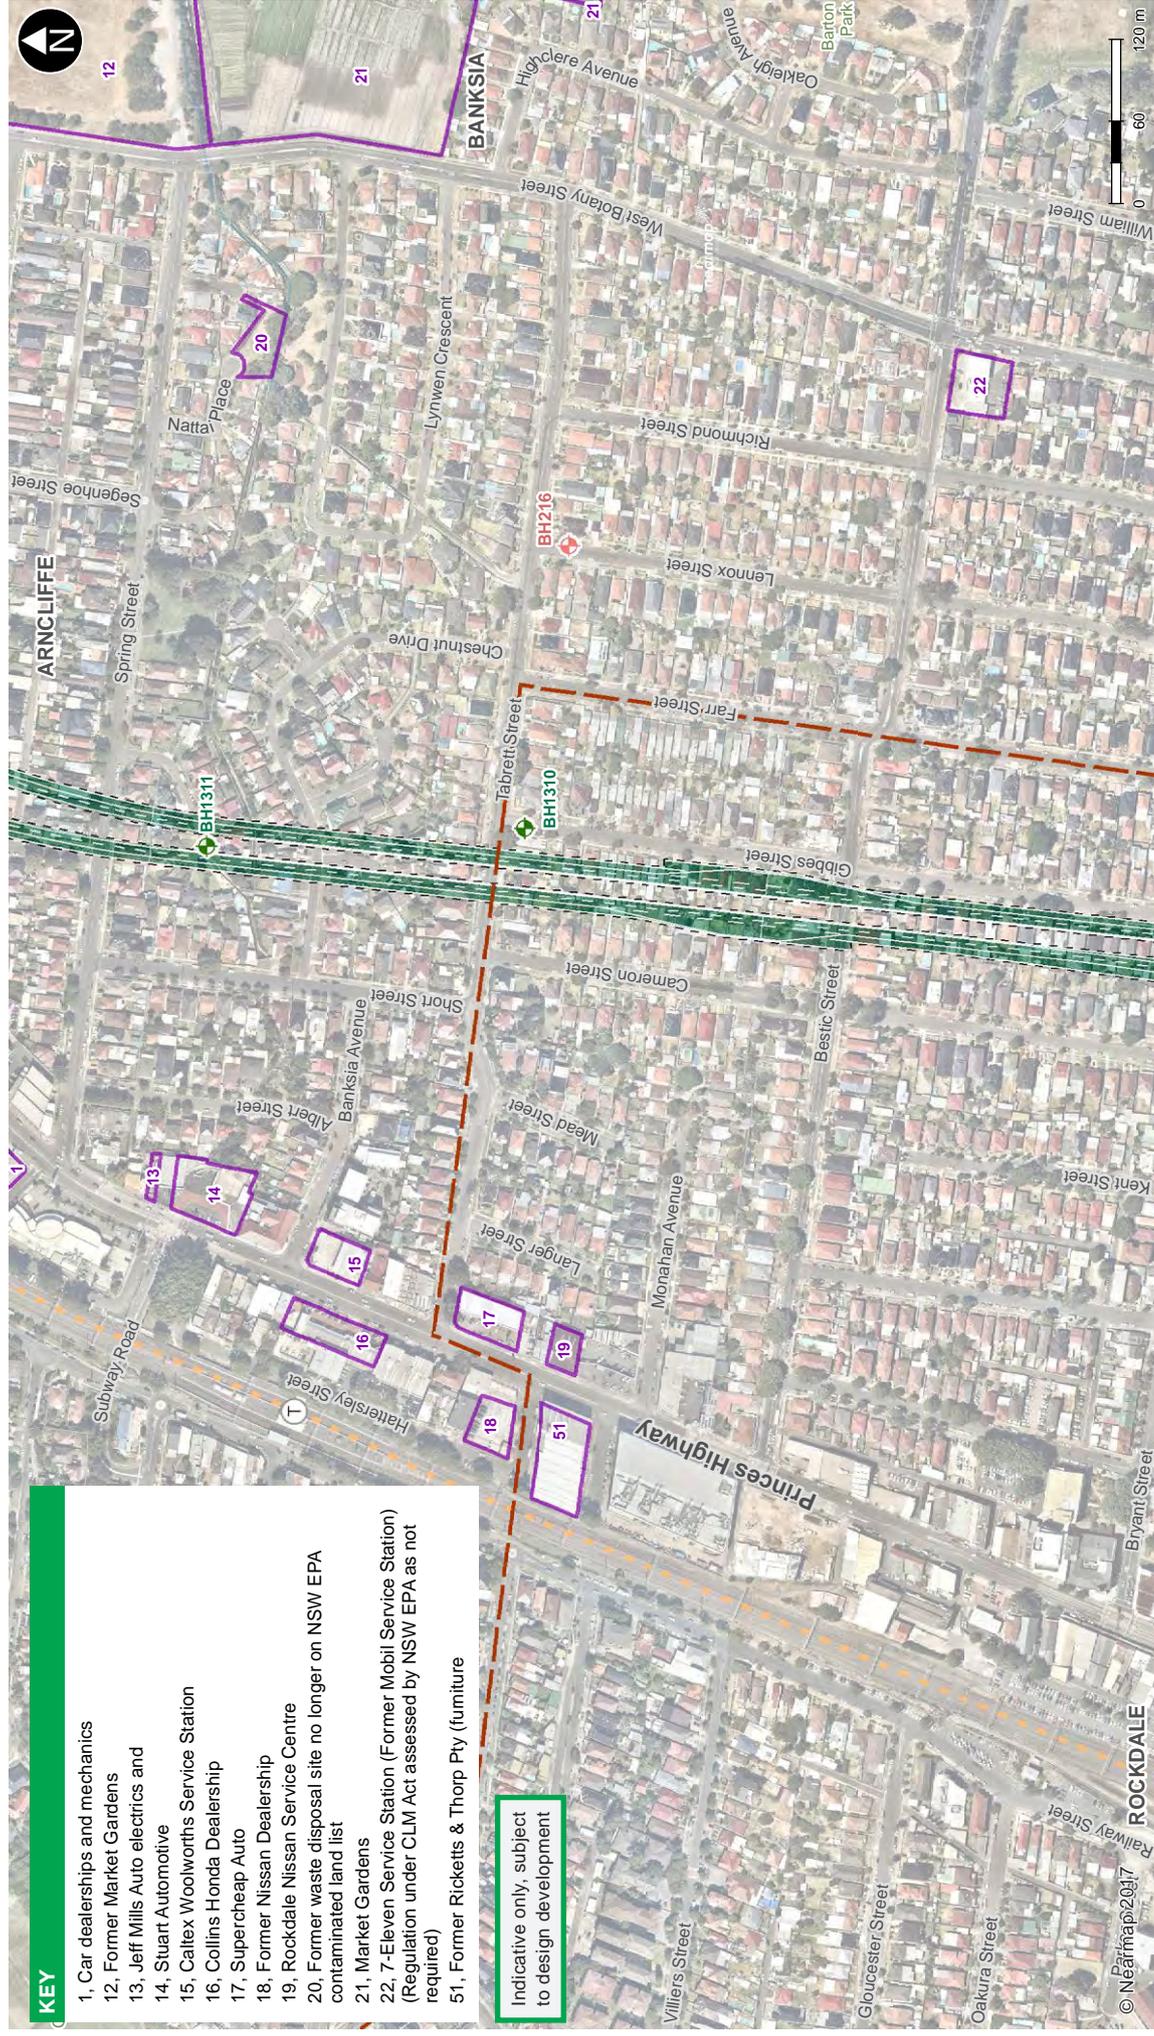
Figure 4-6 Forest Road to Spring Street, Arncliffe

- KEY**
- 1, Car dealerships and mechanics
 - 12, Former Market Gardens
 - 13, Jeff Mills Auto electrics and
 - 14, Stuart Automotive
 - 15, Caltex Woolworths Service Station
 - 16, Collins Honda Dealership
 - 17, Supercheap Auto
 - 18, Former Nissan Dealership
 - 19, Rockdale Nissan Service Centre
 - 20, Former waste disposal site no longer on NSW EPA contaminated land list
 - 21, Market Gardens
 - 22, 7-Eleven Service Station (Former Mobil Service Station) (Regulation under CLM Act assessed by NSW EPA as not required)
 - 51, Former Ricketts & Thorp Pty (furniture)
- Indicative only, subject to design development

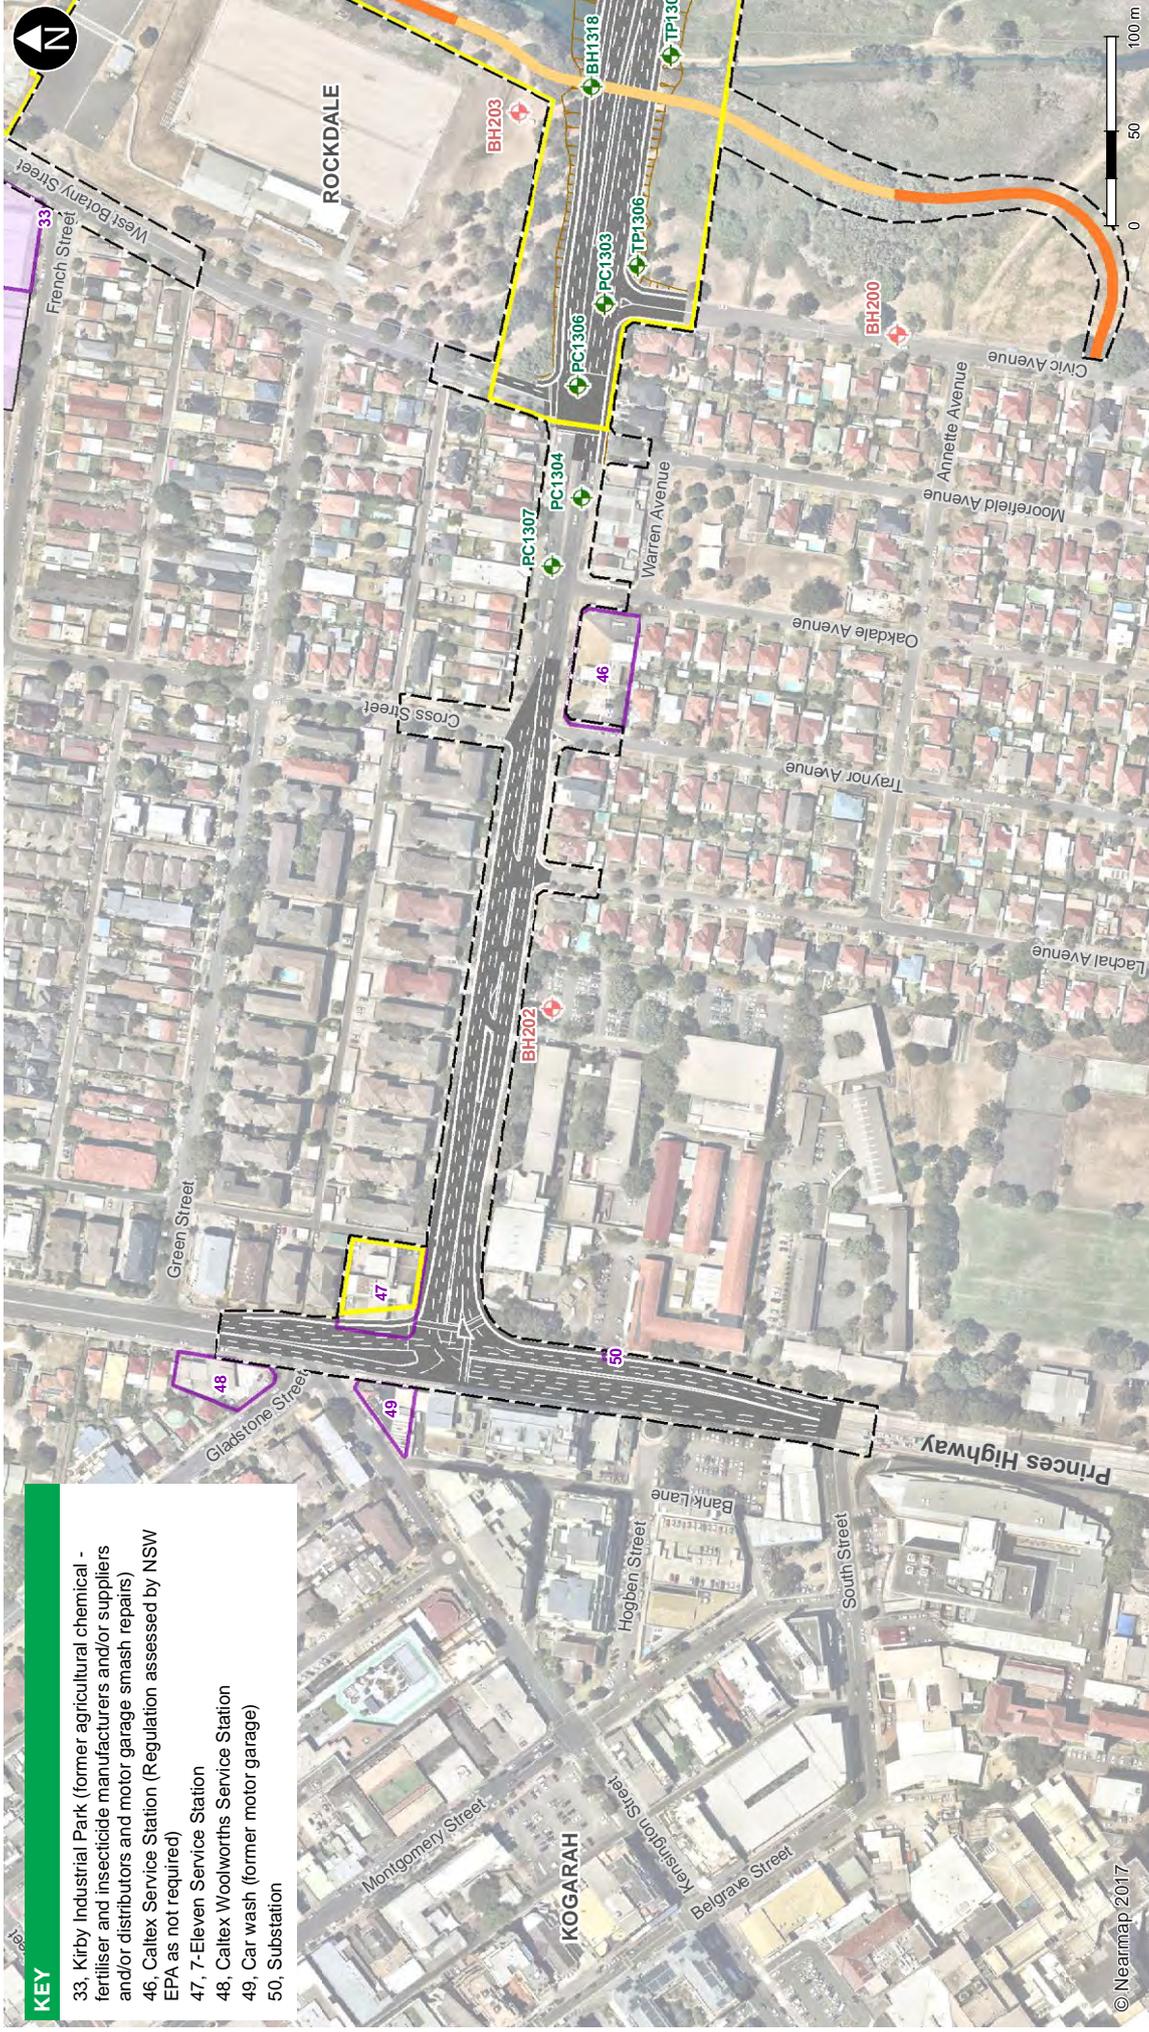
Figure 4-10 President Avenue intersection, Kogarah

33, Kirby Industrial Park (former agricultural chemical - fertiliser and insecticide manufacturers and/or suppliers and/or distributors and motor garage smash repairs)
 46, Caltex Service Station (Regulation assessed by NSW EPA as not required)
 47, 7-Eleven Service Station
 48, Caltex Woodworths Service Station
 49, Car wash (former motor garage)
 50, Substation

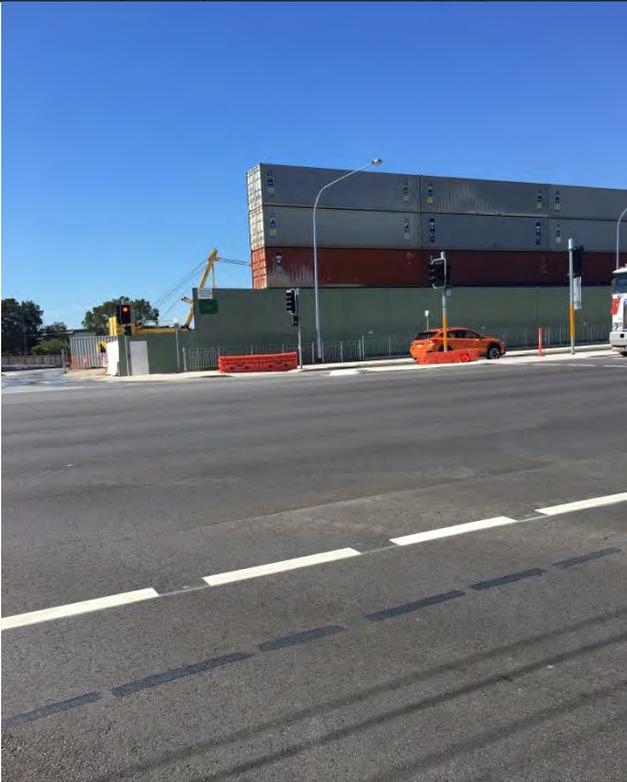
Project Name: Stage 1 F6 Extension		Site Location: 19 Marsh Street, Arncliffe (New M5 Motorway construction ancillary facility), proposed Arncliffe construction ancillary facility (C1) and Motorway Operations Complex (MOC1)	
Photo No. 1	Date: 11/12/2017

Direction Photo Taken: South-east			
Description: Concrete hoarding and shipping containers – boundary of New M5 Motorway construction compound view from Marsh Street

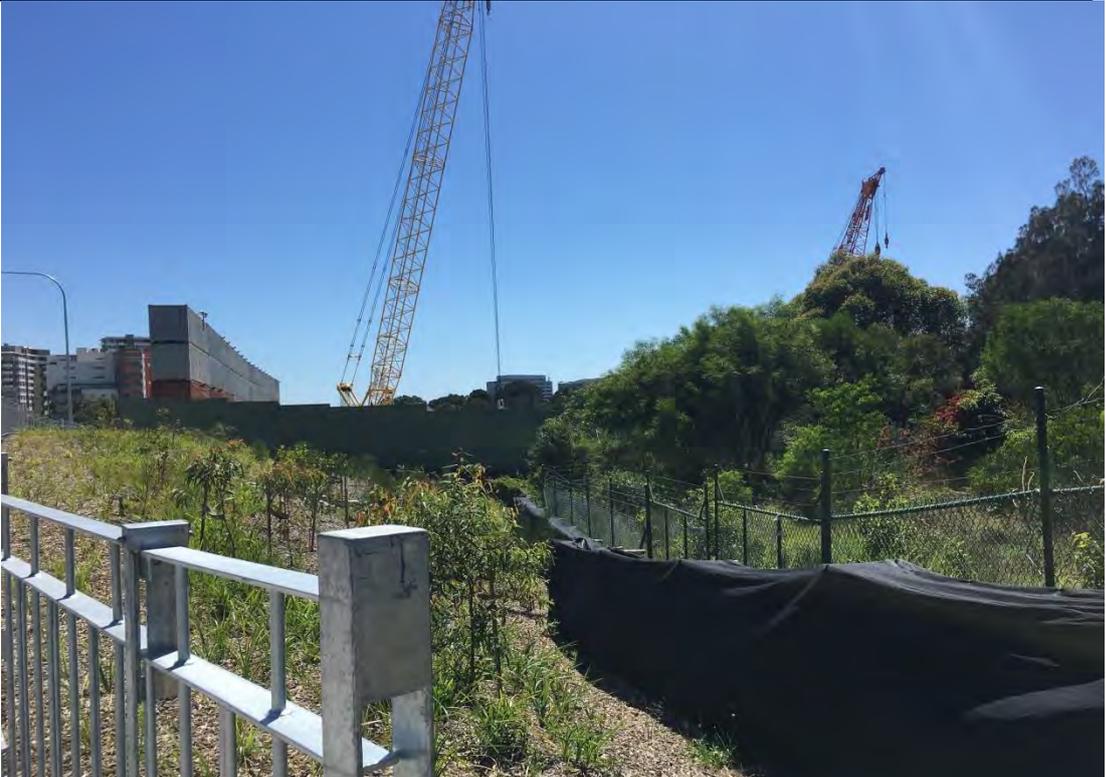
Photo No. 2	Date: 11/12/2017

Direction Photo Taken: North		
Description: View of New M5 Motorway construction ancillary facility from pedestrian/cycleway above M5 East roadway, immediately south of the New M5 Motorway construction ancillary facility

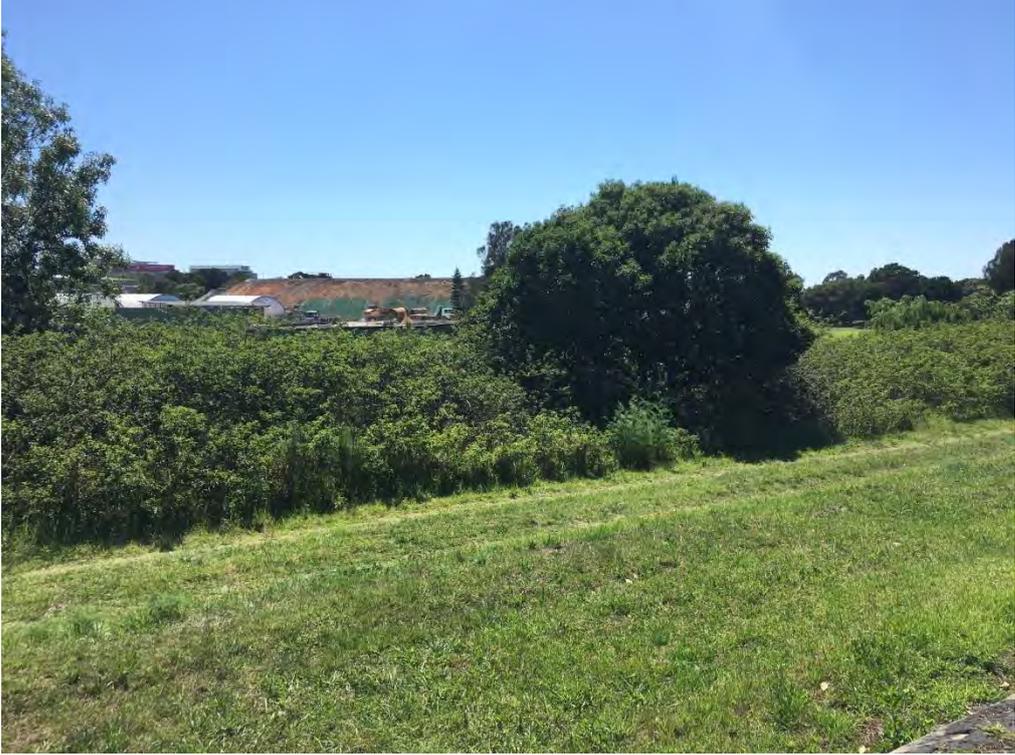
Project Name: Stage 1 F6 Extension		Site Location: 19 Marsh Street, Arncliffe (New M5 Motorway construction ancillary facility), proposed Arncliffe construction ancillary facility (C1) and Motorway Operations Complex (MOC1)	
Photo No. 3	Date: 11/12/2017

Direction Photo Taken: North-east			
Description: Stockpiles, plant and machinery visible from pedestrian/cycleway above M5 East roadway immediately south of the New M5 Motorway construction ancillary facility

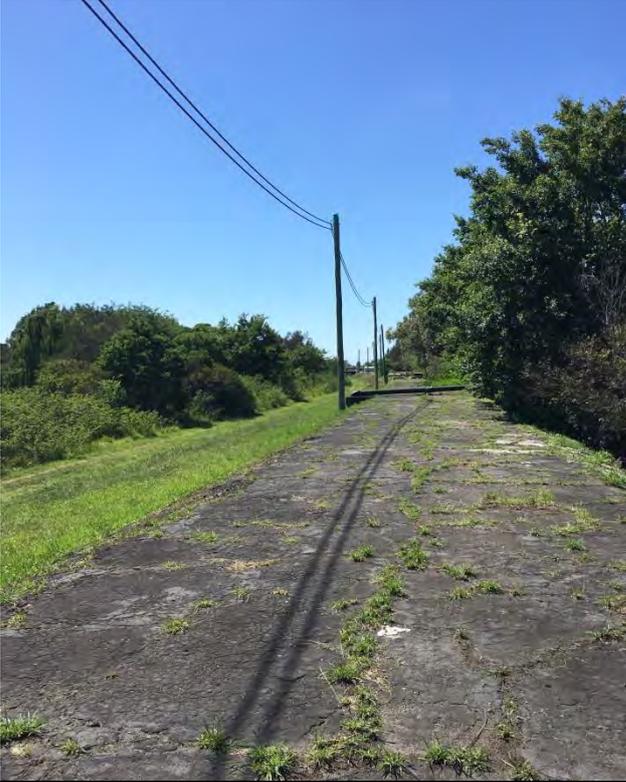
Photo No. 4	Date: 11/12/2017

Direction Photo Taken: East		
Description: South and Western Suburbs Ocean Outfall Sewer pipeline (SWSOOS No. 1) (partially below ground) running west to east south of the New M5 Motorway construction ancillary facility

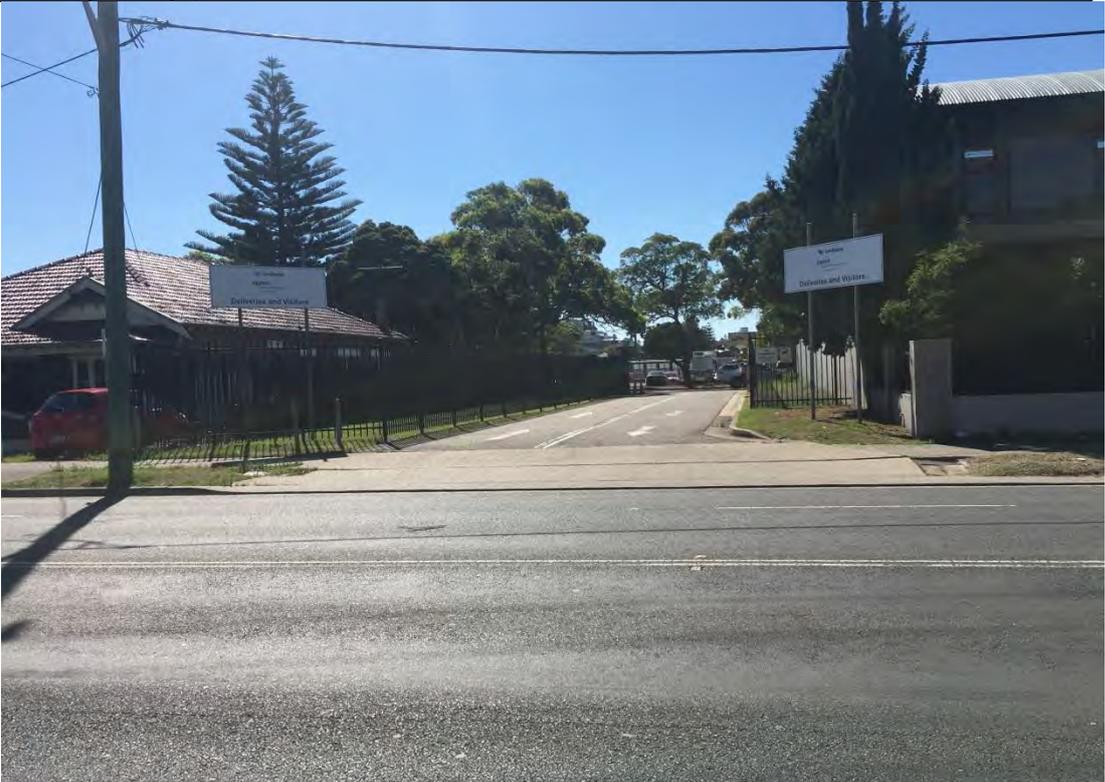
Project Name: Stage 1 F6 Extension		Site Location: Proposed Rockdale Motorway Operations Complex (north) (MOC2) and construction ancillary facility (C2)	
Photo No. 5	Date: 11/12/2017

Direction Photo Taken: South-east			
Description: Site entrance off West Botany Street, Rockdale to the proposed Rockdale Motorway Operations Complex (MOC2) and construction ancillary facility (C2), currently in use by Lendlease TYCO Joint Venture on behalf of Roads and Maritime Services

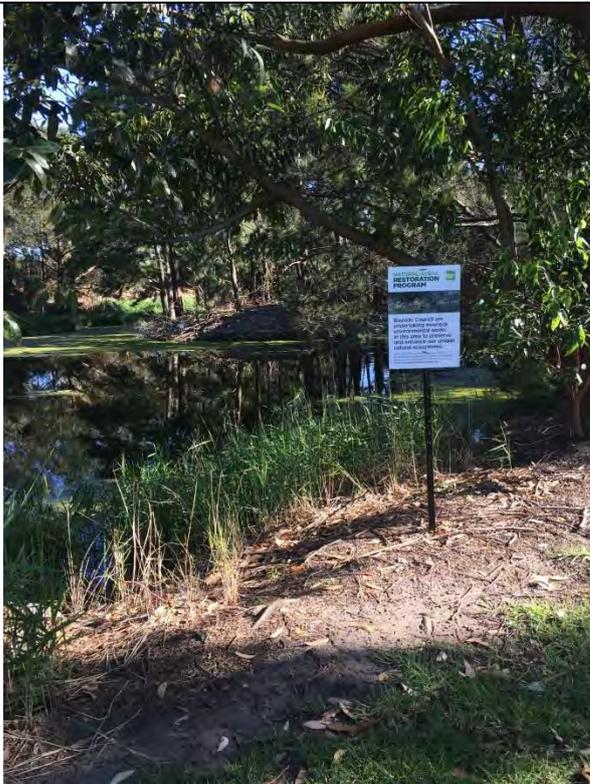
Photo No. 7	Date: 11/12/2017

Direction Photo Taken: North		
Description: Scarborough Ponds between Rockdale Bicentennial Park and the Memorial Fields
