Site Audit Report
0503-1612-1

New Maitland Hospital
Lot 7314 in DP 1162607
Metford Road, Metford NSW

29 January 2018

51731-111832 (Rev 0)
JBS&G Australia Pty Ltd

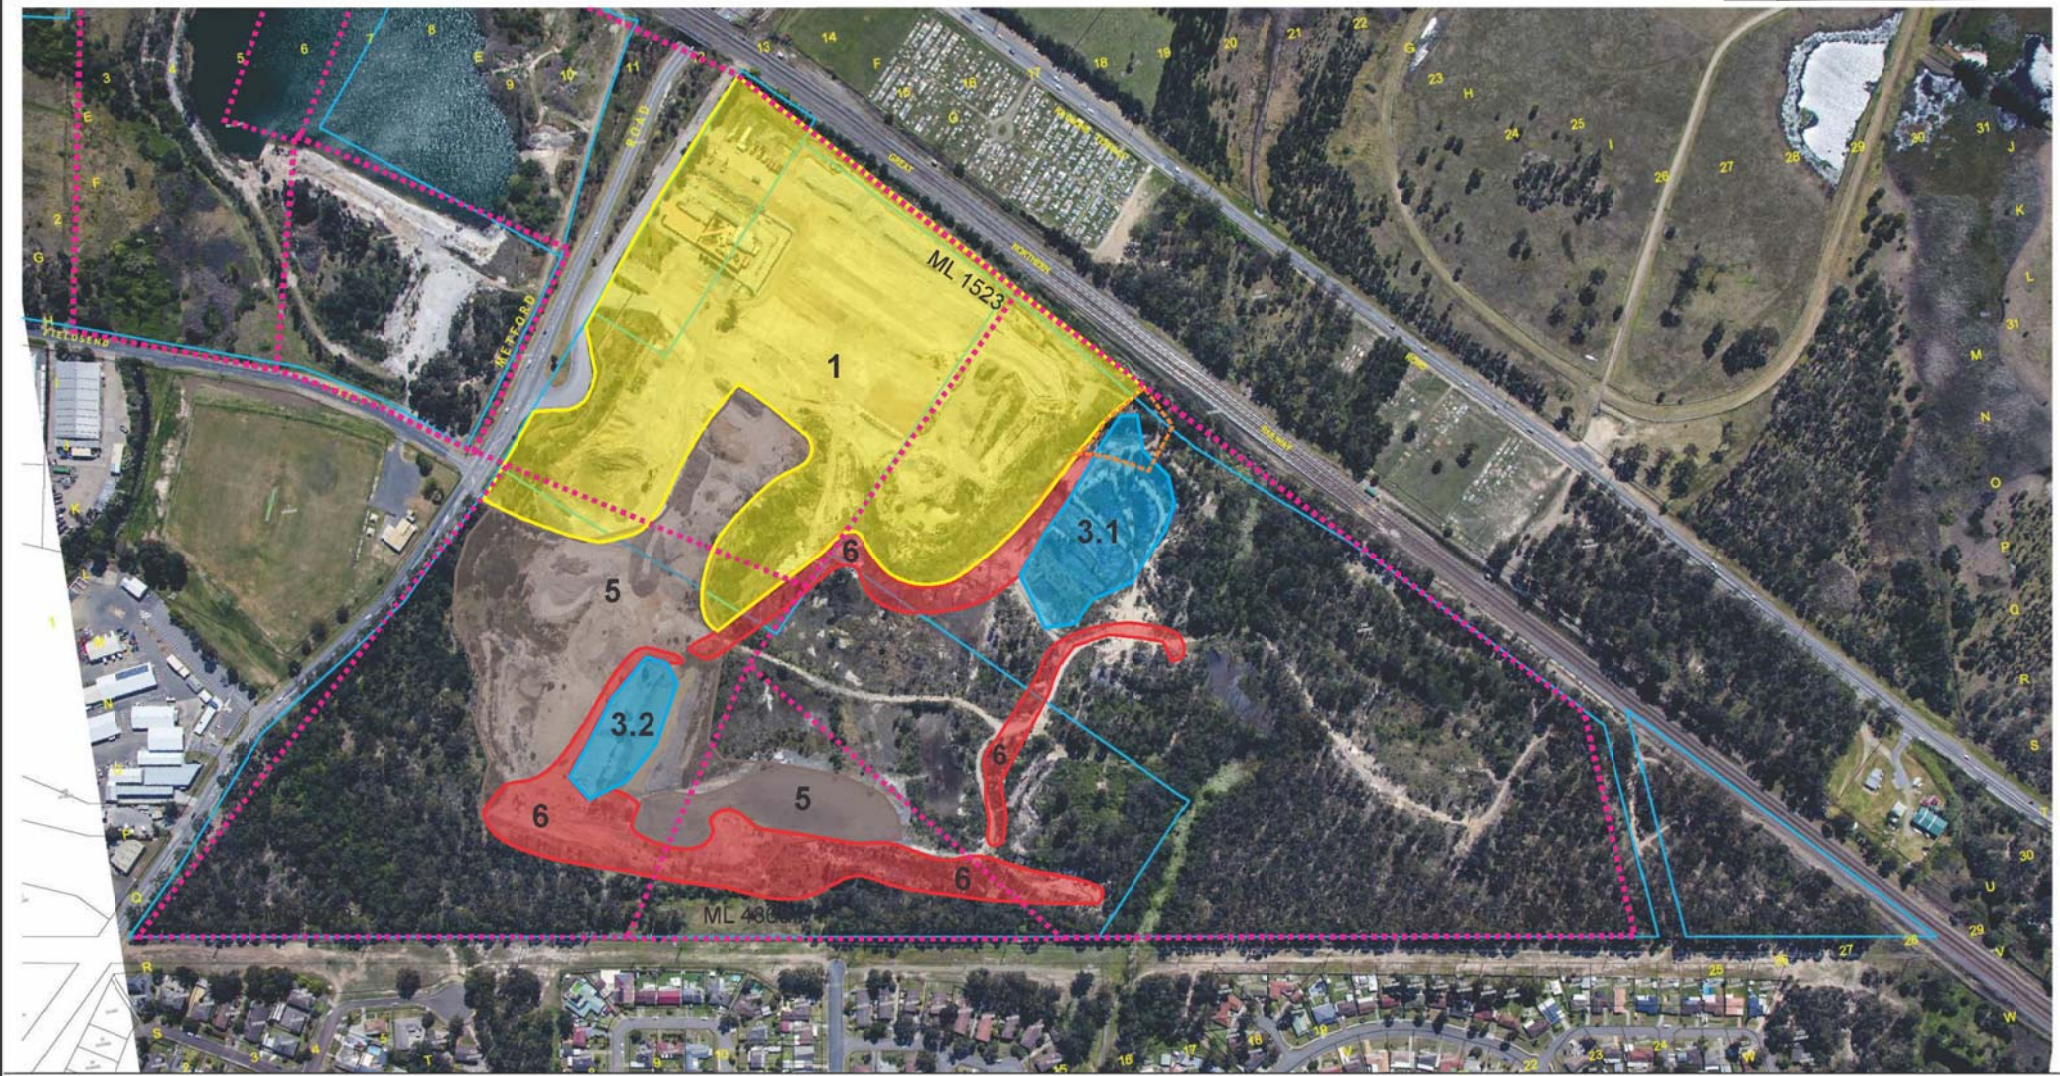
Plan of:	Metford Clay Mine Primary Domains (Operational)	Location:	Metford Clay Mine	Source:	Catalyst Project Consulting Boundaries not surveyed	Our Ref:	MT\2014\MOP 2014\Closure MOP 1400774_6\Fig3
Figure:	3	Council:	Maitland City Council	Survey:	ADW Johnson 239262-GRID-001-C	Plan By:	LGT
Sheet:	1 of 1	Tenures:	ML 1523, 5848, 4865, 5090	Projection:	MGA	Project Manager:	GVT
Version/Date:	A 9/3/2015	Client:	CSR Building Products Ltd	Contour Interval:	N/A	Office:	Thornton

1. Infrastructure Area		6. Void (open cut void)
	3. Water Management Area		
	5. Stockpiled Material		Mining Lease Boundary

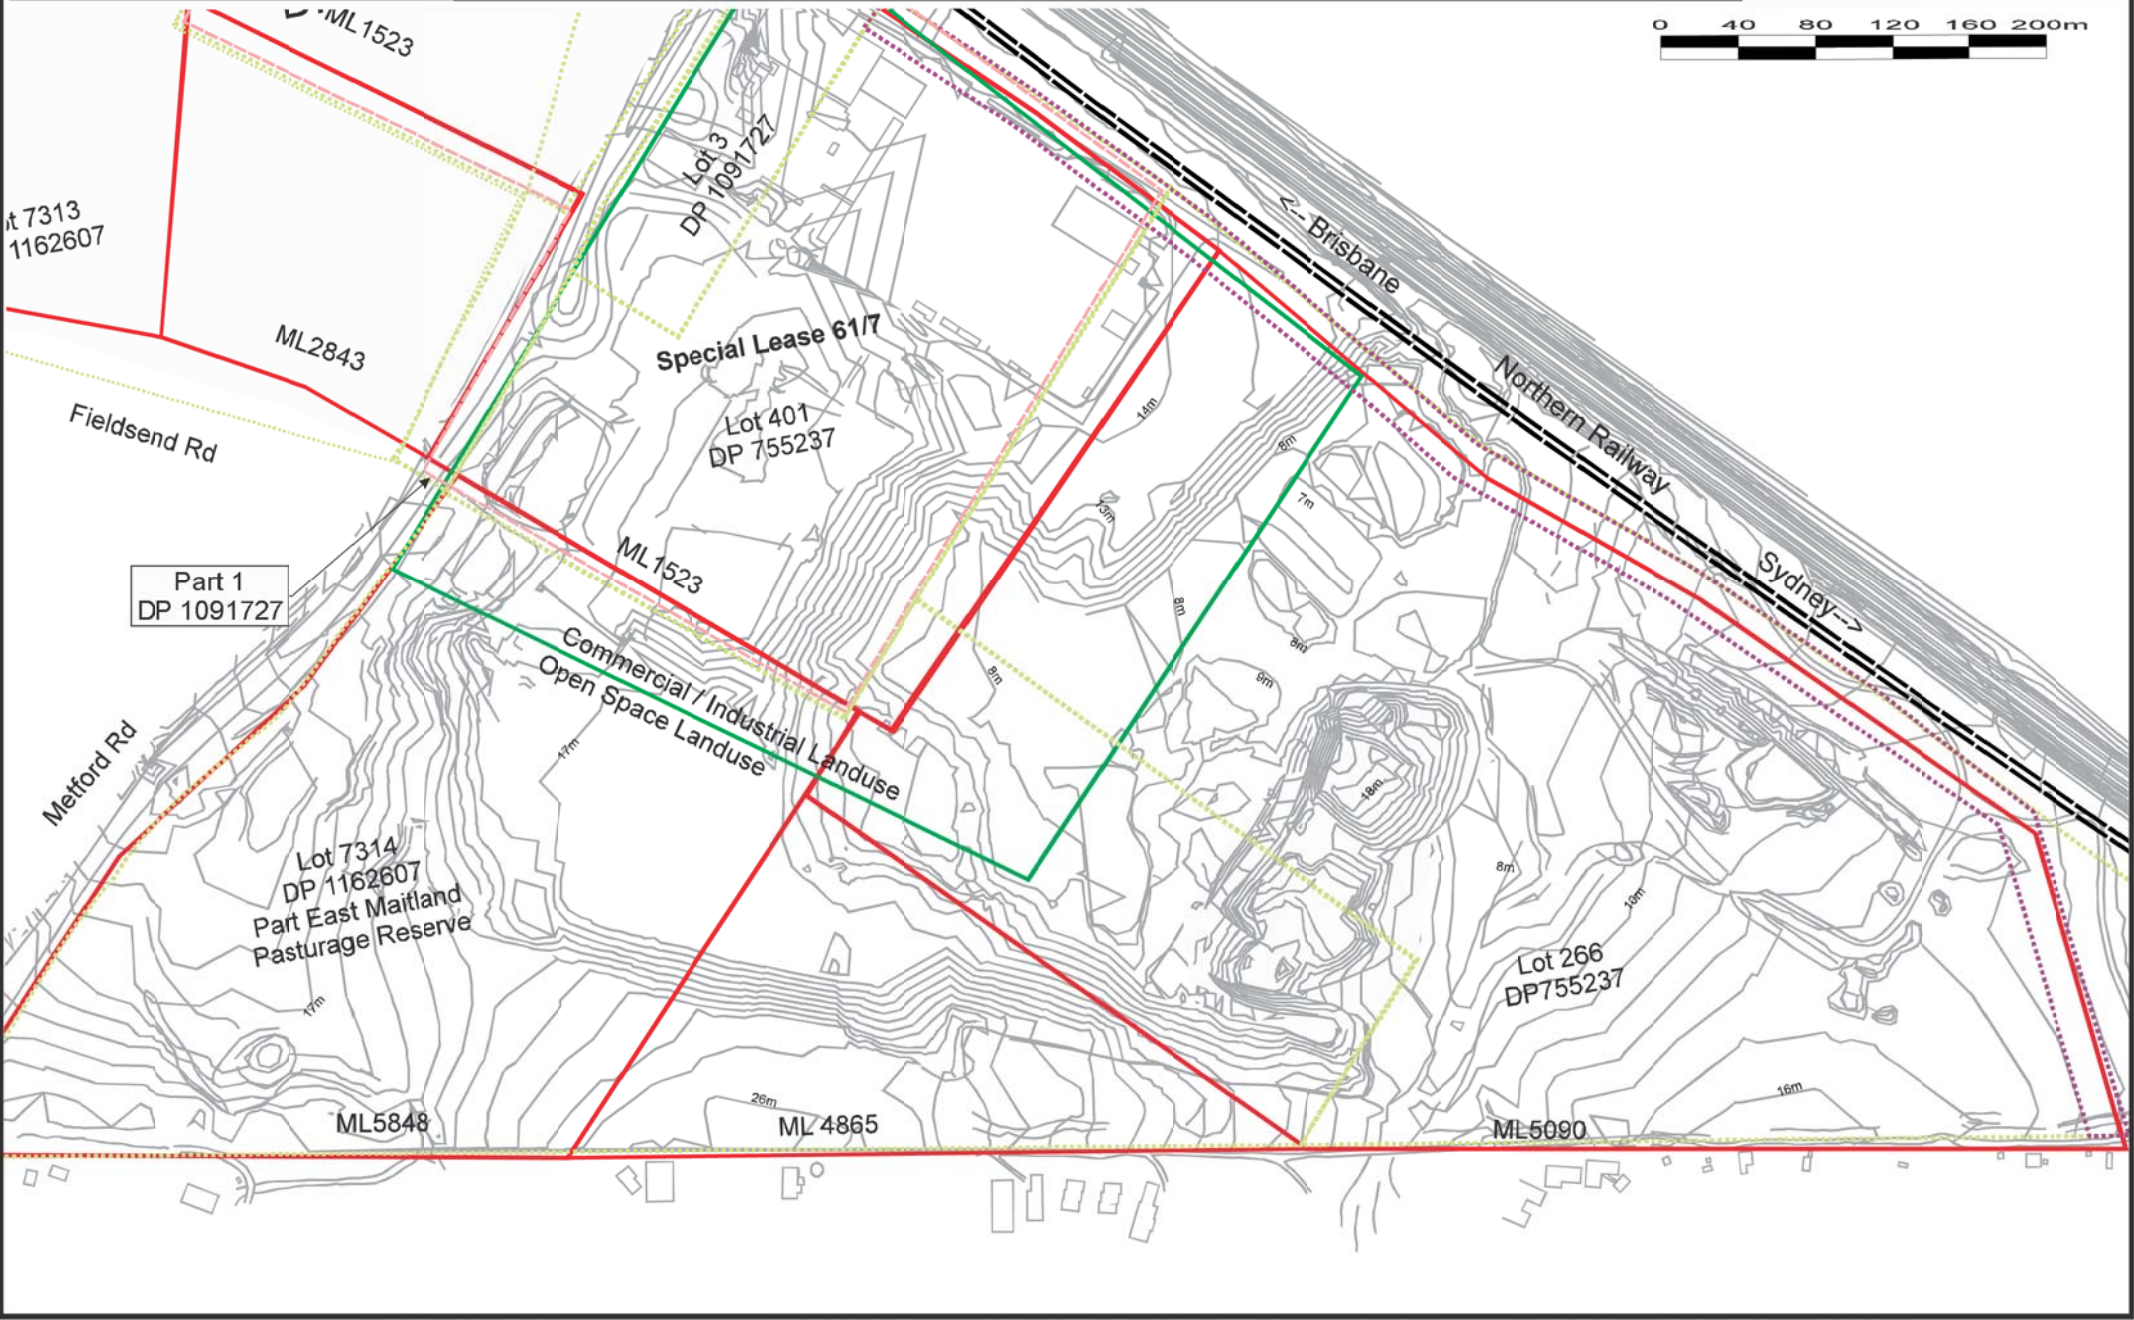
Plan of:	Conceptual Final Landform	Location:	Metford Clay Mine	Source:	From Figure 11 SoEE (Ref 8) Boundaries Not Surveyed	Our Ref:	MT2014MOP 2014 Closure MOP 1400774_6Fig5
Figure:	5	Council:	Maitland City Council	Survey:	AAM Hatch 27/2/06 1m contours	Plan By:	LGT
Sheet:	1 of 1	Tenures:	ML 1523, 5848, 4865, 5090	Projection:	MGA	Project Manager:	GVT
Version/Date:	A 9/03/2015	Client:	CSR Building Products Ltd	Contour Interval:	1m	Office:	Thornton
