## **ARCHAEOLOGICAL TECHNICAL REPORT**

New Maitland Hospital, Metford, NSW

March 2018

Prepared by  
**Umwelt (Australia) Pty Limited**  
on behalf of  
**Health Infrastructure NSW**

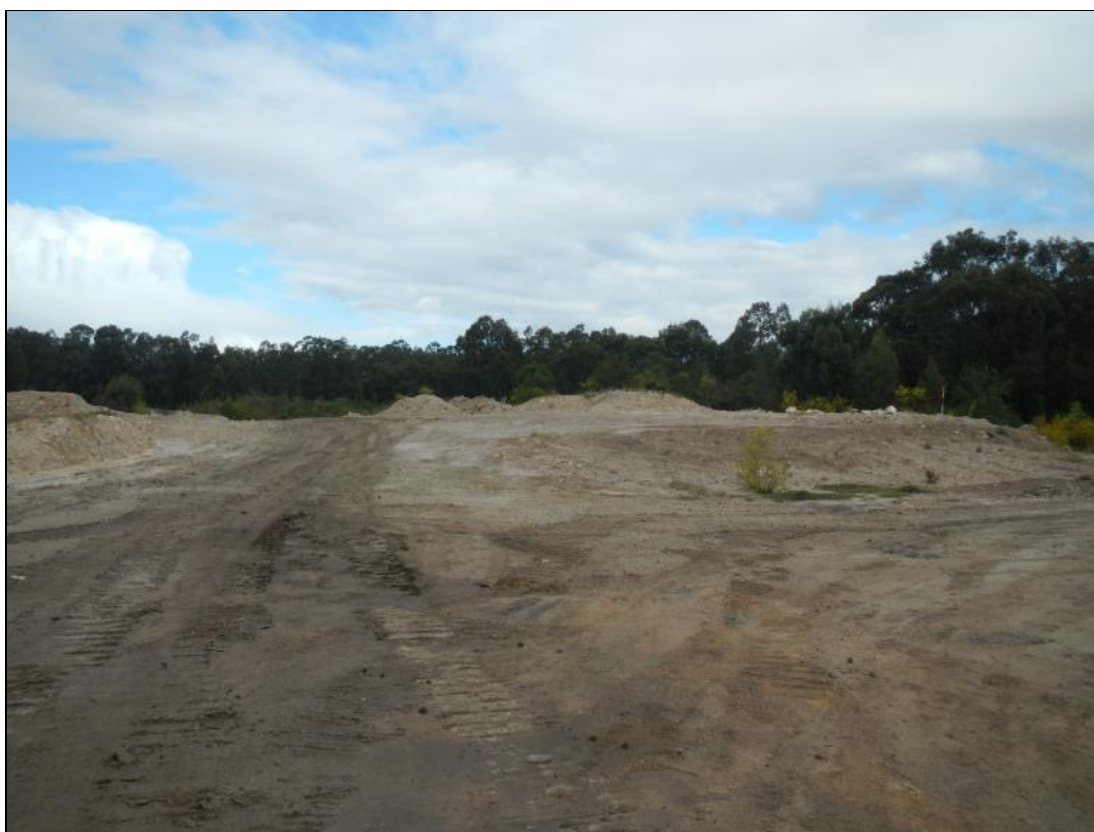
**Plate 5.1** View south overlooking portion of project area stripped of topsoil

Surface visibility across SU1 was high, up to 90 per cent and the level of exposure was very high as a result of topsoil removal (**Plate 5.1 – Plate 5.2**). The archaeological survey did not identify any Aboriginal cultural heritage material and found that there is no archaeological potential within SU1 due to the removal of topsoil and any archaeological deposits that may have been present.

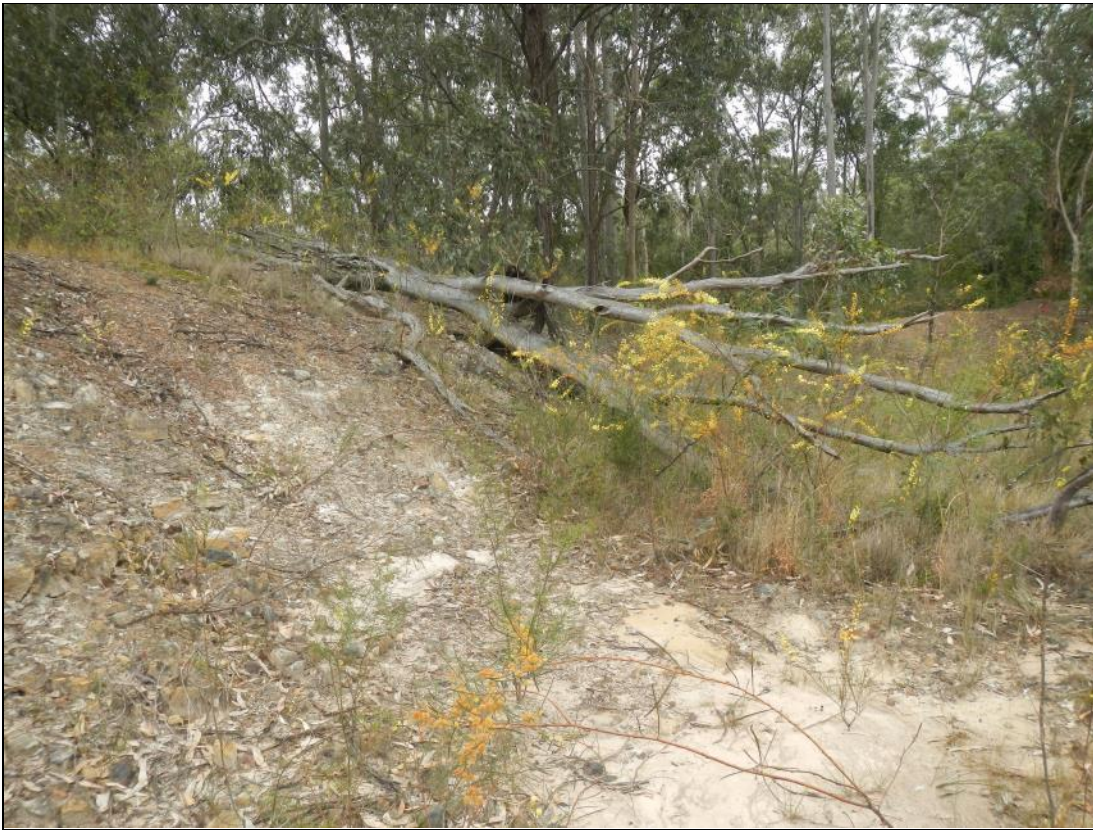
**Plate 5.3** view of mounded bundwall

Survey Unit 2 (SU2) included the disturbed and vegetated quarry bund. Disturbances across SU2 included the dumping of graded topsoil and gravel material to form a bund wall around the edge of the quarry (**Plate 5.3** and **Plate 5.4**)

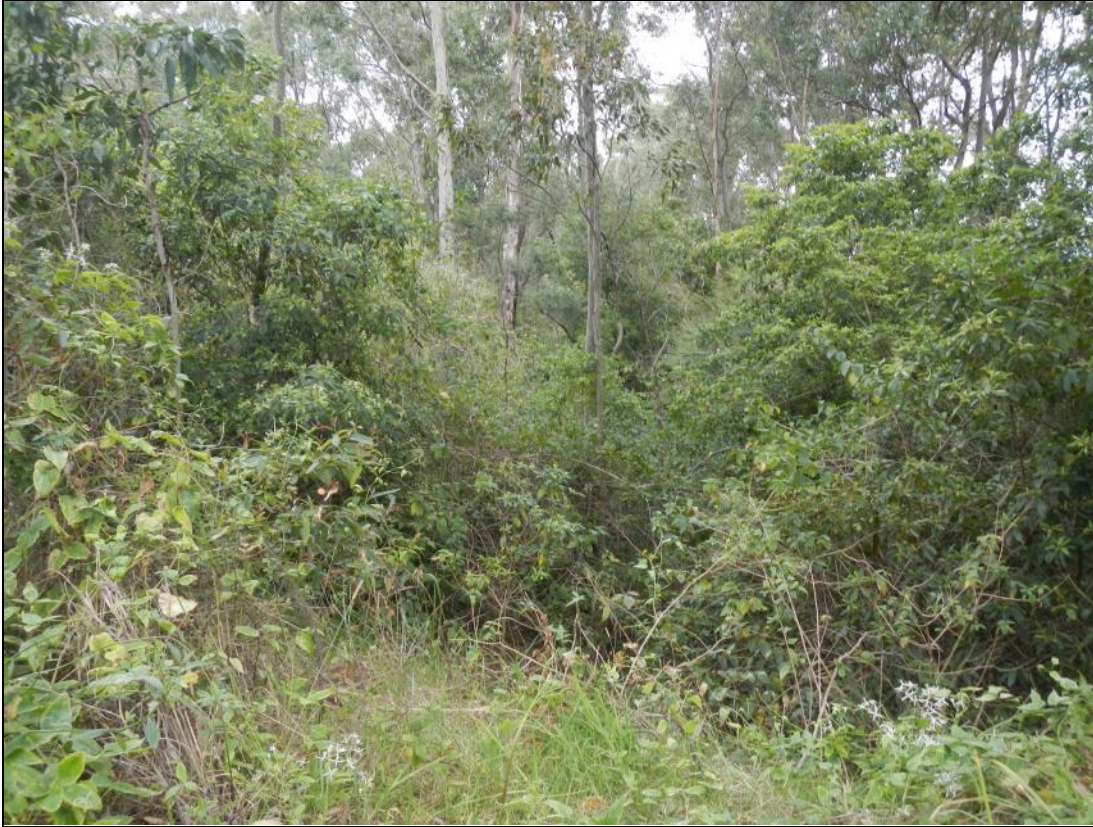
**Plate 5.6** View along western boundary of thick regrowth vegetation

Surface visibility across SU3 was limited due to extensive ground and vegetation cover with the eastern most portion of SU3 subject to a sample survey due to the presence of dense lantana. Surface visibility across SU3 was below 10 per cent with soil exposure identified as approximately 20 per cent (**Plate 5.5** to **Plate 5.7**). The archaeological survey did not identify any Aboriginal cultural heritage material, previously recorded or not and found that there is only low archaeological potential within SU3.

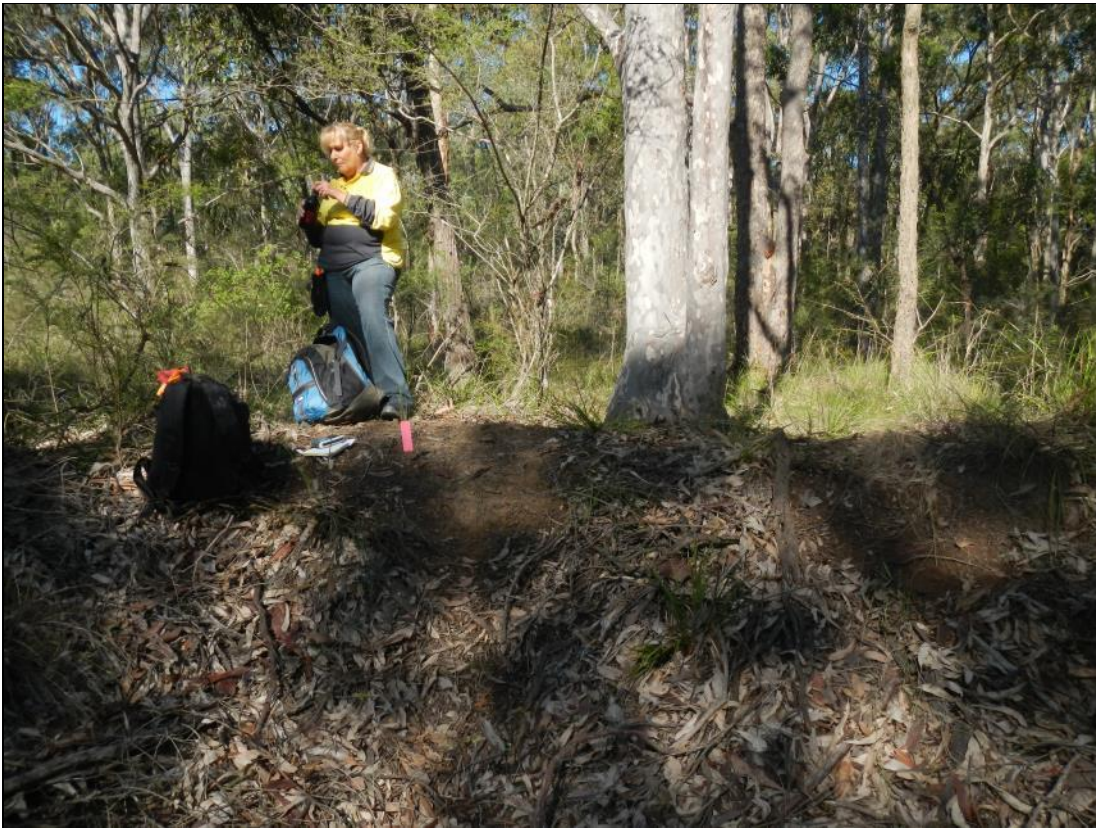
**Plate 5.8** Artefact location

The isolated artefact (AHIMS number 38-4-1684) was not re-identified during the archaeological survey. The isolated artefact was originally located along an area of exposure along an eroded soil profile. The current survey found that the original location of the artefact had been subject to high levels of erosion (**Figure 5.8** to **Figure 5.9**). As such, it has been determined that 38-4-1684 was not re-identified due to the high level of erosion and that the isolated artefact is likely to have moved due to natural post depositional processes.
