# CHAPTER 12

## Heritage

NORTH STAR TO NSW/QUEENSLAND BORDER ENVIRONMENTAL IMPACT STATEMENT

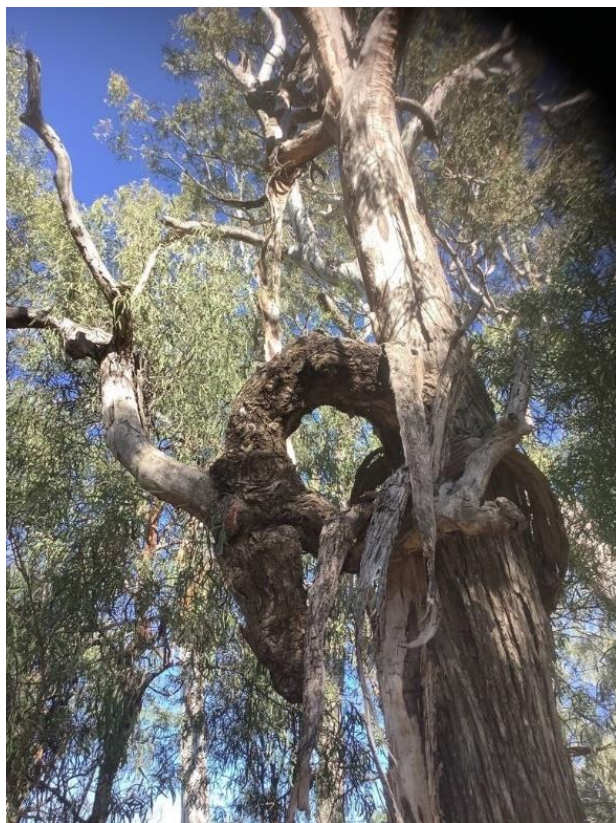
PHOTOGRAPH 12.1 THE 'RING' OF THE RING TREE SHOWN BENT OVER AND GROWING AROUND THE BRANCH BELOW

A 'ring tree' was located on the southern banks of the Macintyre River approximately where the proposed viaduct crosses the river. Ring trees (sometimes called hoop trees) are trees where branches have grown together, fusing and forming a ring. Ring trees can occur through both natural (inosculation) and cultural (grafting) means. Field representatives on the survey, identified this tree as being a marker tree either symbolising a border or point of interest (camp site). Despite this tree's proximity to Toomelah, it was not previously known to the local field representatives.

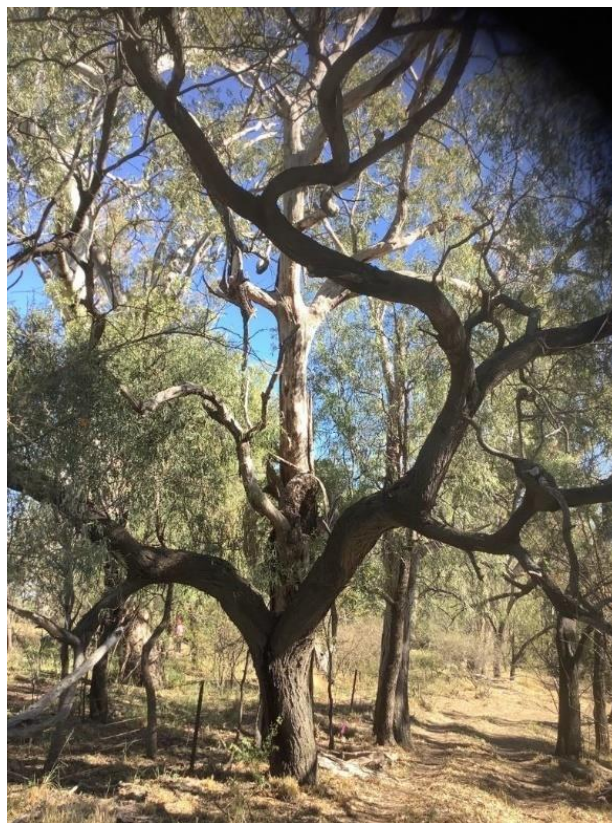
PHOTOGRAPH 12.2 CONTEXT SHOT OF RING TREE ON VEHICLE TRACK LEADING DOWN TO MACINTYRE RIVER. NOTE THAT A SEPARATE TREE IS GROWING IN FRONT

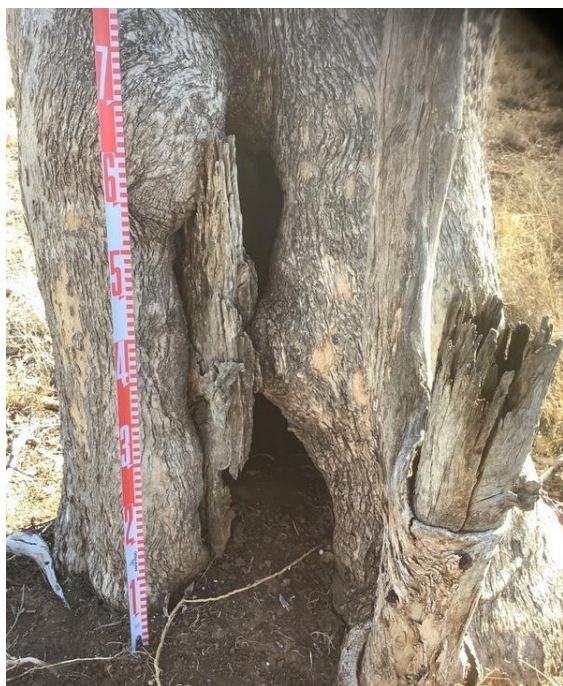
PHOTOGRAPH 12.3 EXAMPLE OF INDETERMINATE SCAR

In addition to the 16 culturally modified trees which were identified and confirmed during the survey, an additional 26 modified trees were identified by survey participants. However, these additional trees could not be convincingly demonstrated to be cultural or natural scars. The scars on these trees were typically either diseased or damaged, or the tree in question was assessed as being young and therefore not likely to have been culturally scarred. Rather than dismiss these trees immediately recommendations are made regarding their reappraisal by an arborist before determining as to whether they should be salvaged.

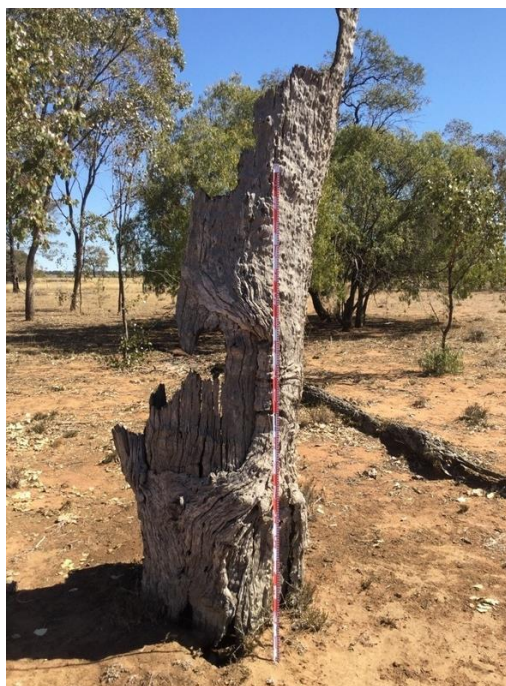
PHOTOGRAPH 12.4 EXAMPLE OF INDETERMINATE SCAR

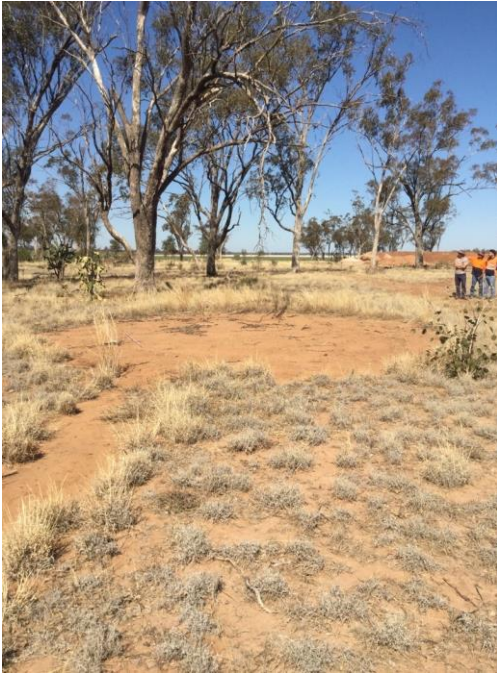
PHOTOGRAPH 12.5 CIRCULAR FEATURE LOOKING WEST

During the survey, a circular feature was identified in the southern half of Site 8, a proposed borrow pit for the proposal. The feature is an almost circular patch of barren ground with nearly no grass, measuring approximately 8 m across. A linear, cleared line connects the circle and extends north east to a nearby access track.

Several hypotheses were put forward to explain this feature, and further detail is provided in Appendix E: Aboriginal Cultural Heritage and Archaeological Assessment. The nature of this feature remains unresolved but at present a decision has been made to avoid it. To clarify its status, further investigations are recommended in Appendix E: Aboriginal Cultural Heritage and Archaeological Assessment.

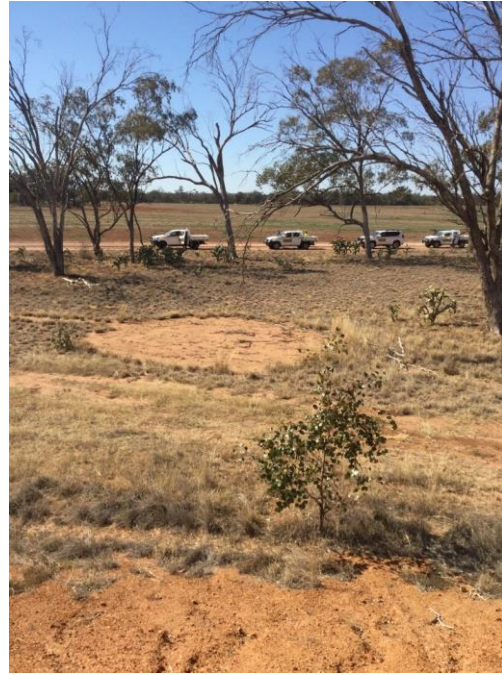
PHOTOGRAPH 12.6 CIRCULAR FEATURE LOOKING EAST
