INLAND
RAIL

Land Resources and Contamination

NORTH STAR TO NSW/QUEENSLAND BORDER ENVIRONMENTAL IMPACT STATEMENT

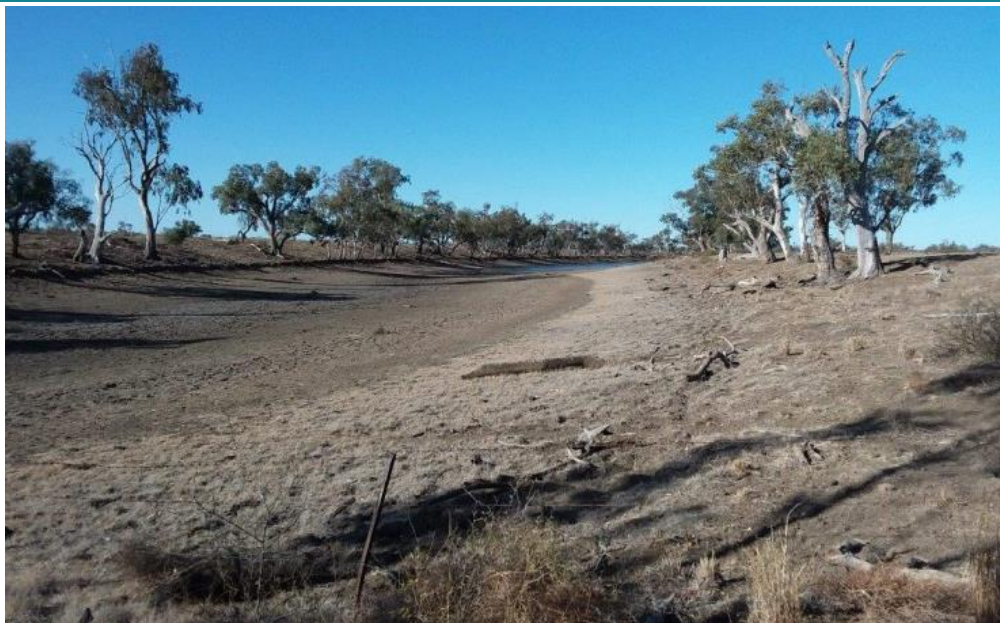
Whalan Creek upstream of Site 7 (Dry at time of assessment—August 2018)

Whalan Creek	<p data-bbox="421 1364 1428 1507">Whalan Creek is a major creek approximately 60 km long that discharges in a westerly direction into the Macintyre River, downstream of Goondiwindi. Whalan Creek is an anabranch of the Macintyre River and appears to also receive flows from the Macintyre River during over-bank flow events. This creek is ephemeral but larger than other creeks in the area, with a well-defined channel likely to flow seasonally.</p> <p data-bbox="421 1518 1428 1632">The creek is approximately 50–70 m wide and runs within a broad agricultural landscape with a mix of grazing and cropping on both banks. The width of the floodplain was undetermined as there were no distinctive features or changes in vegetation to identify the floodplain extent. However, the entire area adjacent to the creek is a floodplain.</p> <p data-bbox="421 1644 1428 1843">These sites are highly disturbed/modified with significant impacts to the waterway and the riparian zone. Riparian vegetation cover is highly degraded/modified, with an overstory of <i>Eucalyptus</i> sp. and <i>Acacia</i> sp. providing sparse cover. There was limited evidence of tree regeneration and shrub/ground cover was low. The bed of the creek is stable and dominated by silt and some sand, and there was limited fish habitat visible at the site. A large pool was visible outside of the assessment reach; however, the creek was otherwise dry at the time of the site inspection.</p>

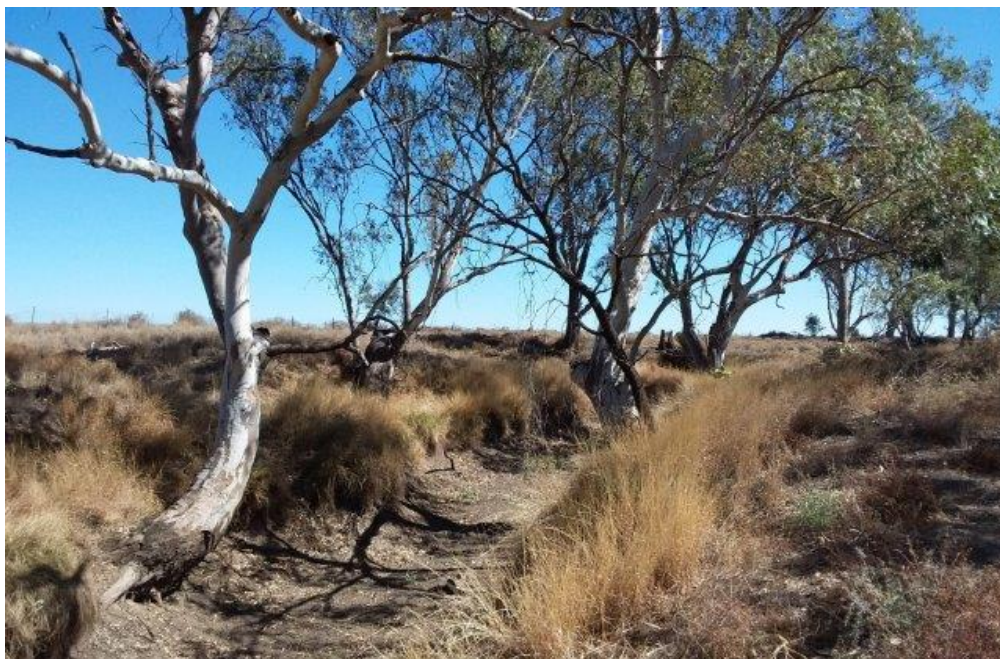
Mobbindry Creek downstream of Site 1 (Dry at time of assessment—August 2018)

The creek is ephemeral, with a well-defined channel. The floodplain is broad and undefined adjacent to Mobbindry Creek. The local land use and the broader catchment are highly modified and impacted by agricultural activities (grazing and cropping). The creek is 26–30 m wide. The riparian corridor comprises an overstorey of *Eucalyptus sp.* and Brigalow, with some shrub cover and a good understory cover. The creek-bank vegetation includes a continuous cover of fringing rushes and sedges. The creek bed was stable at the time of assessment and includes silts and some sand. The channel form was varied but dominated by run habitat, with some pools expected to be present during flow. Obstructions to the waterway include the existing rail-and-road crossing, and there were some natural barriers in the form of large snag piles.

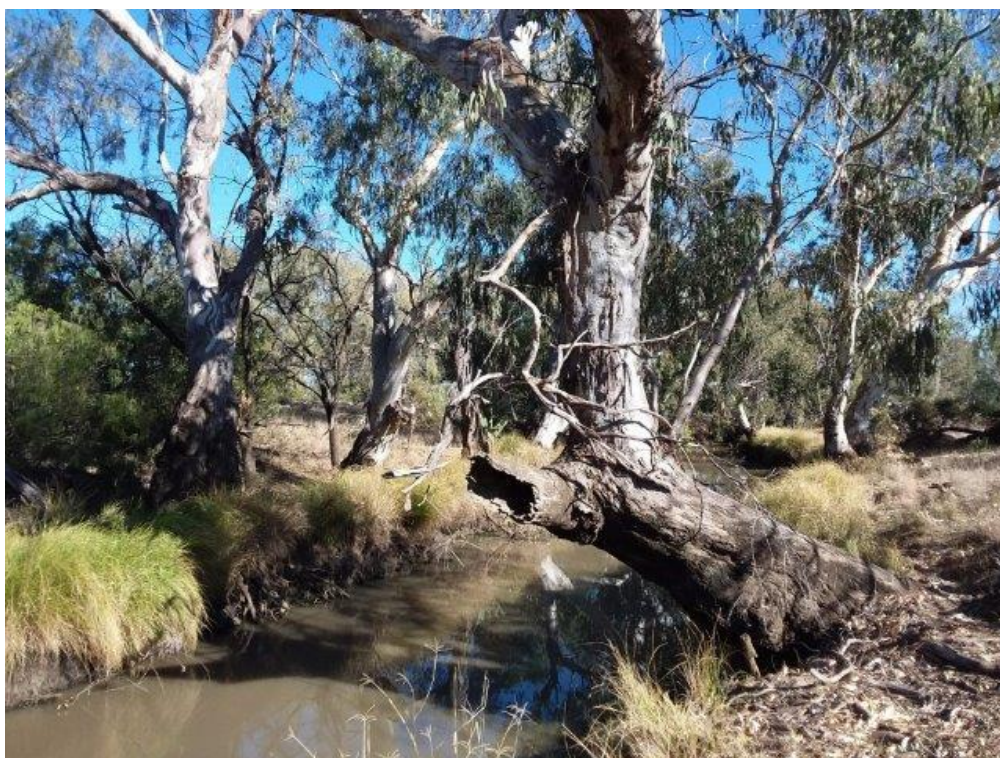
Back Creek upstream of Site 5 (Low flow at time of assessment—August 2018)

This creek is ephemeral, with a well-defined channel. Riparian vegetation was dominated by *Eucalyptus* sp. and Brigalow, with shrubs present and good understory dominated by native species. The creek is approximately 18–30 m wide. The top of the banks along the creek are covered by *Carex* sp. The creek channel was between 1 m deep and 3 m wide at the time of assessment. The substrate is unconsolidated silt with many snags present in the creek. There was a slight sheen to the water and an anaerobic odour generated from the sediment when disturbed.

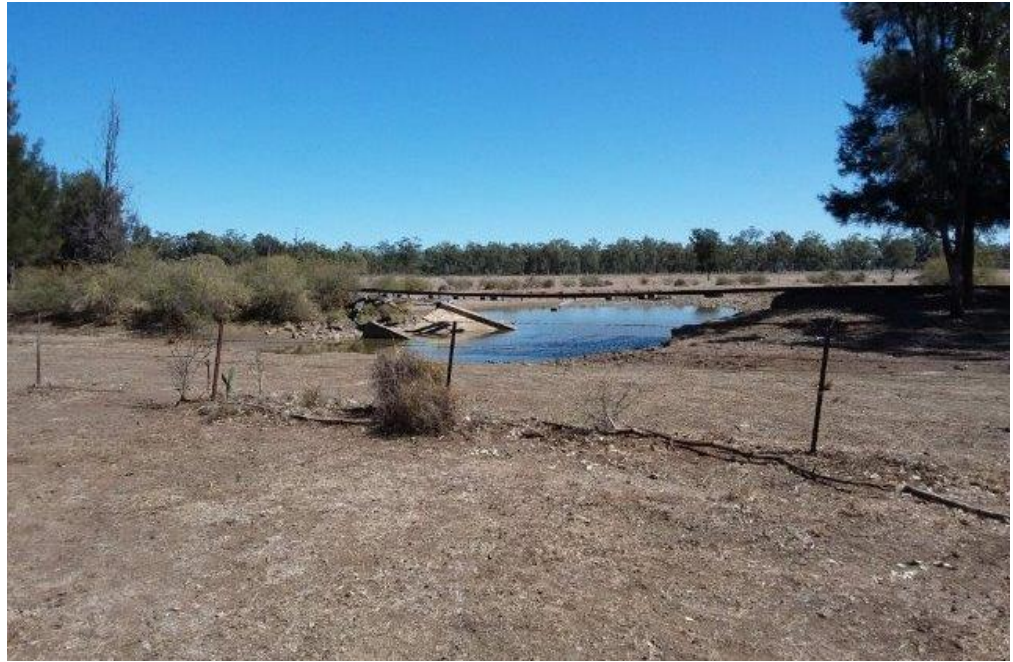
Forest Creek downstream of Site 16 at the rail crossing (Isolated pool at time of assessment—August 2018)

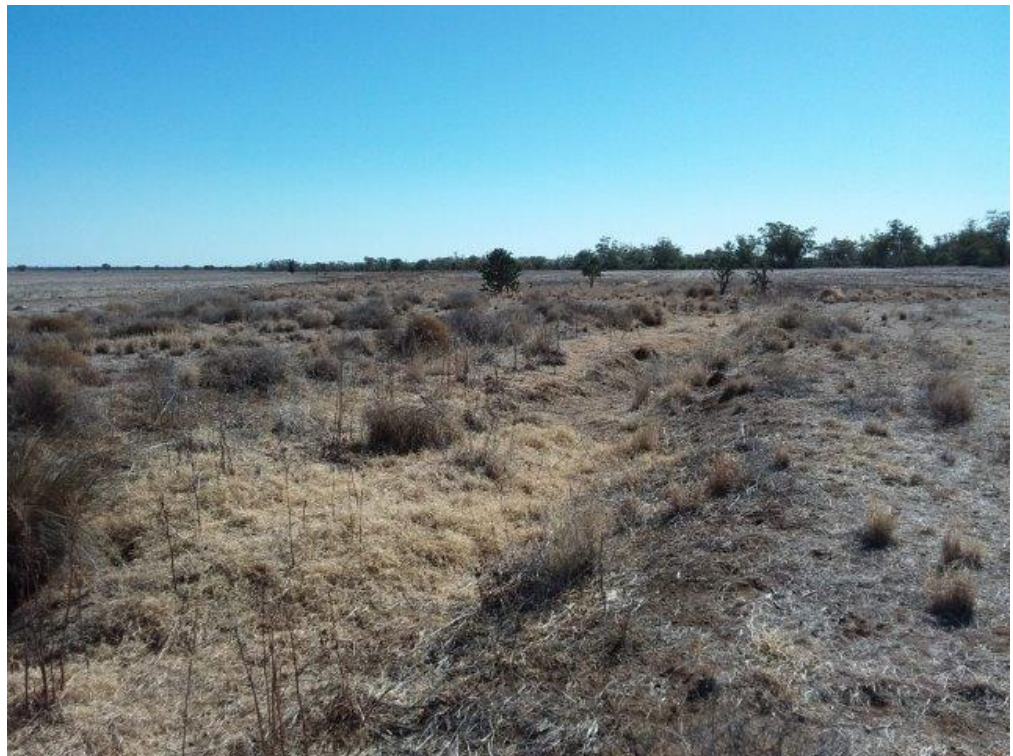
Unnamed tributary of Mobbindry Creek downstream of Site 15 (Dry at the time of assessment—August 2018)

The creek is 9–30 m wide. At the time of assessment it was narrow and shallow (<0.5 m) in parts, with a uniform sand bed. In other reaches it contained highly mobile silt and sand that has a scoured low-flow channel within it. The overstorey riparian zone was non-existent with a highly degraded understorey and ground-cover riparian vegetation. Levees have been constructed along both banks.

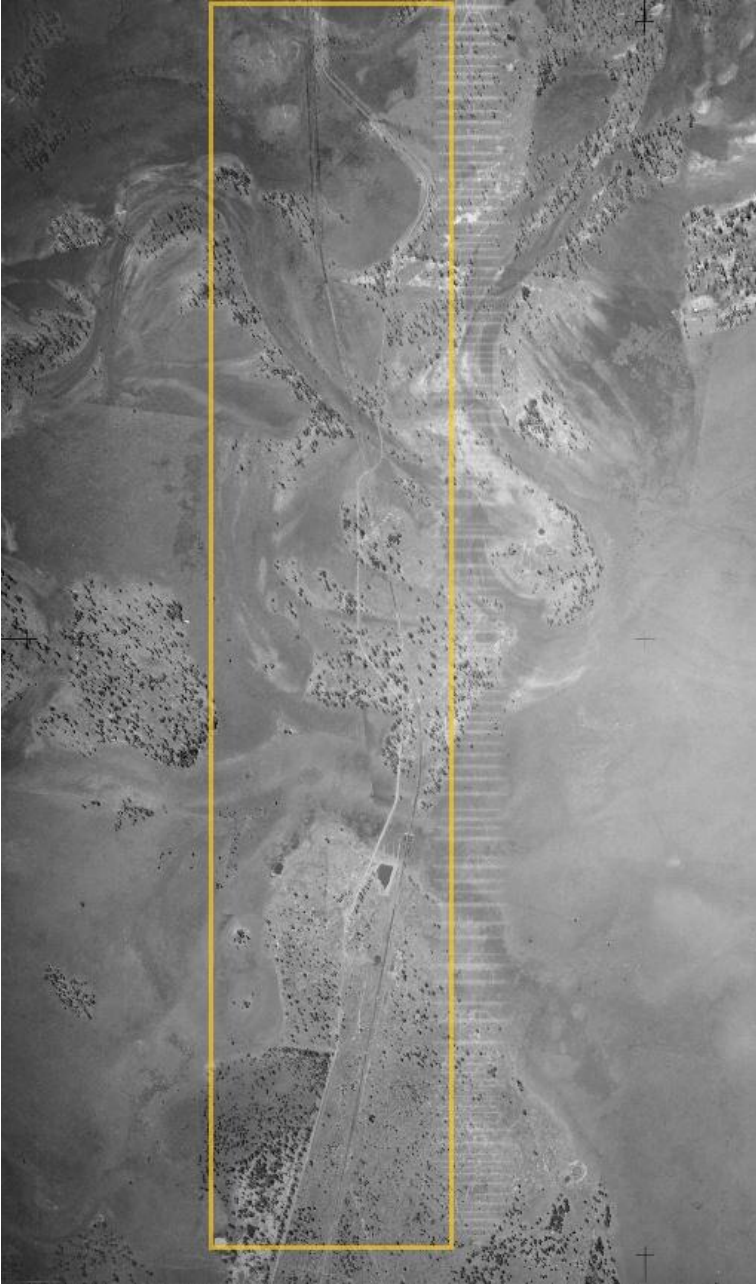
<p>Year: 1949</p> <p>Direction: Aerial</p> <p>Details: Aerial image displays the existing non-operational Boggabilla rail corridor traversing the landscape between North Star and the Macintyre River.</p> <p>It is evident from the aerial image that grazing pastures are the dominant land use in the region.</p> <p>Cleared patches exist east and west of the rail corridor due to land clearing, with eroding soils identifiable through smudge-like patterns on the aerial image to the north. Several private dams also exist near the rail corridor.</p> <p>Source: Queensland Department of Natural Resources and Water (2009).</p>

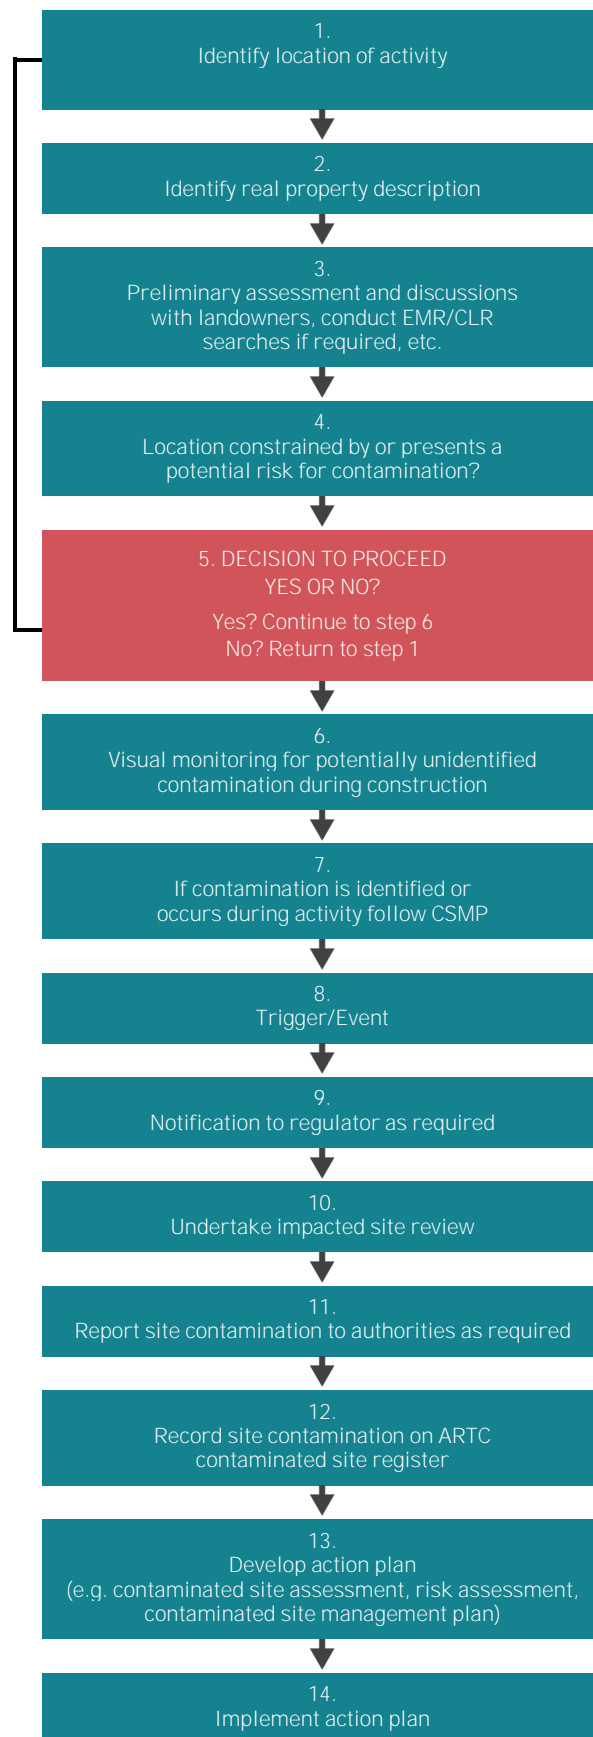
FIGURE 15.16 CONTAMINATED SITE MANAGEMENT PLAN (CSMP) STRATEGY

On conclusion of the desktop assessment, most soil existing in the rail corridor may be suitable for re-use without treatment. However, some materials may require treatment or management prior to re-use and will be subject to assessment by a suitably qualified person. It will also be subject to sampling and laboratory analysis, where it will be screened against applicable health and ecological guidance values/screening criteria.
