Contamination - Gas pipeline

Australian Industrial Energy

Port Kembla Gas Terminal Preliminary Site Investigation - Pipeline Alignment

November 2018

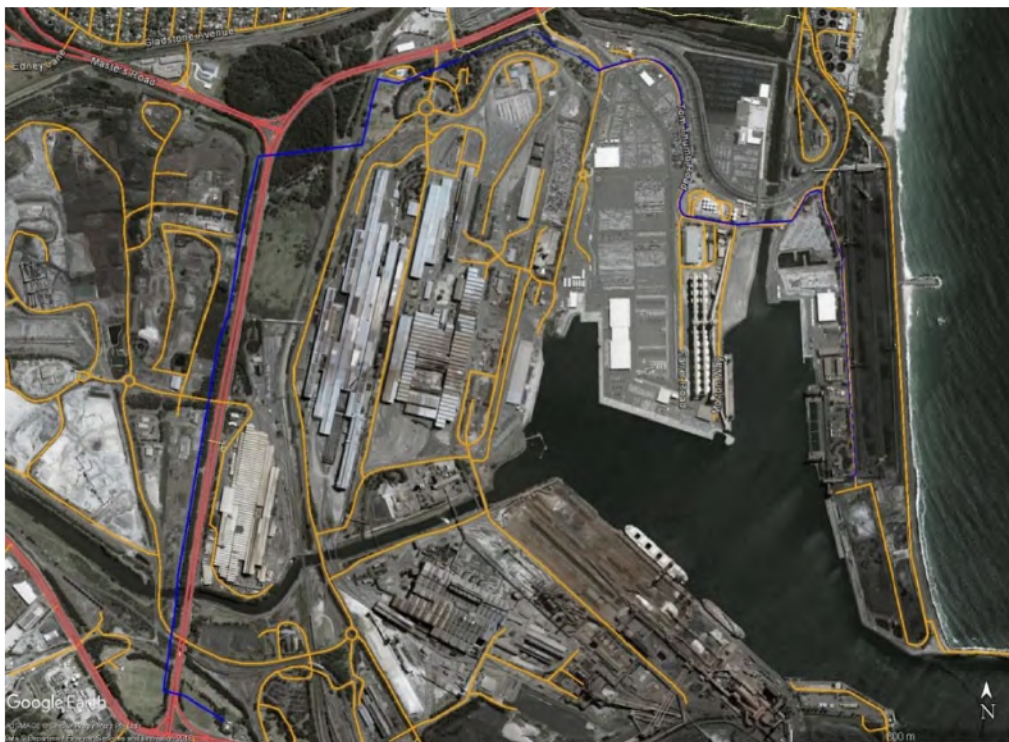
Figure A - Pipeline route (blue line) around Port Kembla district

This report provides the results of a Contamination Assessment for the pipeline route from Berth 101 to the Port Kembla meter station at Cringilla. The contamination assessment for the area within the immediate vicinity of Berth 101 including dredge area has been reported separately. For the purposes of this report, the “site” comprises the pipeline route as indicated in Graphic A, including an 8 m buffer on either side of the alignment.

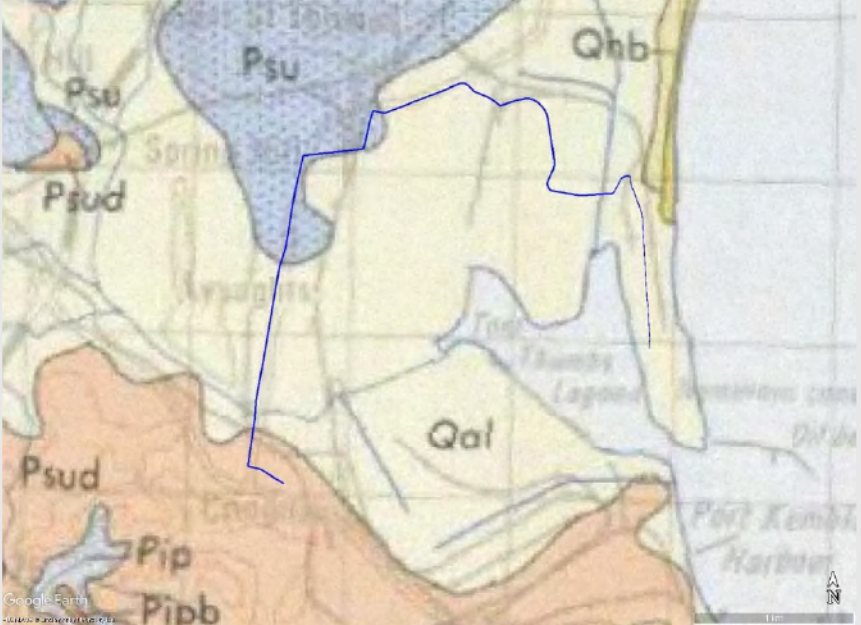
<p>Figure B - Geology of Wollongong - Port Hacking 1:100,000 map extract showing pipeline alignment (blue line)</p>

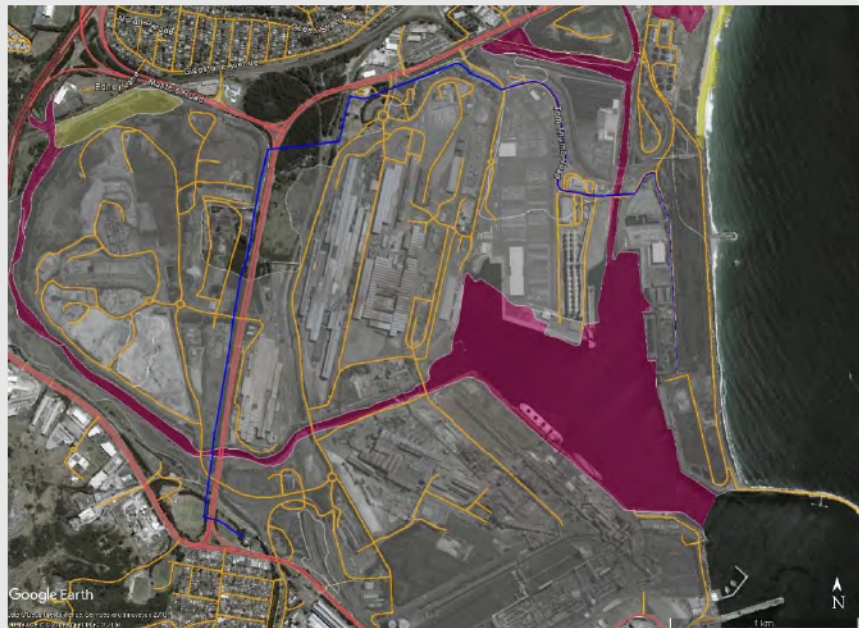
The *Wollongong 1:25,000 Acid Sulfate Soil Risk Map* indicates that the pipeline alignment is underlain by areas of Disturbed Terrain (grey) from 2 m to > 4 m thickness or areas of No Known Occurrence (no colour). Estuarine sediments (dark pink) exist within Allans Creek, Gurungaty Waterway and Inner Harbour and are mapped as having a high probability of occurrence of acid sulphate soils.

Figure C - Wollongong 1:25,000 Acid Sulfate Soil Risk Map extract showing pipeline alignment (blue line)

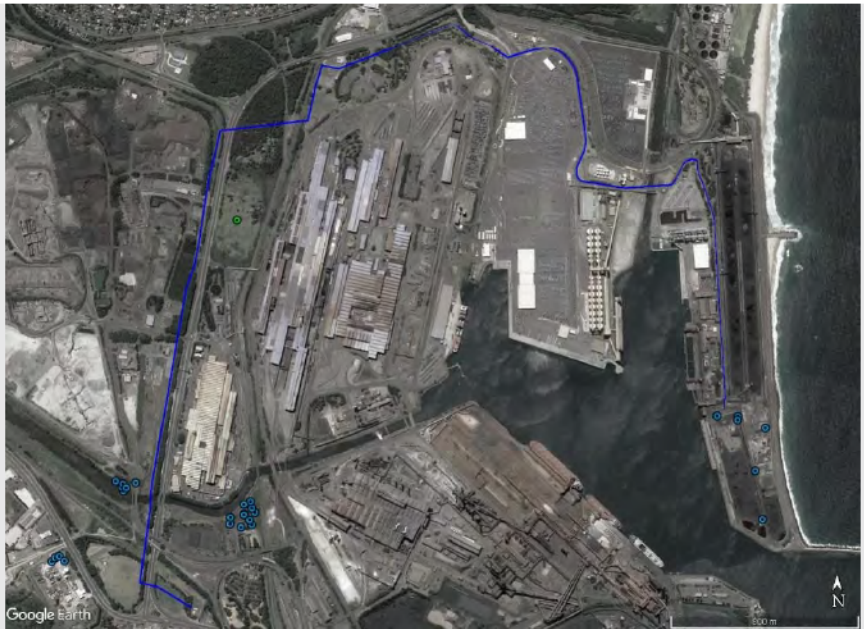
A search of publically registered groundwater bores within 500 m of the alignment returned 61 results, of these only a single bore (GW100678) contained standing water level information. This location is on the western extent of the pipeline alignment, approximately 150 m east of the alignment and had a standing water level of 8.2 m. Bores with reliable location data are shown in Figure D below.

Figure D - Public groundwater bore search results showing pipeline alignment (blue line)

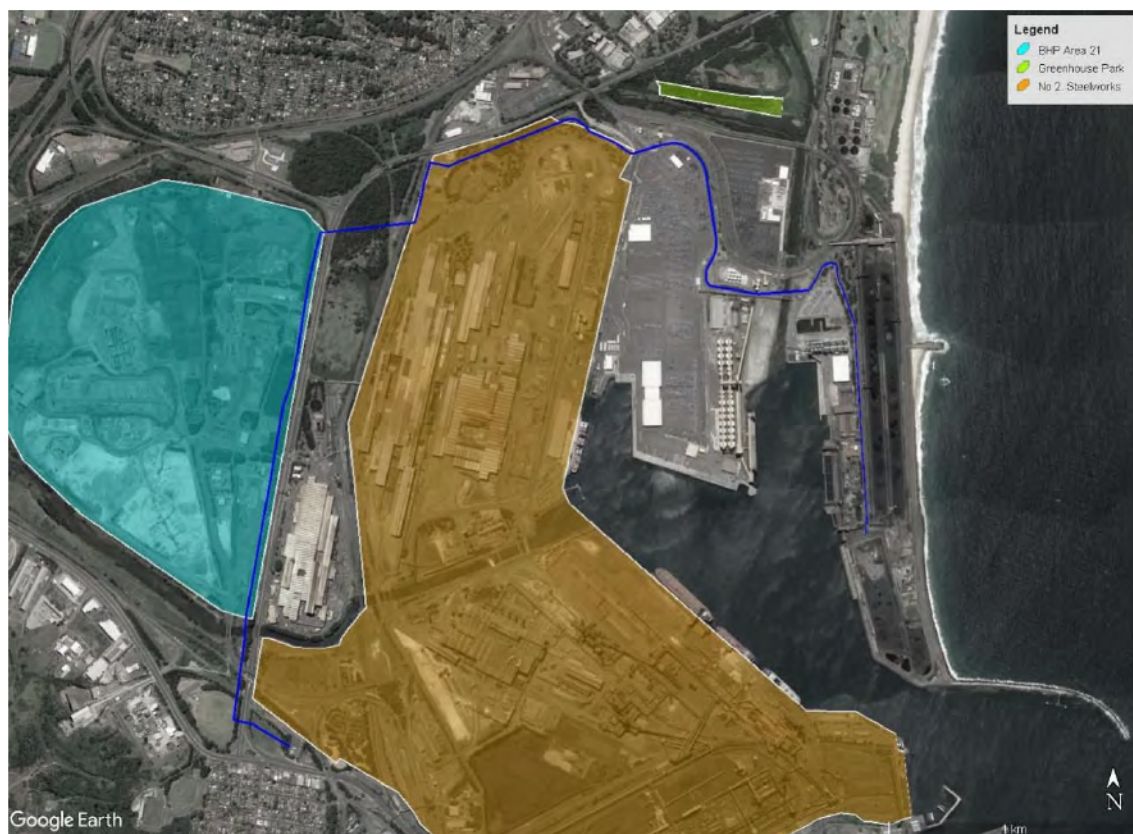
Figure E - NSW EPA Contaminated Sites Records of Notice within 500 m of the pipeline alignment

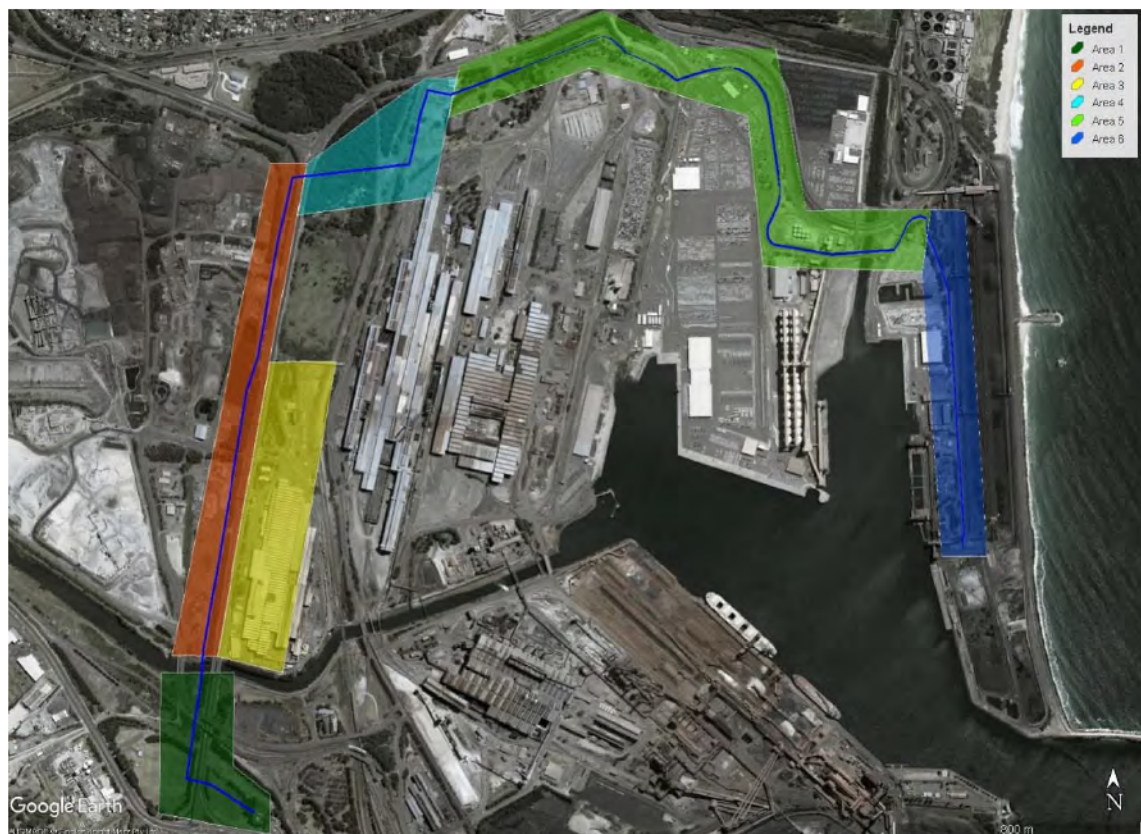
For the purposes of the aerial photography review the site has been divided into six areas as shown in Figure F below.

Figure F - Aerial photography review areas

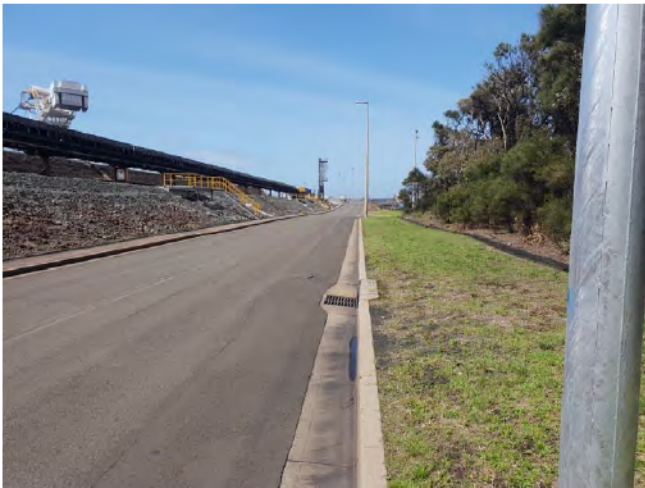
Photograph 1 Looking south along the main access road in PKCT, note coal loader and stockpiles to the left of photograph.

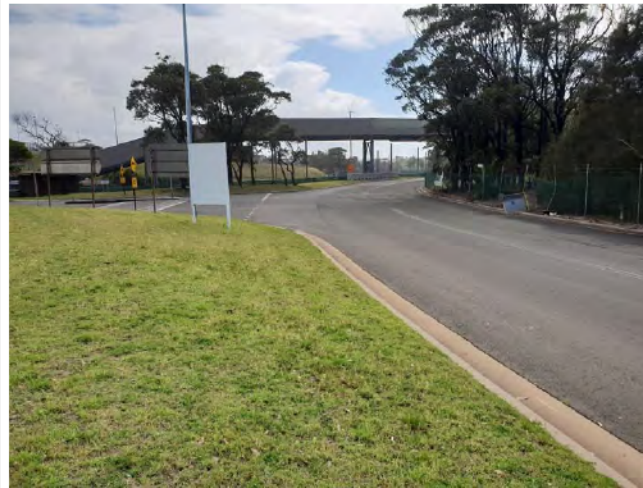
Photograph 2 Looking north towards the intersection of Tom Thumb Rd and Port Kembla Rd, where the proposed pipeline route changes direction from a north-south alignment to approximately east-west.

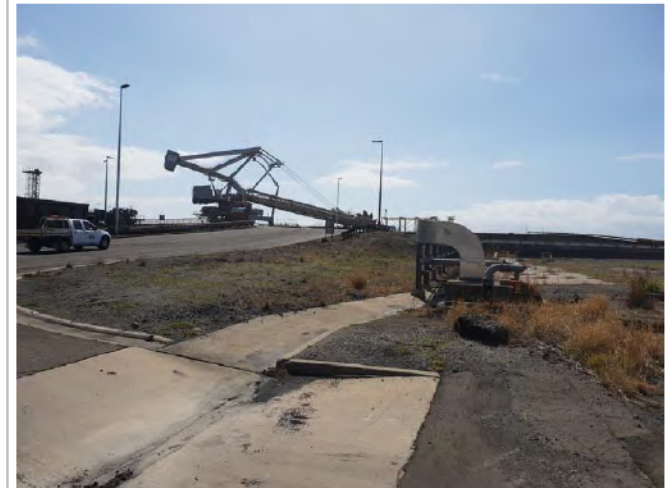
Photograph 3 Looking east towards the northern end of berth and southern end of the coal stockpiles and loaders.

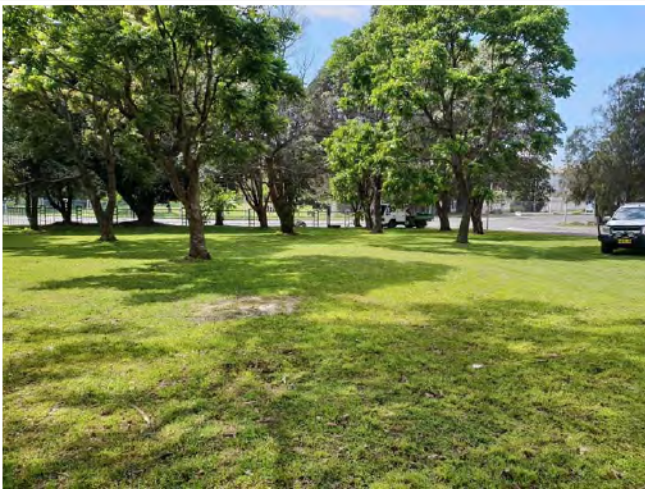
The walkover was conducted in the area around the Bluescope visitor car park which was in the general vicinity of WorleyParsons geotechnical borehole BH-19. The area immediate area around BH-19 was mainly lightly vegetated with grasses and light tree cover, the vegetation did not appear to be distressed (Photograph 4). The area to the south-west of BH-19 was a visitor carpark for BlueScope, south south-east are the boom gates and entrance into BlueScope. There was a building west of BH-19 and paved car parking area located behind it. Drainage in this area is likely to infiltrate into the soil in unpaved areas, with runoff expected to get captured in existing stormwater drains.

Photograph 4 Looking north in the grassed area near BlueScope site entry gate, note backfilled WorleyParsons BH-19 as disturbed ground in the centre left of the photograph

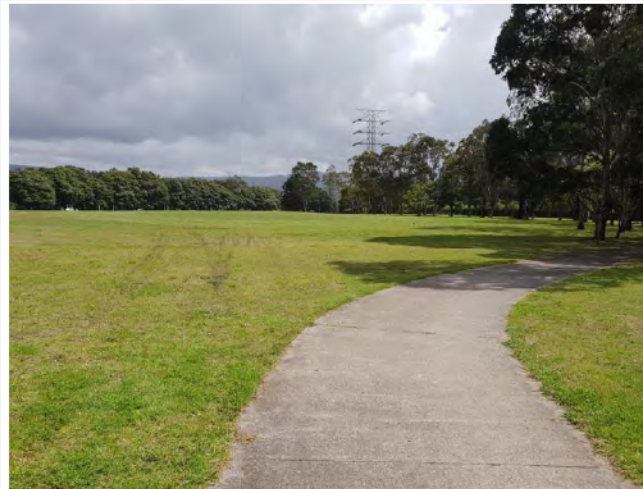
The walkover was conducted on the grassed reserve on the corner of Five Islands Rd and Springhill Rd. The immediate area south, east and north of BH-26 was a grassed reserve (Photograph 5); existing gas infrastructure was present in this area and the location where the proposed pipeline is expected to cross Springhill Road (Photograph 6). Drainage in this area is likely to infiltrate into the soil in unpaved areas, with runoff expected to get captured in existing stormwater drains located on Springhill Rd.

Photograph 5 Looking south-west over the grassed reserve on the corner of Five Islands Rd and Springhill Rd

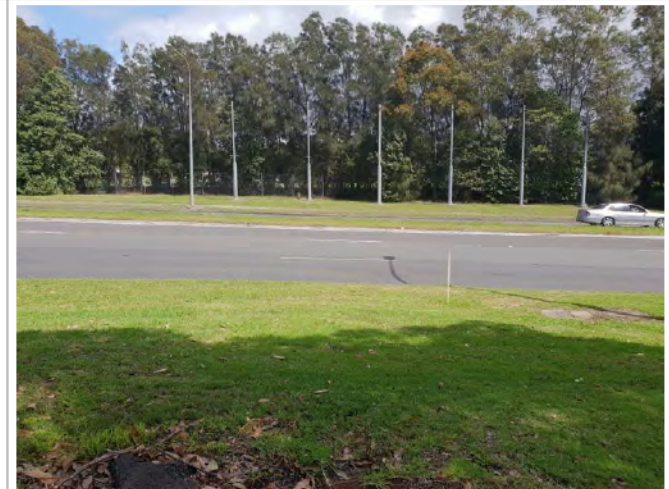
Photograph 6 Looking west towards Springhill Road

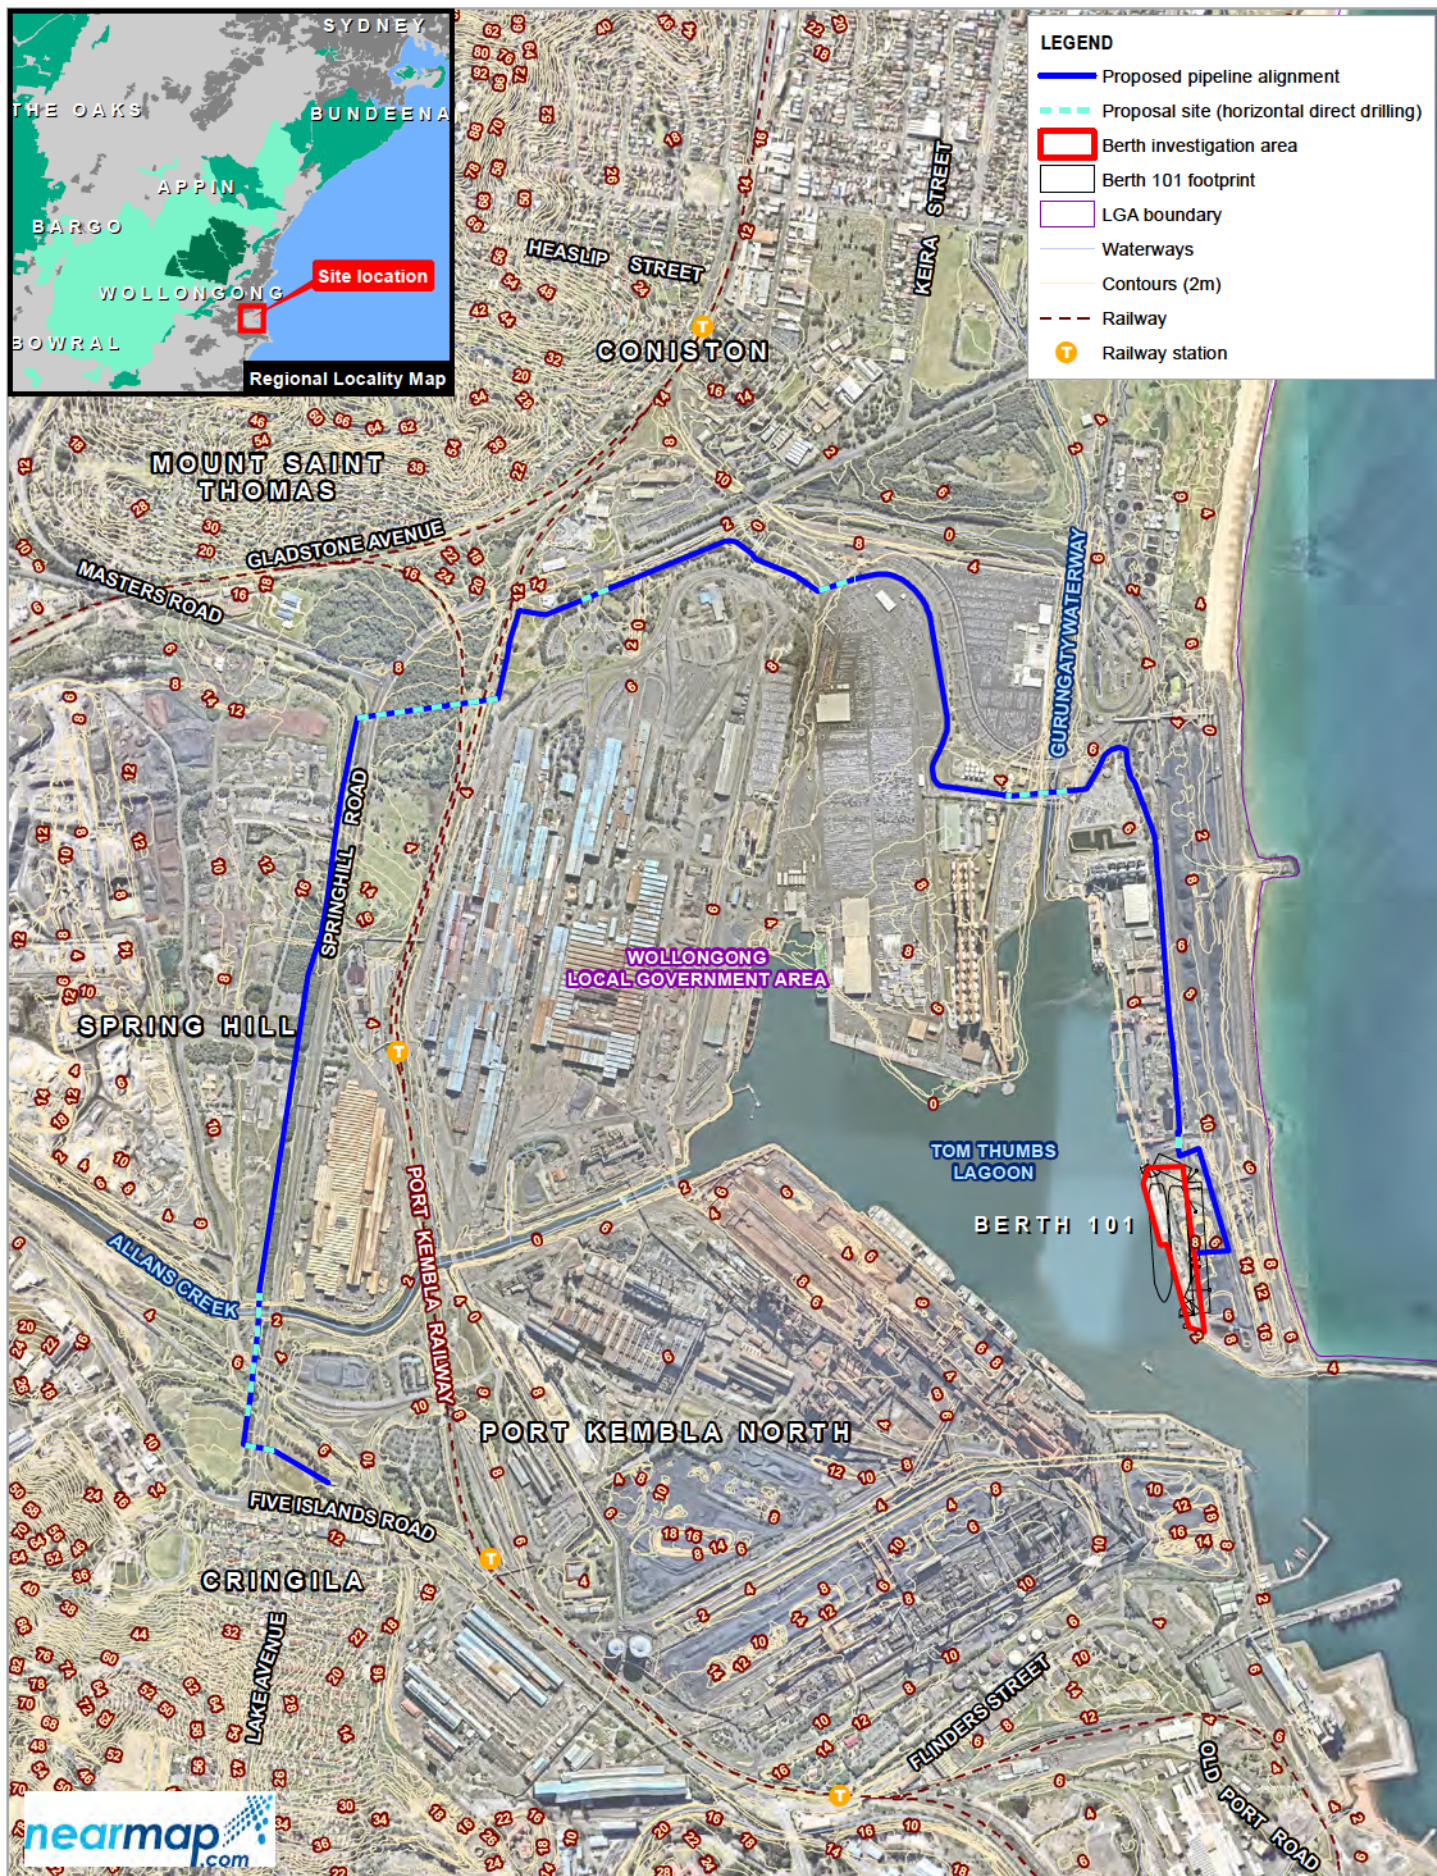
FIGURE 1

Site Location

Site identification details and surrounding land uses are summarised in Table 3-1. The site layout and surrounding areas are shown on Figure 1. For the purposes of this assessment GHD has considered a buffer area of up to 8 m either side of the proposed pipeline route.
